YOUR INSPECTION REPORT

297 St Clair Ave E Toronto, ON

INSPECTION DATE: Wednesday, August 13, 2014

RE: Report No. 44185 297 St Clair Ave E Toronto, ON

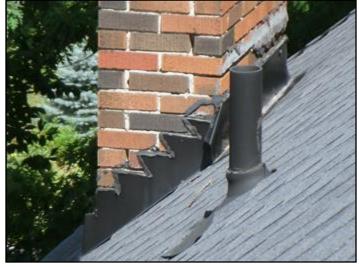
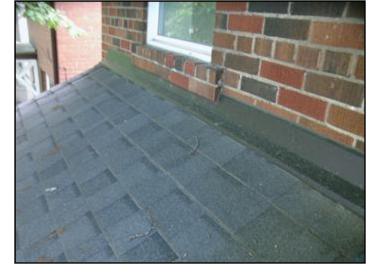
Condition: • Flashings are vulnerable areas Task: Monitor / Improve Time: Regular maintenance

Flashings are vulnerable areas

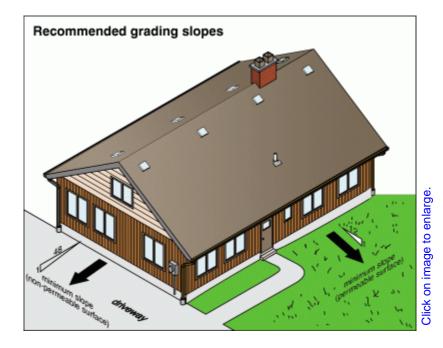
Condition: • The grading around portions of the house is relatively neutral.

Implication(s): When trying to minimize basement leakage, it is always best to be proactive and slope the grades away from the house. Maintain positive slope away from house

Task: Monitor/Improve

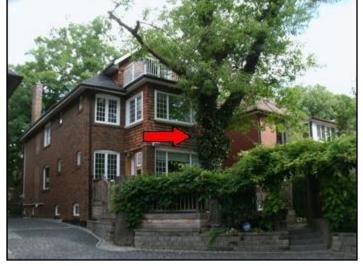
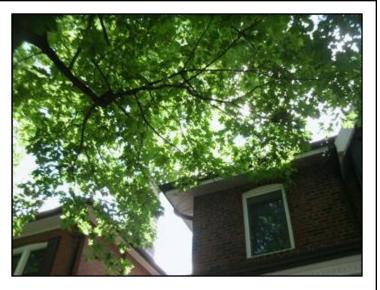
Condition: • <u>Mature tree too close to building</u> Task: Monitor Time: Unpredictable

Mature tree too close to building

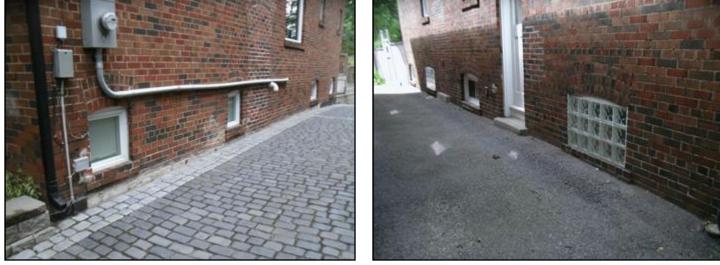
WINDOWS \ Exterior sideCondition: • Sill - clearance inadequate (above exterior grade level)Location: VariousTask: Monitor after heavy stormsTime: Regular maintenance

Sill - clearance inadequate (above exterior...

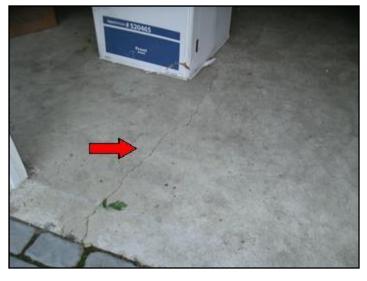
Condition: • Concrete basement, crawlspace and garage floors are not typically part of the structure. Almost all basement, crawlspace and garage concrete floors have minor shrinkage and settlement cracks.

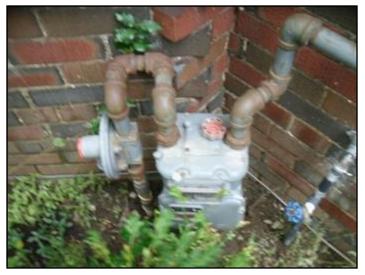
Condition: • No gas tag was found... Task: Provide Time: As required Cost: Minor

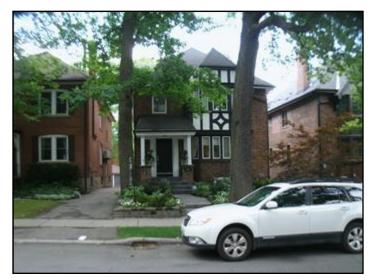
Condition: • A video inspection of the waste plumbing is recommended to determine whether there are tree roots, other obstructions, or damaged pipe. This is common on older properties, especially when mature trees are nearby. This is a great precautionary measure and can help prevent a sewage backup, although many homeowners wait until there are problems with the drains. This Specialty Service can be booked through Carson Dunlop at 1-800-268-7070.

Large trees on front lawn ...

Task: Provide Time: As required Cost: Minor

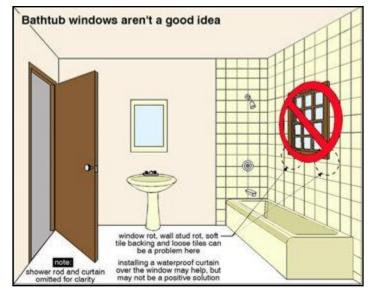
Condition: • Window in bathtub enclosure

Implication(s): Windows in tub enclosures are more prone to water damage. Extra attention should be paid to ensure the area is well sealed and efforts should be made to minimize the amount of water directed at the window.

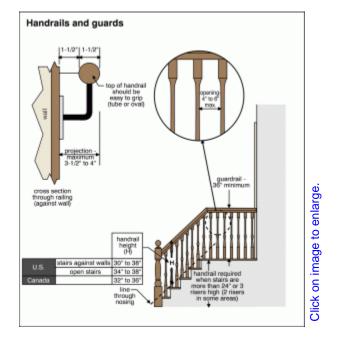
Condition: • Railing missing Location: Basement Task: Provide Time: As required Cost: Depends on approach

Railing missing
