YOUR INSPECTION REPORT

123 Any Street
Anytown, NY 13xxx

Monday, April 11, 2011

Report No. 1010, v.7

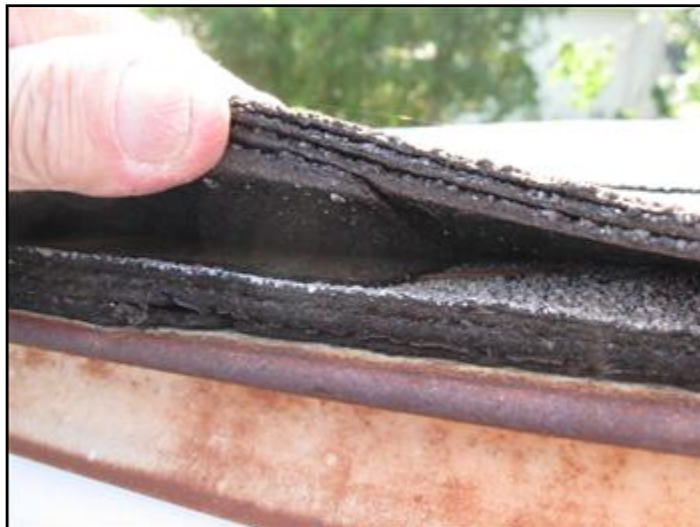
1. Rear roof west

1. Condition: • [Missing, loose or torn](#)

Snow and ice removal??

Implication(s): Chance of water damage to contents, finishes and/or structure

2. Condition: • [Multiple layers](#)

Implication(s): Shortened life expectancy of material

Task: Repair

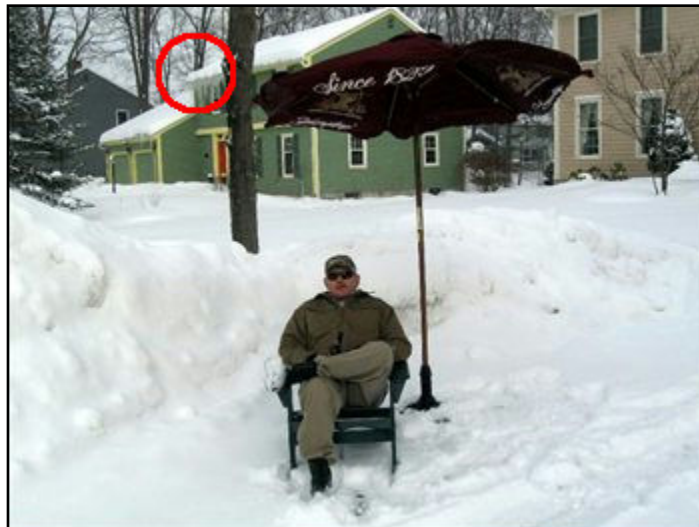
2.

3. Condition: • [Vulnerable to ice damming](#)

Implication(s): Chance of water damage to contents, finishes and/or structure

Task: Further evaluation Improve

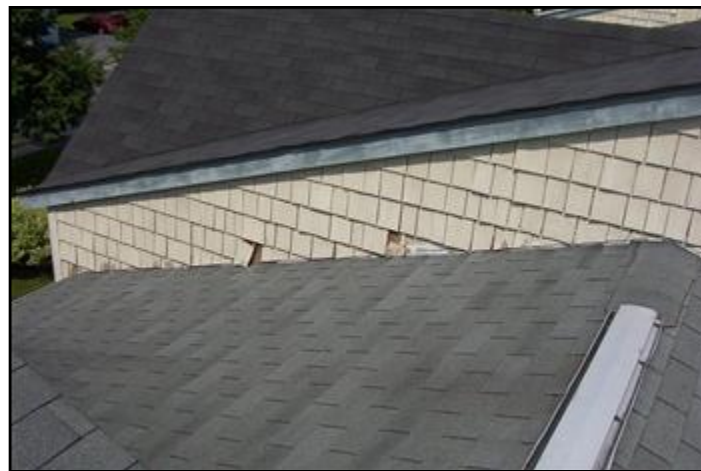
3. West sidewall

5. Condition: • [Siding not cut back](#)

Implication(s): Chance of water damage to contents, finishes and/or structure

Task: Repair

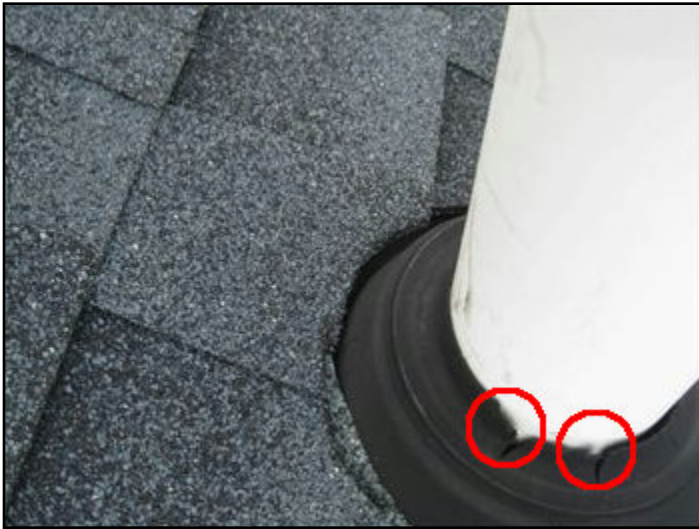
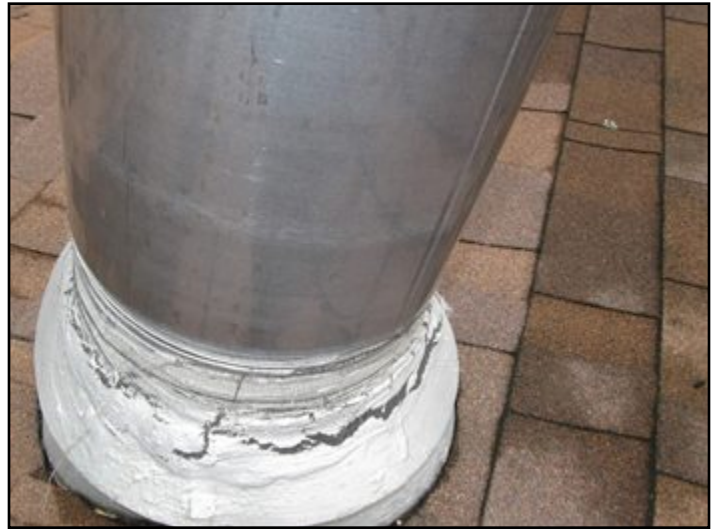
4. South roof

7. Condition: • [Damage](#)

Implication(s): Chance of water damage to contents, finishes and/or structure

Task: Repair

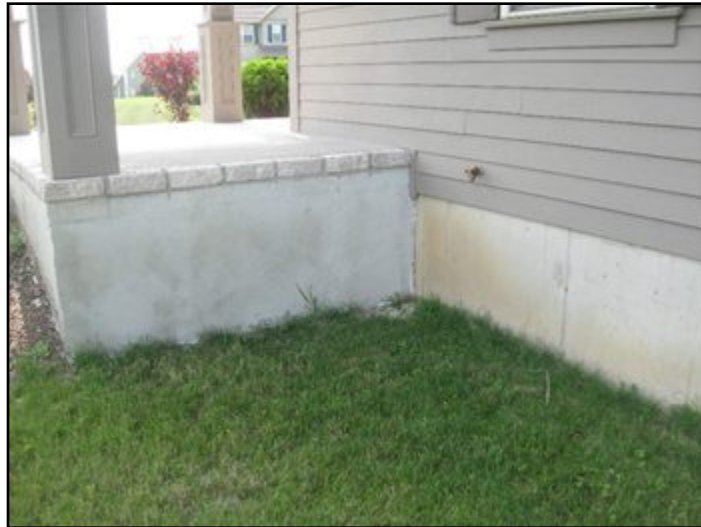
10. North side

10. • Deck/steps guards/railings

30 inches in most jurisdictions

Implication(s): Fall hazard

Task: Repair

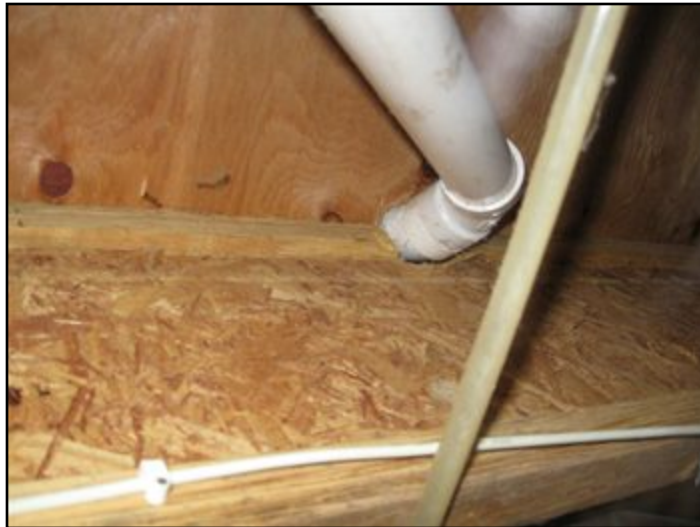
11.

14. Condition: • Cut "I" joist. Check with manufacturer for required repairs

Task: Repair Further evaluation

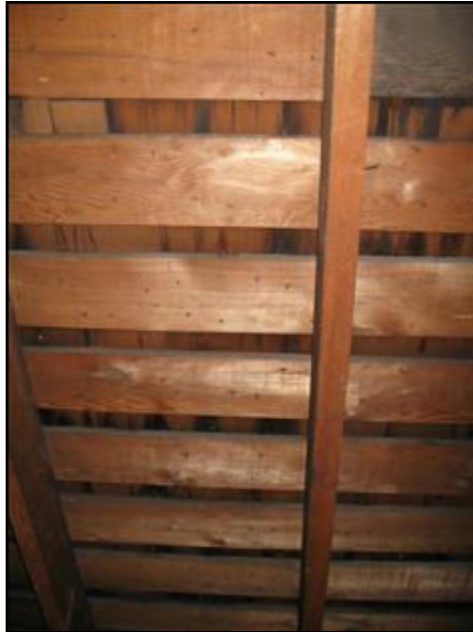
12.

17. Condition: • Roof deck not suitable for asphalt shingles. Manufacturers require T&G boards, osb, plywood etc.

Implication(s): Voids warranty. Leaks, damage to finishing, furnishings

Task: Repair

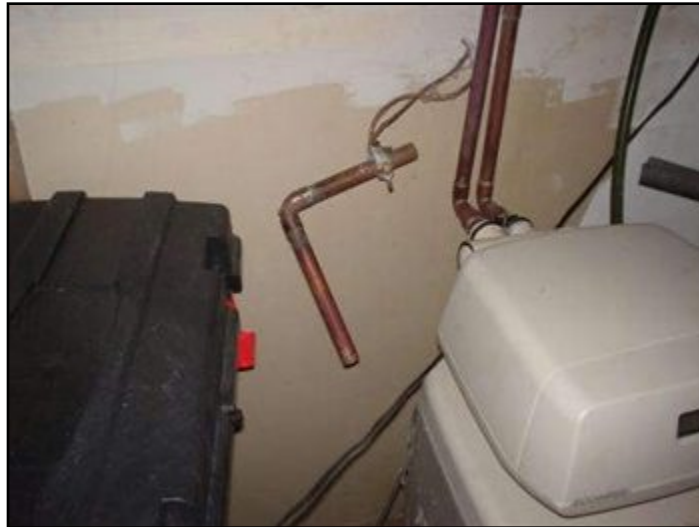
14.

18. Condition: • [Wire attached to abandoned pipe](#)

Implication(s): Electric shock

Task: Repair

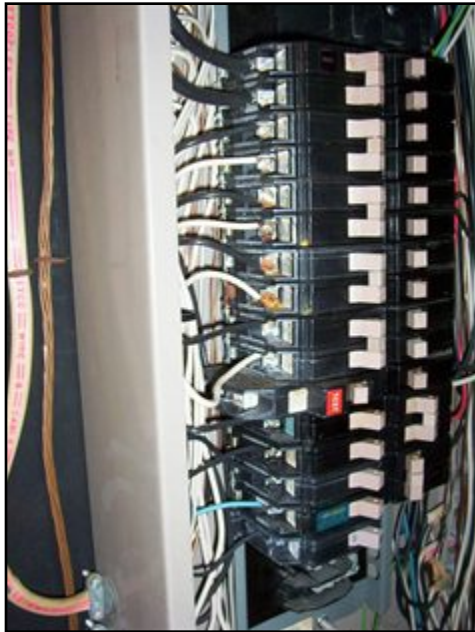
15. Main panel

19. Condition: • [Rust or water in panel](#)

Implication(s): Electric shock | Fire hazard

Task: Repair

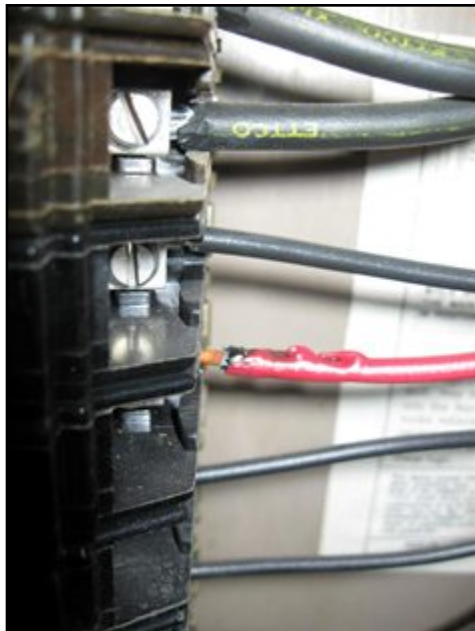
16.

20. Condition: • [Overheating](#)

Implication(s): Fire hazard

Task: Repair

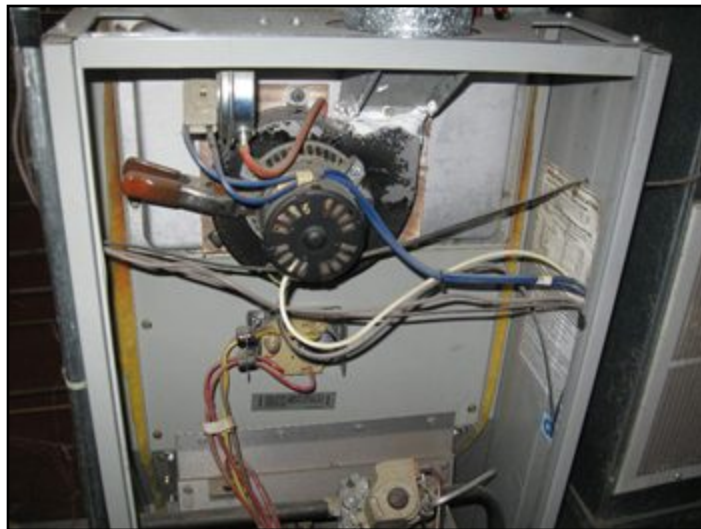
20.

26. Condition: • [Induced draft fan problems](#)

Mounting bolts are broken

Implication(s): Equipment not operating properly | Equipment inoperative | Hazardous combustion products entering home

Task: Repair

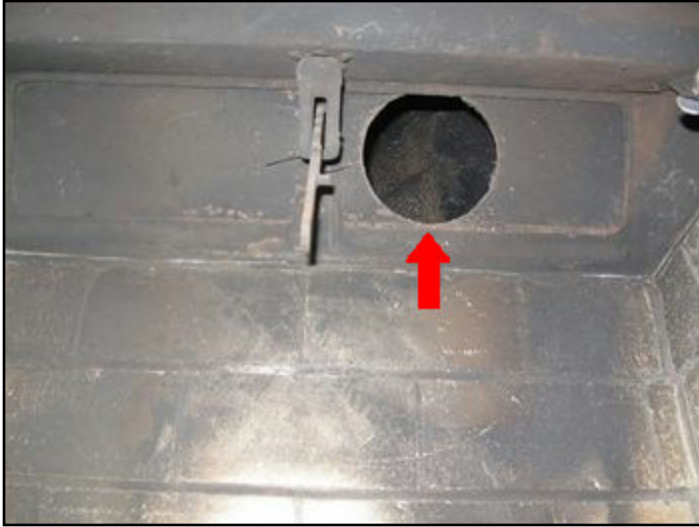
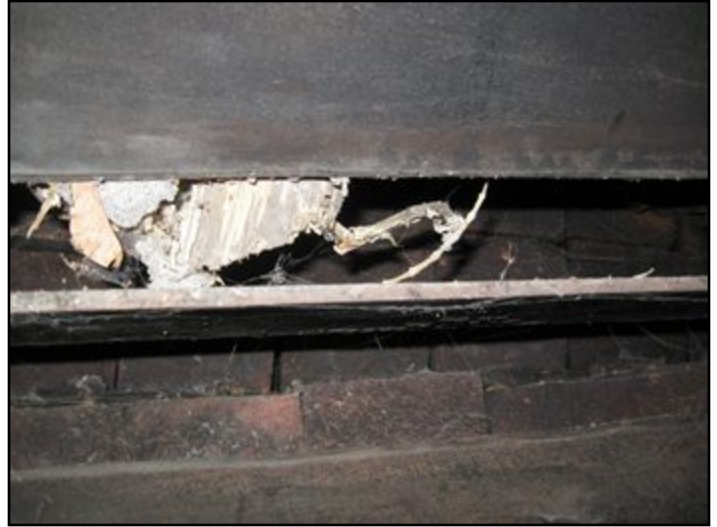
22. Bird parts, etc.

27. Condition: • [Obstructed](#)

Implication(s): Hazardous combustion products entering home

Task: Repair

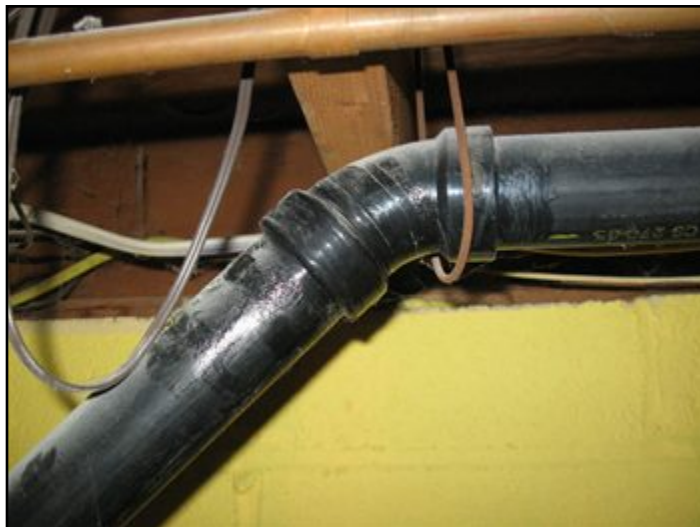
24.

32. Condition: • [Nonstandard materials and patches](#)

Electrical tape repairs

Implication(s): Chance of water damage to contents, finishes and/or structure | Sewage entering the house

Task: Repair

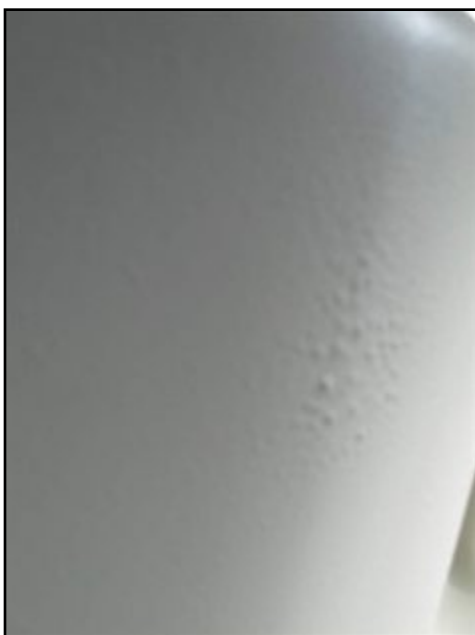
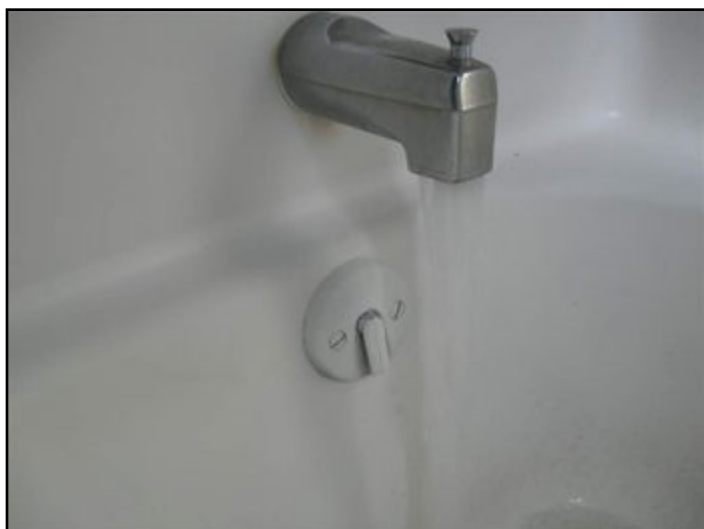
25. Full bath

33. Condition: • [Surface defects](#)

Tub is painted

Implication(s): Cosmetic defects

Task: Repair

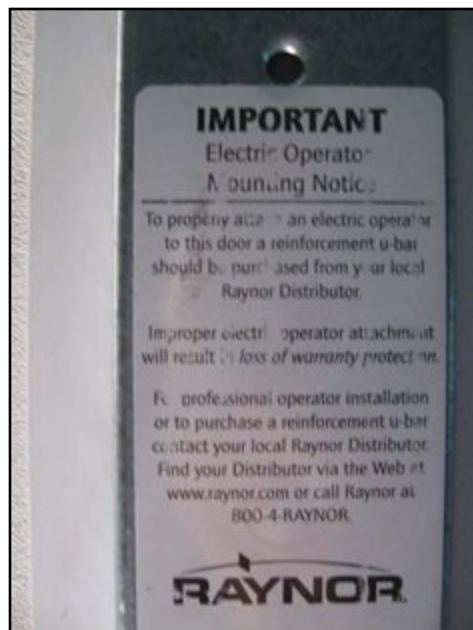
27.

41. Condition: • Door is not reinforced where operator attaches

No reinforcement

Implication(s): Buckled door

Task: Repair
