Your Inspection Report

251 Lukaitis lane.
Duncan, BC

INSPECTION DATE:
Saturday, October 1, 2011

RE: Report No. 1009, v.4
251 Lukaitis lane.
Duncan, BC

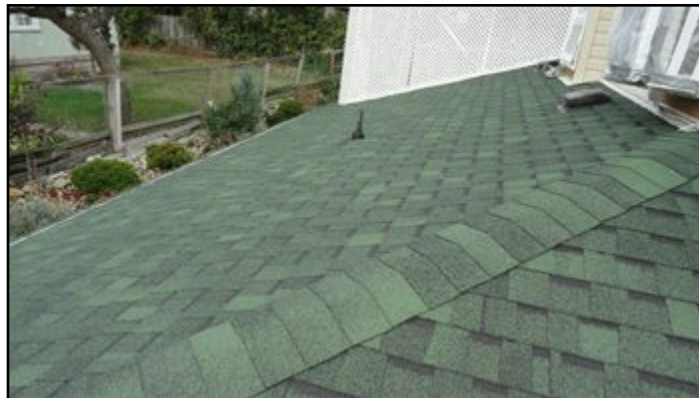
1. • Clean debris off roof and gutters annually

Task: Service annually

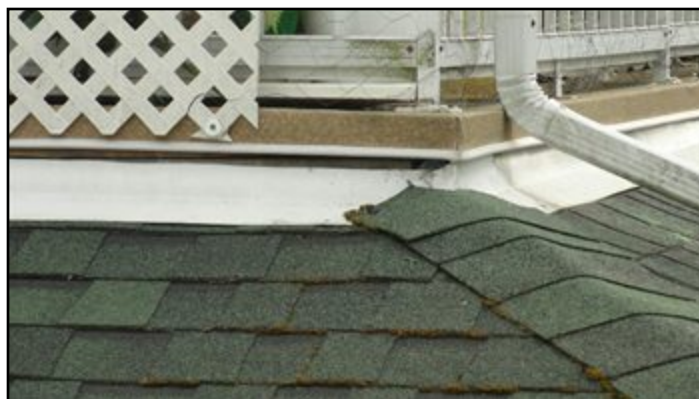
2. **Condition:** • [Vulnerable areas](#)

Poor flashing detail on upper deck does not appear to leak . But wind driven rain could cause leak screw penetrates roof at front of deck .Recommend sealing

Implication(s): Chance of water damage to contents, finishes and/or structure

Task: Improve

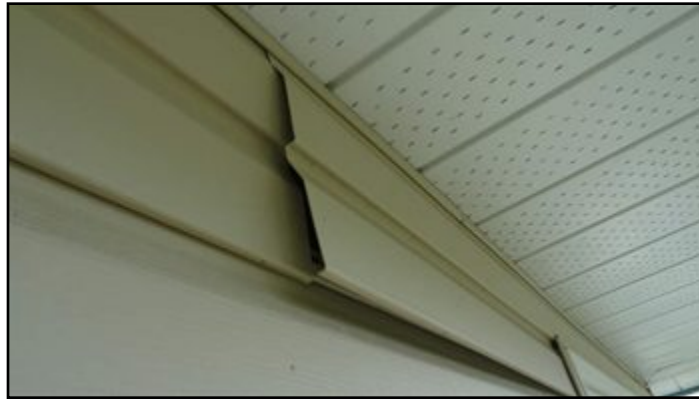
3.

4. **Condition:** • [Loose or missing pieces](#)

Implication(s): Cosmetic defects | Chance of water damage to contents, finishes and/or structure

Location: Southwest

Task: Repair

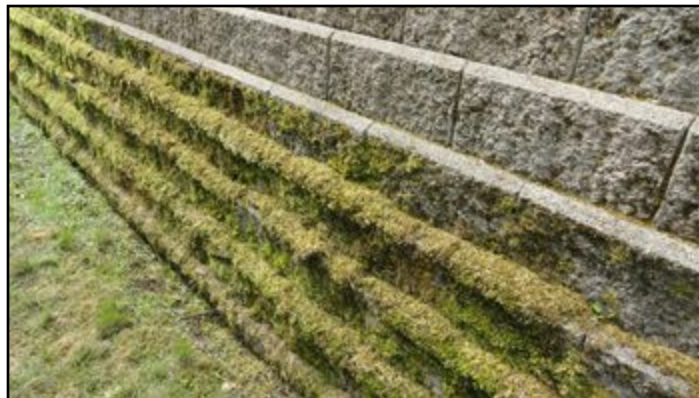
4.

6. Condition: • Retaining wall is moss covered cosmetic only.

Implication(s): Cosmetic.

Task: Clean

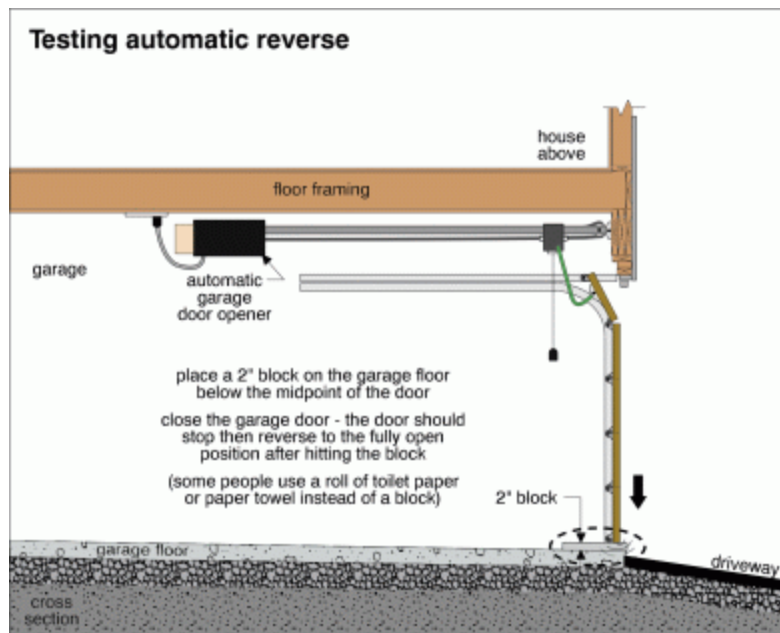
8. Condition: • [Fails to auto reverse](#)

This is a safety issue could result in injury or death auto reverse is not working at all times service needed.

Implication(s): Physical injury

Task: Repair

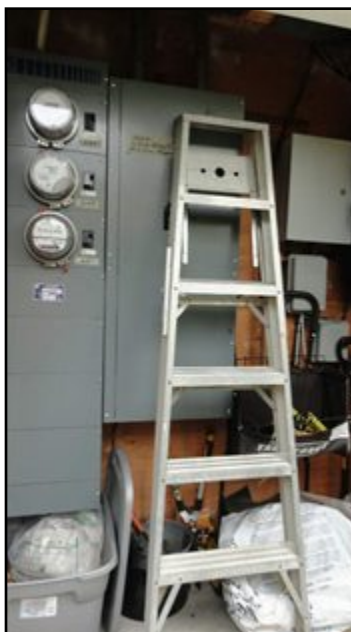
5.

10. Condition: • Hydro room cannot be used as storage. You will need key for access the main disconnect.

Location: Southwest Hydro Room

Task: Improve

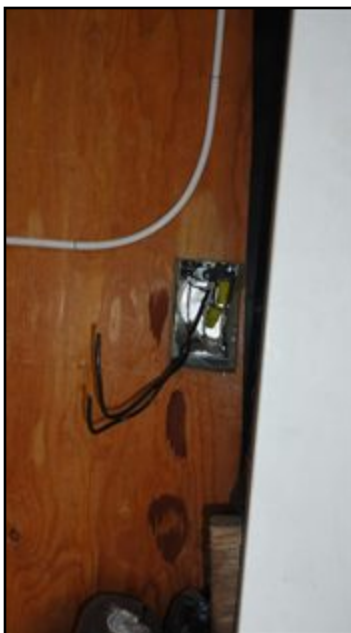
6.

11. Condition: • [Inoperative](#)

No light ever installed in Hydro room in a night emergency this light would be needed to locate main disconnect.

Implication(s): Equipment inoperative

Task: Correct

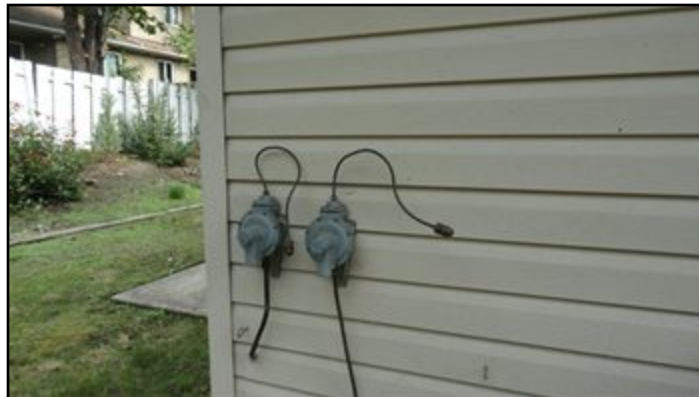
7.

13. • Propane Line

Can not determine which gas regulator services this unit. The resident up stairs has informed me that the line has been cut to install a electric fireplace in her unit. Check if permits were taken out? Hire qualified Gas fitter to determine if fireplace is working and verify that lines have not been tampered with for this unit. Regulator on abandoned fireplace needs to be removed. This is a fire hazard possible explosion may occur if tank is acidently hooked up to wrong regulator.

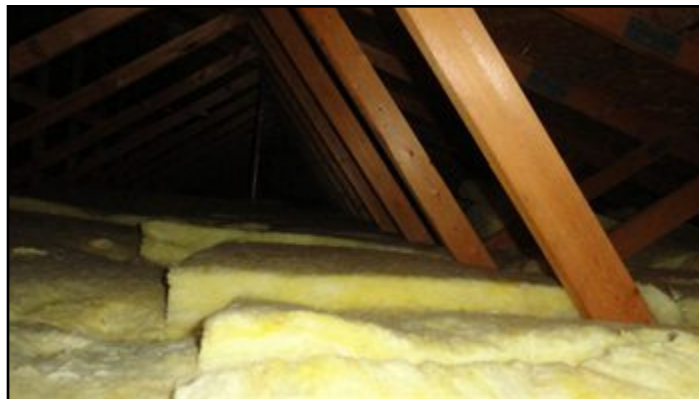
8.

15. Condition: • [Amount less than current standards](#)

Aproximat R 20

Implication(s): Increased heating and cooling costs

Task: Improve

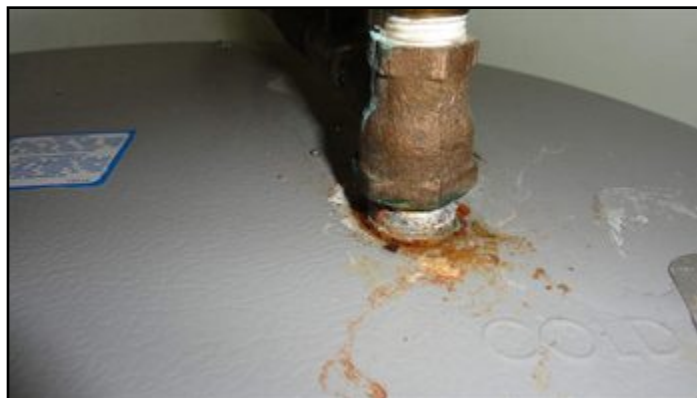
9.

17. Condition: • [Near end of life expectancy](#)

This tank is leaking and need to be replaced before damage is done to structure and contents.

Implication(s): No domestic hot water

Task: Replace
