Your Inspection Report

48 West Avenue
Toronto, ON

INSPECTION DATE:
Thursday, March 5, 2015

Report No. 1009, v.6

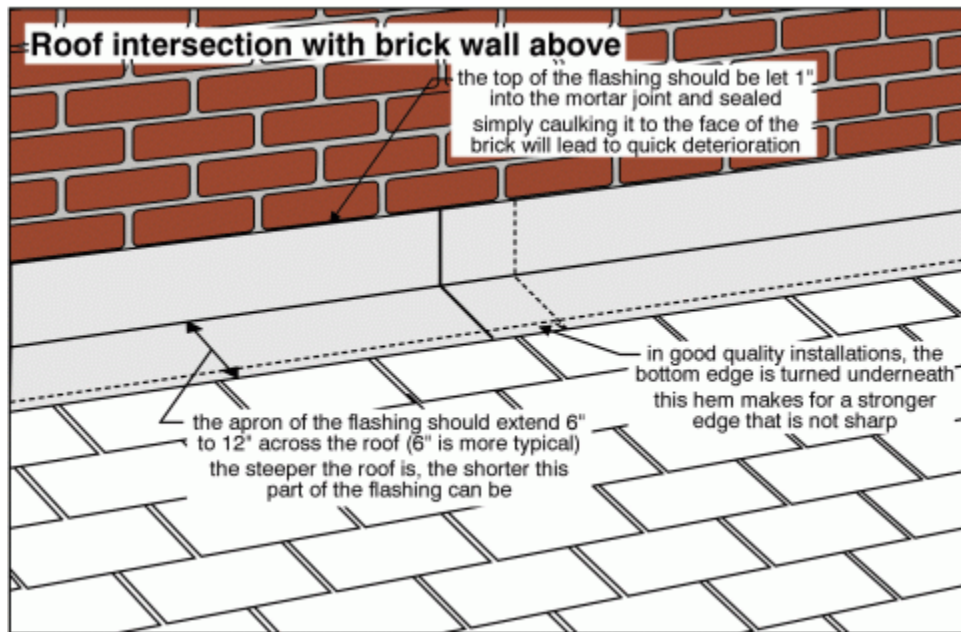
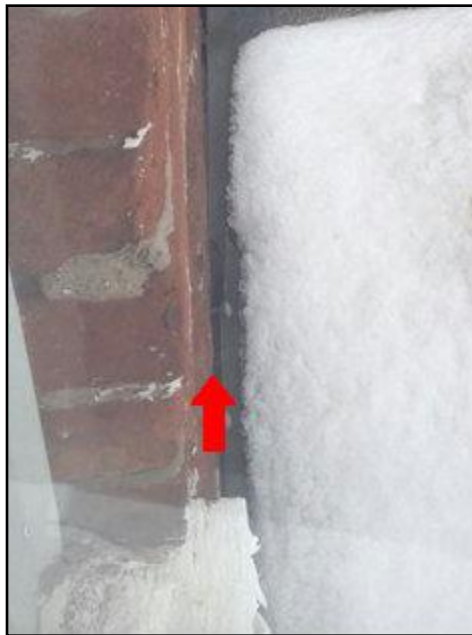
Condition: • [Open at top](#)

Implication(s): Chance of water damage to contents, finishes and/or structure

Location: East Second Floor

Open at top

Task: Repair

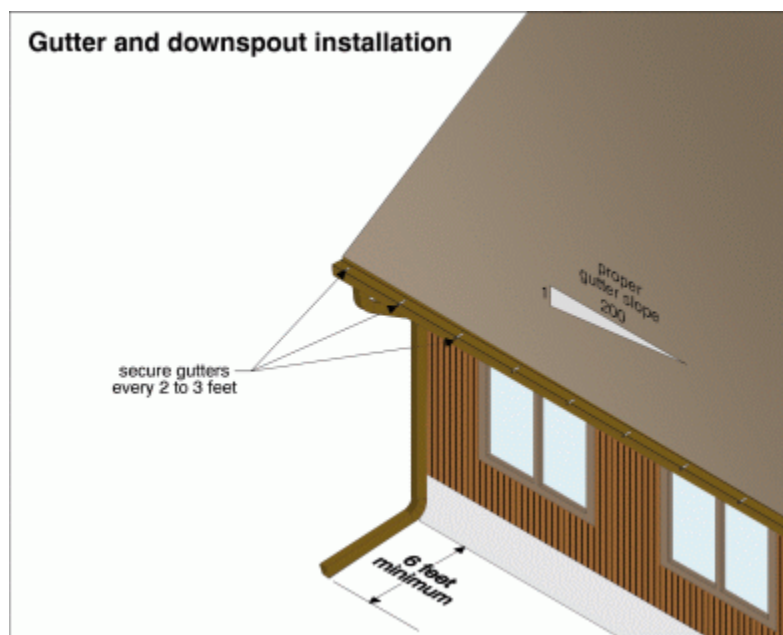
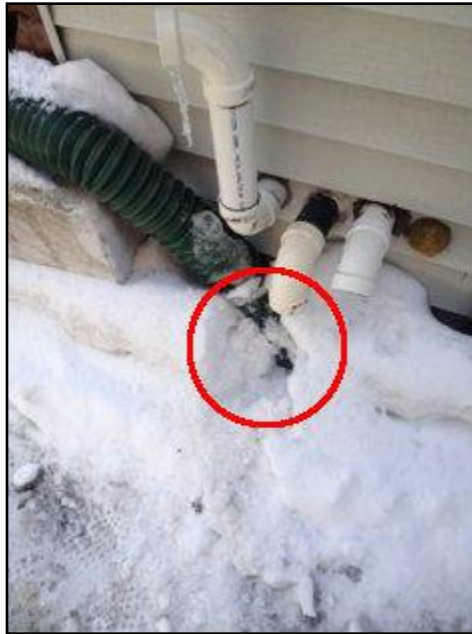
Condition: • [Downspouts end too close to building](#)

Implication(s): Chance of water damage to contents, finishes and/or structure

Location: Northeast

Downspouts end too close to building

Task: Improve

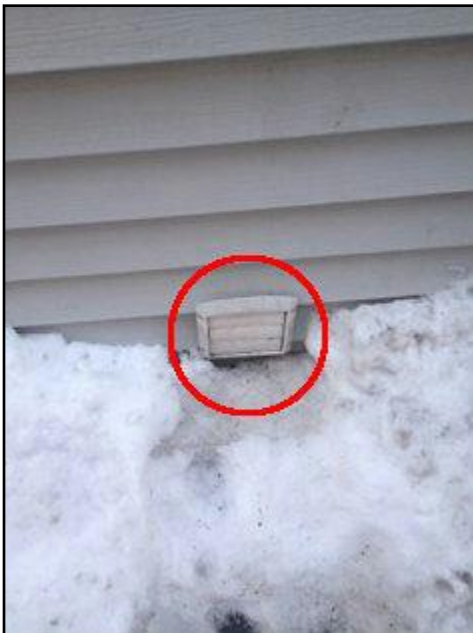
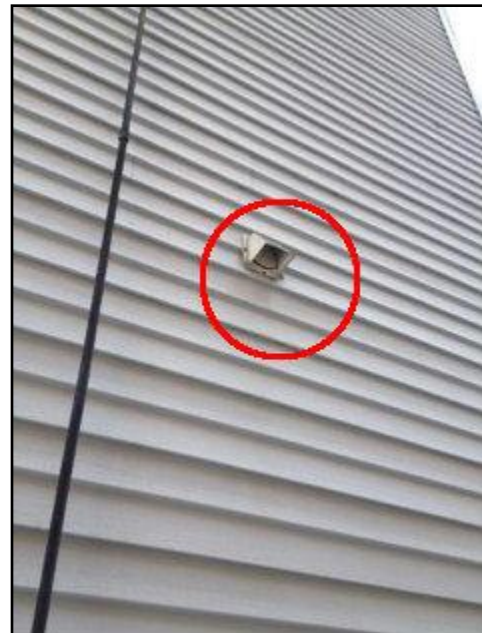
Condition: • [Caulking missing or deteriorated](#)

Location: North

Caulking missing or deteriorated

Task: Provide

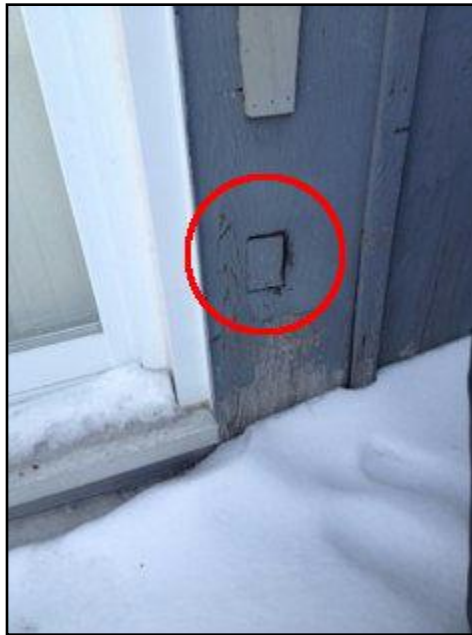
Condition: • Seal patch

Location: West

Task: Repair

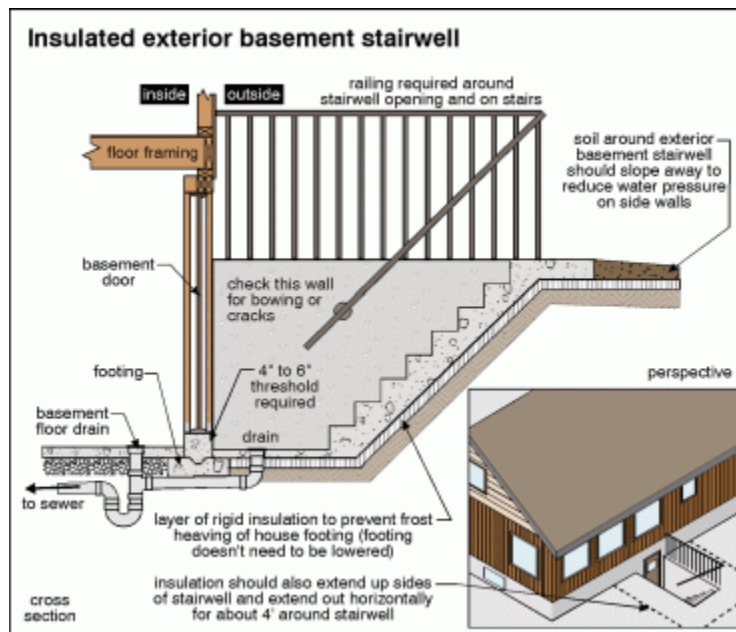
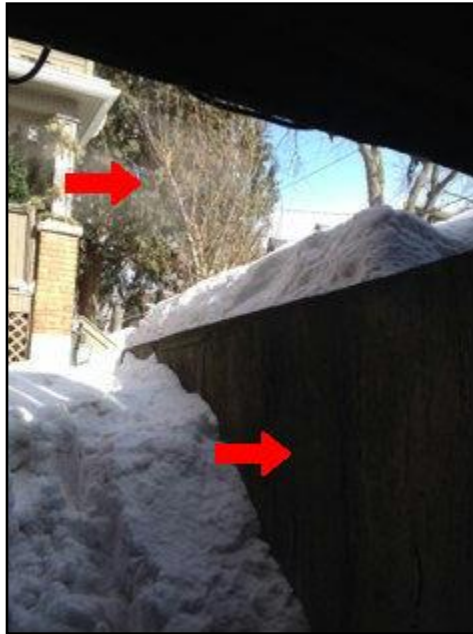
Condition: • [Guard and handrail problems](#)

Implication(s): Fall hazard

Guard and handrail problems

Task: Provide

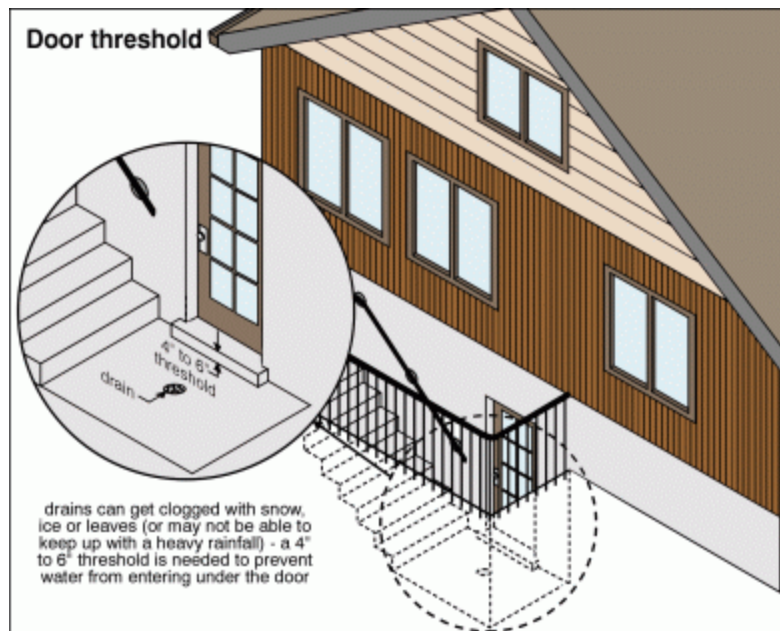
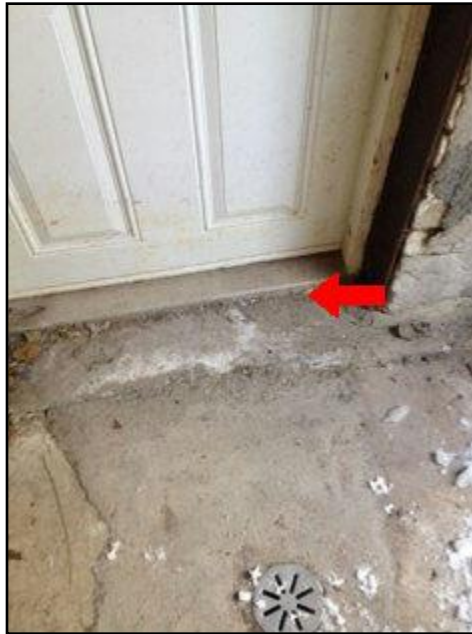
Condition: • [Door threshold missing, too low, not watertight](#)

Implication(s): Chance of water damage to contents, finishes and/or structure

Door threshold missing, too low, not...

Task: Improve

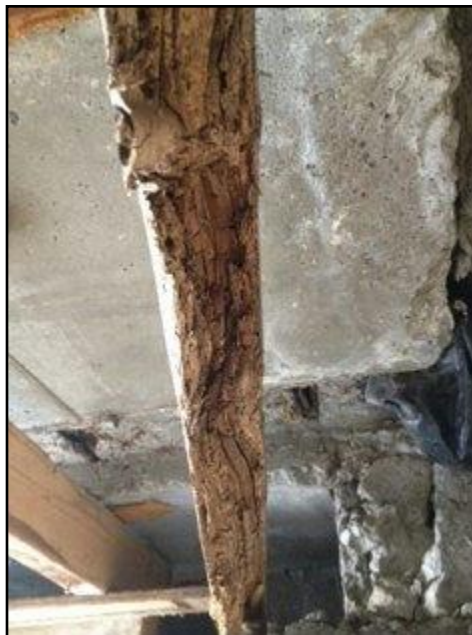
Condition: • [Insect damage](#)

Possible termite damage was found on some non-supporting joists under the front porch. This appears to be old damage. The activity does not appear to have spread to the interior, however a professional termite inspection should be conducted.

Location: South

Insect damage

Task: Further evaluation

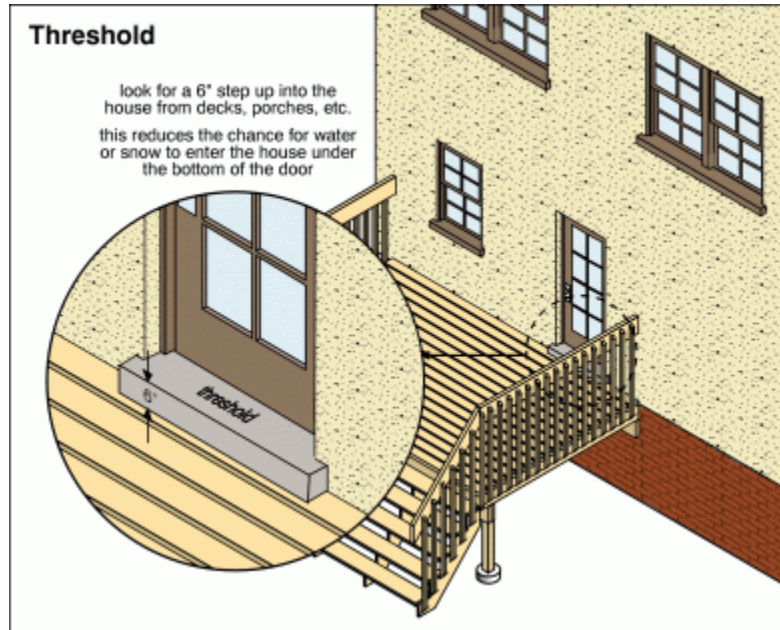
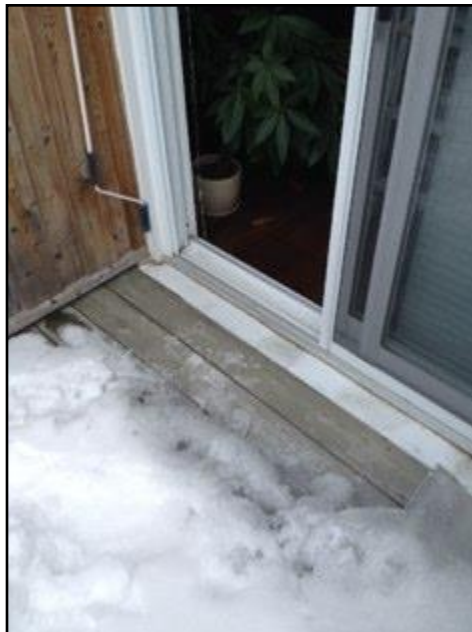
Condition: • [No step up into building](#)

Location: Third Floor

No step up into building

Task: Improve

Time: Next rebuild of deck

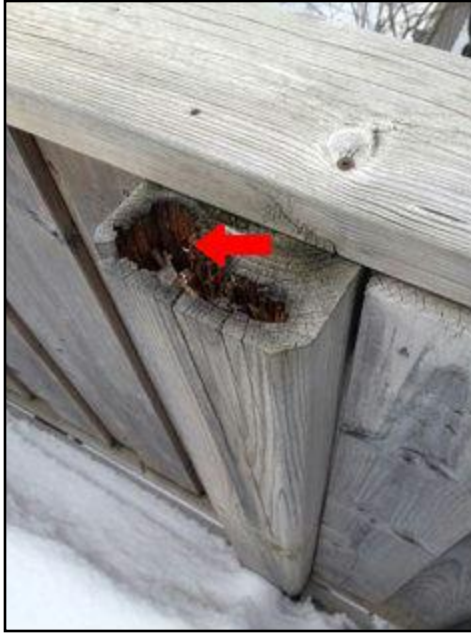
Condition: • Rot

Location: West Third Floor

Rot

Task: Repair

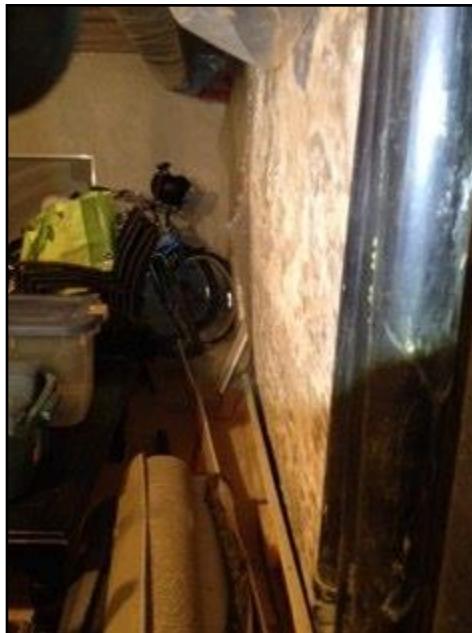
Condition: • [Bowed, bulging or leaning](#)

The appearance of minor bowing may be the result of the application of the parging (cement coating on foundation wall). There are no other indications of this being a structural issue.

Location: Northwest Basement

Possible bowing

Task: Monitor

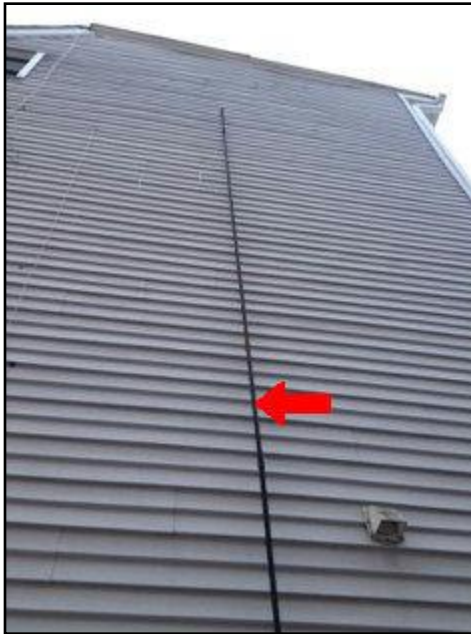
Condition: • Secure conduit to wall.

Location: North

Secure conduit

Task: Improve

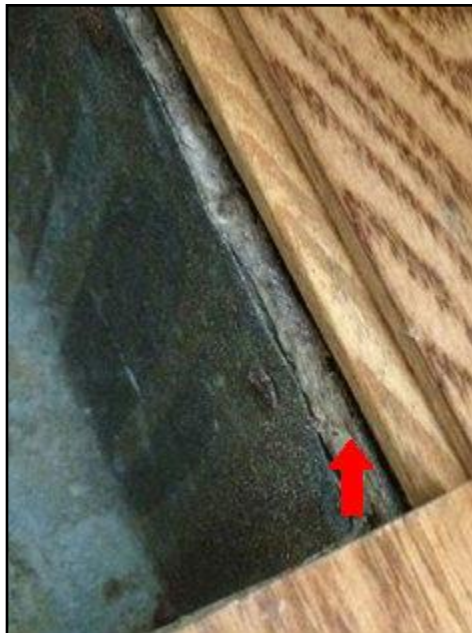
Condition: • Possible asbestos insulation around heating ducts.

One inch insulation bands or gaskets surround two ducts - 1 in the living room and 1 at the front entrance. These bands may contain asbestos. The bands can be encapsulated with tape or sealant. Alternatively then can be removed (\$100 - \$200).

Possible asbestos insulation around heating...

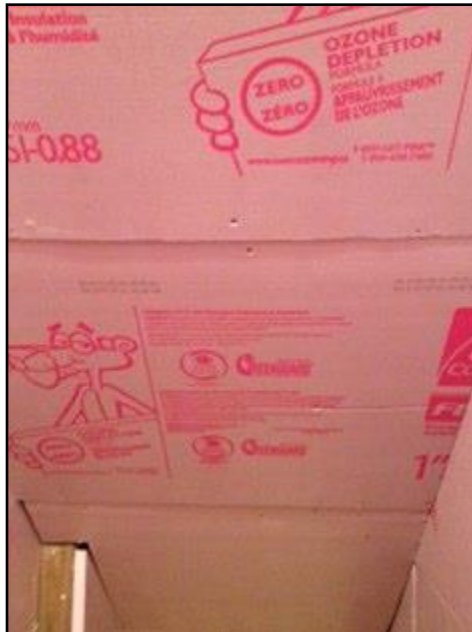
Condition: • [Exposed combustibile insulation](#)

The plastic board insulation is mounted to interior surfaces and the party wall, and therefore not serving a thermal protection function. The easiest solution is removal.

Implication(s): Increased fire hazard

Exposed combustibile insulation

Task: Correct

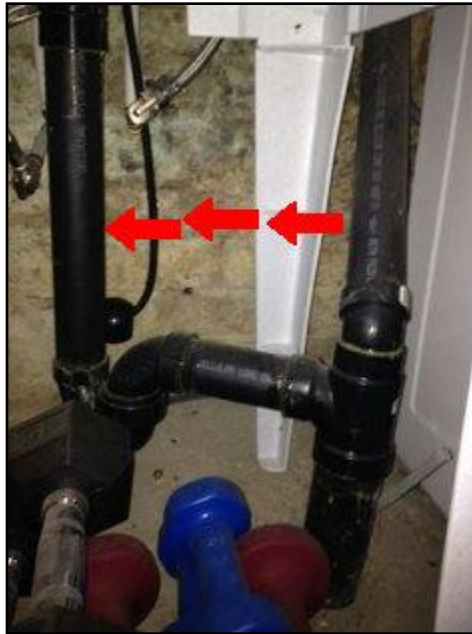
Condition: • [Missing](#)

Implication(s): Sewer gases entering the building

Drain on wrong side of trap

Laundry drain should tie into sink drain upstream of the trap.

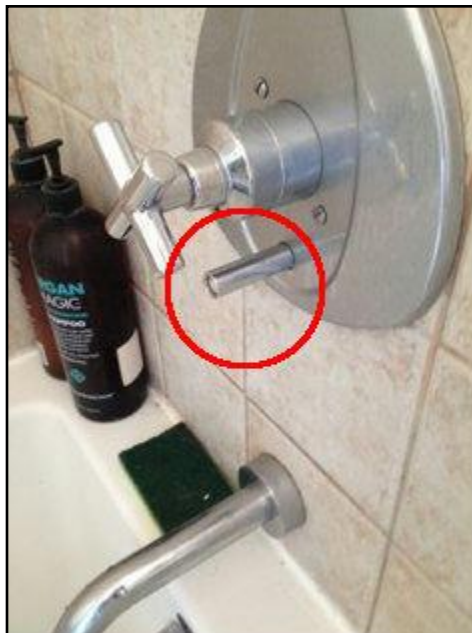
Condition: • [Shower diverter inoperative or defective](#)

Diverter is stuck in the shower position.

Implication(s): Equipment failure

Shower diverter inoperative or defective

Task: Repair

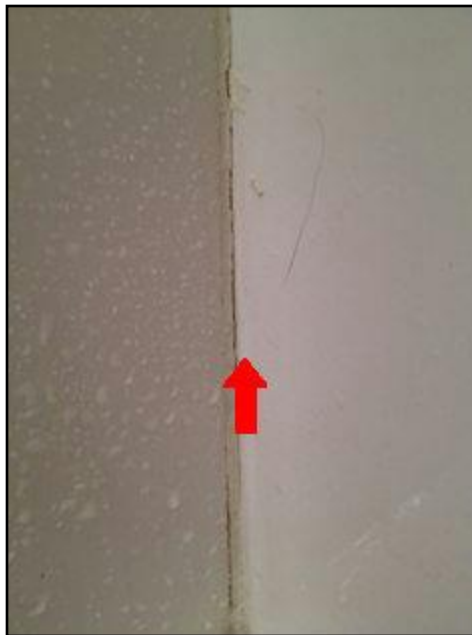
FIXTURES AND FAUCETS \ Bathtub**Condition:** • [Caulking loose, missing or deteriorated](#)**Implication(s):** Chance of water damage to contents, finishes and/or structure**Location:** First Floor Bathroom**Task:** Improve**Time:** Immediate**Cost:** Minor

Caulking loose, missing or deteriorated

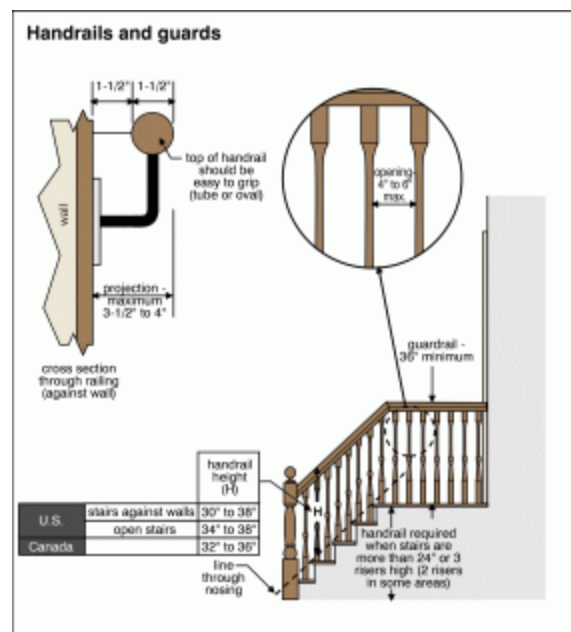
Condition: • [Missing](#)

Implication(s): Fall hazard

Location: Basement & Second Floor Staircase

Task: Provide

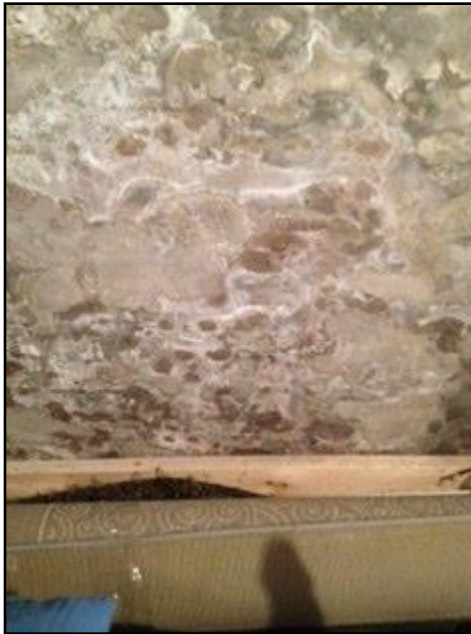
Condition: • [Water marks](#)

Implication(s): Cosmetic defects | Chance of water damage to contents, finishes and/or structure

Location: Northwest Basement

Water marks

Investigate roof drainage, downspout discharge and driveway grading when snow is gone. Read section 10 in the interior section of the reference guide at the end of this report for more information.
