Your Inspection Report

Sample Street
Atlanta, GA 12345

INSPECTION DATE:
Tuesday, December 18, 2012

Home Probe, Inc.
The Home Inspection Company

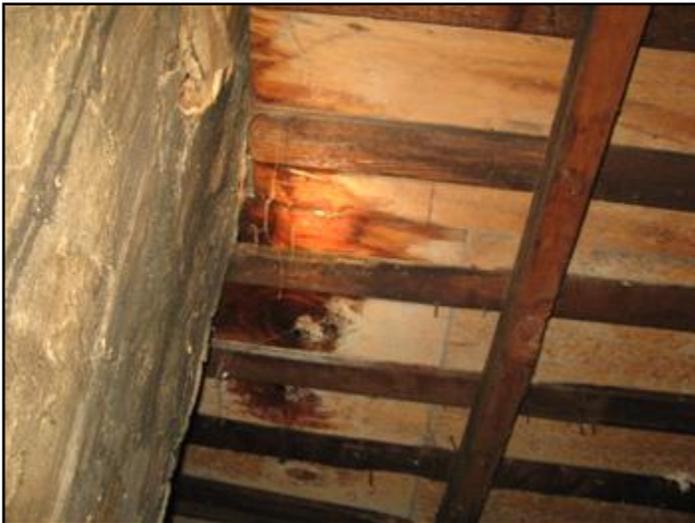
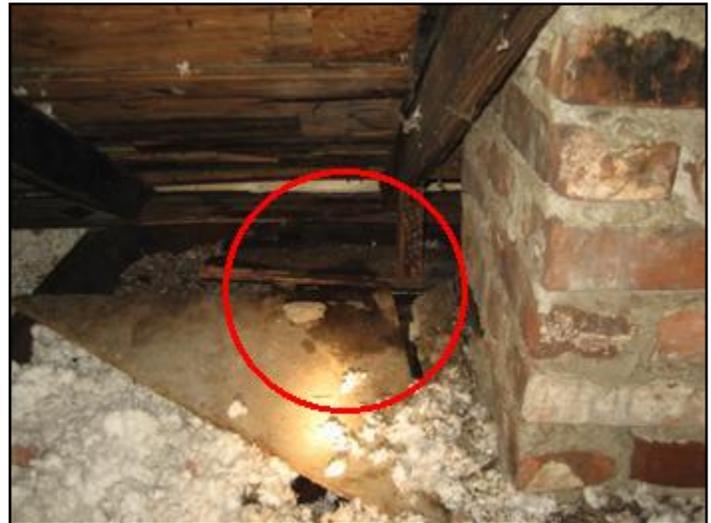
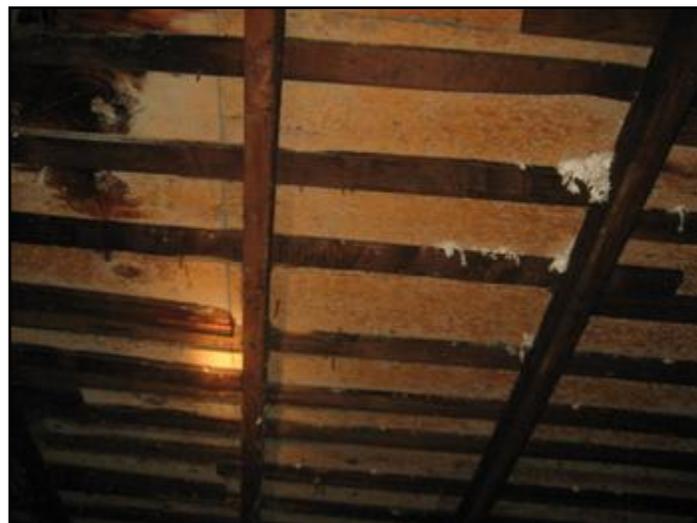
1. Condition: • [Leak](#)

Implication(s): Chance of water damage to contents, finishes and/or structure

Location: Attic at Chimneys

Task: Correct

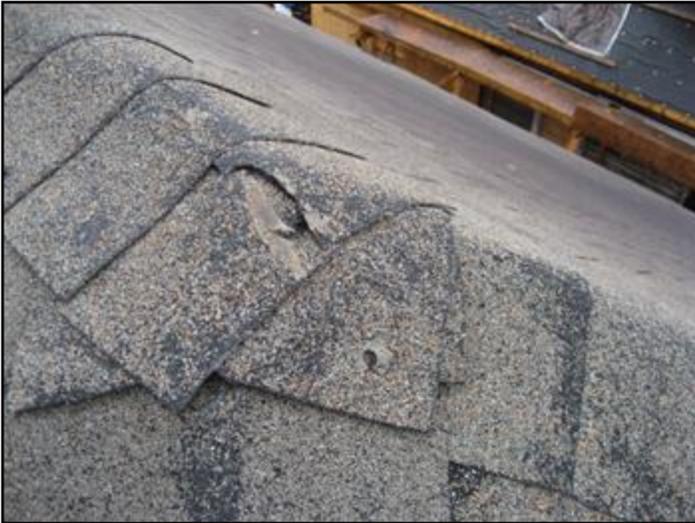
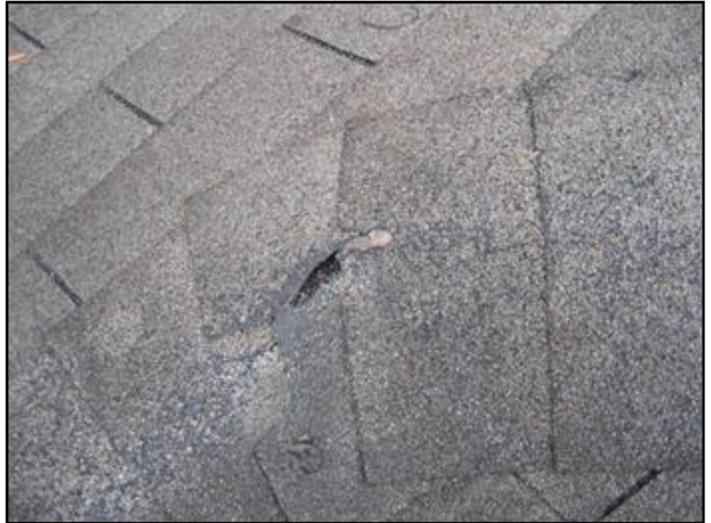
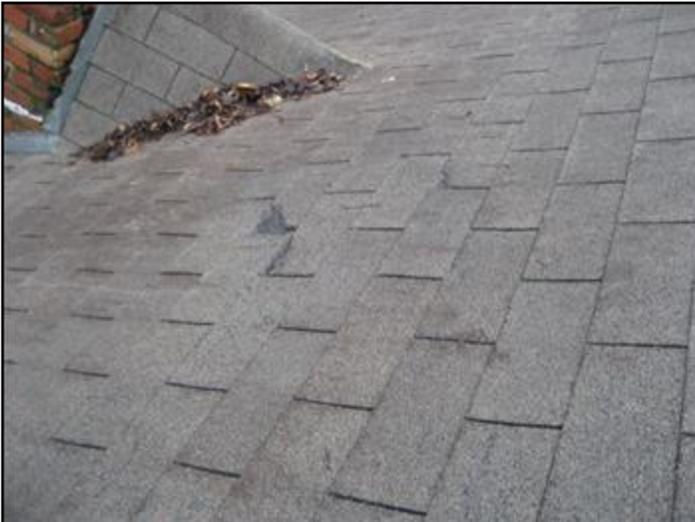
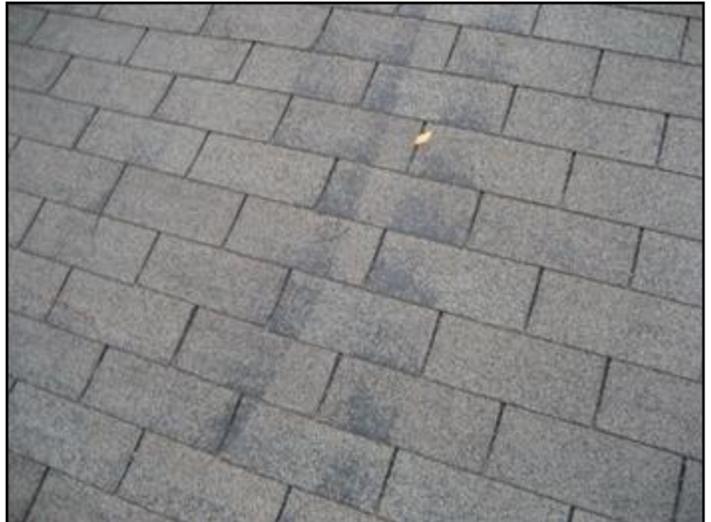
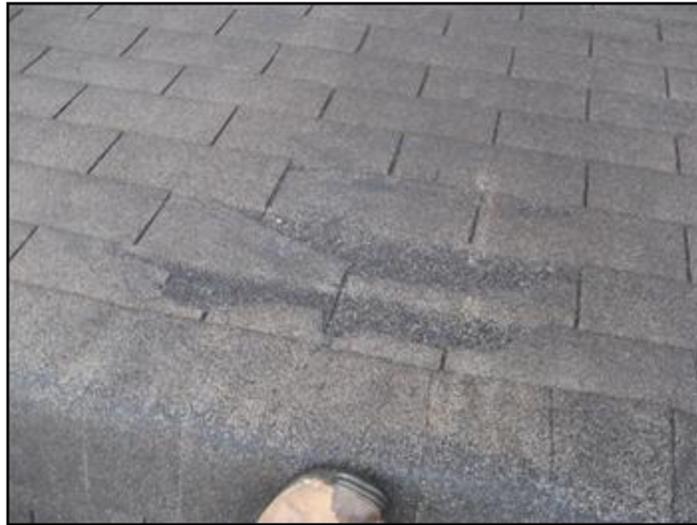
2. Condition: • [Old, worn out](#)

Implication(s): Chance of water damage to contents, finishes and/or structure

Location: Throughout Exterior Roof

Task: Replace

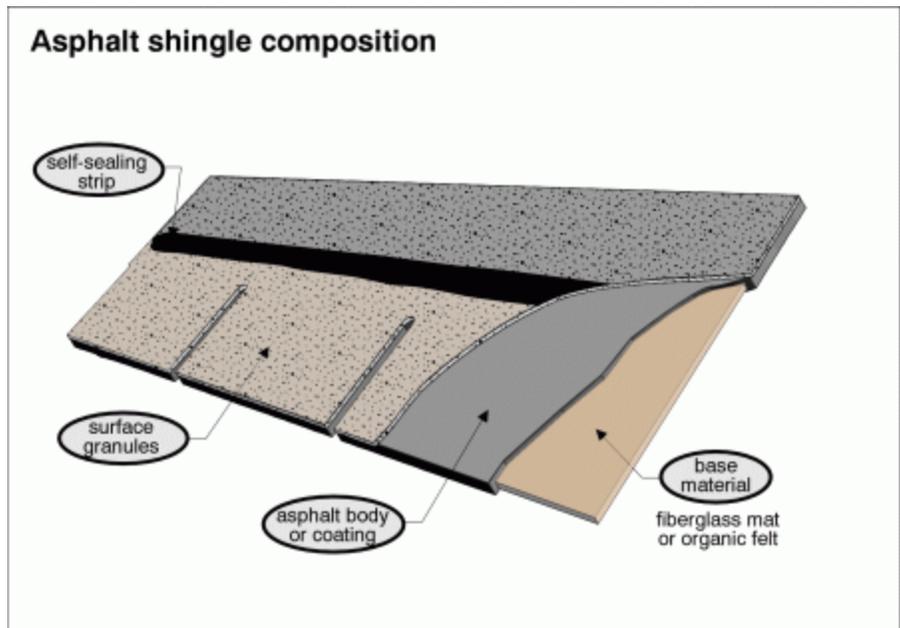
3. Condition: • [Granule loss](#)

Implication(s): Chance of water damage to contents, finishes and/or structure

Location: Throughout Exterior Roof

Task: Replace

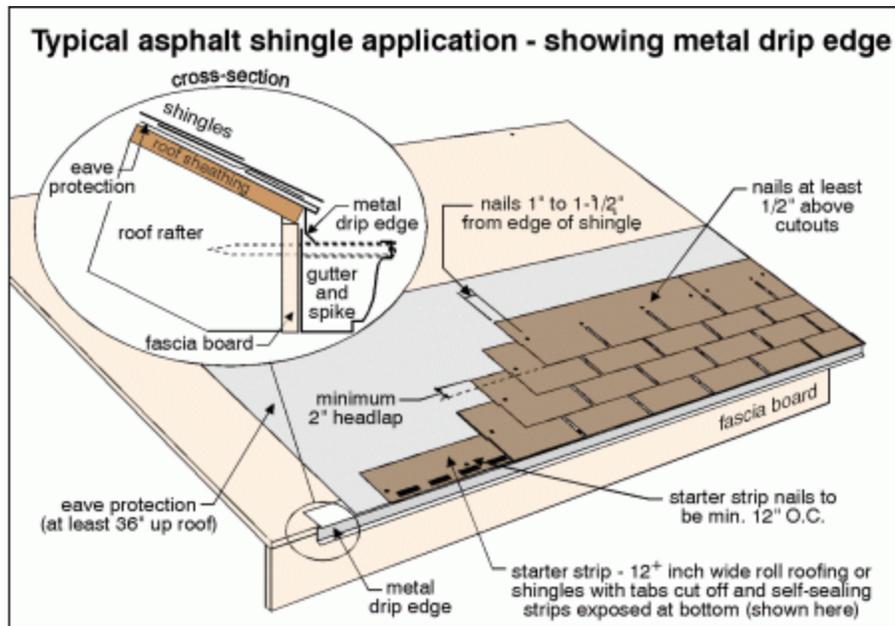
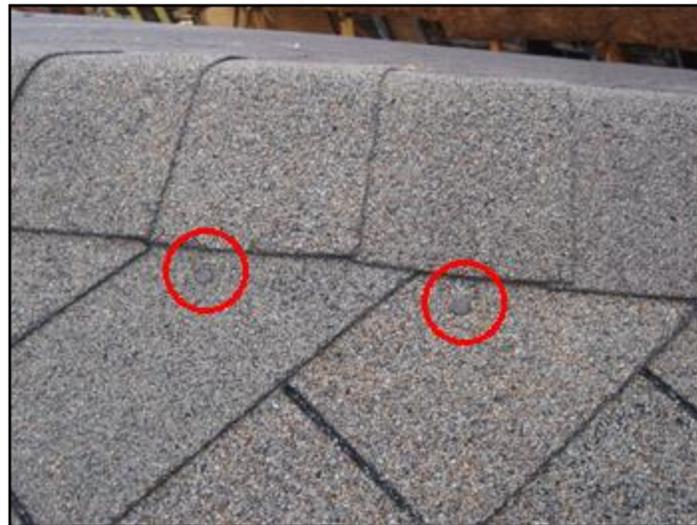
5. Condition: • [Exposed fasteners](#)

Implication(s): Chance of water damage to contents, finishes and/or structure

Location: Throughout Exterior Roof

Task: Correct

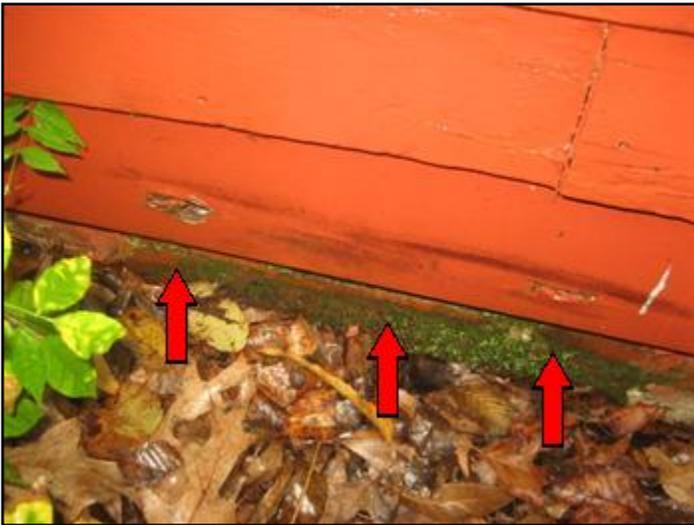
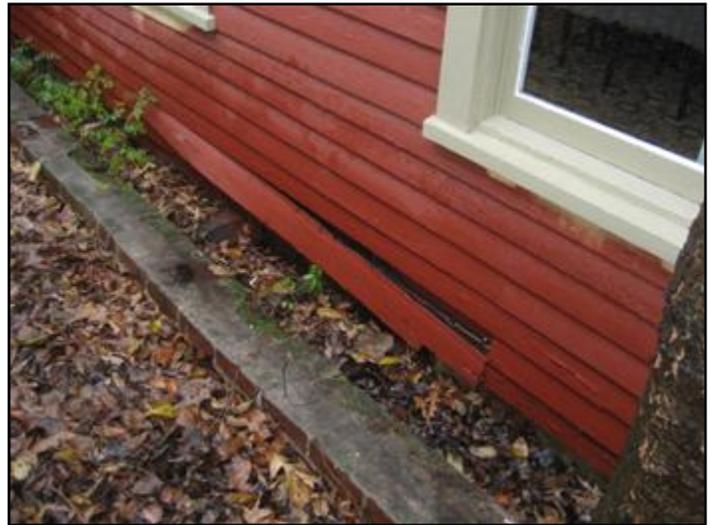
6. Condition: • [Rot or insect damage](#)

Implication(s): Cosmetic defects | Chance of water damage to contents, finishes and/or structure | Material deterioration

Location: Left Side Exterior Wall

Task: Repair or replace

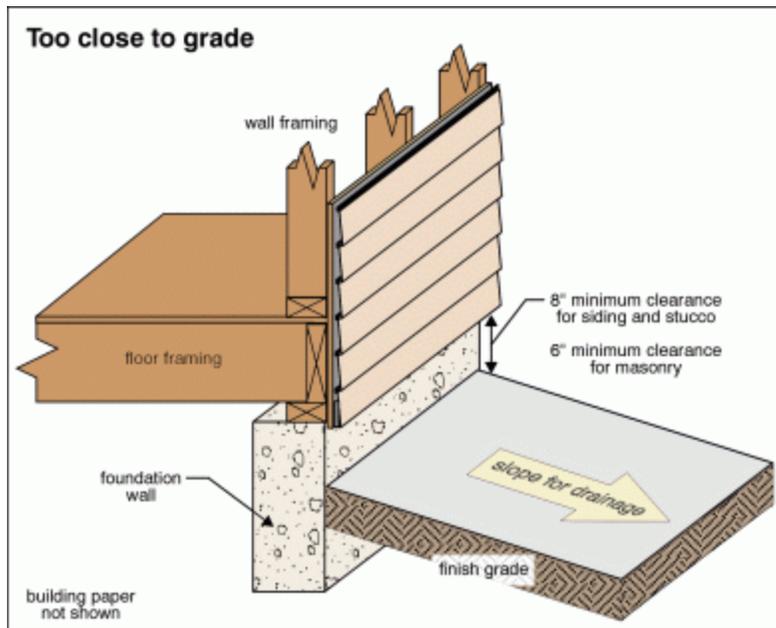
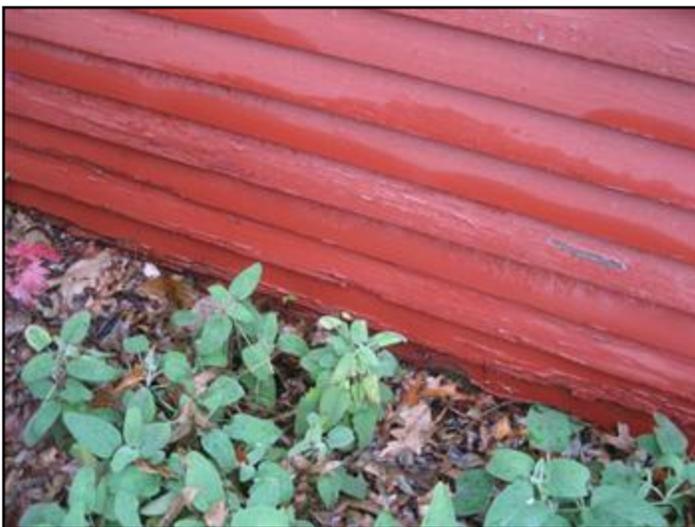
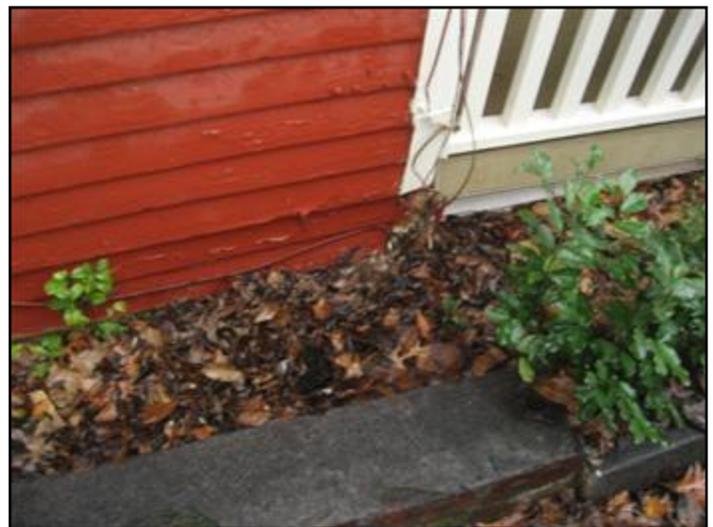
7. Condition: • [Too close to grade](#)

Implication(s): Chance of water damage to contents, finishes and/or structure | Material deterioration | Rot | Insect damage

Location: Left Side Exterior Wall

Task: Improve

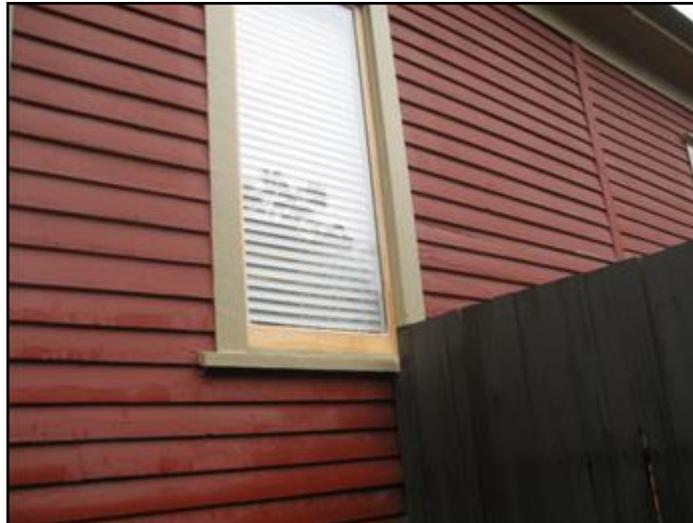
8. Condition: • [Paint or stain needed](#)

Implication(s): Chance of water damage to contents, finishes and/or structure | Material deterioration

Location: Right Side Exterior Master Bathroom

Task: Provide

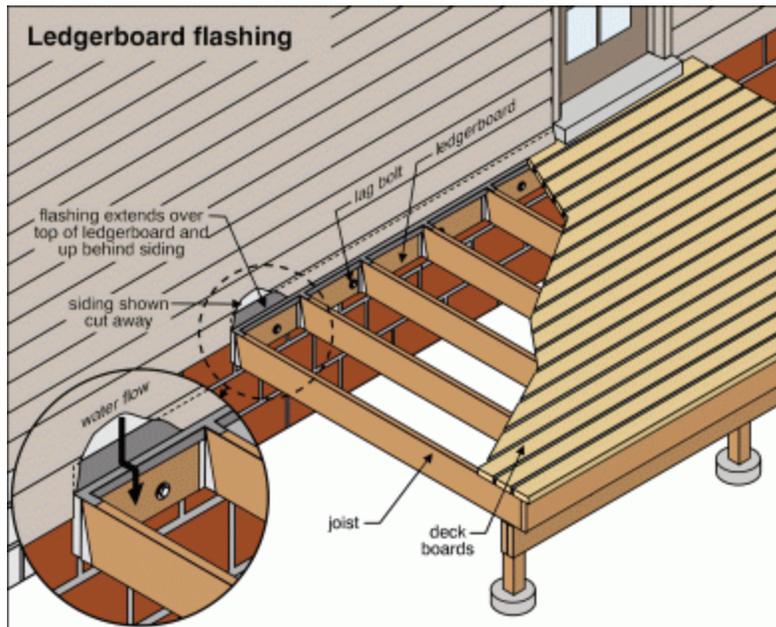
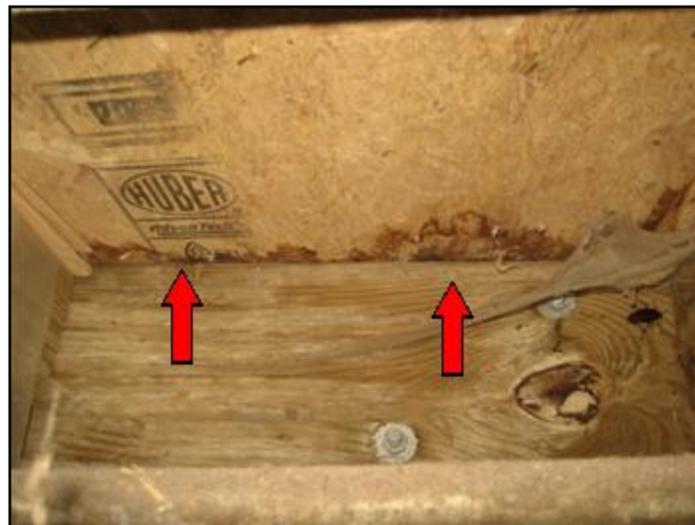
9. Condition: • [Ledgerboard problems](#)

Implication(s): Weakened structure | Chance of movement

Location: Rear Exterior Deck

Task: Improve

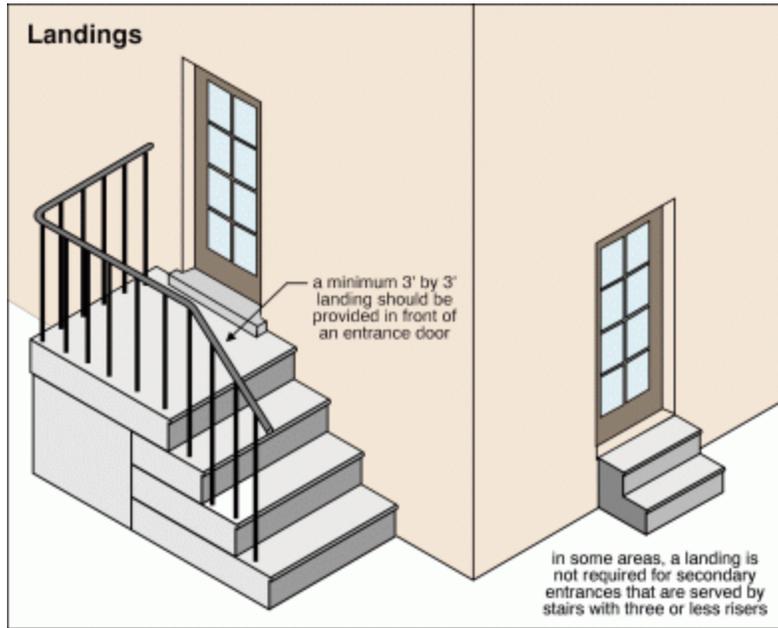
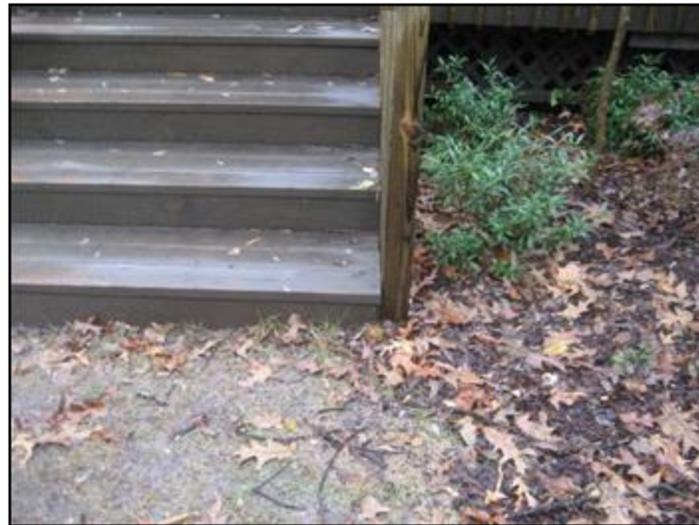
10. Condition: • [Landings missing or undersized](#)

Implication(s): Trip or fall hazard

Location: Rear Exterior Deck

Task: Provide

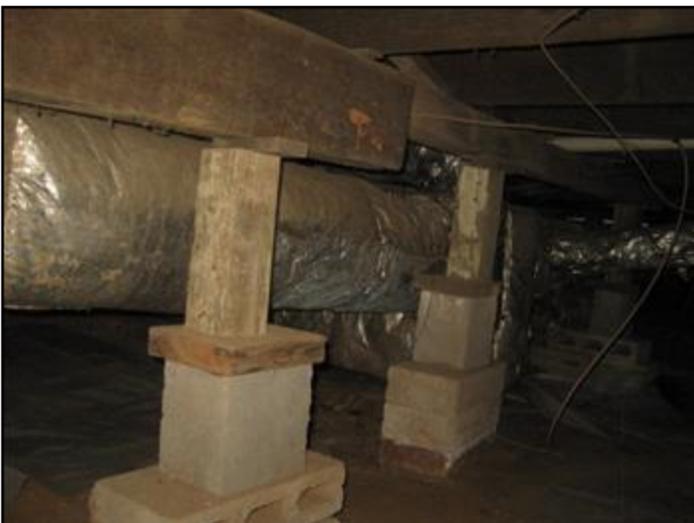
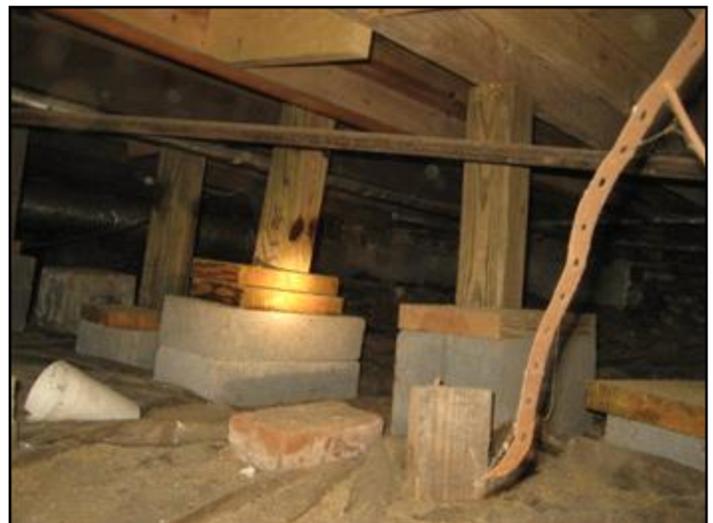
11. Condition: • There are multiple temporary supports installed in the crawlspace that should be replaced with permanent supports.

Location: Throughout Crawl Space

Recommend consulting a qualified framing contractor to determine best approach to remedying the support issues in the crawlspace.

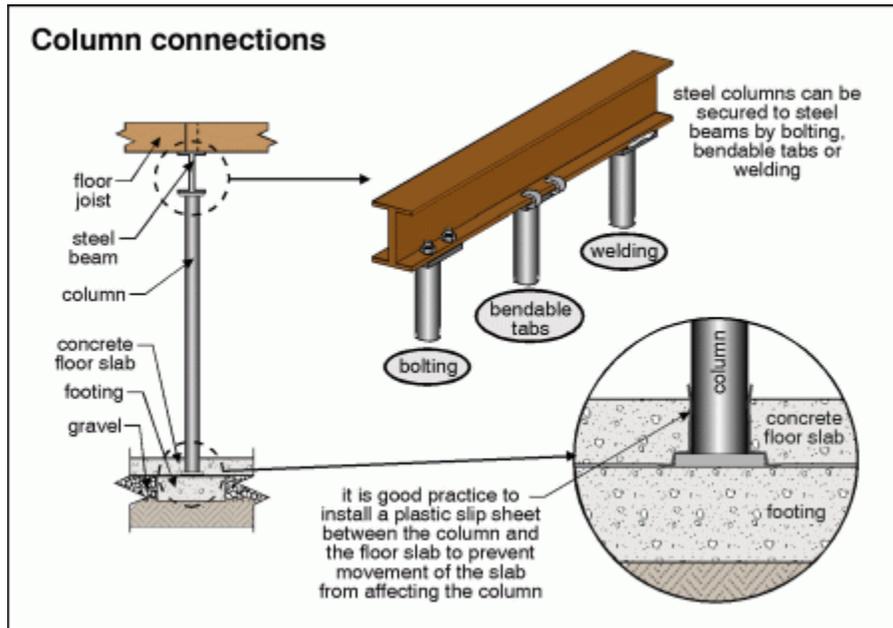
12. Condition: • [Poorly secured at top or bottom](#)
Implication(s): Weakened structure | Chance of structural movement
Location: Throughout Crawl Space
Task: Improve
Time: Less than 1 year

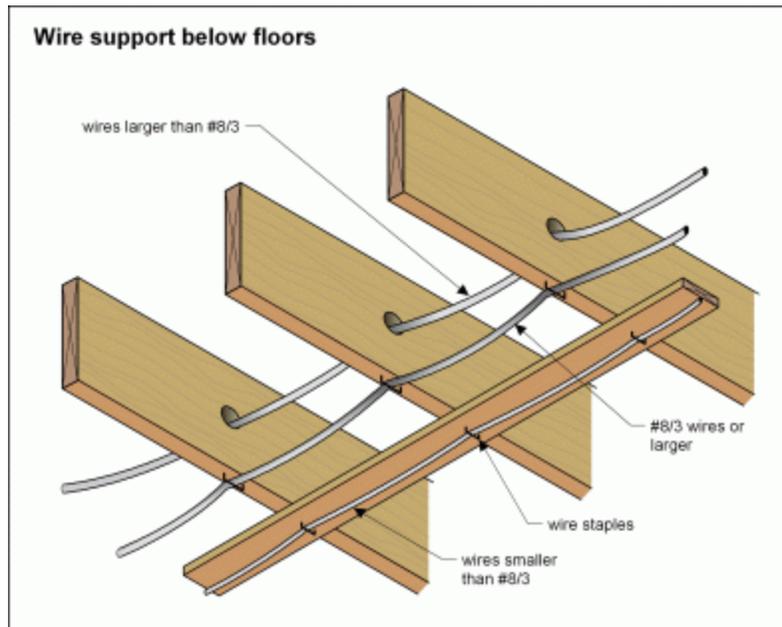
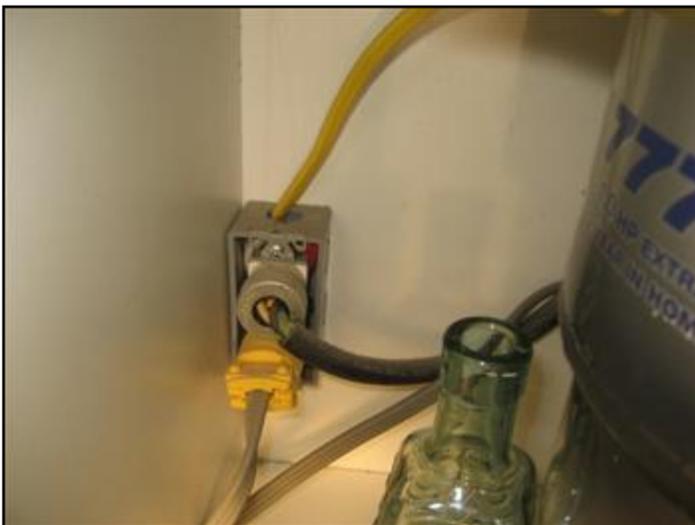
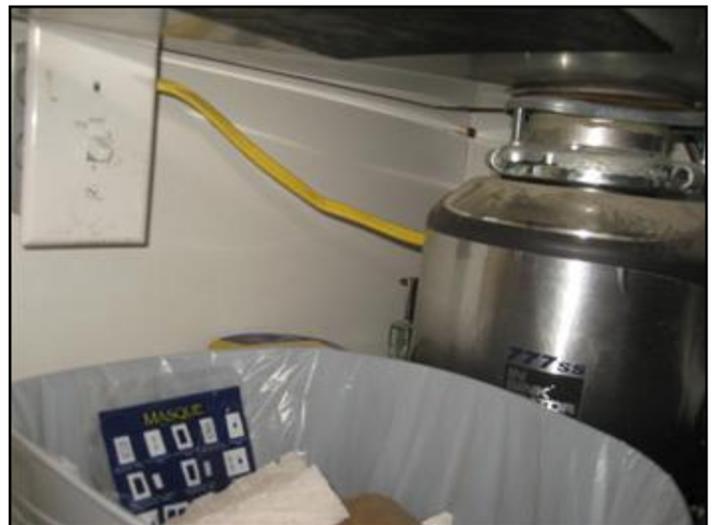
16. Condition: • [Exposed on walls or ceilings](#)

Implication(s): Electric shock

Location: Under Kitchen Sink

Task: Improve

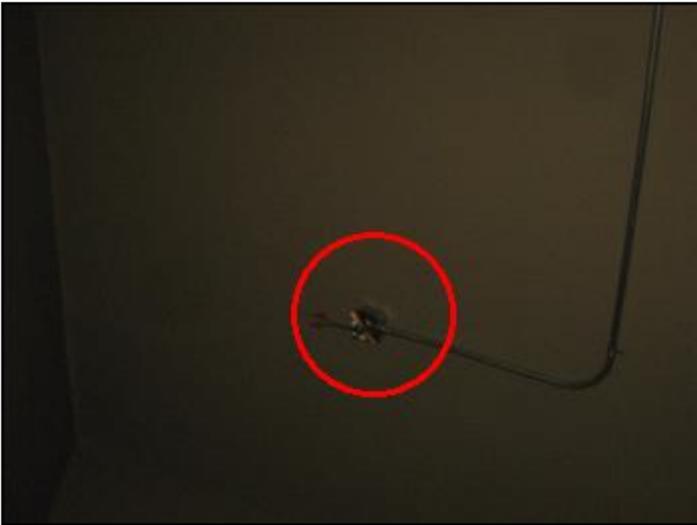
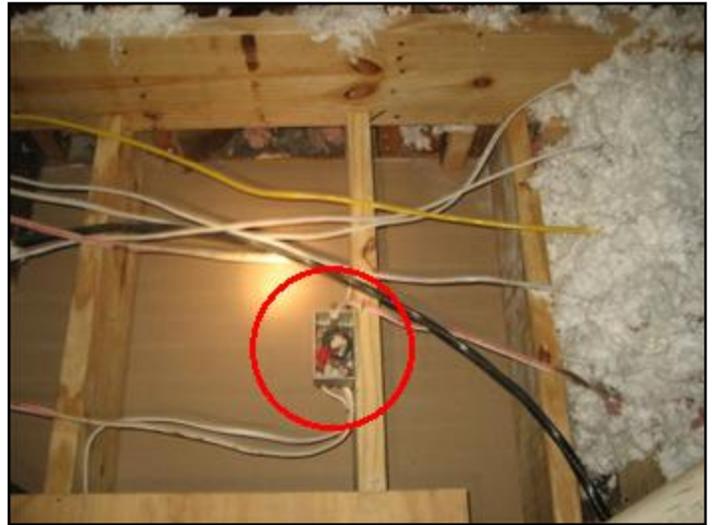
17. Condition: • [Cover loose or missing](#)

Implication(s): Electric shock | Fire hazard

Location: Throughout Attic

Task: Correct

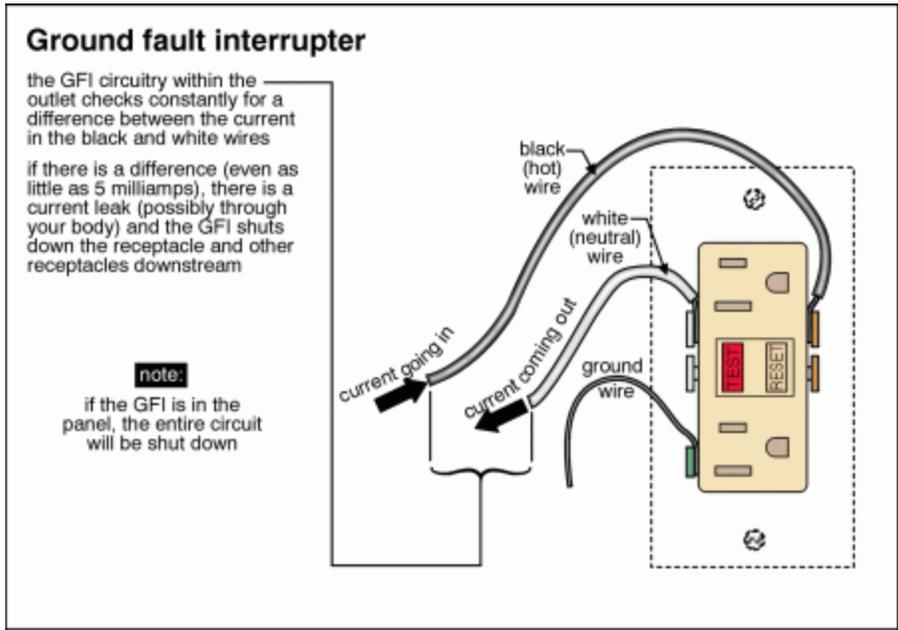
18. Condition: • [Ground Fault Interrupter \(GFI\) needed](#)

Implication(s): Electric shock

Location: Throughout Kitchen

Task: Provide

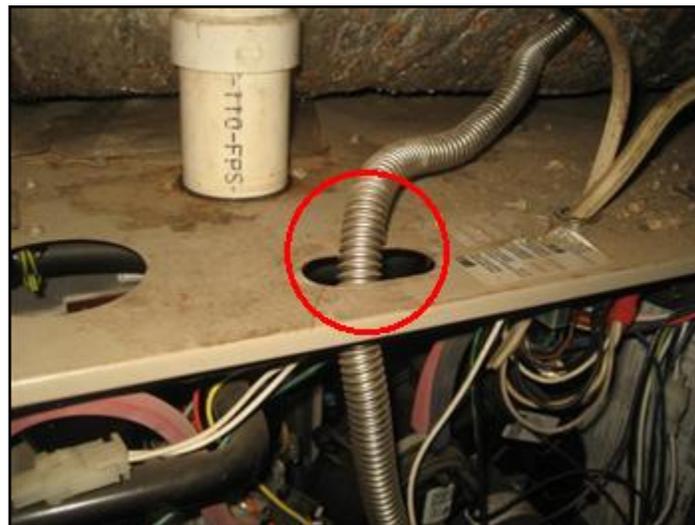
20. Condition: • [Inappropriate materials](#)

Insuflex piping is going through the furnace cabinet.

Implication(s): Equipment not operating properly | Fire or explosion

Location: Crawl Space

Task: Correct

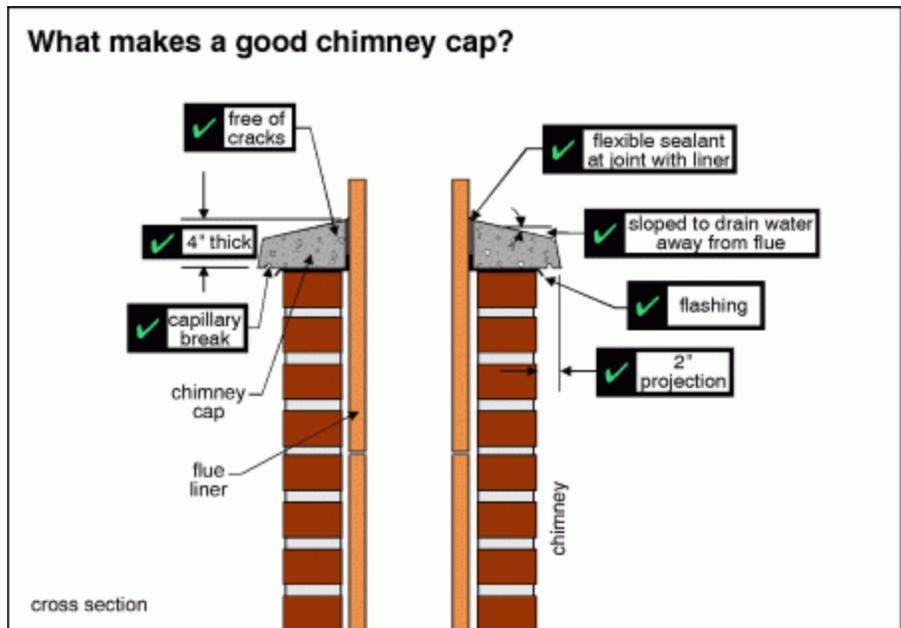
21. Condition: • [Improper slope on cap](#)

Implication(s): Shortened life expectancy of material | Material deterioration

Location: Exterior Roof

Task: Improve

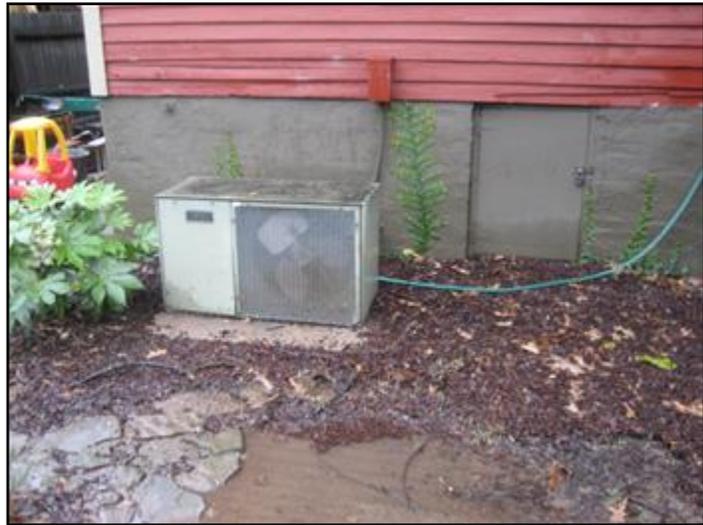
AIR CONDITIONING \ Life expectancy
22. Condition: • [Old](#)
Implication(s): Equipment failure | Reduced comfort
Task: Replace
Time: When necessary
Cost: \$1,000 - \$2,000

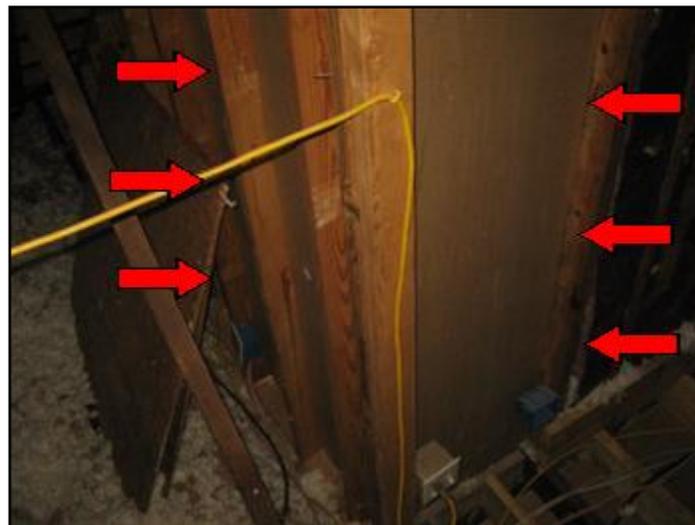
23. Condition: • [Gaps or voids](#)

Section around the kitchen walls and area over laundry room.

Implication(s): Increased heating and cooling costs | Reduced comfort

Location: Attic Kitchen

Task: Provide

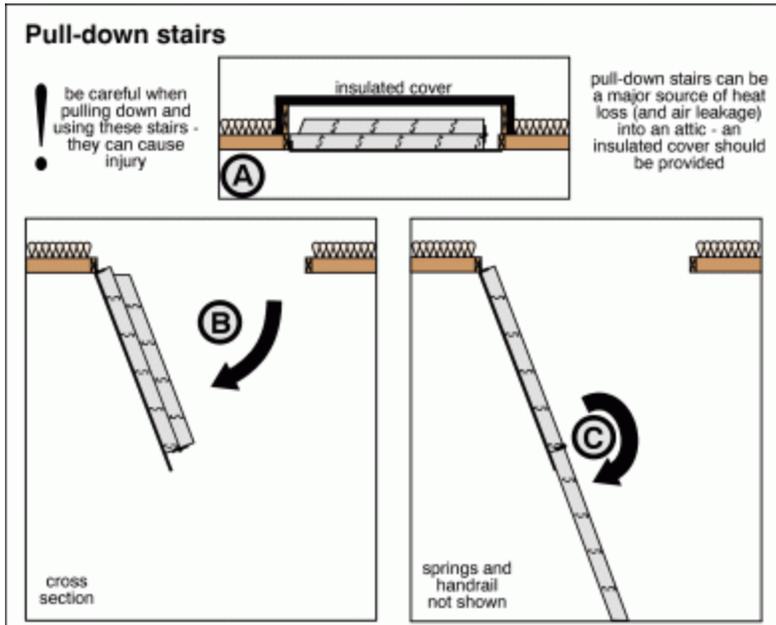
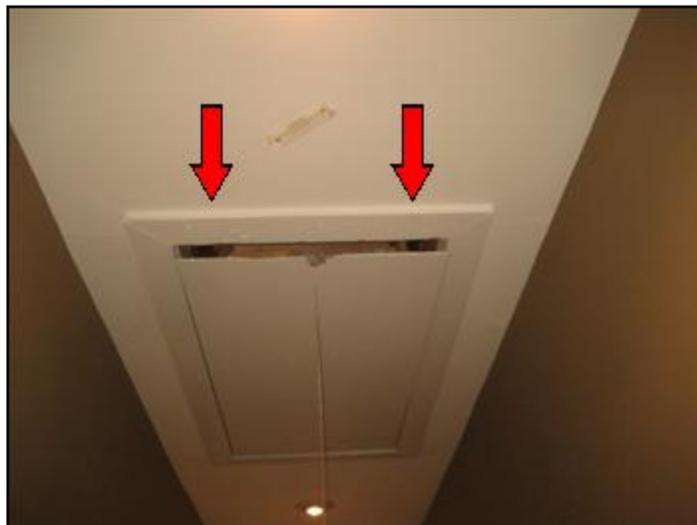
24. Condition: • [Not weatherstripped](#)

Implication(s): Chance of condensation damage to finishes and/or structure | Increased heating and cooling costs | Reduced comfort

Location: Attic

Task: Correct

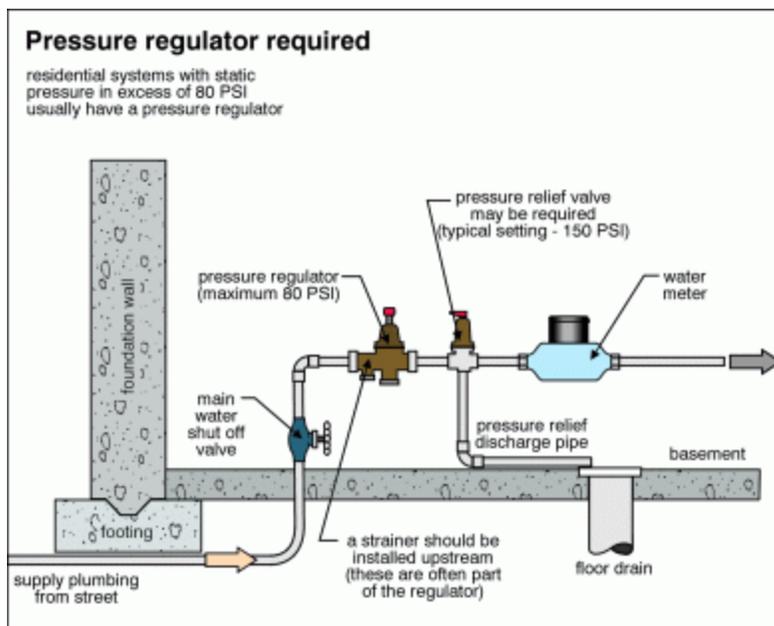
25. Condition: • [Missing](#)

Implication(s): Chance of water damage to contents, finishes and/or structure | Leakage | Damage to equipment

Location: Crawl Space

Task: Provide

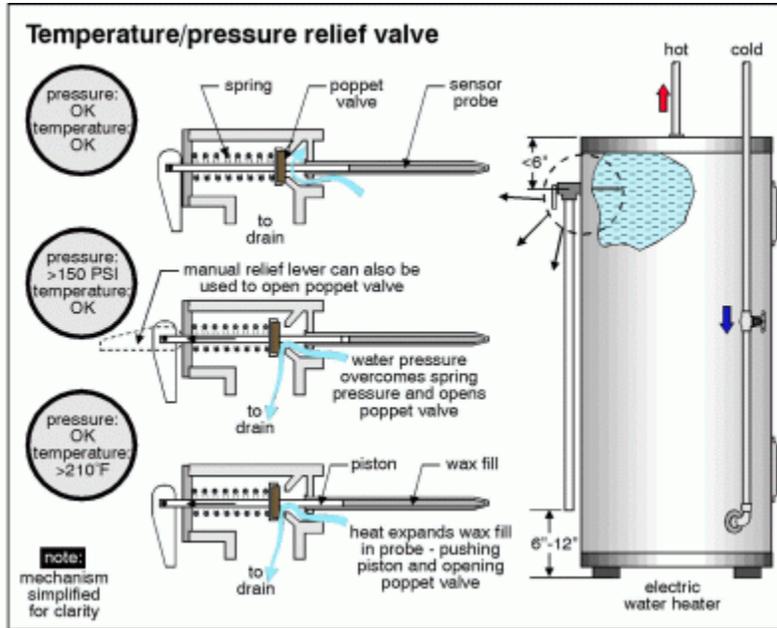
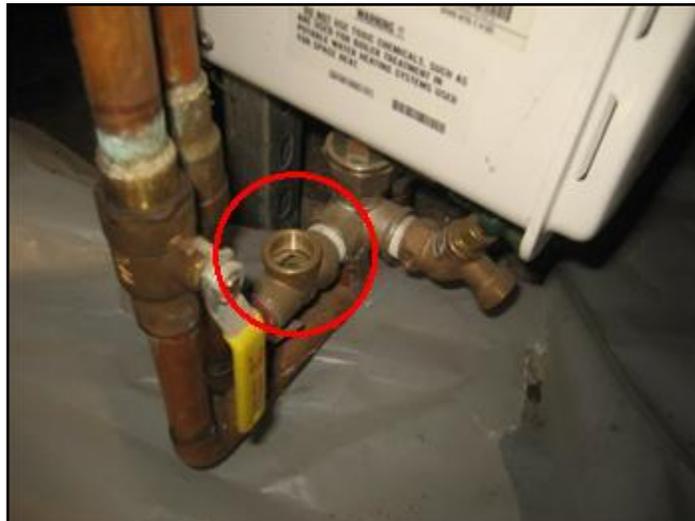
26. Condition: • [Discharge tube missing](#)

Implication(s): Scalding

Location: Crawl Space

Task: Provide

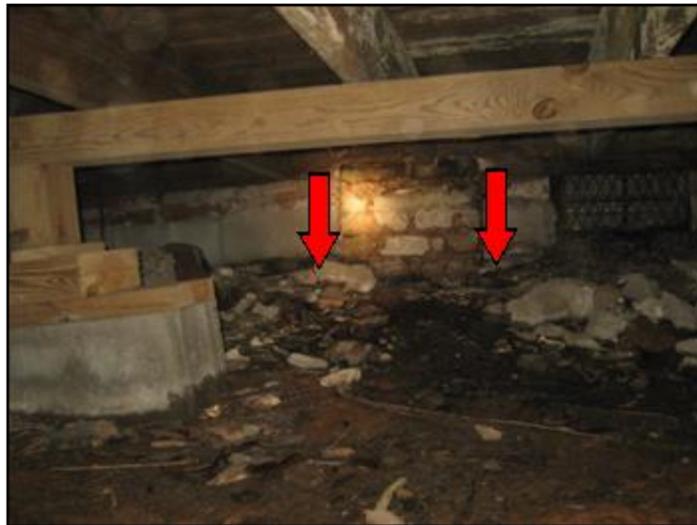
- Present
- Water

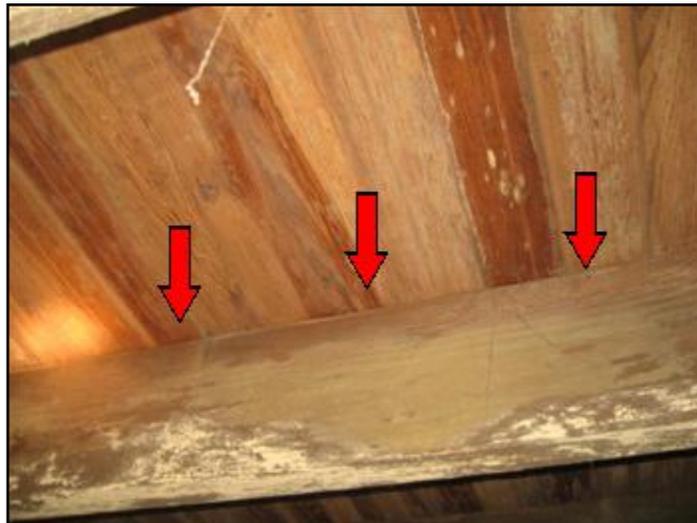
- Mold

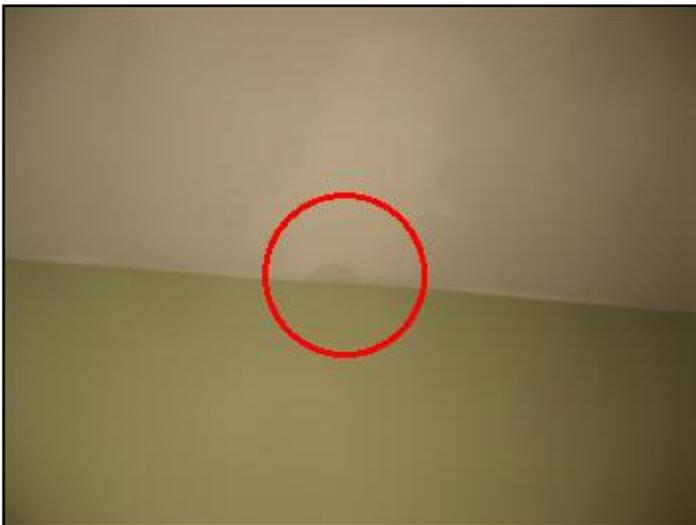
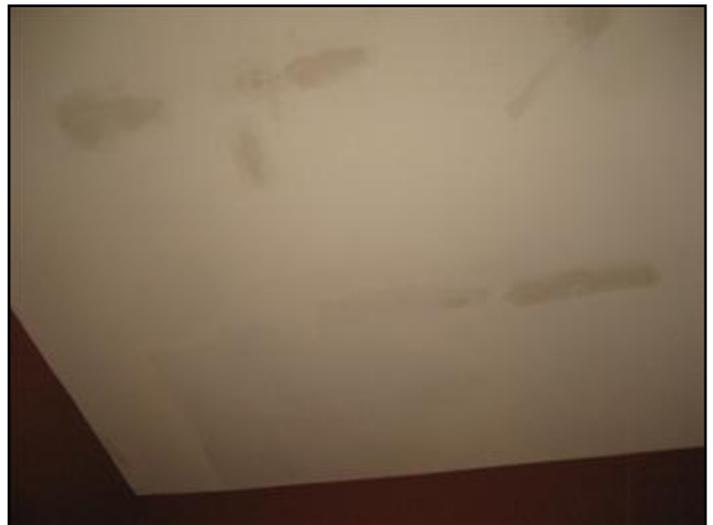
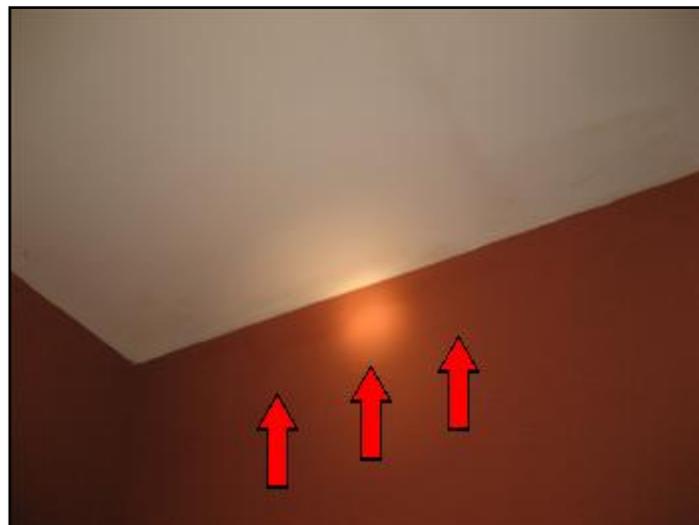
28. Condition: • Stains

Water stains present in front and middle bedrooms from leaks at the chimney in this area. Painting has been done in these areas to conceal stains.

Implication(s): Cosmetic defects

Location: Front Bedroom

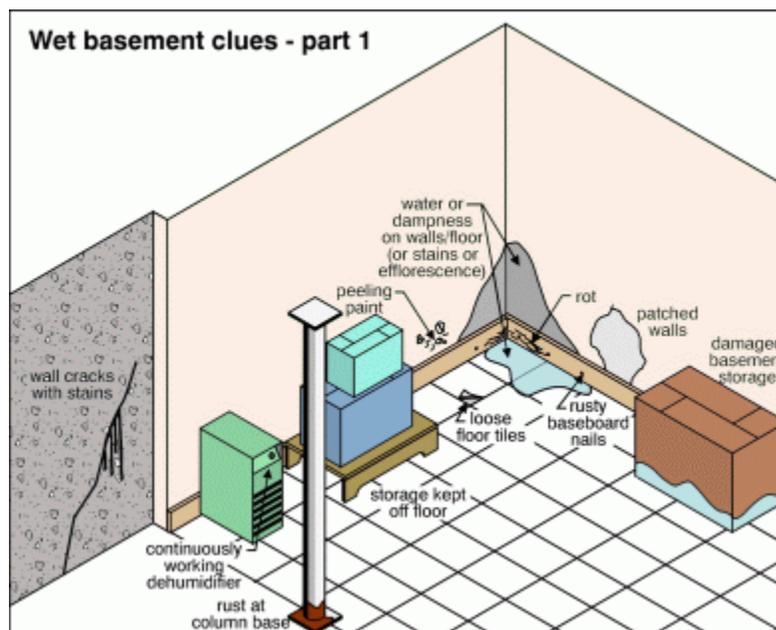
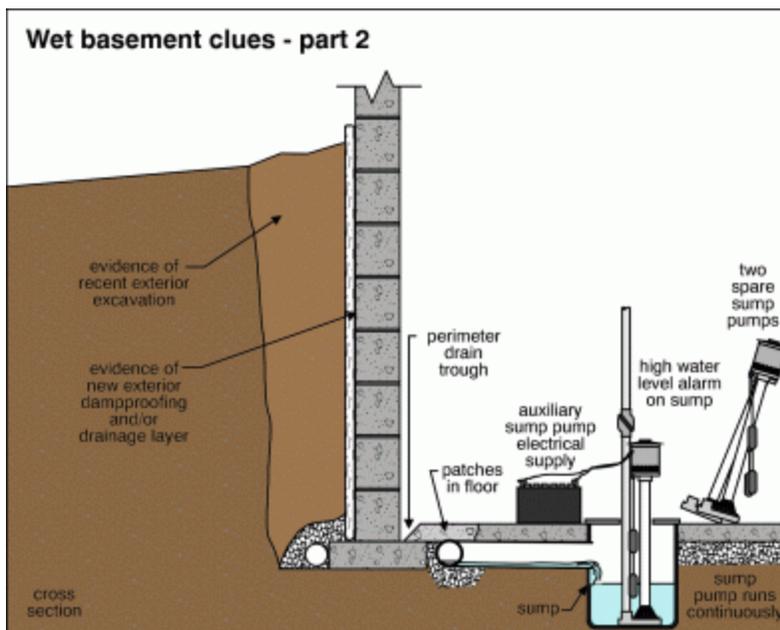
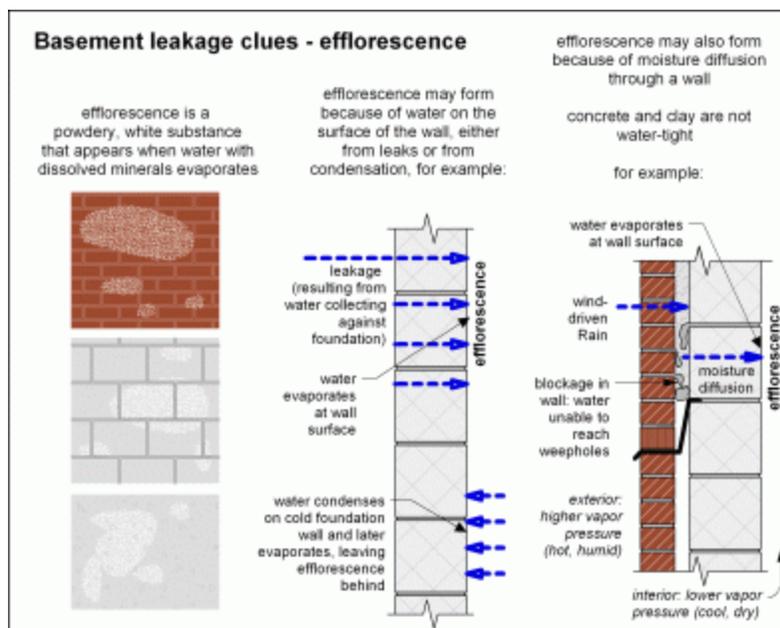
31. Condition: • [Efflorescence](#)

Water coming into the basement.

Implication(s): Cosmetic defects | Chance of water damage to contents, finishes and/or structure**Location:** Front**Task:** Correct**Time:** Less than 1 year**Cost:** Up to - \$10,000

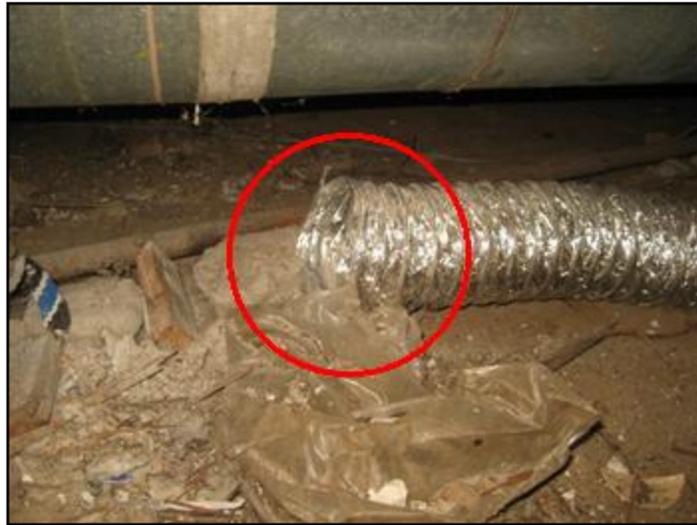
32. Condition: • Not vented to exterior

Implication(s): Chance of condensation damage to finishes and/or structure

Location: Crawl Space

Task: Repair
