INSPECTION REPORT

For the Property at:
**** * BLVD
CLEVELAND HTS, OH

Prepared for: CHARLES *****
Inspection Date: Monday, June 8, 2009
Prepared by: John Cundiff

RE: Report No. 1123, v.3

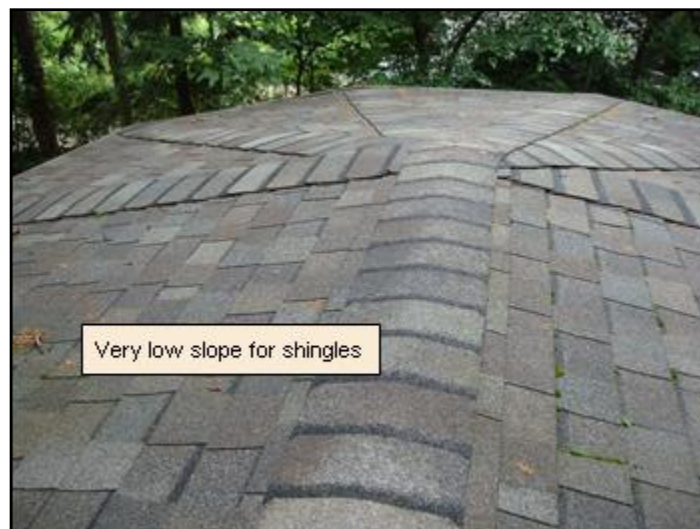
1.

Condition: • [Slope too low](#)

Implication(s): Chance of water damage to contents, finishes and/or structure

Location: Rear

Note: Vulnerable to wind driven rain entrance, wind uplift and damage.

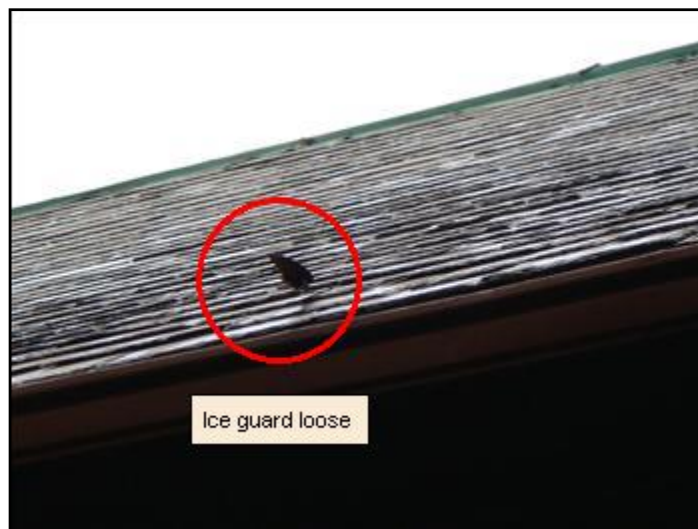
2.

Condition: • [Missing, loose or broken pieces](#)

Implication(s): Chance of water damage to contents, finishes and/or structure | Damage or physical injury due to falling materials

Location: Various Roof

Task: Repair

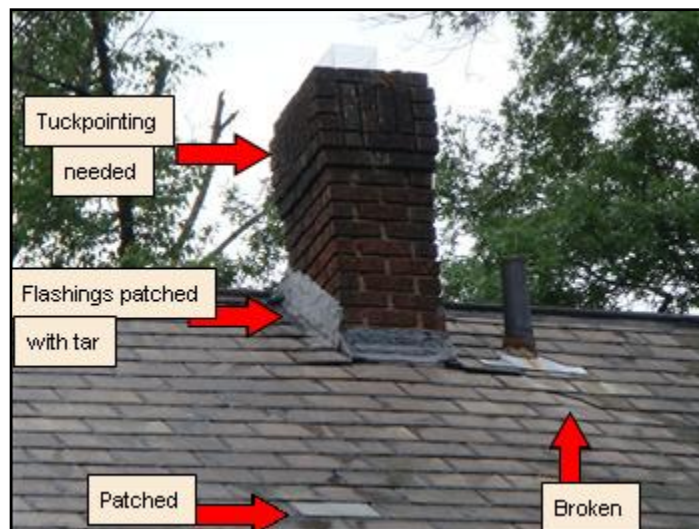
3.

Condition: • [Patched](#)

Implication(s): Chance of water damage to contents, finishes and/or structure

Location: Various Roof

Task: Monitor

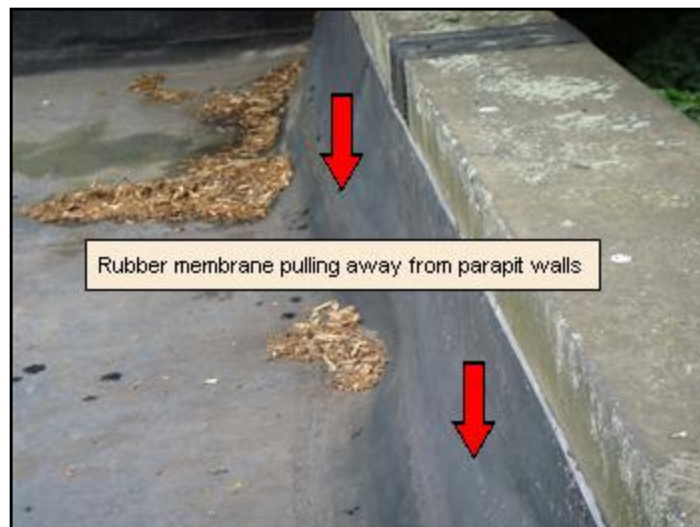
5.

Condition: • [Taut, tenting](#)

Location: Throughout Roof

Note: Rubber roof is pulling away from parapet walls and cant strip. Premature roof failure will result if left unimpaired.

Task: Repair

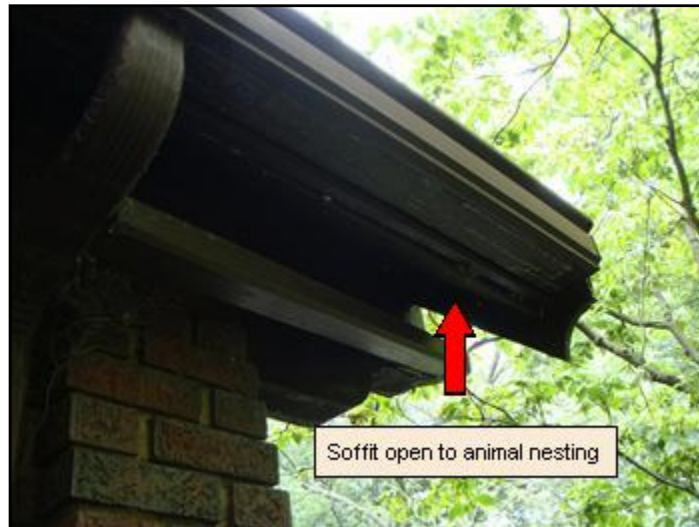
6.

Condition: • [Loose or missing pieces](#)

Location: Right side

Task: Repair

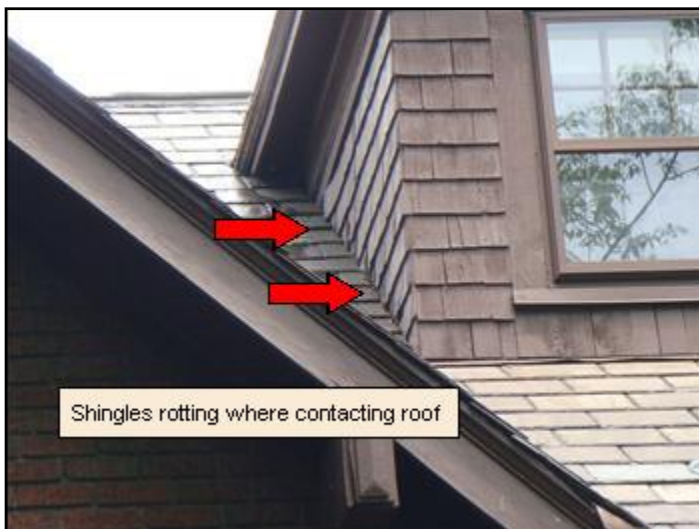
7.

Condition: • In contact with roof, drawing water up into siding

Location: Front dormers

Task: Repair

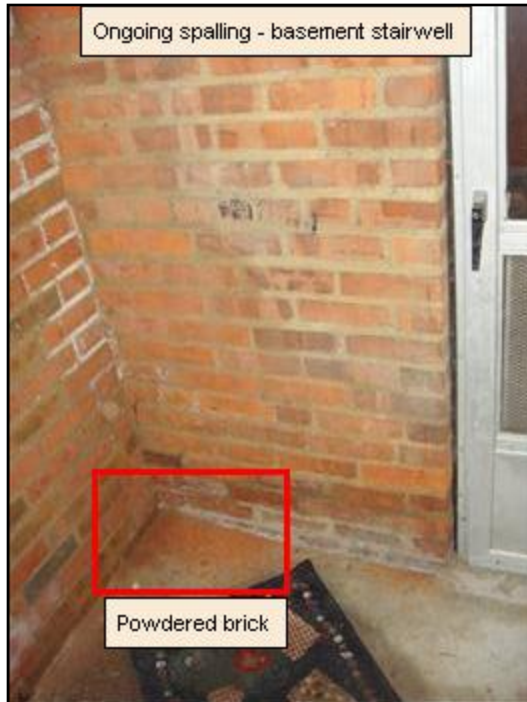
9.

Condition: • [Spalling](#)

Location: Basement

Note: The masonry within the basement stairwell is severely spalling. If the conditions supporting spalling are not corrected, the deterioration will accelerate. Once deteriorated masonry is repaired, steps should be taken to limit moisture collection and absorption.

Task: Repair

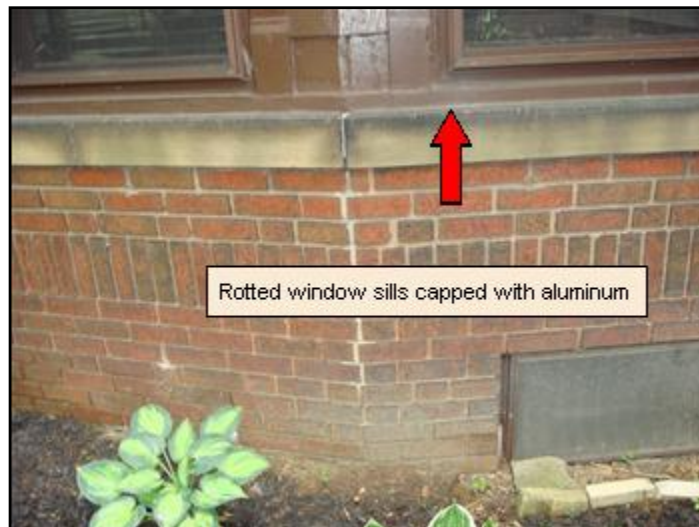
11.

Condition: • [Rot](#)

Location: Various Exterior

Task: Repair or replace

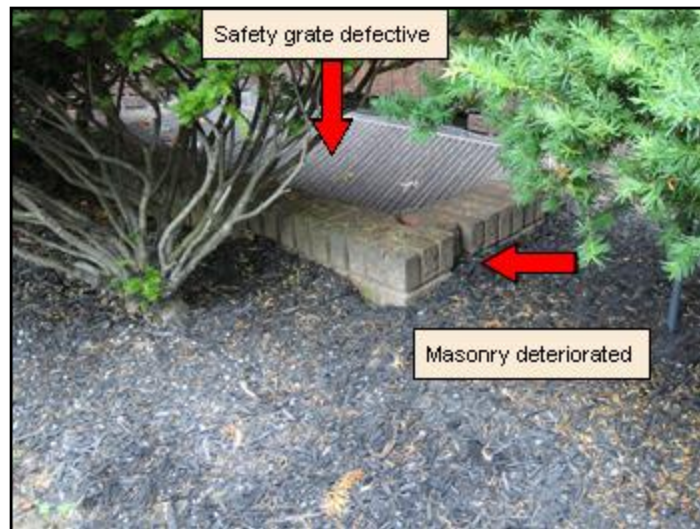
12.

Condition: • Safety grate missing or defective

Implication(s): Fall hazard

Location: Front

Task: Repair or replace

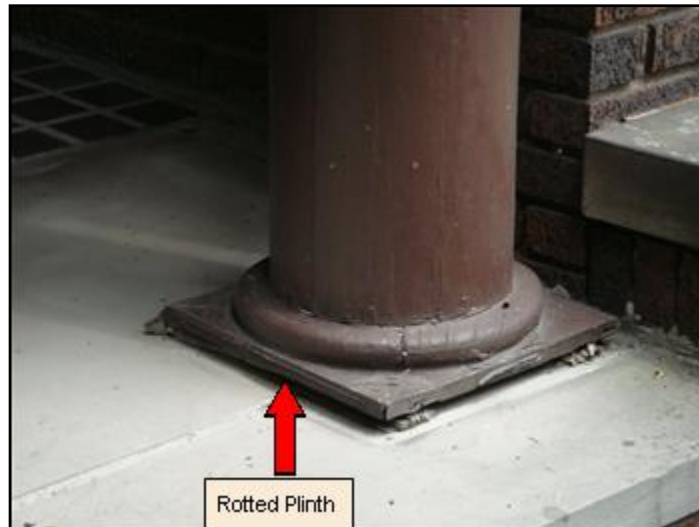
13.

Condition: • [Rot or insect damage](#)

Location: Front Porch

Task: Repair or replace

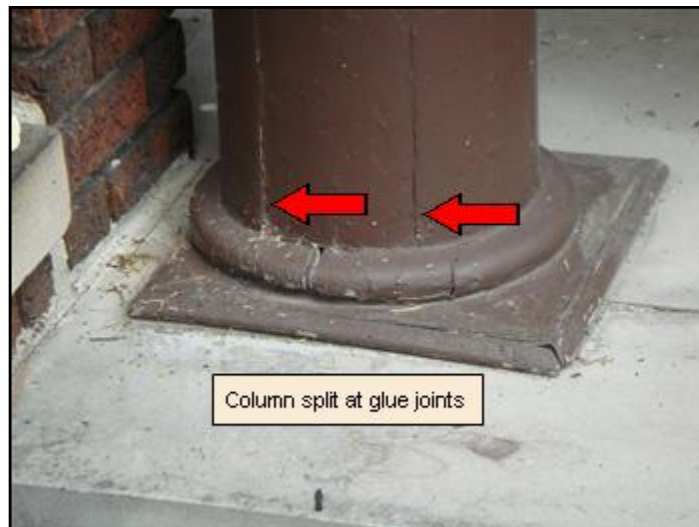
14.

Condition: • [Cracked](#)

Location: Front Porch

Task: Repair or replace

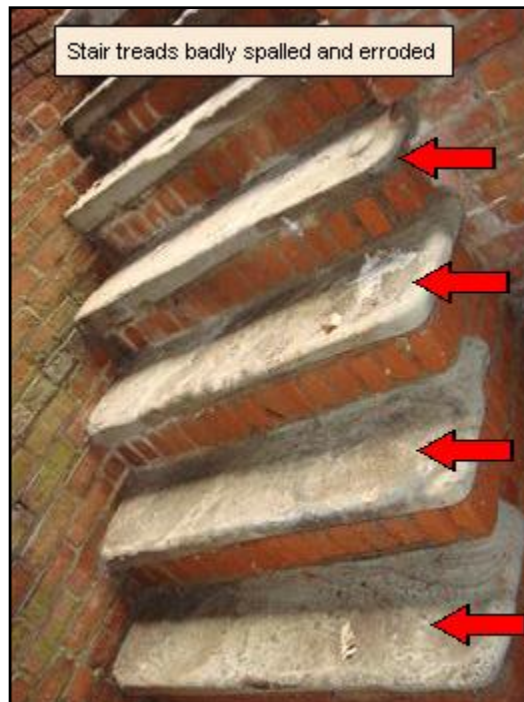
15.

Condition: • [Masonry or concrete spalling](#)

Location: Basement

Task: Repair or replace

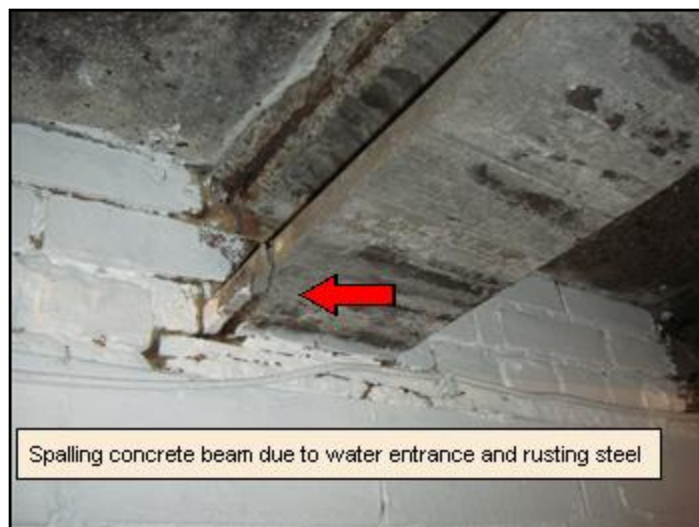
22.

Condition: • [Rust](#)

Note: Concrete beam shows slight spalling due to water penetration.

Task: Repair, prevent further rusting

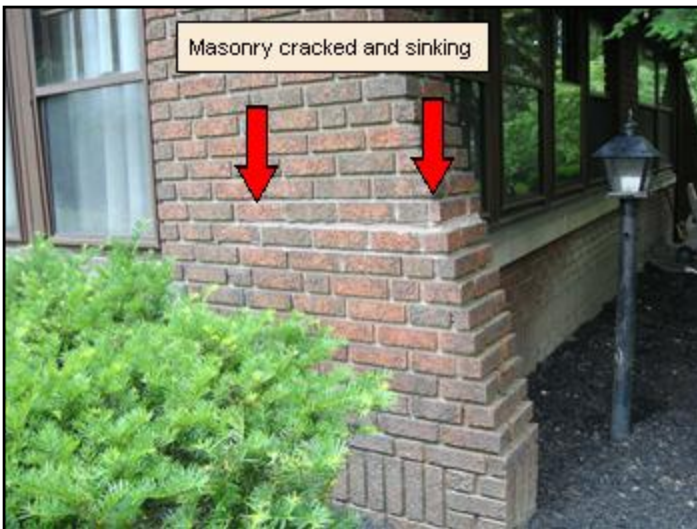
23.

Condition: • [Cracked](#)

Note: The masonry wing wall is cracked and sinking. Mortar has been repaired, though it is not possible to determine if the footer has been replaced or underpinned. Request specific disclosure from owner. Consult masonry contractor for further evaluation and repair.

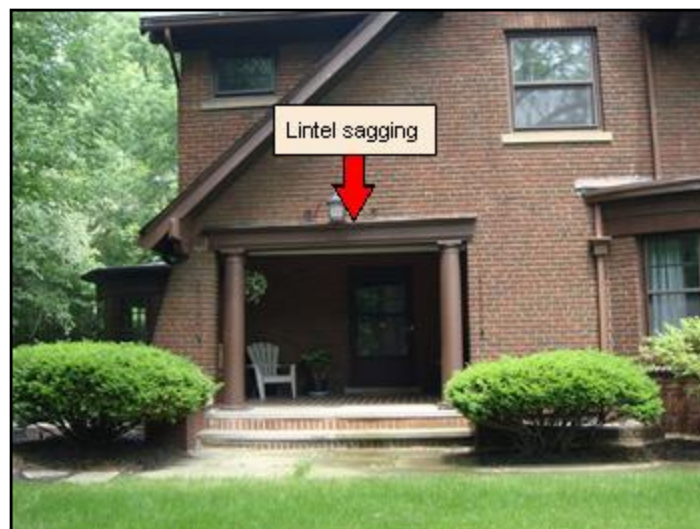
25.

Condition: • [Lintels sagging](#)

Location: Front Exterior

Task: Monitor for continued movement

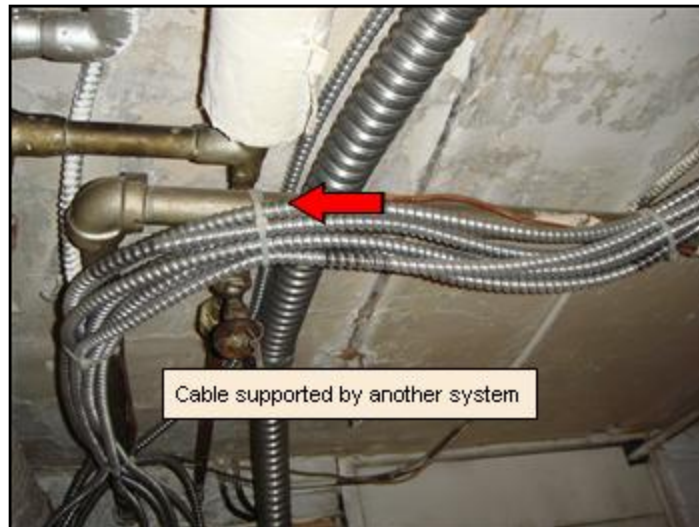
27.

Condition: • [Not well secured](#)

Implication(s): Electric shock | Fire hazard

Note: Electric cables and conduit should not be supported by another system ie: plumbing pipes, ducts, etc.

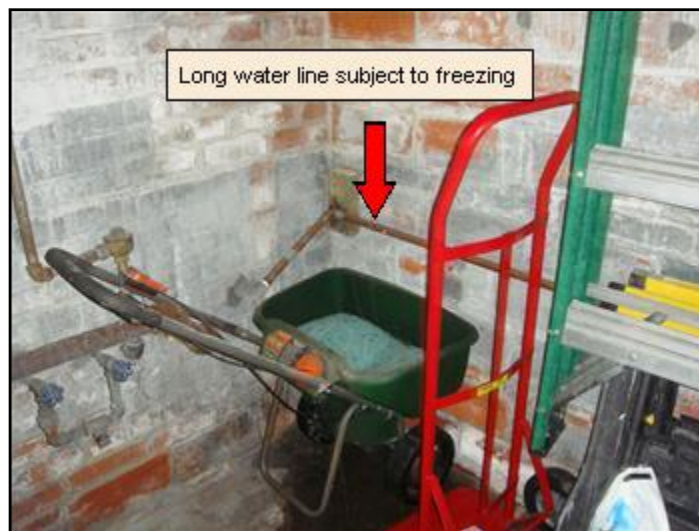
37.

Condition: • Subject to freezing

Implication(s): Ruptured plumbing

Task: Monitor

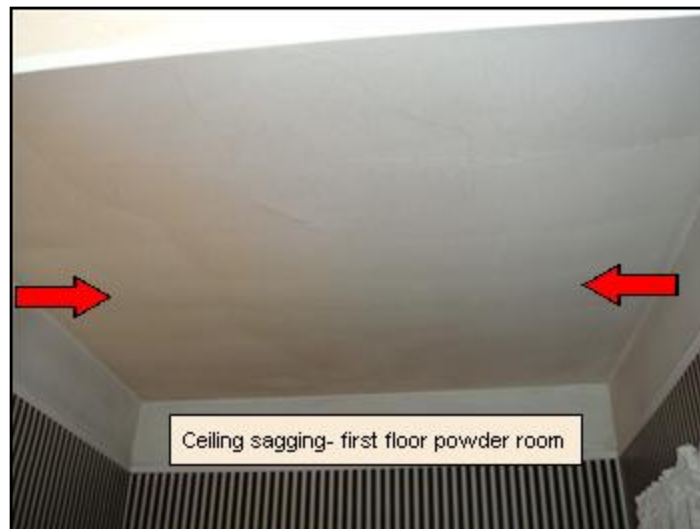
38.

Condition: • [Sag](#)

Implication(s): Cosmetic defects | Chance of movement

Note: Ceiling threatens collapse. Safety hazard.

Task: Repair

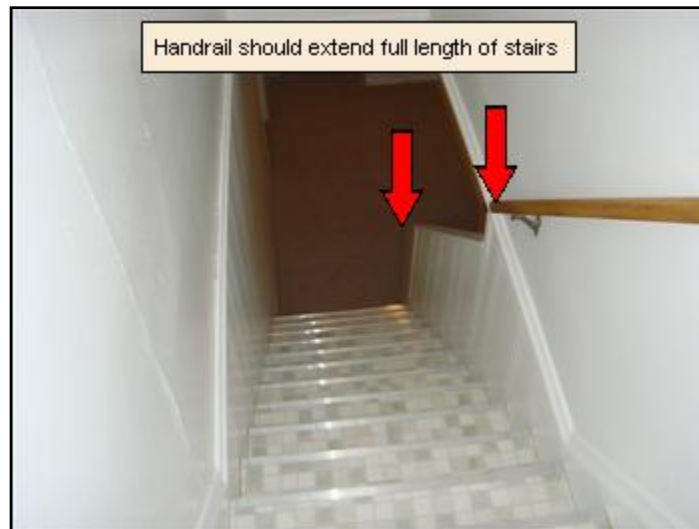
39.

Condition: • Handrail does not extend equal to the stairway length.

Implication(s): Safety hazard

Task: Repair
