INSPECTION REPORT

For the Property at:
6266 PARK RIDGE DRIVE
PARK CITY , UT

Prepared for: BUTCH CASSIDY
Inspection Date: Friday, May 4, 2007
Prepared by: Matthew Stouffer

RE: Report No. 1044, v.8
6266 Park Ridge Drive
Park City , UT
84098

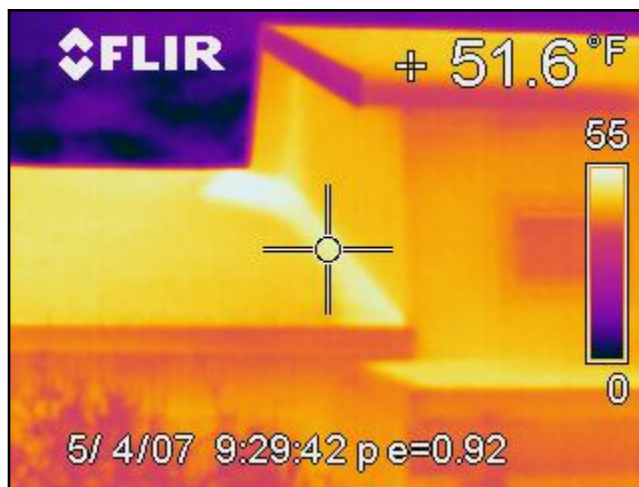
- There is poor insulation along the South roof wall intersection.

1. Poor insulation along roof wall intersection

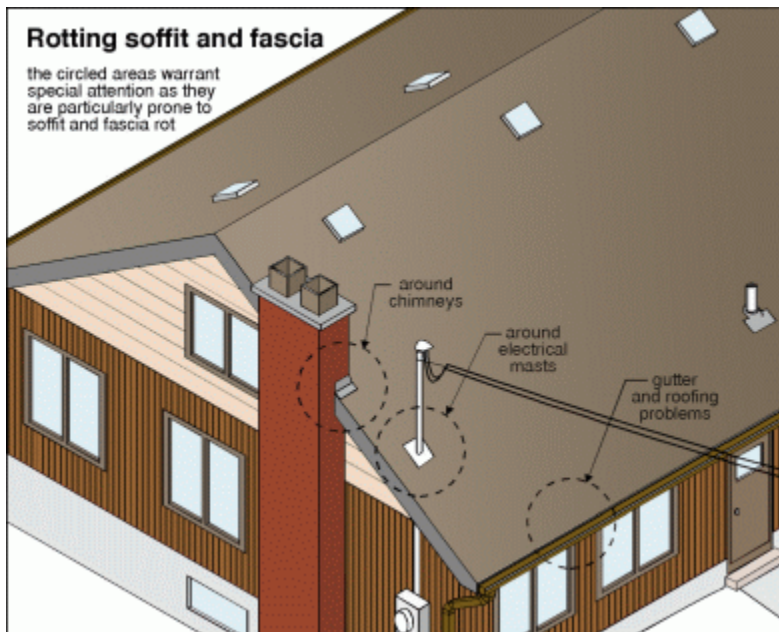
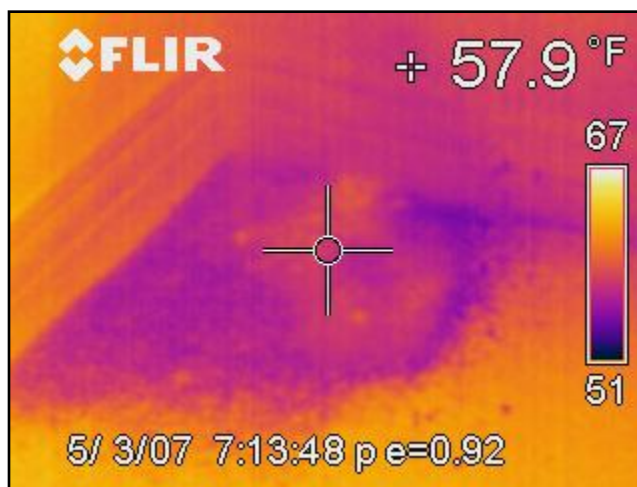
Condition: • [Rot or insect damage](#)

Note: Water damage is present along the master bedroom wall and floor. The water penetration is a result of missing kick out flashings.

2. Water damage/rot resulting from poor flashing

Task: Repair

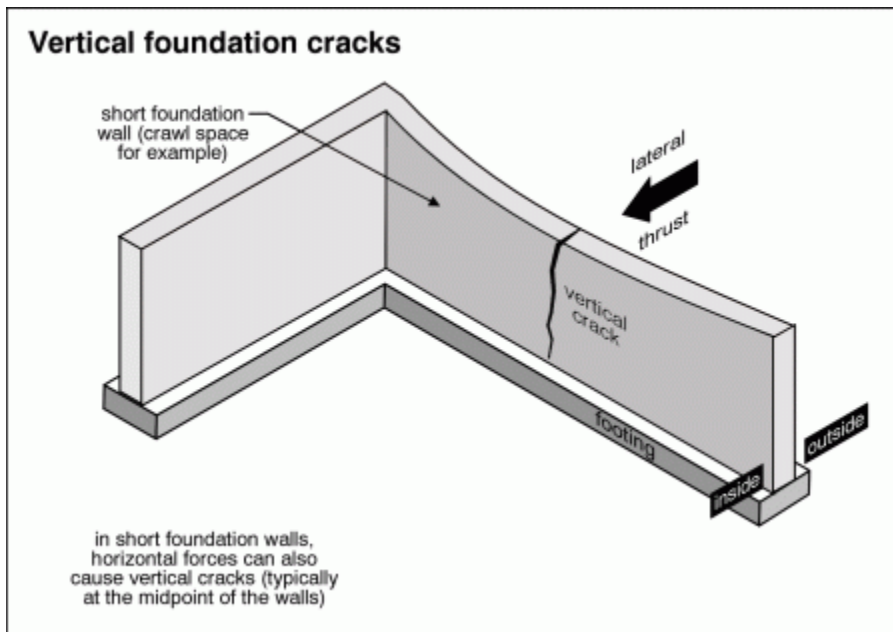
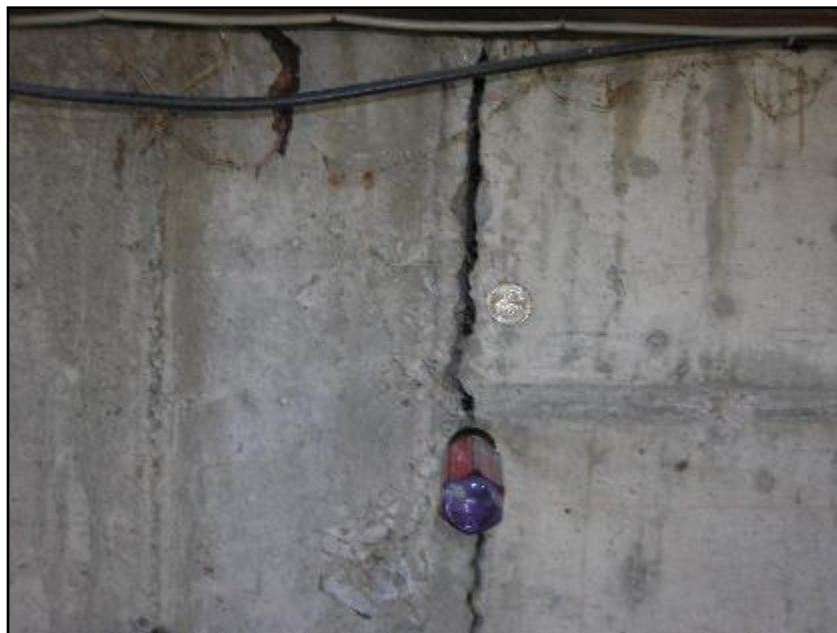
Condition: • [Cracked](#)

Note: A large crack is present along the Northern aspect of the foundation. Suggest further evaluation by structural engineer.

3. Crack in foundation

Task: Further evaluation

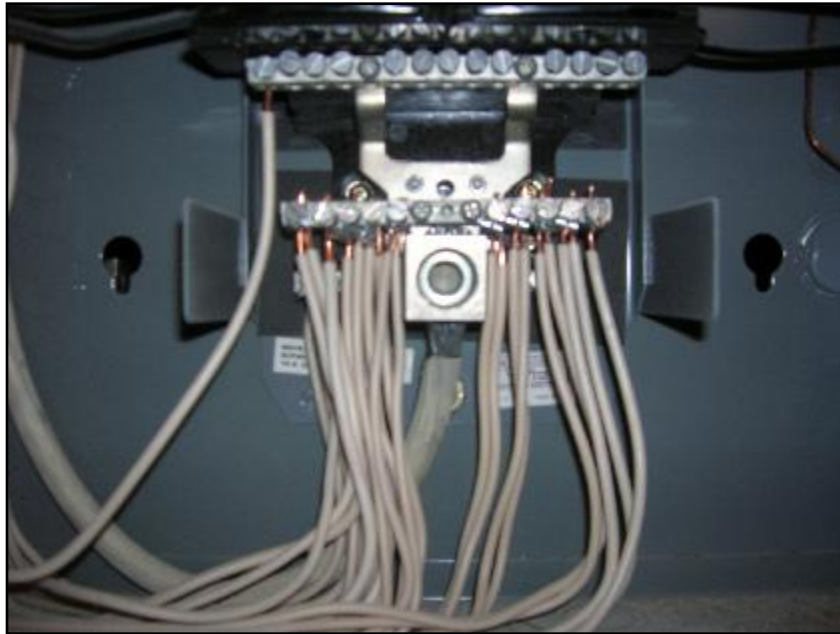
Condition: • Neutral wires in the distribution panel need to be in separate terminals.

4. Neutral wires without seperate terminals

Task: Improve

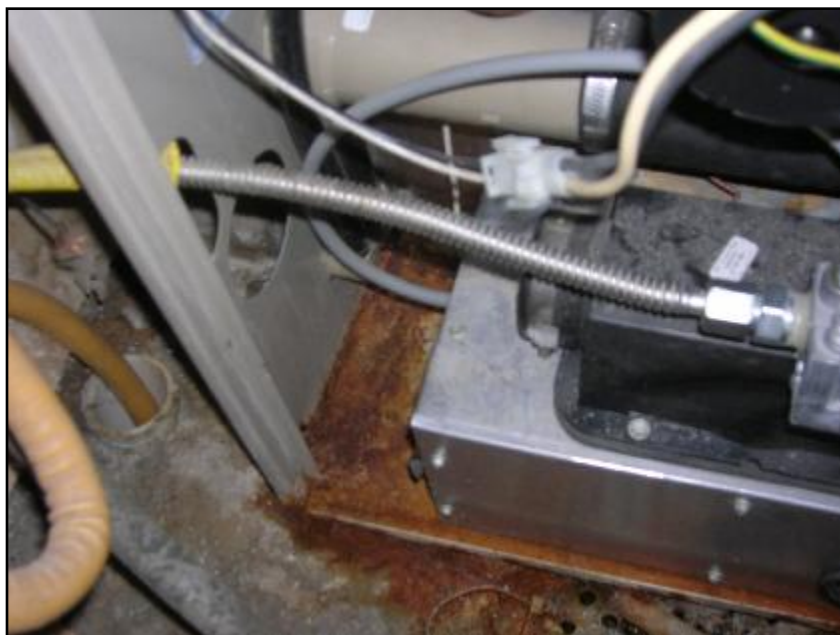
Condition: • [Rust](#)

Note: In addition to the rust, flexible gas piping is not allowed to penetrate the housing of the furnace. This should be replaced with solid gas piping.

5. Rust in furnace

Task: Repair

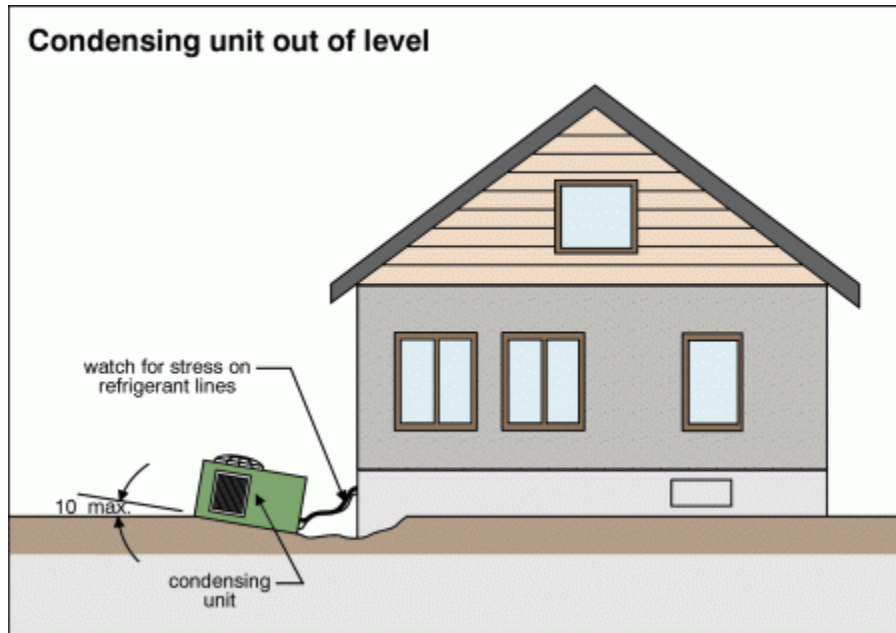
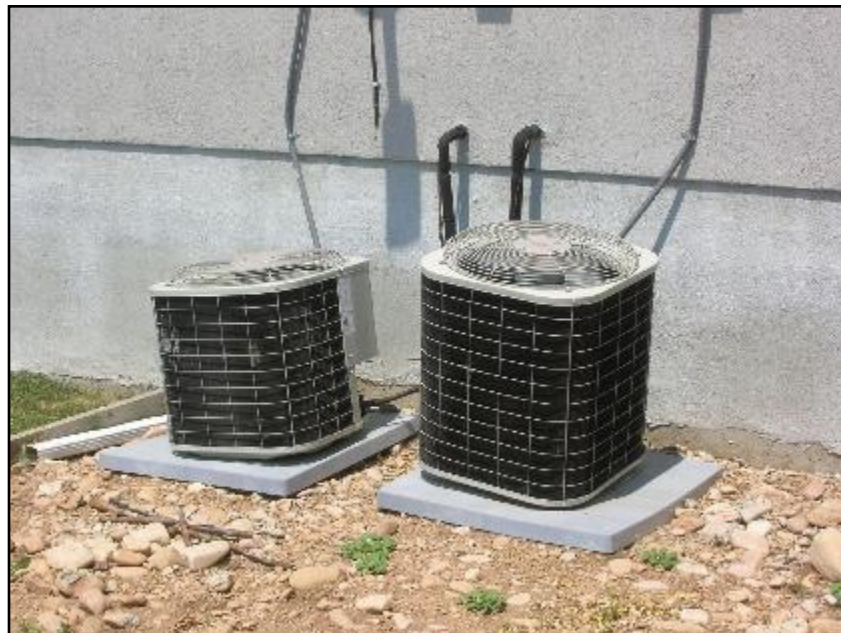
Condition: • [Out of level](#)

Note: The compressor units are not level.

6. Compressors out of level

Task: Improve

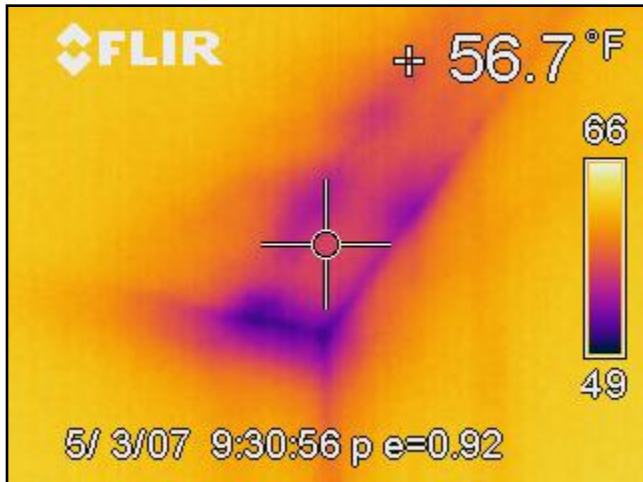
Condition: • A section Insulation is missing in the ceiling of the North second floor bedroom.

7. Missing insulation

Task: Correct

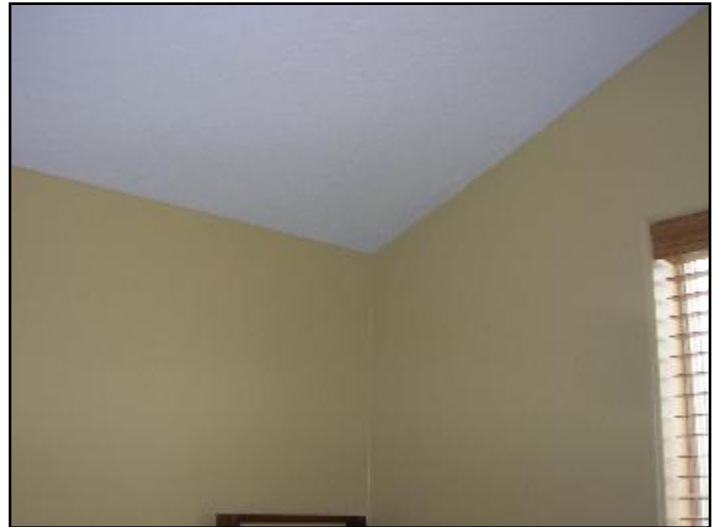
8. Area of missing insulation

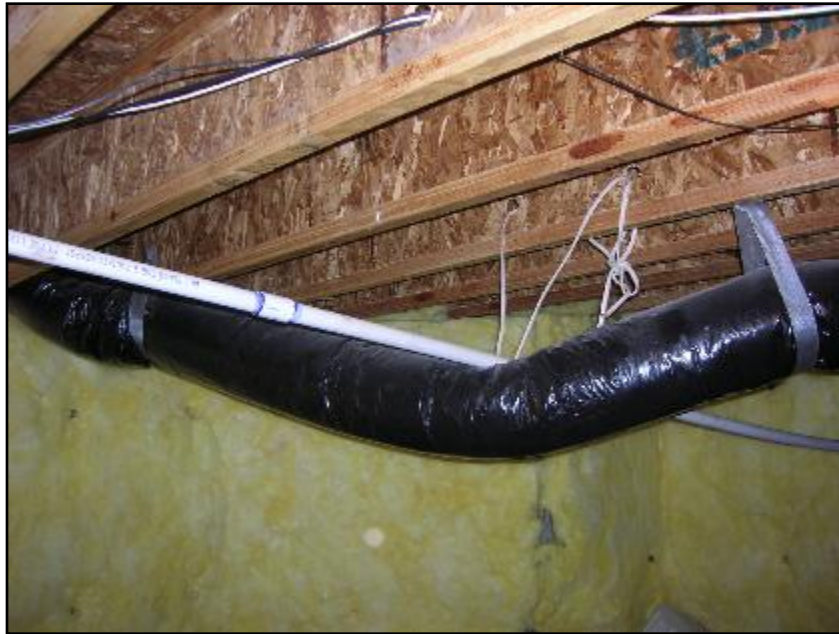
Condition: • [Poor support](#)

9. Poor support for PVC water line

Task: Improve

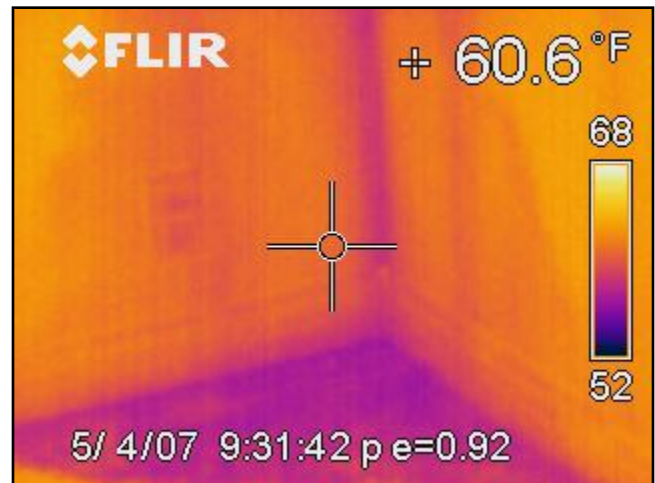
11. Moisture in area

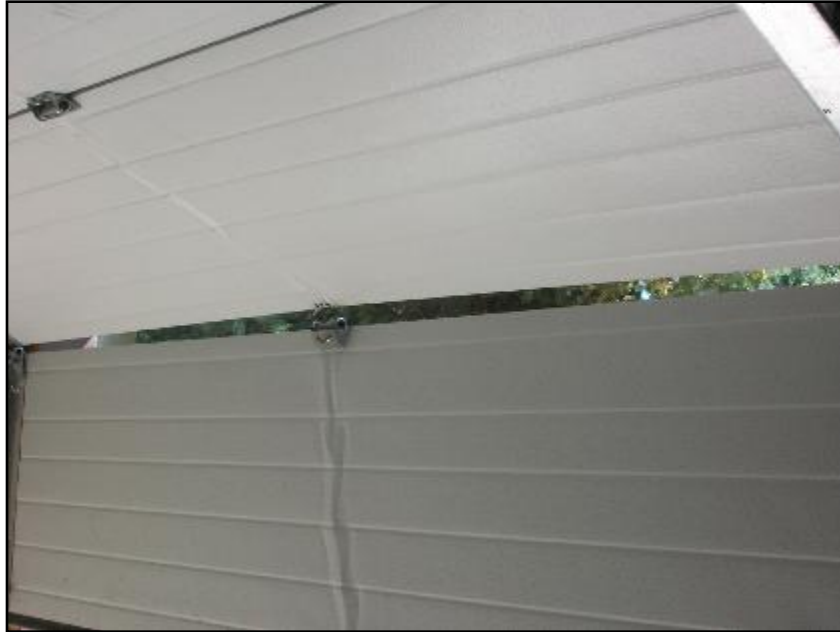
Condition: • [Rusted or dented](#)

12. Mechanical damage to garage door

Task: Repair
