INSPECTION REPORT

For the Property at:
3614 - 44 AVE
EDMONTON, AB

Prepared for: GLADYS HOUGH
Inspection Date: Tuesday, May 31, 2011
Prepared by: Don Schmidt

Report No. 1277

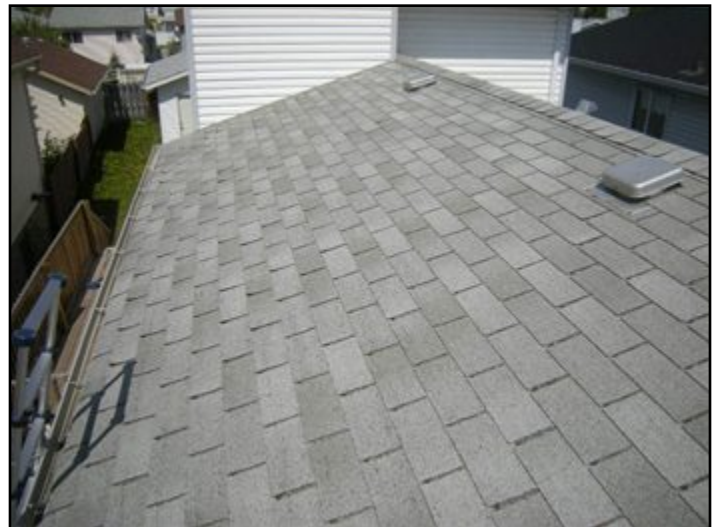
6.

Condition: • Some of the shingle courses are not space correctly.

Location: Right Side Garage Roof

Task: Correct Further evaluation

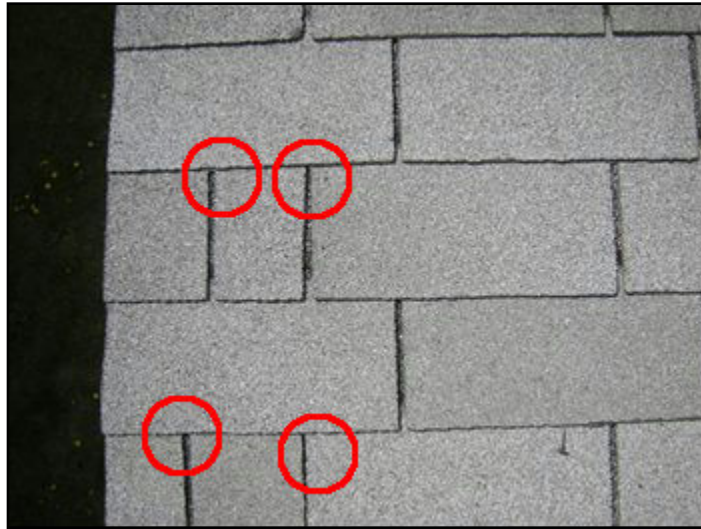
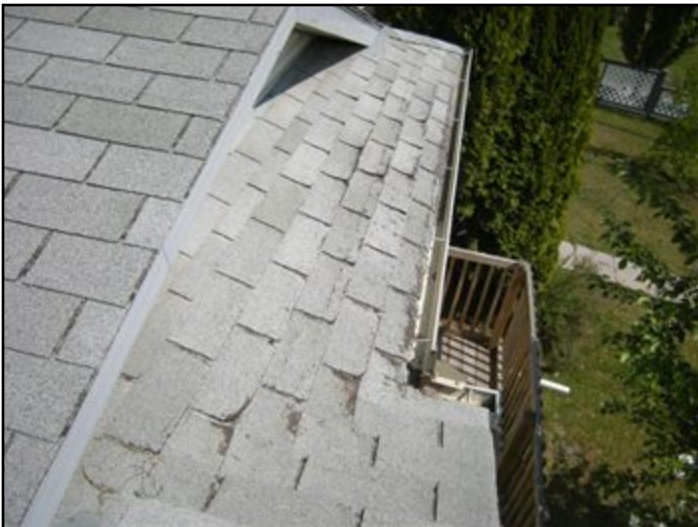
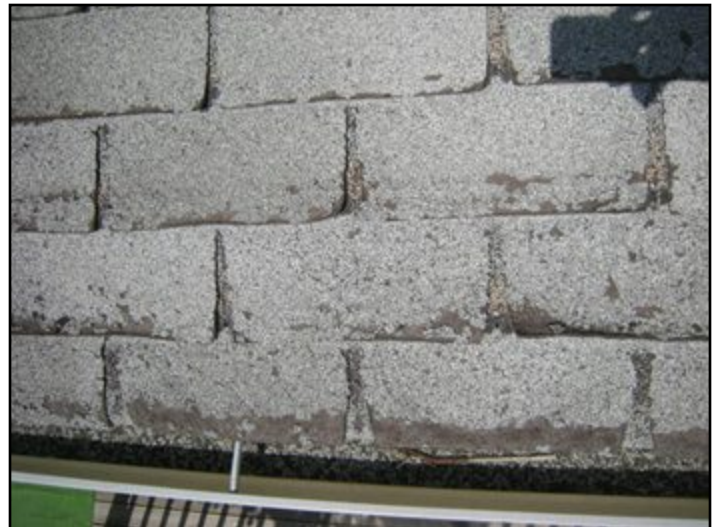
Condition: • [Cupping, curling, clawing](#)

Implication(s): Chance of water damage to contents, finishes and/or structure

Location: Various Roof

Task: Inspect annually Repair or replace

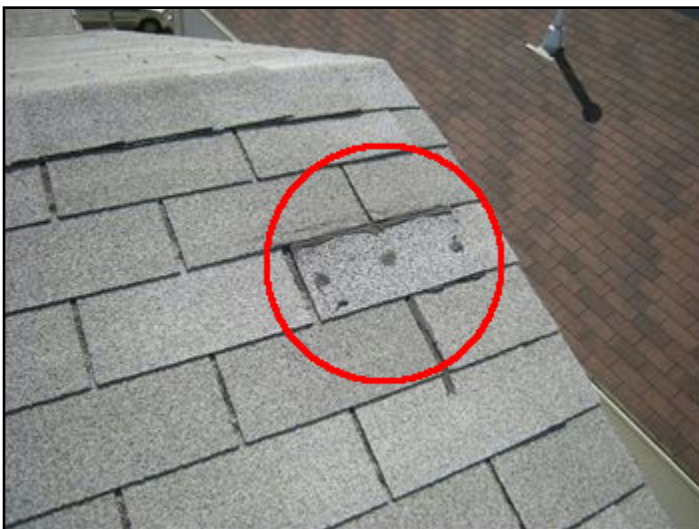
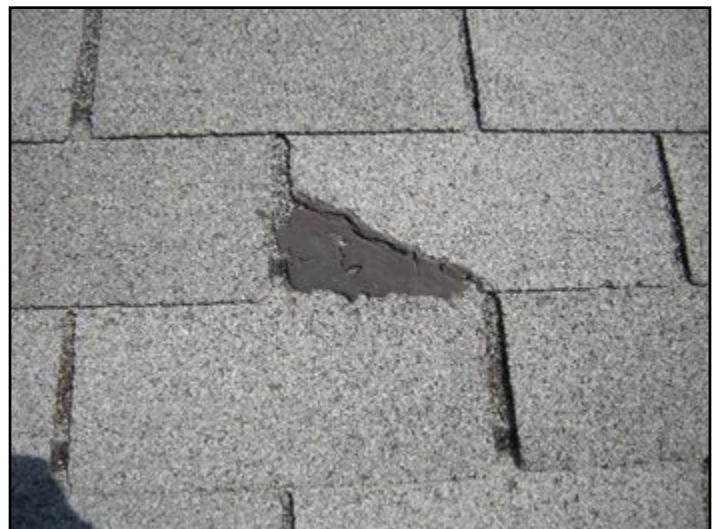
Condition: • [Patched](#)

Implication(s): Chance of water damage to contents, finishes and/or structure

Location: Various Roof

Task: Inspect annually Repair

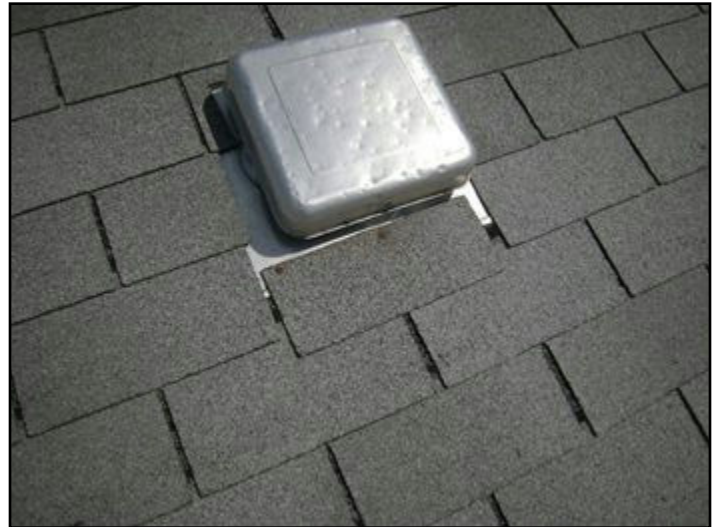
13.

Condition: • Inspect & repair, as needed.

Location: Various Roof

Task: Further evaluation Service

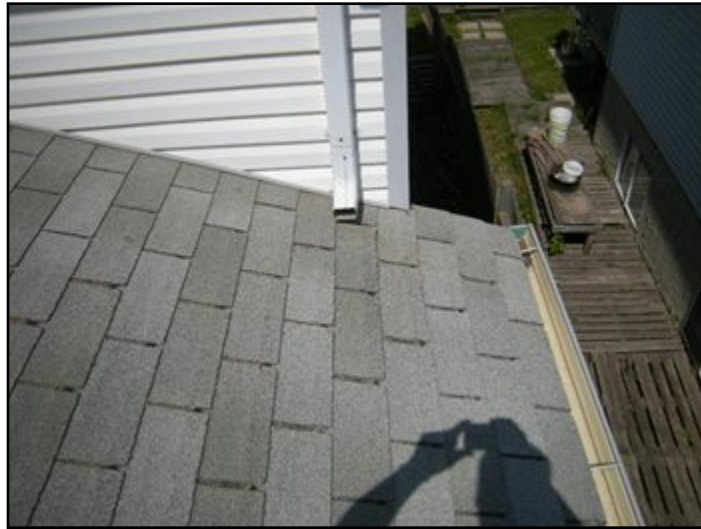
14.

Condition: • [Downspouts discharging onto roofs](#)

Implication(s): Chance of water damage to contents, finishes and/or structure

Location: Various First Floor Roof

Task: Improve

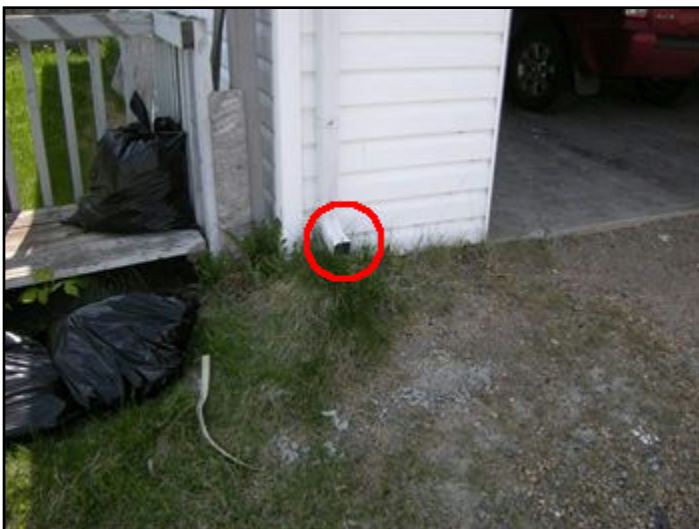
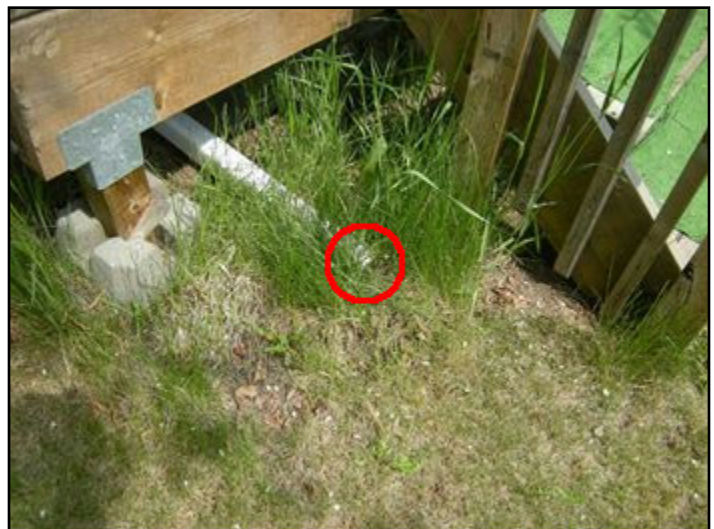
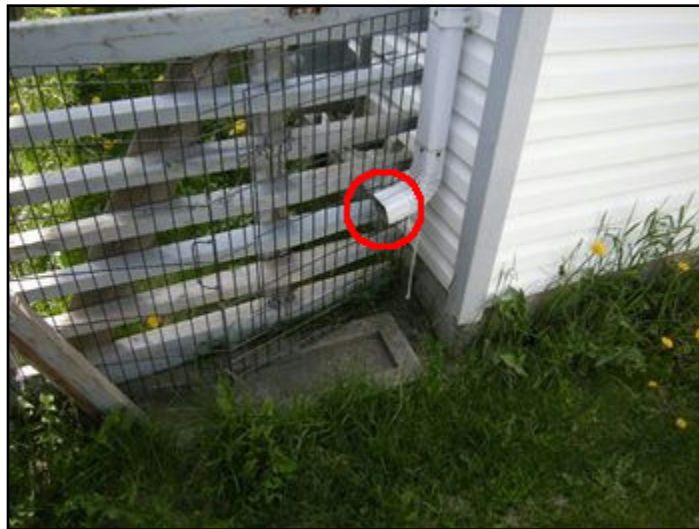
Condition: • Should discharge 6ft. from home

Implication(s): Chance of water damage to contents, finishes and/or structure

Location: Various Exterior Wall

Task: Improve

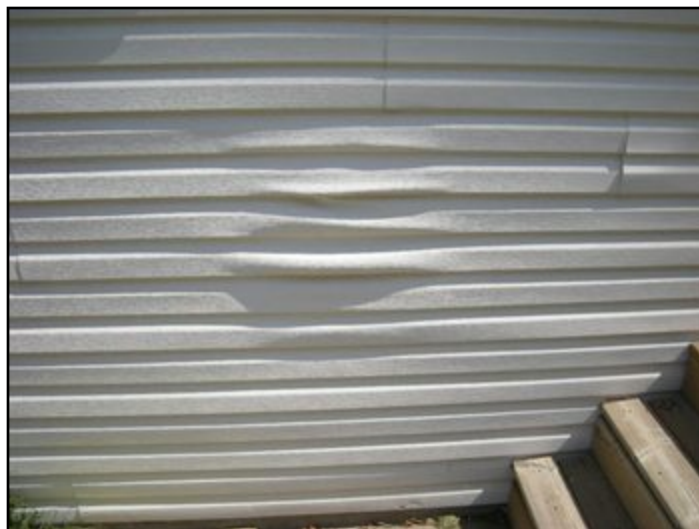
18.

Condition: • [Mechanical damage](#)

Implication(s): Cosmetic defects | Chance of water damage to contents, finishes and/or structure

Location: Rear Left Side Exterior Wall

Task: Replace

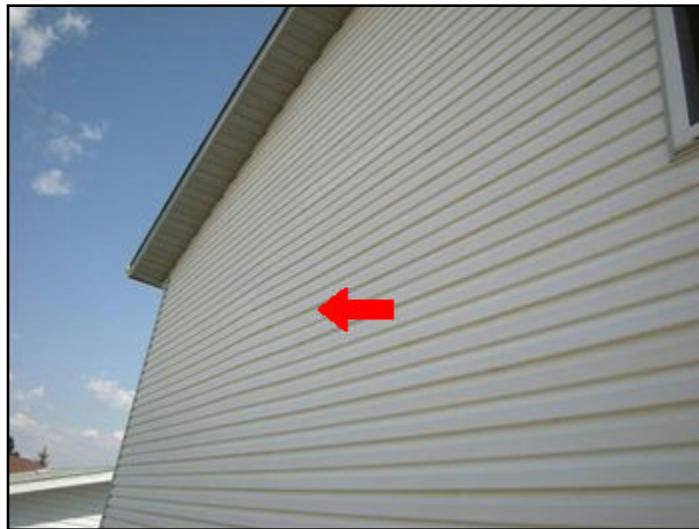
19.

Condition: • [Buckled or wavy](#)

Implication(s): Cosmetic defects | Chance of water damage to contents, finishes and/or structure

Location: Various

Task: Inspect annually Repair

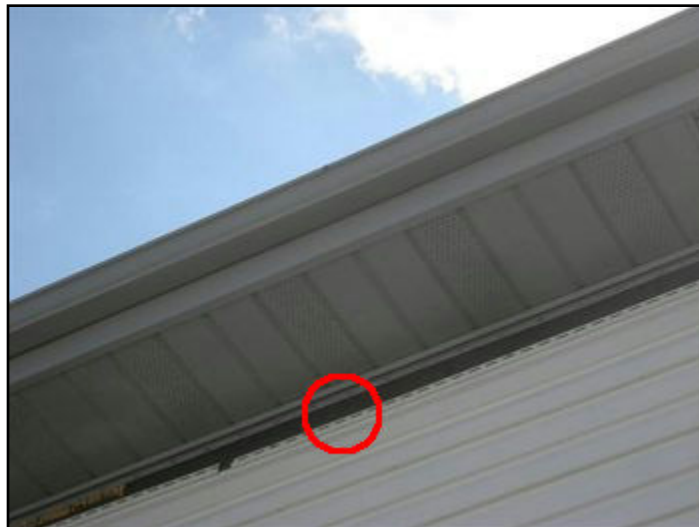
20.

Condition: • [Loose or missing pieces](#)

Implication(s): Cosmetic defects | Chance of water damage to contents, finishes and/or structure

Location: Rear Exterior Wall Second Floor

Task: Replace

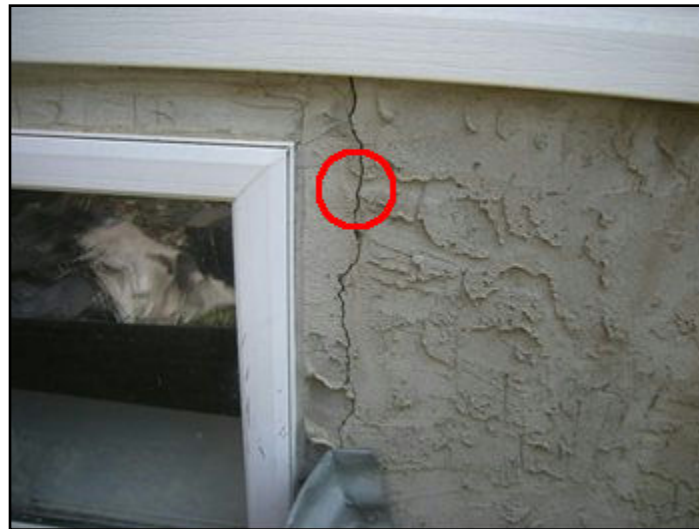
21.

Condition: • [Parging damaged or missing](#)

Location: Left Side Exterior Wall

Task: Repair

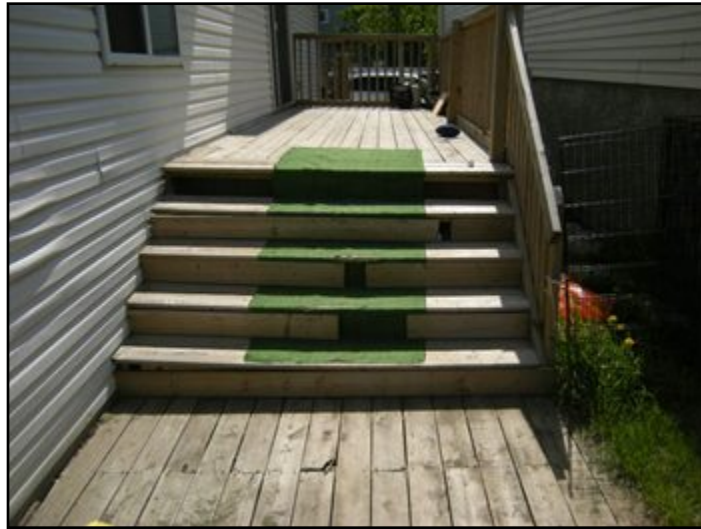
22.

Condition: • [Steps springy, loose or sagging](#)

Implication(s): Trip or fall hazard

Location: Rear Left Side Deck

Task: Repair or replace

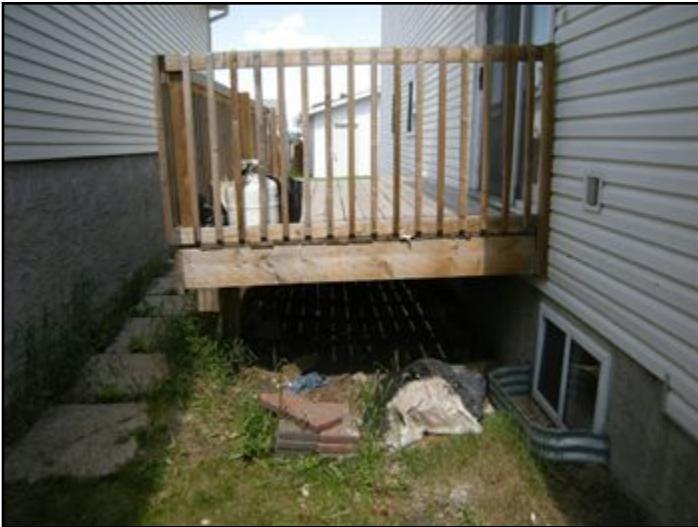
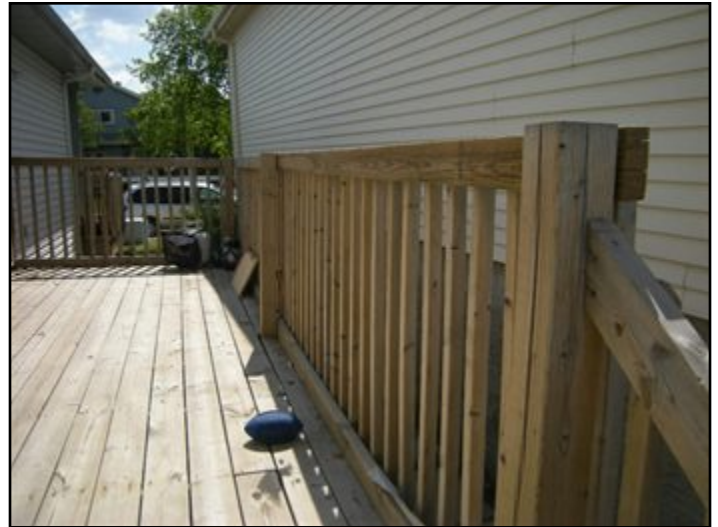
Condition: • Front and Left Side deck structure and railing need to be assessed further. Both decks are leaning/sagging as well as the railings.

Location: Front Left Side Deck

Task: Further evaluation Repair or replace

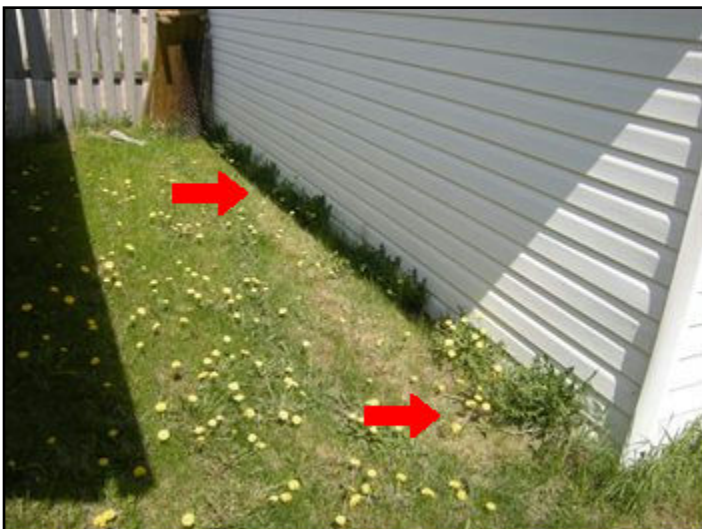
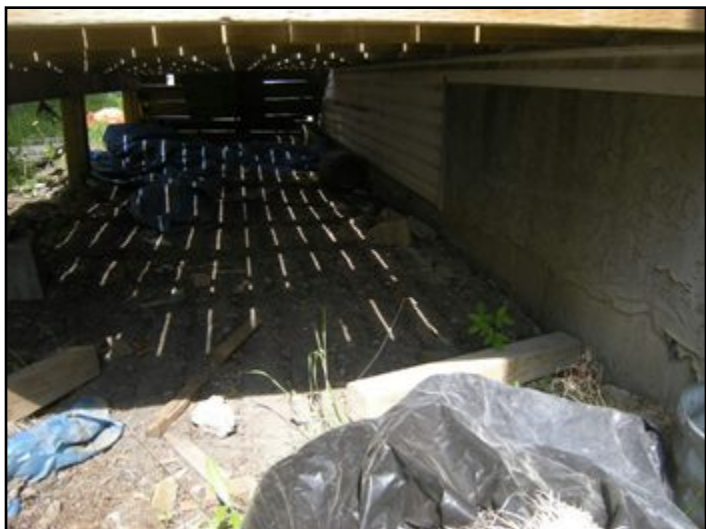
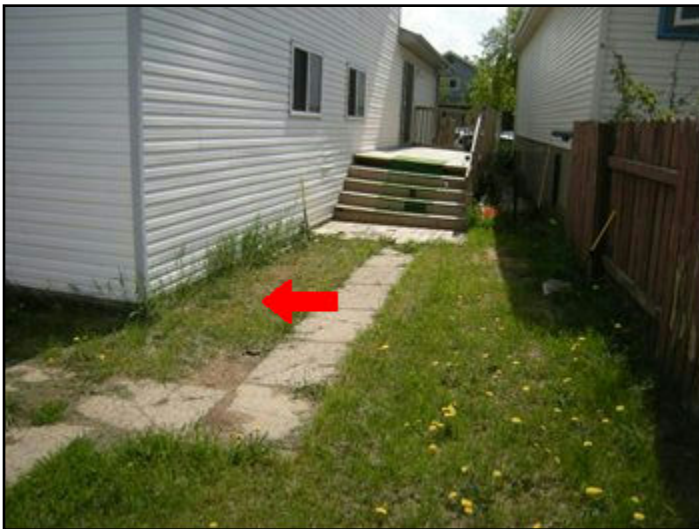
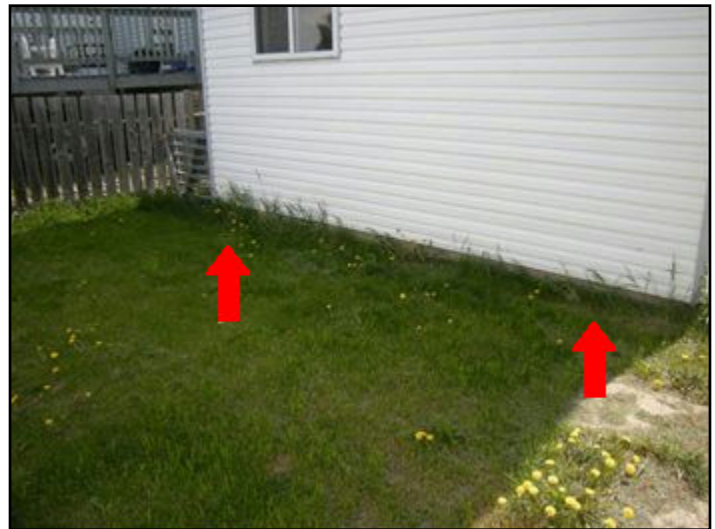
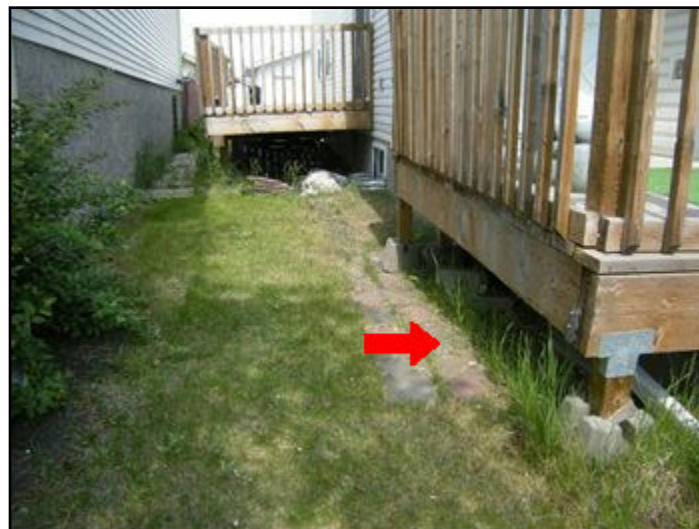
Condition: • [Improper slope](#)

Implication(s): Chance of water damage to contents, finishes and/or structure

Location: Various Yard

Task: Further evaluation Improve

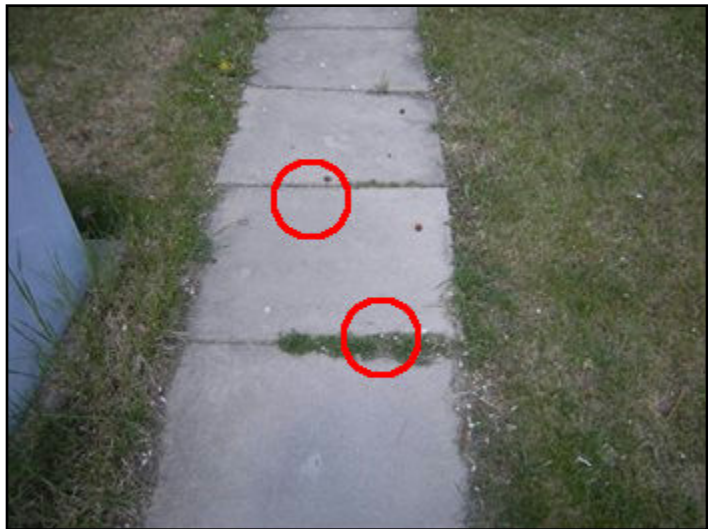
31.

Condition: • [Uneven \(trip hazard\)](#)

Implication(s): Physical injury

Location: Front Yard

Task: Improve

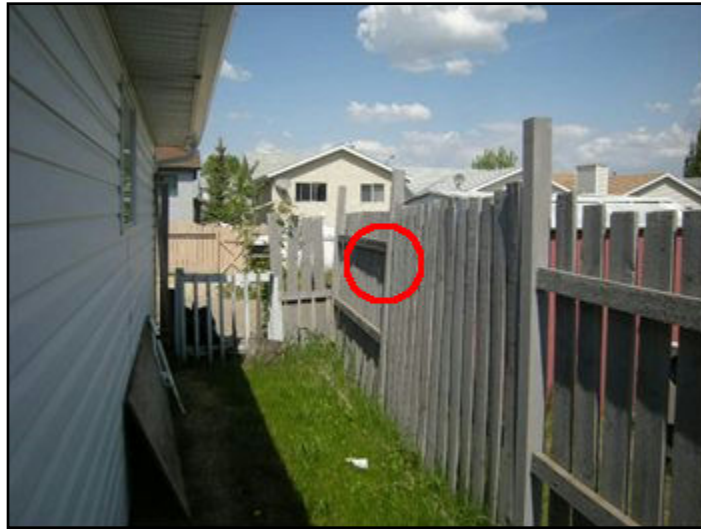
32.

Condition: • Leaning

Implication(s): Chance of movement | Damage or physical injury due to falling materials

Location: Rear Right Side Yard

Task: Further evaluation Improve

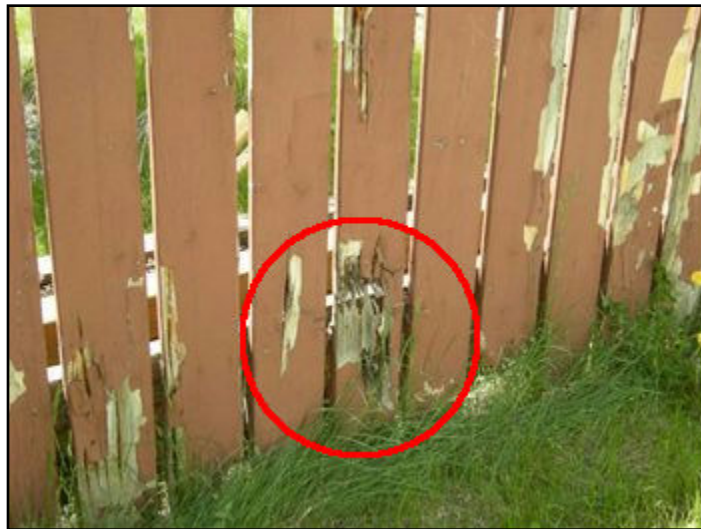
33.

Condition: • Rot

Implication(s): Material deterioration

Location: Left Side Yard

Task: Repair or replace

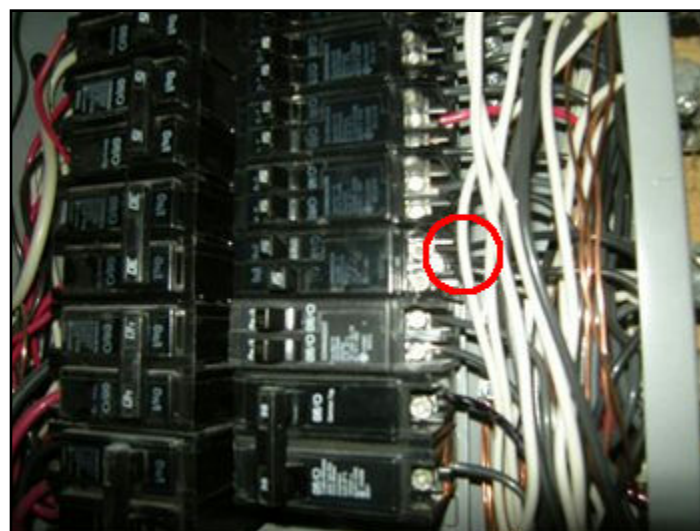
40.

Condition: • [Double taps](#)

Implication(s): Fire hazard

Location: Basement

Task: Correct Further evaluation

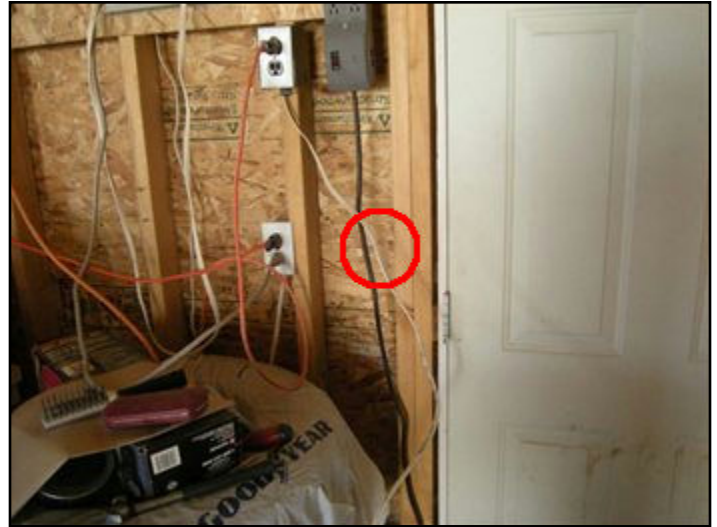
42.

Condition: • [Extension cord used as permanent wiring](#)

Implication(s): Electric shock | Fire hazard

Location: Garage

Task: Correct Further evaluation

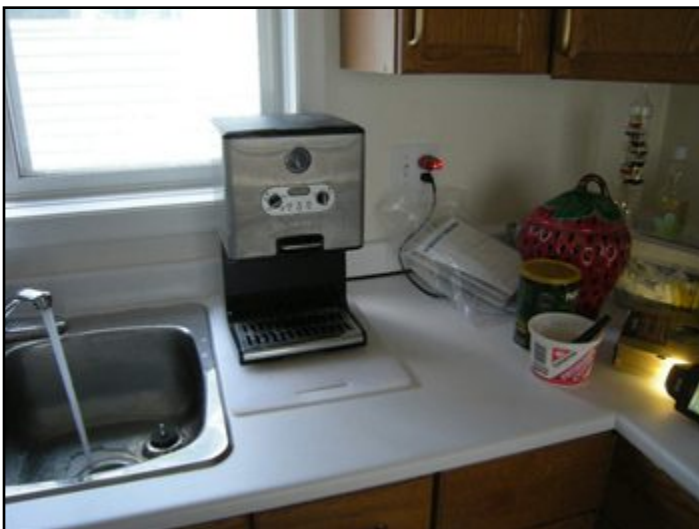
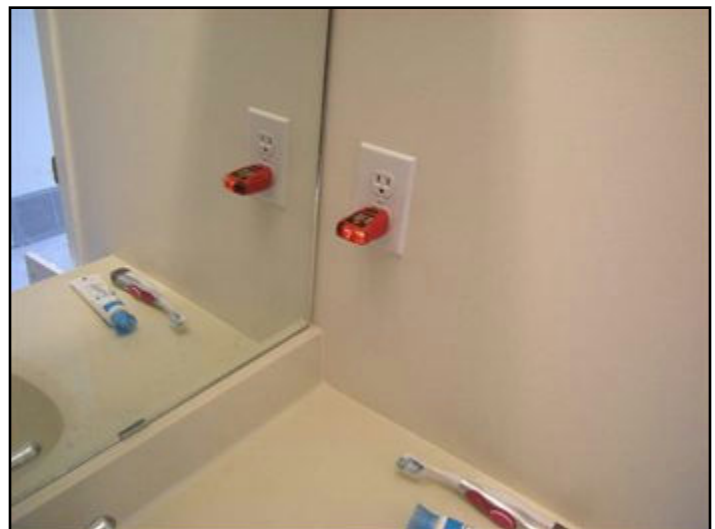
Condition: • [Ground Fault Interrupter \(GFI\) needed](#)

Implication(s): Electric shock

Location: Various

Recommend installing GFI breakers on all outlets not already installed, close to sinks in bathrooms and kitchen and all exterior outlets.

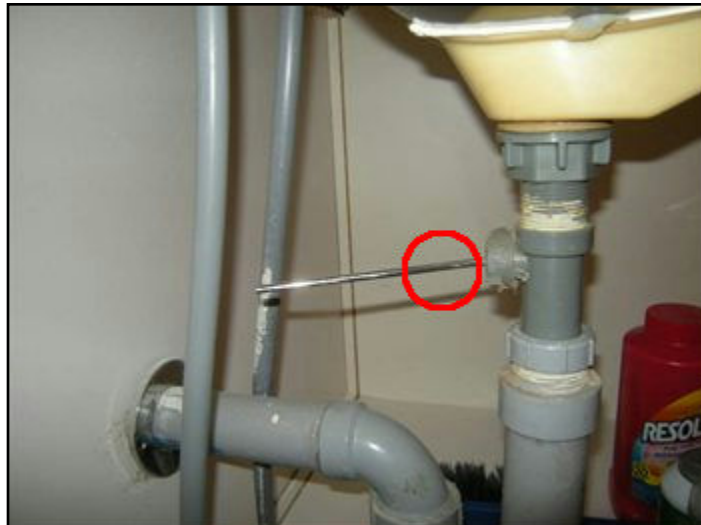
60.

Condition: • Drain plug mechanism not attached. Missing pieces.

Location: First Floor Bathroom Hallway Bathroom

Task: Repair

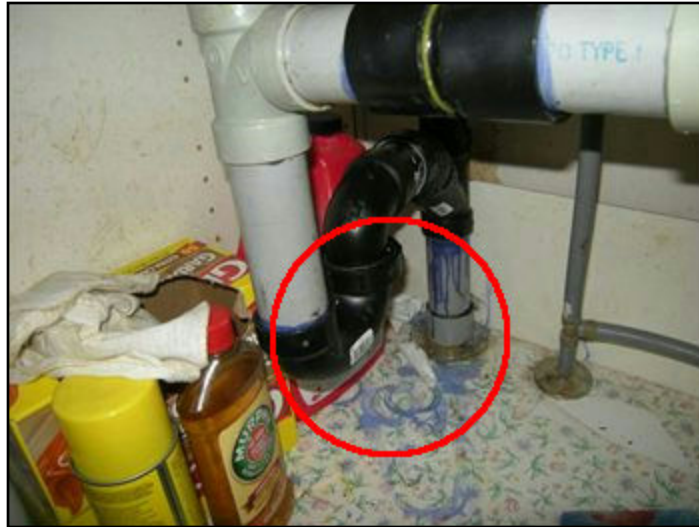
61.

Condition: • [Leak](#)

Implication(s): Sewage entering the house

Location: Kitchen

Task: Repair

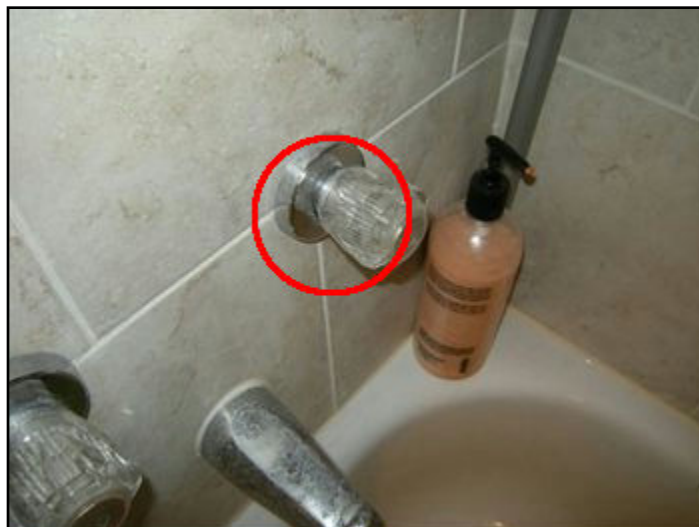
62.

Condition: • [Stiff or inoperative](#)

Implication(s): System inoperative or difficult to operate

Location: Bathroom Master Bathroom

Task: Further evaluation Repair or replace

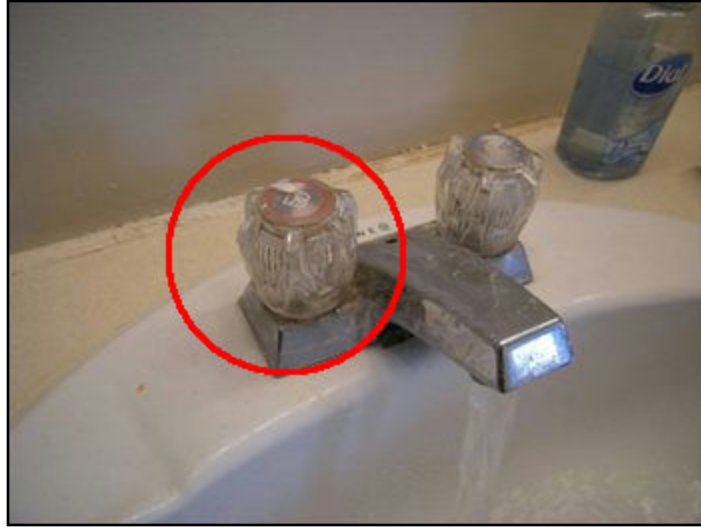
63.

Condition: • [Loose](#)

Implication(s): Equipment failure

Location: First Floor Bathroom Hallway Bathroom

Task: Repair or replace

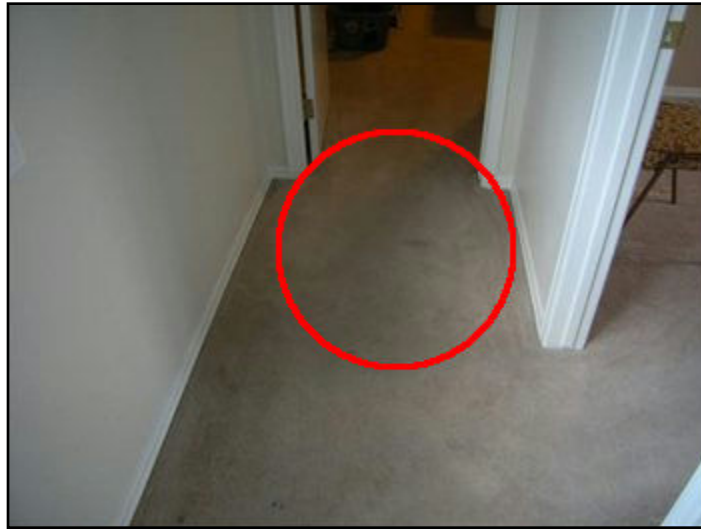
67.

Condition: • [Squeaks](#)

Implication(s): Noise nuisance

Location: Second Floor Hallway Bathroom

Task: Further evaluation Improve

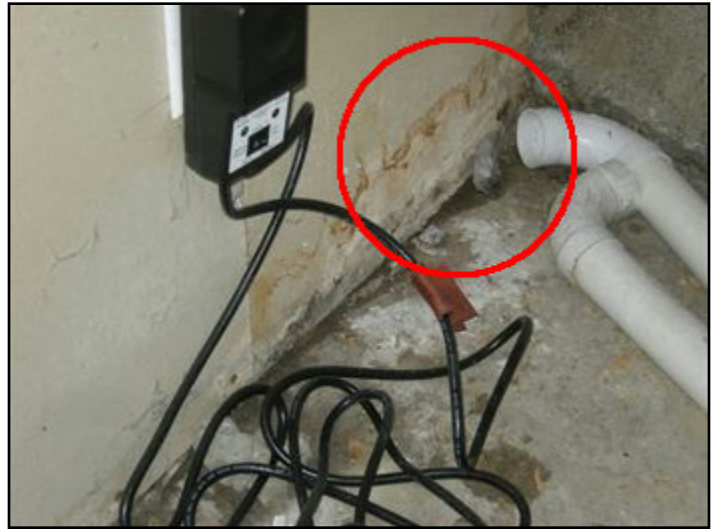
69.

Condition: • [Water damage](#)

Active water infiltration (as indicated by red light on moisture meter) in furnace room exterior wall. Recommend removal of drywall to determine source of water and or leak.

Implication(s): Cosmetic defects

Location: Basement Furnace Room

Task: Further evaluation Repair

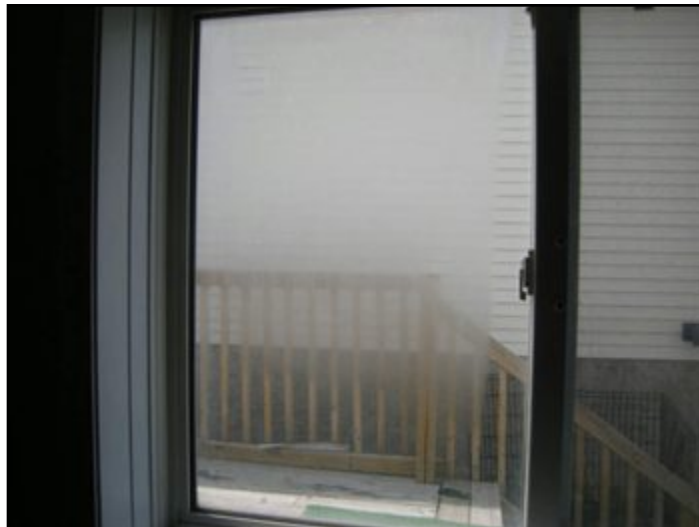
70.

Condition: • [Lost seal on double or triple glazing](#)

3 windows.

Implication(s): Cosmetic defects

Task: Further evaluation Repair

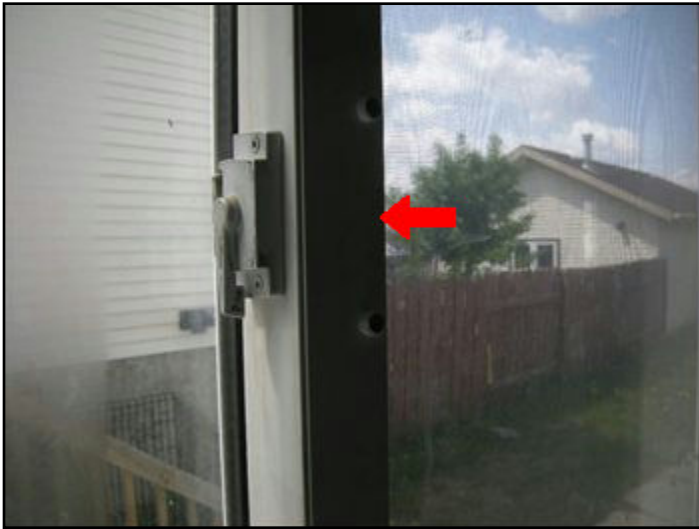
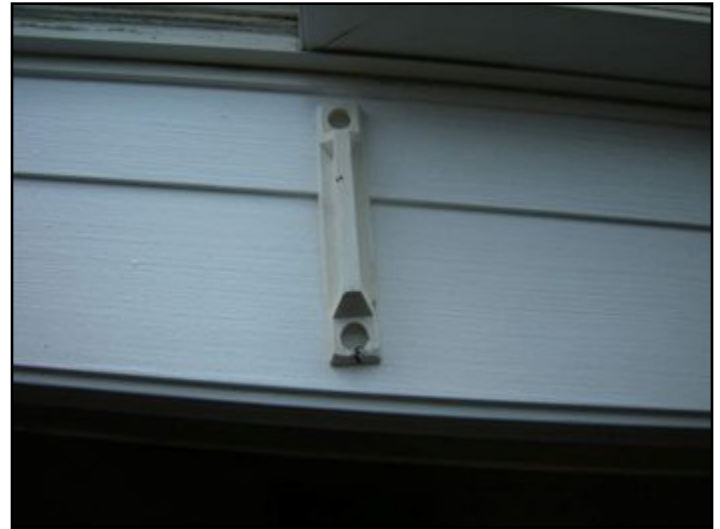
Condition: • [Missing](#)

Implication(s): System inoperative or difficult to operate

Location: Various

Task: Further evaluation Replace

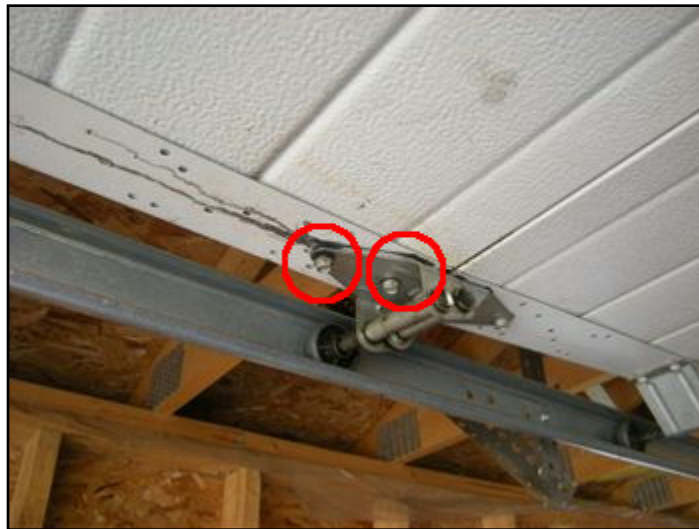
74.

Condition: • Loose Hardware

Location: Garage

Task: Further evaluation Service

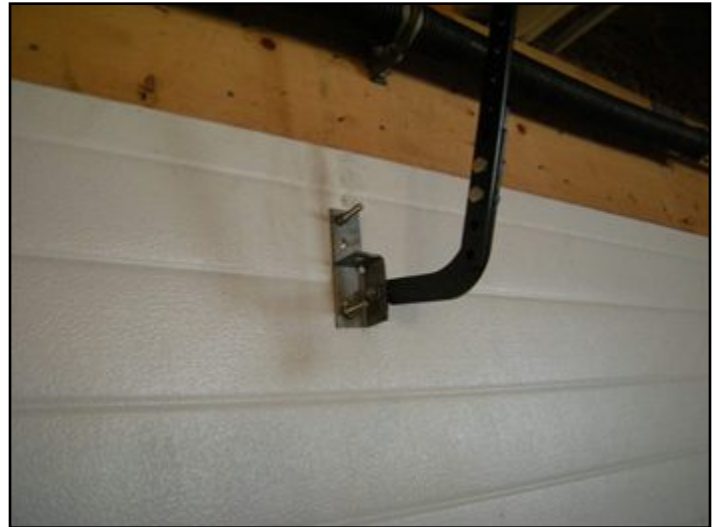
76.

Condition: • [Rusted or dented](#)

Implication(s): Material deterioration

Location: Garage

Task: Monitor
