Your Inspection Report

123 Abc St.
Bakersfield, CA 93314

INSPECTION DATE:
Tuesday, February 10, 2015

RE: Report No. 1141, v.4
123 Abc St.
Bakersfield, CA
93314

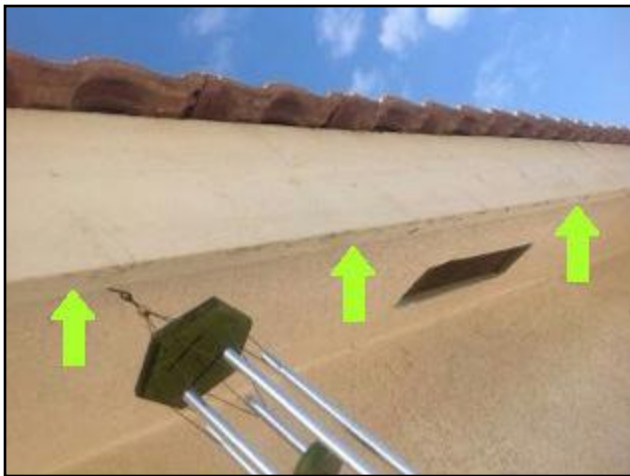
Condition: • Chipping or peeling paint

Location: Various locations

1. Chipping or peeling paint

Task: Scrape and Repaint

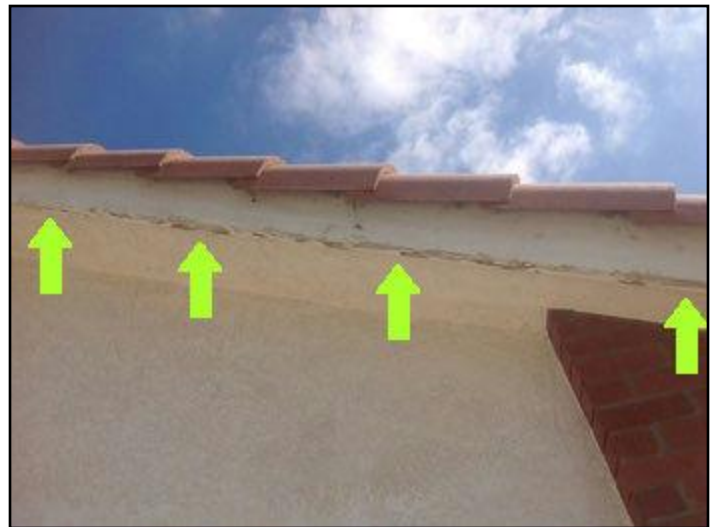
2. Chipping or peeling paint

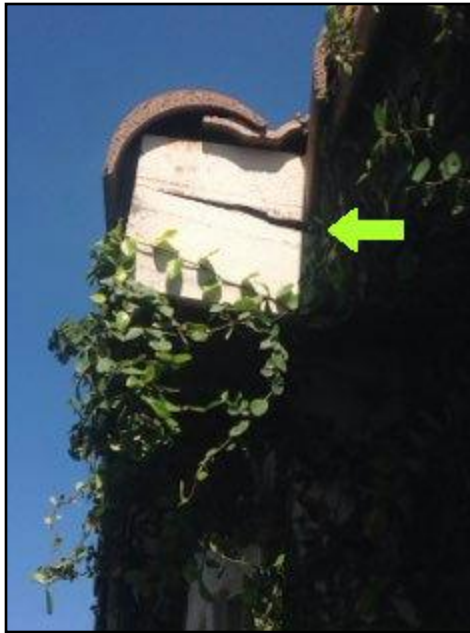
Condition: • [Damage](#)

Implication(s): Cosmetic defects | Chance of water damage to contents, finishes and/or structure

Location: Front of the house on the south side

3. Damage

Task: Replace

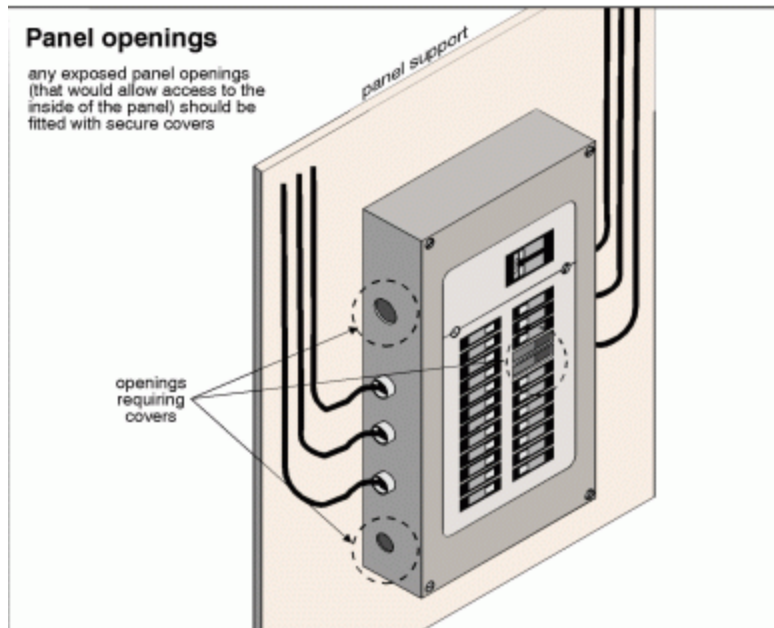
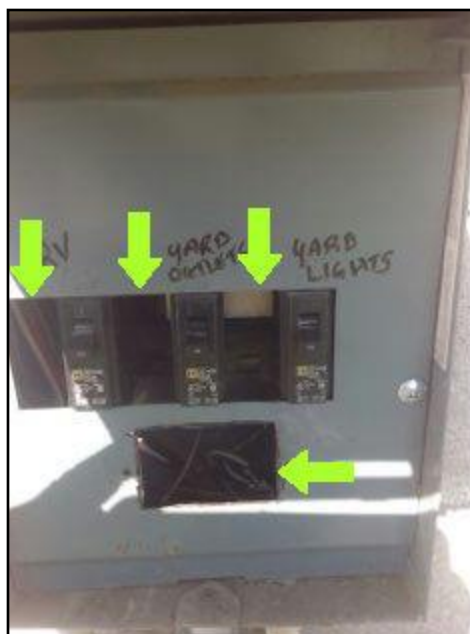
Condition: • [Openings in panel](#)

Breaker blanks needed

Implication(s): Electric shock | Fire hazard

Location: Sub panel on North fence

4. Openings in panel

Task: Safety Concern; Correct

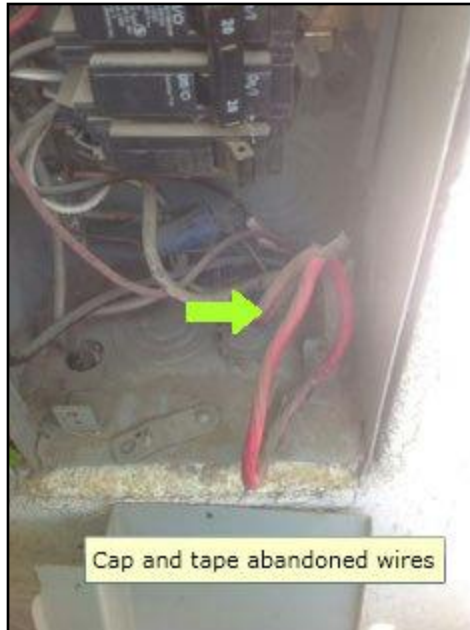
Condition: • [Abandoned wires in panel](#)

Implication(s): Electric shock

5. Abandoned wires in panel

Cap and tape abandoned wires

Task: Safety Concern; Correct

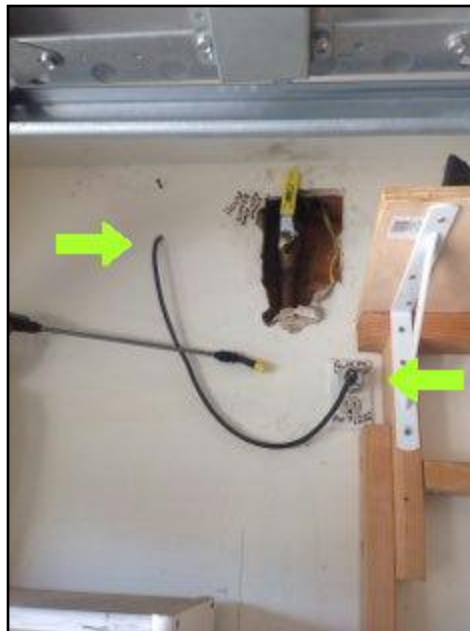
Condition: • [Extension cord used as permanent wiring](#)

Implication(s): Electric shock | Fire hazard

Location: Garage

6. Extension cord used as permanent wiring

Task: Repair or replace

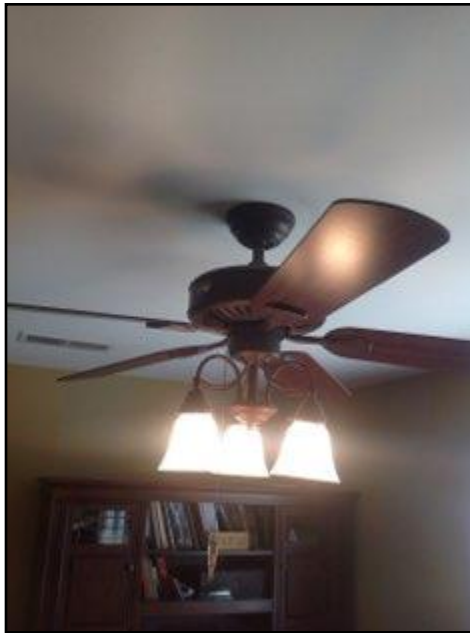
Condition: • Light functioned but fan did not

Location: Bedroom

7. Light functioned but fan did not

Task: Repair or replace

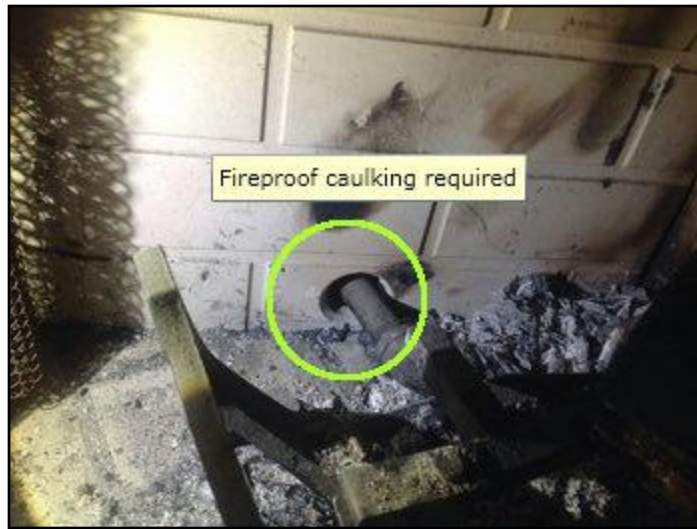
Condition: • Firebox not sealed

Location: Living Room

8. Firebox not sealed

Task: Safety Concern; Correct

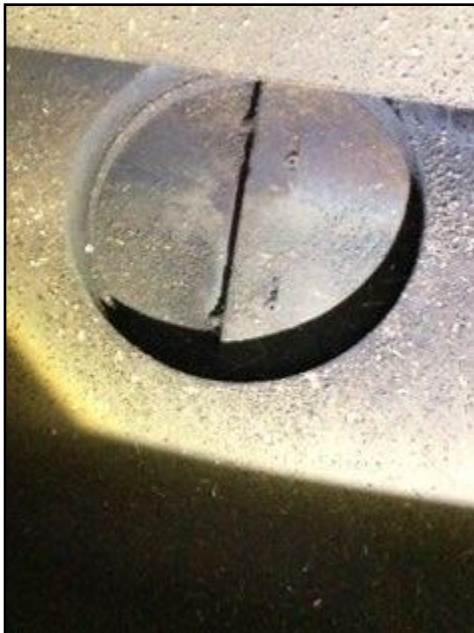
Condition: • [Damper in existing fireplace not fixed open](#)

A safety clip on the damper is a requirement to prevent the damper from closing completely. If the gas gets turned on accidentally and the damper is closed completely the gas will enter the home. The safety clip will allow the gas to go up the chimney.

Implication(s): Hazardous combustion products entering home

9. Damper in existing fireplace not fixed open

Task: Safety Concern; Correct

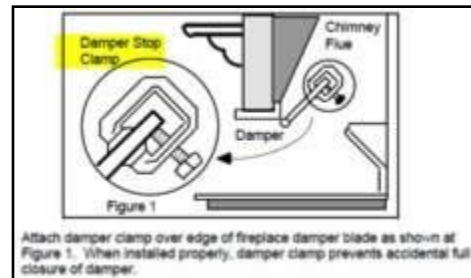
10. Damper stop needed

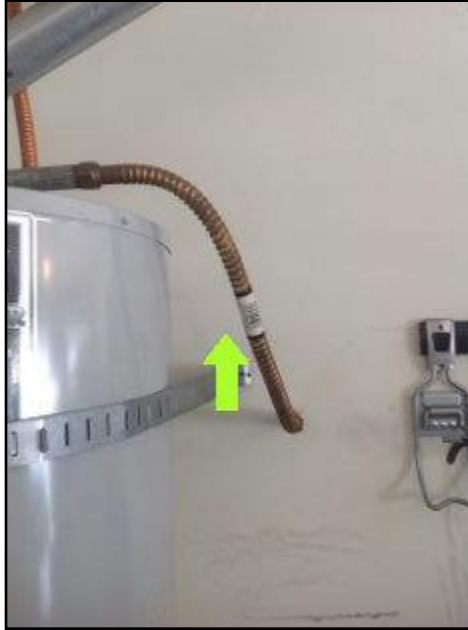
Condition: • Improper material used for TPR discharge pipe

11. Improper material used for TPR discharge pipe

Task: Safety Concern; Recommend Upgrade to current standards

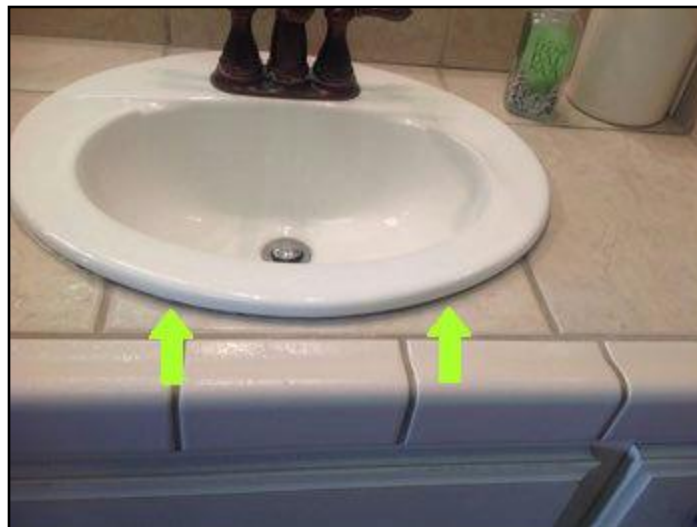
Condition: • Caulking needed

Location: Hallway Bathroom

12. Caulking needed

Task: Re-seal and Maintain

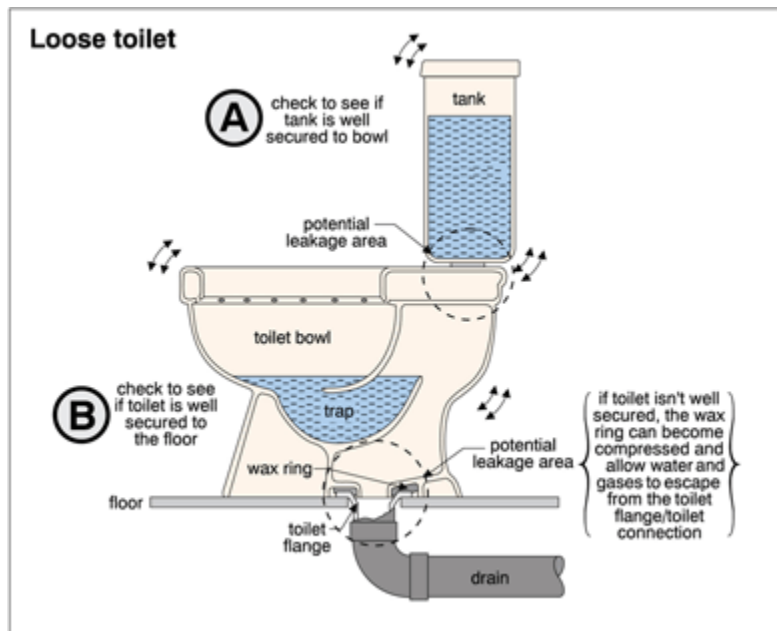
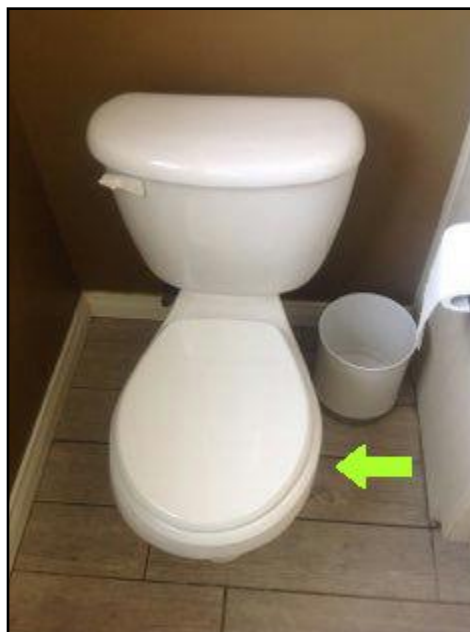
Condition: • [Loose](#)

Implication(s): Chance of water damage to contents, finishes and/or structure | Sewage entering the building

Location: Hallway Bathroom

13. Loose

Task: Repair

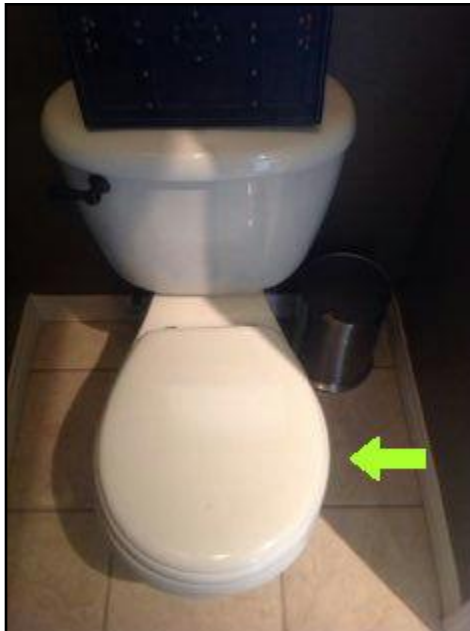
Condition: • [Loose](#)

Implication(s): Chance of water damage to contents, finishes and/or structure | Sewage entering the building

14. Loose

Task: Repair

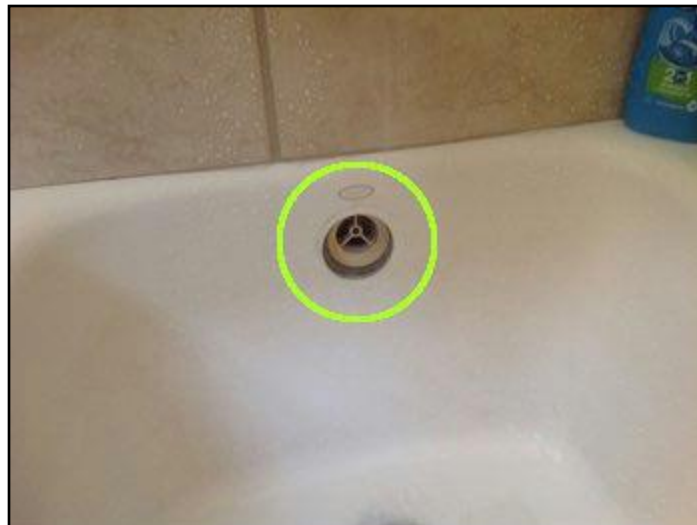
Condition: • Overflow cap missing

Location: Hallway Bathroom

15. Overflow cap missing

Task: Replace

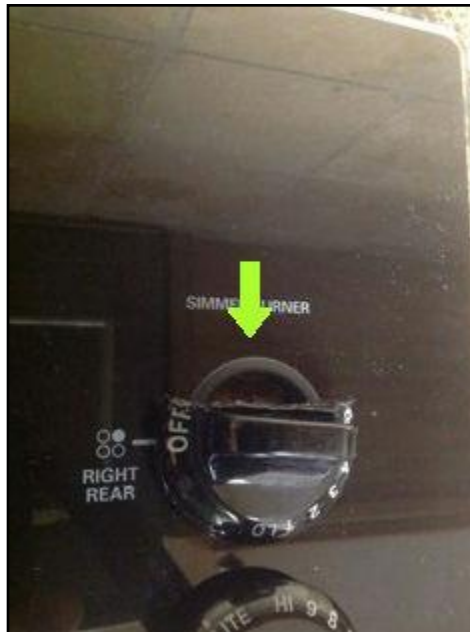
Condition: • Knobs broken

Location: Kitchen

16. Knobs broken

Task: Replace

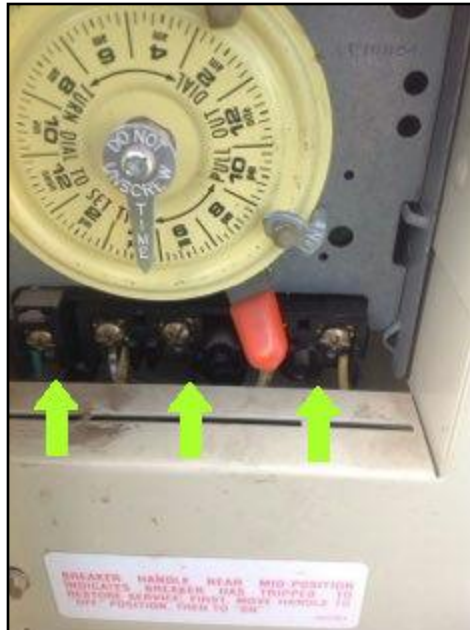
Condition: • No safety barrier

Implication(s): Shock hazard

17. No safety barrier

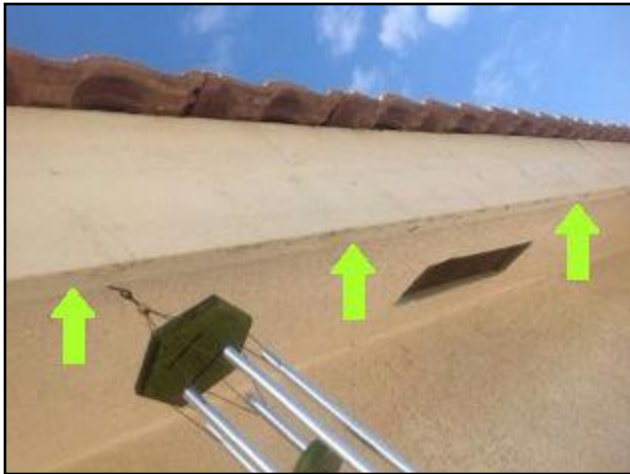
2. Condition: • Chipping or peeling paint

19. Chipping or peeling paint

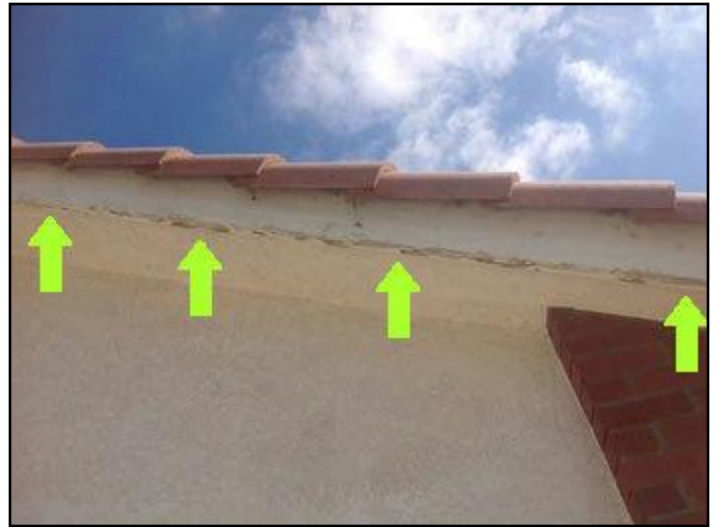
20. Chipping or peeling paint

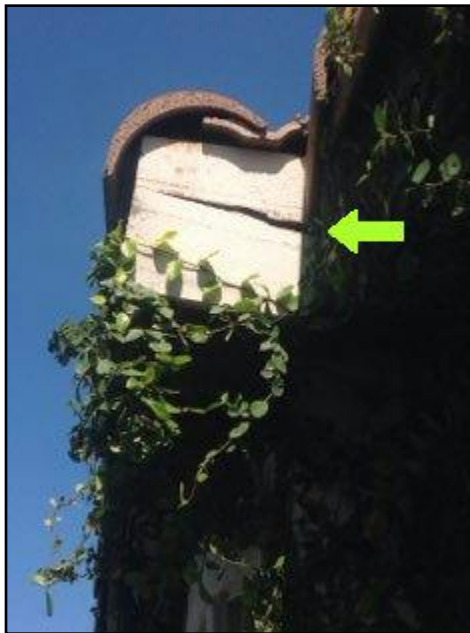
3. Condition: • [Damage](#)

Implication(s): Cosmetic defects | Chance of water damage to contents, finishes and/or structure

Location: Front of the house on the south side

21. Damage

Task: Replace

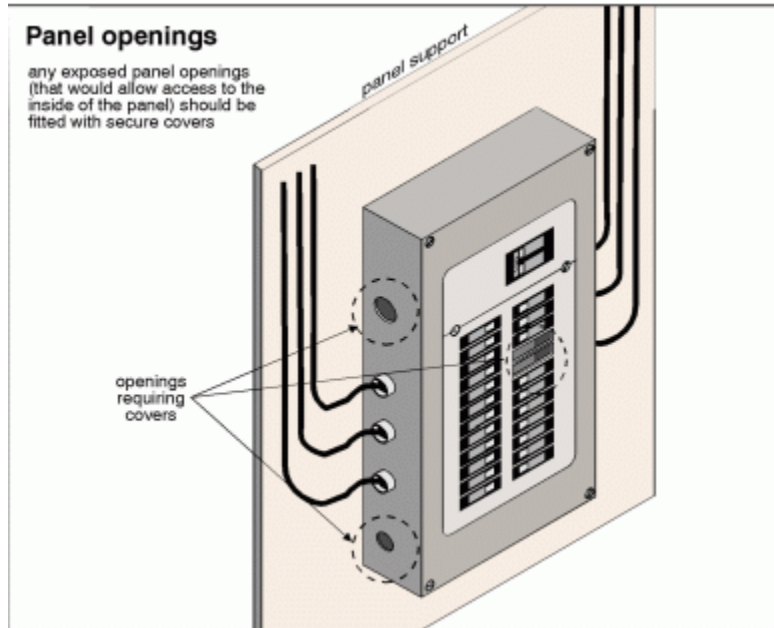
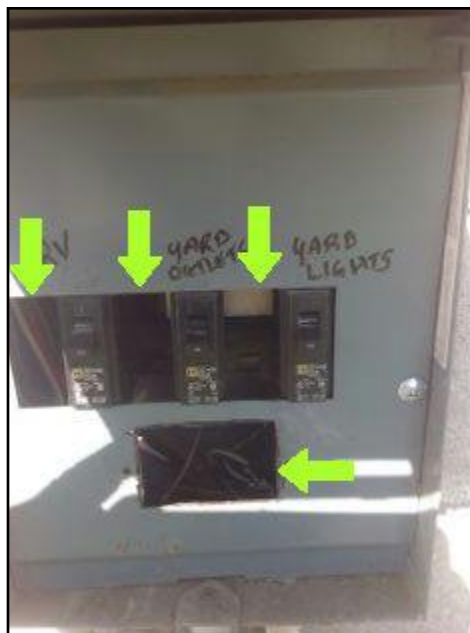
7. Condition: • [Openings in panel](#)

Implication(s): Electric shock | Fire hazard

Location: Sub panel on North fence

24. Openings in panel

Task: Safety Concern; Correct

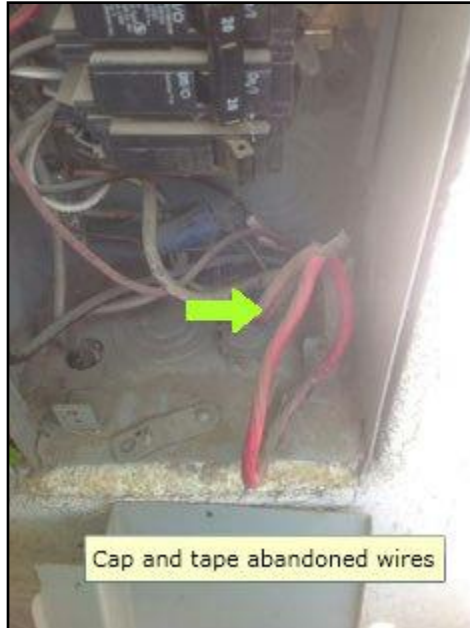
8. Condition: • [Abandoned wires in panel](#)

Implication(s): Electric shock

25. Abandoned wires in panel

Task: Safety Concern; Correct

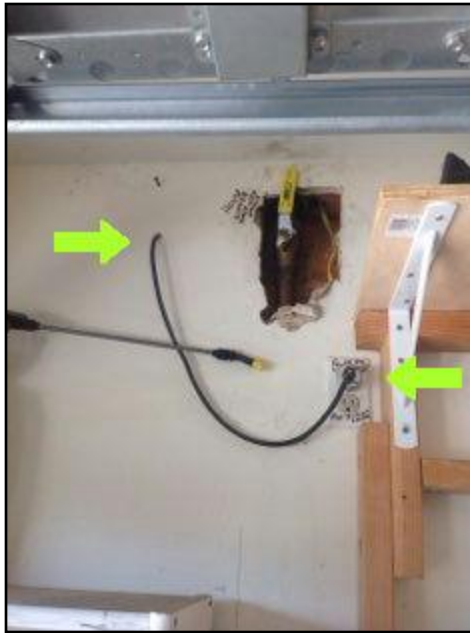
9. Condition: • [Extension cord used as permanent wiring](#)

Implication(s): Electric shock | Fire hazard

Location: Garage

26. Extension cord used as permanent wiring

Task: Repair or replace

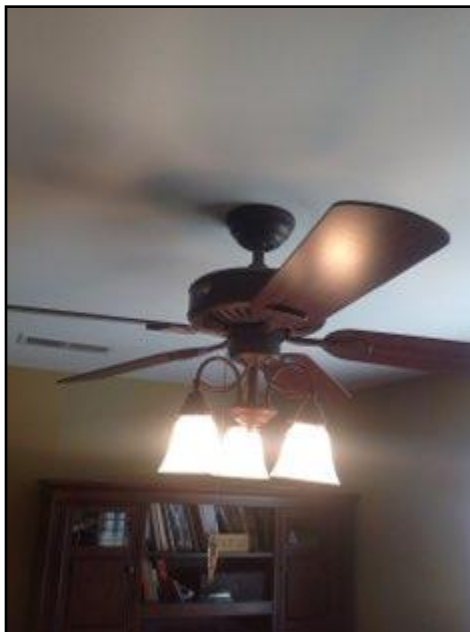
10. **Condition:** • Light functioned but fan did not

Location: Bedroom

27. Light functioned but fan did not

Task: Repair or replace

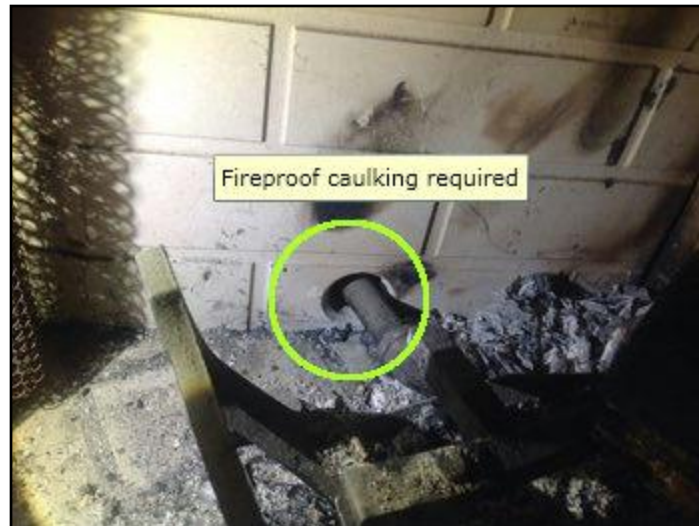
13. **Condition:** • Firebox not sealed

30. Firebox not sealed

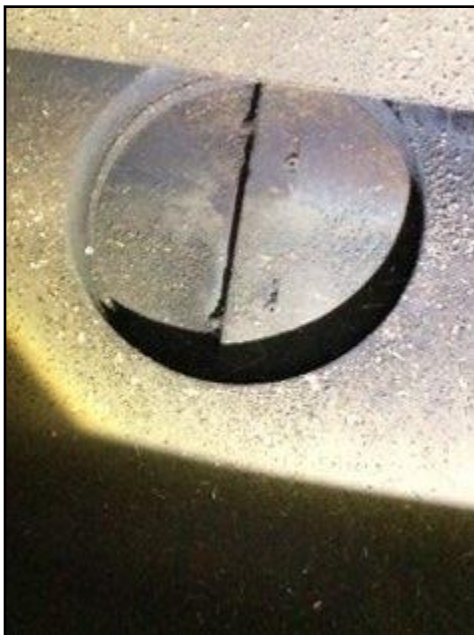
14. Condition: • [Damper in existing fireplace not fixed open](#)

Implication(s): Hazardous combustion products entering home

31. Damper in existing fireplace not fixed open

Task: Safety Concern; Correct

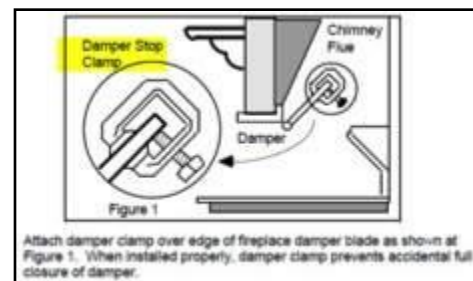
32. Damper stop needed

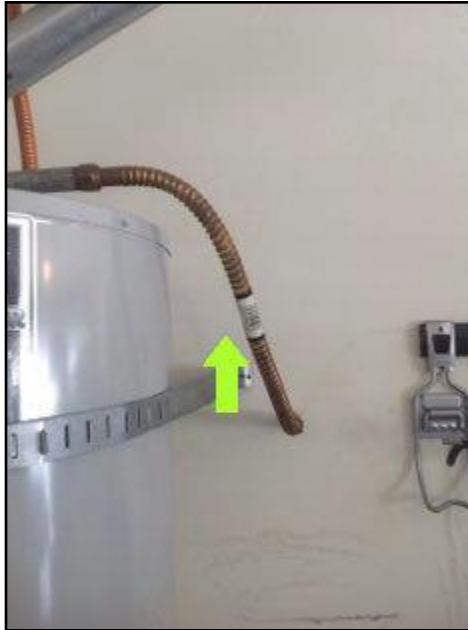
17. Condition: • Improper material used for TPR discharge pipe

37. Improper material used for TPR discharge pipe

Task: Safety Concern; Recommend Upgrade to current standards

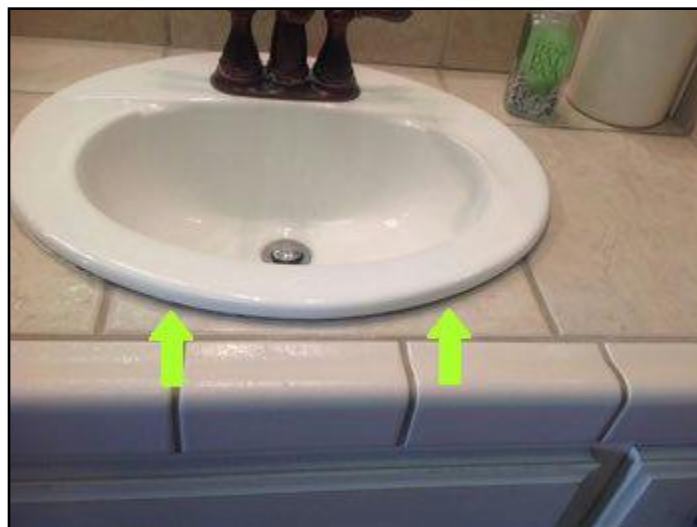
18. Condition: • Caulking needed

Location: Hallway Bathroom

38. Caulking needed

Task: Re-seal and Maintain

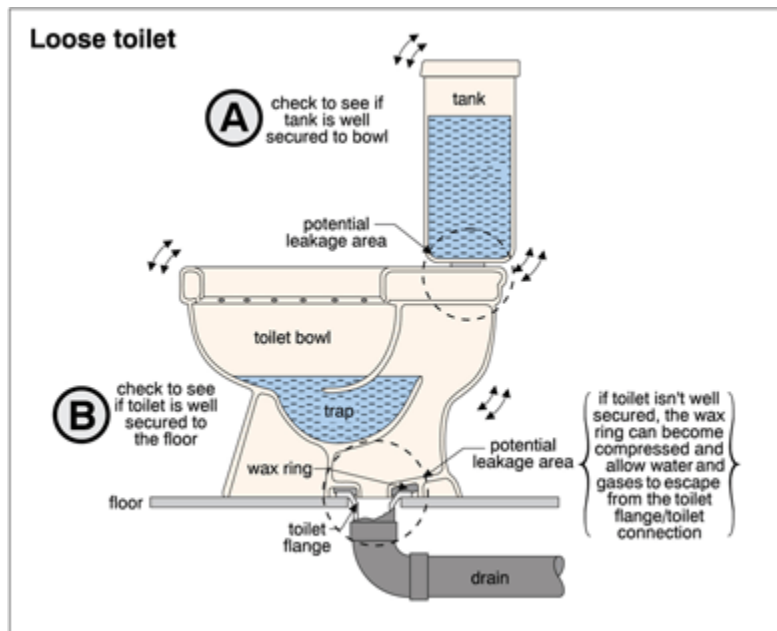
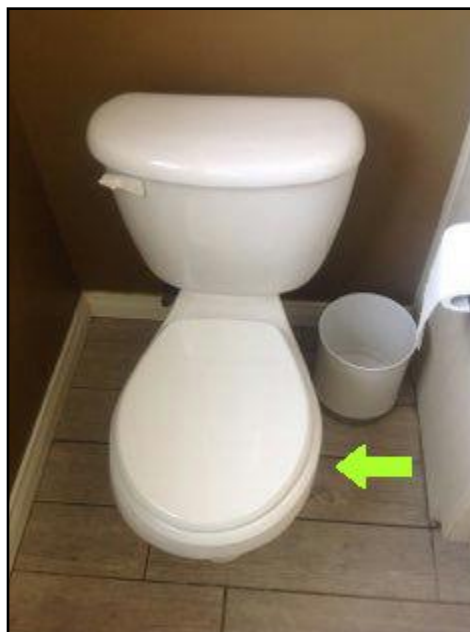
19. Condition: • [Loose](#)

Implication(s): Chance of water damage to contents, finishes and/or structure | Sewage entering the building

Location: Hallway Bathroom

39. Loose

Task: Repair

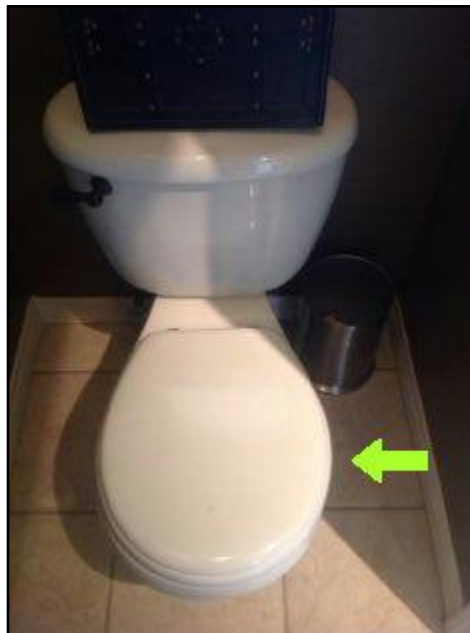
20. Condition: • [Loose](#)

Implication(s): Chance of water damage to contents, finishes and/or structure | Sewage entering the building

40. Loose

Task: Repair

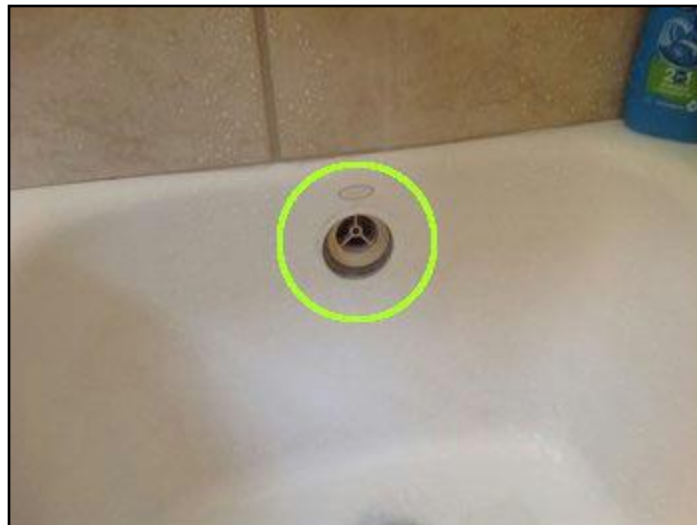
21. Condition: • Overflow cap missing

Location: Hallway Bathroom

41. Overflow cap missing

Task: Replace

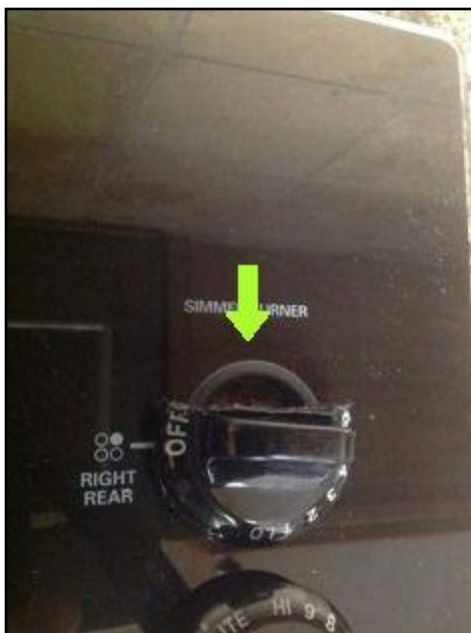
22. Condition: • Knobs broken

53. Knobs broken

Task: Replace

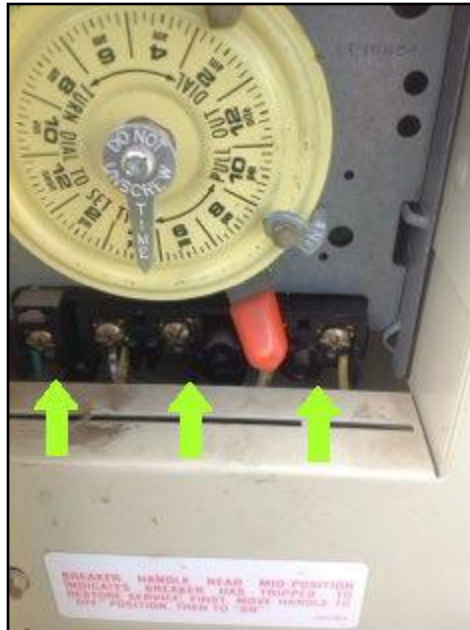
23. Condition: • No safety barrier

Implication(s): Shock hazard

57. No safety barrier
