Your Inspection Report

123 Any Street
Any Town, TN 54321

INSPECTION DATE:
Tuesday, April 19, 2011

RE: Report No. 1343, v.2
123 Any Street
Any Town, TN
54321

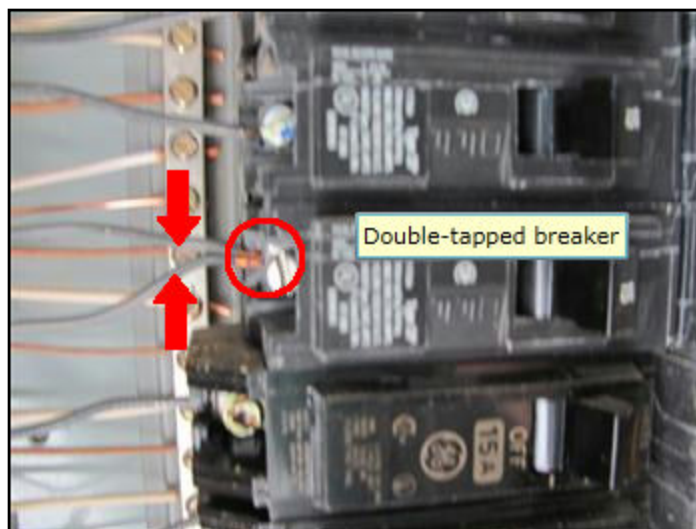
21.

SERVICE BOX, GROUNDING AND PANEL \ Distribution panel

Condition: • [Double taps](#)

Implication(s): Fire hazard

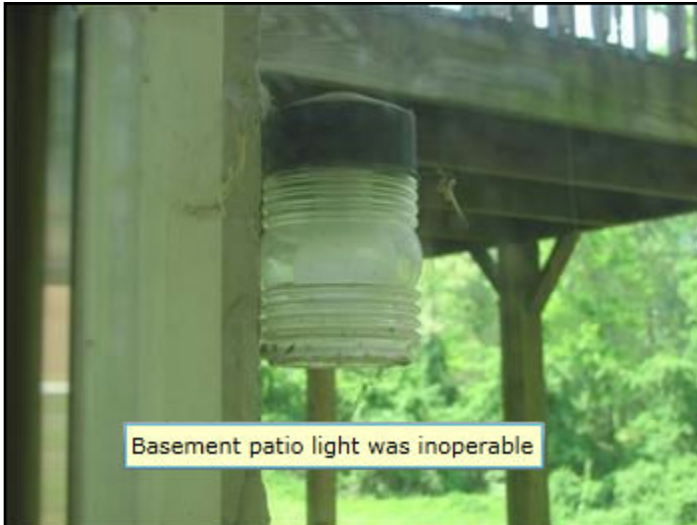
22.

DISTRIBUTION SYSTEM \ Lights

Condition: • [Inoperative](#)

Implication(s): Inadequate lighting

Location: Second Floor Bedroom

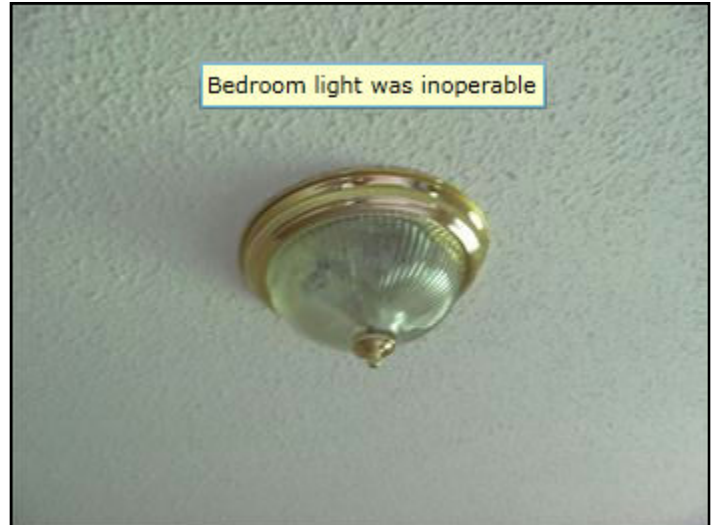
23.

Condition: • [Loose](#)

Implication(s): Electric shock | Fire hazard

Location: Garage

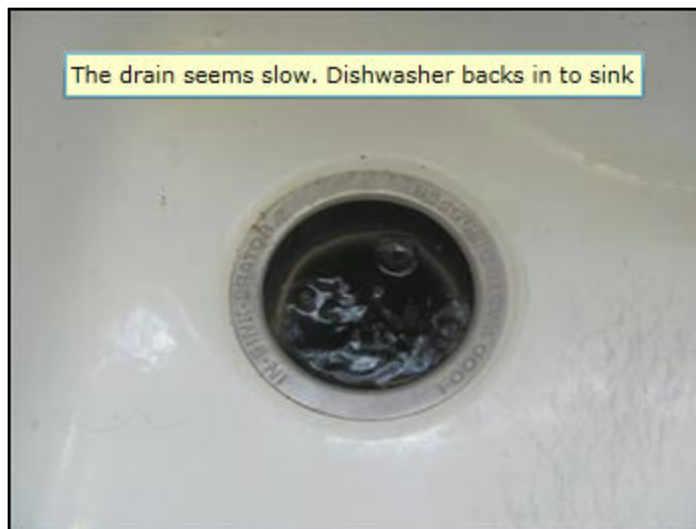
30.

Condition: • [Clogged](#)

Implication(s): Sewage entering the house

The drain seems slow. Dishwasher backs in to sink

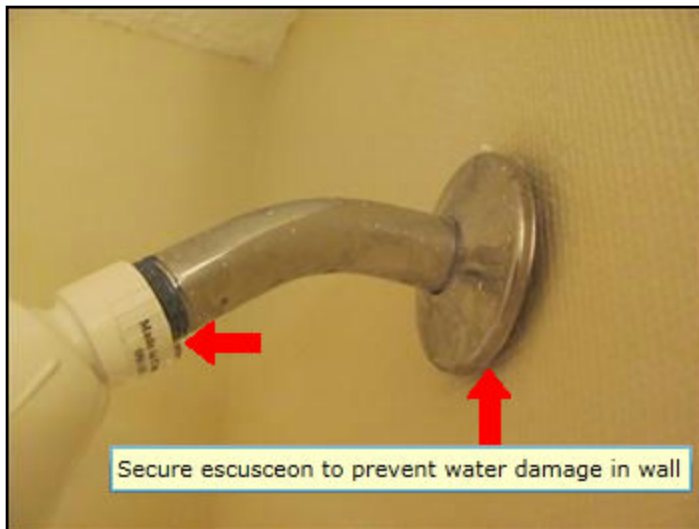
31.

Condition: • [Drip, leak](#)

Implication(s): Chance of water damage to contents, finishes and/or structure

Secure escutcheon to prevent water damage in wall

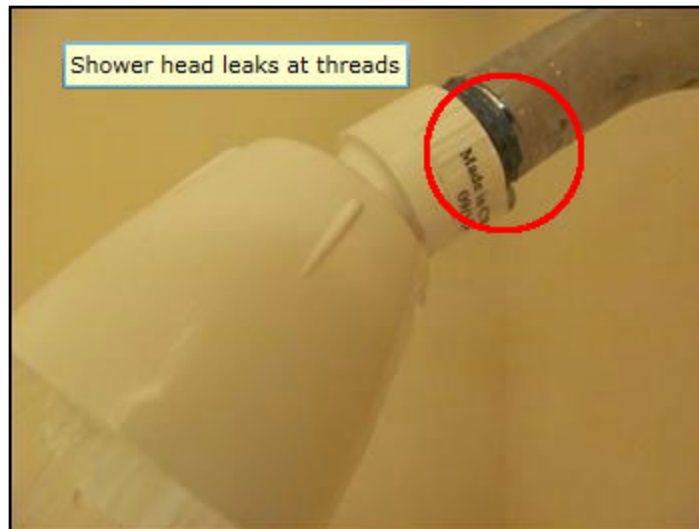
32.

Shower head leaks at threads

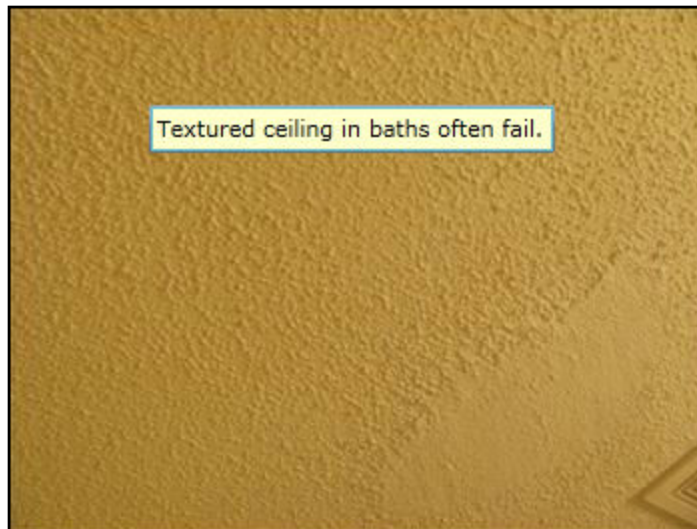
36.

Condition: • [Textured ceilings in poor locations](#)

Implication(s): Cosmetic defects | Material deterioration

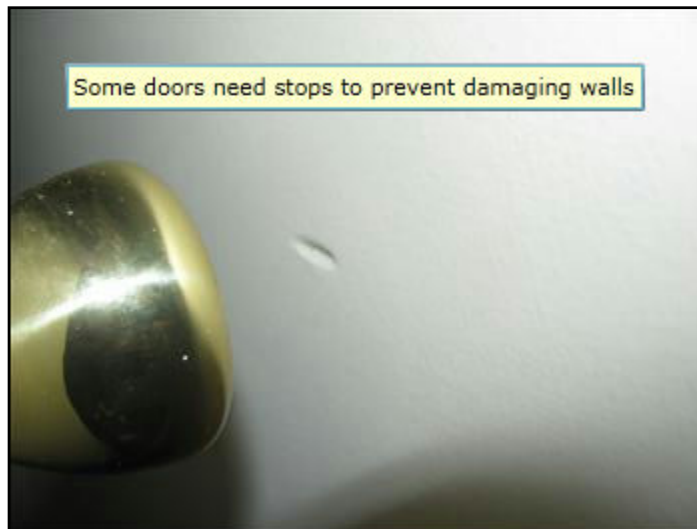
37.

DOORS \ Hardware

Condition: • Door stops are missing.

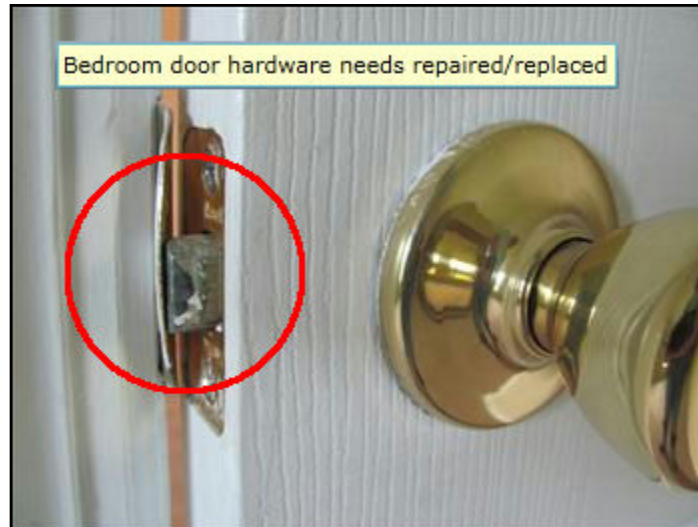
38.

Condition: • [Inoperable](#)

Location: Second Floor Bedroom
