For the Property at:  
**1234 SOMEWHERE**  
PITTSBURGH, PA 15219

Prepared for: JANE CLIENT  
Inspection Date: Friday, August 24, 2012  
Prepared by: John Fleenor

RE: Report No. 1008, v.2  
1234 Somewhere  
Pittsburgh, PA  
15219

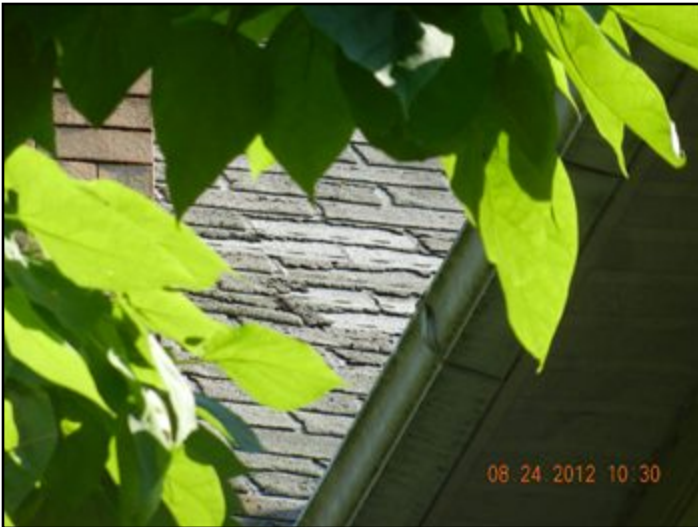
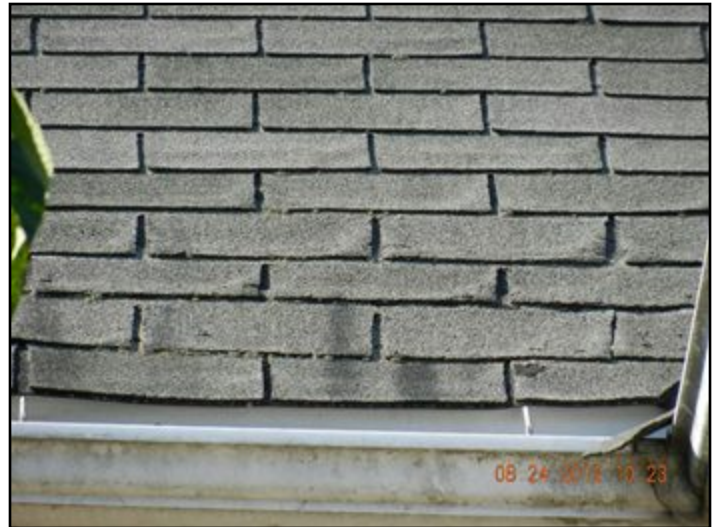
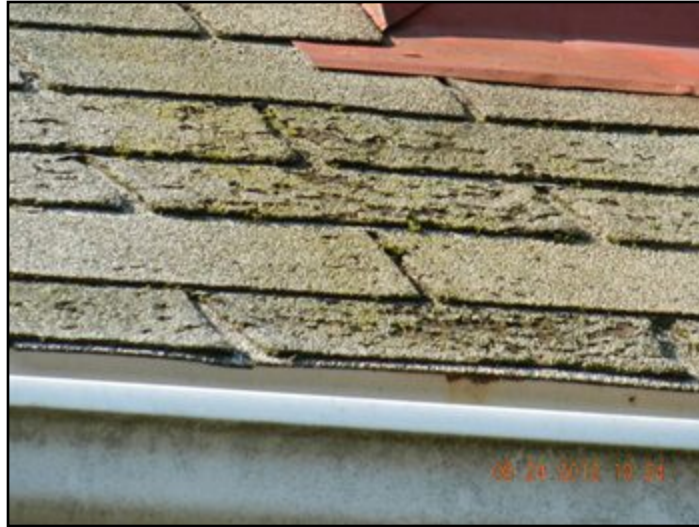
**2. Condition:** • [Cupping, curling, clawing](#)

The roof is at the end of its life and should be replaced before active leaking begins.

1. Cupping, curling, clawing

2. Cupping, curling, clawing

3. Cupping, curling, clawing

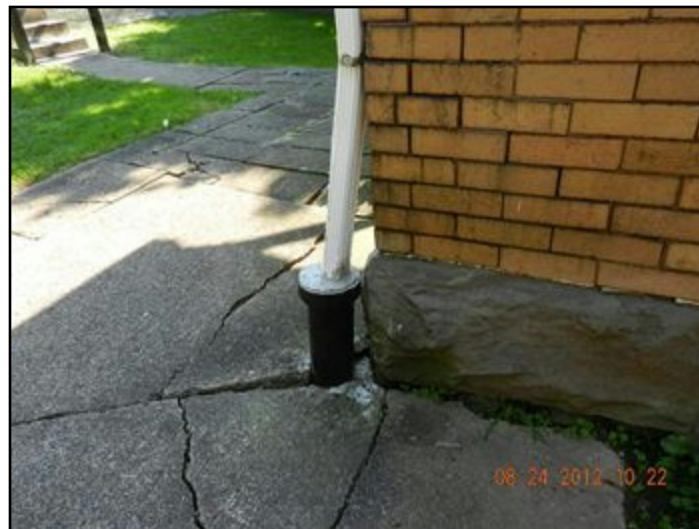
4. Condition: • [Downspouts discharging below grade](#)

All downspouts should be diverted above grade, away from the foundation.

4. Downspouts discharging below grade

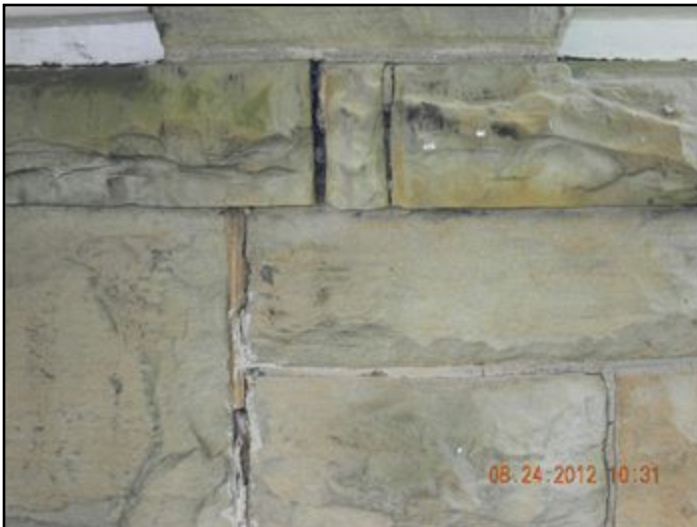
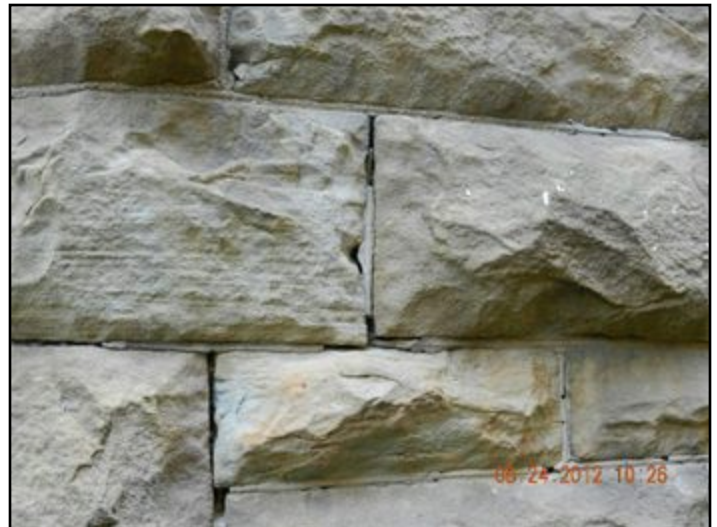
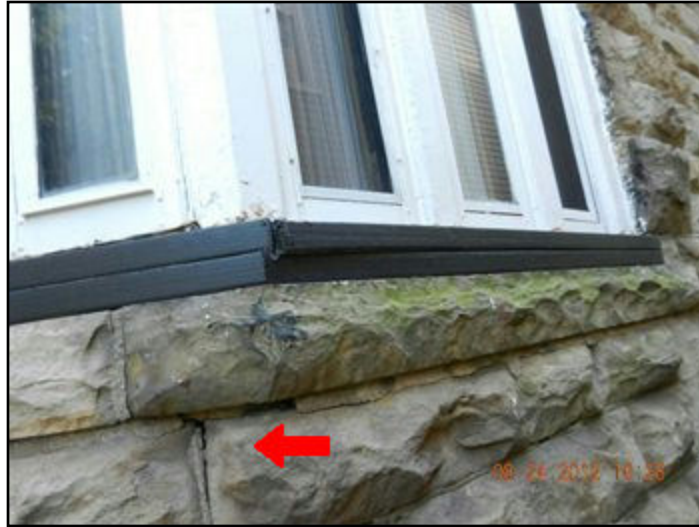
5. Condition: • [Mortar deterioration](#)

5. Mortar deterioration

6. Mortar deterioration

7. Mortar deterioration

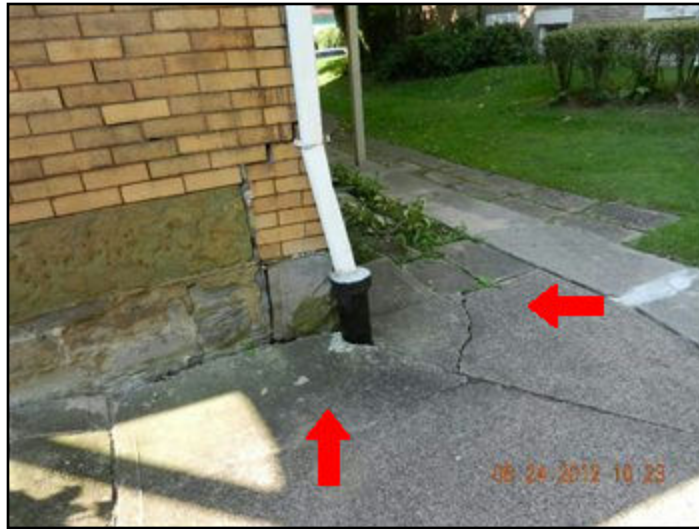
### 6. Condition: • [Improper slope or drainage](#)

The sidewalk and paving at the back of the house has settled so that water drains towards the house. The sidewalk should be replaced and the grade improved so water sheds away from the building perimeter.

8. Improper slope or drainage

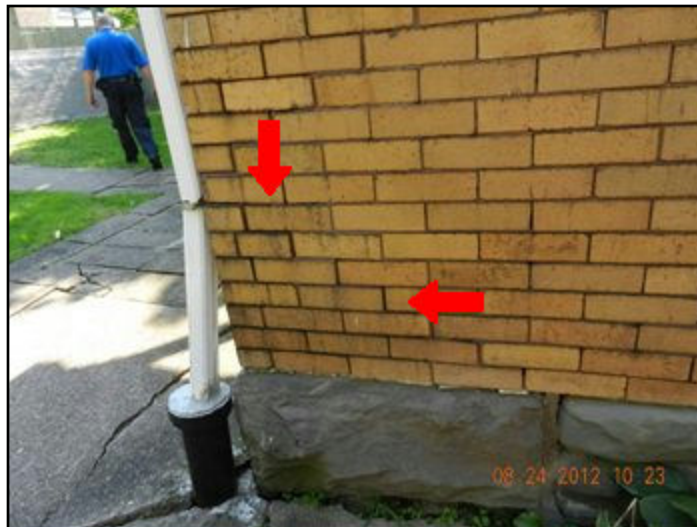
#### **7. Condition:** • [Settled](#)

The foundation has settled at the corner where the sidewalk has sunk. The condition is noted and should be monitored and measured for additional movement overtime. The important step is to stop water damage in this corner by correcting grading and removing moisture from downspouts.

9. Settled

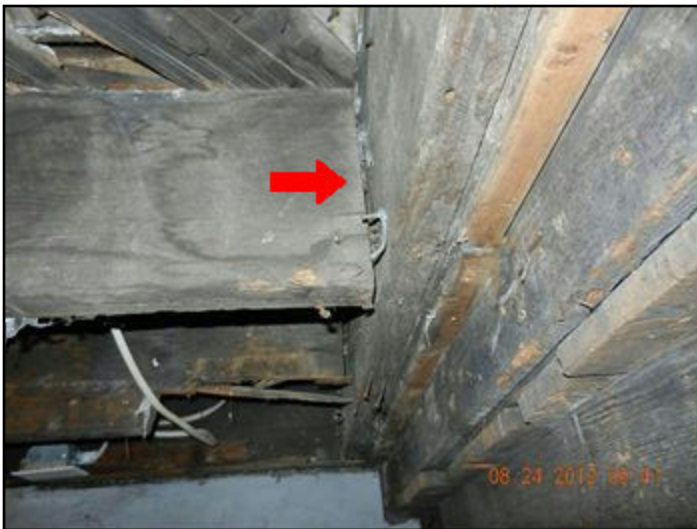
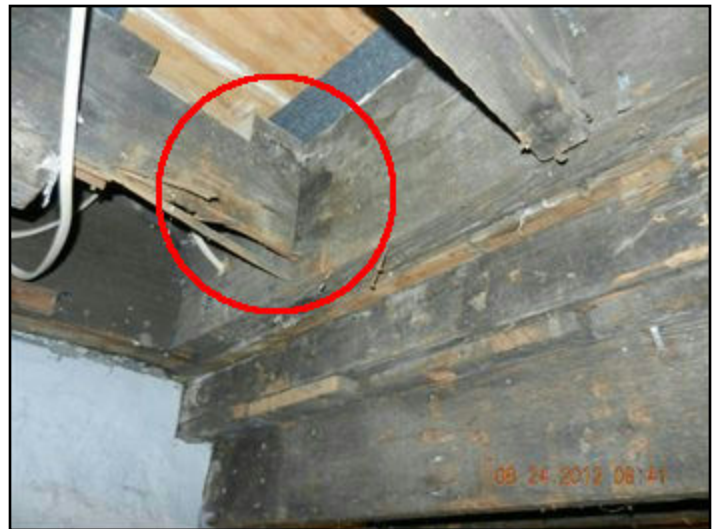
9. Condition: • [Poor end bearing, joist hanger connections](#)

Joists have been notched, and damaged and do not bare well on supporting beam. Have this repaired by a qualified contractor.

10. Poor end bearing, joist hanger connections

11. Poor end bearing, joist hanger connections

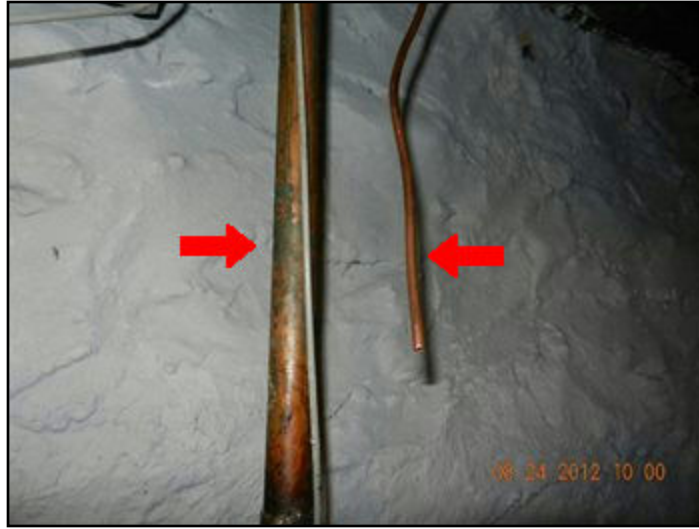
10. Condition: • [Poor connections](#)

Ground wire not connected to plumbing. Attach ground to plumbing with appropriate clamp.

15. *Poor connections*

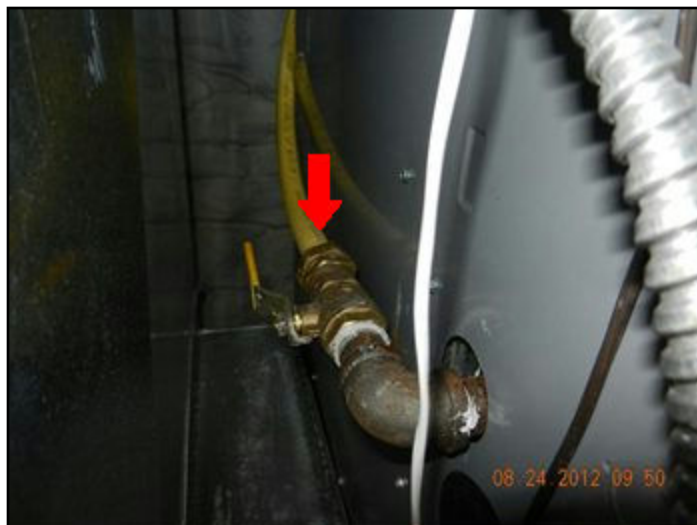
11. **Condition:** • [Leak](#)

Gas leak detected at the union at the furnace shut off valve.

19. Leak

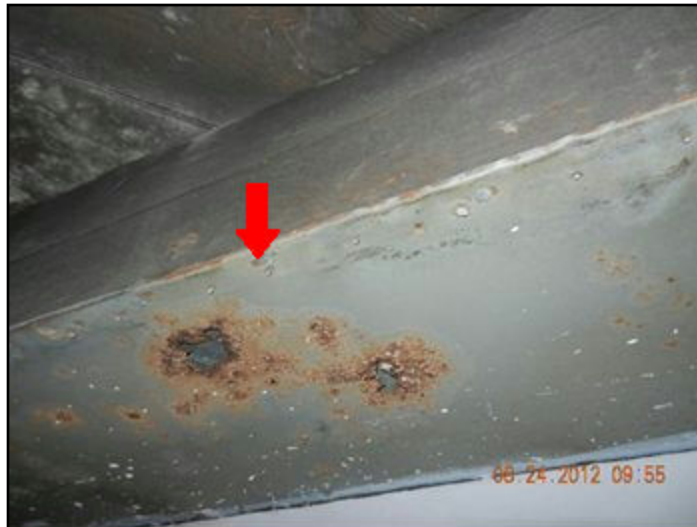
**12. Condition:** • Rusted duct work. Supply duct is rusted through in places.

20. Rusted HVAC return duct

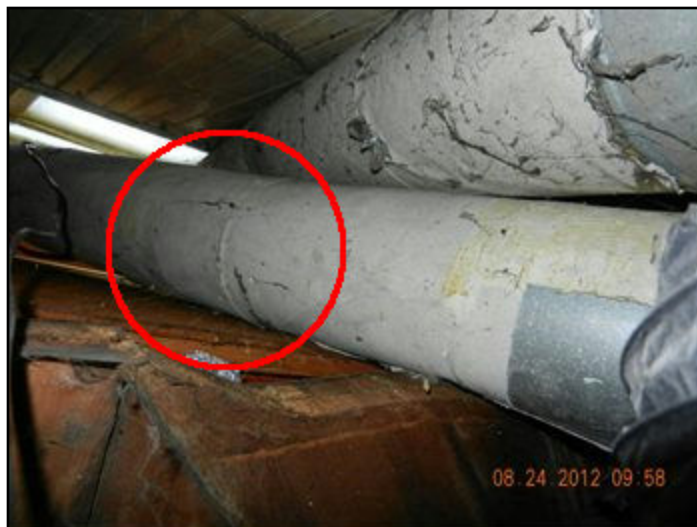
**13. Condition:** • Duct insulation likely contains asbestos. Have it removed by a qualified asbestos contractor

21. Asbestos lining ductwork

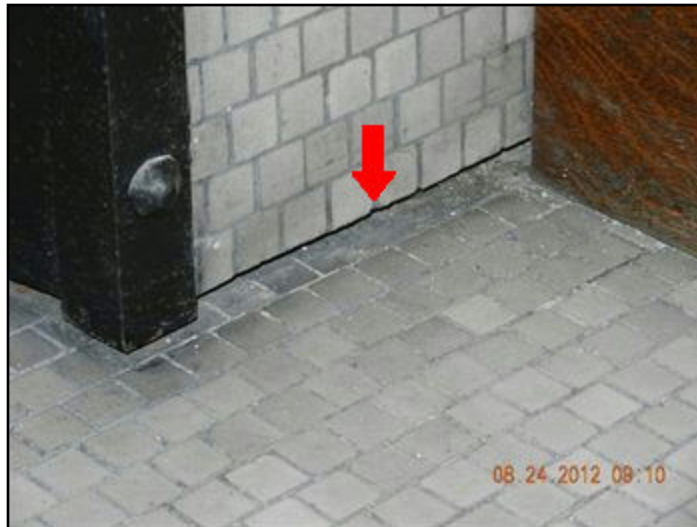
14. Condition: • [Settled](#)

22. Settled

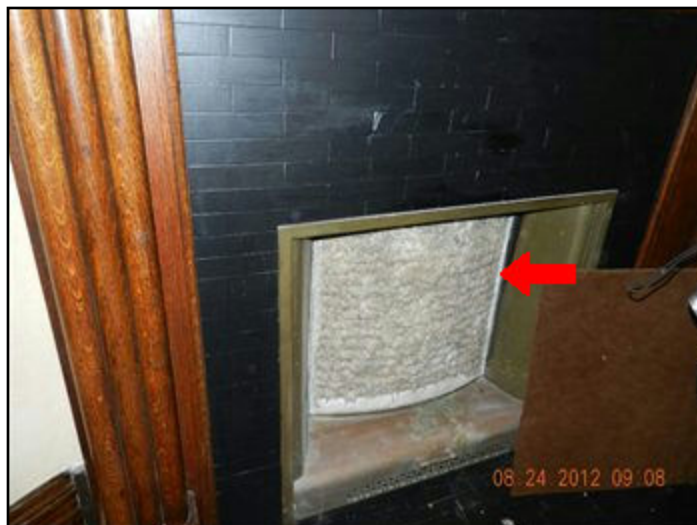
23.

15. Condition: • At least one fireplace in the house contains asbestos materials that should be removed or sealed. Have a qualified contractor do the work.

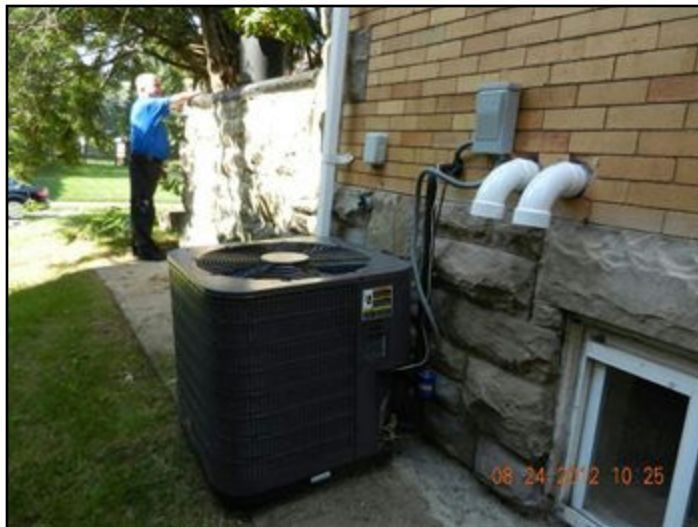
- 10°
- This suggests performance issues. Service may be needed.

24. This suggests performance issues. Service...

**16. Condition:** • [Inadequate cooling](#)

An audible buzz was coming from the condenser unit, the condenser unit is less than a year old but did not achieve adequate cooling during the inspection. Have a qualified HVAC professional evaluate and repair as necessary.

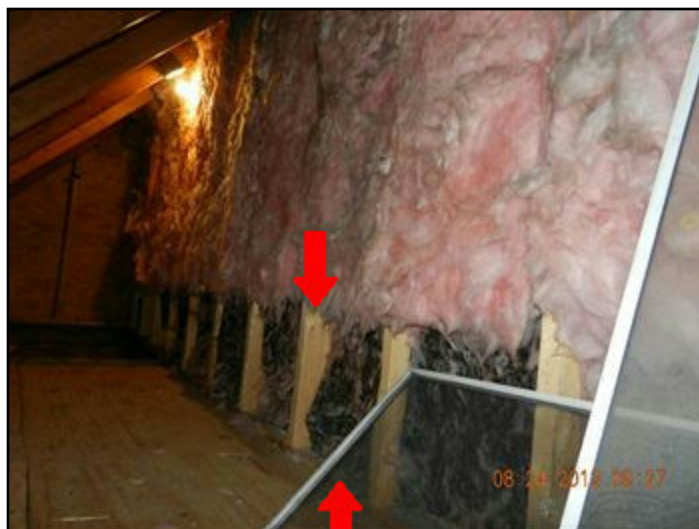
**17. Condition:** • [Inadequate in knee wall areas](#)

Insulation in Right side knee wall is missing to the height a squirrel can reach. Squirrel activity in the Knee wall in the past is likely. No squirrels seen during the inspection.

**25.** *Inadequate in knee wall areas*
