Your Inspection Report

247 Bellwoods Avenue
Toronto, ON M6J 2R3

Tuesday, August 13, 2019

RE: Report No. 2869
247 Bellwoods Avenue
Toronto, ON
M6J 2R3

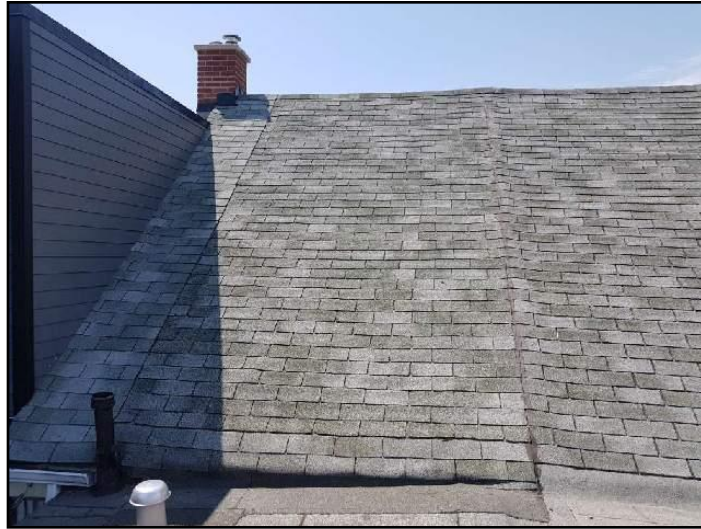
1. Asphalt shingles

Porch roof due for immediate reshingling, reshingle main roof in 2-3 years.

Task: Replace

Time: 2-3 years

Cost: \$7,000 - \$8,000

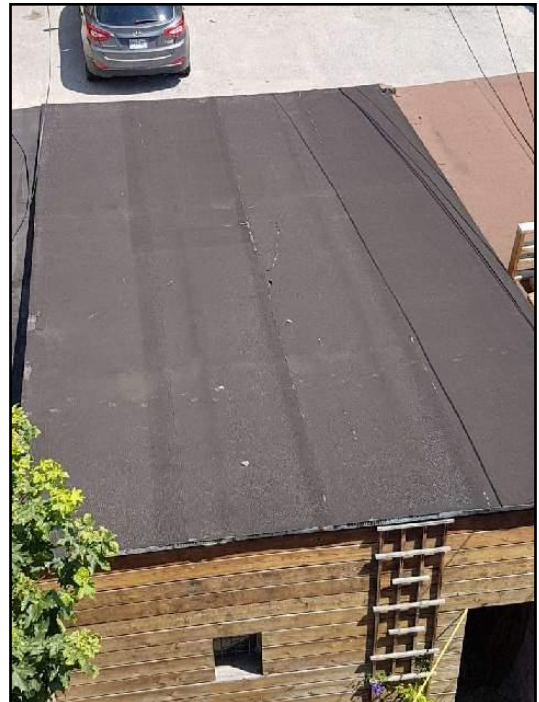
3. Garage

Garage roof damaged and leaking, although these areas could be repaired, recommend resurfacing roof due to age.

Task: Replace

Time: Immediate

Cost: \$3,000 - \$4,000

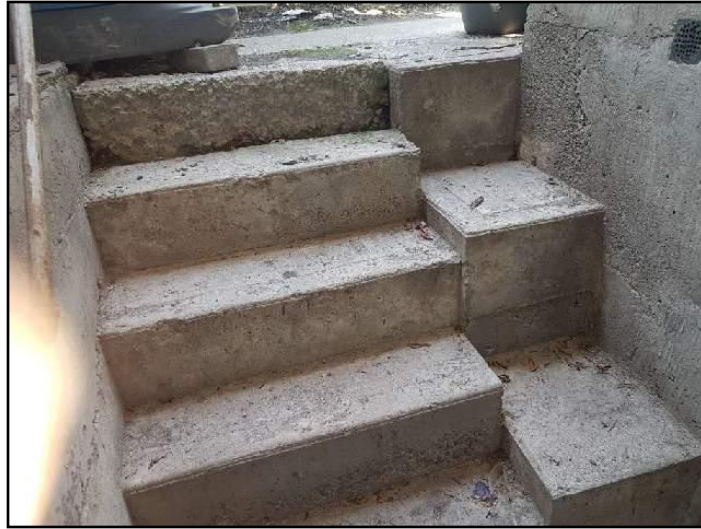
6. Step and landing problems

4. Condition: • [Step and landing problems](#)

Implication(s): Trip or fall hazard

Awkward exterior steps should be reconfigured to create step up into basement and eliminate trip hazards if this is to be used as anything but an emergency exit.

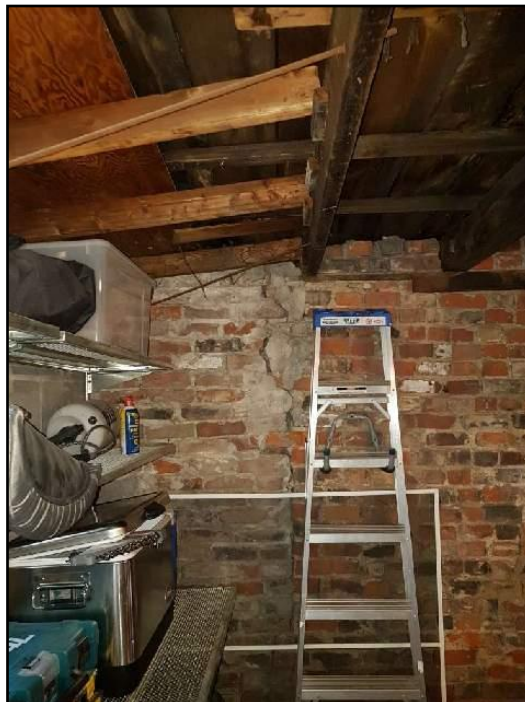
7.

5. Condition: • Garge roof poorly supported when extended, improve support and introduce lateral support to brick wall when resurfacing garage roof.

Task: Repair

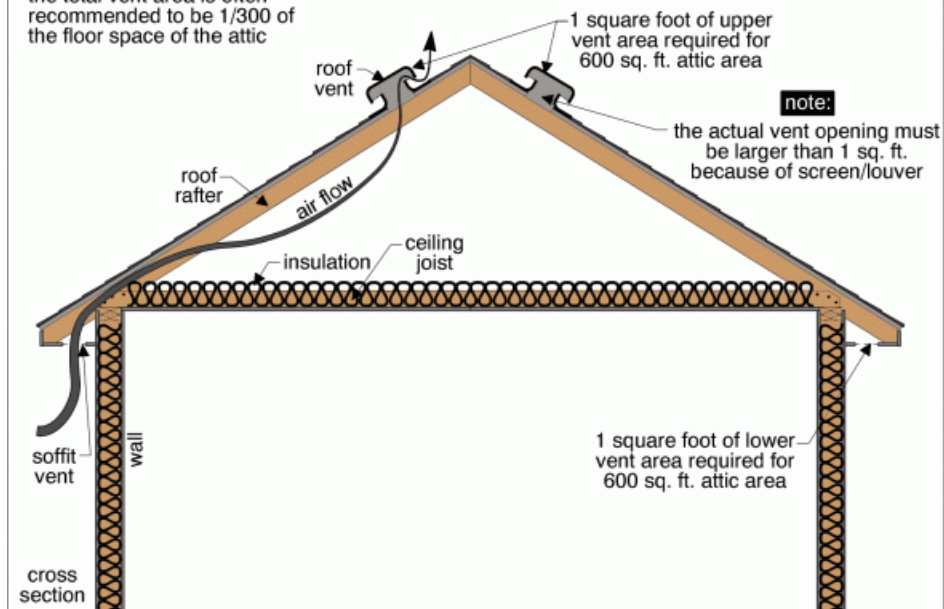
Recommended amount of attic ventilation

12. Condition: • [Inadequate](#)

Implication(s): Chance of condensation damage to finishes and/or structure

the total vent area is often recommended to be 1/300 of the floor space of the attic
