# INSPECTION REPORT

For the Property at:  
**SE-14-26-20W**  
DAUPHIN, MB R7N3L9

Prepared for: BRIAN JAEB  
Inspection Date: Thursday, December 14, 2017  
Prepared by: Brian Jaeb

RE: Report No. 1004  
SE-14-26-20W  
Dauphin, MB  
R7N3L9

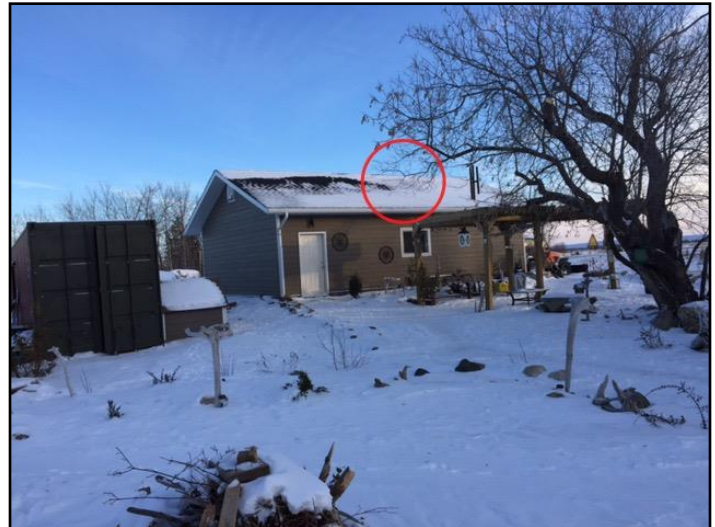
2. Asphalt shingles snow on roof

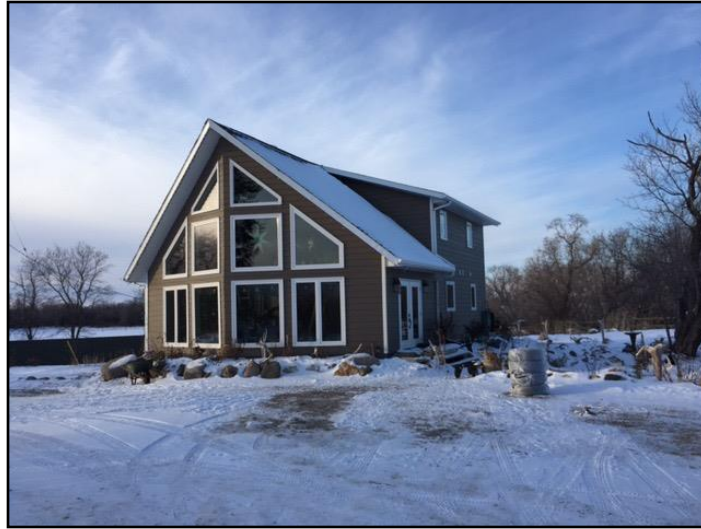
3. Snow/ice/frost

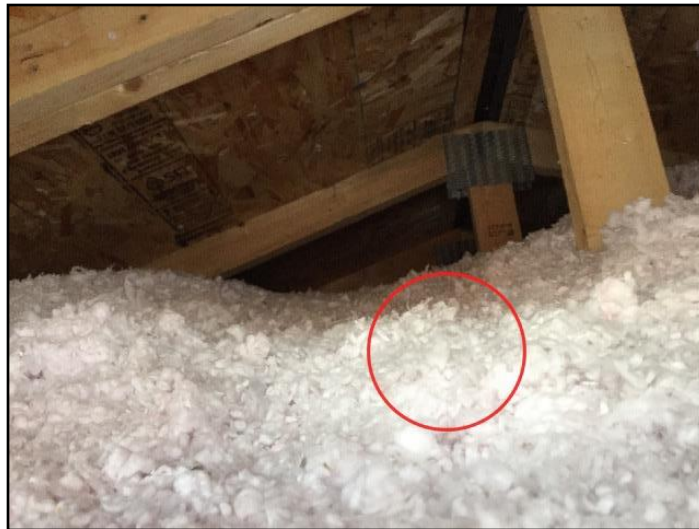
8. Entered but access was limited

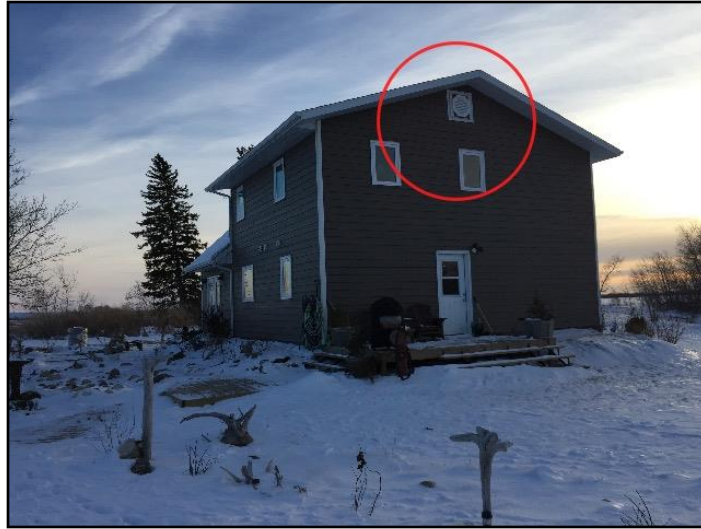
9. Inspected from access hatch

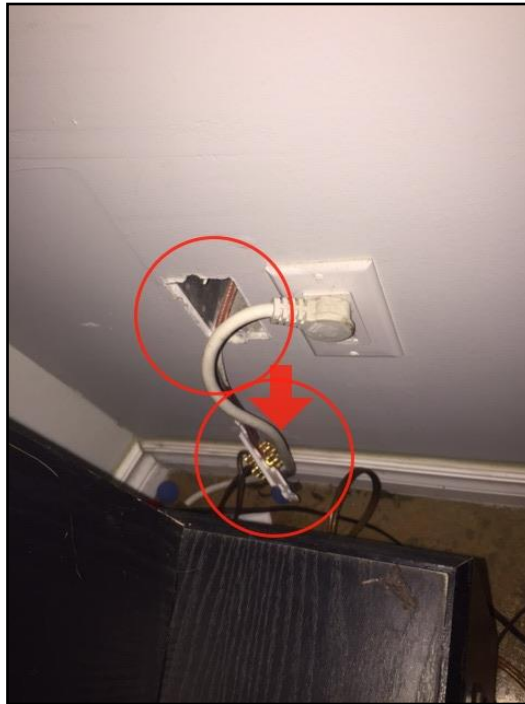
2. Condition: • [Missing](#)

Implication(s): Electric shock

Location: Front First Floor Living Room

13. For outlet (receptacle) is loose

Task: Replace

Time: Immediate

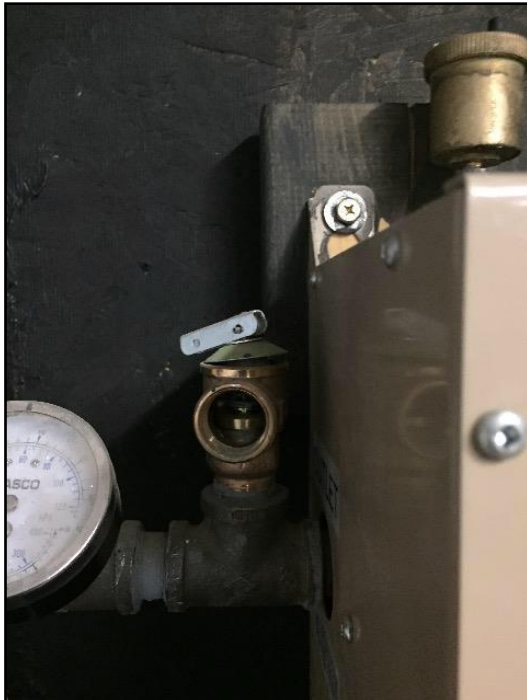
3. Condition: • [No piped extension](#)

Implication(s): Steam explosion

20. No piped extension/garage

Task: Provide

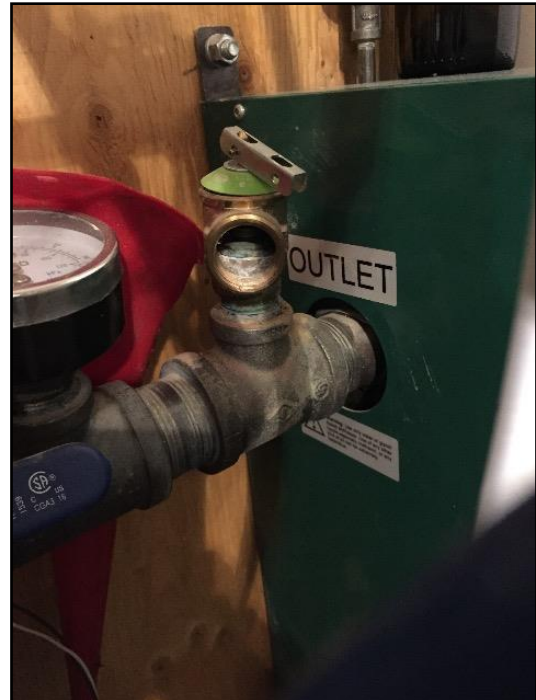
Location: First Floor Utility Room

21. No piped extension
