# YOUR INSPECTION REPORT

30 Riverview Gardens  
Toronto, ON M6S 4E5

INSPECTION DATE:  
Wednesday, August 29, 2018

RE: Report No. 2320  
30 Riverview Gardens  
Toronto, ON  
M6S 4E5

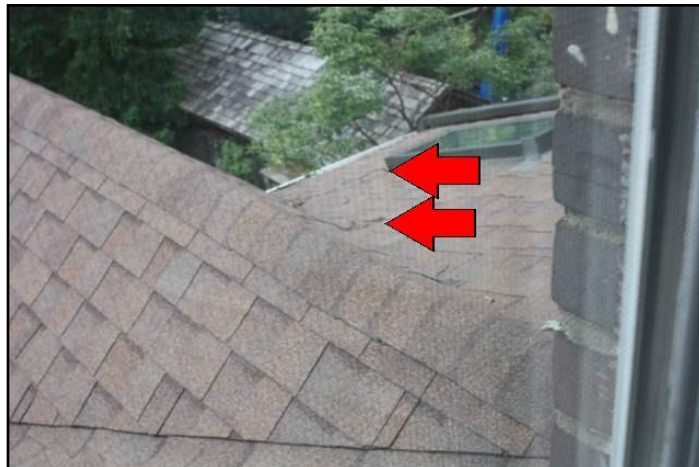
**Condition:** • Debris/moss

**Implication(s):** Shortened life expectancy of material

**Location:** Rear Exterior Roof

1. Example

**Task:** Clean

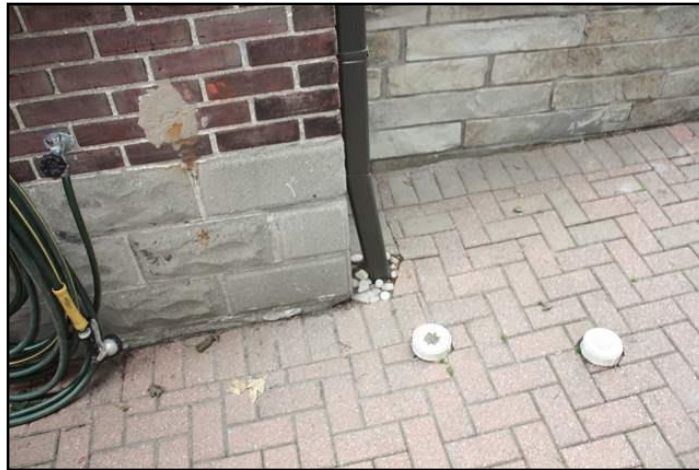
Condition: • [Discharge below grade](#)

Implication(s): Chance of water damage to contents, finishes and/or structure

Location: Various Exterior

2. Discharge below grade

Task: Monitor / Improve

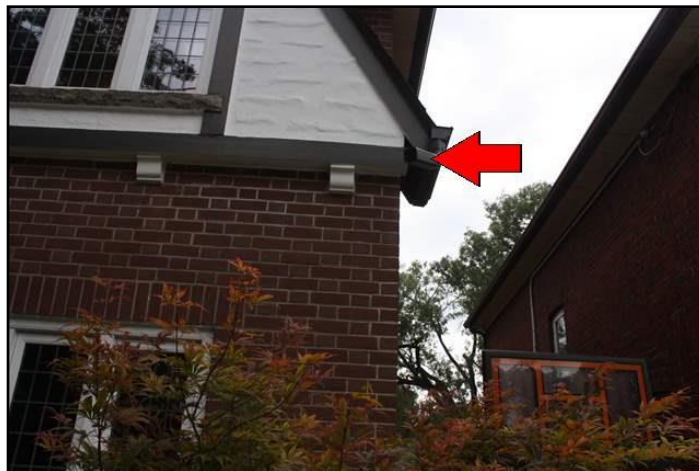
**Condition:** • [Discharge too close to building](#)

**Implication(s):** Chance of water damage to contents, finishes and/or structure

**Location:** Front Exterior

3. Discharge too close to building

**Task:** Improve

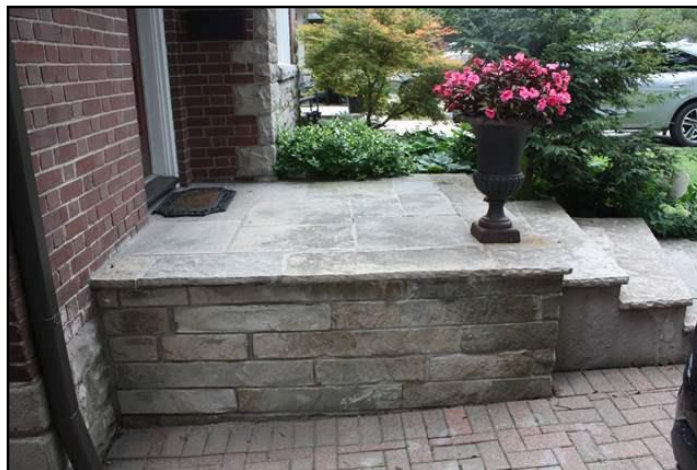
**Condition:** • [Missing](#)

**Implication(s):** Fall hazard

**Location:** Front Exterior Porch

4. Missing

**Task:** Provide Guardrail

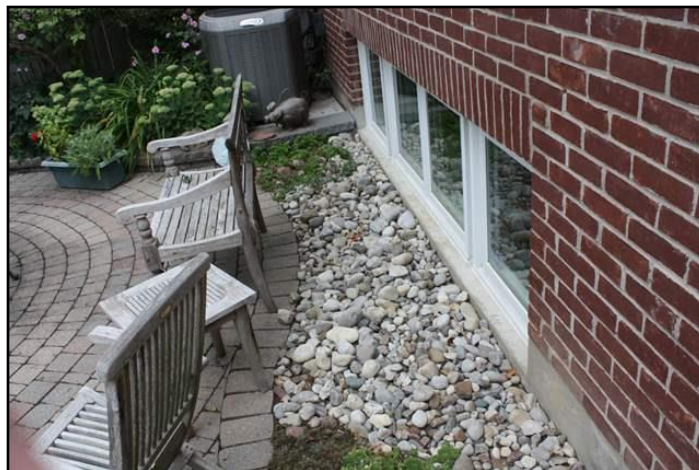
**Condition:** • [Porous material](#)

**Implication(s):** Chance of water damage to contents, finishes and/or structure

**Location:** Rear Exterior

5. Porous material

**Task:** Monitor / Improve

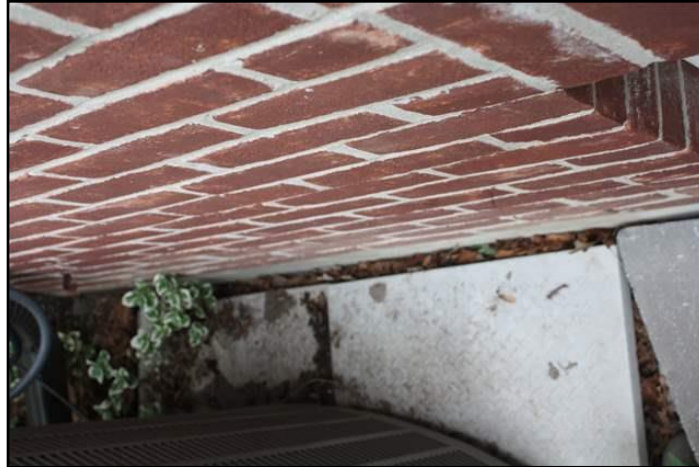
**Condition:** • Unsealed gap at building

**Implication(s):** Chance of water damage to contents, finishes and/or structure

**Location:** Rear Exterior

6. Unsealed gap at building

**Task:** Improve / Seal

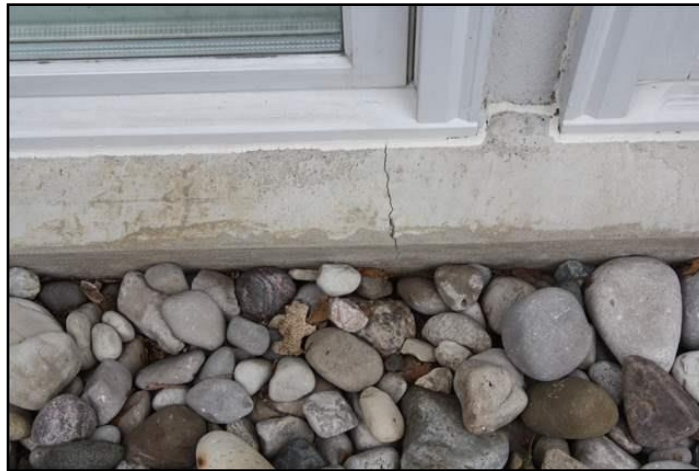
**Condition:** • Typical minor cracks

**Implication(s):** Chance of water entering building

**Location:** Rear Exterior Window sill

7. Typical minor cracks

**Task:** Repair

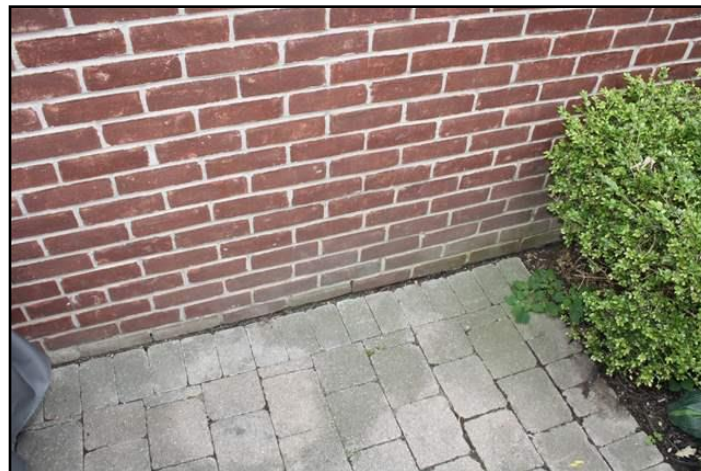
**Condition:** • [Masonry or wood too close to grade](#)

**Implication(s):** Chance of damage to structure

**Location:** Right Side Exterior Addition

8. Masonry too close to grade

**Task:** Monitor / Improve / Click link to read more information

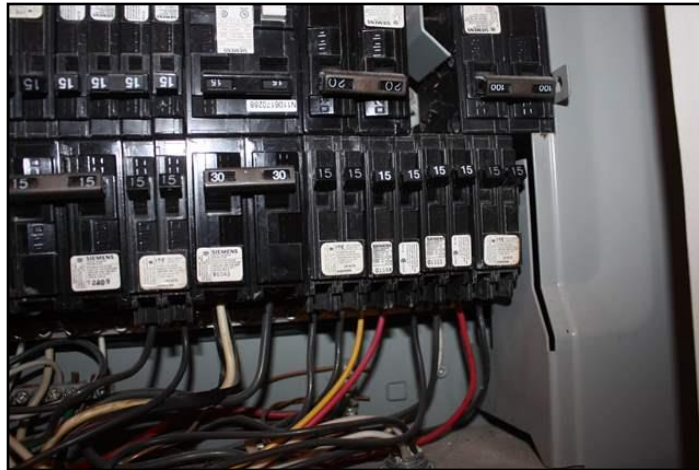
**Condition:** • [No links for multi-wire circuits](#)

9. No links for multi-wire circuits

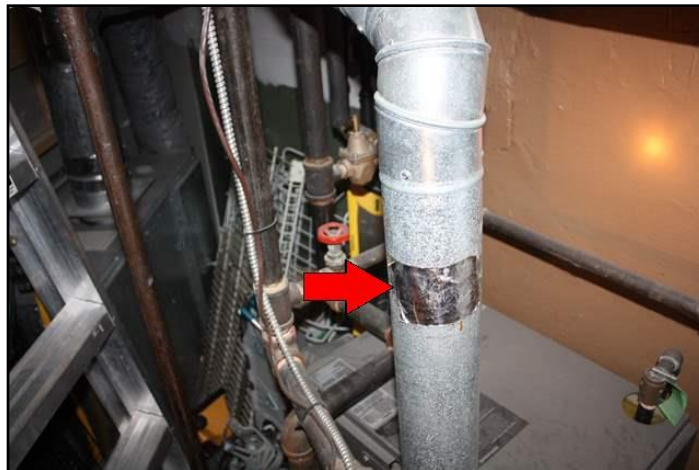
**Condition:** • [Improper material](#)

**Implication(s):** Fire hazard | Hazardous combustion products entering home

10. Improper material

**Task:** Service

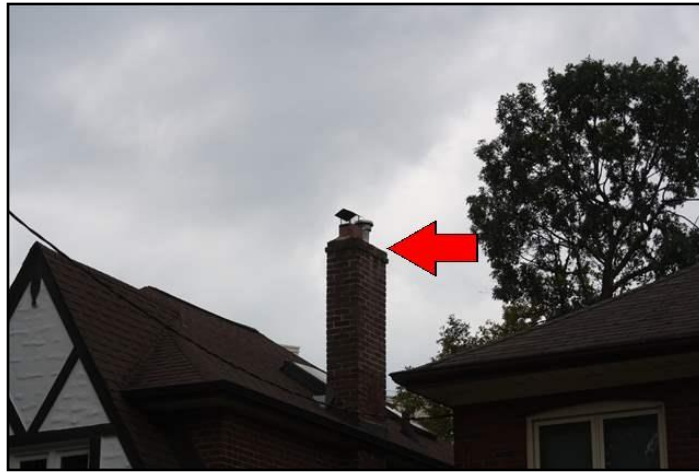
**Condition:** • [No drip edge on cap](#)

**Implication(s):** Chance of water damage to contents, finishes and/or structure | Shortened life expectancy of material |

Material deterioration

11. No drip edge on cap

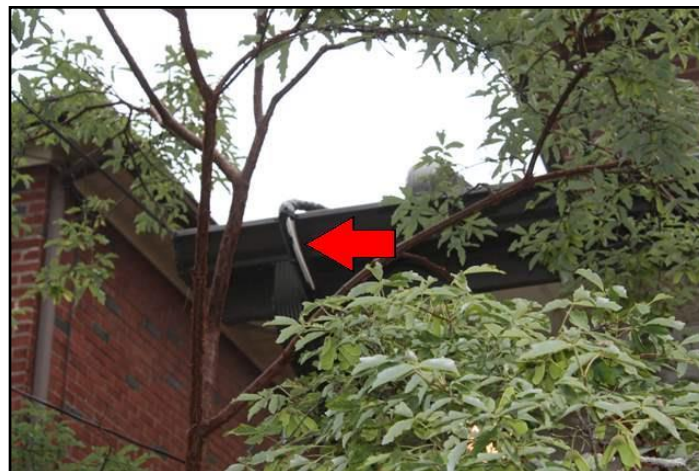
**Condition:** • [Insulation - missing](#)

12. Insulation - missing

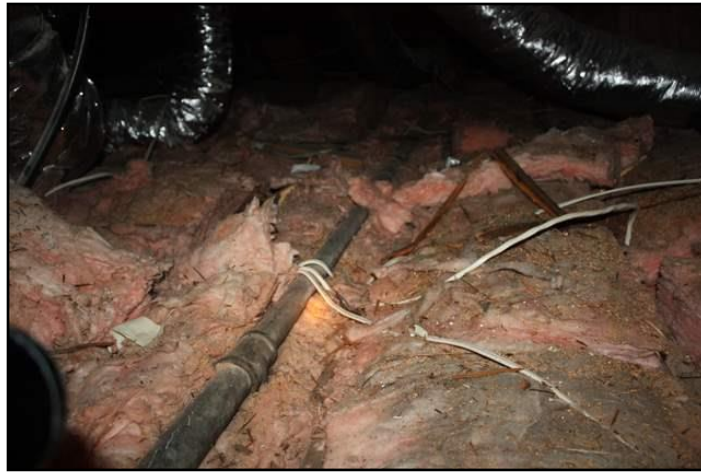
Condition: • [Amount less than current standards](#)

14. Amount less than current standards

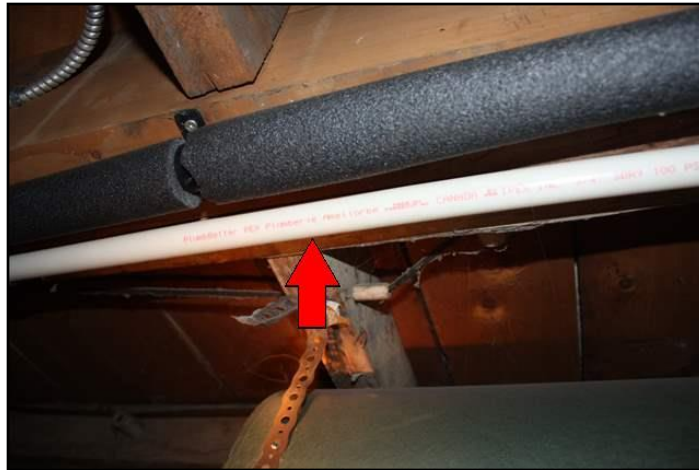
**Condition:** • IPEX piping (Kitec, PlumbBetter, IPEX AQUA, WarmRite, XPA and related brands) in use

15. IPEX piping (Kitec, PlumbBetter, IPEX AQUA,...)

**Task:** Monitor

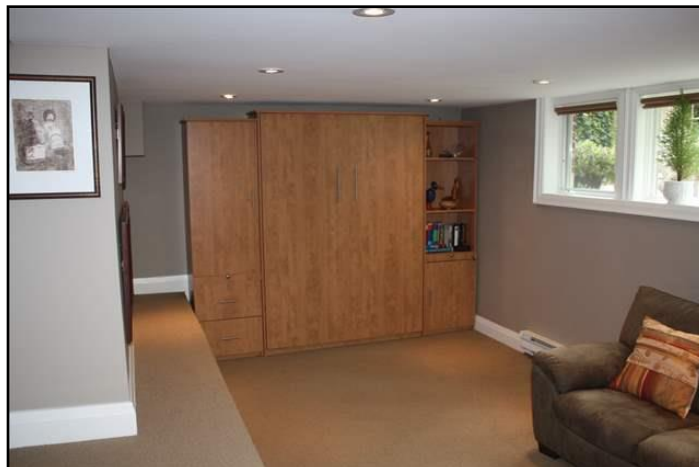
16. Addition

Unable to locate floor drain in rear addition. Since this is the lowest area of the basement, a floor drain (or sump pit and pump) should be installed.

**Condition:** • [Missing](#)

**Implication(s):** Chance of water damage to contents, finishes and/or structure

**Task:** Provide floor drain or sump pump

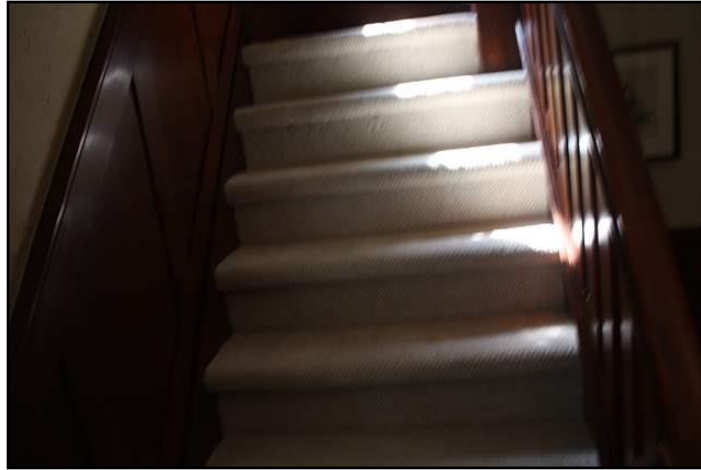
**Condition:** • [Worn or damaged](#)

**Implication(s):** Trip or fall hazard | Weakened structure

17. Worn or damaged

**Task:** Repair

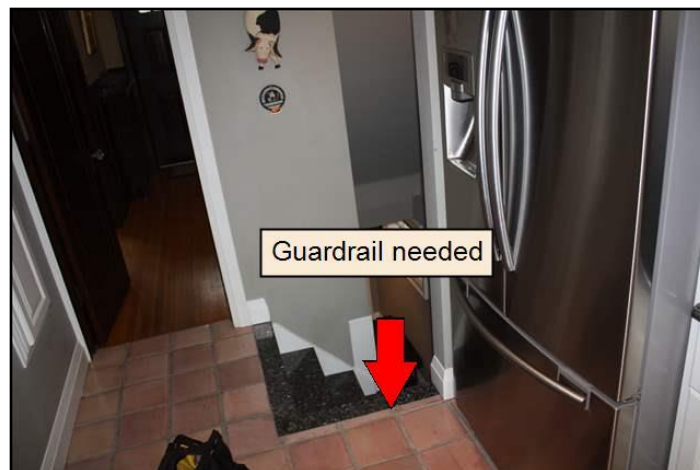
**Condition:** • [Missing](#)

**Implication(s):** Fall hazard

18. Missing Guardrail
