# Your Inspection Report

xxx My Street  
My Town, MA 02000

**INSPECTION DATE:**  
Monday, October 30, 2017

RE: Report No. 1424, v.2  
xxx My Street  
My Town, MA  
02000

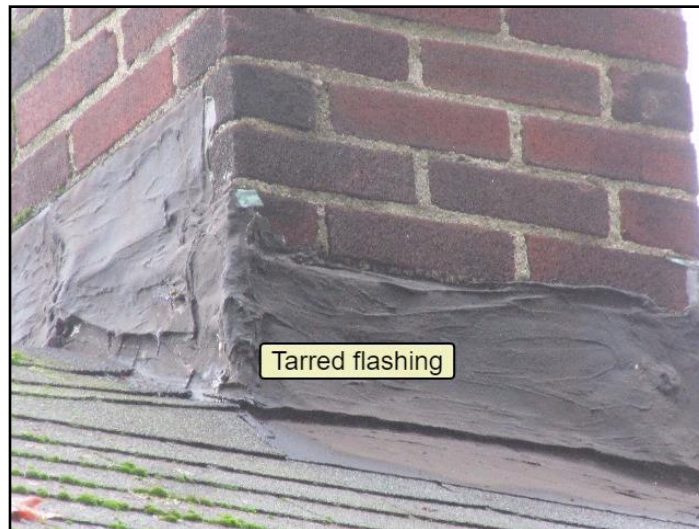
5. Upgrade when roof is replaced

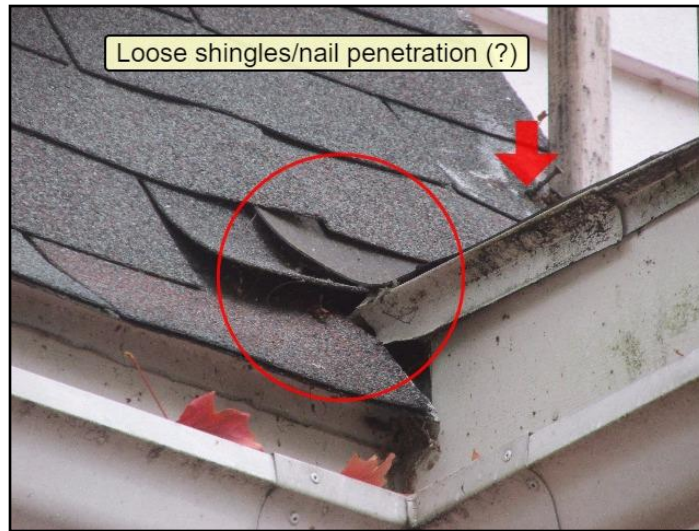
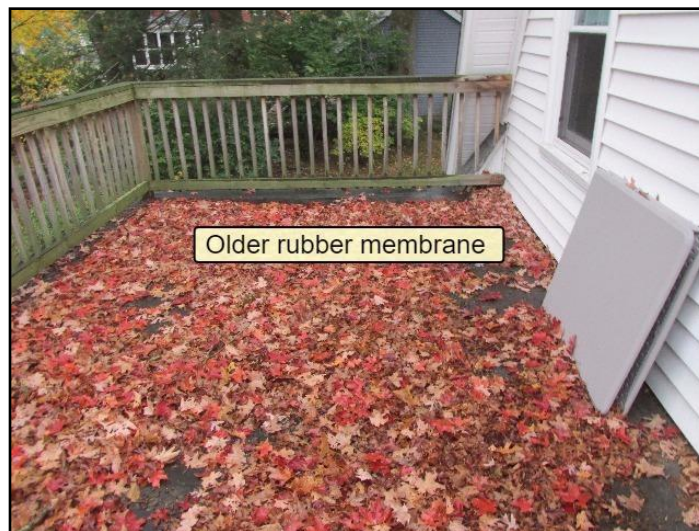
- The asphalt shingles were older, worn, significantly moss covered and well into the 2nd half of their service life. It is recommended to have the roof be closely monitored for further wear and that estimates for replacement be obtained for future planning and budgeting.

7. Near end of life expectancy

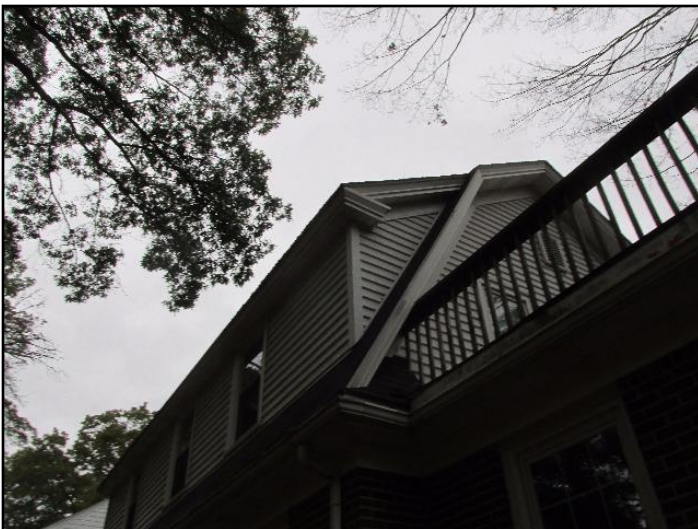
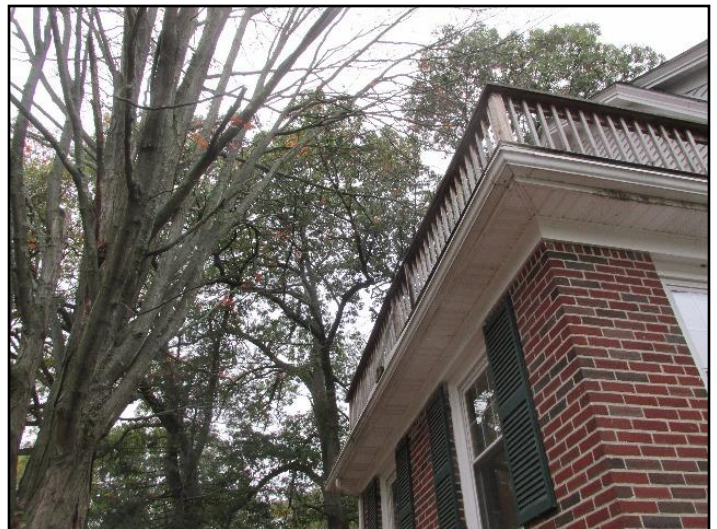
**8.** *There were trees branches overhanging the...*

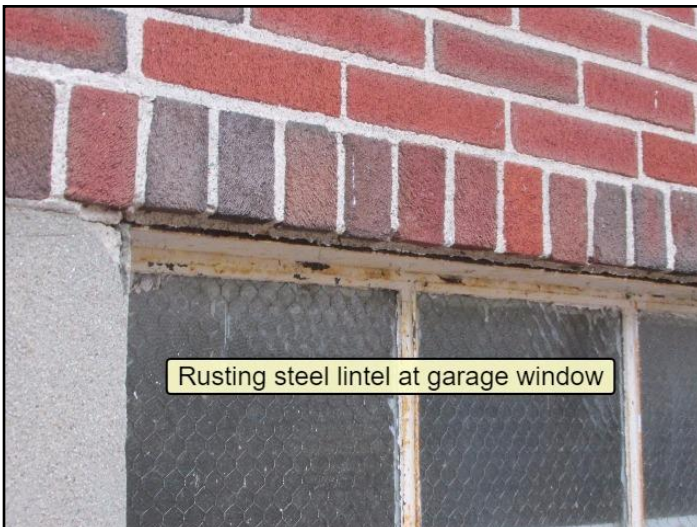
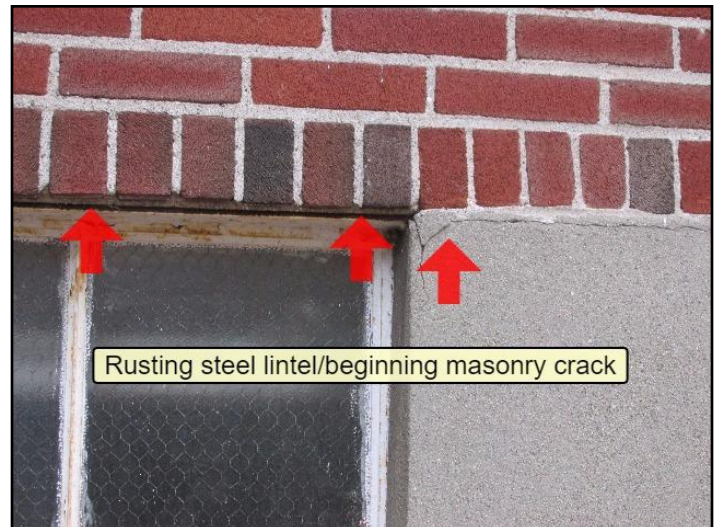
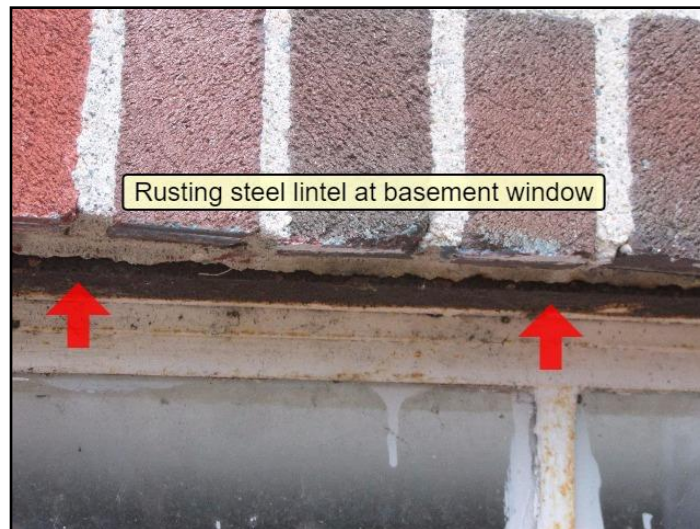
**7.** • The steel lintels on this building were rusty. When steel lintels rust they usually expand and can crack the masonry. I recommend that the lintels be properly prepped, caulked and repainted.

10. The steel lintels on this building were...

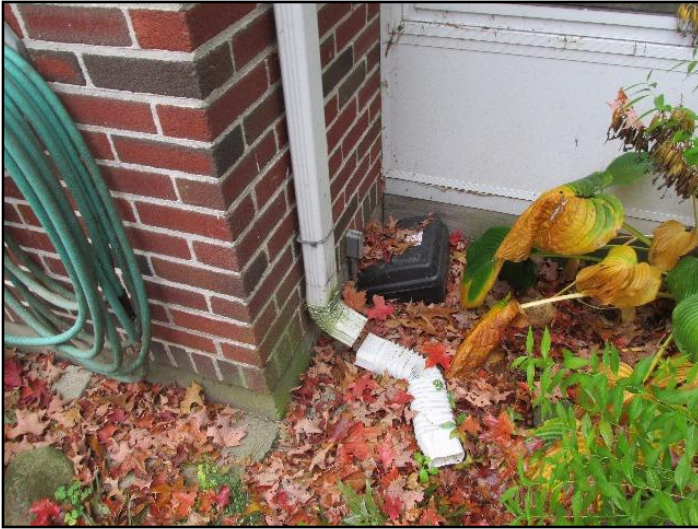
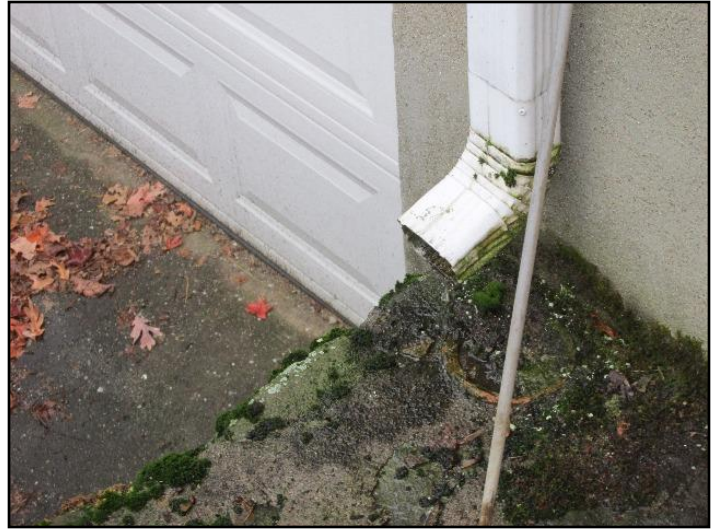
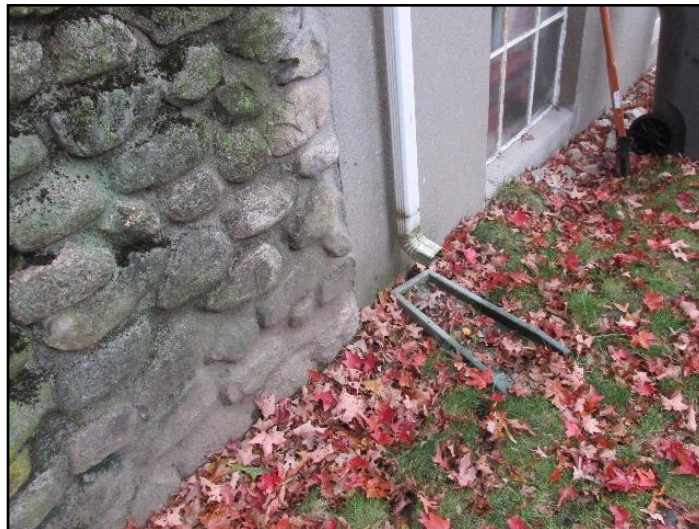
Downspouts carry roof water to the ground and should have extensions that direct the water to an appropriate distance, 5 or 6 feet, from the foundation. If there are no downspouts, or if the extensions are too short, the roof water may eventually end up in the basement. I recommend that the downspout at the front left be extended to carry the water to an appropriate distance from the house.

13. Not connected to leader/not extended

14. Should discharge 6 feet from building

15. Should discharge 6 feet from building

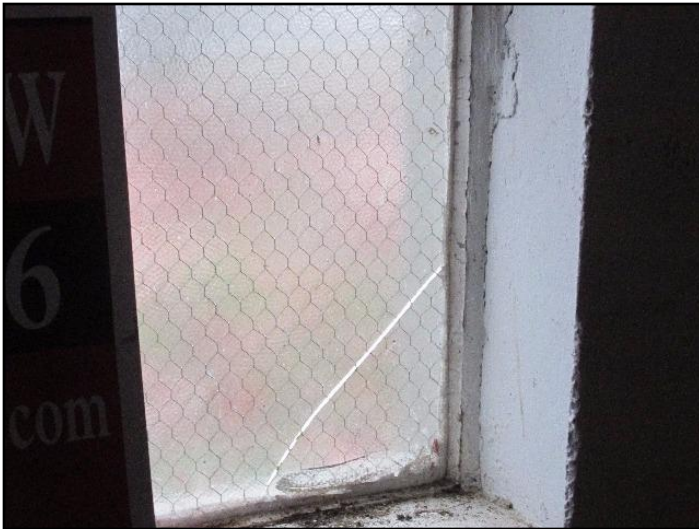
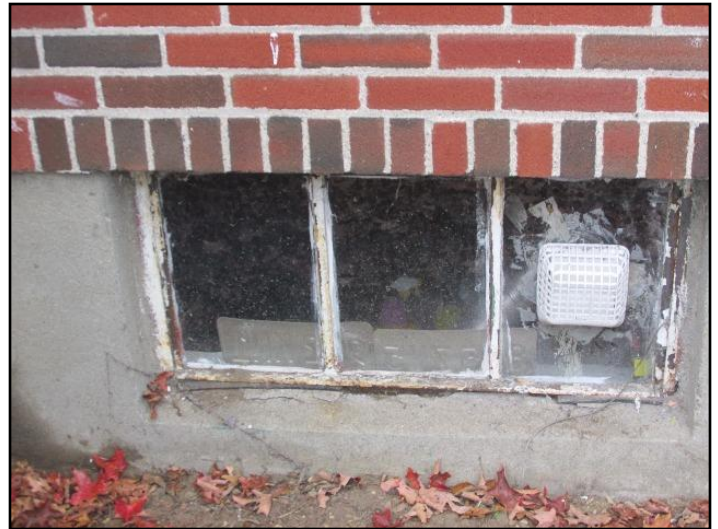
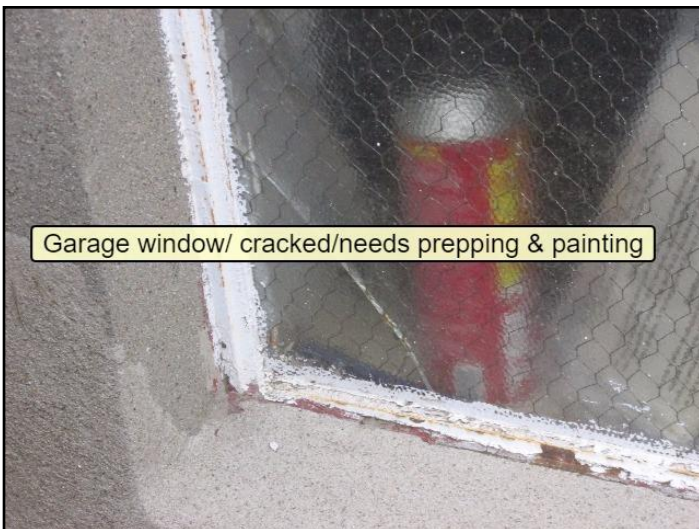
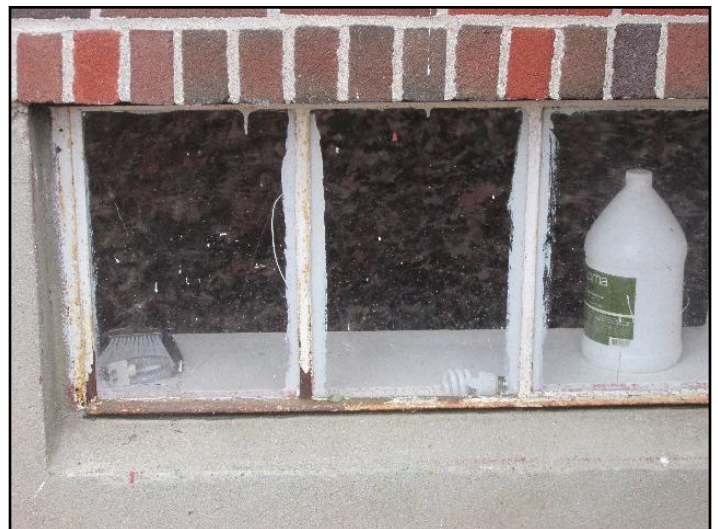
Several of the basement windows are older, steel that framed that are rusting, need repair, prepping and painting. Some have cracked panes which should be replaced.

16. Caulking missing or deteriorated

Garage window/ cracked/needs prepping & painting

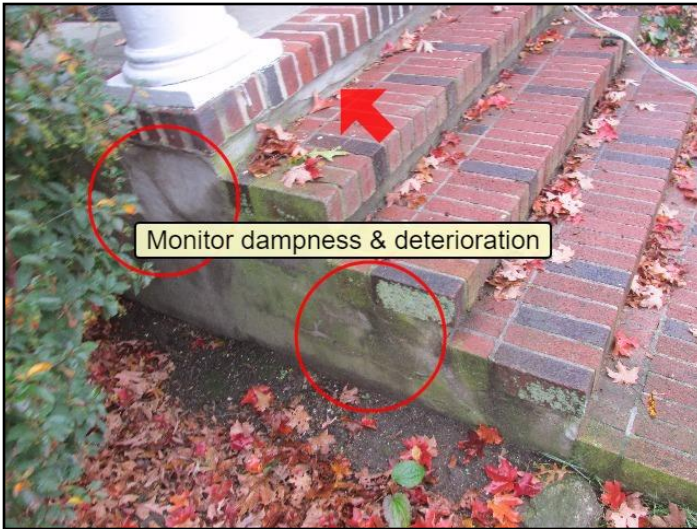
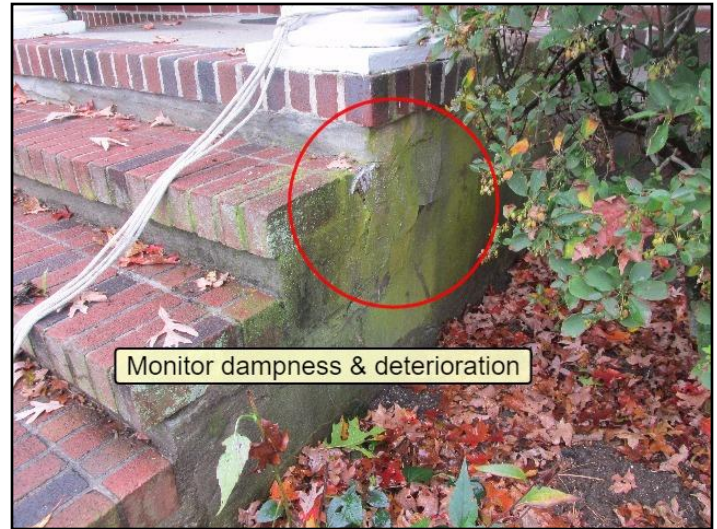
There was some deterioration at the sides of the masonry at the front steps. These areas should be closely monitored for further deterioration and repaired as may become necessary.

20. Masonry or concrete spalling

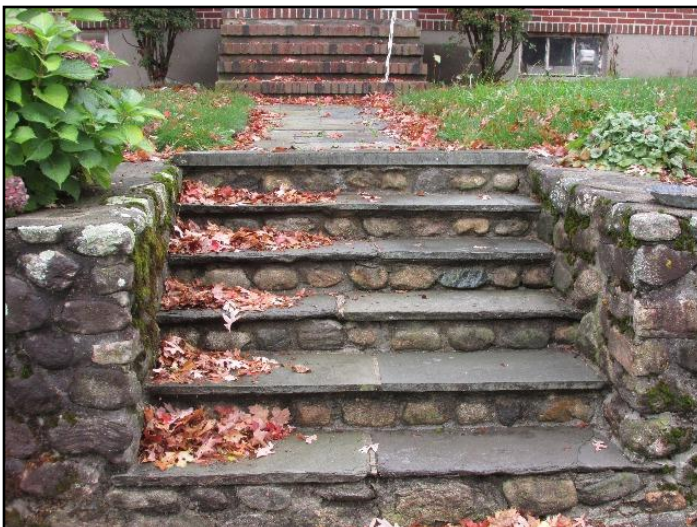
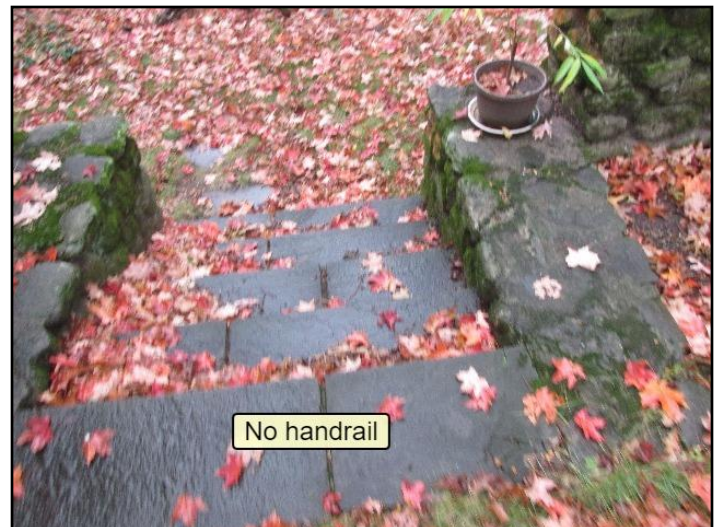
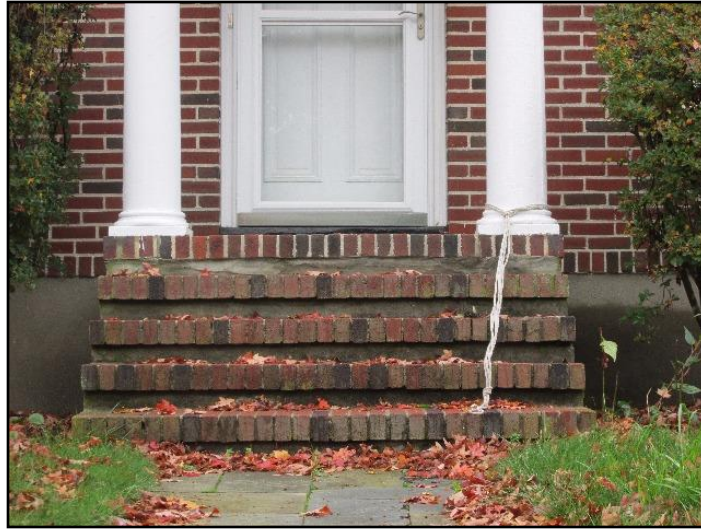
There were no hand railings at the either the upper or lower front masonry steps or at the rear left side steps. Handrails are required wherever there are four or more continuous risers. I recommend that proper hand railings be installed for safety.

22. No hand railing

23. Missing

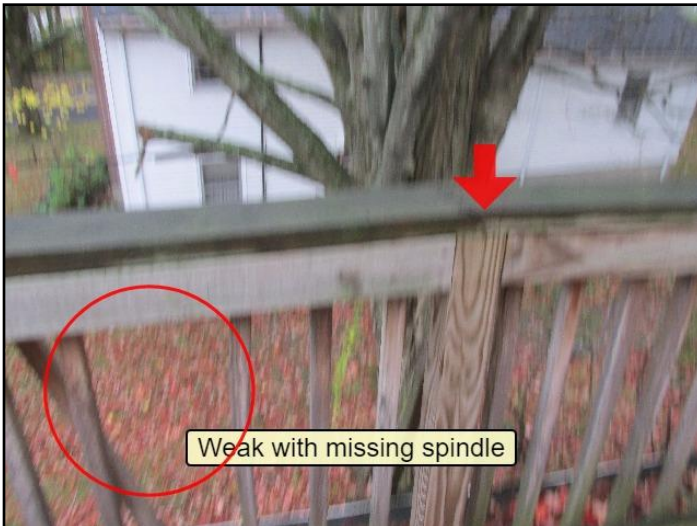
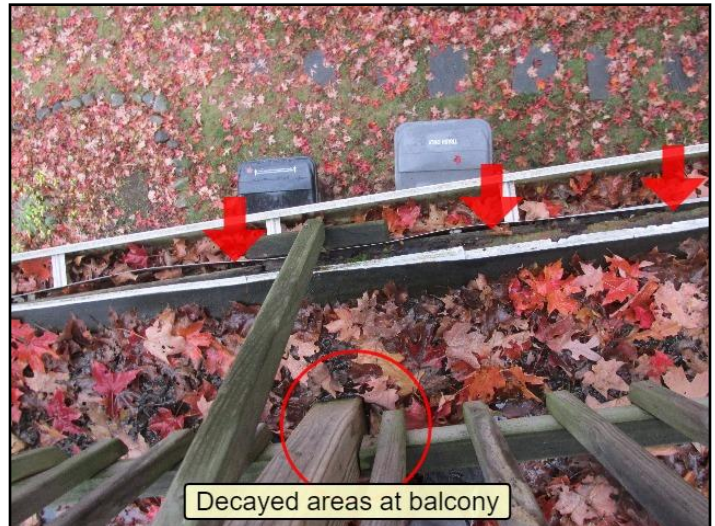
There is some decay at some of the wood support posts and the trim boards at the edges of the 2nd floor left side of the balcony above the garage structure. Further inspection by a licensed contractor is recommended and estimates for repairs should be obtained.

25. Rot or insect damage

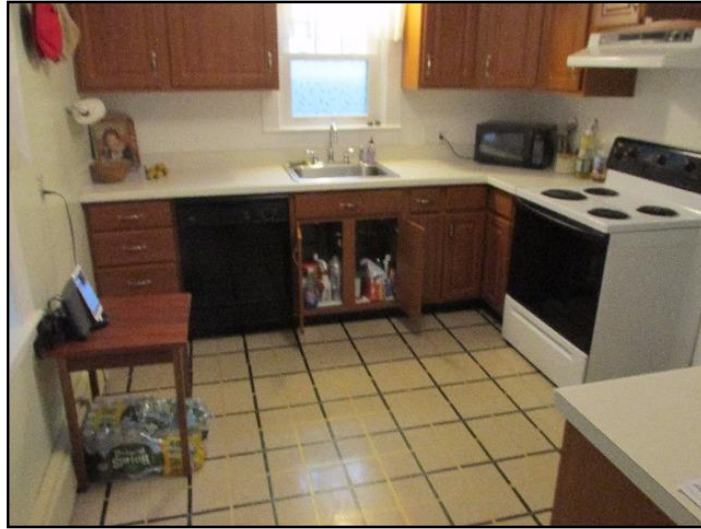
There was only one receptacle outlet observed at the kitchen sink counter. It was not ground fault protected. Upgrading this to a GFCI receptacle is recommended and adding additional outlet receptacles is recommended.

**30.** *Too few outlets*

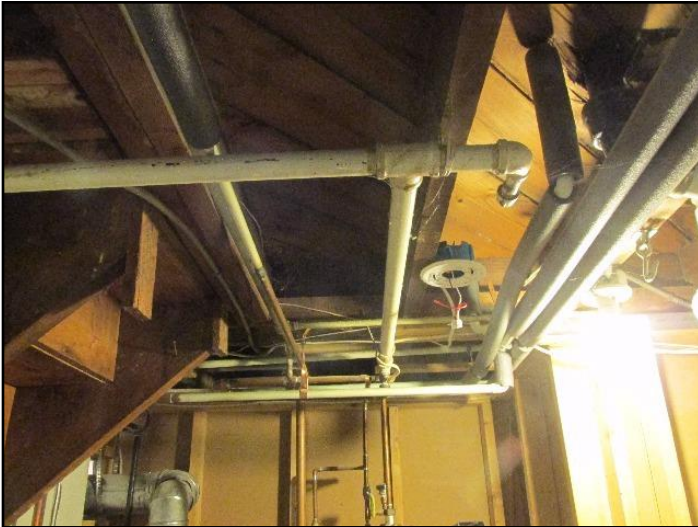
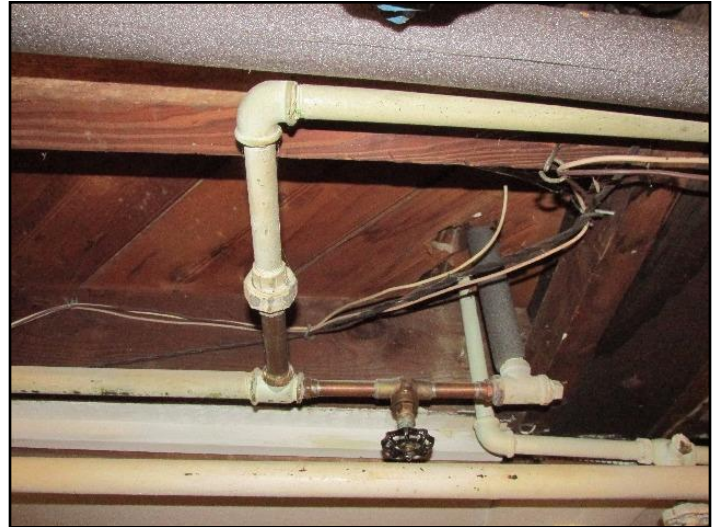
**General:** • There are some older galvanized steel and brass supply pipes in this house. No problems were evident at the time of inspection but these are threaded pipes the often can leak at the threaded joints over time. These pipes should be carefullt monitored for problems.

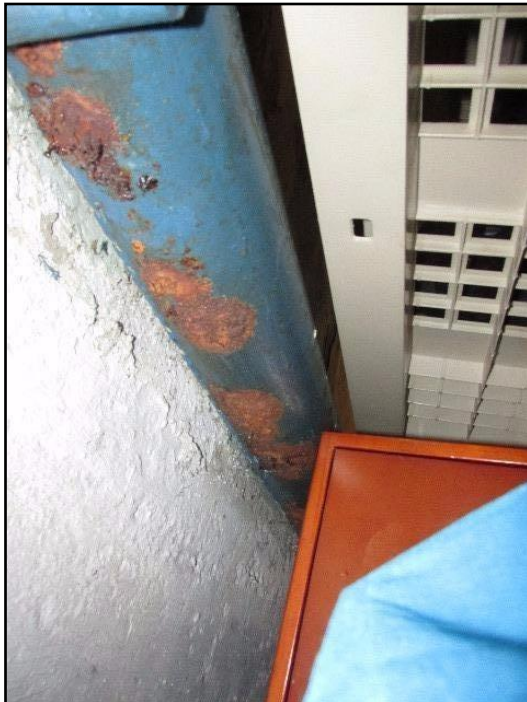
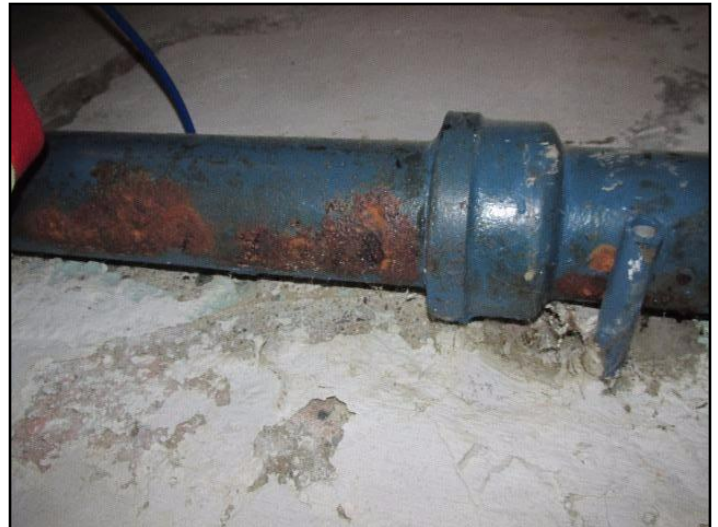
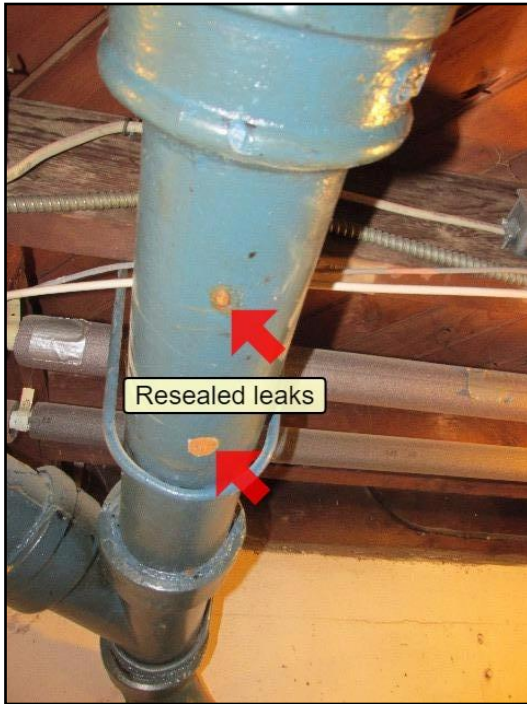
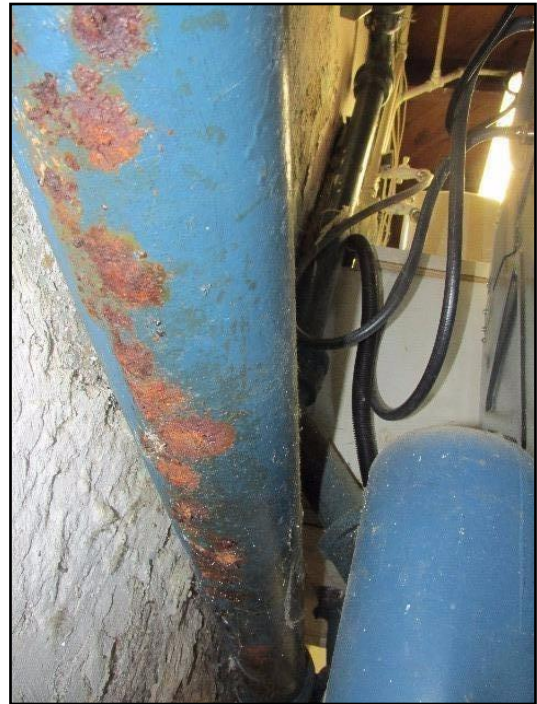
There was significant rusting on the underside of several areas of the main cast iron waste pipe along the rear and right side of the basement wall and ceiling. These pipes are original to the dwelling. There were several rust stains on the floor and areas where the pipes had leaked and resealed. These waste pipes should be further inspected by a licensed plumber and replaced as needed immediately.

38. *Rust*

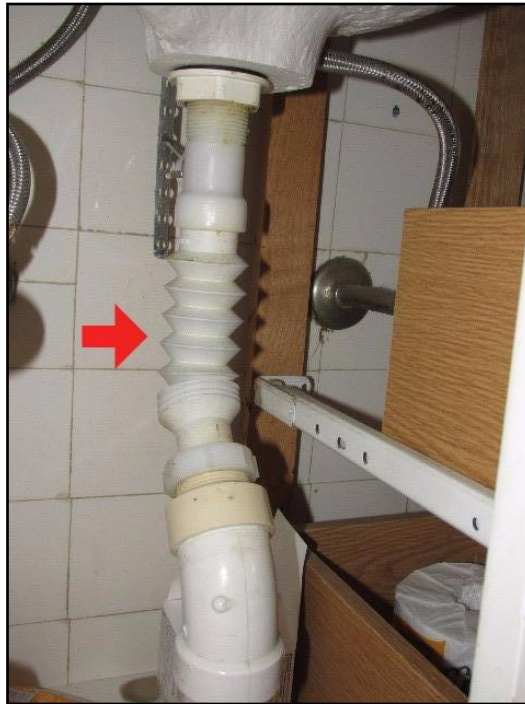
There is potential for leaking at the flexible drain piping beneath the upstairs bathroom sink. This is a non-standard drain pipe fitting with no trap beneath the sink (a drum trap in the floor is assumed). This installation should be monitored for problems and upgraded as may become necessary.

42. Nonstandard shape or material

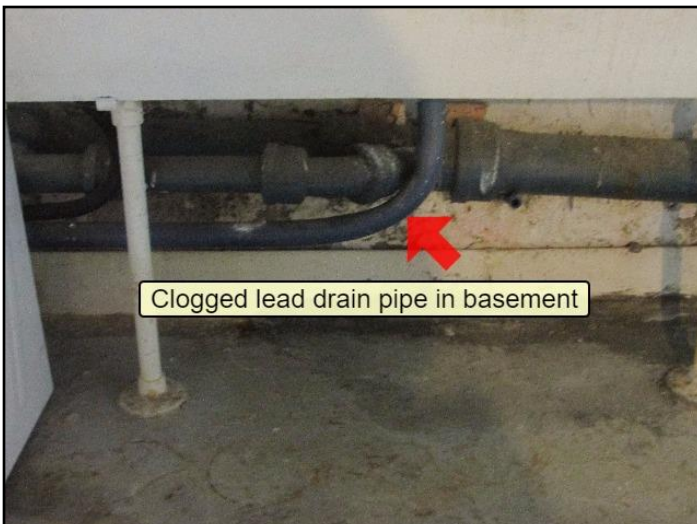
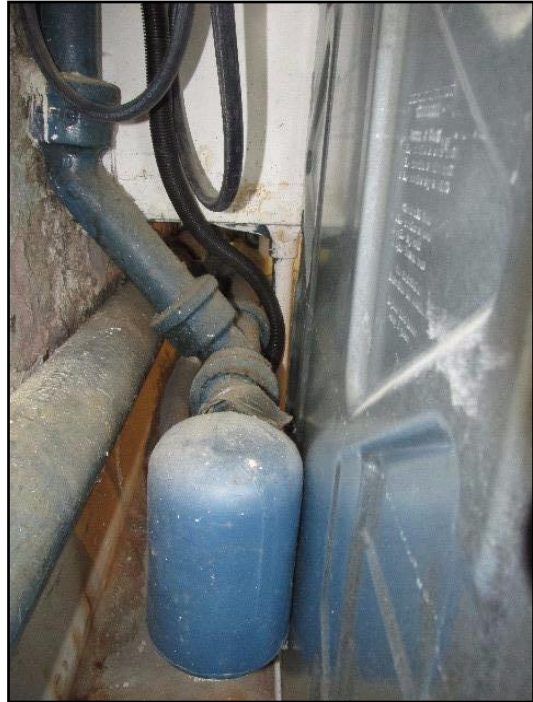
There is an old lead trap and drain pipe serving the laundry sink/washing machine in the basement. This pipe is clogged. In general, lead is considered an unsafe material at the interior of housing. I recommend further evaluation, upgrading and repair be a licensed plumber.

43. Clogged

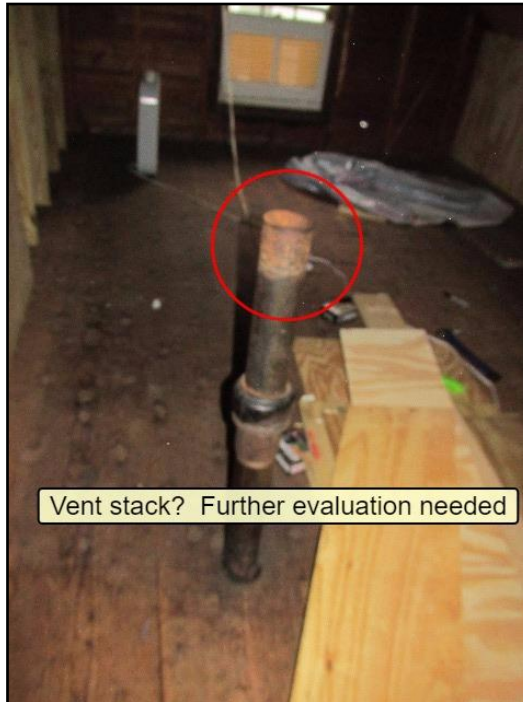
There was an open ended plumbing vent pipe which terminated in the middle area of the attic. These vents are usually required to extend up past the roof a minimum of 6+ inches. This pipe appeared to be no longer used as a active vent pipe, however this could not be verified at the time of inspection. I recommend further evaluation by a licensed plumber.

45. Vent termination problems

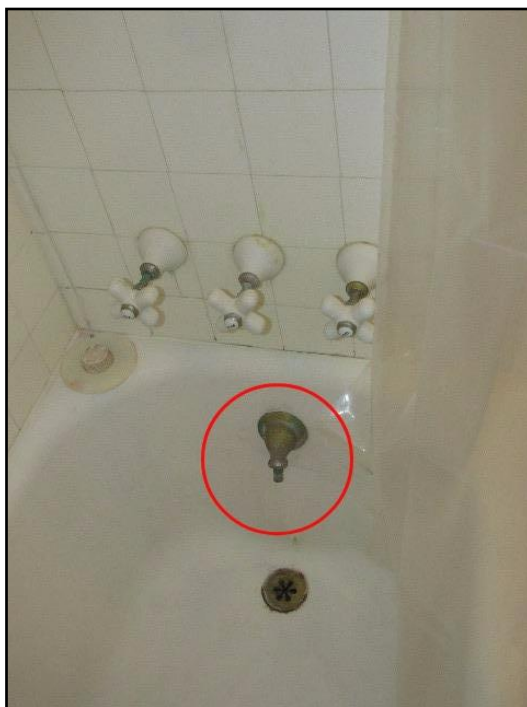
46. Cross connections

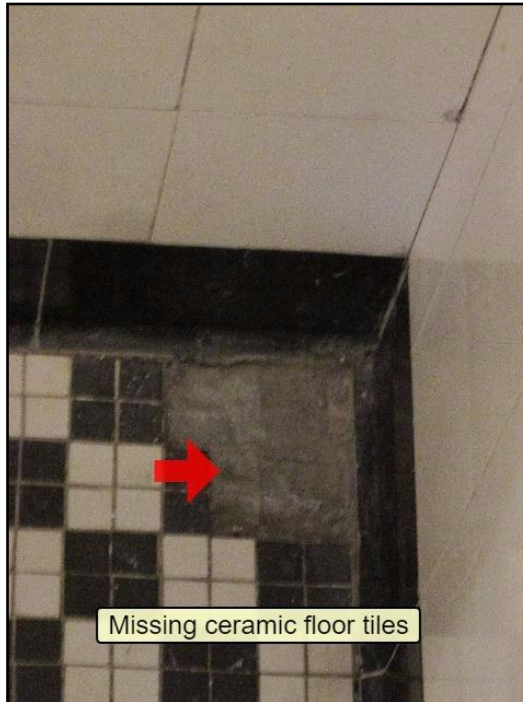
48. Tiles missing

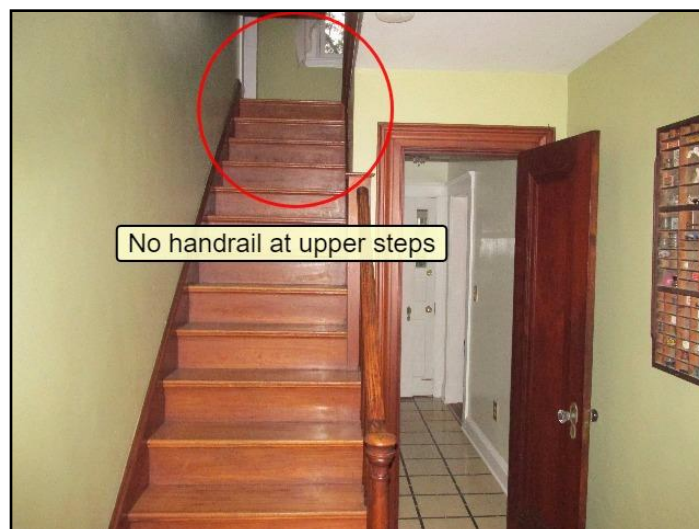
49.

**37. Condition:** • There was no hand railing at the upper six steps at the staircase from the 1st floor to the 2nd floor. A handrail at these upper steps is recommended for safety.
