# YOUR INSPECTION REPORT

596 Durie Street  
Toronto, ON M6S 3H1

Wednesday, February 12, 2020

RE: Report No. 2609, v.3  
596 Durie Street  
Toronto, ON  
M6S 3H1

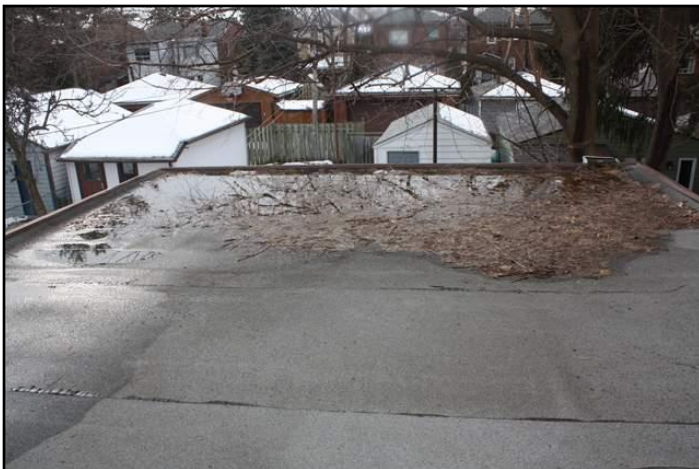
**Condition:** • [Ponding](#)

**Implication(s):** Chance of water damage to contents, finishes and/or structure

1. Ponding

Click on blue link above for more information. Consult with Roofing contractor to improve roof drainage towards roof drain.

**Task:** Improve roof drainage

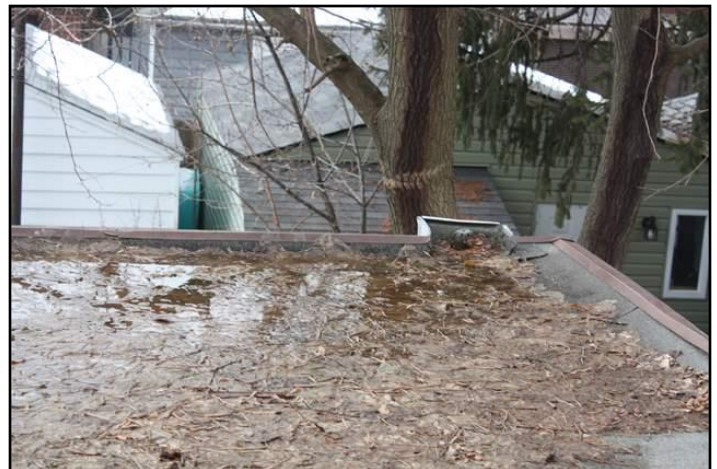
2. Ponding

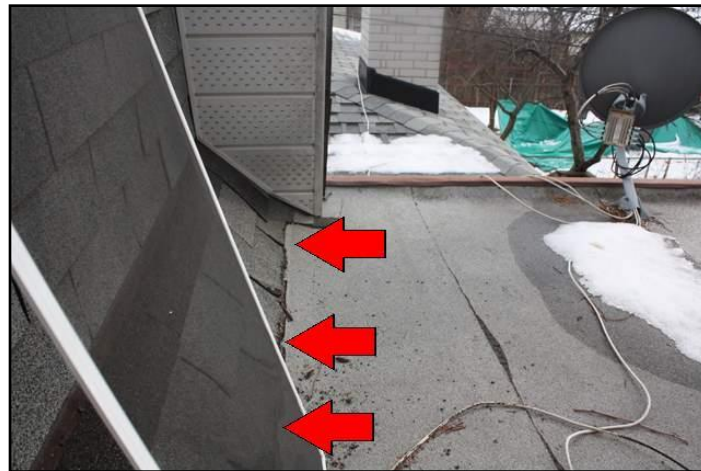
**Condition:** • [Missing, too short](#)

**Implication(s):** Chance of water damage to contents, finishes and/or structure

5. Missing, too short

**Task:** Provide flashing where sloped roof meets flat roof

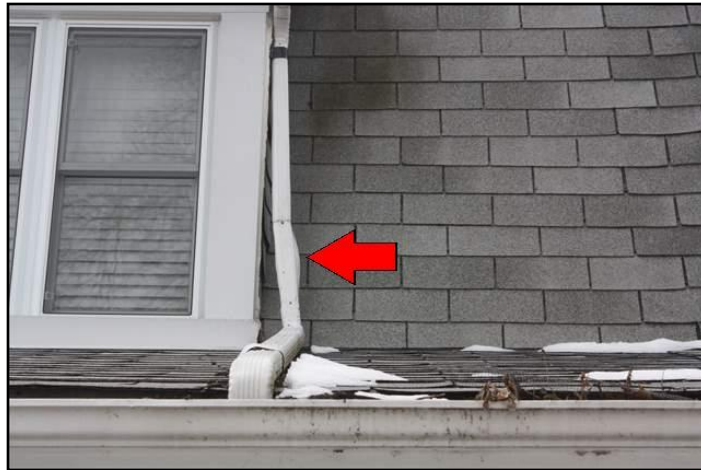
Condition: • [Damage](#)

Implication(s): Chance of water damage to contents, finishes and/or structure

6. Damage

Task: Repair / Replace

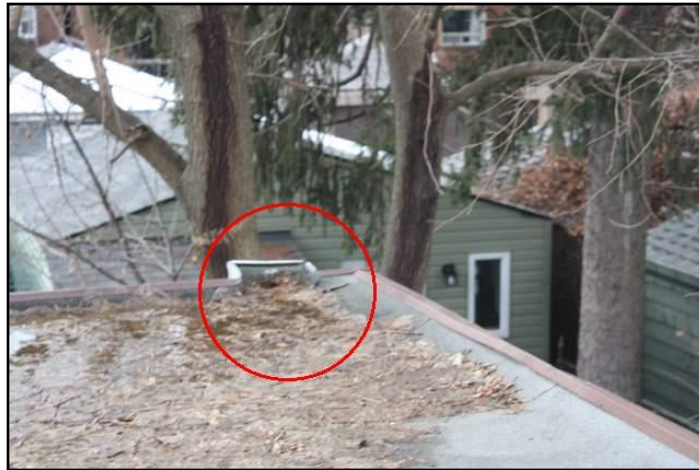
Condition: • [Clogged](#)

Implication(s): Chance of water damage to contents, finishes and/or structure

7. Clogged

Task: Clean

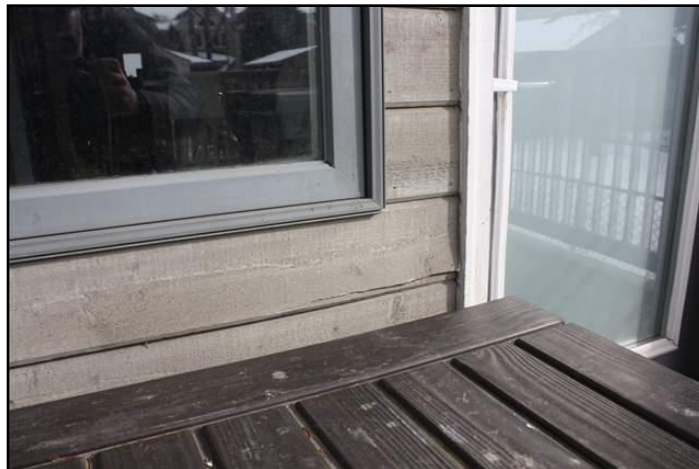
**Condition:** • [Cracked, split or broken](#)

**Implication(s):** Chance of water damage to contents, finishes and/or structure

8. Cracked, split or broken

**Task:** Repair

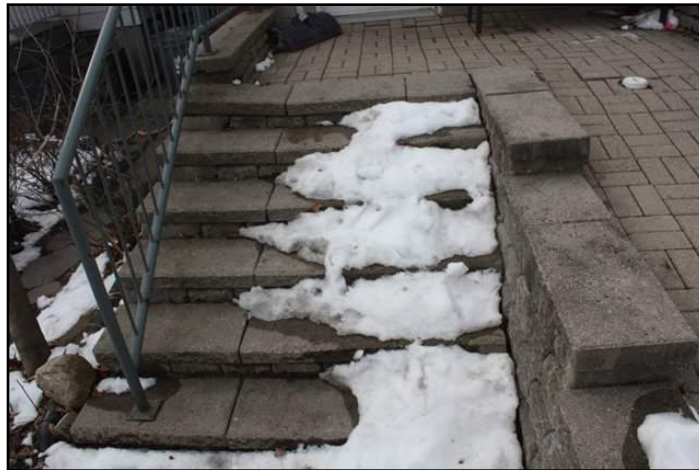
**Condition:** • [Steps or landings settling or heaving](#)

**Implication(s):** Trip or fall hazard | Weakened structure

10. Steps or landings settling or heaving

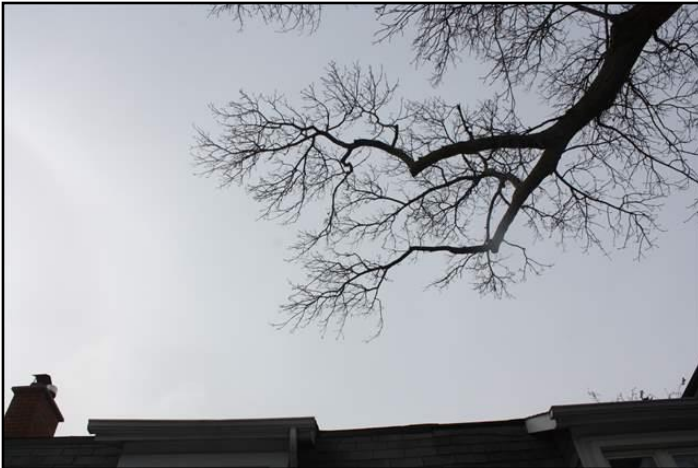
**Condition:** • [Trees or shrubs too close to building](#)

11. Trees or shrubs too close to building

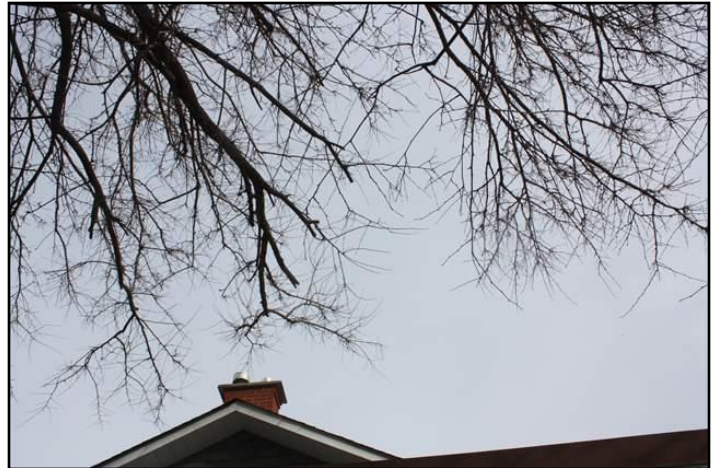
12. Trees or shrubs too close to building

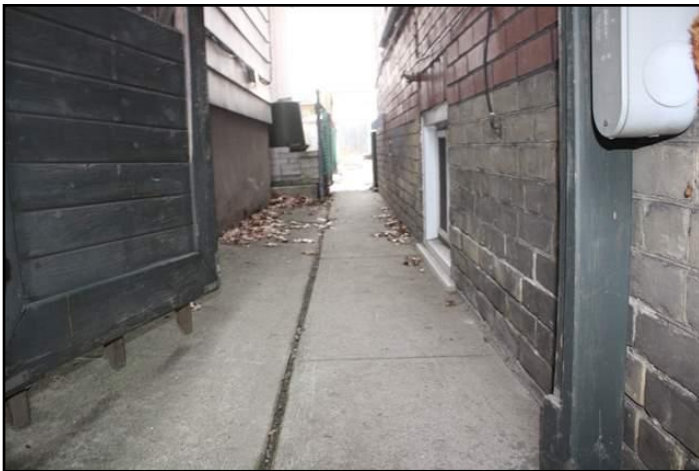
**Condition:** • [Improper slope or drainage](#)

Walk/patio sloping towards house

13. Improper slope or drainage

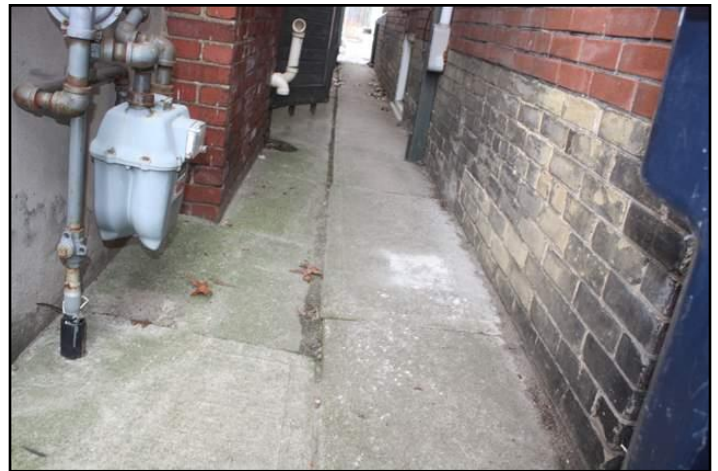
14. Improper slope or drainage

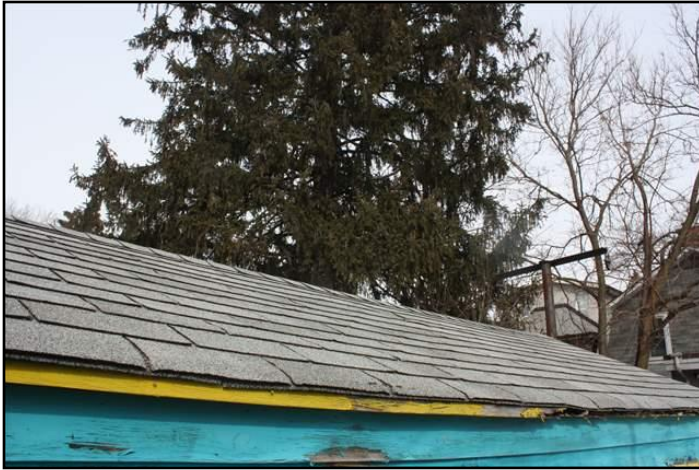
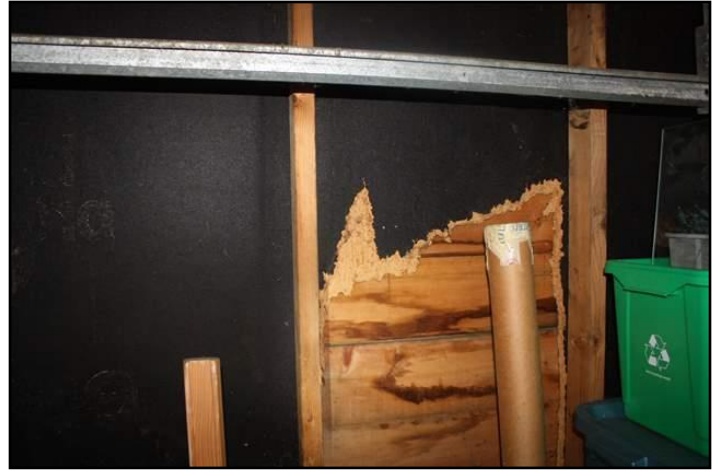
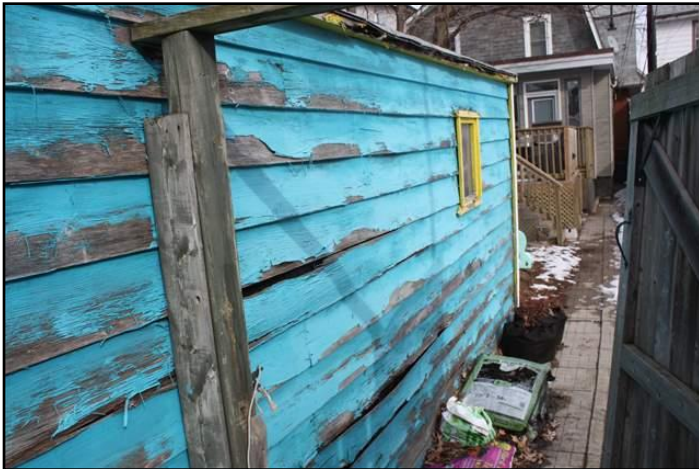
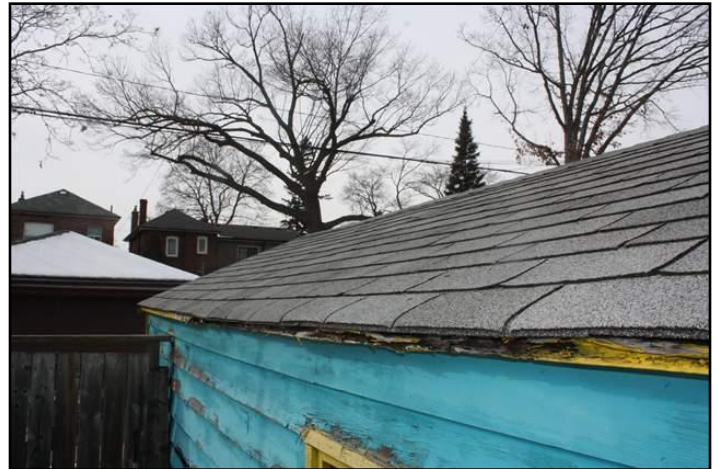
**Condition:** • Aging Garage

This is a typical old garage commonly found in Toronto. The concrete floor has settled and cracked. There wood cladding is very old and damaged. The roof is aging. Replacement garages are expensive, therefore most people choose to repair garage ongoing as needed.

15. Aging Garage

**Task:** Repair

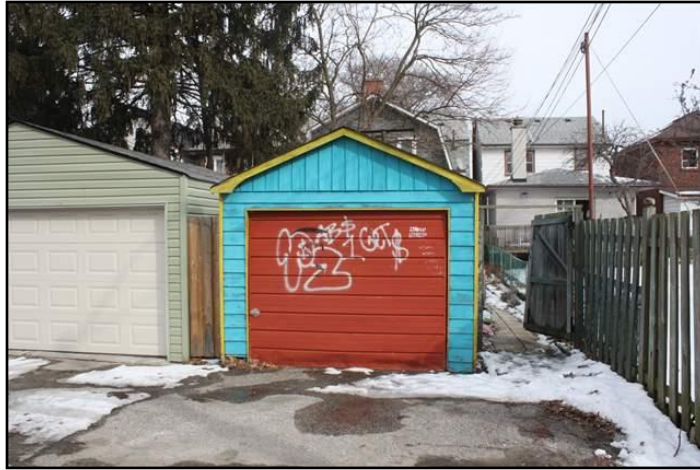
Garage door is non functional

**Condition:** • Damage

19. Damage

**Task:** Repair / Replace

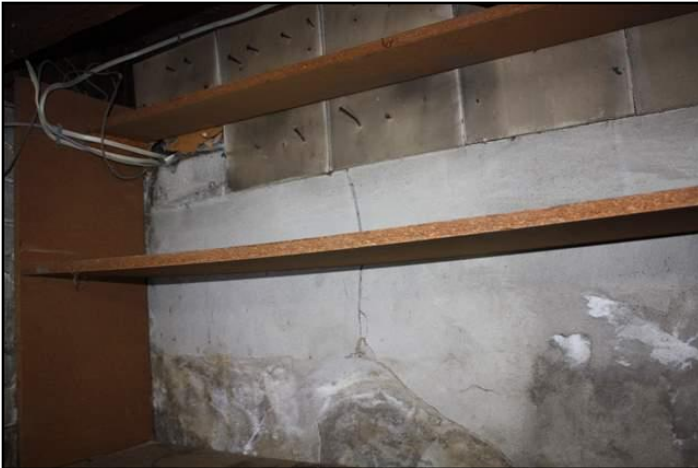
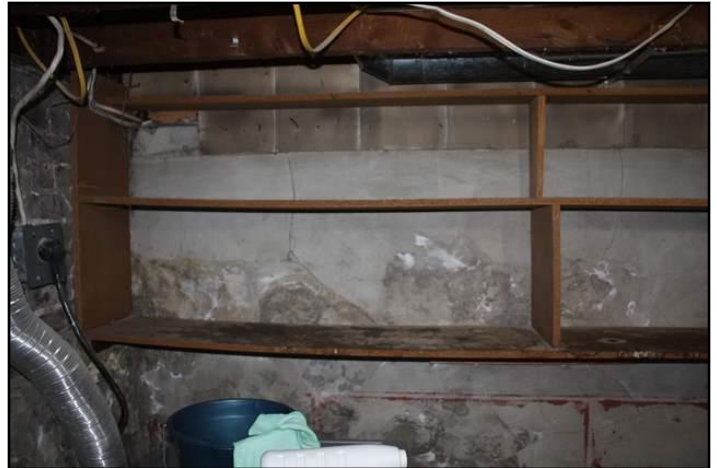
**Condition:** • [Parging damaged or missing](#)

It is common to provide parging on older stone foundations. Since stone foundations tend to be porous and damp, the parging will break down over time and crack/crumble. We recommend providing new parging (using a breathable cement meant for foundation wall applications). Providing new parging will help to provide a reference point of when the walls were repaired.

**Implication(s):** Chance of damage to structure | Shortened life expectancy of material

20. Parging damaged or missing

**Task:** Repair / Replace

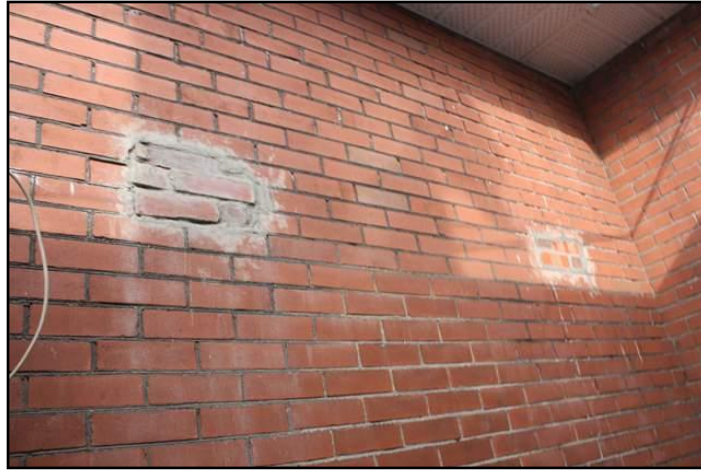
**Condition:** • [Prior repairs](#)

22. Prior repairs

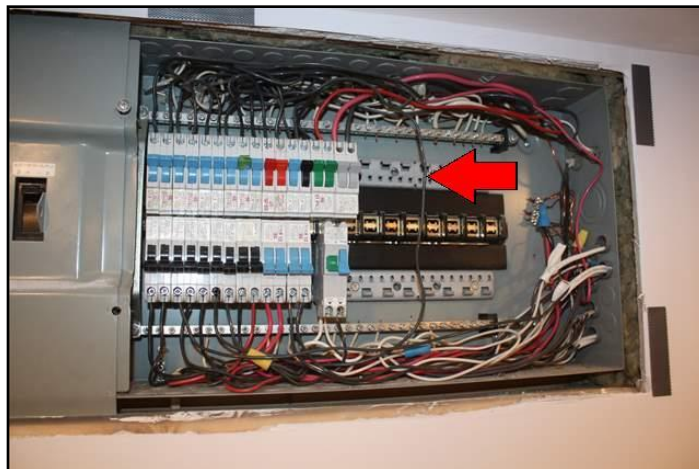
**Condition:** • [Wire crossing bus connections](#)

**Implication(s):** Fire hazard | Electric shock

23. Wire crossing bus connections

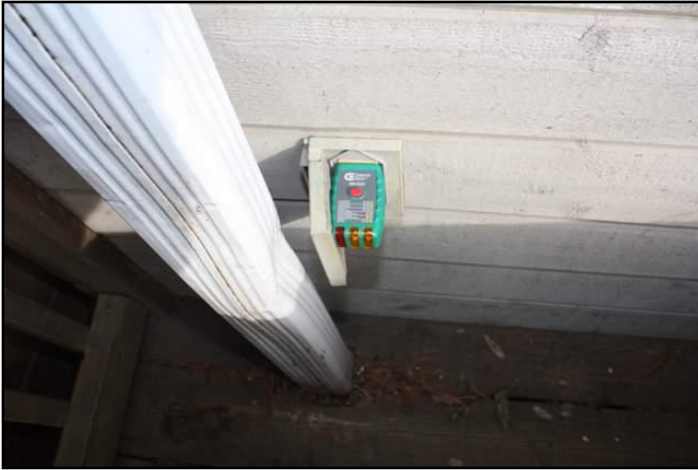
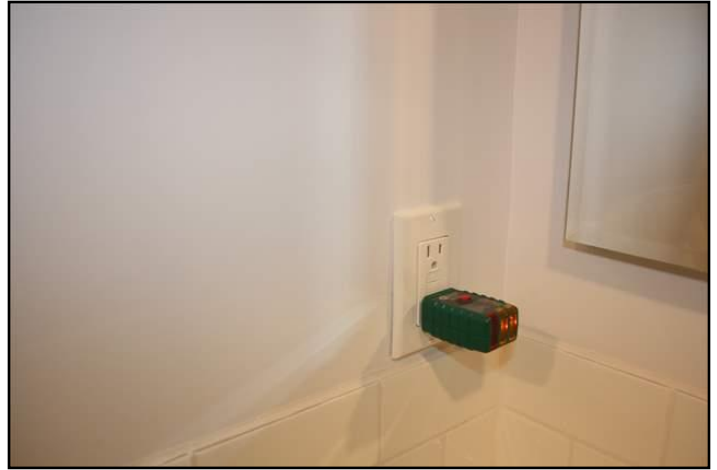
**Condition:** • [Test faulty on GFCI/GFI \(Ground Fault Circuit Interrupter\)](#)

24. Test faulty on GFCI/GFI (Ground Fault...

**Task:** Replace

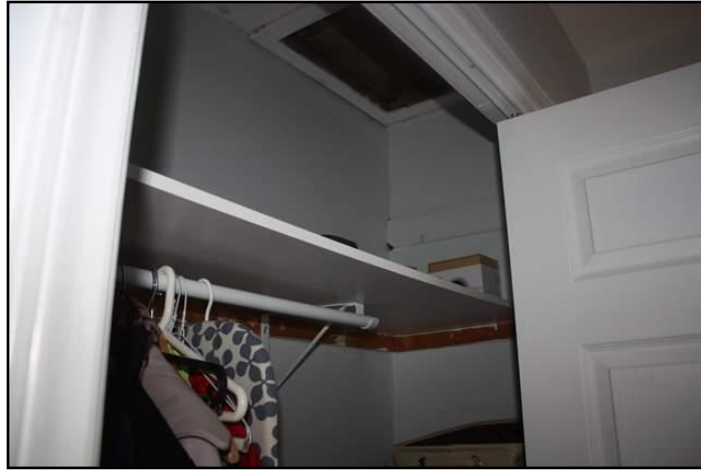
**Condition:** • [Inaccessible](#)

Built-in closet railing / Shelving restricted access to the attic. Provide access and inspect. Attics are important areas and should be inspected from time to time for : Water leakage/damage, Mold, insulation levels, presence of asbestos, animal activity, ventilation, and structural integrity.

26. Inaccessible

**Task:** Provide access and inspect

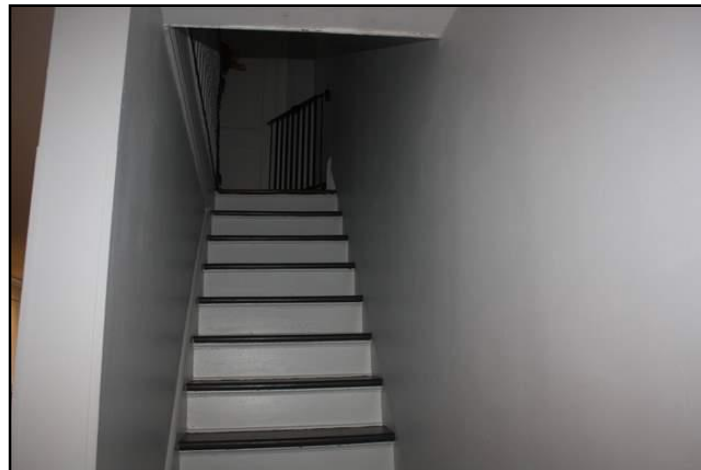
**Condition:** • [Missing](#)

**Implication(s):** Fall hazard

28. Missing

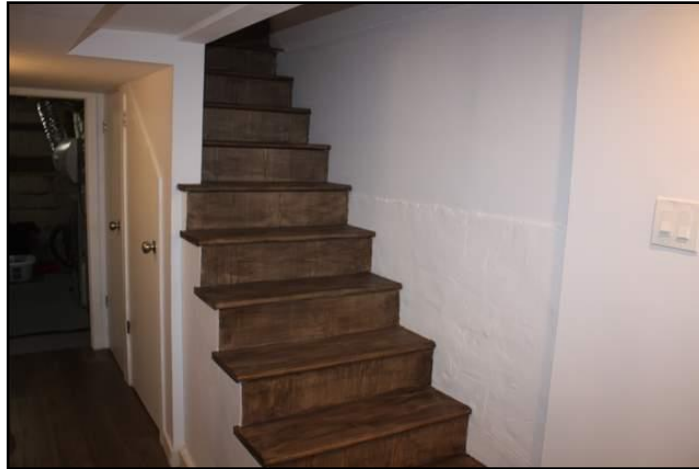
**Condition:** • [Missing](#)

**Implication(s):** Fall hazard

29. Missing
