Your Inspection Report

15 Sunnylea Ave E Toronto, ON

INSPECTION DATE: Wednesday, November 9, 2016

RE: Report No. 56013 15 Sunnylea Ave E Toronto, ON

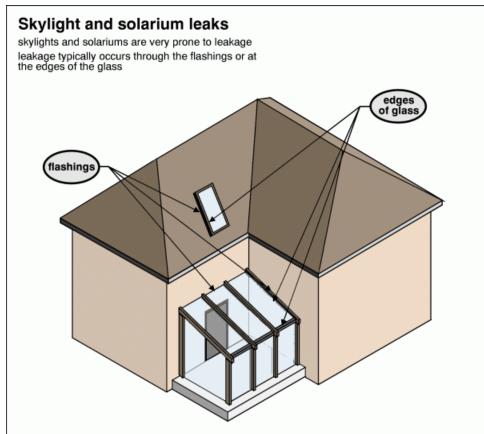
Condition: • <u>Skylight(s)</u> - <u>vulnerable area for leaks</u> Task: Monitor Time: Ongoing

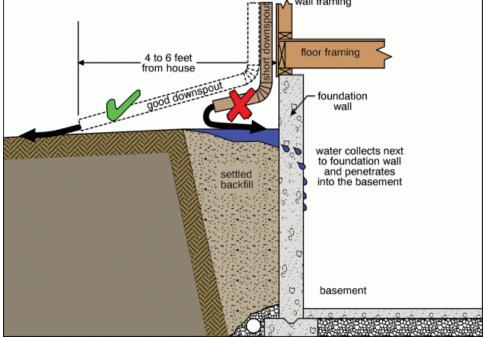
Condition: • Discharge too close to Foundation (should discharge at least 2 m / 6 ft away); provide Downspout Extension Location: Various Exterior Task: Improve Time: Less than 1 year

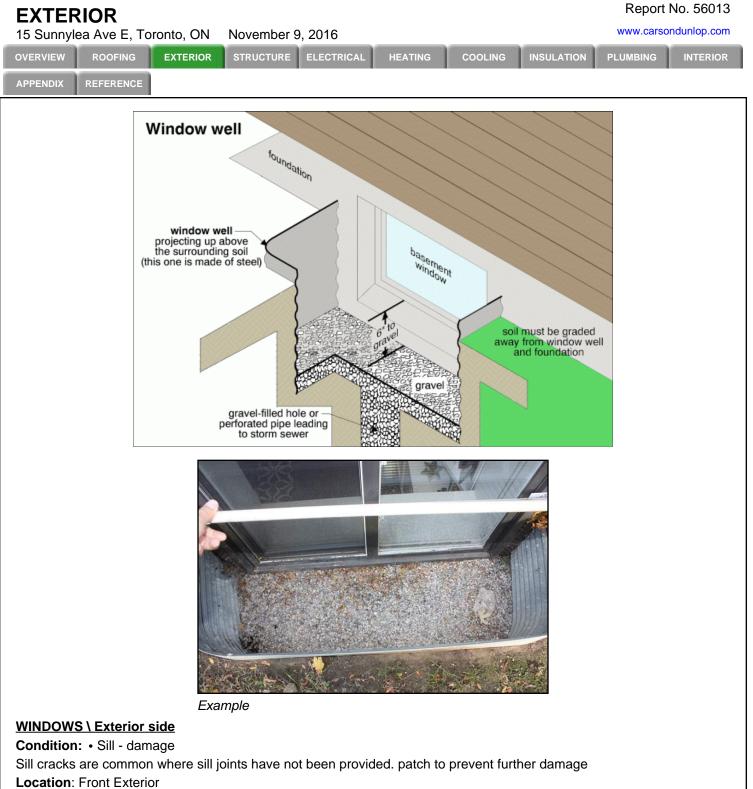
Condition: • Window Well - missing 6 to 8 inches clearance below window Location: Rear Exterior Task: Improve Time: Less than 1 year Cost: Minor

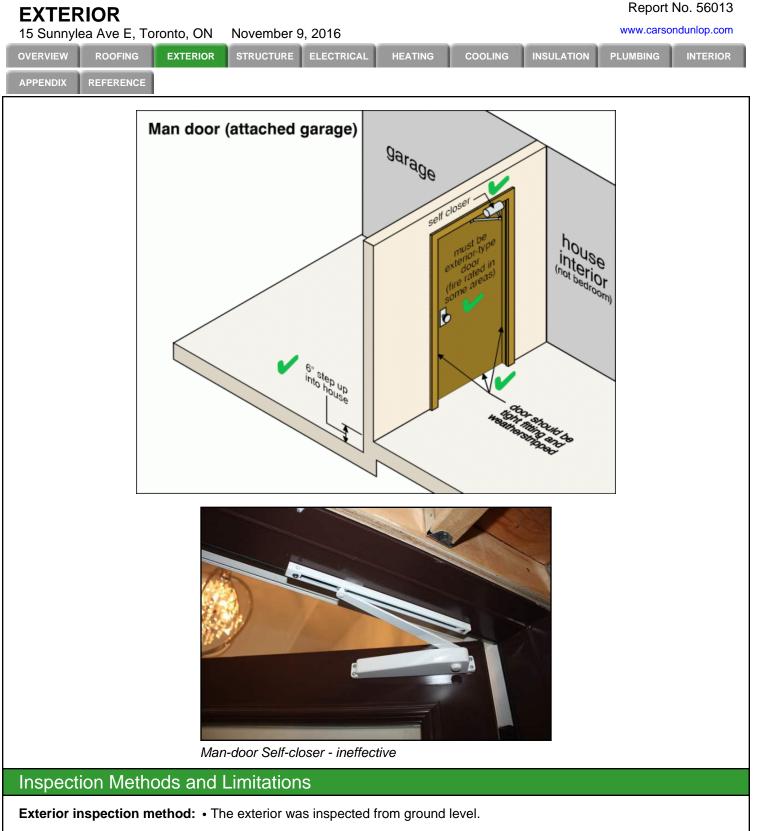
Condition: • Man-door Self-closer - ineffective

Does not close fully - needs adjustment. Also, self closer should not be type that can remain open. Location: Garage Task: Correct Time: As soon as possible

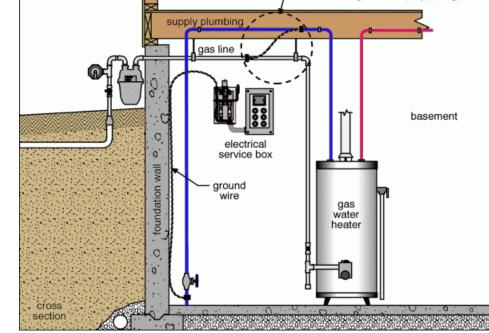
Condition: • Bonding (for Gas Piping) - not visible Bonding not found - If not present, have electrician install bonding wire Location: Basement

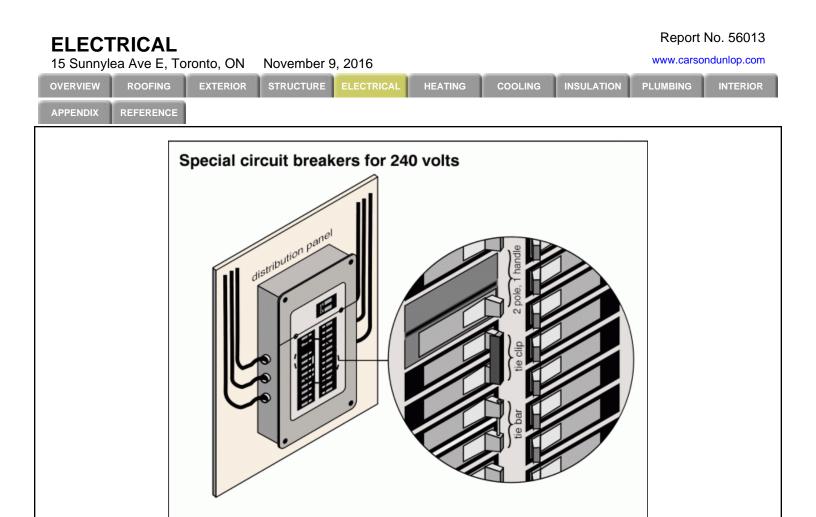
Condition: • Link - missing on multiwire circuit Location: Basement Panel Task: Correct Time: Immediate Cost: Minor
