Your Inspection Report

55 Parkdale Rd
Toronto, ON

INSPECTION DATE:
Thursday, June 2, 2016

RE: Report No. 53827
55 Parkdale Rd
Toronto, ON

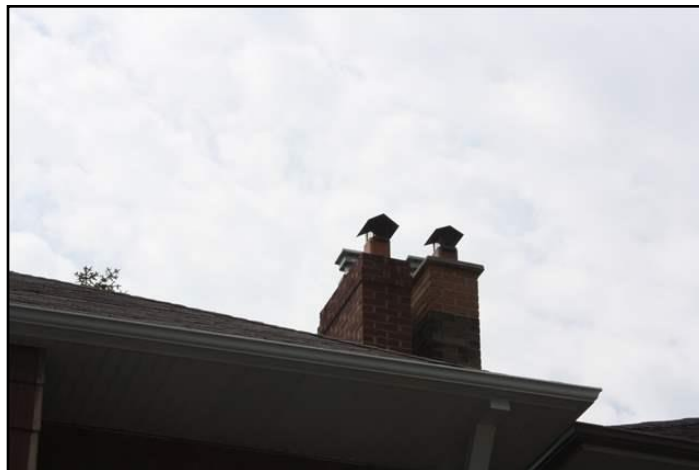
Condition: • [Masonry Cap - missing](#)

Masonry Cap - missing

Time: Less than 1 year

Cost: \$500 - \$1,000

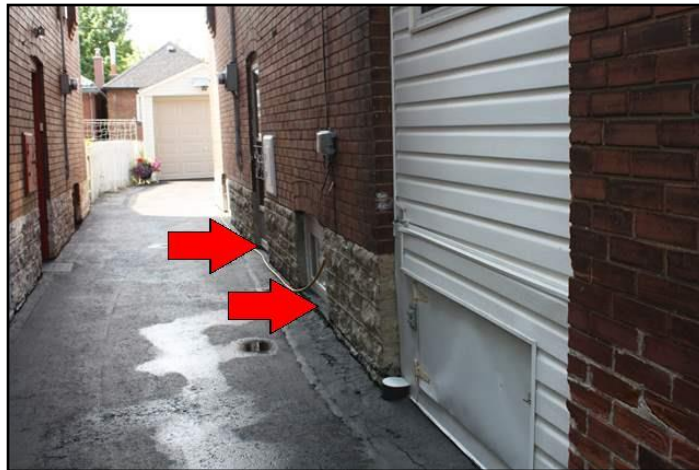
Condition: • Sill - clearance inadequate (above grade level)

Sill - clearance inadequate (above grade...

Task: Monitor / Improve

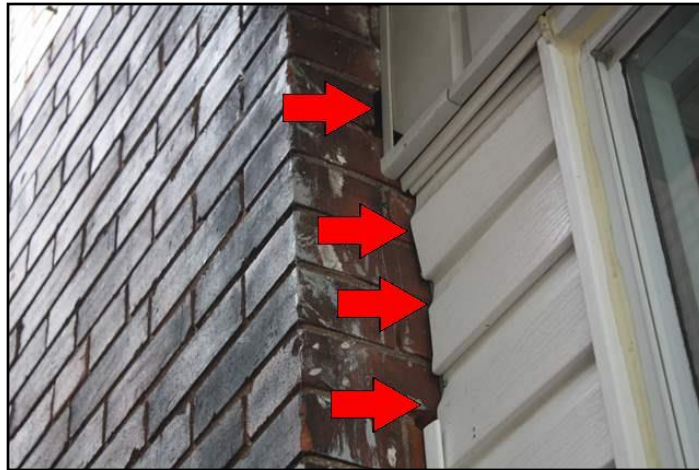
Condition: • Gap at wall should be sealed

Gaps at wall should be sealed

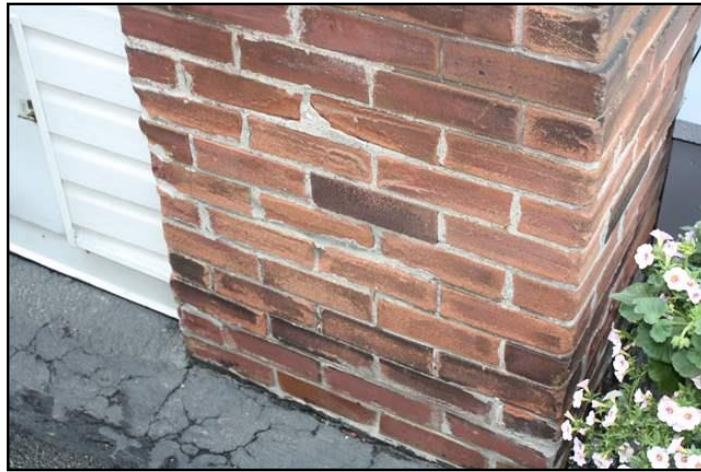
Condition: • [Spalling](#)

Example of Spalling

Task: Repair

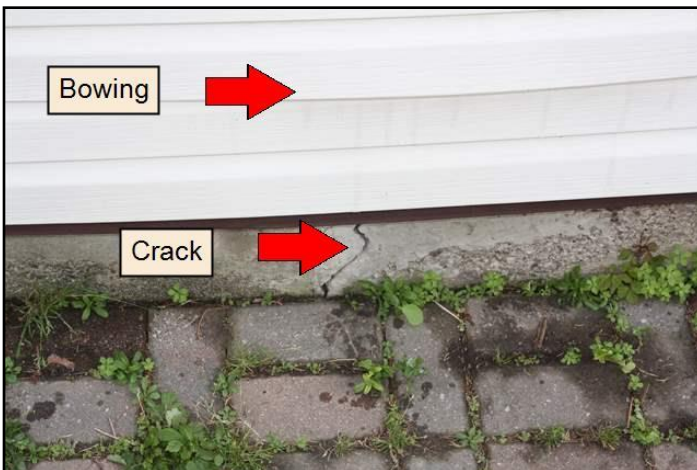
Right side of garage

Cracks and wall bowing were noted. Due to the garage storage, we were unable to inspect the interior of the garage. The exterior vinyl siding limited our view of the walls.

Task: Repair / Replace

Cost: Not Determined - Consult with Specialist

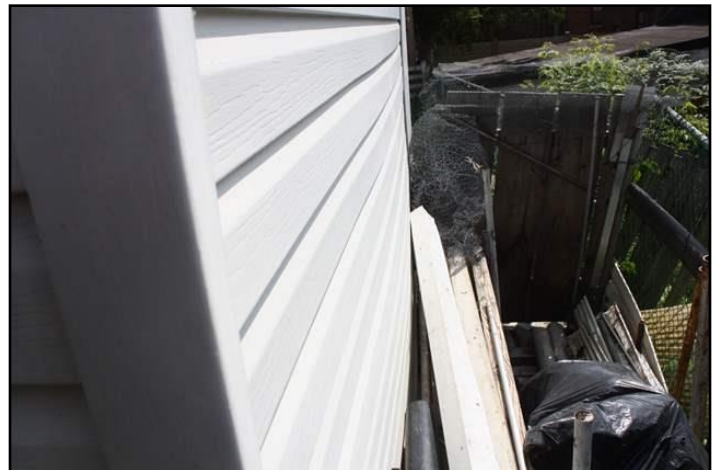
Rear garage wall bowing noted

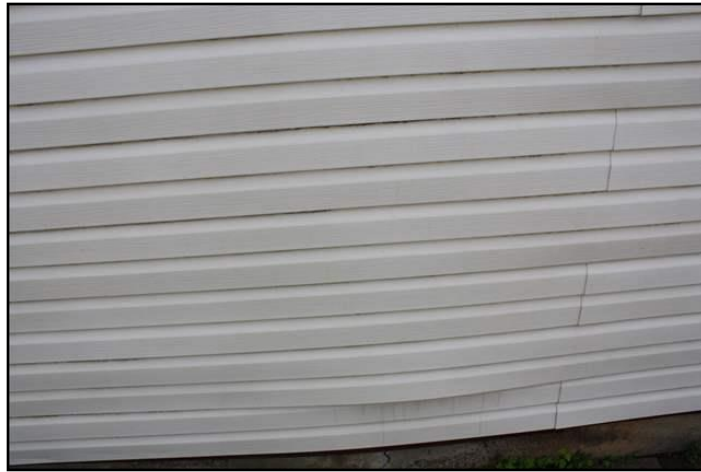
Condition: • [Typical low quality](#)

Typical low quality

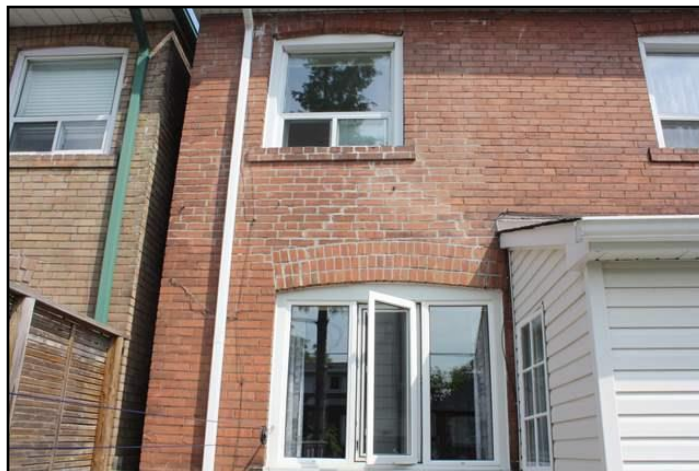
- Condition:** • [Prior repairs noted](#)

Example of Prior repairs

Task: Monitor

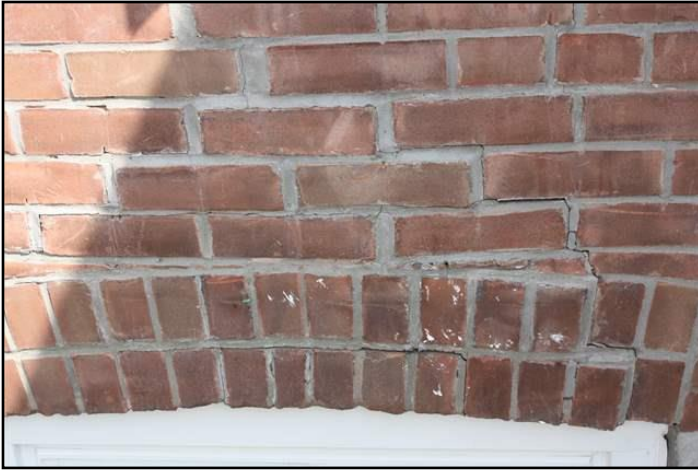
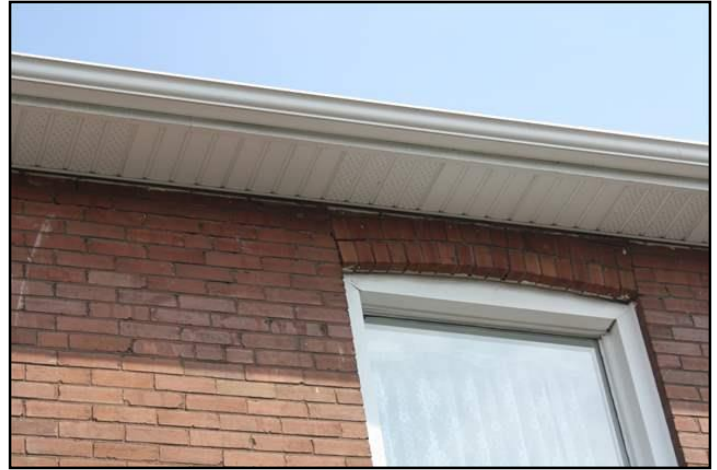
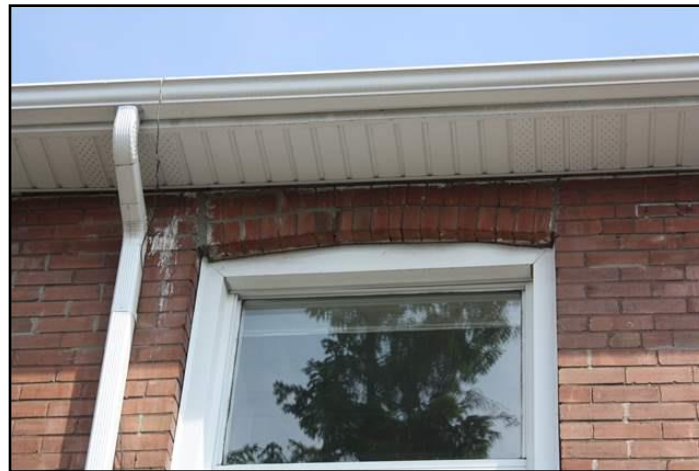
- Condition:** • [Cracks](#)

Arch movement noted at rear window. Consult with masonry specialist to repair / tuckpoint all arches

Task: Repair

Cost: Consult with specialist

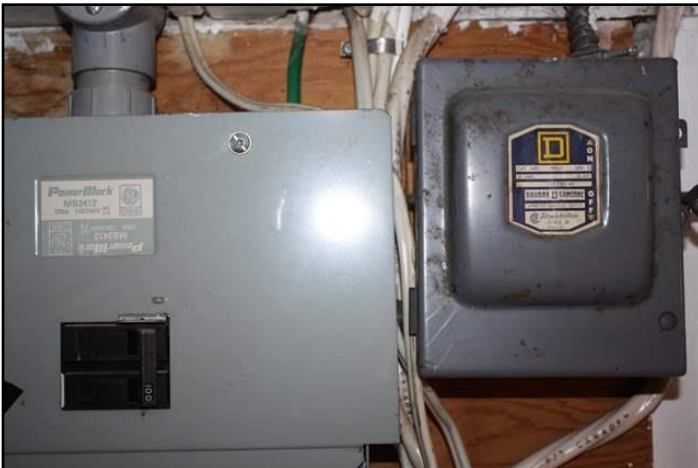
Condition: • [Disconnect missing at Main Panel](#)

Disconnect missing at Main Panel

Task: Correct

Time: Immediate

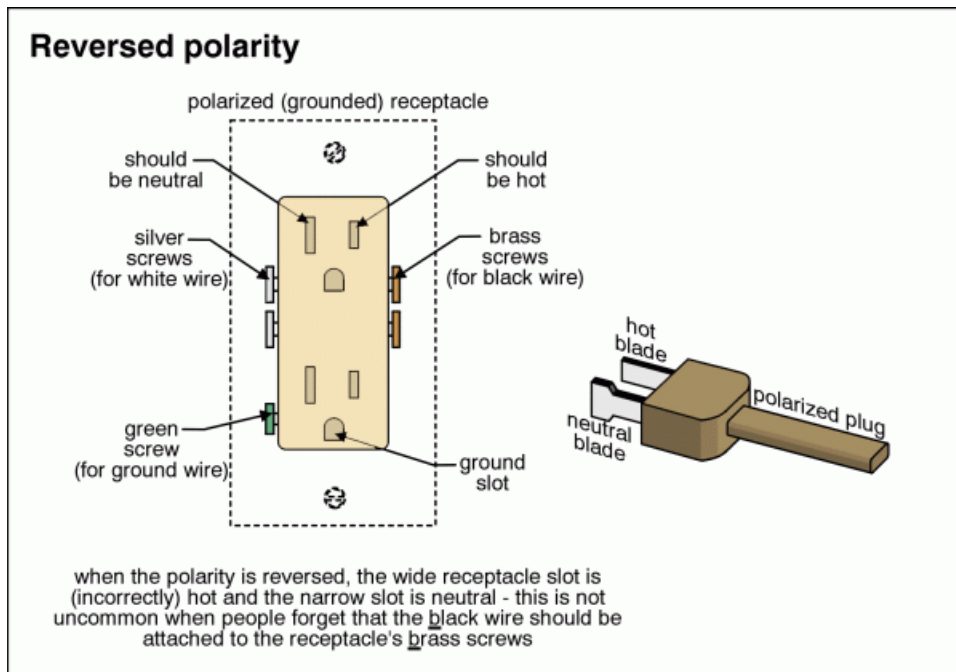
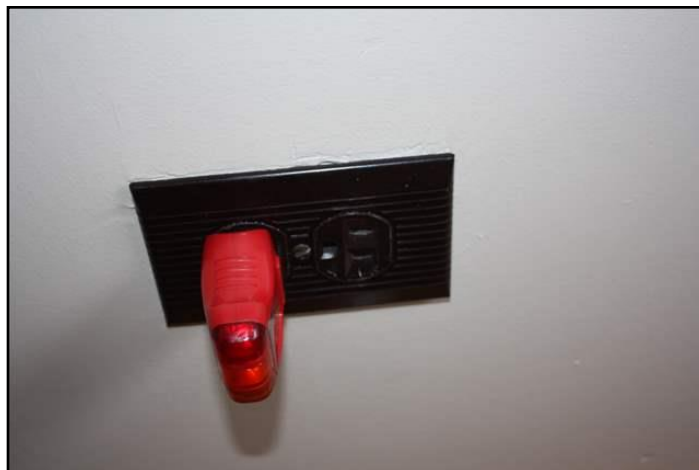
Condition: • [Reversed polarity \(black / white wires reversed\)](#)

Reversed polarity (black / white wires...)

Time: Immediate

Cost: Minor

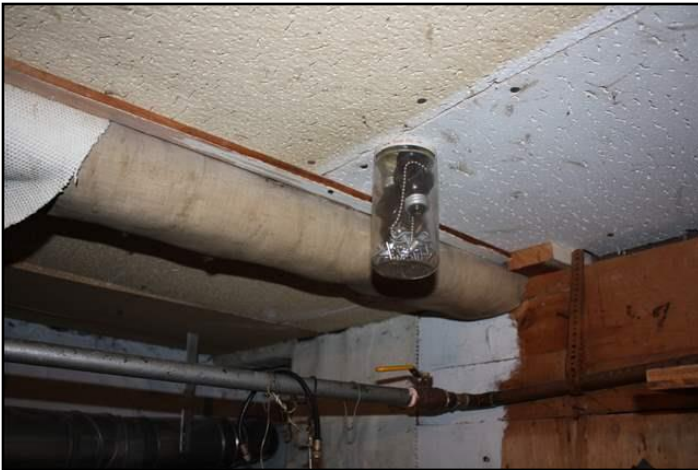
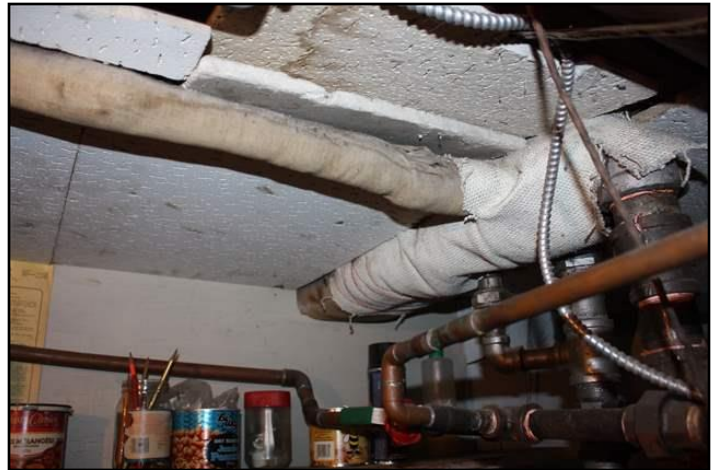
Condition: • The insulation on heating pipes may contain asbestos. Health Canada recommends the insulation be left in place undisturbed. If the insulation is damaged or is to be disturbed, and if it contains asbestos (confirm with Laboratory test), precautions should be taken that asbestos fibers are not released into the house air during the work. Please see the Asbestos article in the Supplementary section of the Home Reference Book.

Location: Basement Boiler Room

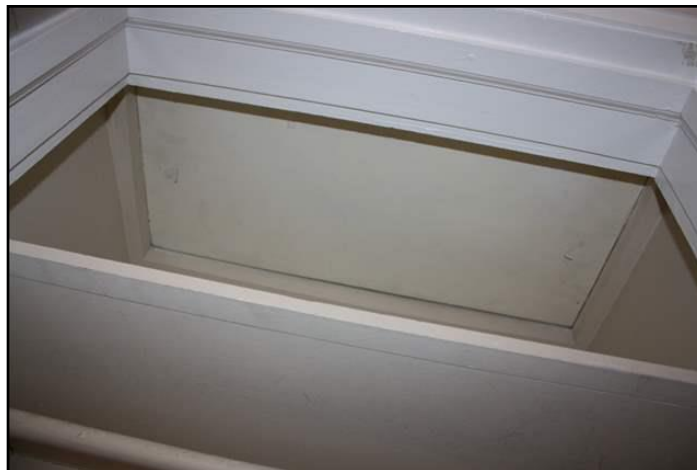
Condition: • Access Hatch - missing/too small

Double hatch noted (there is a second hatch about one foot above the first one)

Access Hatch - too small

Task: Improve

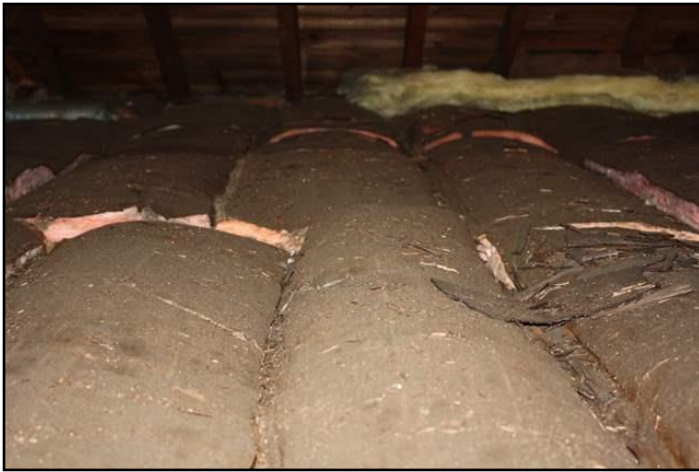
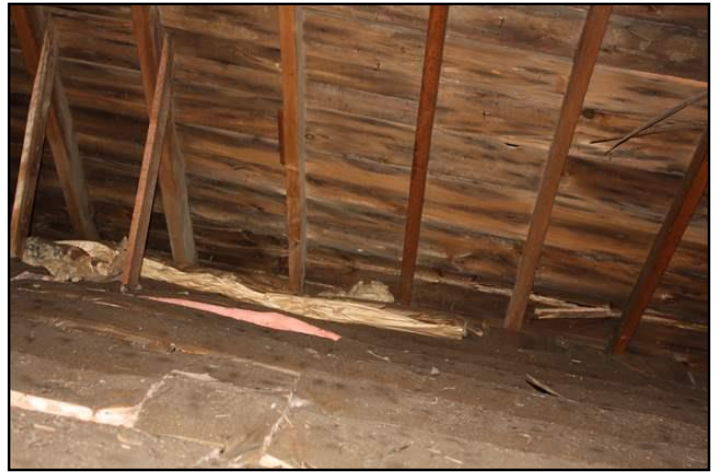
Condition: • [Insulation level below modern standards](#)

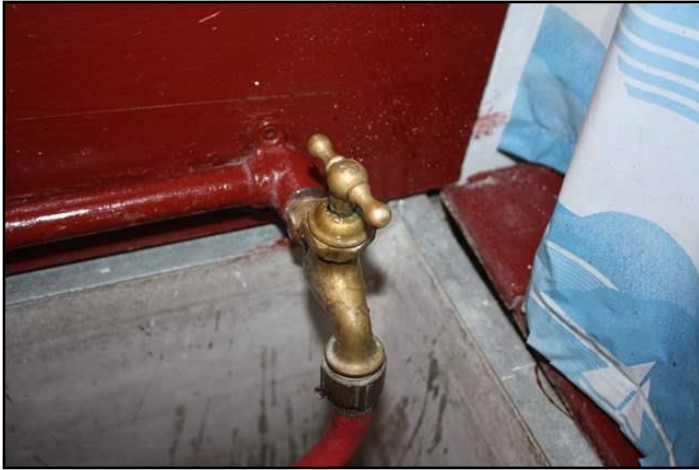
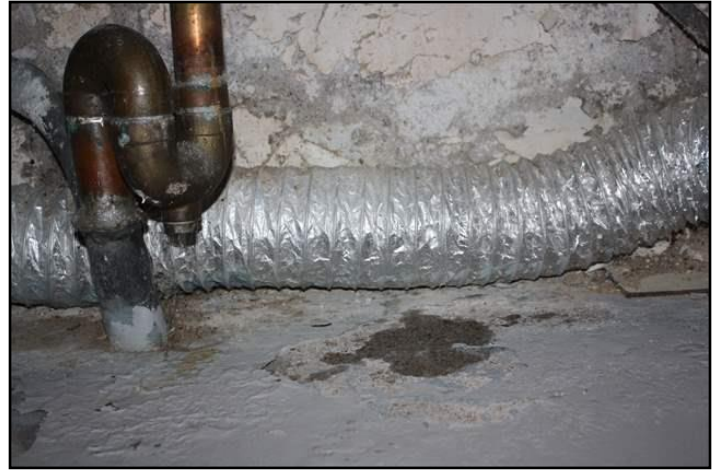
Condition: • [Leak](#)

Very old tub. Leak noted below tub and at fixtures.

Task: Repair / Replace

Time: As soon as possible

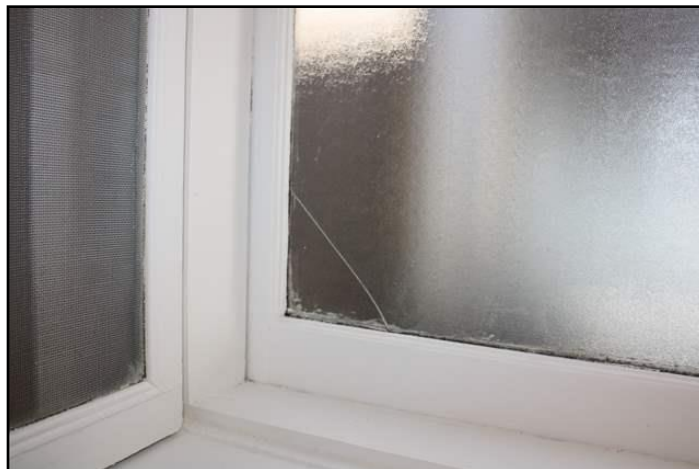
Condition: • [Glass - cracks](#)

Glass - cracks

Task: Replace

Cost: Minor

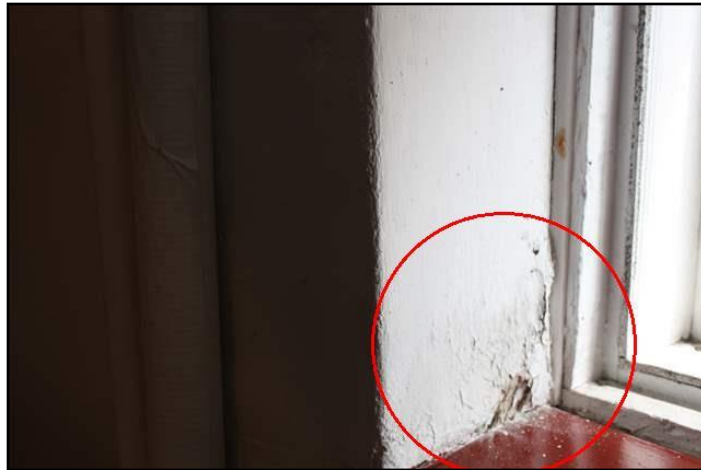
Condition: • [Dampness](#)

Using a moisture meter, dampness was noted.

Task: Repair / Ensure exterior window wall gaps are well sealed

Time: As soon as possible

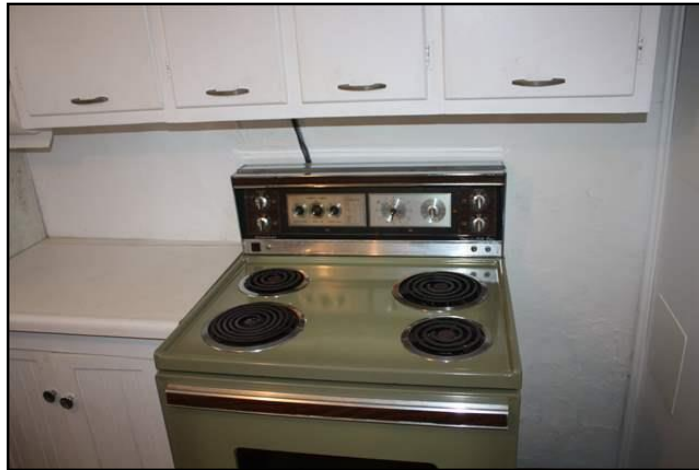
Condition: • Combustible clearance inadequate
protect wood cabinets - provide range hood.

Location: Basement

Combustible clearance inadequate

Task: Provide range hood if oven is to remain
