INSPECTION REPORT

2328 8 TH AVENUE NORTH EAST
CALGARY, AB T2E 0V1

RE: Report No. 1421
2328 8 th Avenue North East
Calgary, AB
T2E 0V1

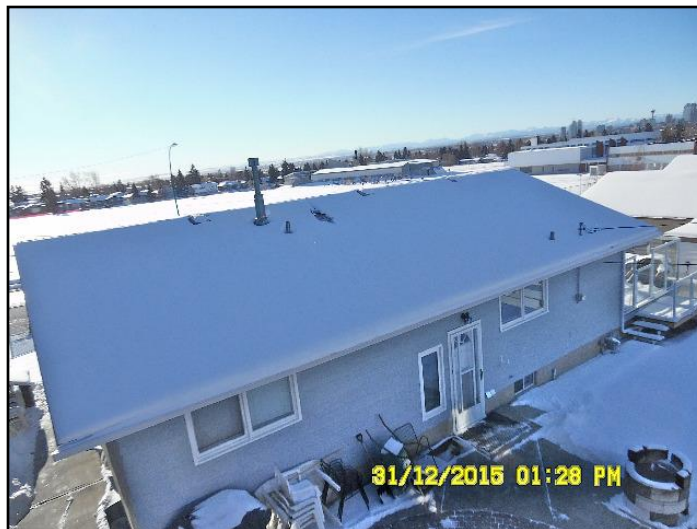
House Roof

General: • "Roof seems to be recent and in a good shape". It is my Opinion as an expert in court actions fo or Insurance Claims that the roof was recently replaced from a hail claim. The roof shingles are installed according to manufactures specifications and is providing protection from the weather conditions during the inspection.

Note: The Shingles are Asphalt impregnated Fiberglass and were installed during the summer month and are sealed together.

Condition: • No roofing recommendations are offered as a result of this inspection.

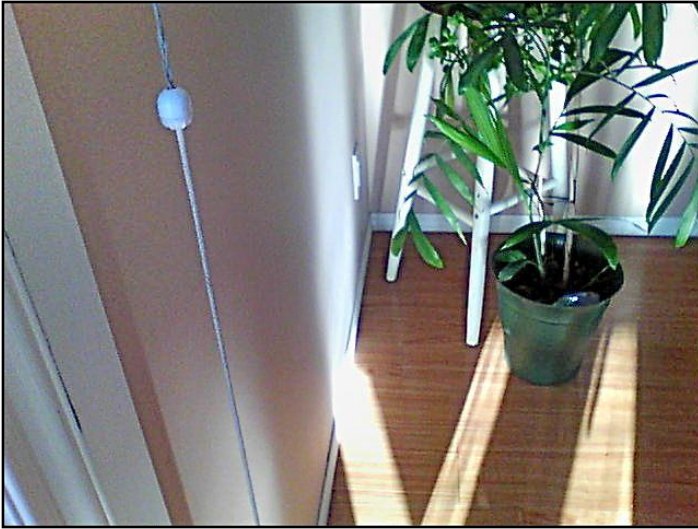
The 2 By 4 Stud Walls Triple stud corners found with infra red camera. Solid wood to outside wall with little insulation.

Corners wood posts

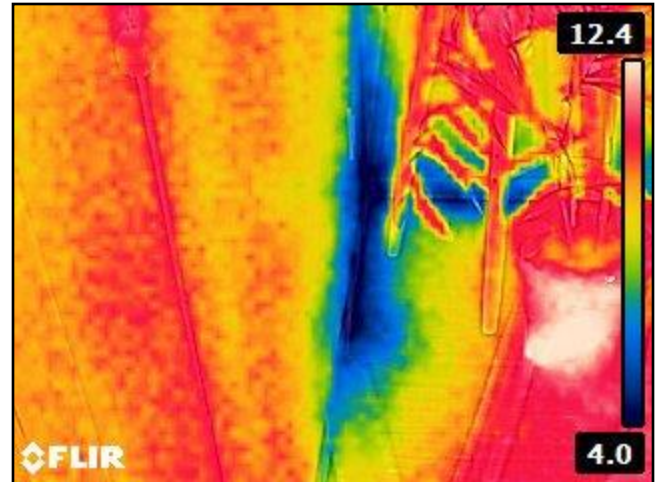
Corners Cold

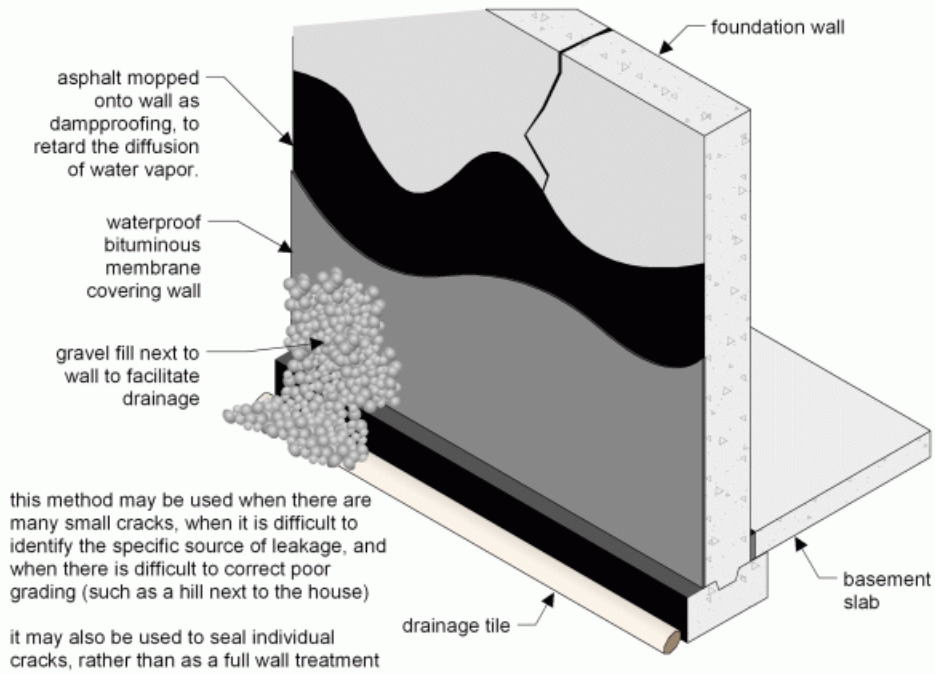
Condition: • Typical minor cracks

Settlement of 3 cracks on outside repaired and patched in 1995 and downspouts re-directed to west wall down hill.

Implication(s): Chance of water entering building

Crack repair - exterior patching

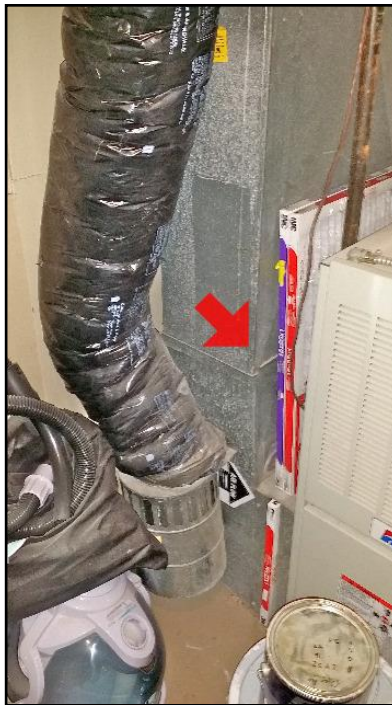
Filter 24 X 16

Condition: • [Dirty](#)

Replace filter every month of Continuous operation or every three months of normal use. Proper Direction of air flow through filter catches more dust.

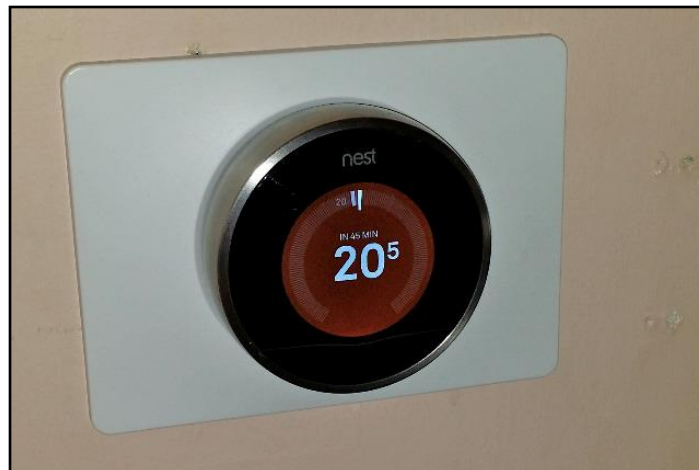
Nest Thermostat

Co Detector To be Installed with Nest 2016

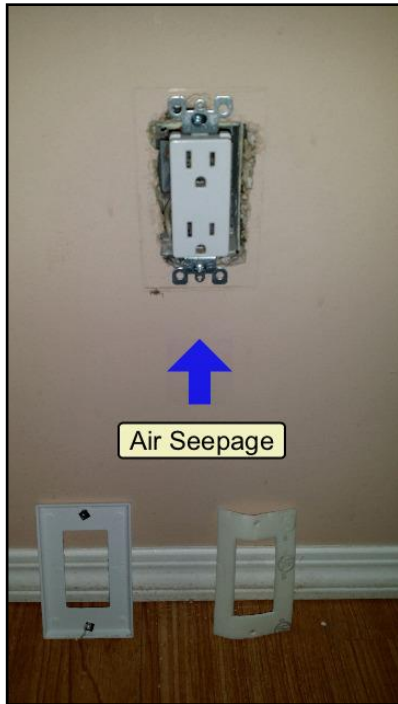
General: • Wall outlets leaking air into house. Add insulators around outlets, cable, phone and switches.

Open around box

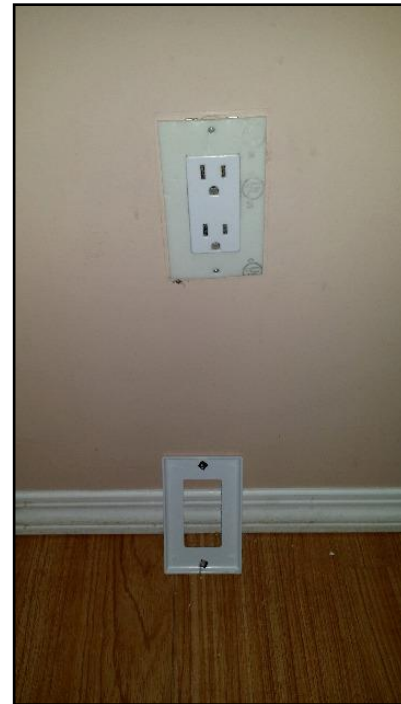
Sealed Gasket

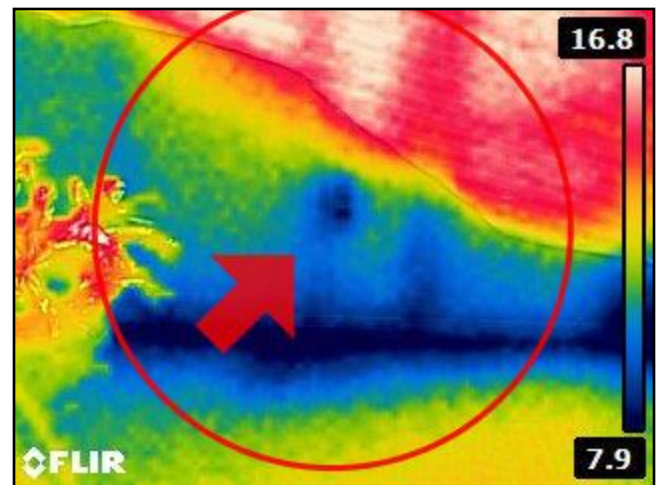
Cold around box

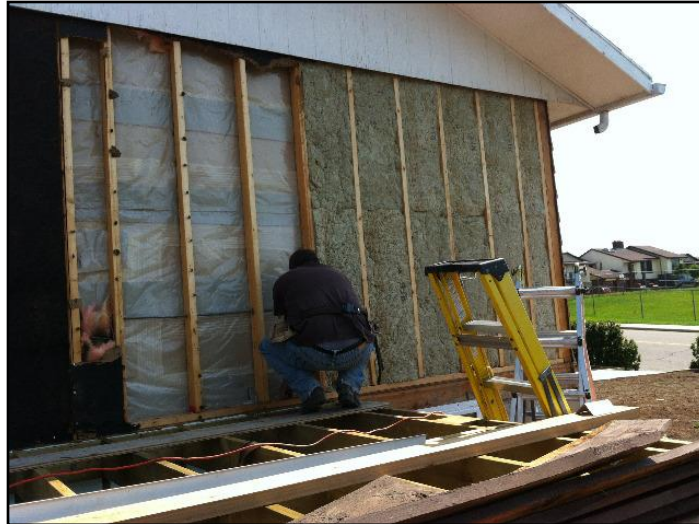
West Wall

West wall added insulation from outside in 2013.
