YOUR INSPECTION REPORT

104 Magwood Court
Toronto, ON M6S 2M6

INSPECTION DATE:
Tuesday, April 19, 2022

RE: Report No. 7049, v.2
104 Magwood Court
Toronto, ON
M6S 2M6

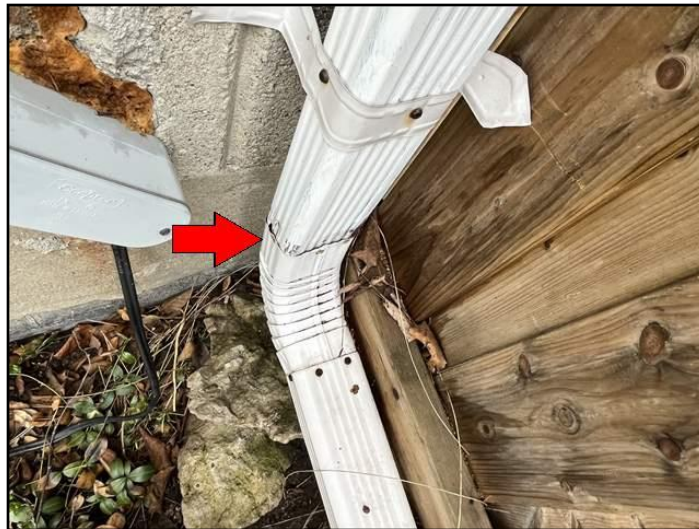
1. Connections loose

Condition: • [Connections loose](#)

Task: Repair

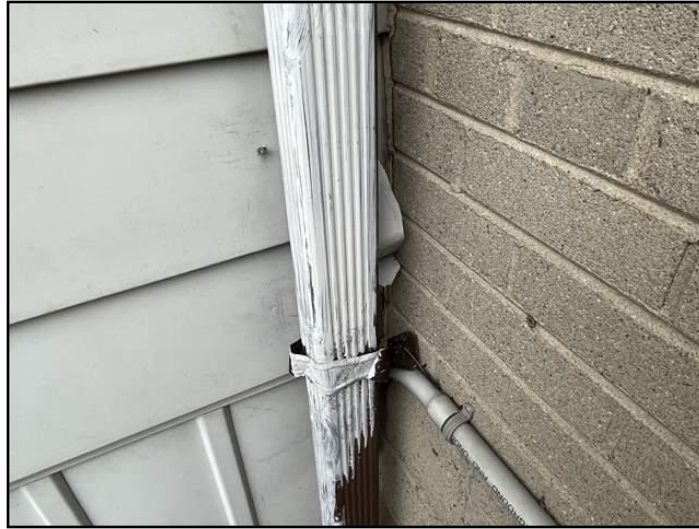
2. Not well secured

Condition: • [Not well secured](#)

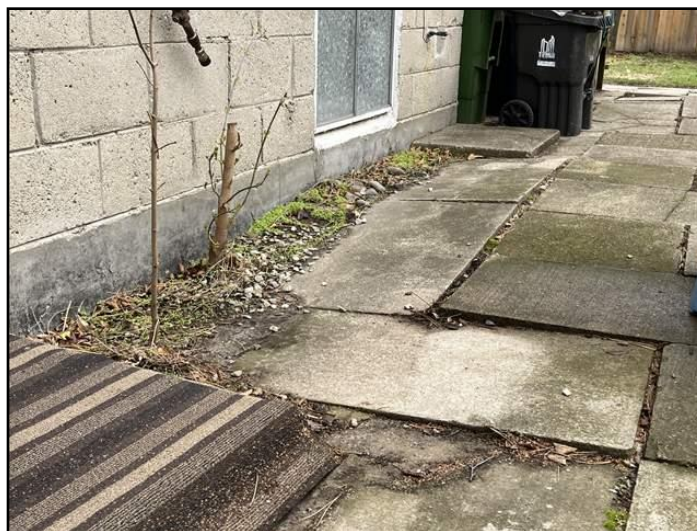
3. Slope toward building

Condition: • [Slope toward building](#)

Patio has settled and the grading is sloping toward the house. By grading, we are referring to the ground beside the home from wall to at least 6-feet away. Repair/Replace patio/grading to promote water drainage away from home

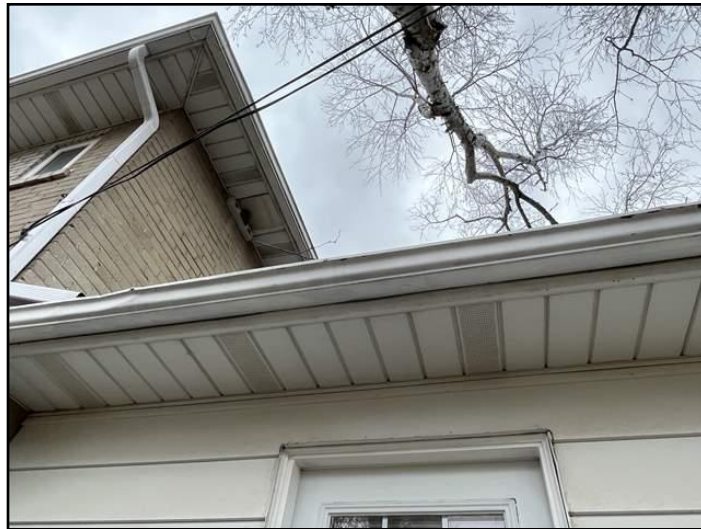
4. *Tree Branch Maintenance*

Condition: • Tree Branch Maintenance

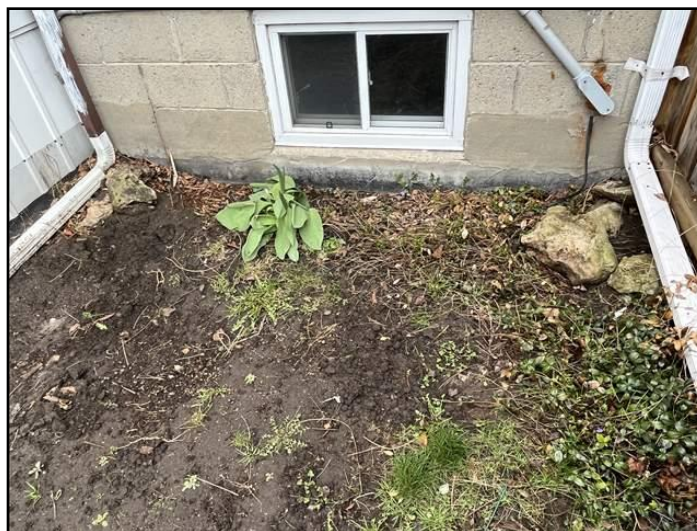
5. Low Areas

Condition: • Low Areas.

Low areas or settlement was noted in some areas. Monitor drainage especially after heavy rainfalls and improve grade to slope away from home for at least 6 feet. This will help promote good drainage away from home. This is normal maintenance for all homes.

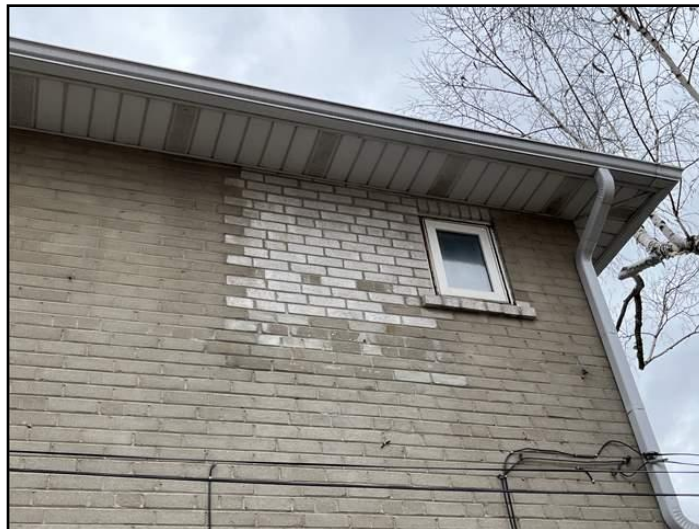
6. *Prior repairs*

Condition: • [Prior repairs](#)

Location: Rear Exterior Wall

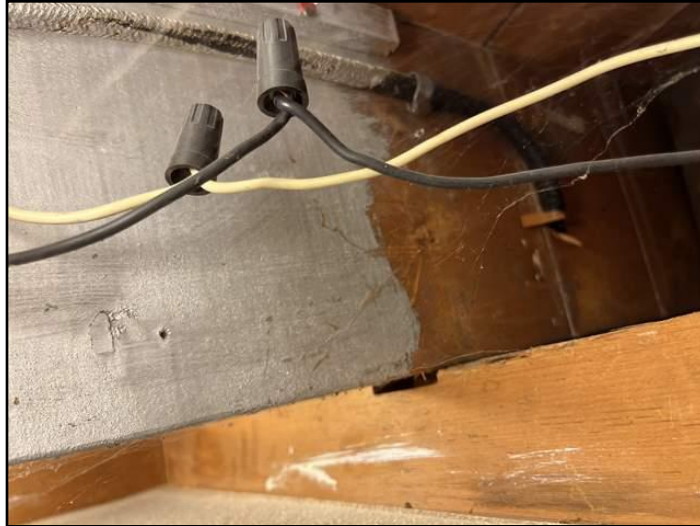
8. Open splices

Condition: • [Open splices](#)

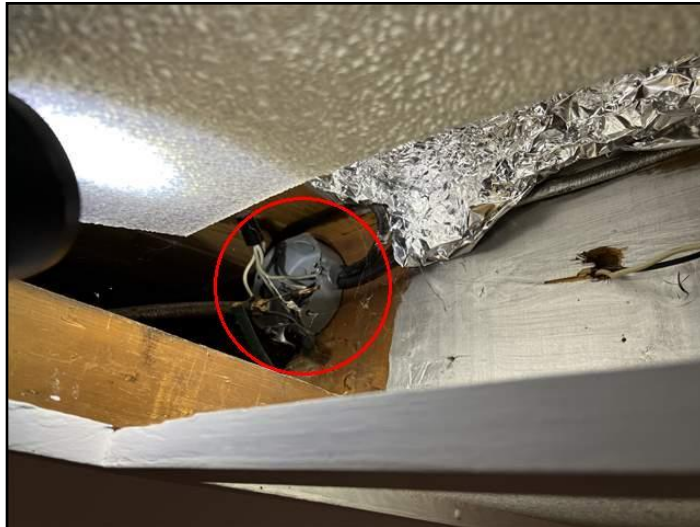
9. Cover missing

Condition: • [Cover loose or missing](#)

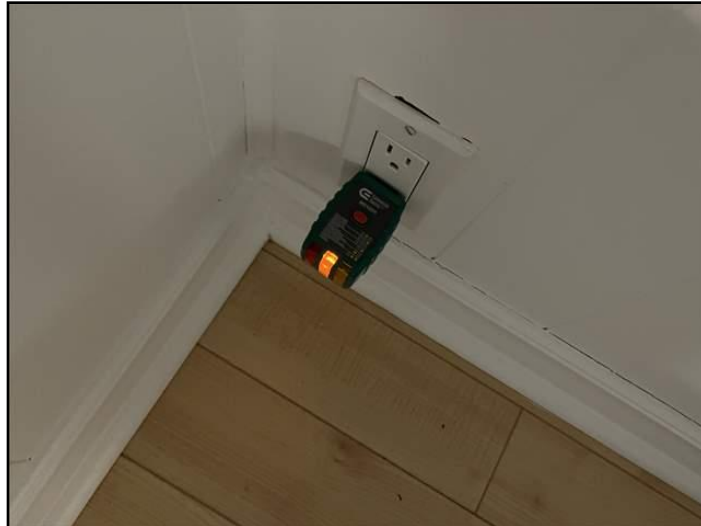
10. *Ungrounded*

Condition: • [Ungrounded](#)

Task: Replace with gfi outlet

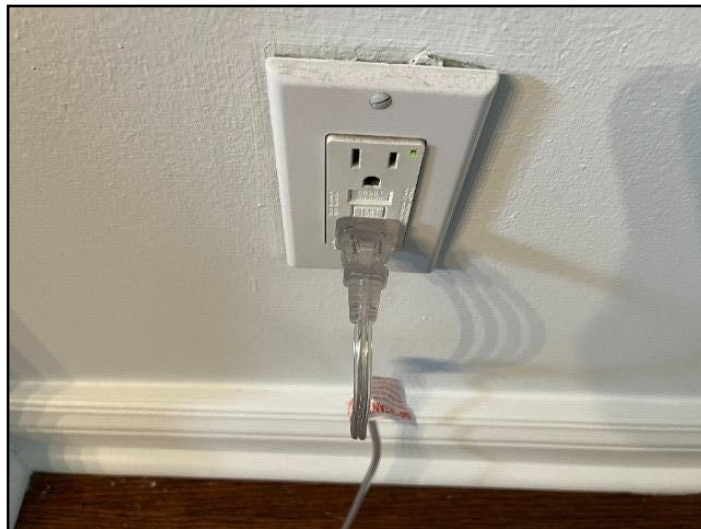
11. *example of gfi outlet in ungrounded area*

Condition: • [Ungrounded](#)

Location: Various First Floor / Second Floor

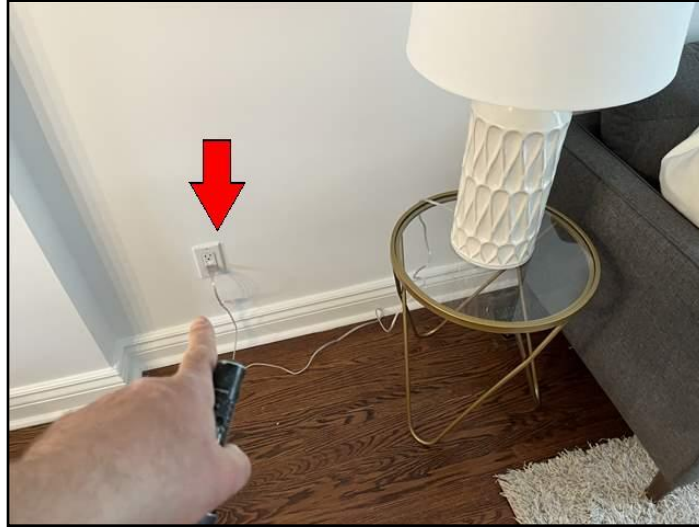
12. Loose

Condition: • [Loose](#)

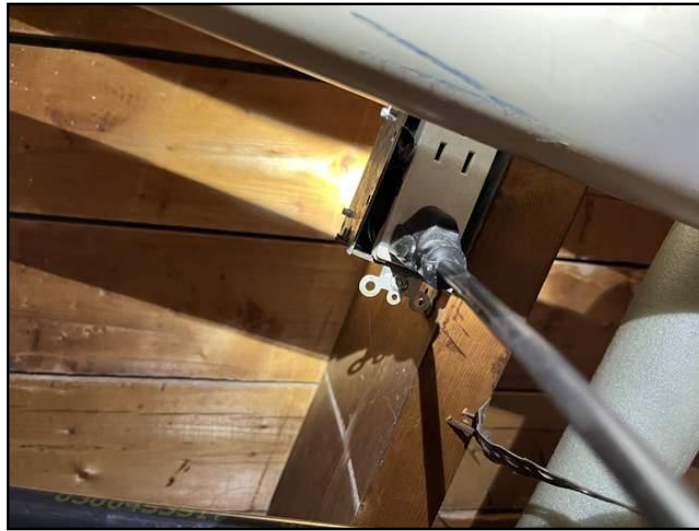
13. For outlet (receptacle) is missing

Condition: • For outlet (receptacle) is missing

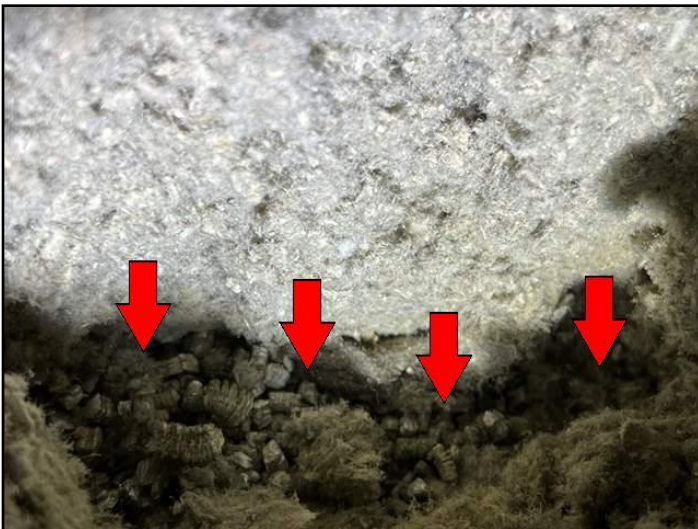
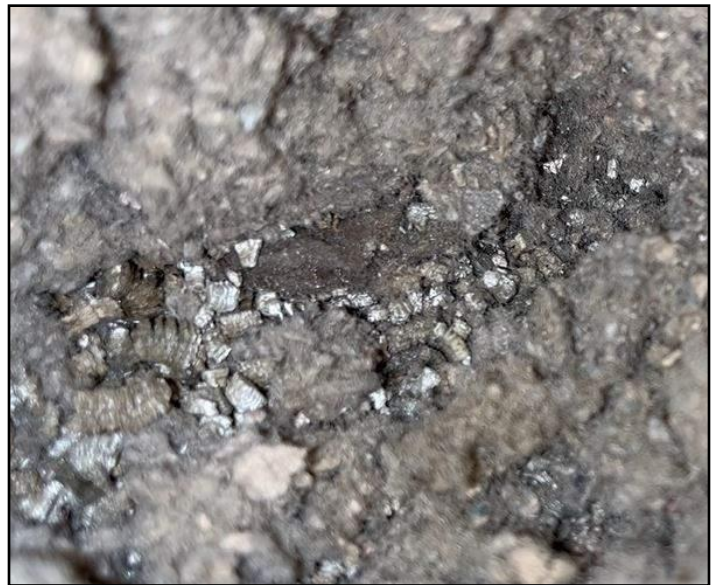
Condition: • [Possible Zonolite \(vermiculite\)](#)

Vermiculite insulation was found in the attic (below the cellulose fiber). This type of insulation often contains some asbestos, which can be confirmed with proper laboratory testing. Health Canada's position is that vermiculite insulation is best left in place undisturbed, and health precautions should be taken if working in the attic or disturbing the insulation.

Task: See note

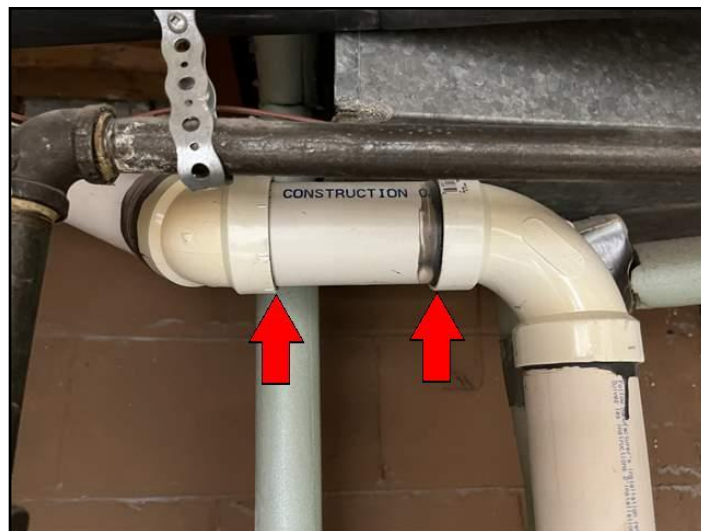
16. Poor slope (short run)

Condition: • [Poor slope](#)

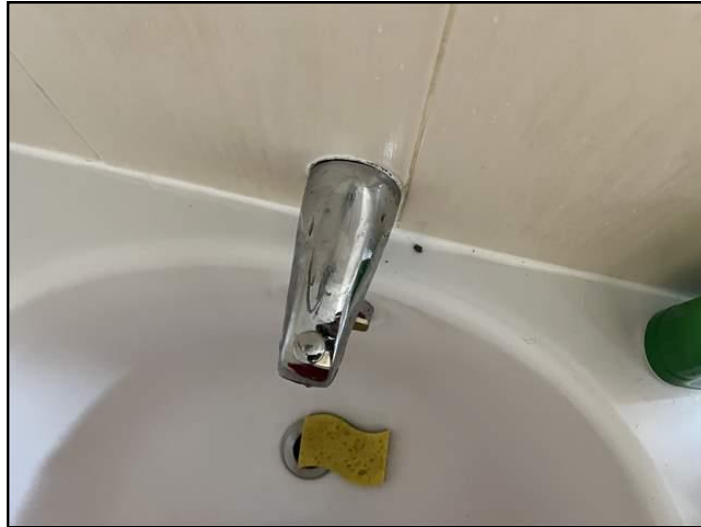
17. Loose

Condition: • [Loose](#)

Task: Repair / Replace

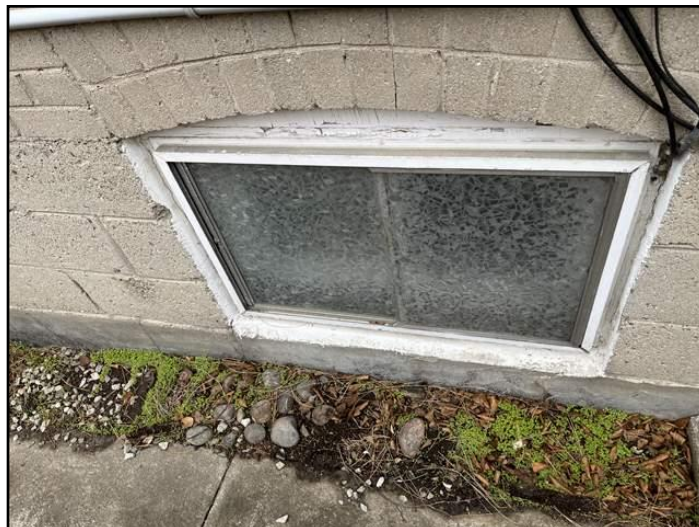
Condition: • Older basement windows noted

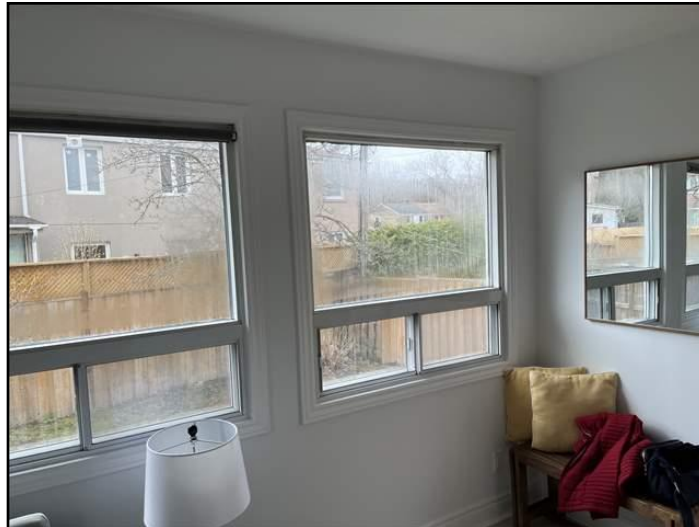
19. Lost seal on double or triple glazing

Condition: • [Lost seal on double or triple glazing](#)

Task: Replace

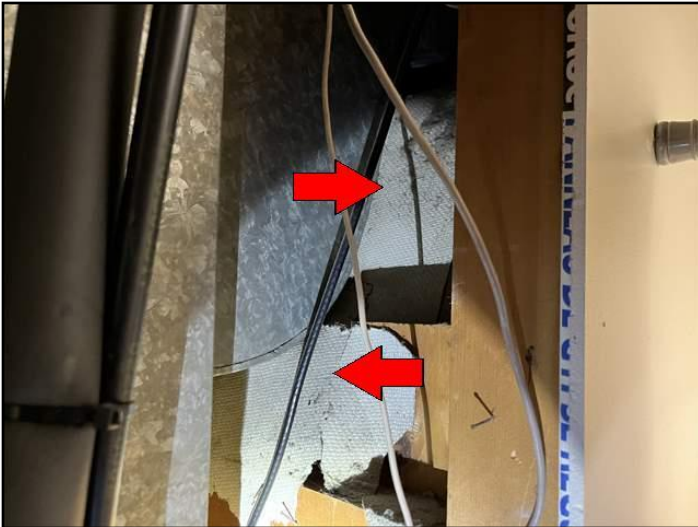
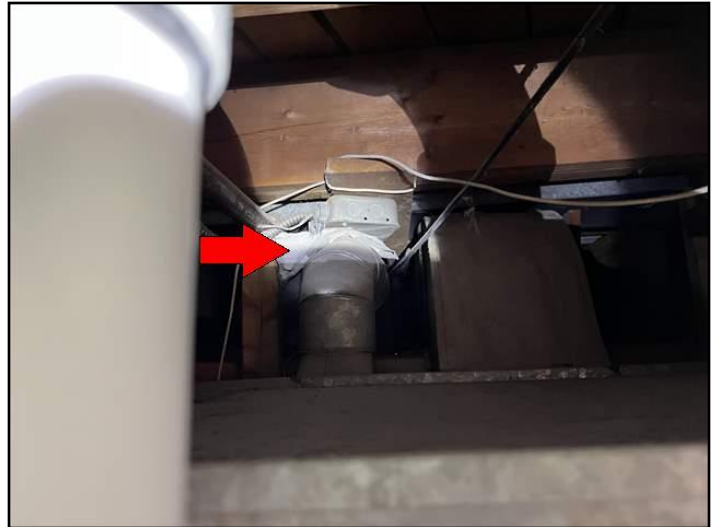
20. Viewed in furnace room

Condition: • Possible asbestos containing materials

During the era when this house was built, it was very common to use asbestos type insulation to protect the floors from heating ducts. Determining the material type is outside the scope of this inspection. Health Canada recommends that any

asbestos material found should stay in place undisturbed. If you plan to remodel or if this is a concern, consult with a specialist for lab testing to confirm if asbestos is present.
