YOUR INSPECTION REPORT

546 Beresford Avenue
Toronto, ON M6S 3C3

INSPECTION DATE:
Friday, March 23, 2018

RE: Report No. 2247
546 Beresford Avenue
Toronto, ON
M6S 3C3

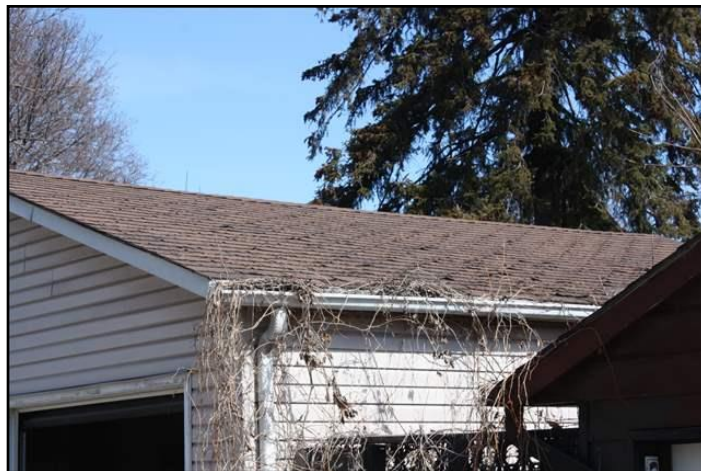
Condition: • [Old, worn out](#)

Implication(s): Chance of water damage to contents, finishes and/or structure

1. Old, worn out

Task: Replace

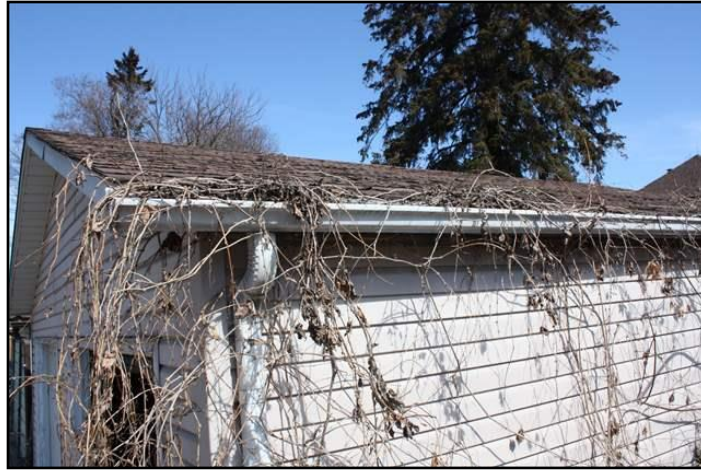
Condition: • [Clogged](#)

Implication(s): Chance of water damage to contents, finishes and/or structure

2. Clogged

Task: Clean

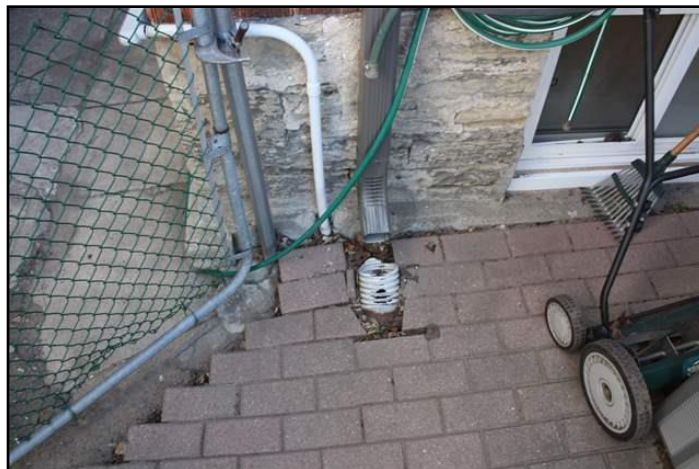
Condition: • [Should discharge 6 feet from building](#)

Implication(s): Chance of water damage to contents, finishes and/or structure

3. Should discharge 6 feet from building

Task: Improve

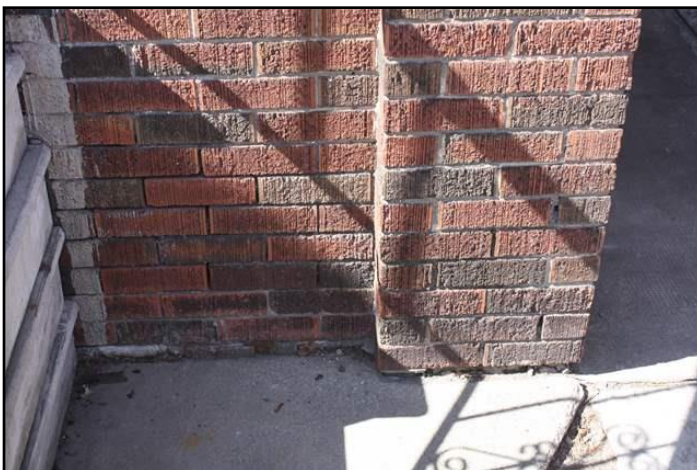
Condition: • [Spalling](#)

Implication(s): Weakened structure | Chance of structural movement

4. Spalling

Task: Repair

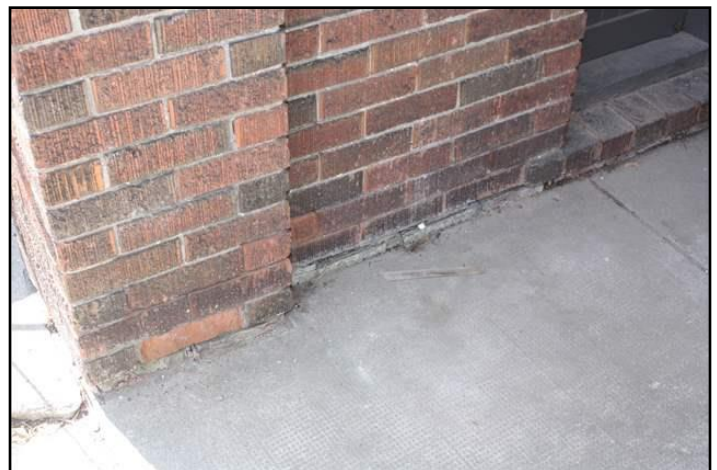
5. Spalling

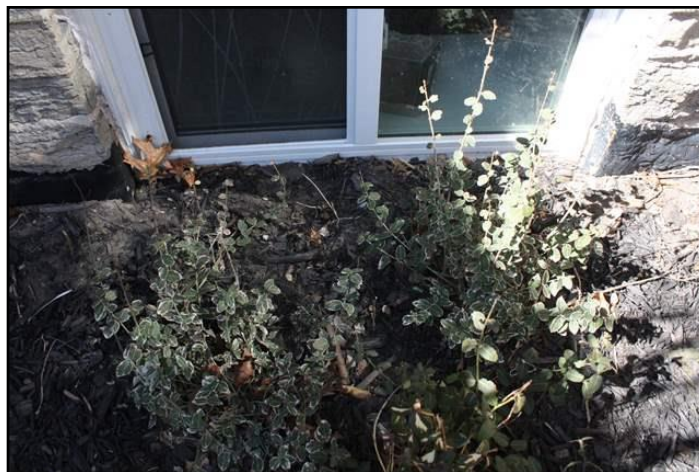
Condition: • [Missing](#)

Sill - less than 15 cm / 6 inches above finished grade level. This is common in homes of this age.

Window wells help manage the water in areas where windows are at or below grade. A properly installed window well will help prevent water entry / damage to windows and structure. THIS IS SOMETHING TO MONITOR FOR NOW, especially through the Spring rainy season. In the meantime, you may consider adding clear window covers to manage the water in this area.

6. Missing

Task: Monitor / Improve

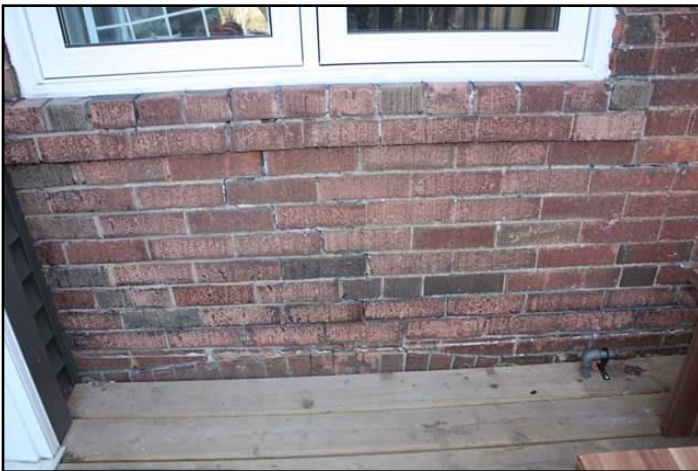
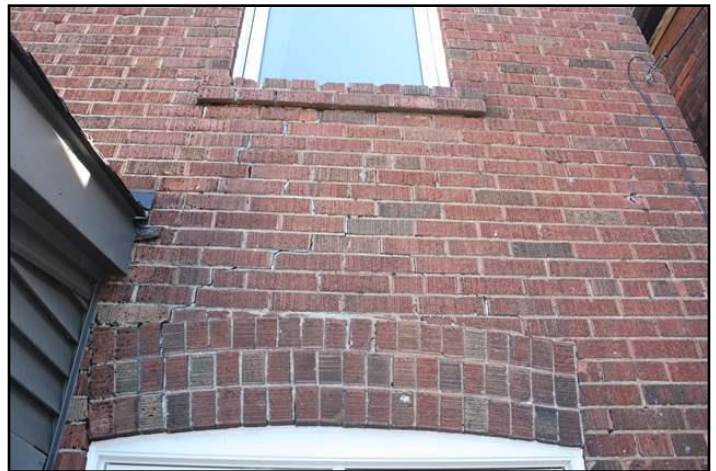
Condition: • [Cracked](#)

Settlement Cracks noted at wall. These are common above and below windows and doors, especially above arches in older homes. We cannot determine from a one time visit how long cracks have been present and if the movement is still active or stable. Our recommendation is to repair the cracks (Tuckpoint mortar and patch bricks) to prevent water entry and/or further damage. Note the date, and monitor for activity. Crack repairs / maintenance can be expected with most homes of this age.

Implication(s): Weakened structure

Task: Patch

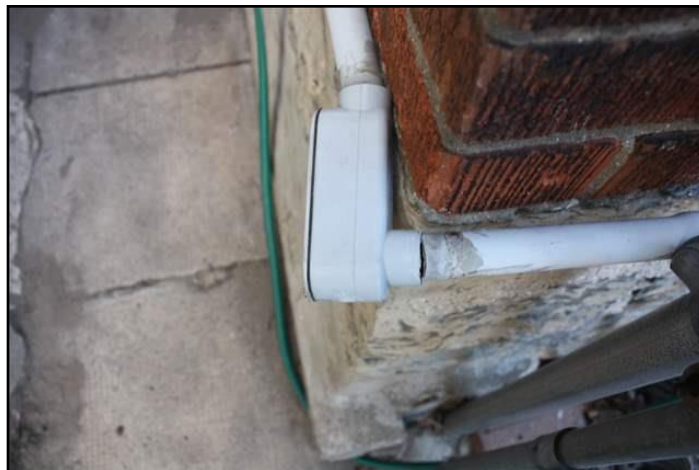
Condition: • Conduit disconnected

13. Conduit disconnected

Task: Improve

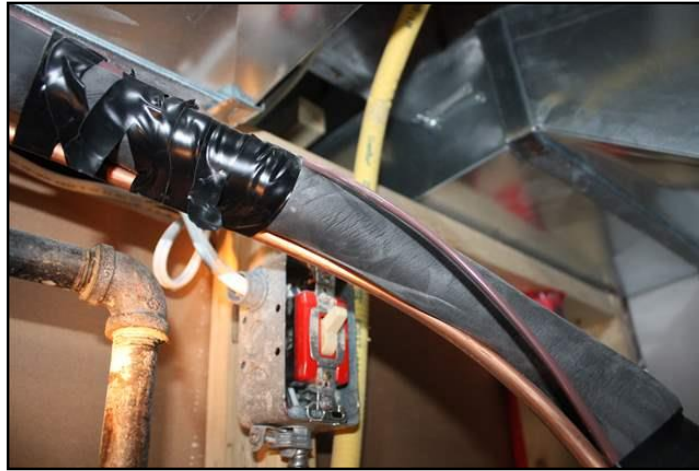
Condition: • For switch is missing

14. For switch is missing

Task: Correct

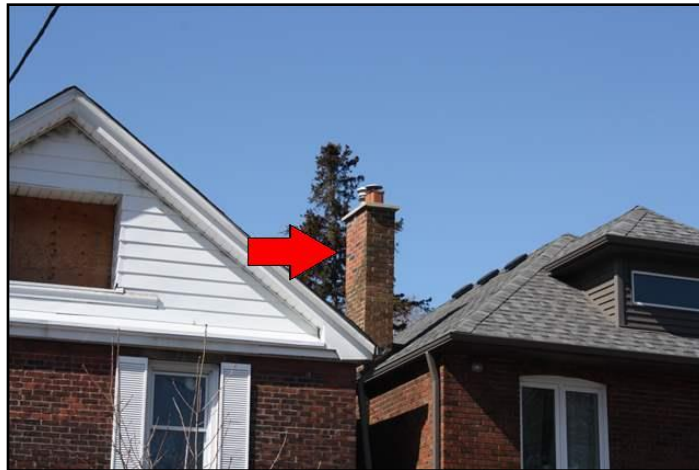
15.

Condition: • Prior Repairs masonry chimney

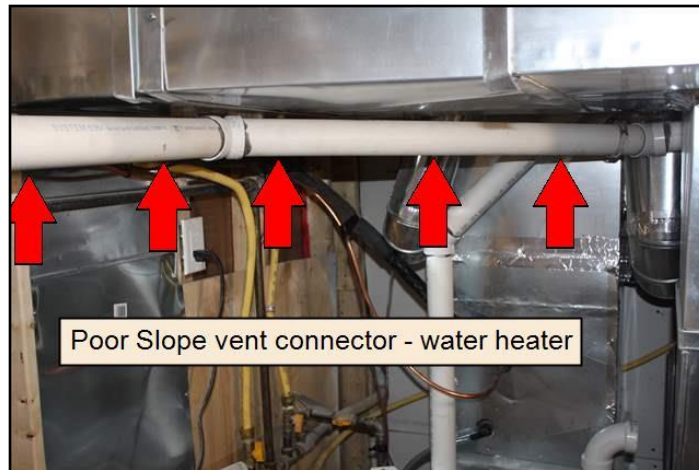
Condition: • [Poor slope](#)

Implication(s): Equipment not operating properly | Hazardous combustion products entering home

18. Poor slope

Task: Further evaluation / Correct

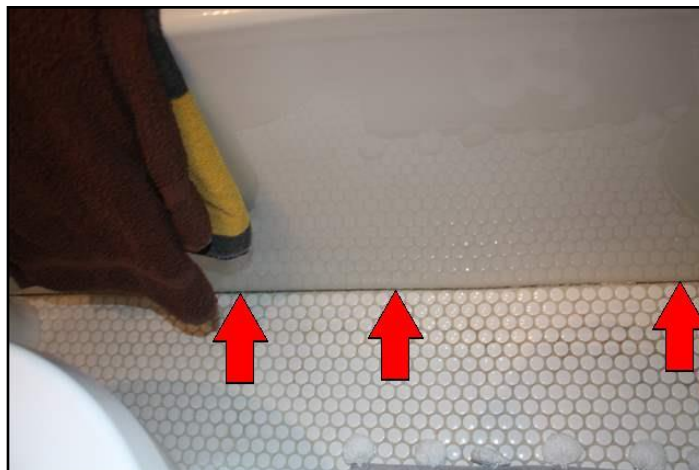
Condition: • [Caulking loose, missing or deteriorated](#)

Implication(s): Chance of water damage to contents, finishes and/or structure

19. Caulking loose, missing or deteriorated

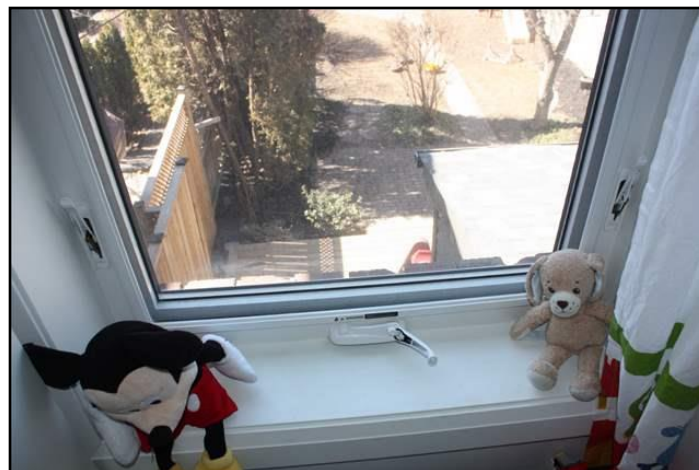
Condition: • [Inoperative](#)

20. Does not fully close

Task: Repair

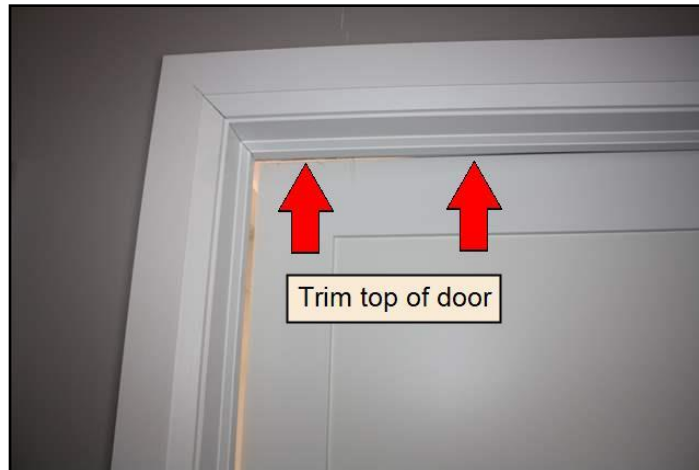
Condition: • [Loose or poor fit](#)

Implication(s): Chance of damage to finishes and structure

21. Door rubs top of frame

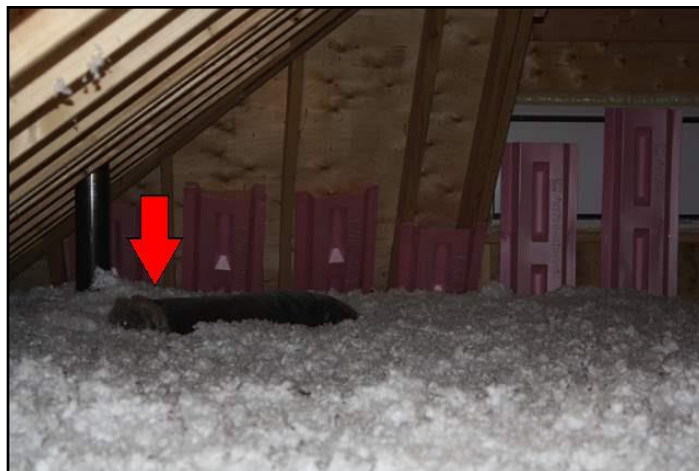
Condition: • [Not vented to exterior](#)

Implication(s): Chance of condensation damage to finishes and/or structure

22. Not vented to exterior
