# Your Inspection Report

68 Degrassi Street  
Toronto, ON

**INSPECTION DATE:**  
Friday, February 13, 2015

**PREPARED BY:**  
Brian Hardie

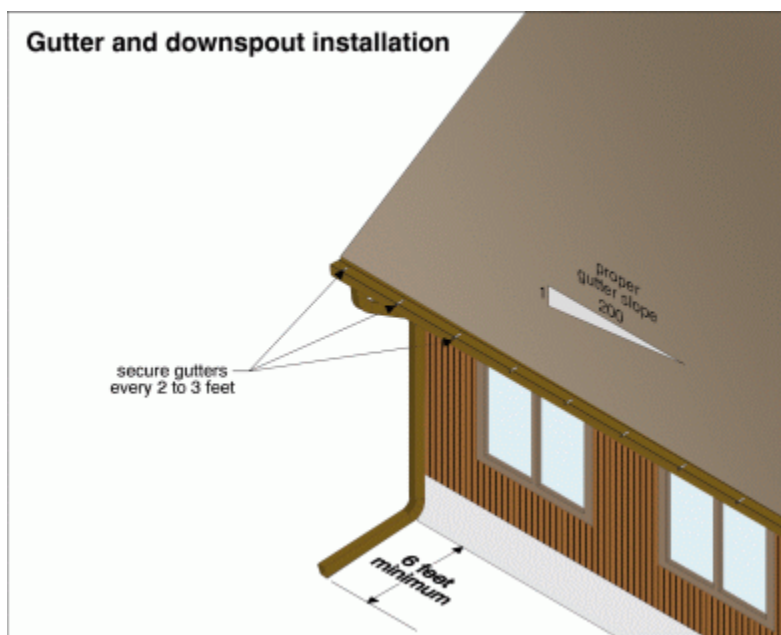
Condition: • [Downspouts discharging below grade](#)

Implication(s): Chance of water damage to contents, finishes and/or structure

Location: Southwest

Task: Improve

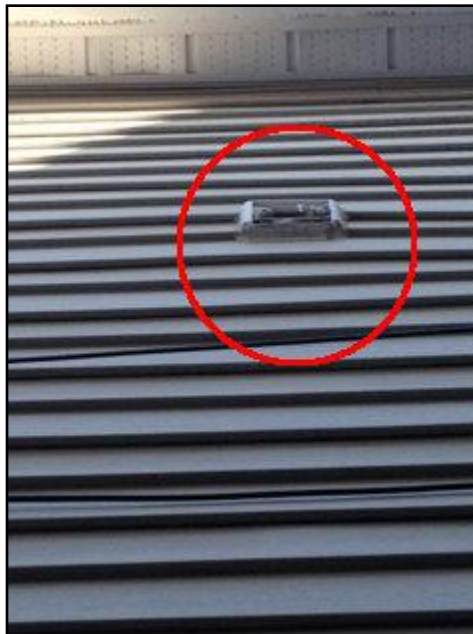
Condition: • Clean 2nd floor dryer vent

Location: Southwest Second Floor

*Clean vent*

Task: Clean

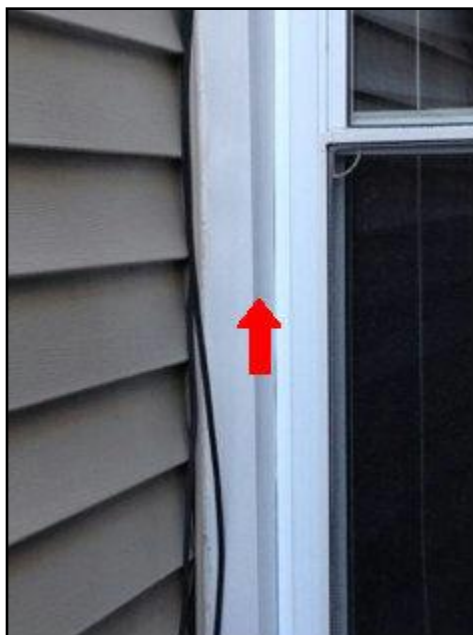
**Condition:** • [Caulking missing, loose or deteriorated](#)

**Implication(s):** Chance of water damage to contents, finishes and/or structure

**Location:** Various

*Caulking missing, loose or deteriorated*

**Task:** Provide

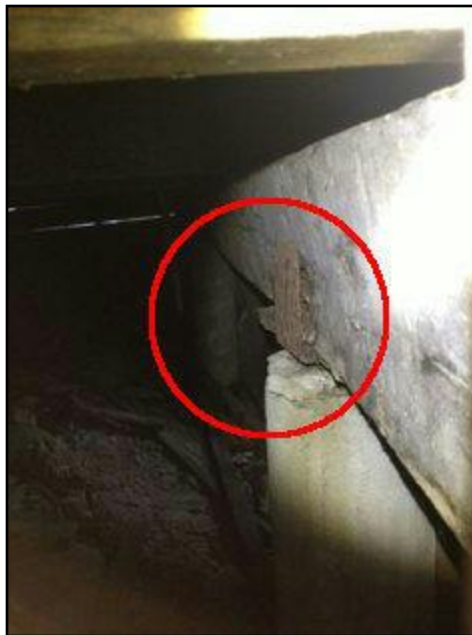
**Condition:** • [Rot](#)

**Implication(s):** Weakened structure | Chance of movement

**Location:** West

*Rot*

**Task:** Further evaluation/Repair

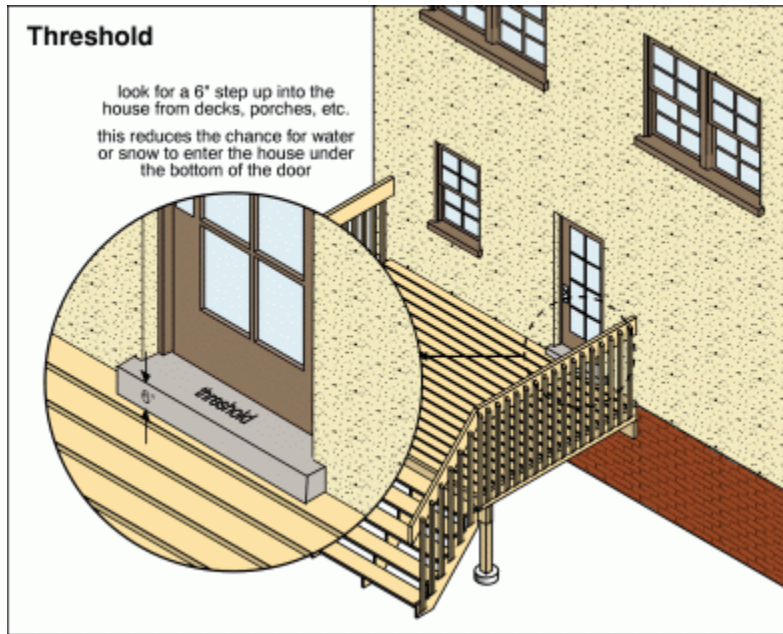
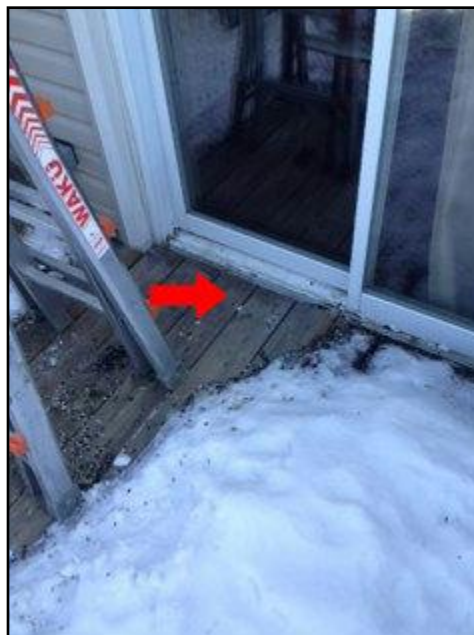
**Condition:** • [No step up into building](#)

**Implication(s):** Chance of water damage to contents, finishes and/or structure | Material deterioration

**Location:** Third Floor Balcony

No step up into building

**Task:** Correct

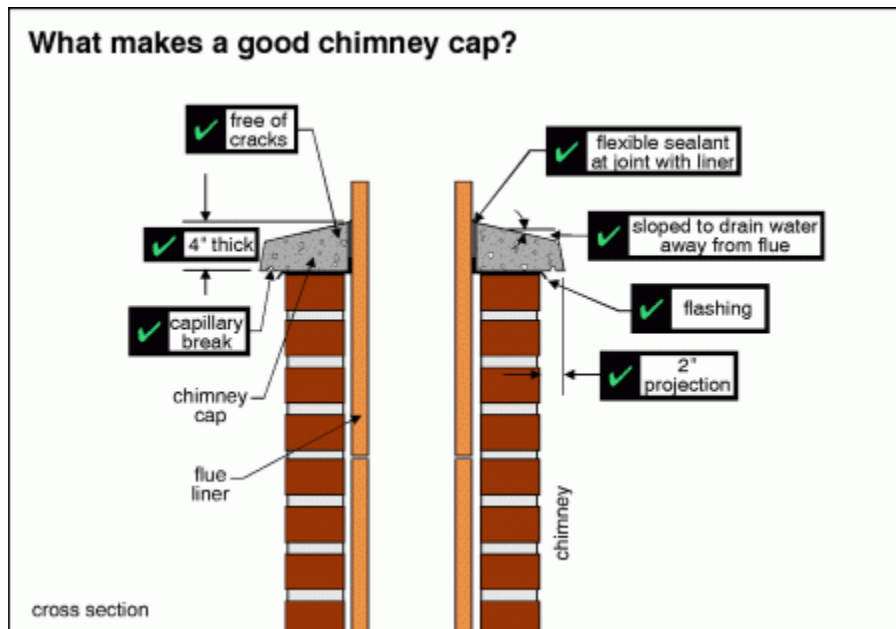
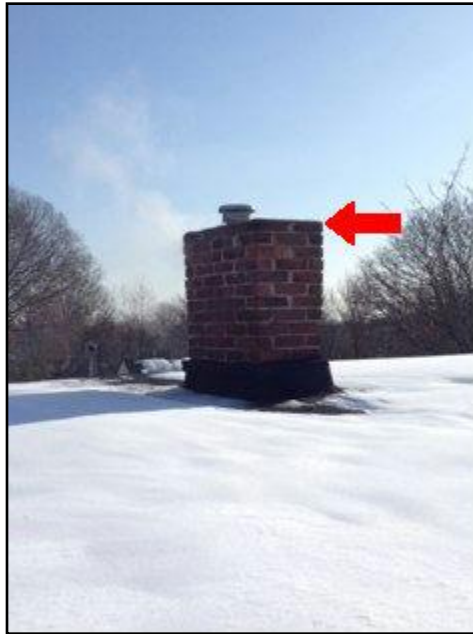
### CHIMNEY AND VENT \ Masonry chimney cap

Condition: • [Missing](#)

Implication(s): Chance of water damage to contents, finishes and/or structure | Shortened life expectancy of material

*Missing*

Task: Provide

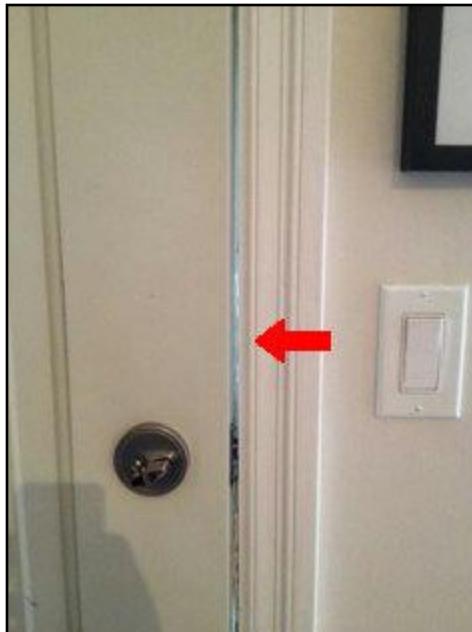
Condition: • [Weatherstripping missing or ineffective](#)

Implication(s): Chance of water entering building | Increased heating and cooling costs | Reduced comfort

Location: West First Floor

*Weatherstripping missing or ineffective*

Task: Improve

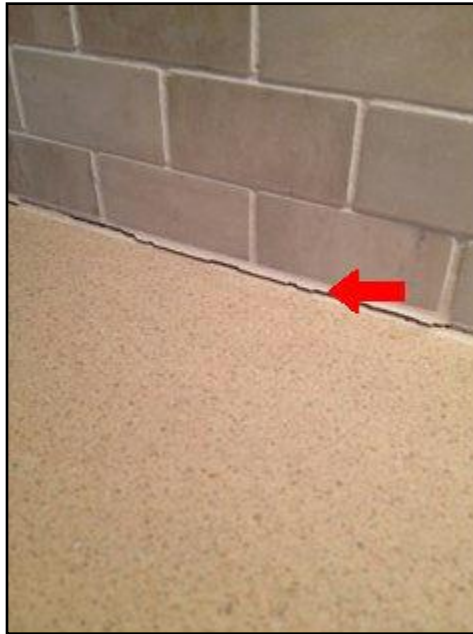
Condition: • Repair caulking

Location: Third Floor Kitchen

Task: Repair
