Your Inspection Report

Ontario
Sarnia, ON

INSPECTION DATE:
Monday, August 13, 2018

RE: Report No. 1920, v.4
Ontario
Sarnia, ON

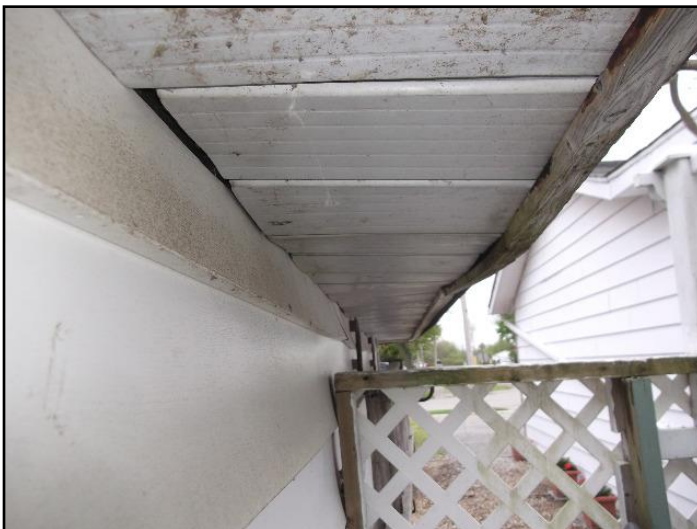
35. Loose or missing pieces

7. Condition: • [Loose or missing pieces](#)

We suggest replacing the damaged and loose fascia and soffits. Priming and painting the wood trim with exterior-grade paints and possibly cladding with aluminum may be completed.

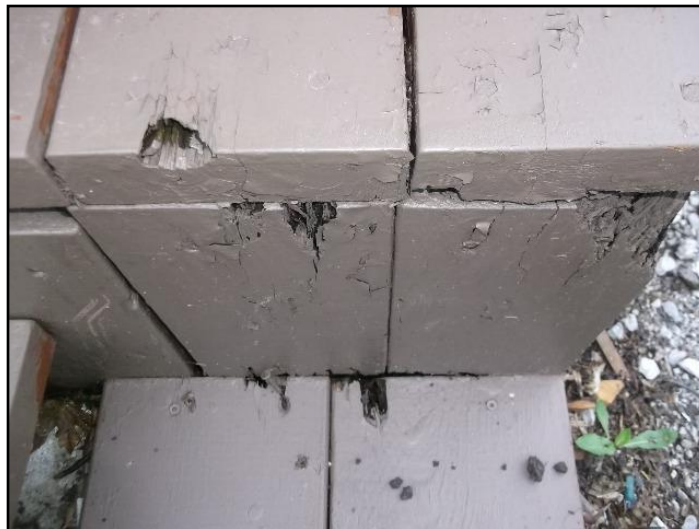
38. Rot or insect damage

Condition: • [Rot or insect damage](#)

Implication(s): Weakened structure | Chance of movement | Material deterioration

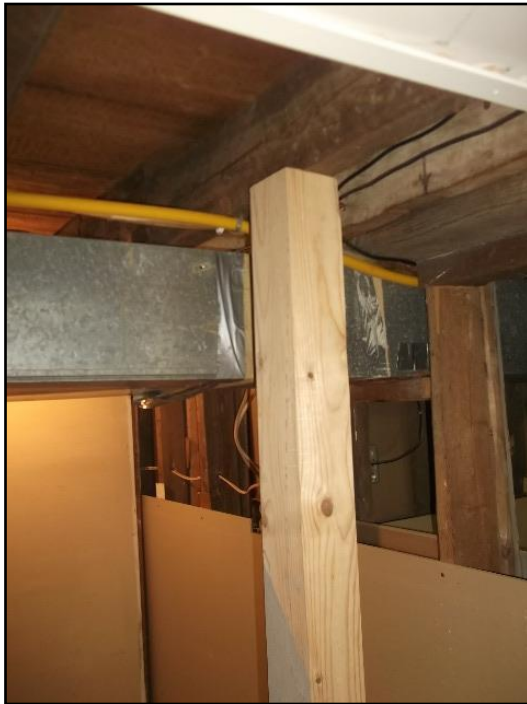
42. Unsecured wood column

Note: A single wood column located at the east basement is not secured at the top or bottom possibly allowing shifting to occur. A wood beam which is located at the east basement, though well supported, appears to have been damaged from wood-boring insects.

We recommend a qualified and competent framer or carpenter complete any necessary repairs.

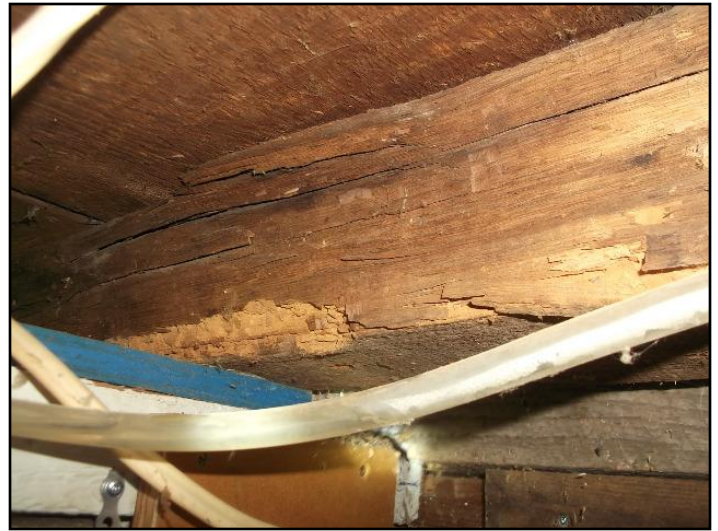
43. Damaged wood beam

14. Condition: • [Rot, insect or fire damage](#)

We recommend a qualified and licensed carpenter to complete any necessary repairs.

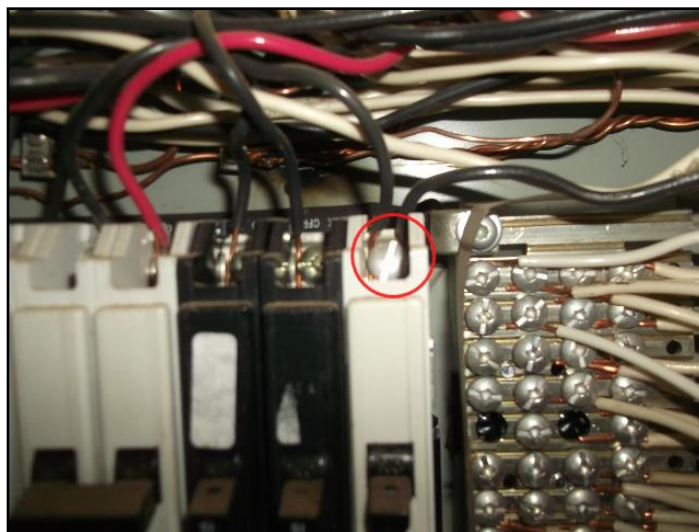
57. Double taps

22. Condition: • [Double taps](#)

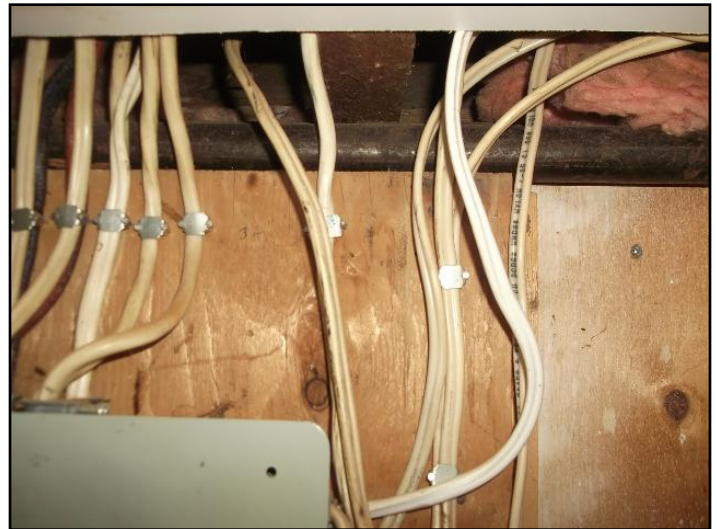
59. Not well secured

23. Condition: • [Not well secured](#)

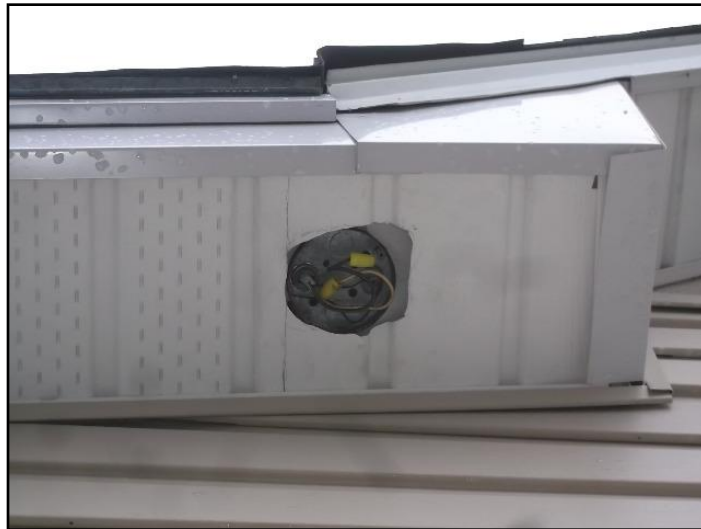
65. Missing

32. Condition: • [Missing](#)

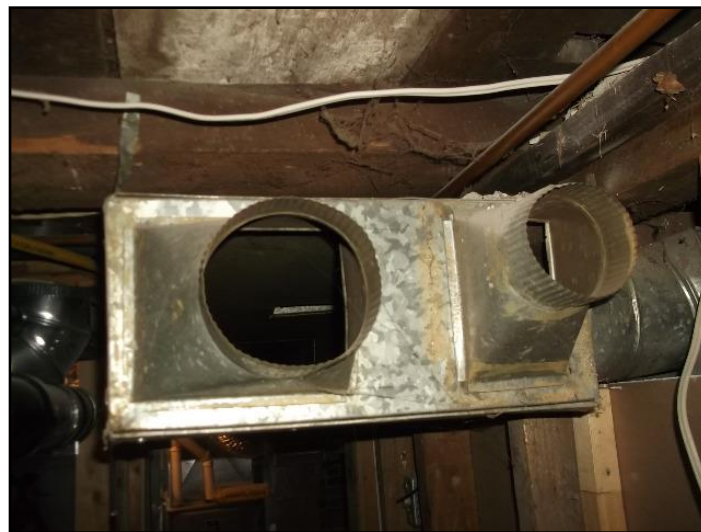
73. Disconnected ducts

Condition: • [Disconnected ducts](#)

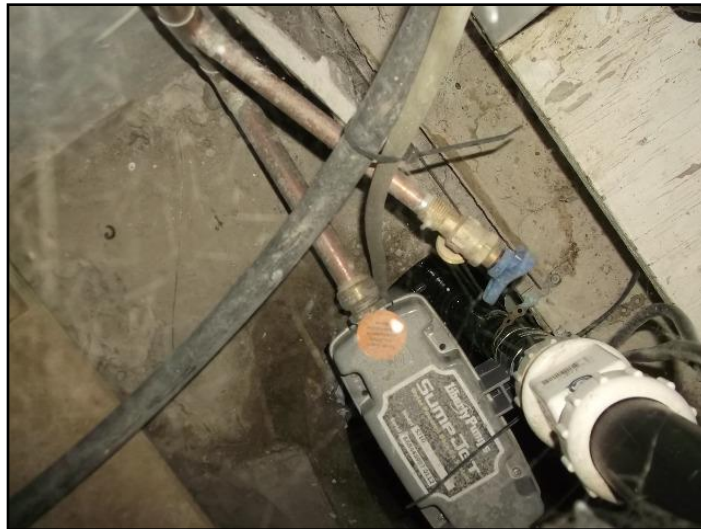
88. Sump pump

WASTE PLUMBING \ Sump pump**Condition:** • [Lid missing, rotted or not secure](#)

The sump pump operated as required. A check valve was present. A back up system was observed. The cover was missing.

We recommend providing a cover to help prevent debris from falling into the pit and preventing the pump from operating and allowing water spill into the basement.

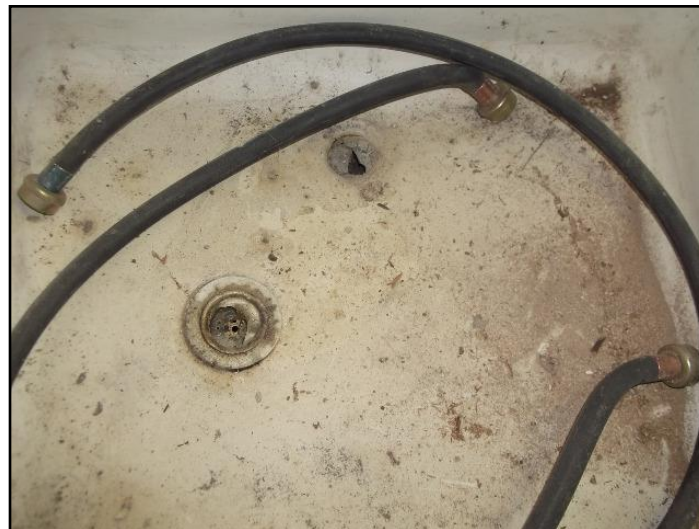
91.

48. Condition: • The laundry tub appeared to be damaged and may require replacement.
