YOUR INSPECTION REPORT

269 Martin Grove Road
Toronto, ON M9B 4L2

Monday, November 6, 2023

RE: Report No. 7385
269 Martin Grove Road
Toronto, ON
M9B 4L2

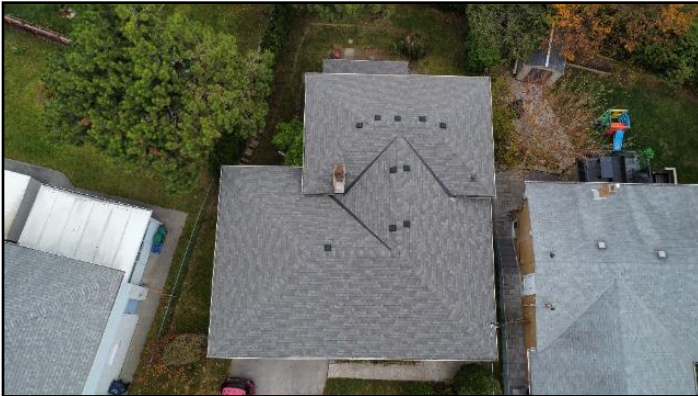
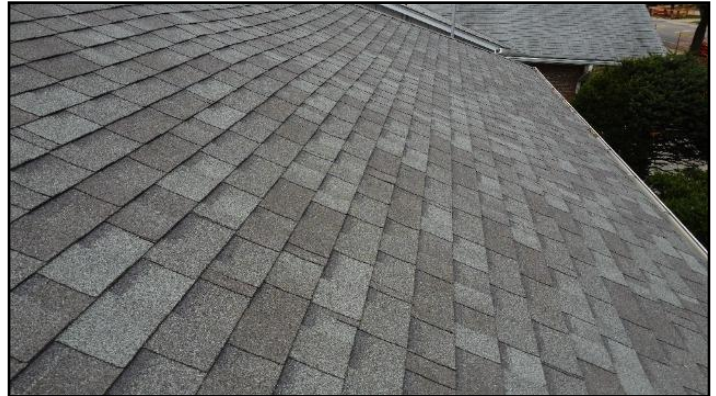
Good Condition overall

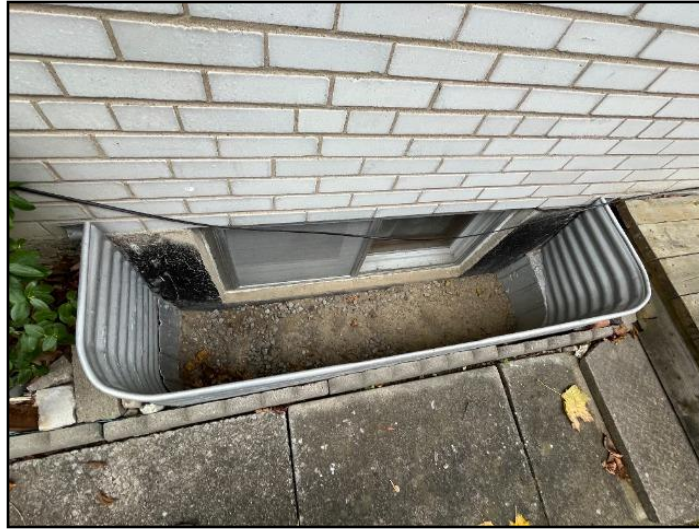
3. Less than 6 inches below window

Condition: • [Less than 6 inches below window](#)

Time: Less than 1 year

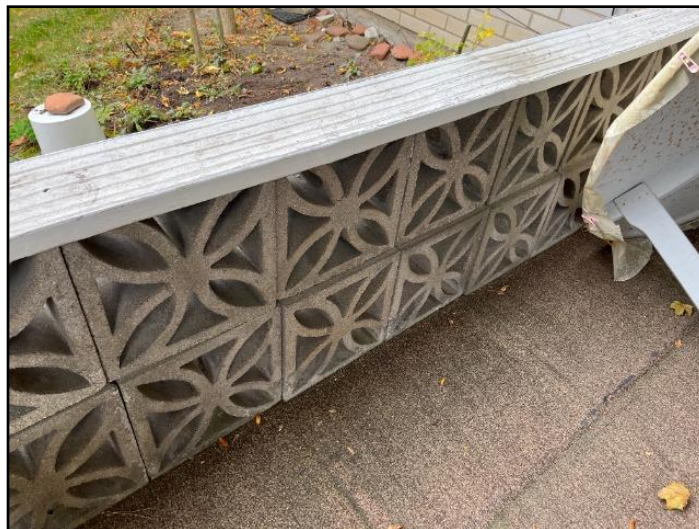
4.

Condition: • Decorative walls not secured

Task: Improve or remove

Time: As soon as practical

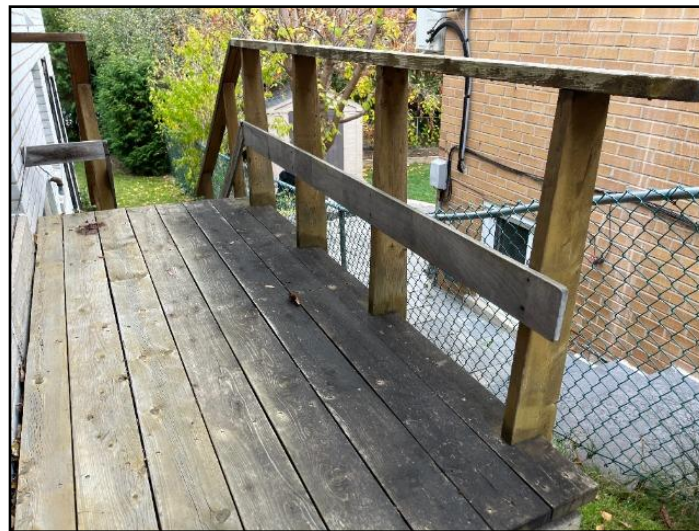
5. Spindles (balusters) climbable

Condition: • [Spindles \(balusters\) climbable](#)

Task: Replace

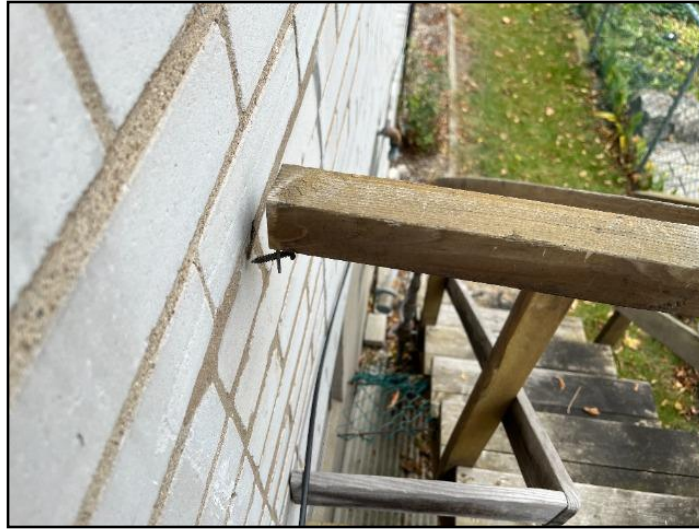
6.

Condition: • Guard not secured to wall

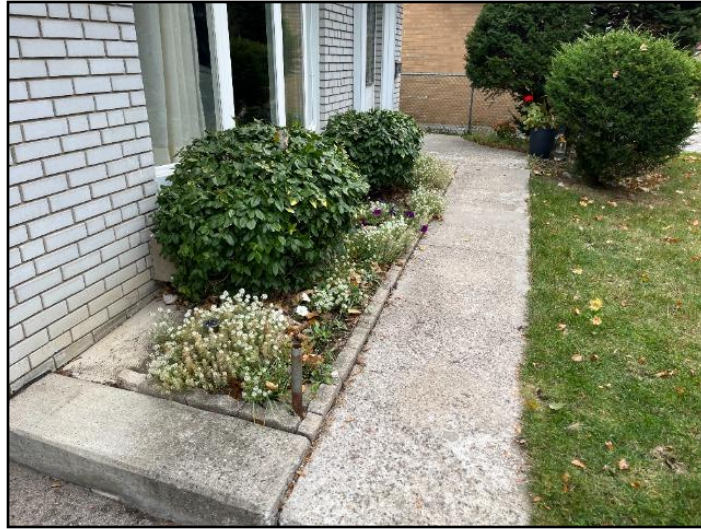
7. Planters and gardens against walls

Condition: • [Planters and gardens against walls](#)

Time: When necessary

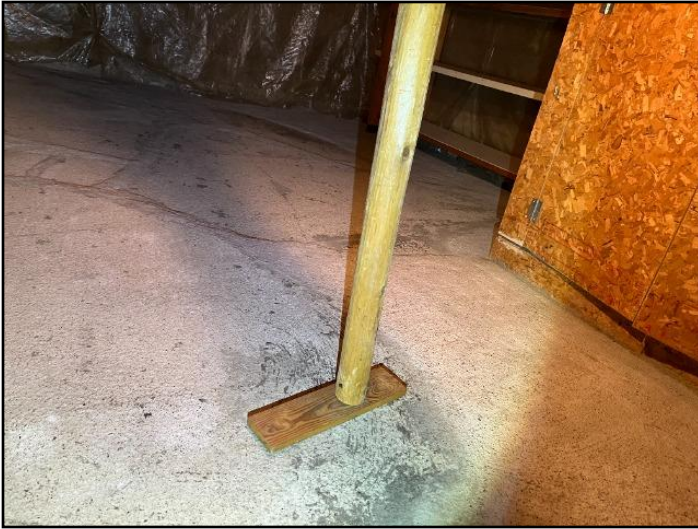
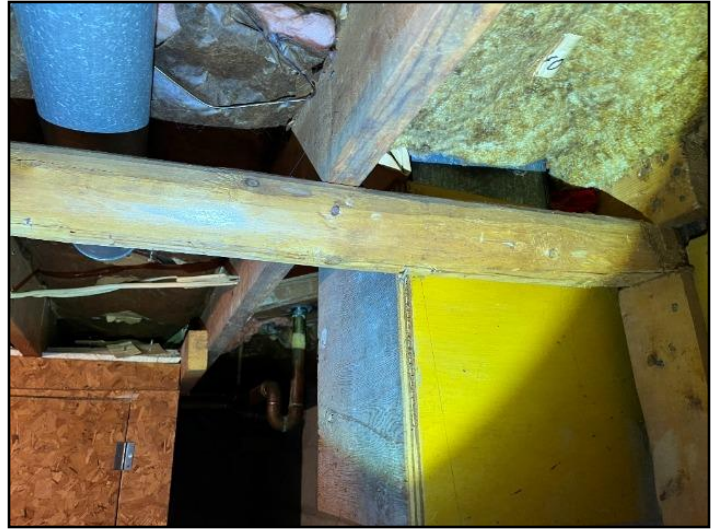
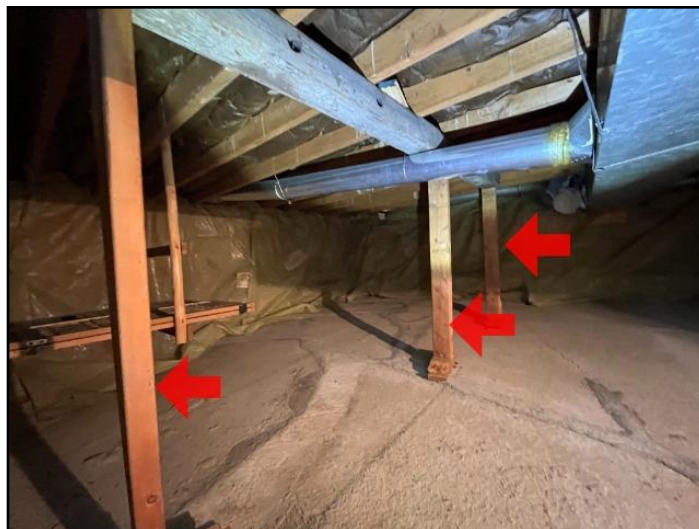
Condition: • [Prior repairs](#)

Various posts and beams were added in various areas as additional support likely to improve sagging or creaky areas. At some point, you may wish to replace with permanent supports in these areas.

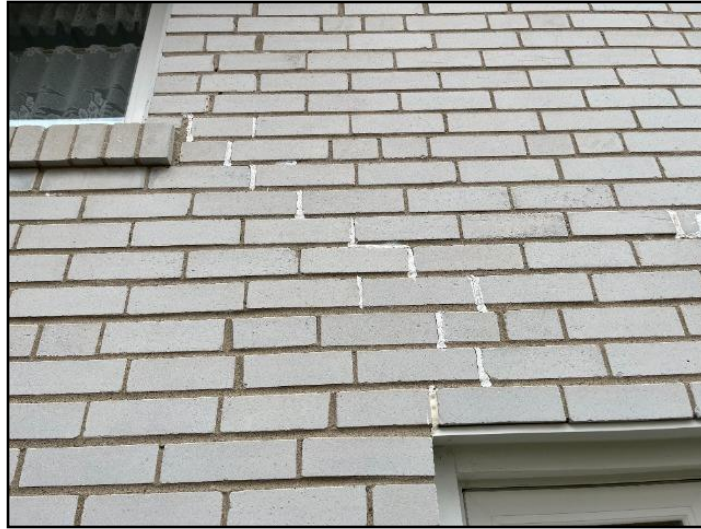
11. example

Condition: • [Prior repairs](#)

It is common to find a multitude of wall repairs on homes of this age

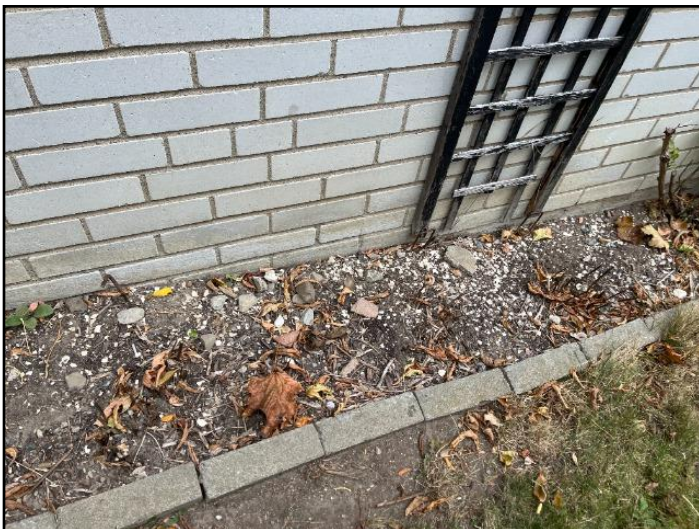
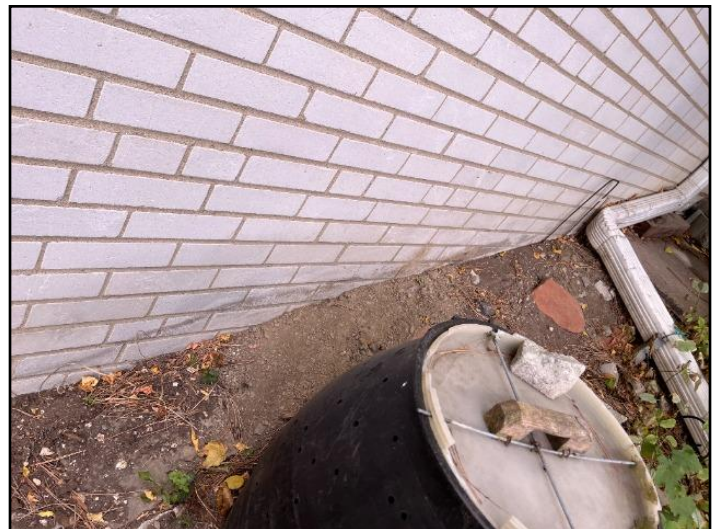
Condition: • [Masonry too close to grade](#)

Task: Monitor / Improve / Click link to read more information

Time: When/if landscaping or as necessary

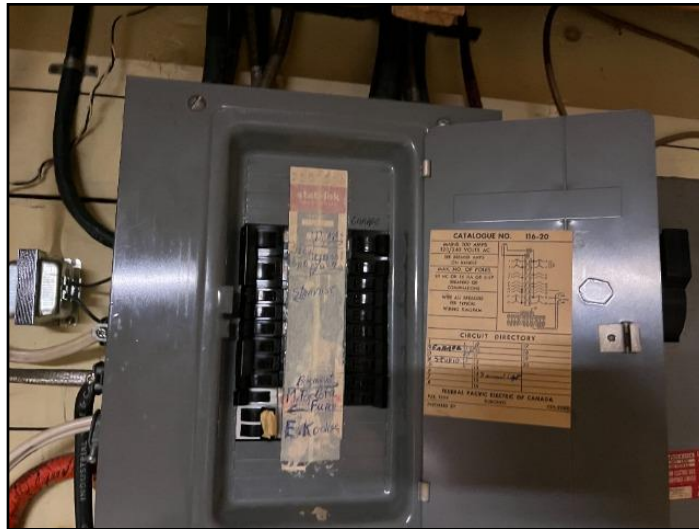
15. A Federal Pacific Stab-Lok panel is...

Condition: • A Federal Pacific Stab-Lok panel is installed. There have been reported problems with these panels.

Time: As soon as possible

Cost: If upgrading to new panel is required, approximately \$1500

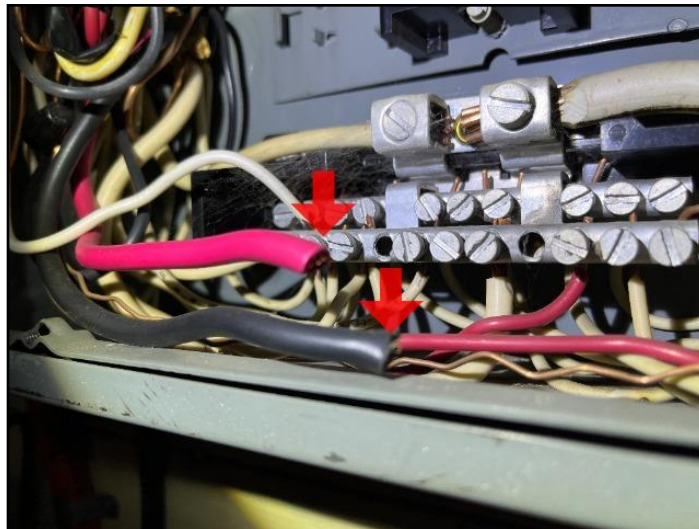
16. Abandoned wires in panel

Condition: • [Abandoned wires in panel](#)

Time: As Soon As Possible

Cost: Less than \$100

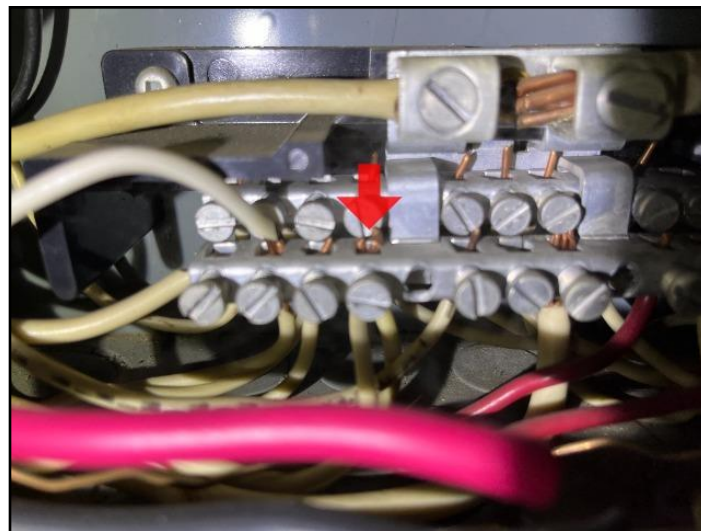
17. Double taps

Condition: • [Double taps](#)

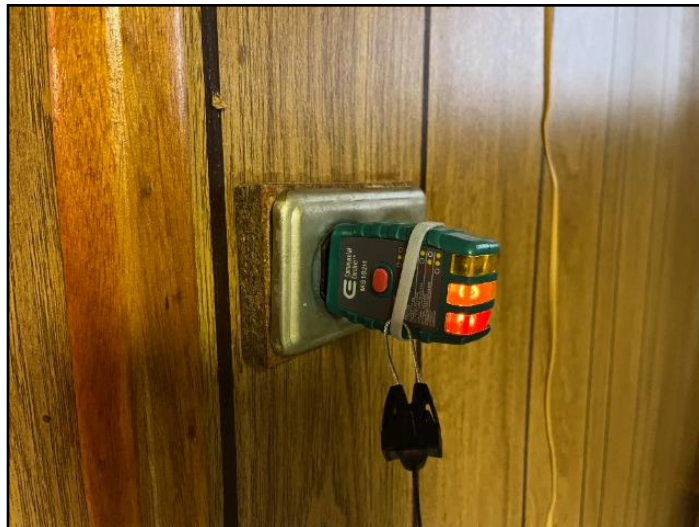
18. Reversed polarity

Condition: • [Reversed polarity](#)

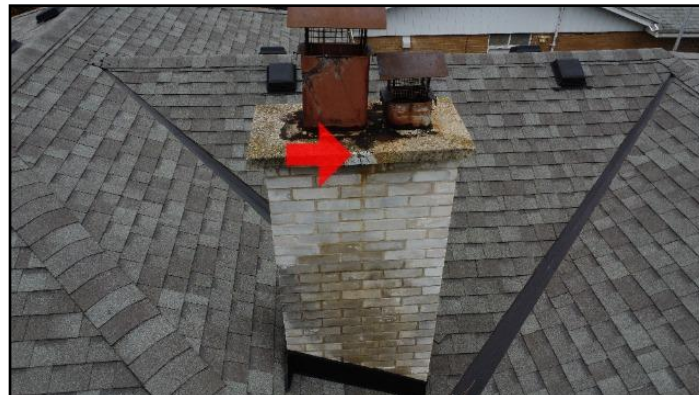
19. Cracked

Condition: • [Cracked](#)

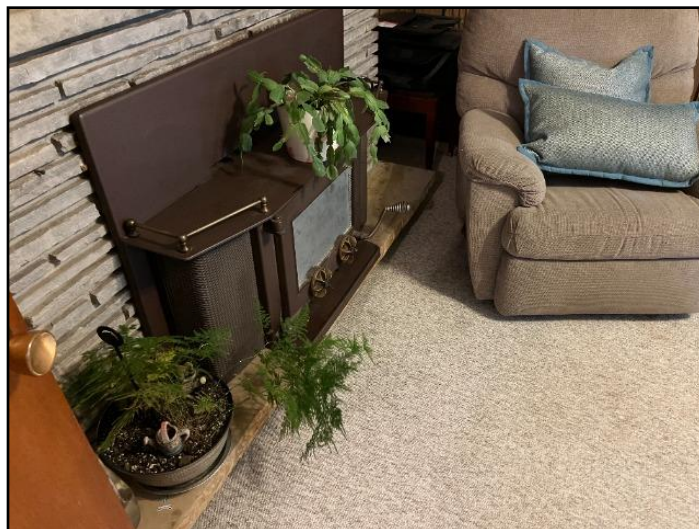
20. Floor - combustible clearance inadequate

Condition: • [Floor - combustible clearance inadequate](#)

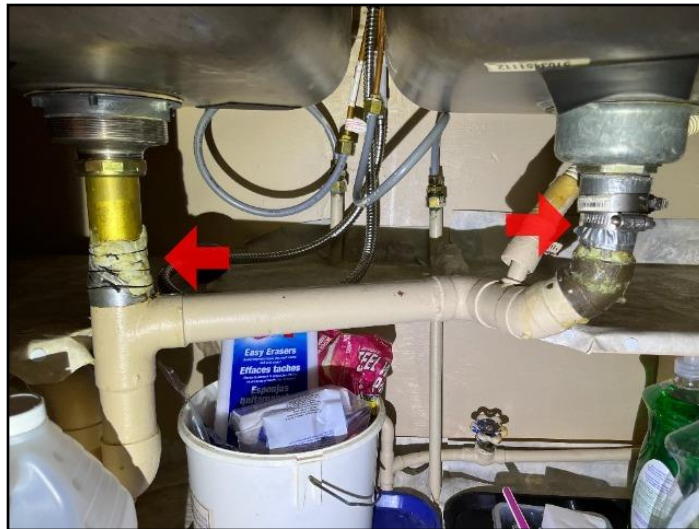
23. Nonstandard materials and patches

Condition: • [Nonstandard materials and patches](#)

Task: Repair / Replace

Time: Prior to first use

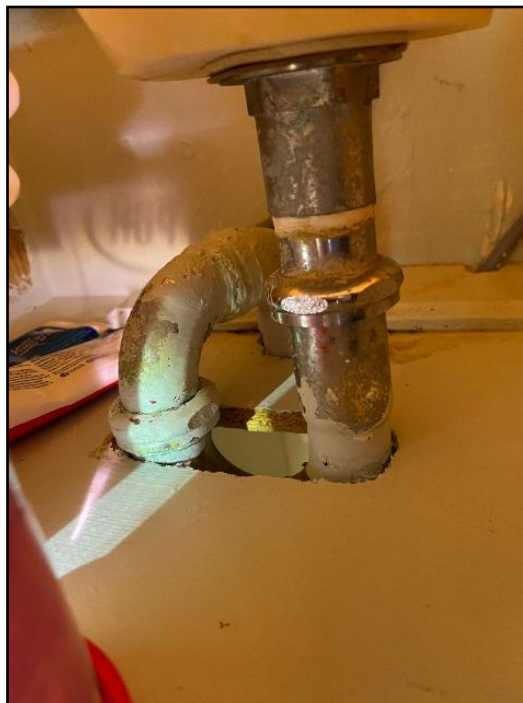
24. *Nonstandard shape or material*

Condition: • [Nonstandard shape or material](#)

S-traps can lead to siphoning

Time: If necessary

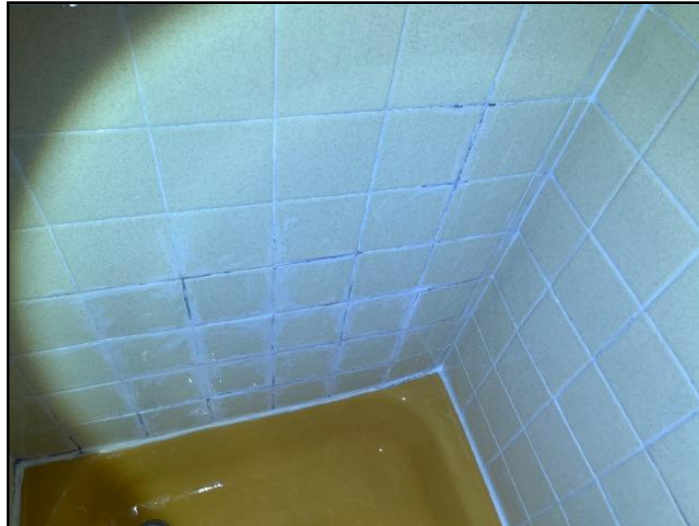
25.

Condition: • Prior wall damage. Enclosure bulging in one area

Task: Replace

Time: When remodelling

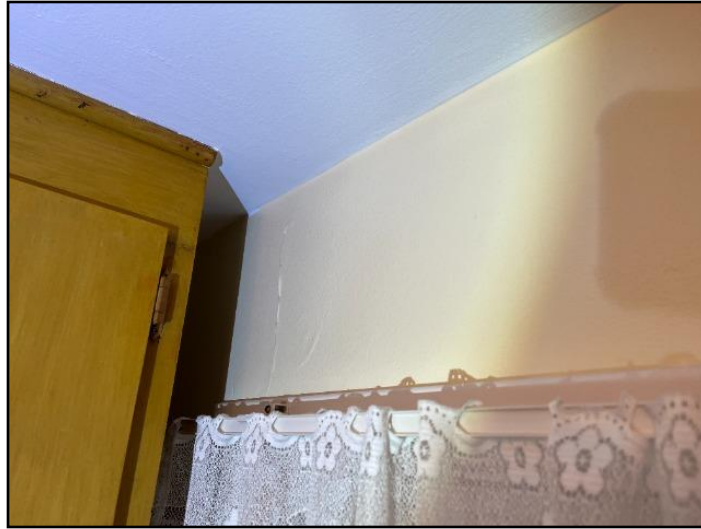
26. Damaged

Condition: • Damaged

Minor damage. Tested with moisture meter and was dry at time of inspection

Task: Repair

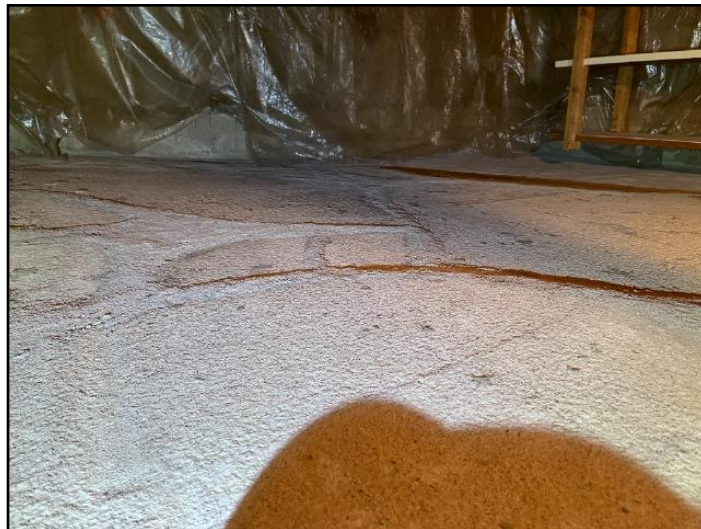
27. example

Condition: • The crawlspace floors are not level / Sloping. FYI- The crawlspace floor appears to have been lowered at some point in the past however this was not confirmed.

Time: As needed

Cost: Consult specialist when desired

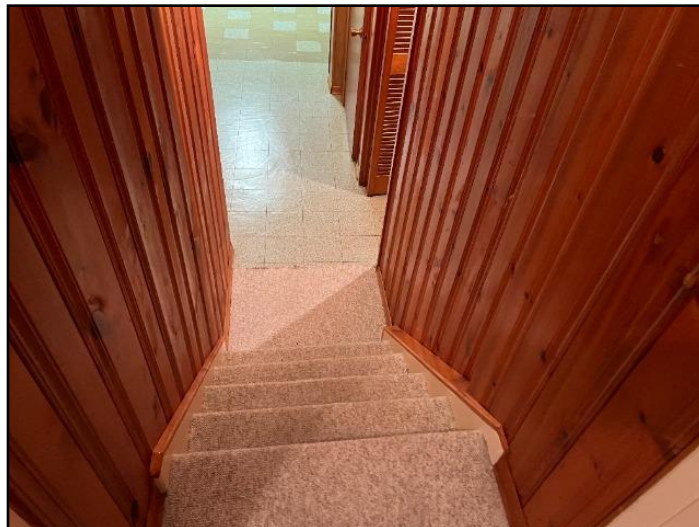
28. Missing

Condition: • [Missing](#)

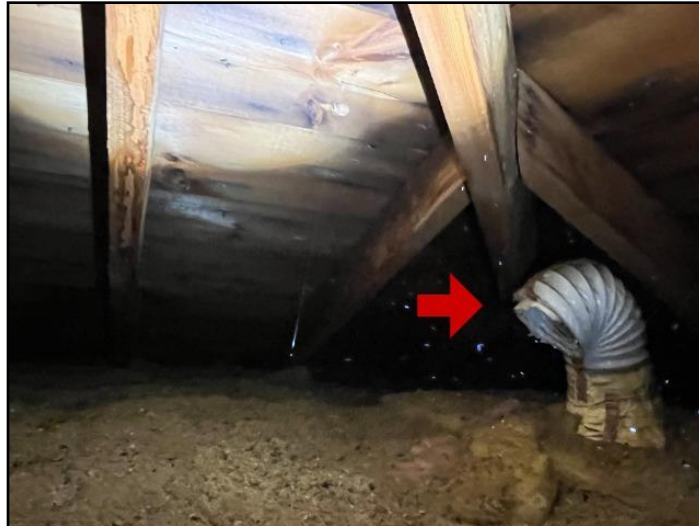
29. Not vented to exterior

Condition: • [Not vented to exterior](#)

Task: Correct

Time: As Soon As Possible

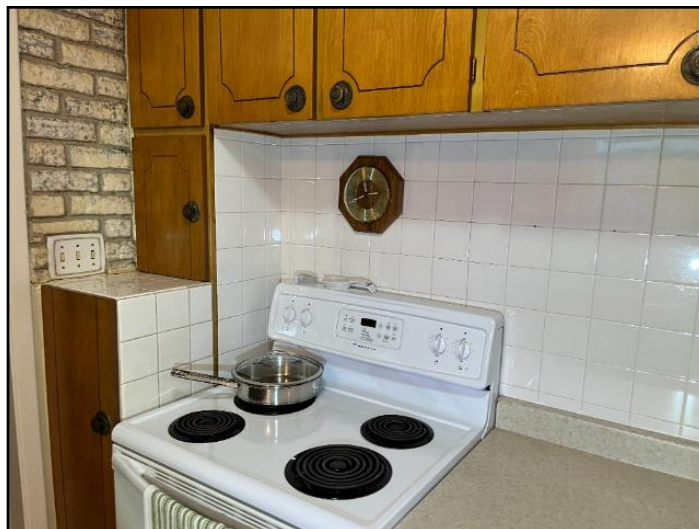
30. Missing

Condition: • Missing

Oven hoods are important for fire prevention (pot fires) as it offers protection to the nearby cabinet. Secondary reason is to provide exhaust to help eliminate moisture. (fan on ceiling observed. Ideally should be located in range hood above)

Time: Prior to first use

Cost: \$1,000 - and up

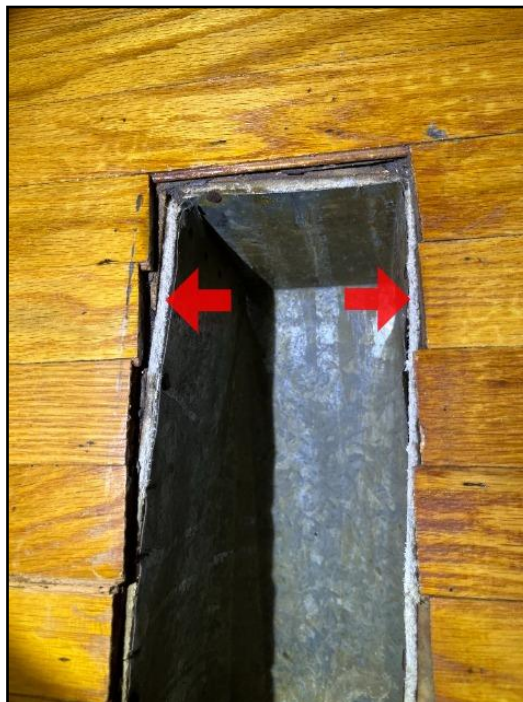
31. Possible asbestos containing materials

Condition: • Possible asbestos containing materials

During the era when this house was built, it was very common to wrap registers with insulation to protect the floors from overheating. This type of insulation typically contains some asbestos. Determining the material type is outside the scope of this inspection. Health Canada recommends that any asbestos material found should stay in place undisturbed. If you plan to remodel or if this is a concern, consult with a specialist for lab testing to confirm if asbestos is present.

Time: Before disturbing material / Discretionary

Cost: \$150-\$250 per register if asbestos present
