YOUR INSPECTION REPORT

1234 Main Street
Sioux Falls, SD 57104

Thursday, November 5, 2020

RE: Report No. 1001, v.7
1234 Main Street
Sioux Falls, SD
57104

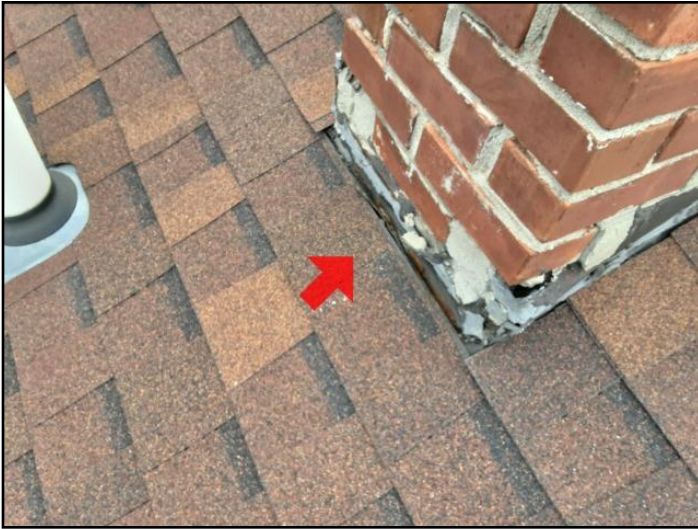
1. Condition: • Flashing not set into shingles properly

Implication(s): Chance of leaking, Chance of moisture damage to structure and finish

Flashing not set into shingles properly

Task: Repair

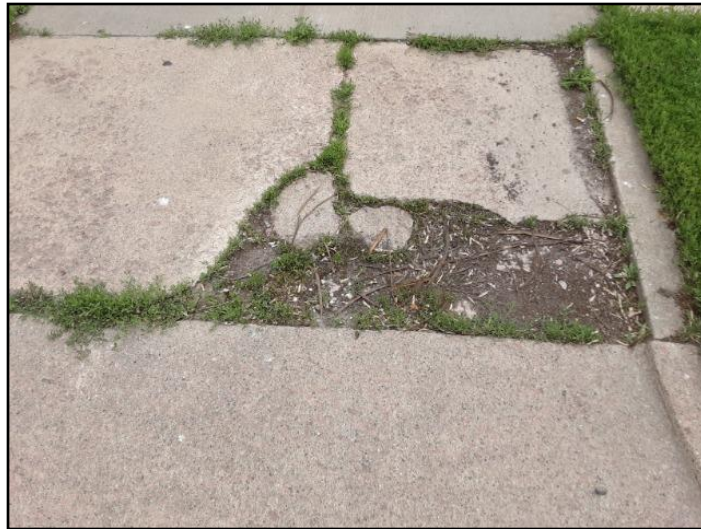
2. Condition: • Cracked and damaged concrete

Cracked and damaged concrete

Task: Improve/Seal

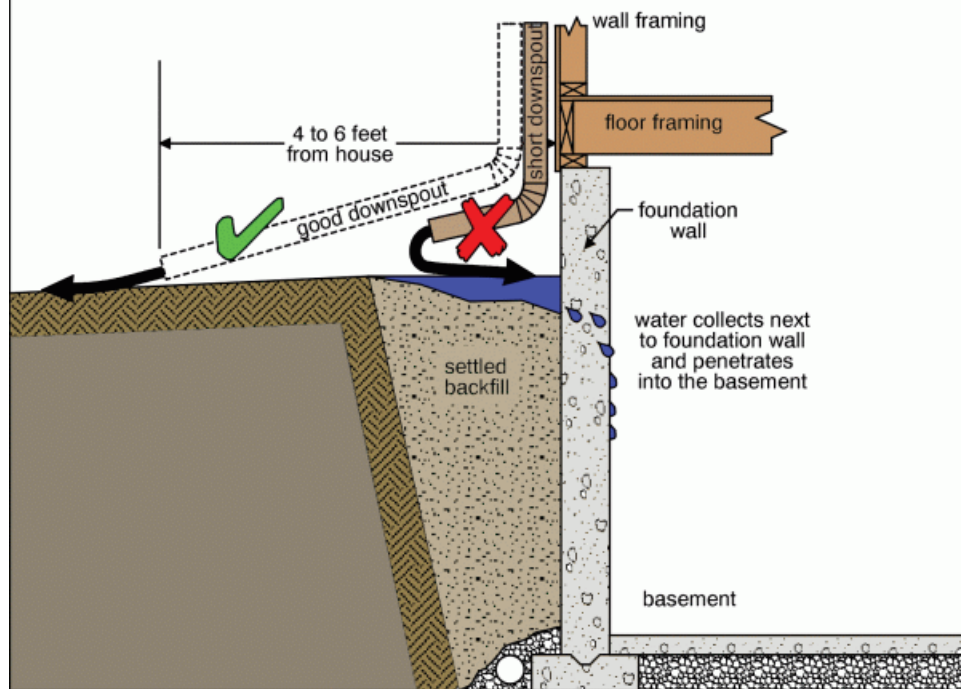
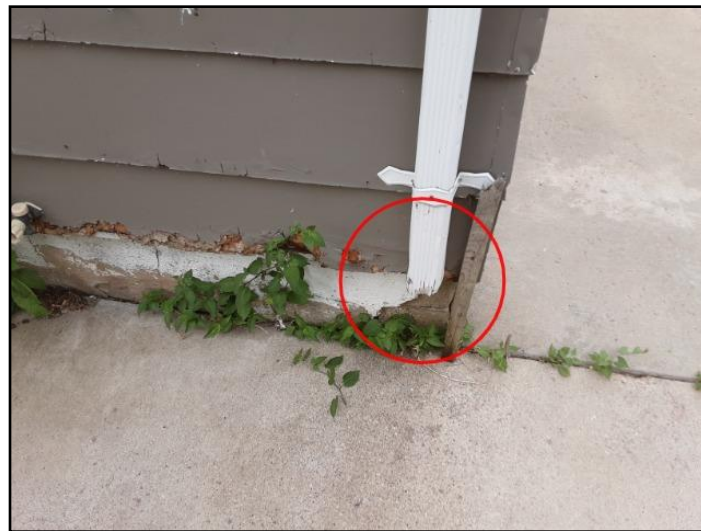
3. Condition: • Downspout extension(s) missing

Implication(s): Chance of moisture entering basement, Chance of moisture damage to foundation

Downspout extension too short

Downspout extension(s) missing

Task: Install extension

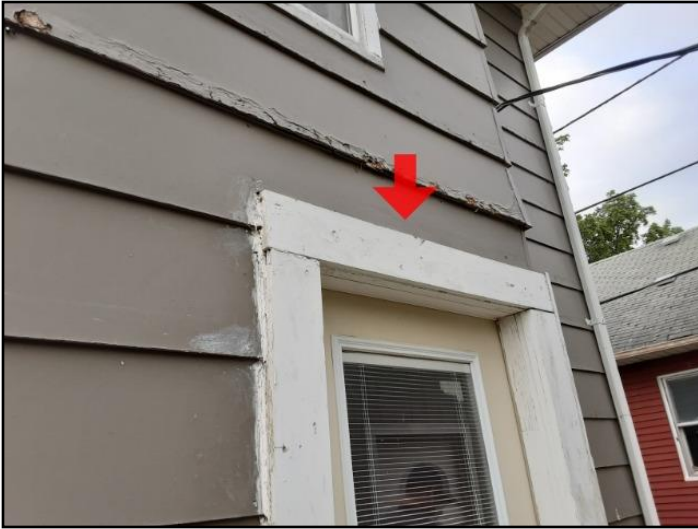
4. Condition: • Dripcap(s) missing

Implication(s): Chance of moisture damage to structure and finishes

Drip cap(s) missing

Task: Install dripcap or Maintain caulking

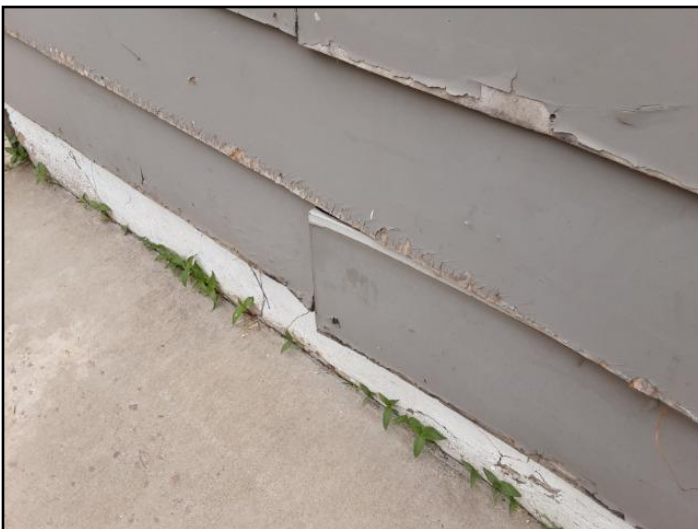
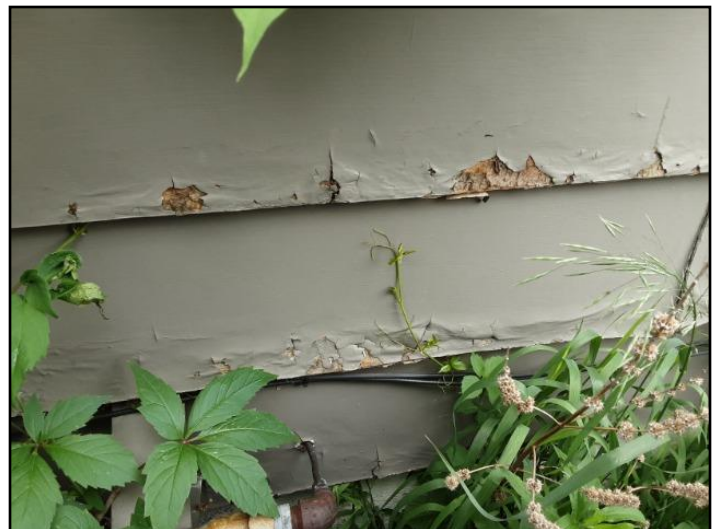
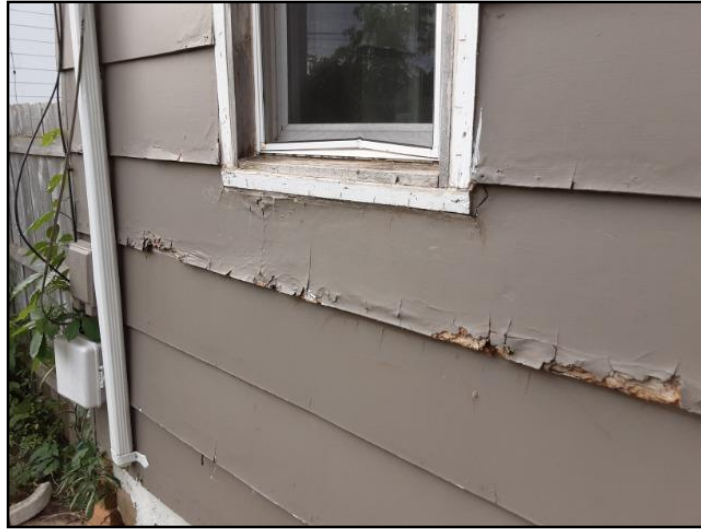
5. Condition: • Moisture damage

Implication(s): Material deterioration, Chance of moisture damage to structure

Moisture damage

Task: Repair

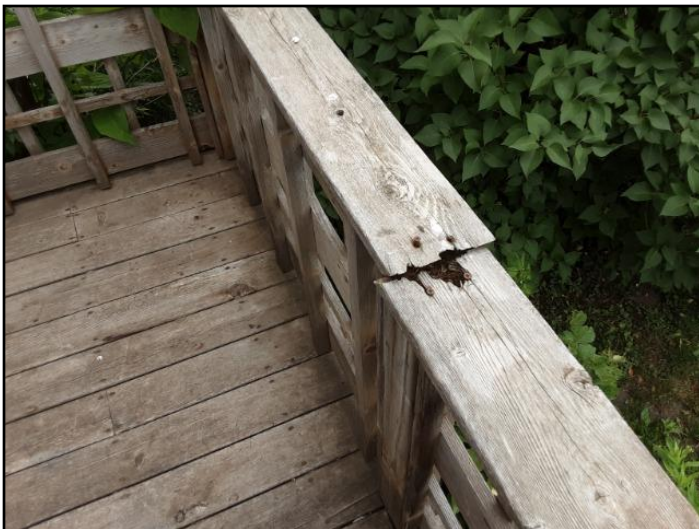
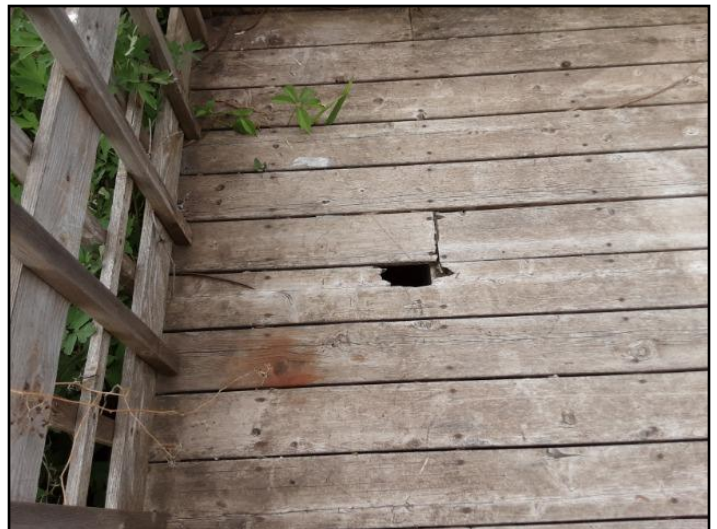
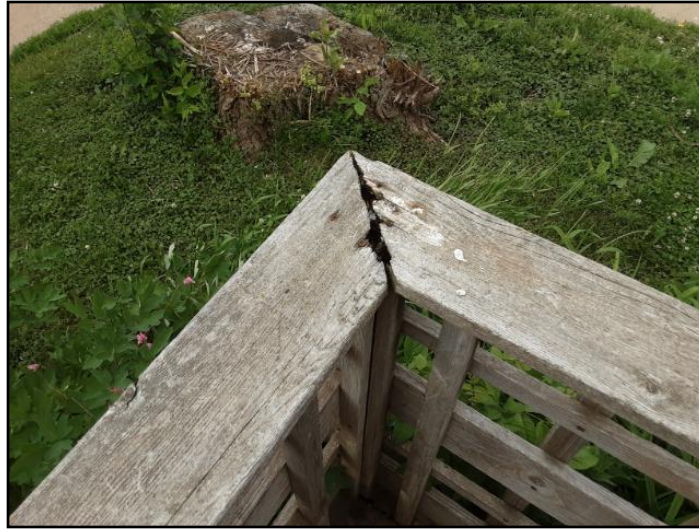
6. Condition: • Moisture damage

Implication(s): Material deterioration

Moisture damage

Task: Repair, Seal

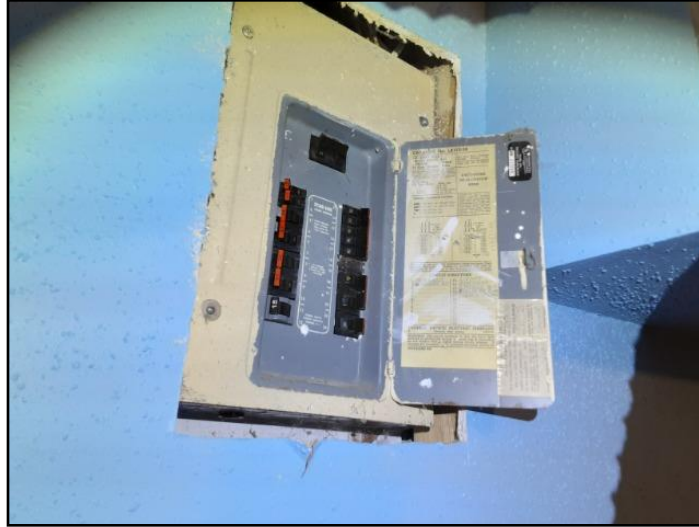
7. Condition: • Federal Pacific electrical panel

Implication(s): Fire hazard

Federal Pacific electrical panel

Task: Further evaluation by a professional

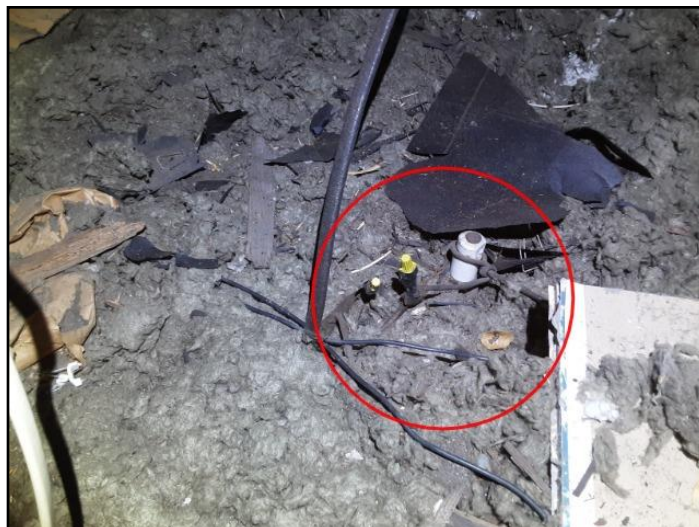
8. Condition: • Live knob and tube present

Implication(s): Increased fire risk

Live knob and tube present

Task: Further evaluation by a professional

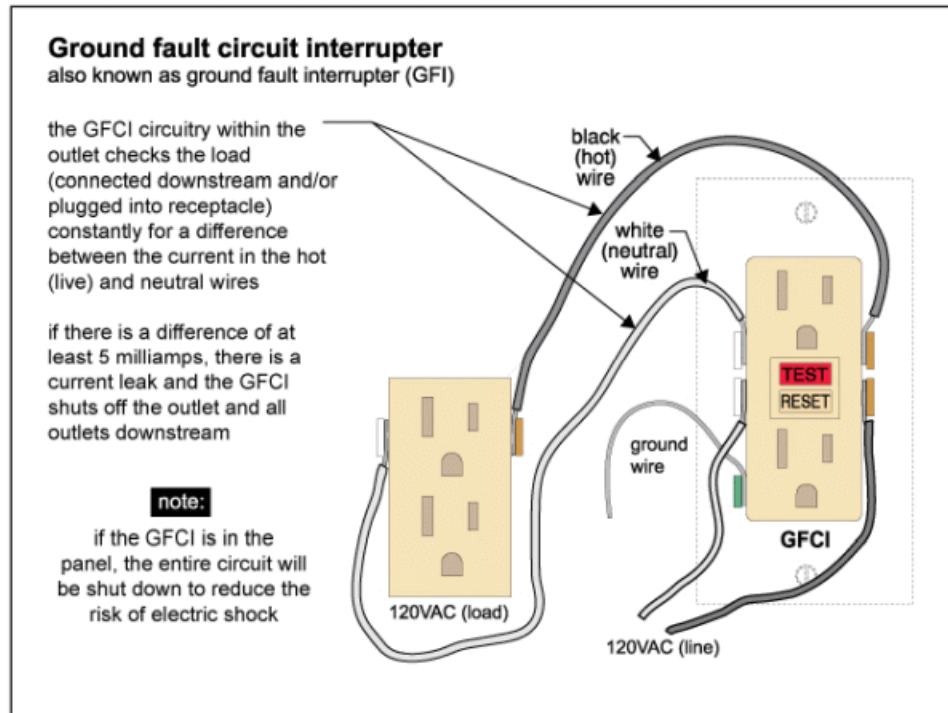
DISTRIBUTION SYSTEM \ Outlets (receptacles)**9. Condition:** • Tests faulty on GFCI outlet

The outlet functions but does not trip properly as a GFCI

Implication(s): Chance of electric shock

Task: Replace

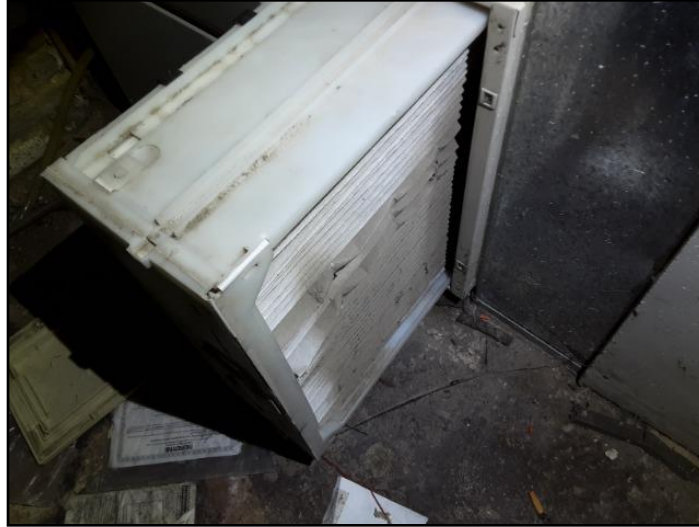
11. Condition: • Dirty furnace filter

Implication(s): Equipment ineffective | Increased heating costs | Reduced comfort | Increased maintenance costs

Dirty furnace filter

Task: Replace filter

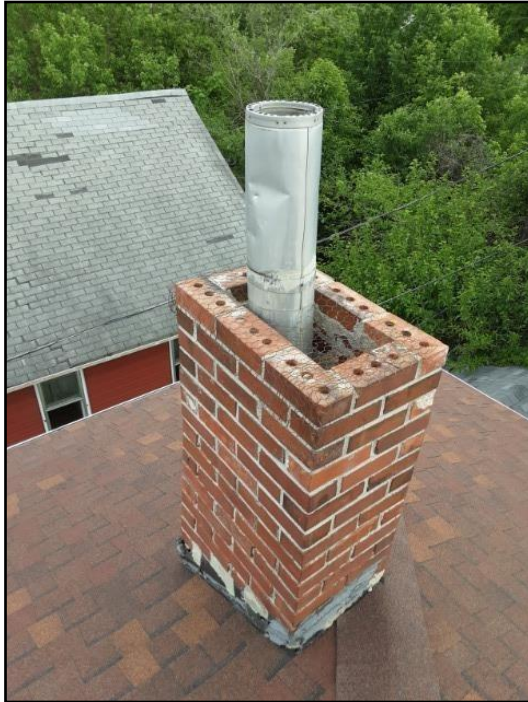
12. Condition: • Missing chimney cap

Implication(s): Chance of water damage to structure, finishes and contents | Shortened life expectancy of material

Missing chimney cap

Task: Improve

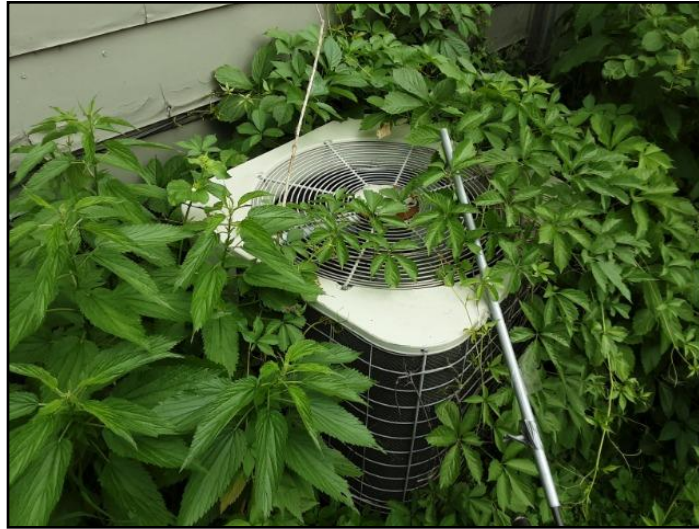
13. Condition: • Vegetation around AC unit

Implication(s): Decreased life efficiency, Decreased life expectancy

Vegetation around AC unit

Task: Improve

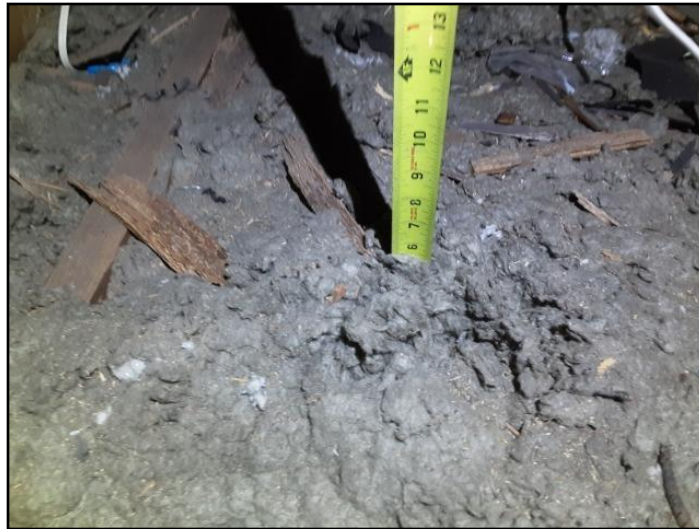
14. Condition: • [Amount less than current standards](#)

The current standard for house attic insulation is 12 to 14 inches. There is approximately 6 inches present in the house attic

Amount less than current standards: 6 inches

Task: Improve

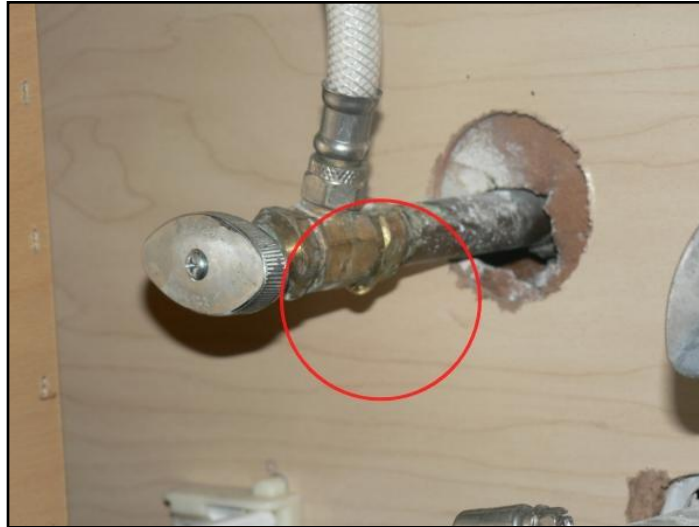
16. Condition: • Leak

Implication(s): Chance of water damage to contents, finishes and/or structure

Leak

Task: Repair

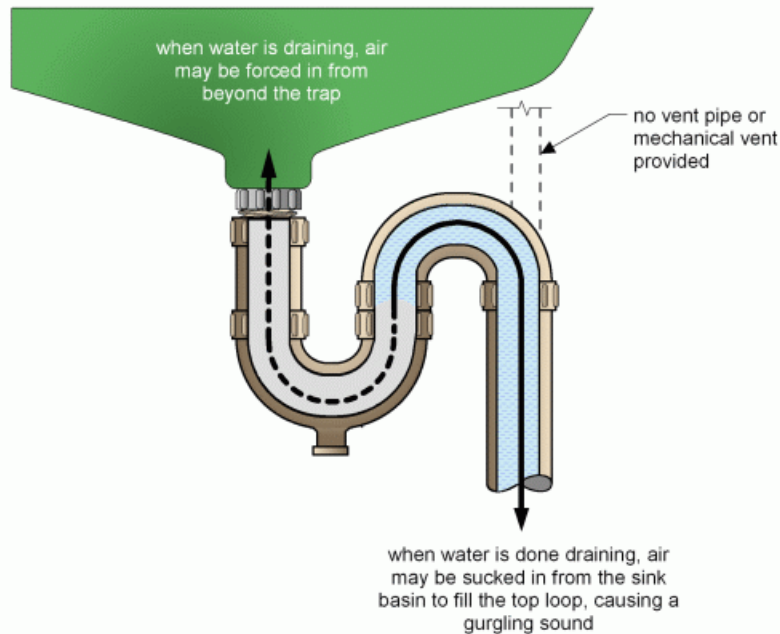
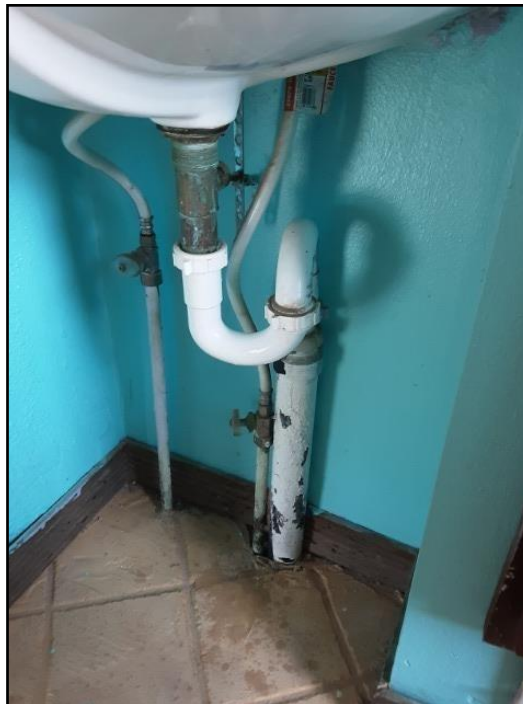
17. Condition: • S style plumbing trap

Implication(s): Chance of sewer gases entering living space

S-traps can lead to siphoning

S style plumbing trap

Task: Monitor

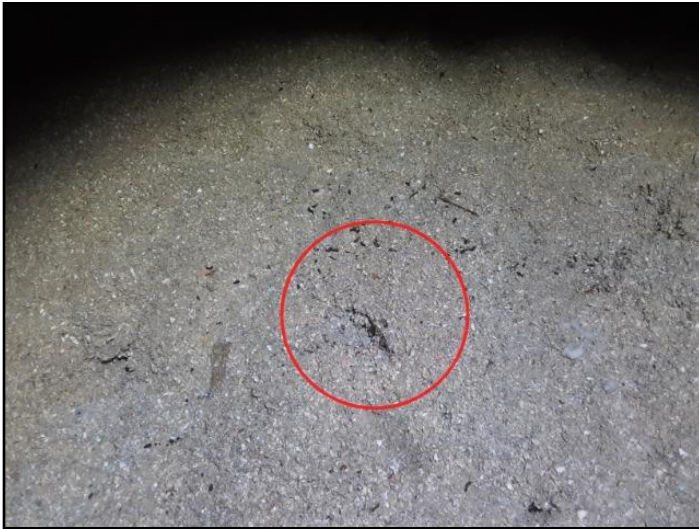
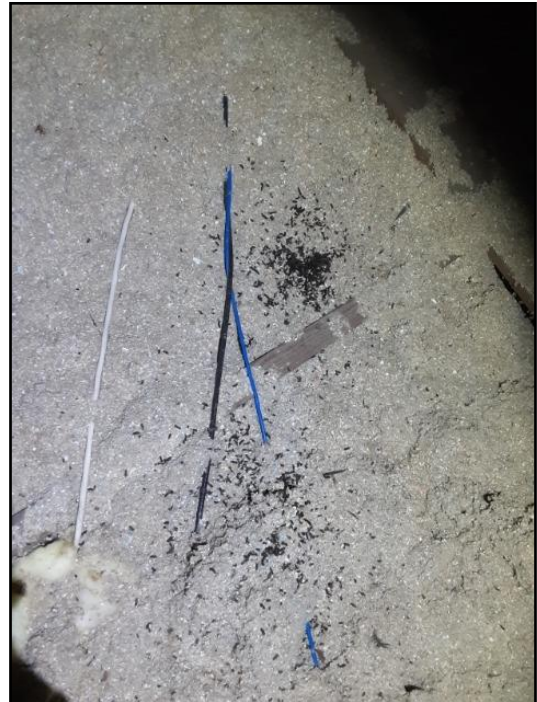
19. Condition: • Bat droppings in attic

Bat droppings in attic

Task: Further evaluation by professional

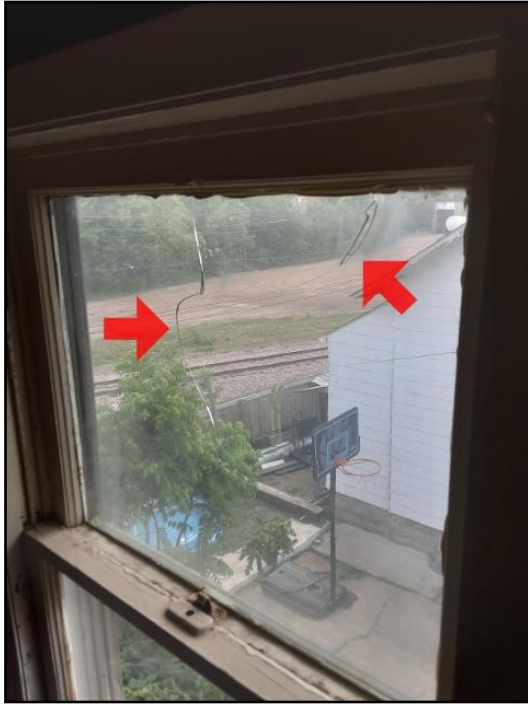
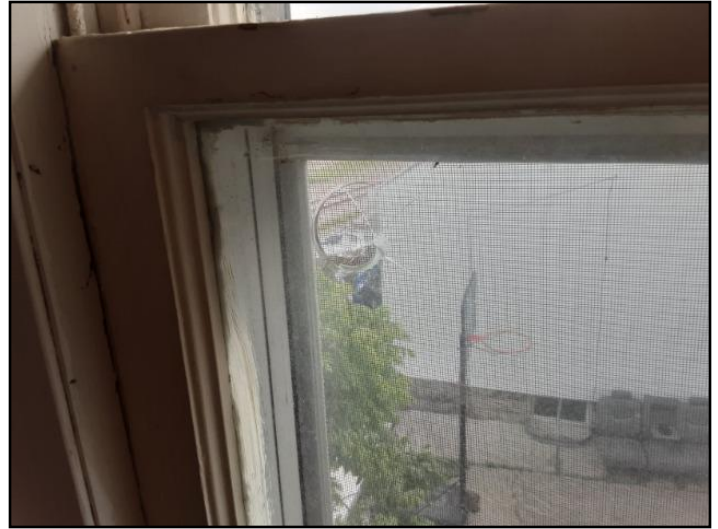
20. Condition: • Window(s) cracked

Window(s) cracked

Task: Repair or replace

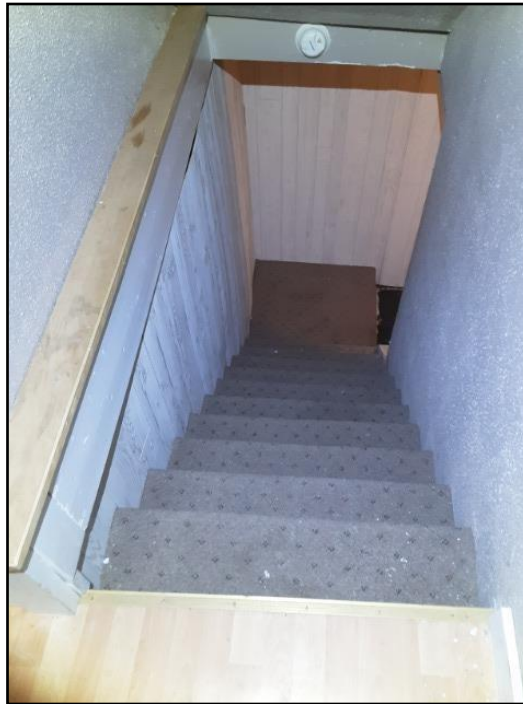
21. Condition: • Handrail missing

It is recommended to have a handrail on any set of stairs with 4 risers or more

Implication(s): Fall hazard

Handrail missing

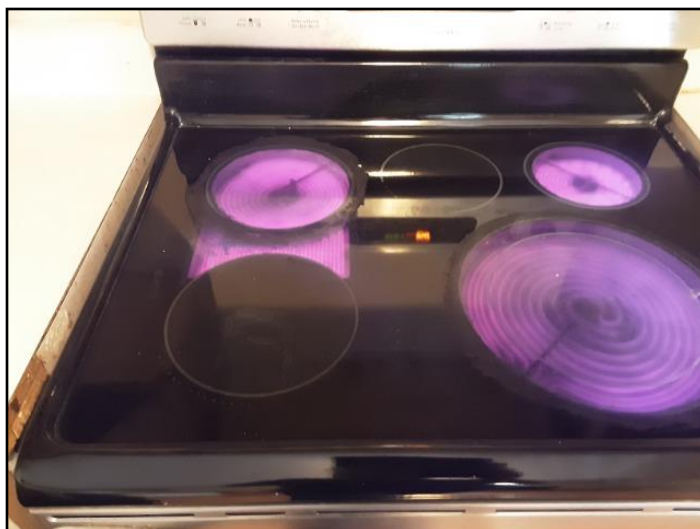
23. Condition: • Burner inoperative

Burner inoperative

Task: Repair

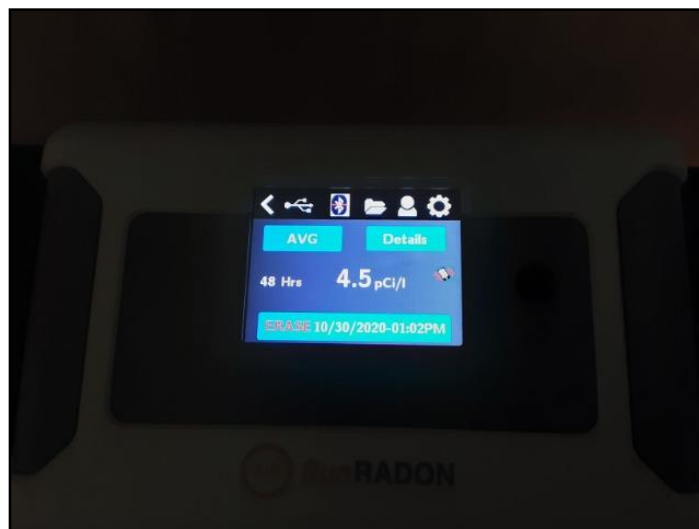
- Result:
4.5

Result: 4.5

- The US EPA has set an action level of 4.0 pCi/L, at or above this level of radon, the EPA recommends you take
