INSPECTION REPORT

For the Property at:
120 MY ROADIS PRIVATE
OTTAWA, ON

Prepared for: JON SMITH
Inspection Date: Tuesday, October 8, 2019
Prepared by: Peter Weeks RHI NCH ACI

RE: Report No. 2519, v.2
120 My Roadis Private
Ottawa, ON

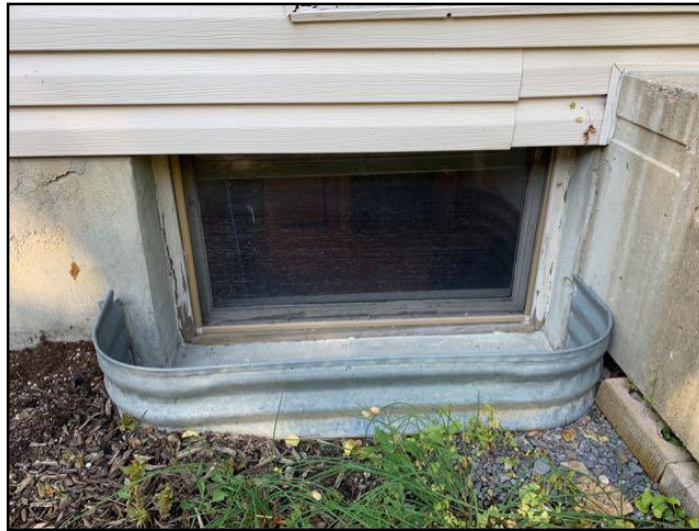
8. *Paint or stain needed*

6. Condition: • [Paint or stain needed](#)

Implication(s): Chance of water damage to structure, finishes and contents | Material deterioration

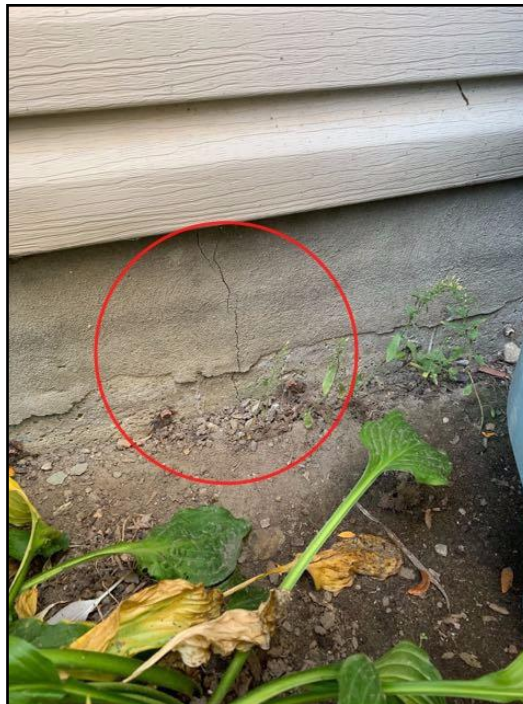
9. Typical minor cracks

7. Condition: • Typical minor cracks

One visible crack at the right side of the foundation - this location was apparently previously repaired. Injection repairs could be made if there is water or moisture penetration inside the living space. Maintain good exterior grading and keep the downspouts directed away from the building at all times.

Task: Monitor / Repair

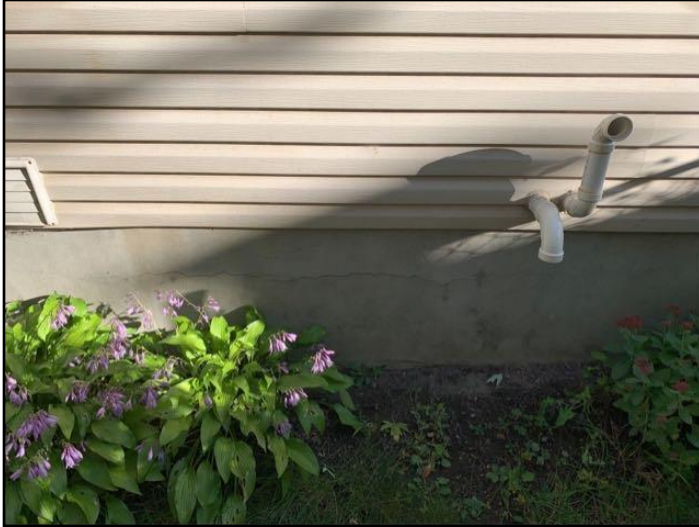
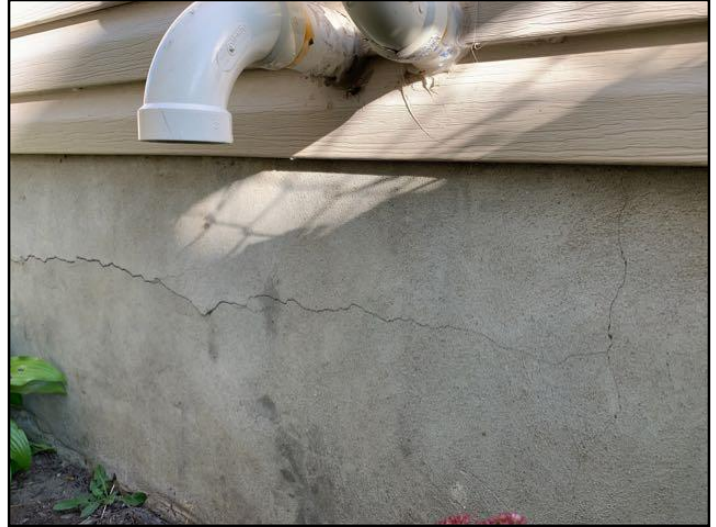
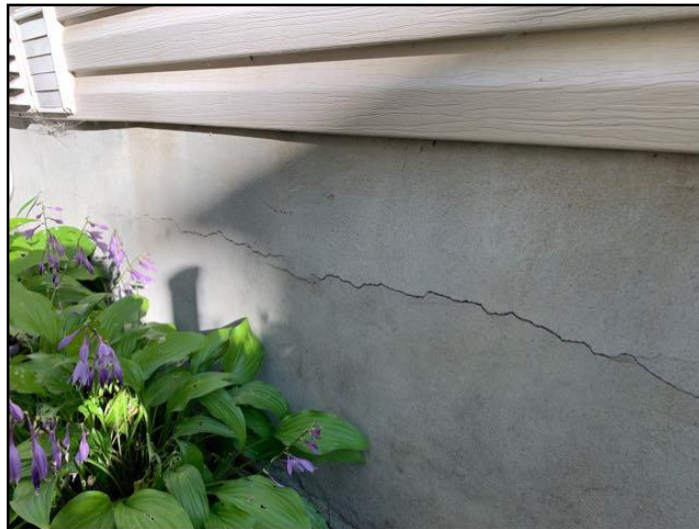
8. Condition: • Cracked horizontally

Parging is cracked horizontally at the right side of the foundation near the back of the house.

Task: Monitor / Repair

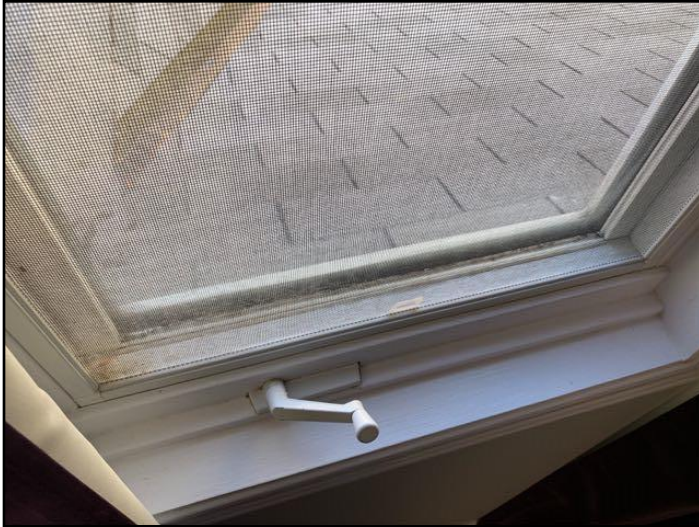
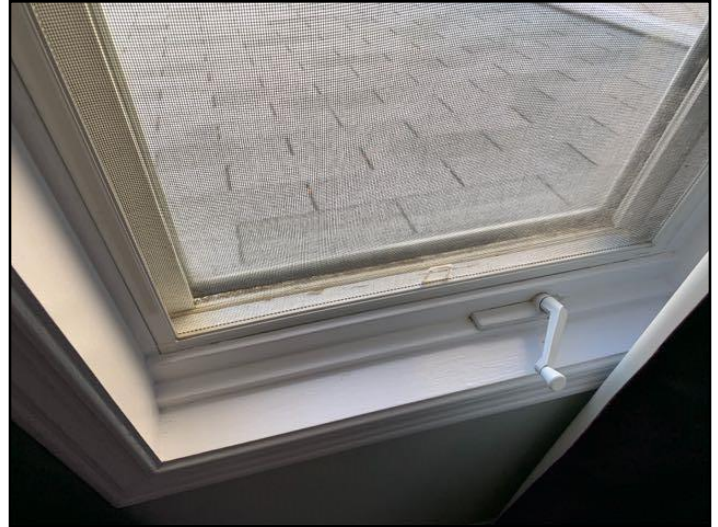
13. Visible mold evaluation is not included in...

Minor mildew at the windows - local cleaning needed

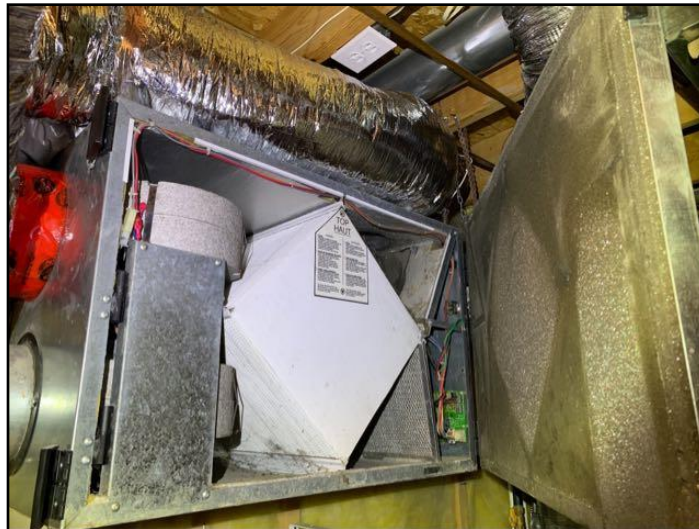
24. HRV needs immediate service. Dirty

15. Condition: • HRV needs immediate service. Dirty

Task: Clean

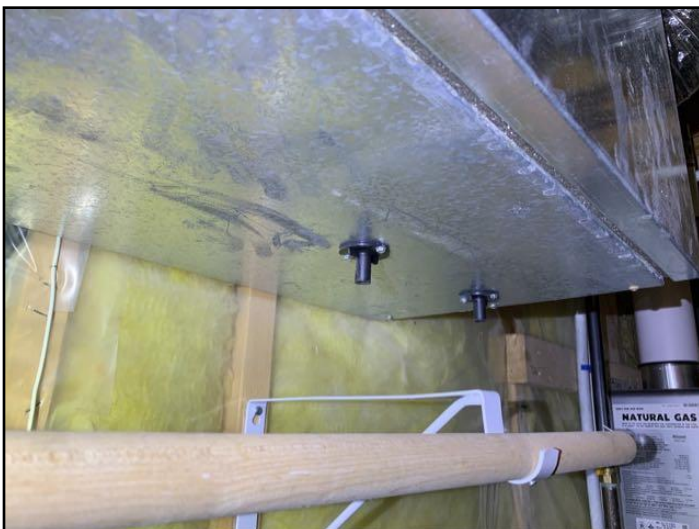
25. Missing the condensate line

17. Condition: • The HRV is missing the condensate line that is designed to collect humidity and drain it below the slab.

Task: Correct - Provide Install

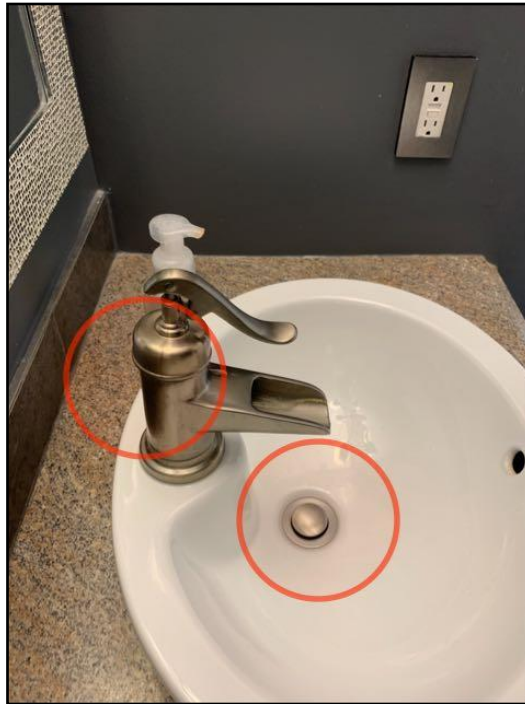
41. Drain stop ineffective

26. Condition: • Drain stop ineffective

Missing lever to engage the drain plug.

Task: Correct

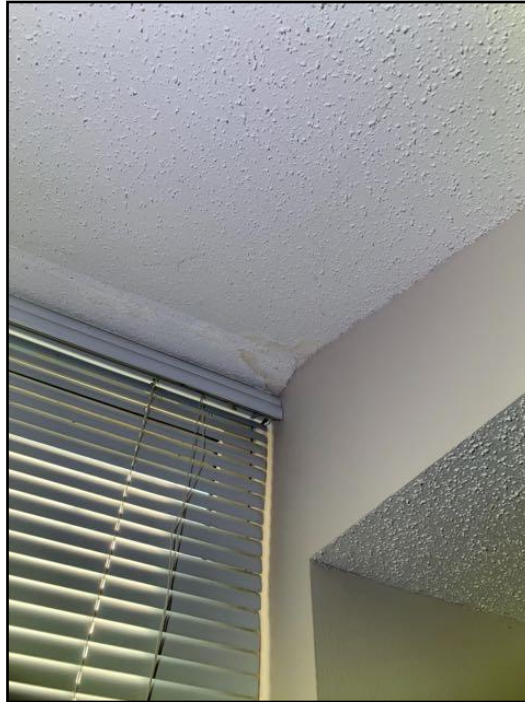
44. Stains

27. Condition: • Stains

Implication(s): Chance of water damage to structure, finishes and contents

Task: Monitor / Repair

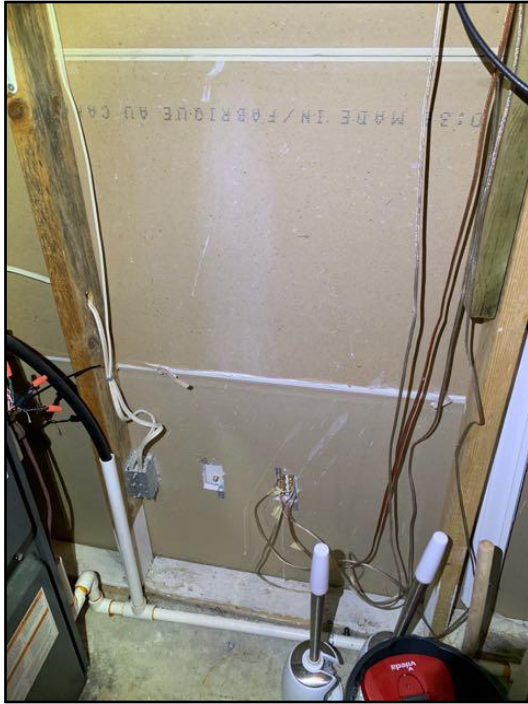
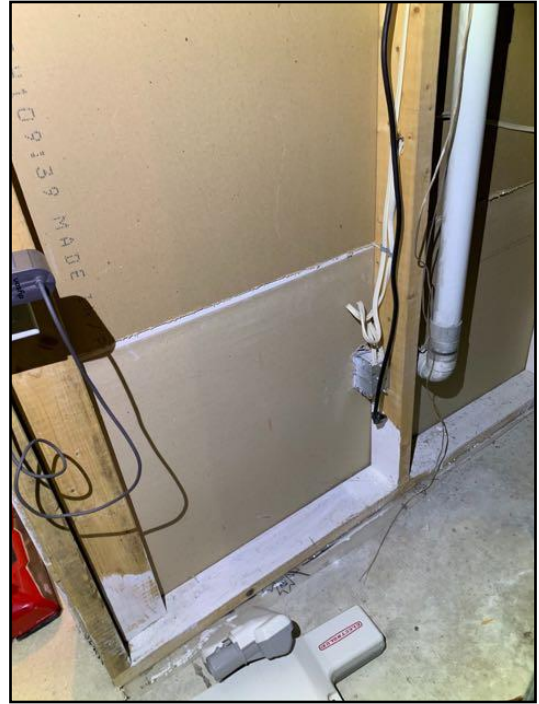
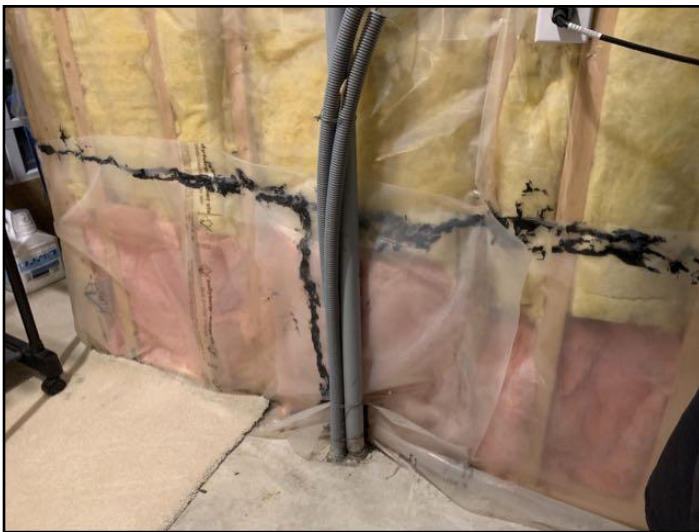
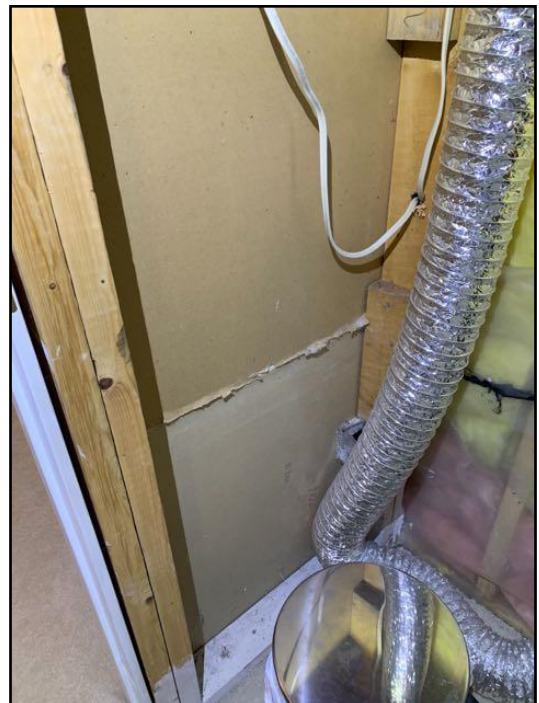
28. Condition: • Patched

Drywall all cut at 24 inches in the basement - sign that there was water damage or flood for some reason - further evaluation recommended.

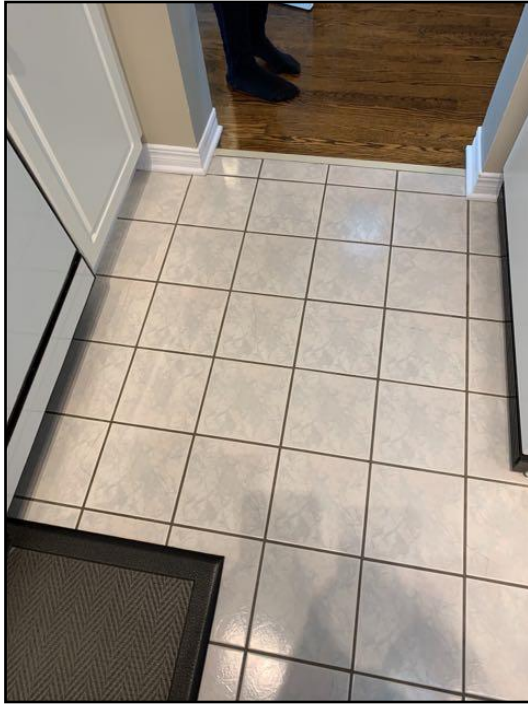
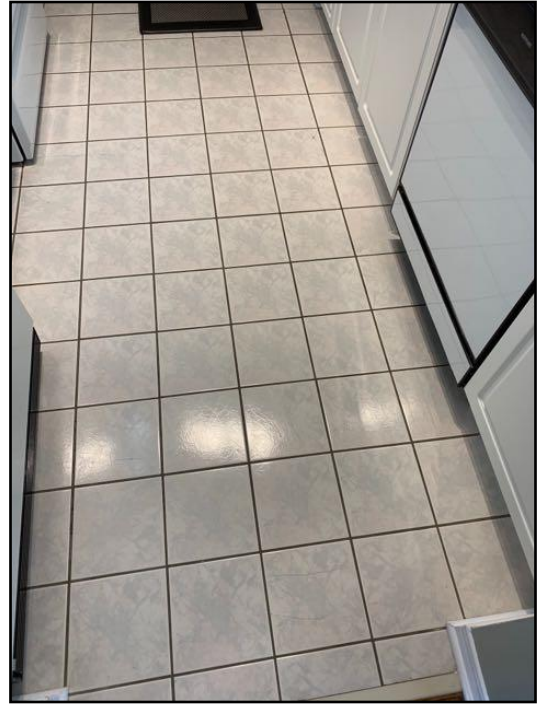
29. Condition: • [Tiles cracked](#)

About 50 % of the kitchen floor tiles are cracked. Replace when needed.

Implication(s): Trip or fall hazard

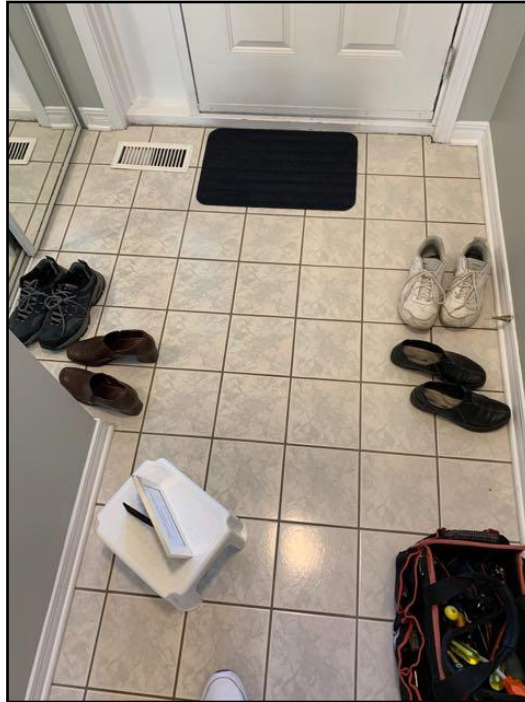
51. Tiles cracked

30. Condition: • [Tiles cracked](#)

Various cracked tiles.

Implication(s): Trip or fall hazard

Task: Replace

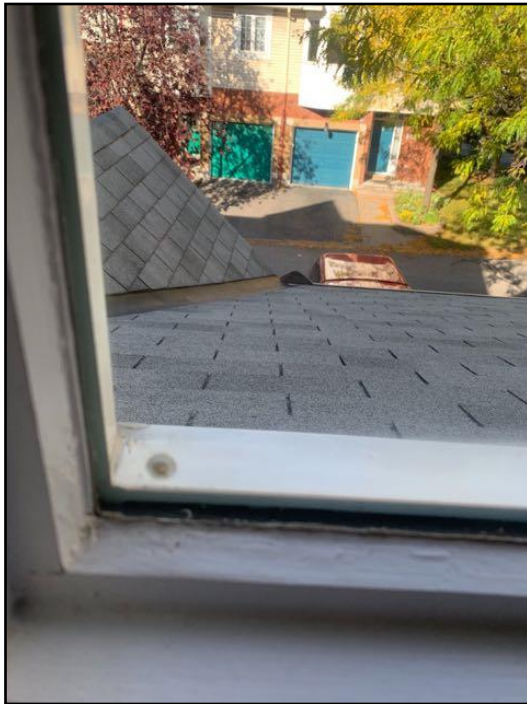
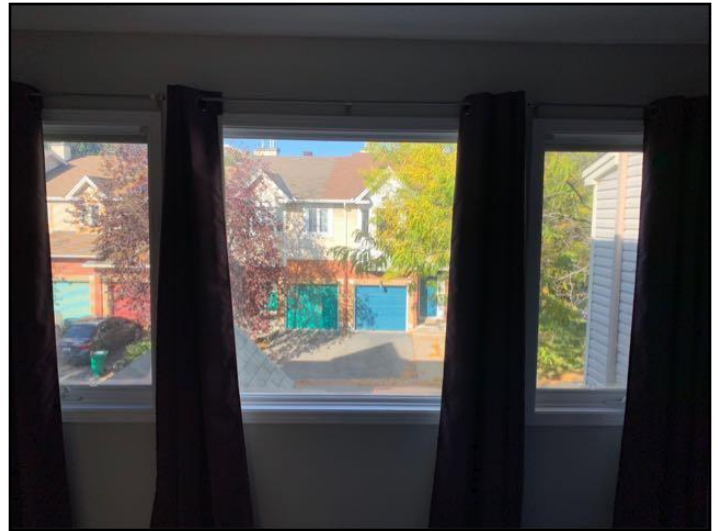
31. Condition: • [Lost seal on double or triple glazing](#)

Seals broken (water, frost and stains between glass) at no less than one of the double glazed window panes (there may be more). Budget for replacements as needed. Typical life should be about 20 to 25 years.

Task: Replace
