Your Inspection Report

123 Main Street
Tampa, FL 33619

INSPECTION DATE:
Wednesday, July 6, 2016

Report No. 2396, v.3

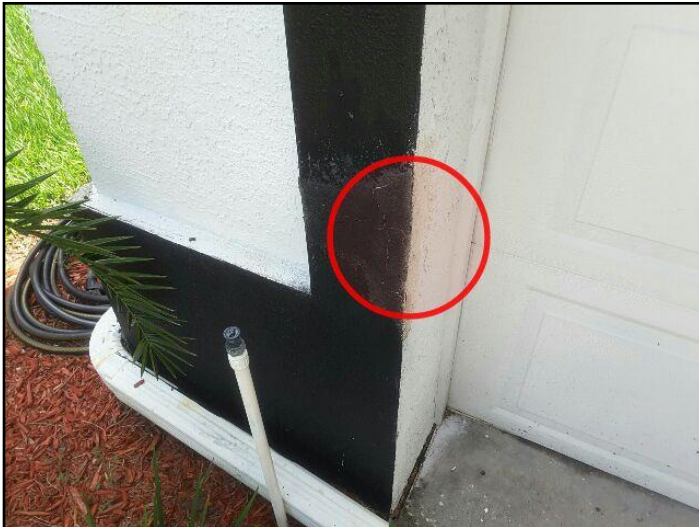
Condition: • [Minor cracks](#)

Implication(s): Shortened life expectancy of material

1. Minor cracks

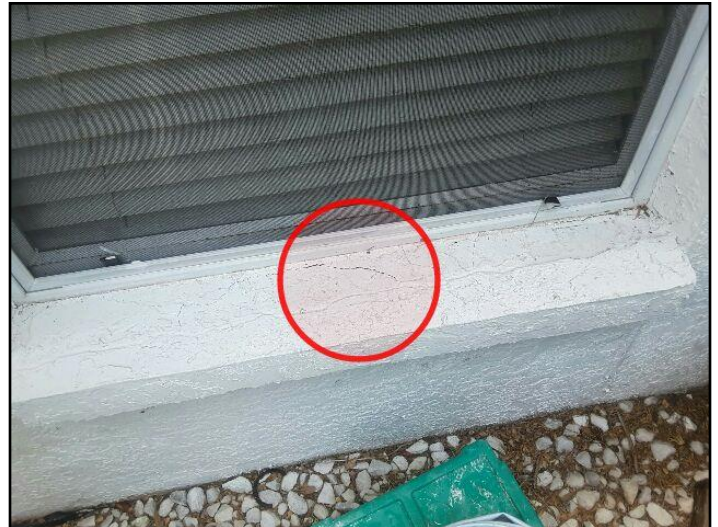
2. Minor cracks

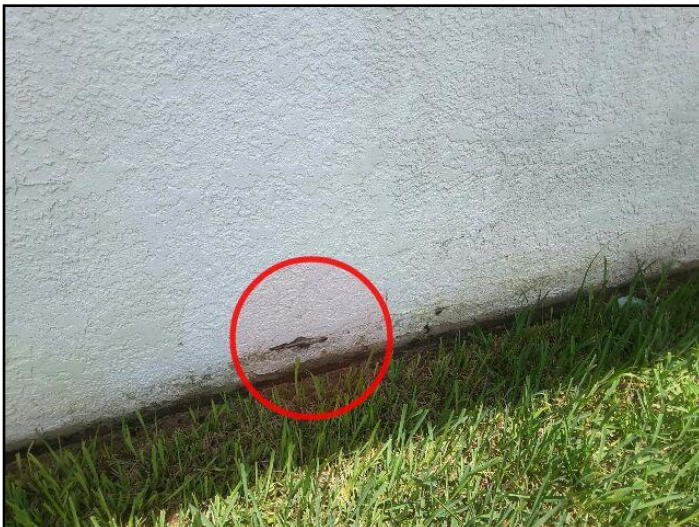
3. Minor cracks

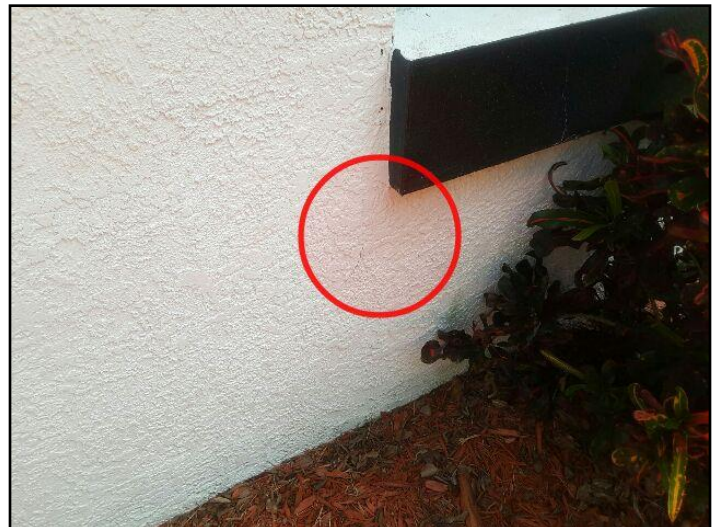
4. Minor cracks

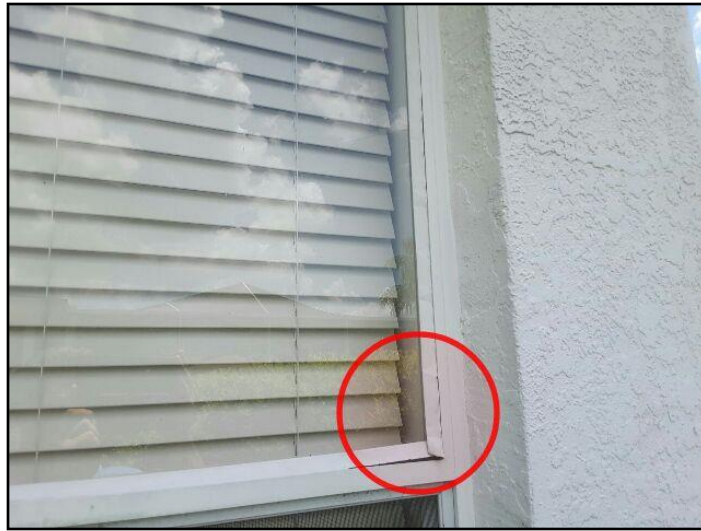
Condition: • [Damage](#)

Implication(s): Chance of water damage to contents, finishes and/or structure

5. Damage

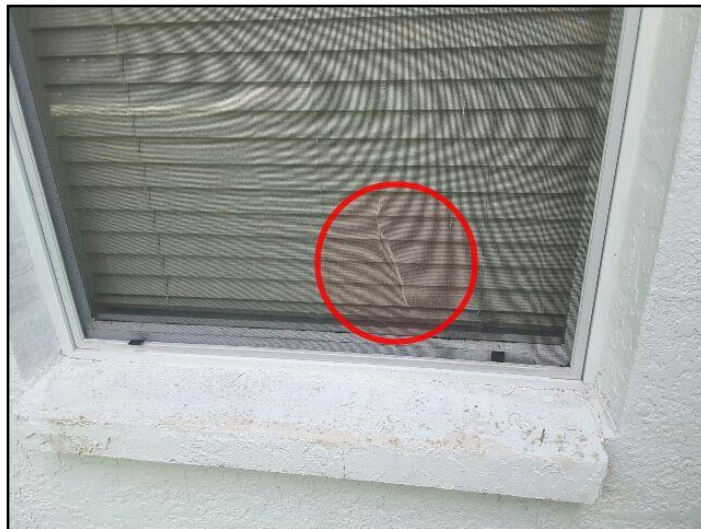
Condition: • [Torn or holes](#)

Implication(s): Chance of pests entering building

6. Torn or holes

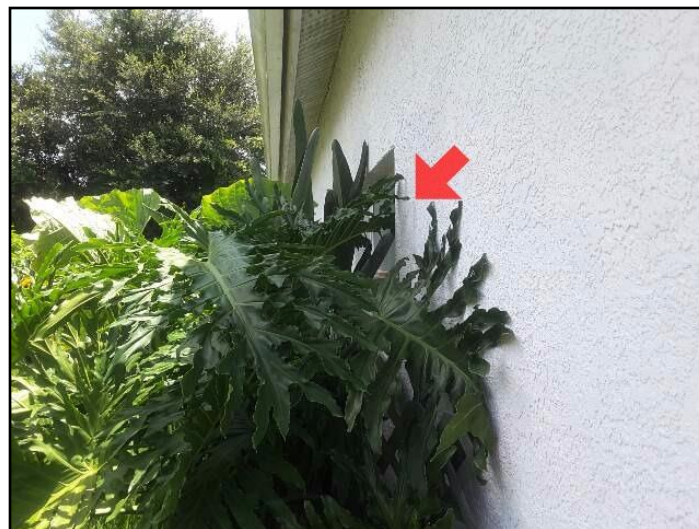
Condition: • [Trees or shrubs too close to building](#)

Implication(s): Chance of water damage to contents, finishes and/or structure | Chance of pests entering building | Material deterioration

7. Trees or shrubs too close to building

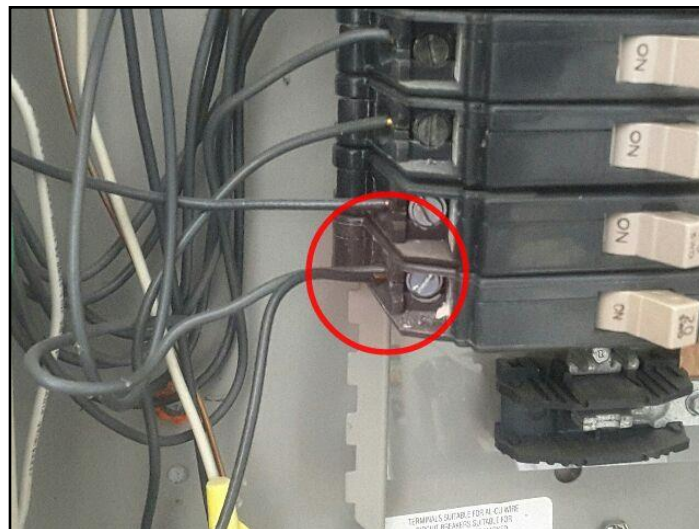
Condition: • [Double taps](#)

Implication(s): Fire hazard

8. Double taps

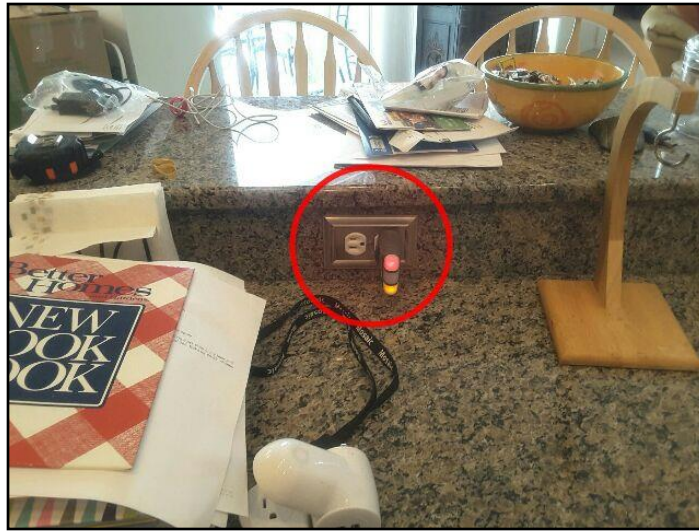
Condition: • [Reversed polarity](#)

Implication(s): Electric shock

9. Reversed polarity

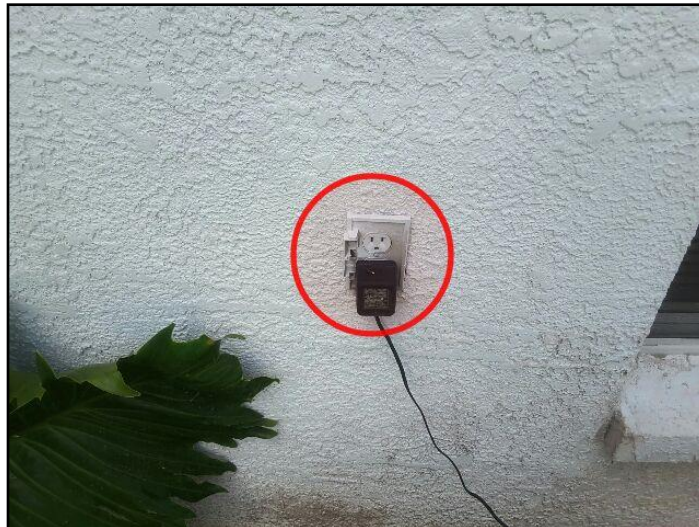
Condition: • Weather protection needed

10. Weather protection needed

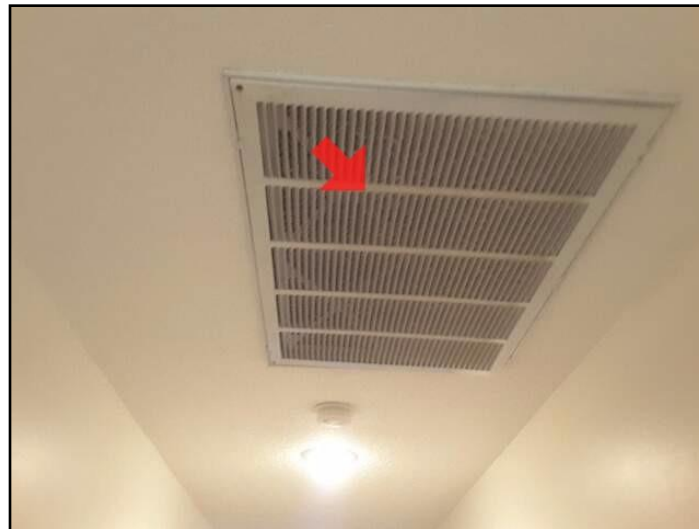
Condition: • [Dirty](#)

Implication(s): Increased heating costs | Reduced comfort

11. Dirty

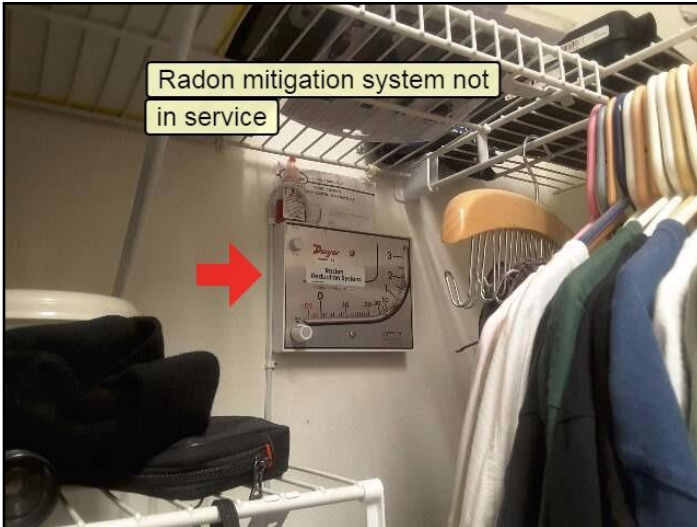
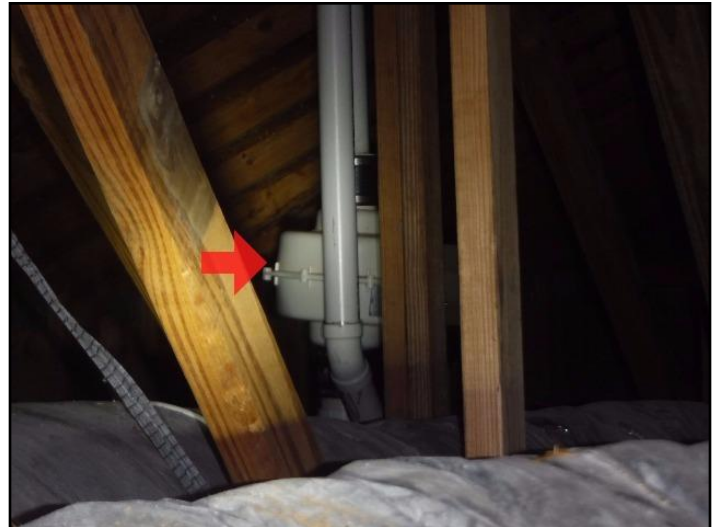
- Radon mitigation system noted. Not operating at time of inspection

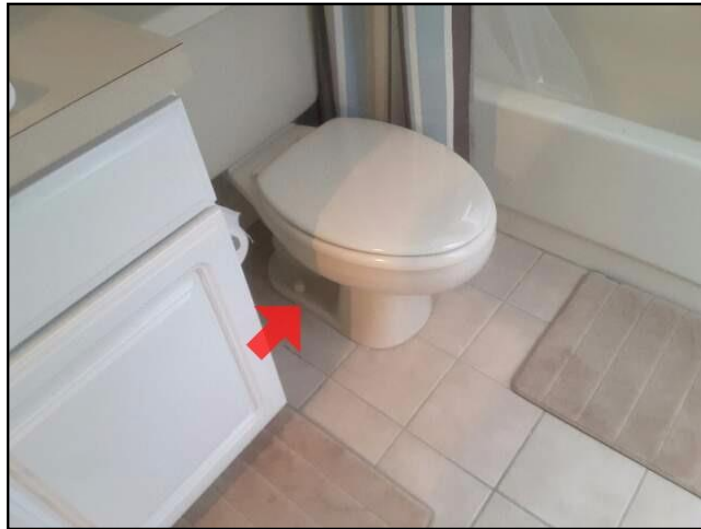
Condition: • [Loose](#)

Implication(s): Chance of water damage to contents, finishes and/or structure | Sewage entering the building

14. Loose

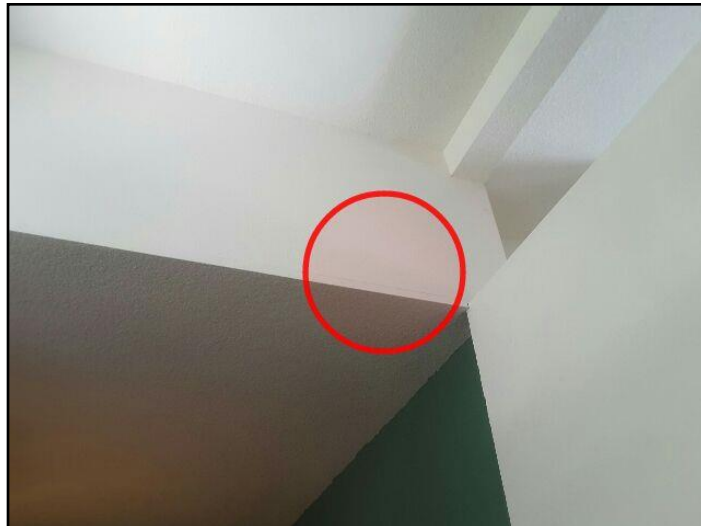
Condition: • Typical flaws

15. Typical flaws

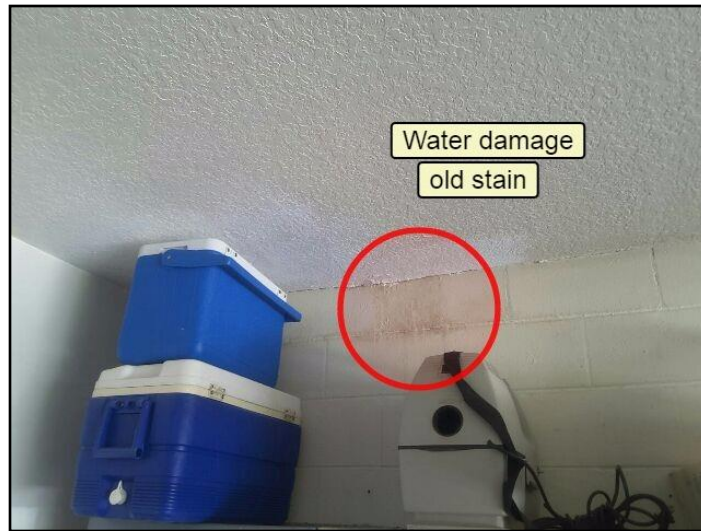
Condition: • [Damage](#)

Implication(s): Material deterioration | Damage or physical injury due to falling materials

16. Damage

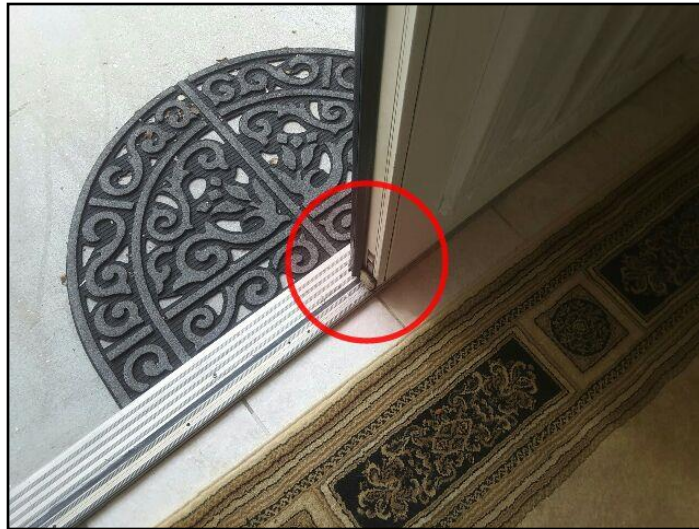
Condition: • Adjustment needed

17. Adjustment needed

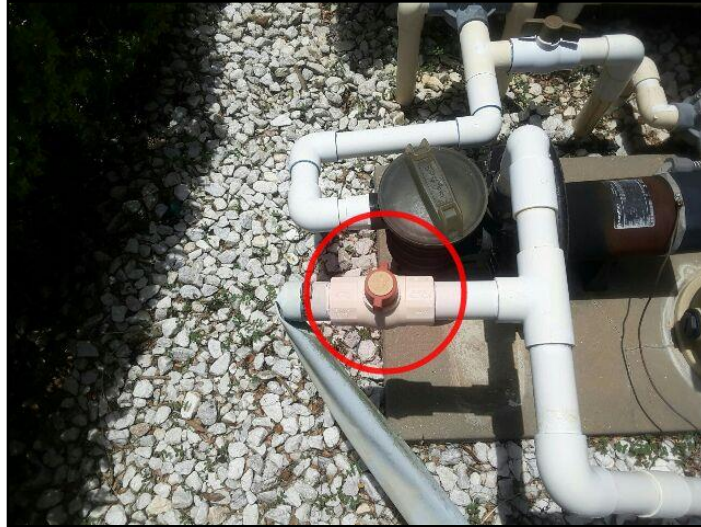
- Valves broken or inoperable

18. *Valves broken or inoperable*

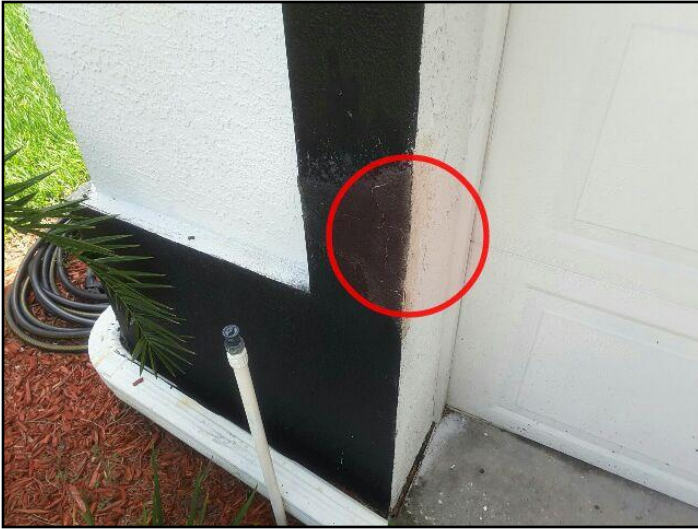
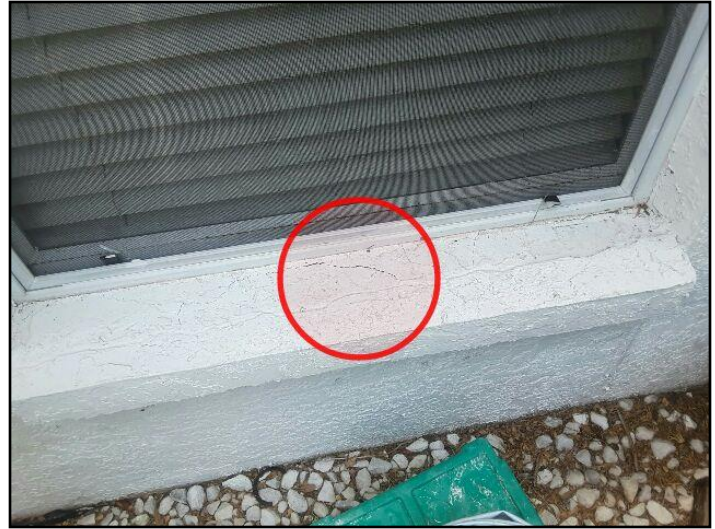
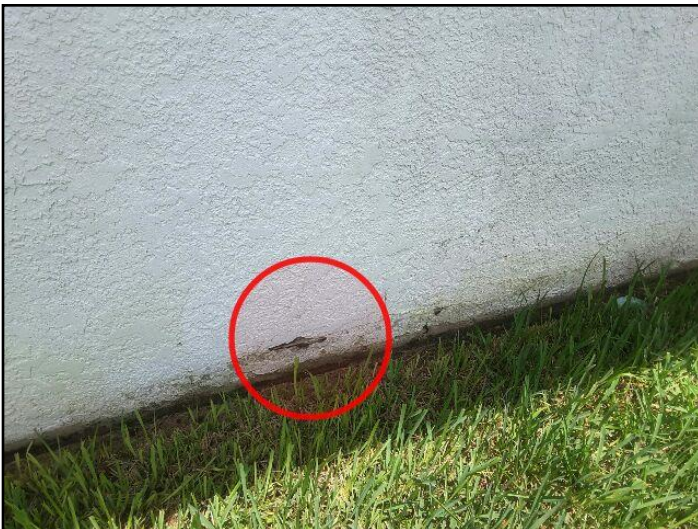
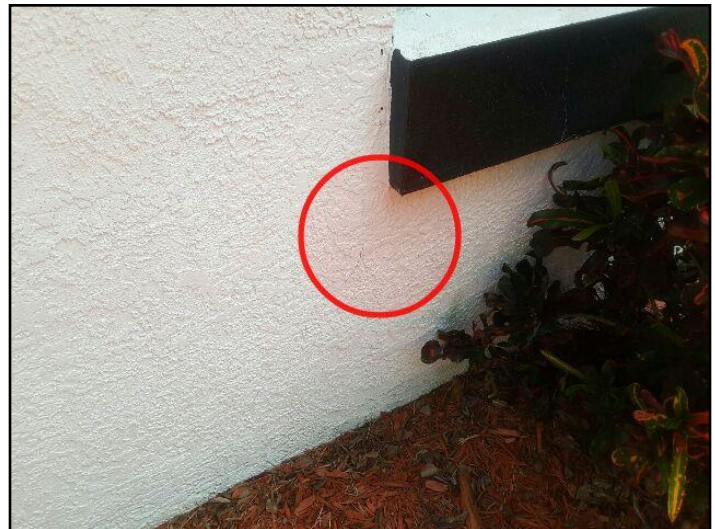
2. Condition: • [Minor cracks](#)

Implication(s): Shortened life expectancy of material

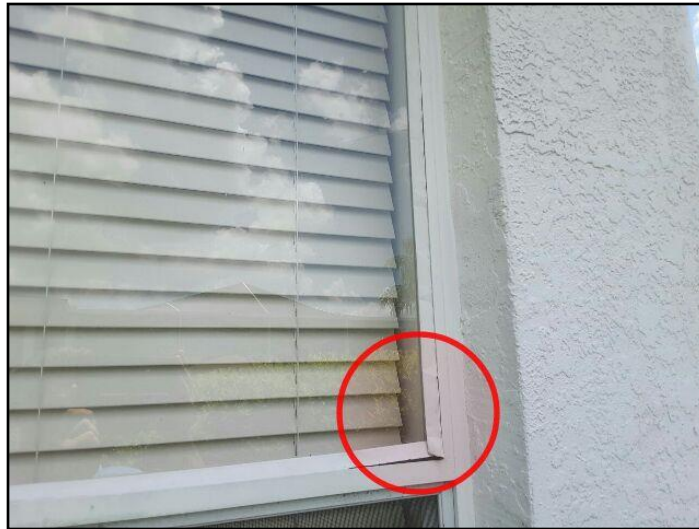
3. Condition: • [Damage](#)

Implication(s): Chance of water damage to contents, finishes and/or structure

29. Damage

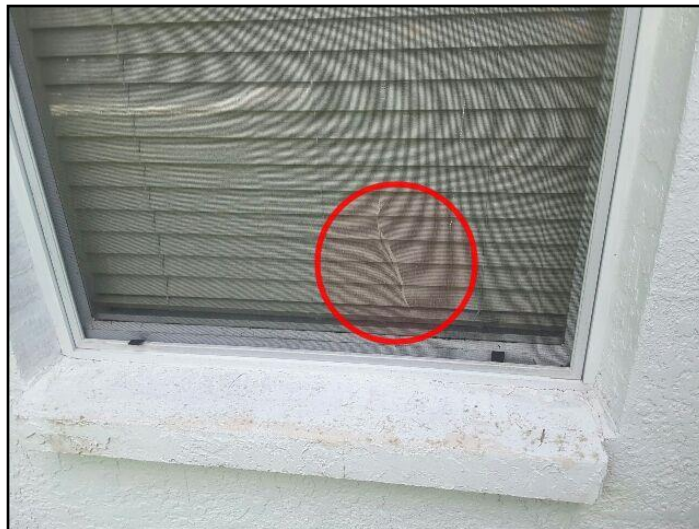
4. Condition: • [Torn or holes](#)

Implication(s): Chance of pests entering building

30. Torn or holes

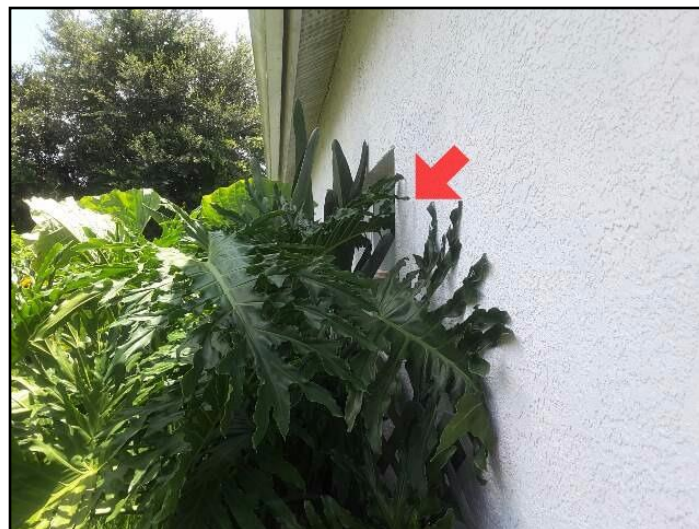
5. Condition: • [Trees or shrubs too close to building](#)

Implication(s): Chance of water damage to contents, finishes and/or structure | Chance of pests entering building | Material deterioration

31. Trees or shrubs too close to building

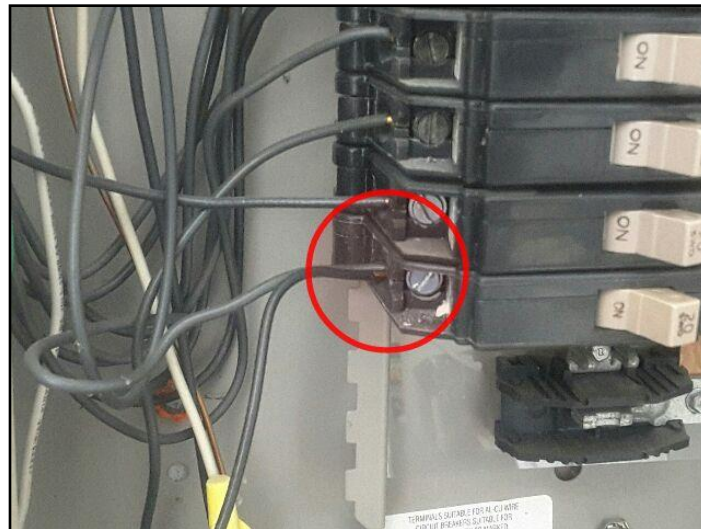
8. Condition: • [Double taps](#)

Implication(s): Fire hazard

36. Double taps

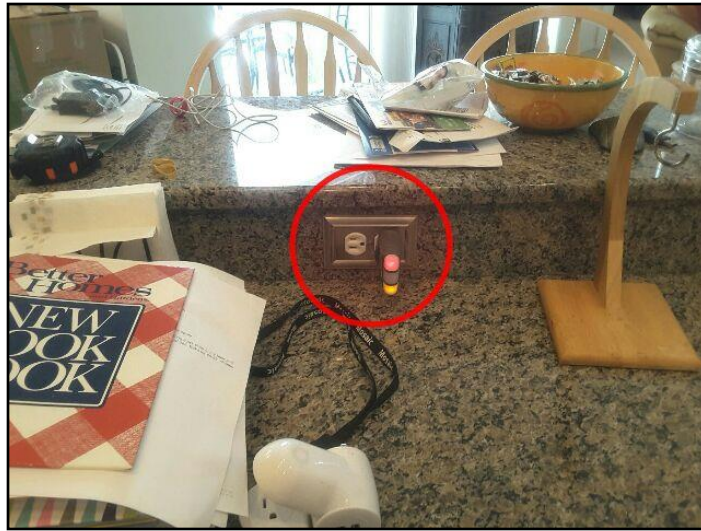
9. Condition: • [Reversed polarity](#)

Implication(s): Electric shock

37. Reversed polarity

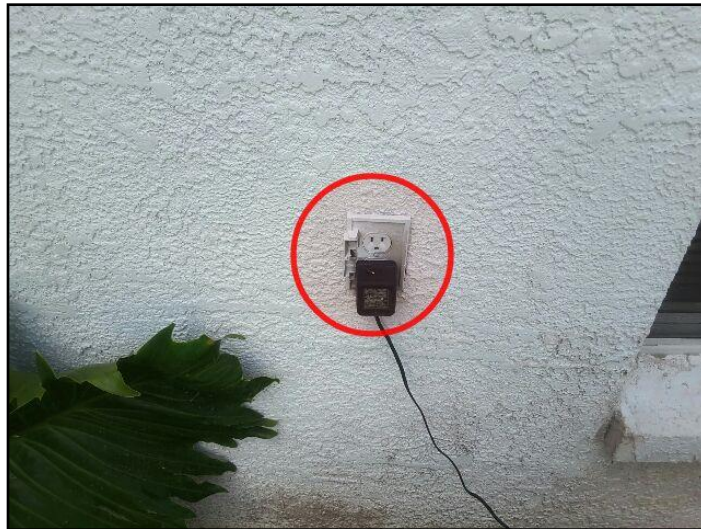
10. Condition: • Weather protection needed

38. Weather protection needed

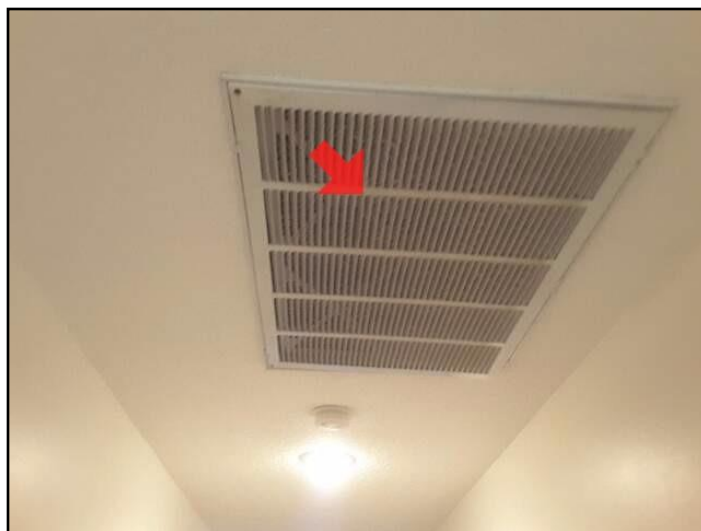
11. Condition: • [Dirty](#)

Implication(s): Increased heating costs | Reduced comfort

40. Dirty

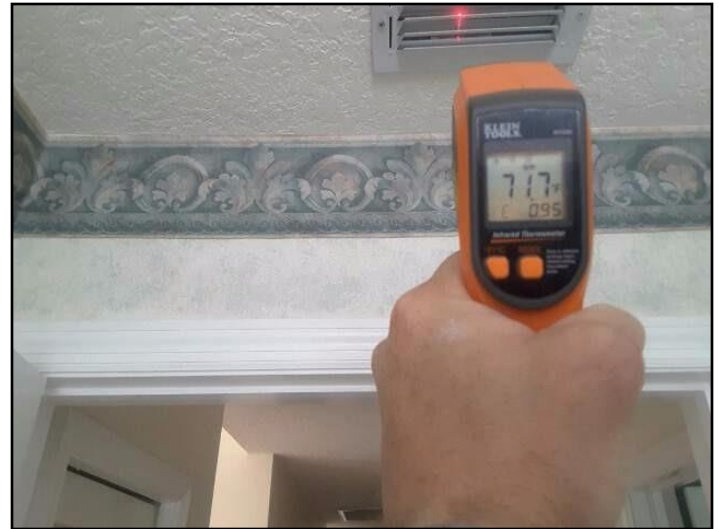
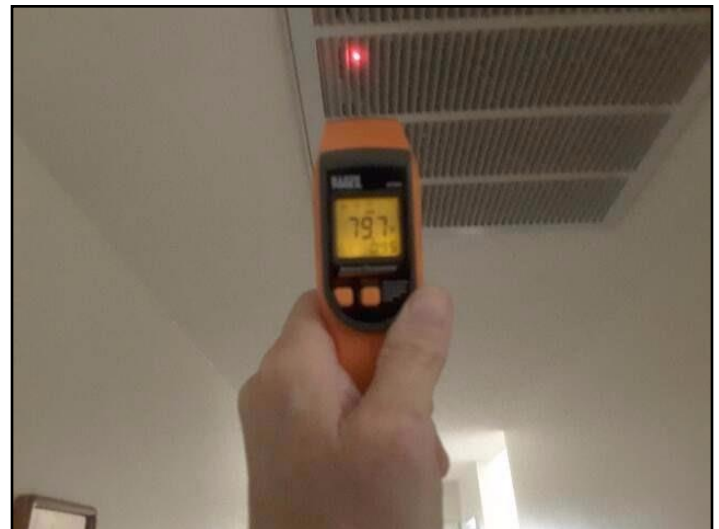
43. 70°

45. 79°

Temperature difference: • 8 deg.

Temperature difference: • Acceptable temperature difference: 14° to 22° • This suggests performance issues. Service may be needed.

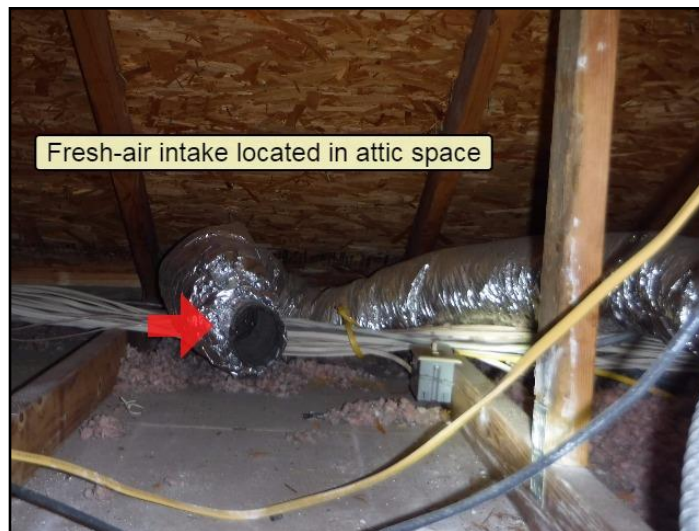
46.

12. • HVAC system has a fresh-air intake duct located in the attic space. Extreme hot air in attic may be making system operate at a marginal level.

Heat pump was operating at a marginal level. Recommending a service call by a licensed HVAC professional. Outside air intake noted in attic space. Fresh air intake is bringing in extreme hot attic air. May be the cause of the performance issues.

Evaluation by a licensed HVAC professional is recommended

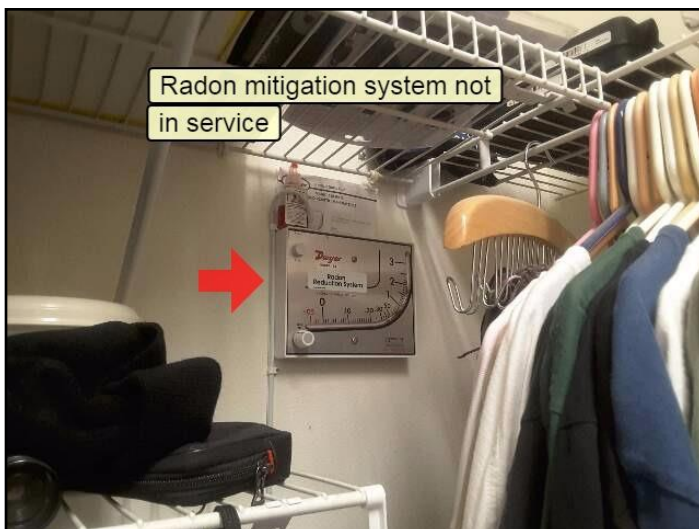
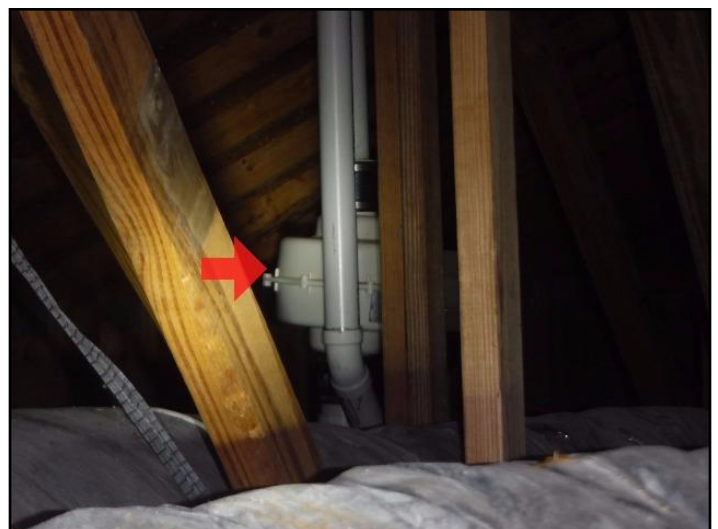
15. • Radon mitigation system noted. Not operating at time of inspection

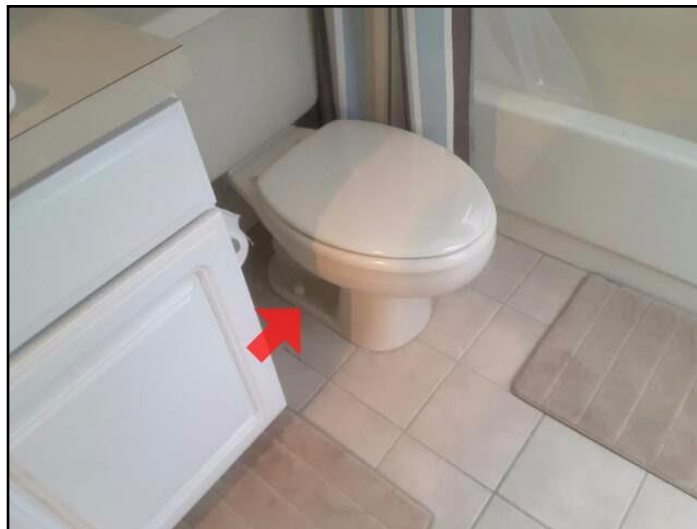
17. Condition: • [Loose](#)

Implication(s): Chance of water damage to contents, finishes and/or structure | Sewage entering the building

56. Loose

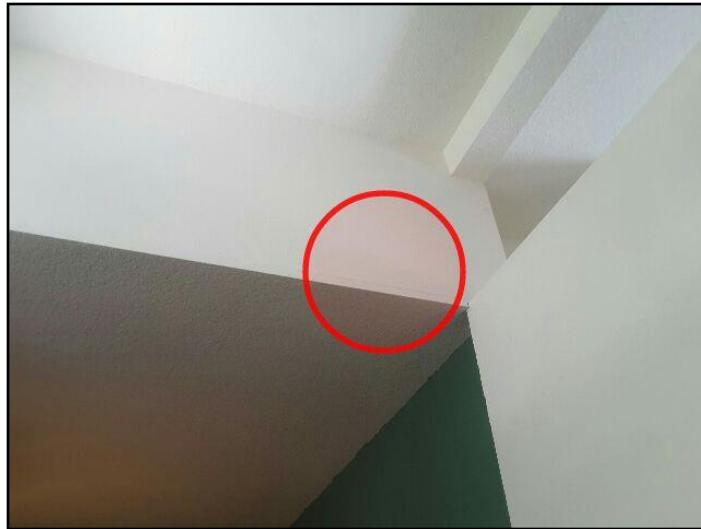
19. Condition: • Typical flaws

57. Typical flaws

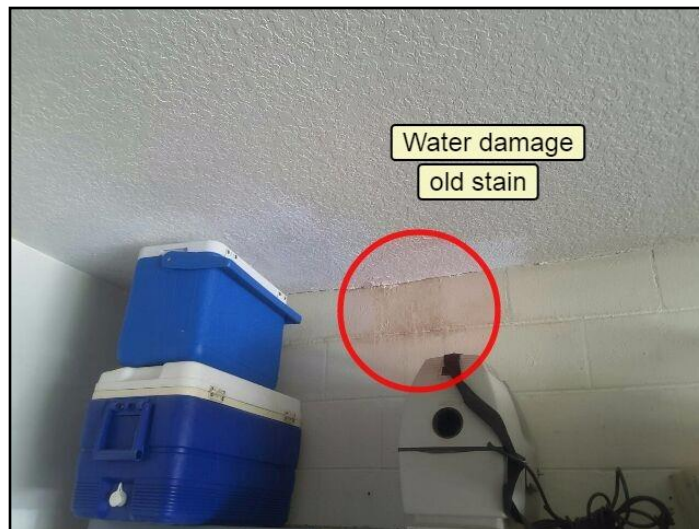
20. Condition: • [Damage](#)

Implication(s): Material deterioration | Damage or physical injury due to falling materials

58. Damage

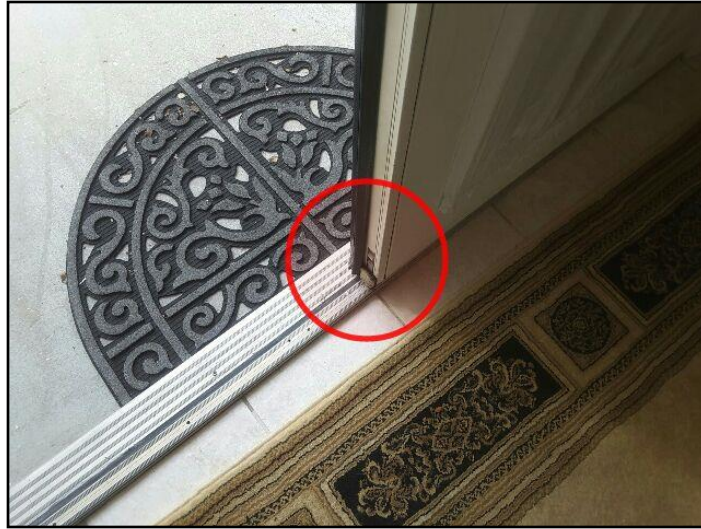
22. Condition: • Adjustment needed

59. *Adjustment needed*

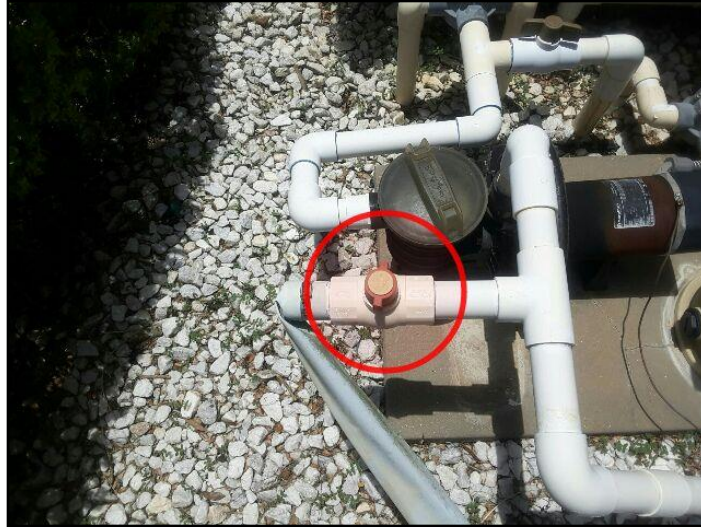
23. • Valves broken or inoperable

68. Valves broken or inoperable
