YOUR Inspection Report

1569 Skyline Dr
Mississauga, ON L5E 2W6

Friday, June 7, 2019

Report No. 5566

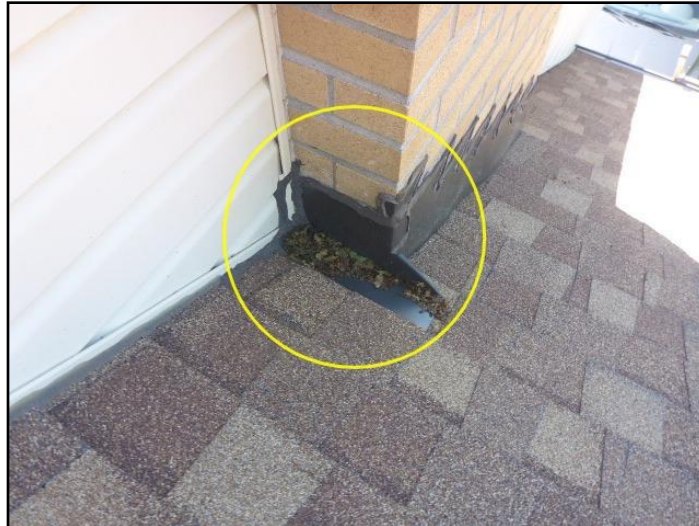
Condition: • Flashings are vulnerable areas

Vulnerable areas noted

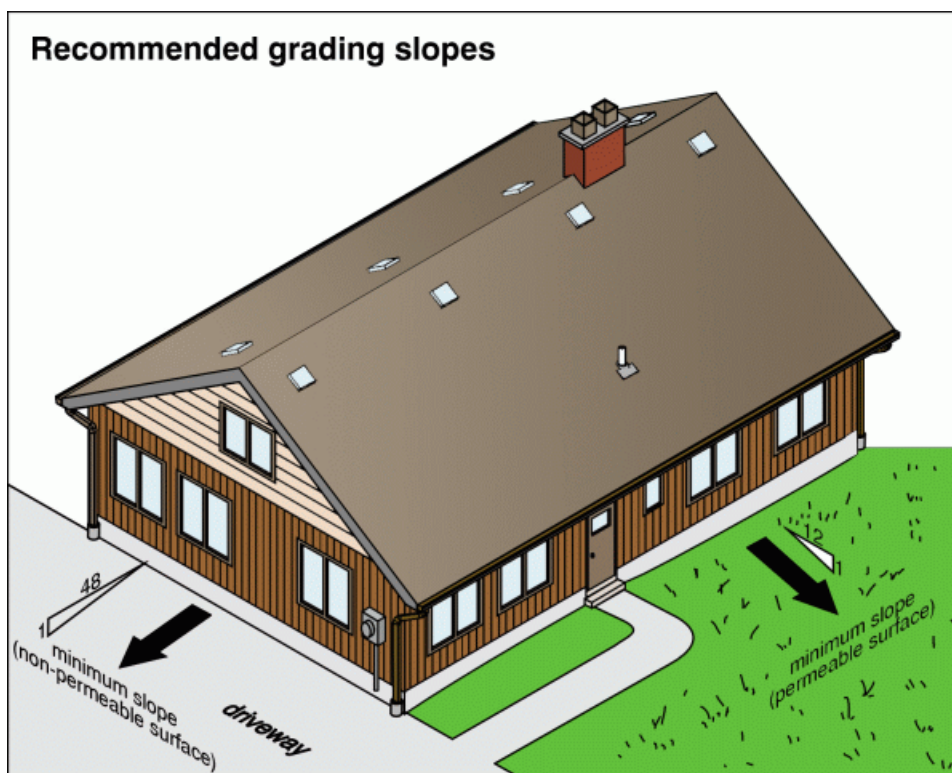
Condition: • [Low areas](#)

To reduce the likelihood of water penetration to the basement, always maintain a positive slope away from the foundation wall.

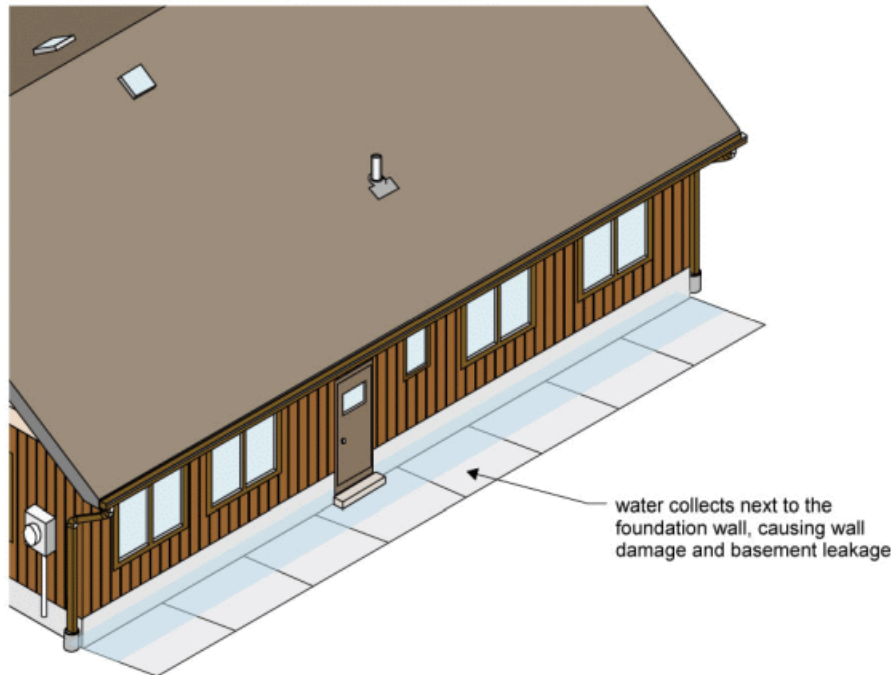
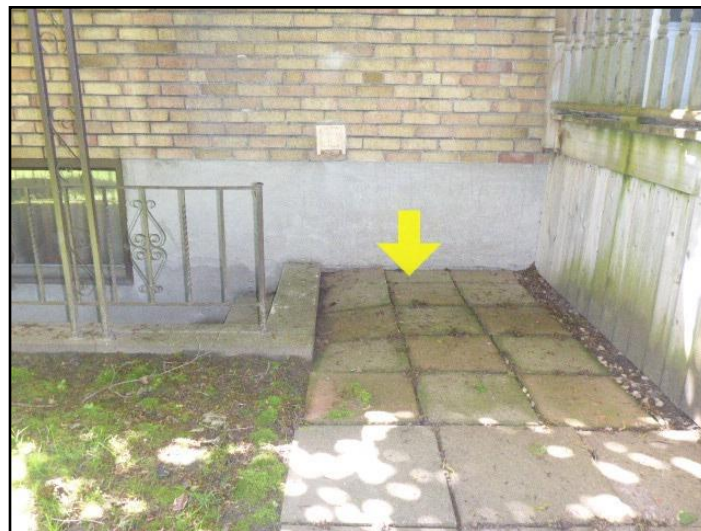
Condition: • [Slope away from house](#)

Walk/patio sloping towards house

Slope away from the foundation

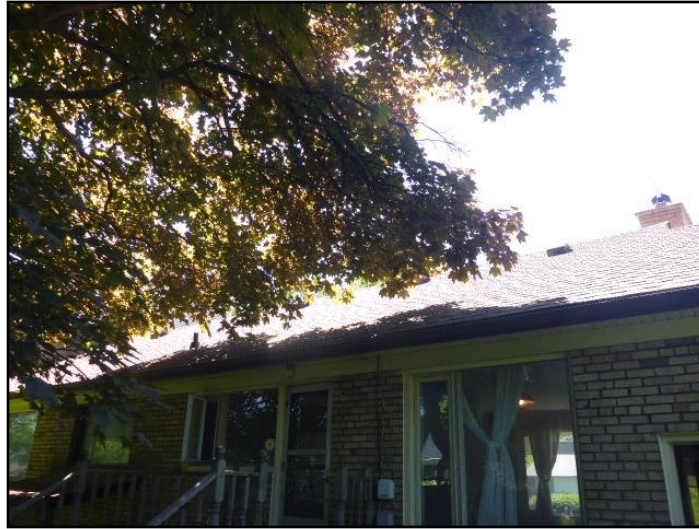
Condition: • [Shrubs/trees too close to building](#)

Keep trimmed back

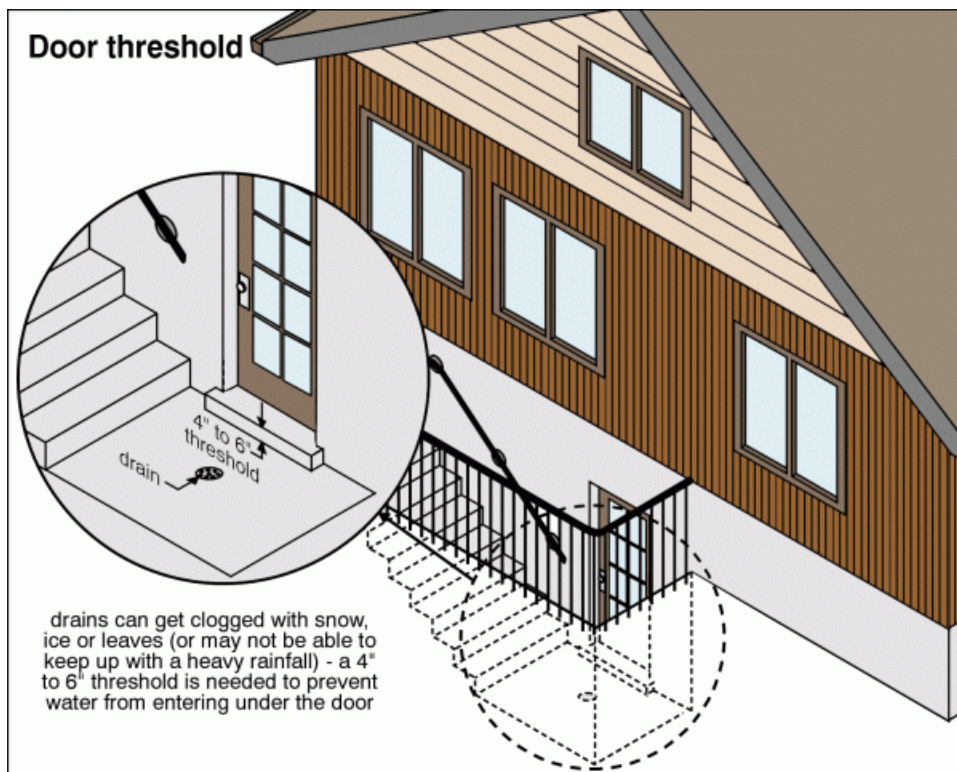
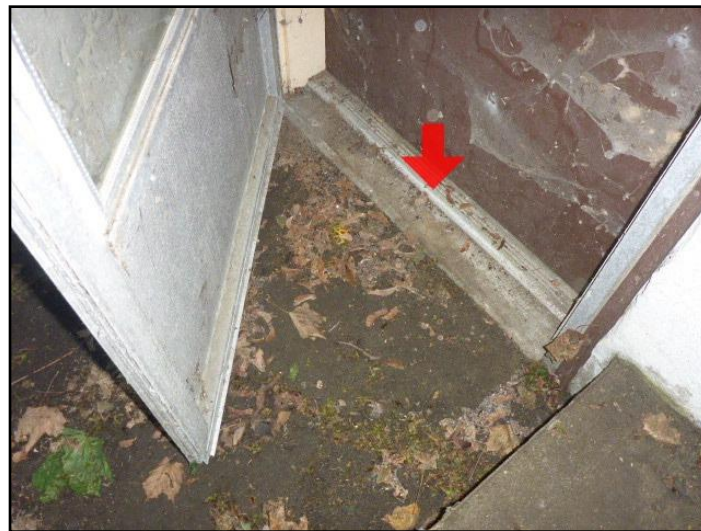
Condition: • [Threshold too low \(7.5\)](#)

Low threshold noted

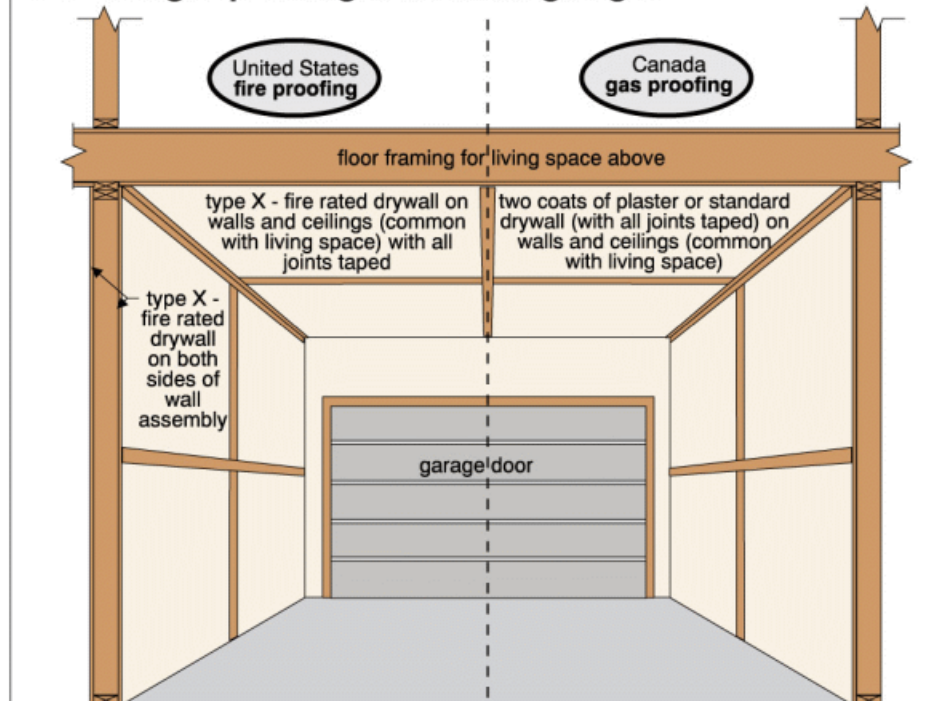
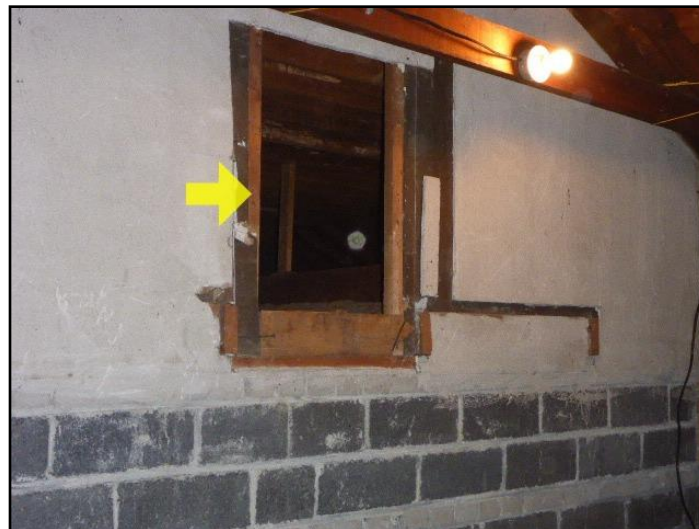
Condition: • Storage in the garage prevented a thorough inspection for gas proofing issues. Be sure to seal any hole/gaps that are discovered once the space is clear to prevent the migration of gases into the living space.

Fire and gas proofing in attached garages

Air tight door required

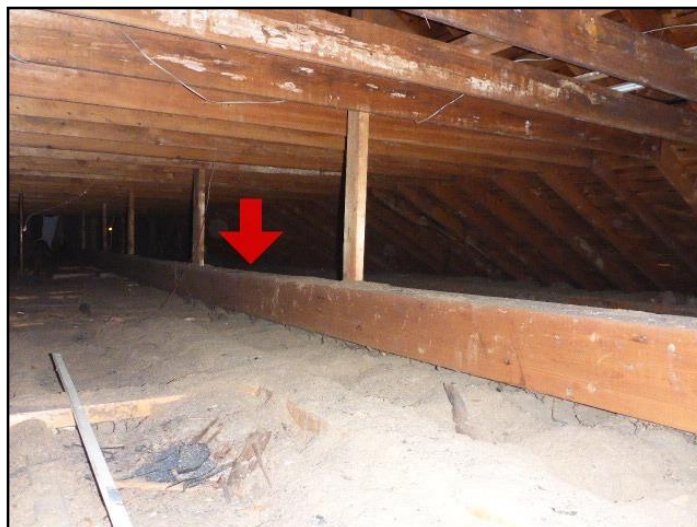
Condition: • There is a built up been in the attic space that runs from one end of the home to the other. It's purpose/function is unknown.

Unknown purpose/function

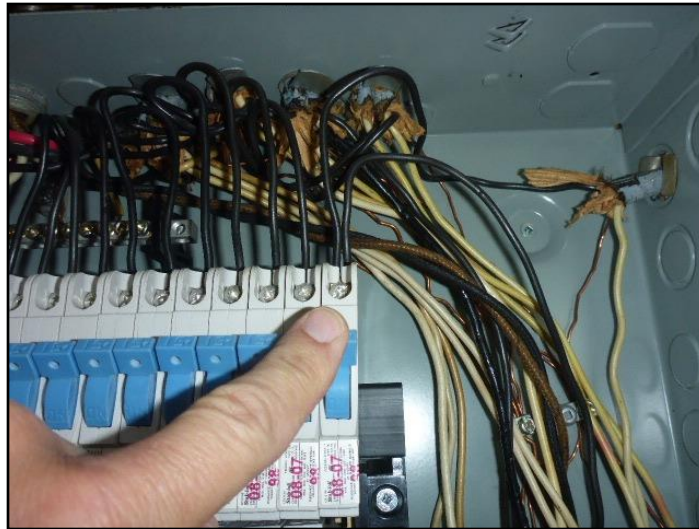
Condition: • [Double tap \(two wires on one breaker or fuse\)](#)

Double taps noted

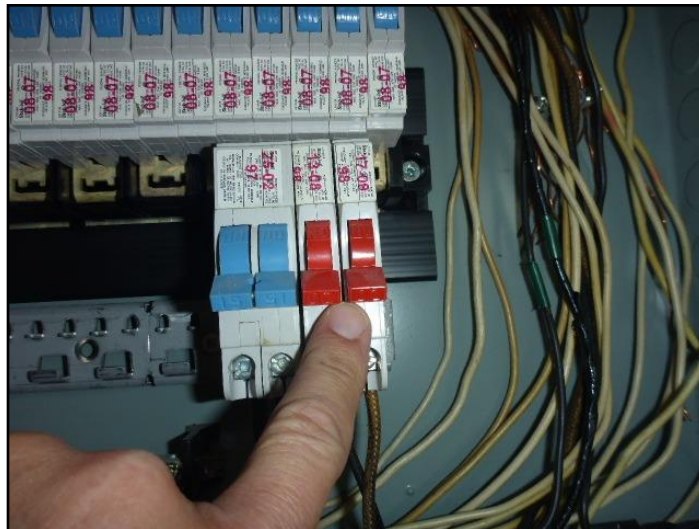
Condition: • [Link missing on multiwire circuit](#)

Missing link noted

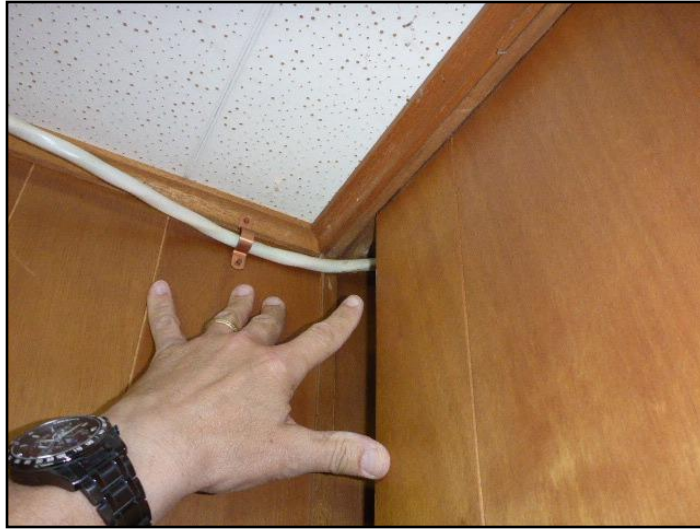
Condition: • [Exposed](#)

Door hits wire

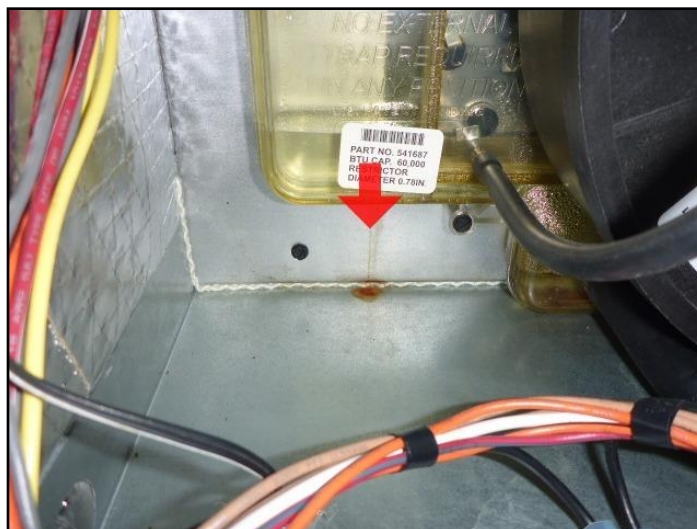
Condition: • Prior condensate leaks noted inside furnace cabinet.

Stain inside furnace cabinet

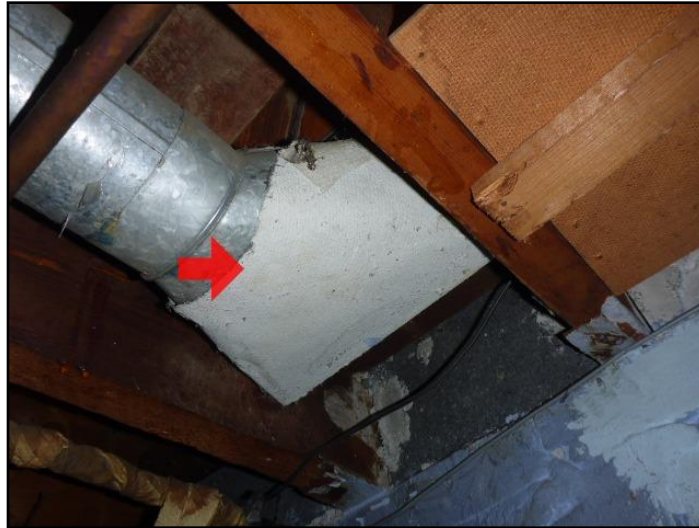
Condition: • Finding and identifying environmental issues such as asbestos is outside the scope of a home inspection. Asbestos may be present in many building products and materials. An Environmental Consultant can assist if this is a concern.

Likely an asbestos-containing material

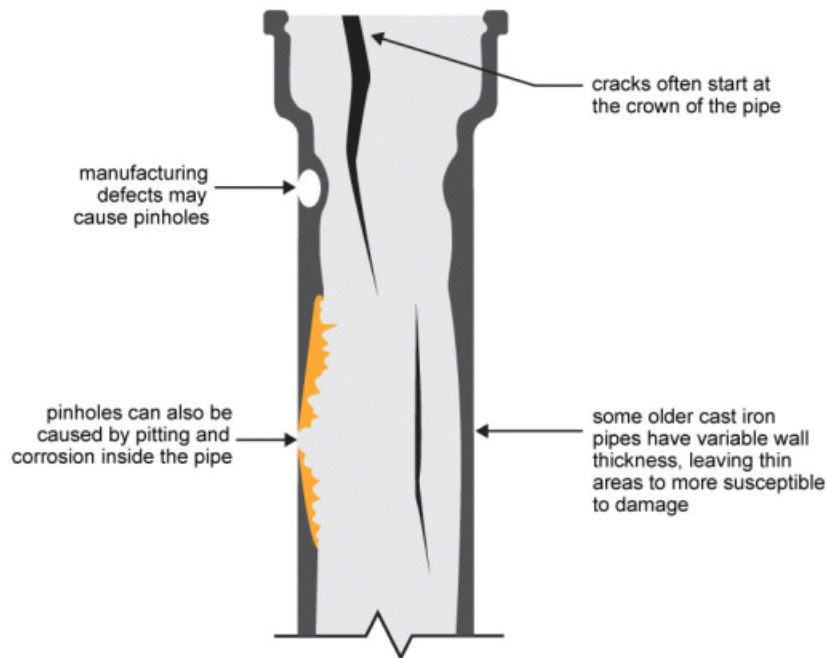
Condition: • The cast iron waste piping is near the end of its normal life expectancy and is prone to rusting through or splitting. Replacement may be required in the near future.

Pinholing and cracks in cast iron stacks

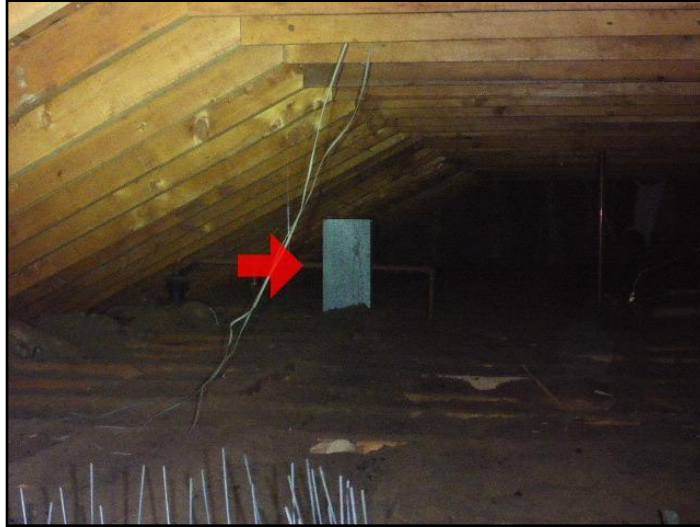
Condition: • [Discharge should be to exterior](#)

Should be insulated and vent to roof

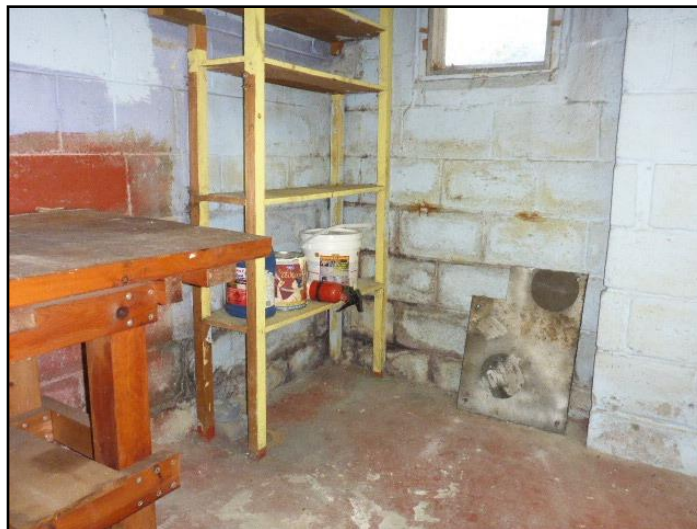
Condition: • Evidence of basement leakage was noted.

Mould/water stains in basement
