INSPECTION REPORT

For the Property at:
123 RAINY STREET
FARGO, ND 58103

Prepared for: JOHN DOE
Inspection Date: Monday, February 11, 2019
Prepared by: Cody Lewis

RE: Report No. 1193, v.2
123 Rainy Street
Fargo, ND
58103

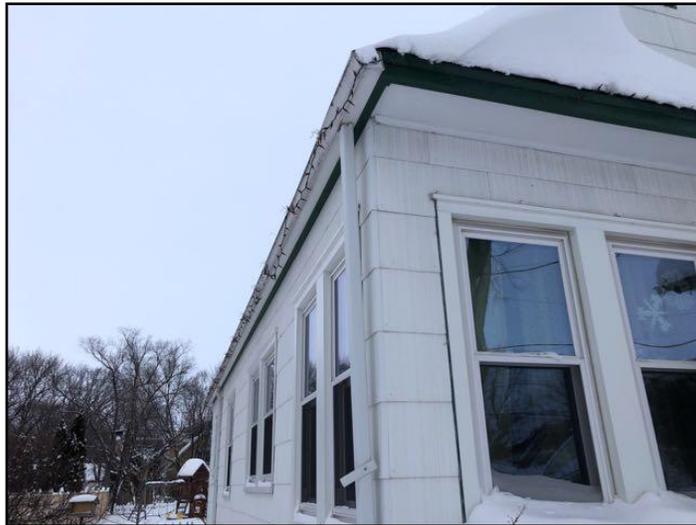
Condition: • [Not well secured](#)

Southwest downspout is not well secured against the wall. Consult a contractor to secure.

Not well secured

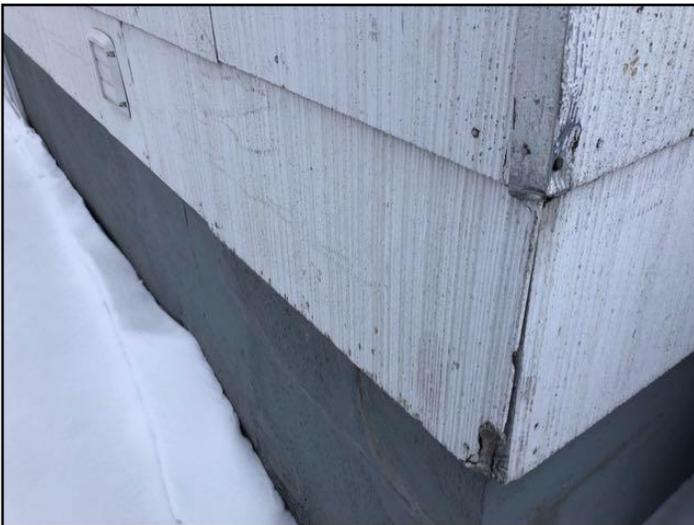
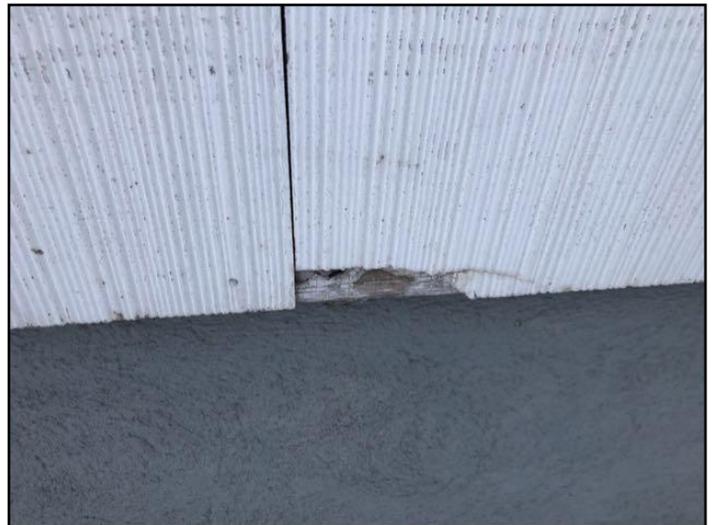
Condition: • The siding material appears to be asbestos cement. There is typical minor damage in several areas. Recommend repairing where needed; if replacement is desired it is usually advisable to minimize disturbance of the material. Presence of asbestos can only be confirmed by laboratory testing.

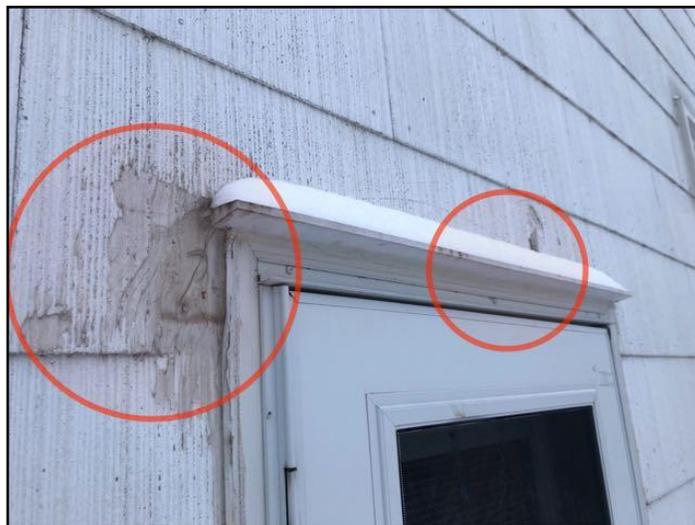
Condition: • Damage

Noted damage and patched repairs around the back (north) exterior door. Monitor repairs for adequacy.

Damage

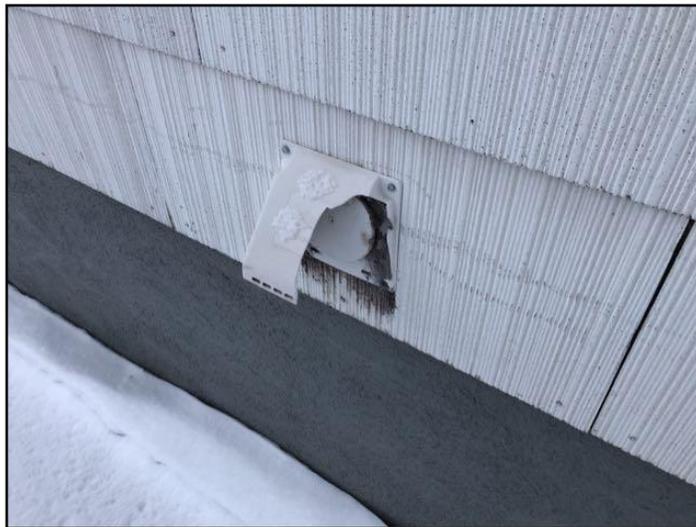
Condition: • Cover damaged

Laundry vent cover damaged. Replace.

Cover damaged

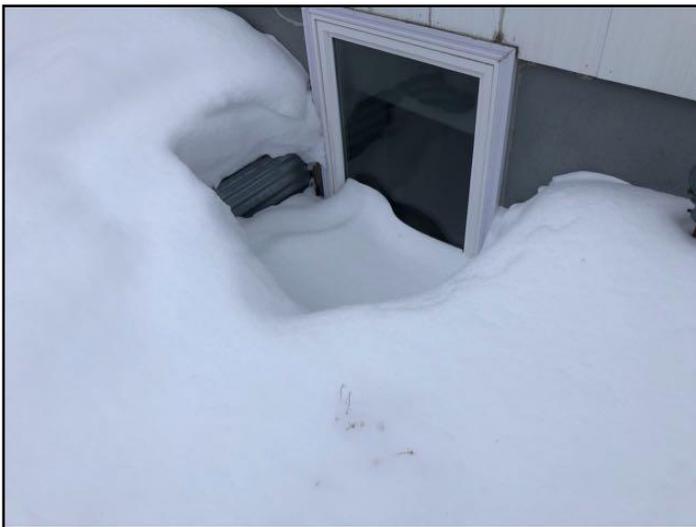
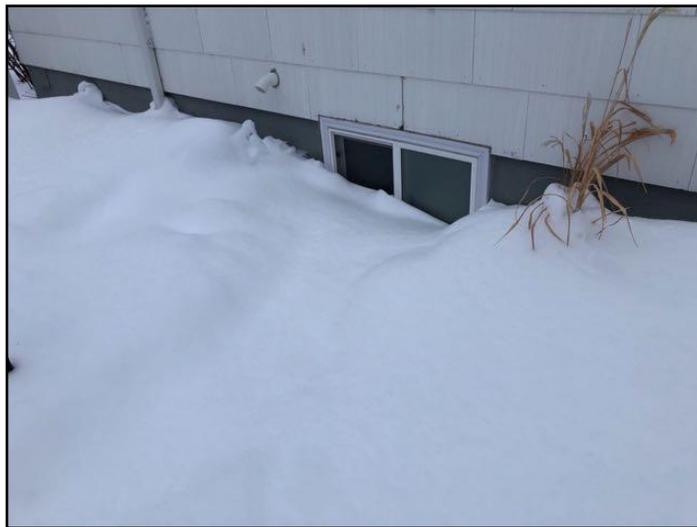
Condition: • Noted snow accumulation inside window wells. If drains are not present, water can pool and leak during melt. If no drains are present consider using covers to limit snow accumulation in the window well.

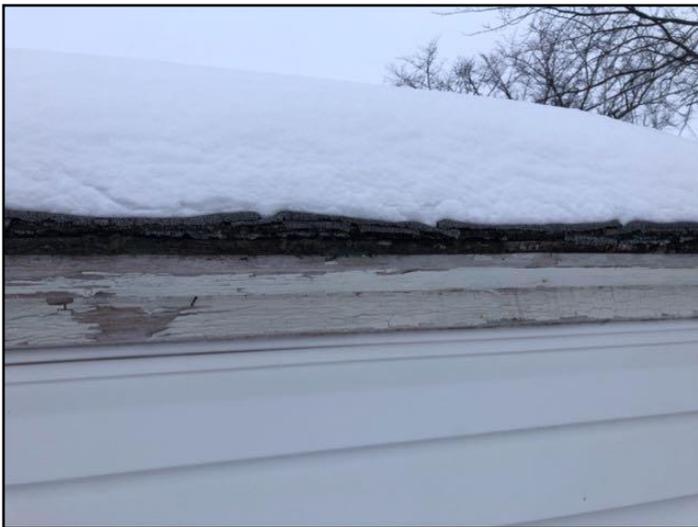
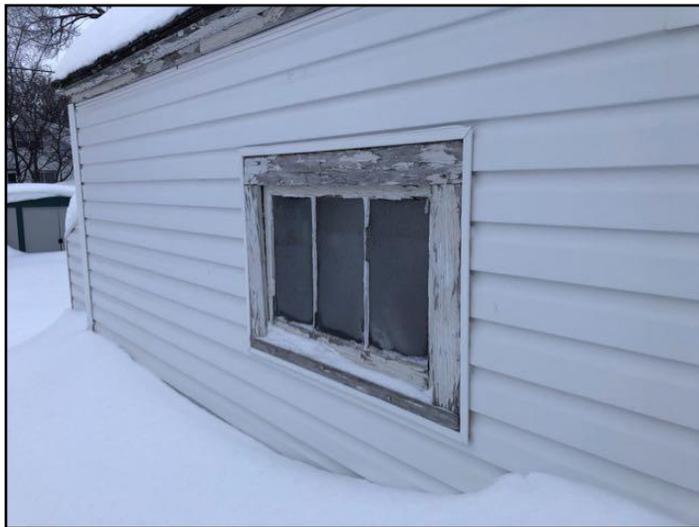
Condition: • Typical low quality structure

Typical low quality structure

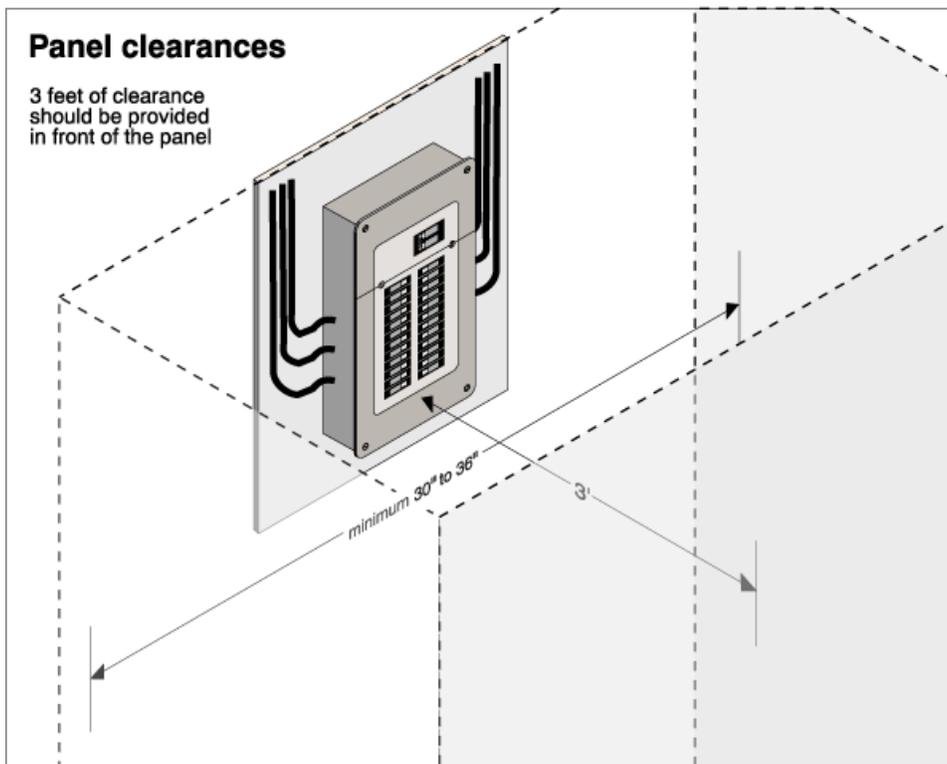
Condition: • [Poor access](#)

Poor access to service panel due to router and coax cable. Recommend re mounting network equipment away from the panel to allow clear access.

Poor access

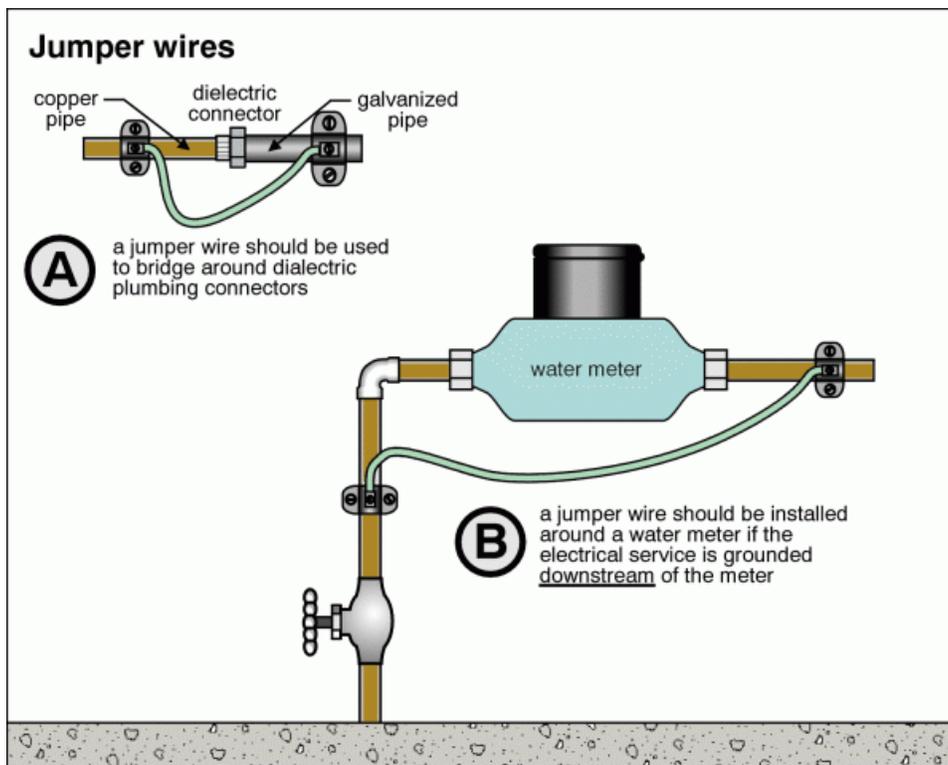
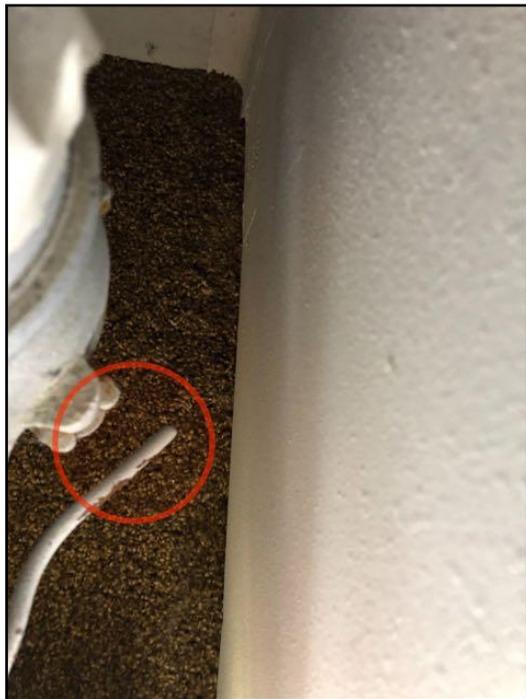
Condition: • [No jumper for meters and valves](#)

No jumper for meters and valves

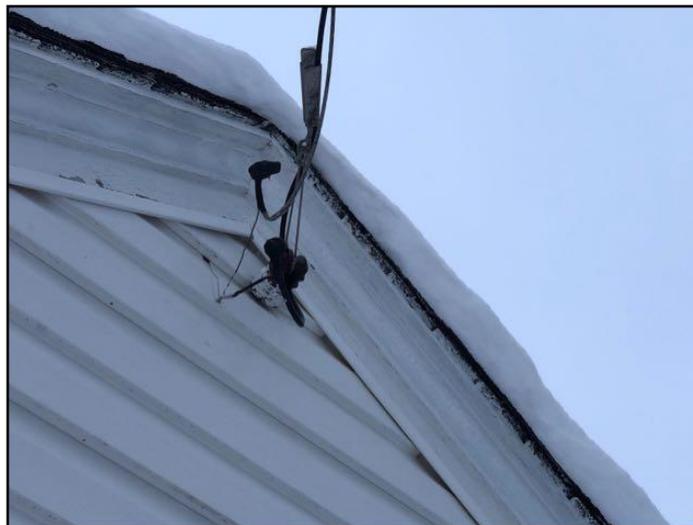
Condition: • Noted small gauge wire spliced with overhead cable from house to garage. Garage electrical components inaccessible due to storage. Recommend evaluation by electrician.

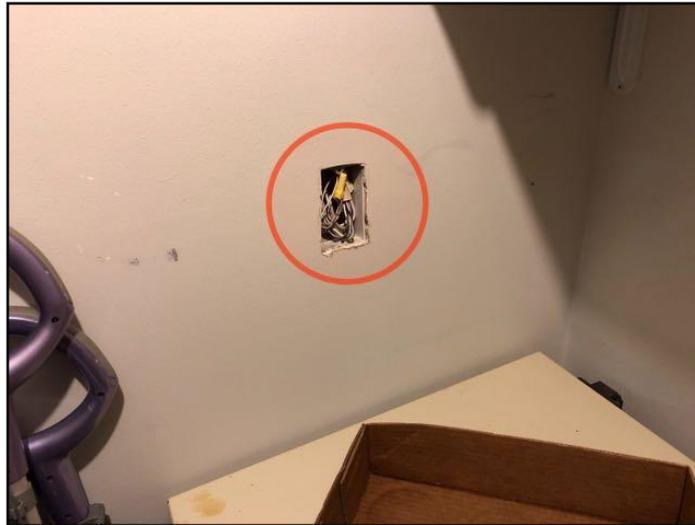
Condition: • [Cover loose or missing](#)

Uncovered junction box in basement. Add a cover.

Cover loose or missing

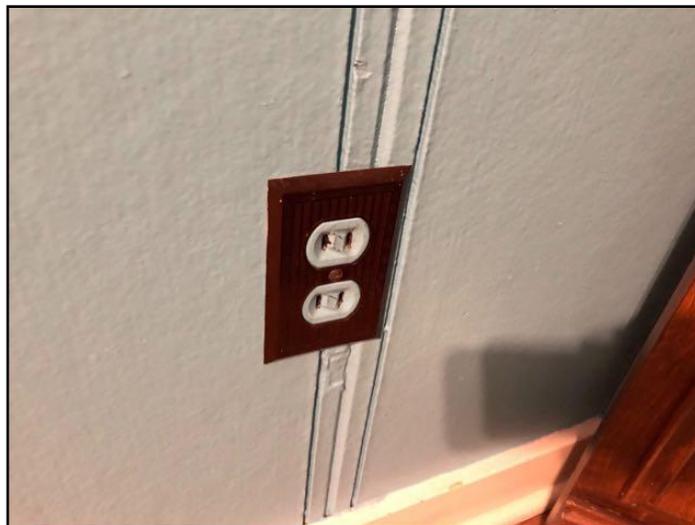
Condition: • [Some of the receptacles are older 2 prong type. This is not a defect, but does indicate lack of an equipment ground.](#) If updating the receptacles is desired, refer to the link for further reading.

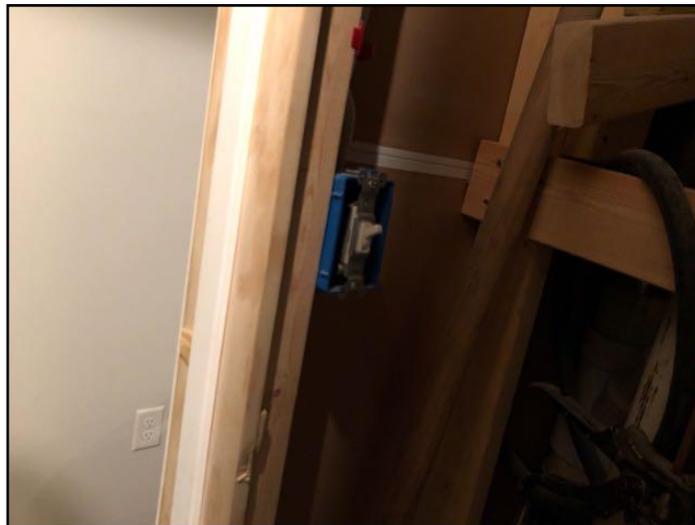
Condition: • For switch is missing

For switch is missing

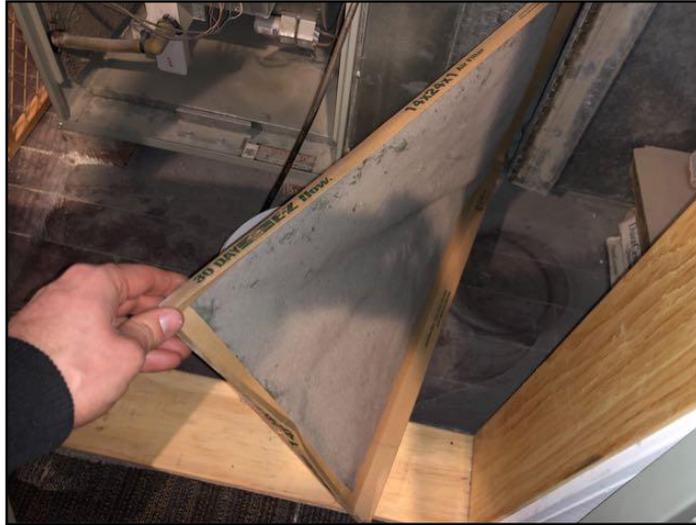
Condition: • [Dirty](#)

Filter is dirty and is a low quality "rock filter." Replace and consider using a higher quality pleated filter to improve IAQ and protect circulation equipment.

Dirty

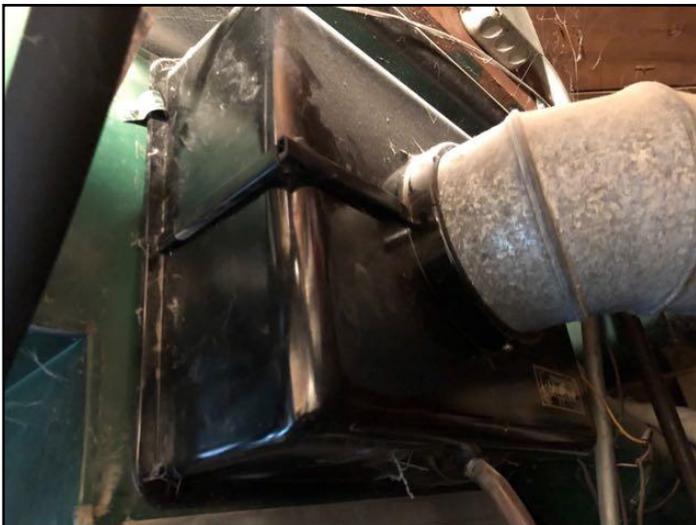
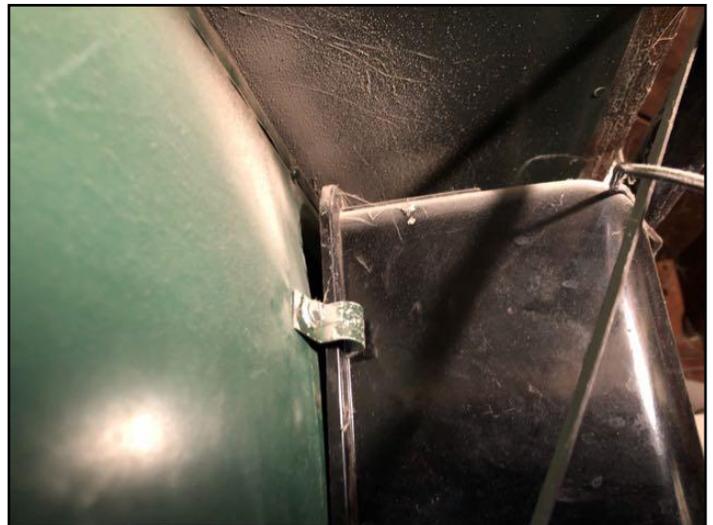
Condition: • The central humidifier is installed loosely on the duct. Recommend better securing and sealing around the duct.

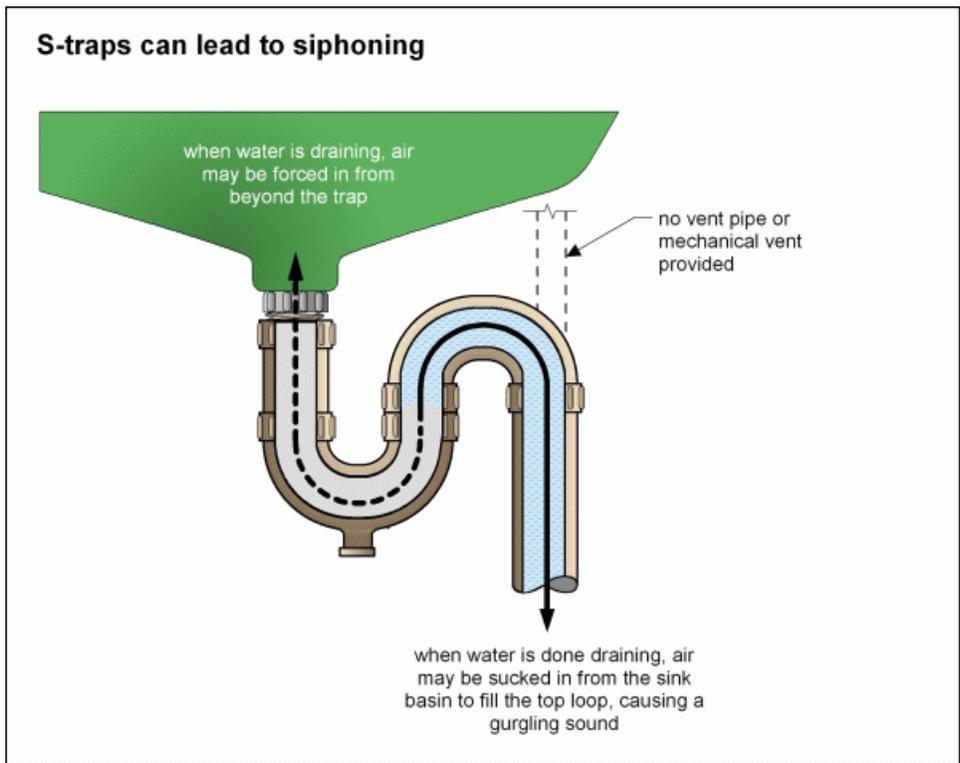
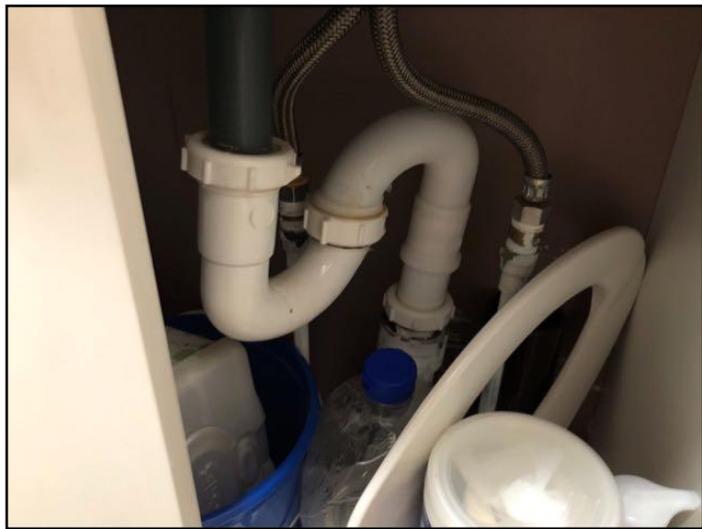
Condition: • [S trap noted on bathroom sink. This trap design can be vulnerable to siphoning. If sewer gas odors are suspected, consult a plumber to correct. See link for further reading on S traps.](#)

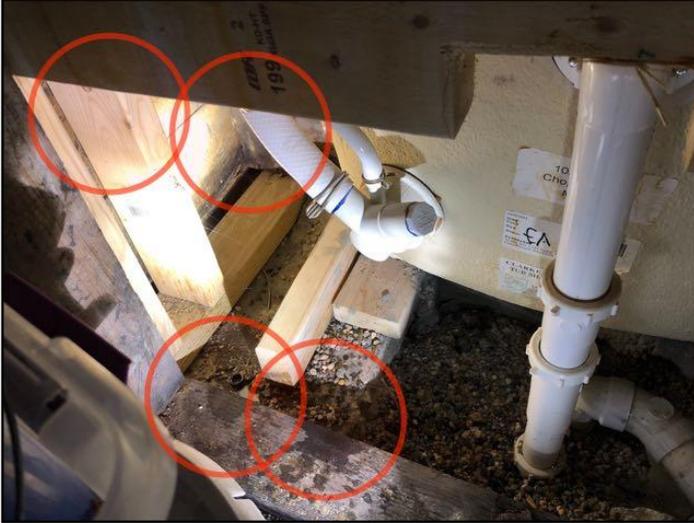
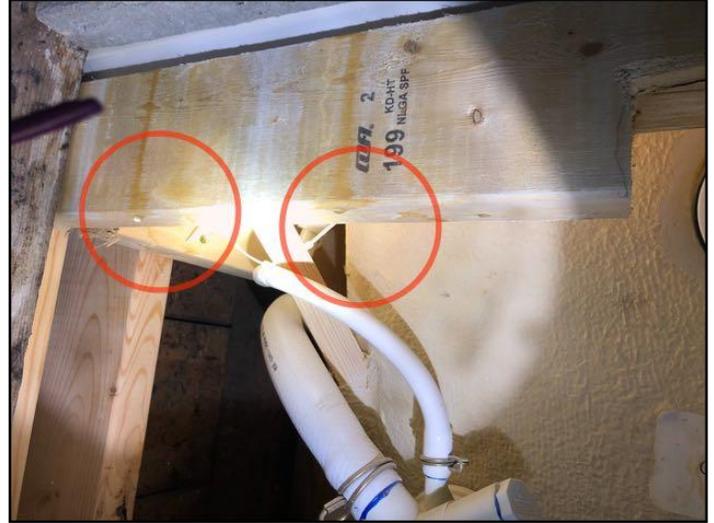
Condition: • [Leak](#)

Noted a leak in the plumbing access around the jacuzzi tub. The leak may be due to inadequate caulking on the

surround. Consult a plumber to diagnose and repair.

Leak

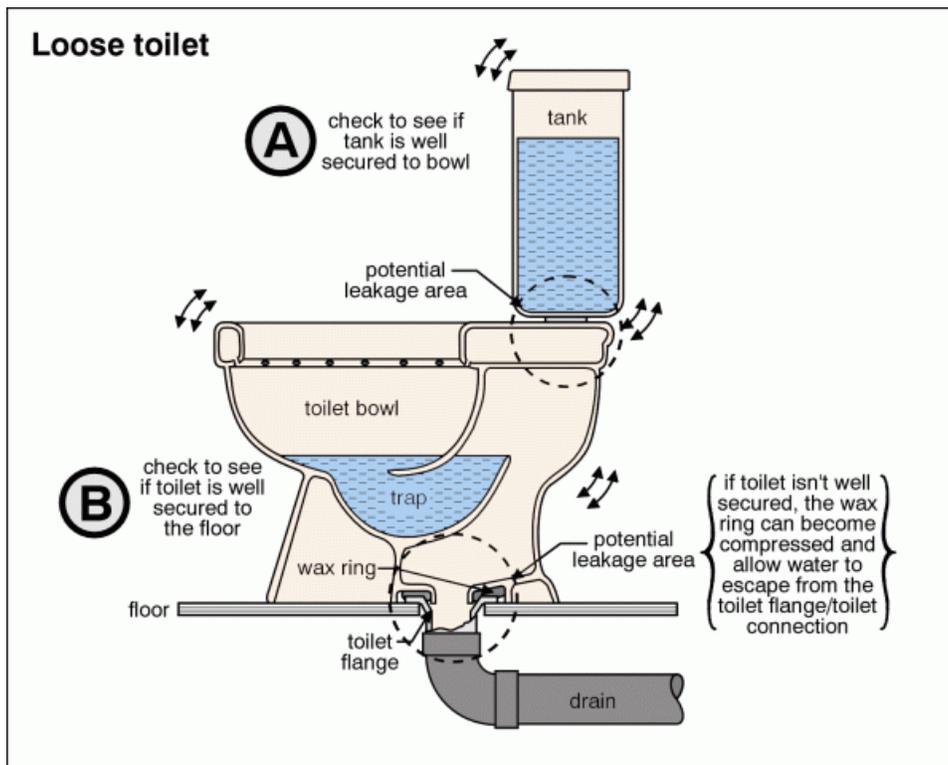
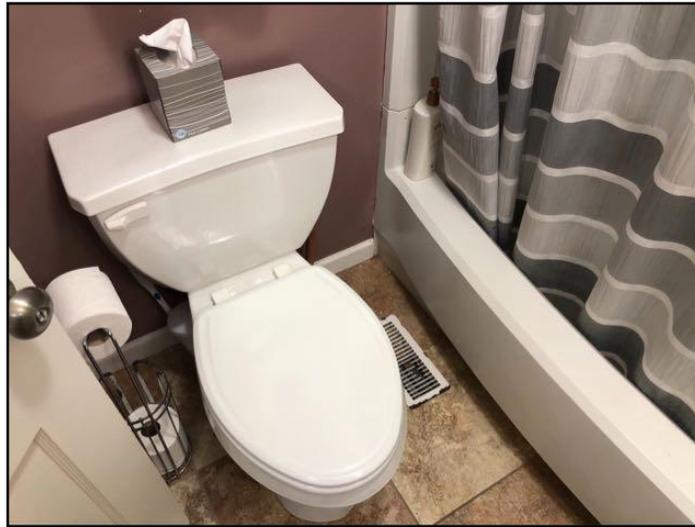
Condition: • [Loose](#)

Main floor toilet is very loose. Consult a plumber to secure and, if necessary, replace the wax ring to prevent leaks

Loose

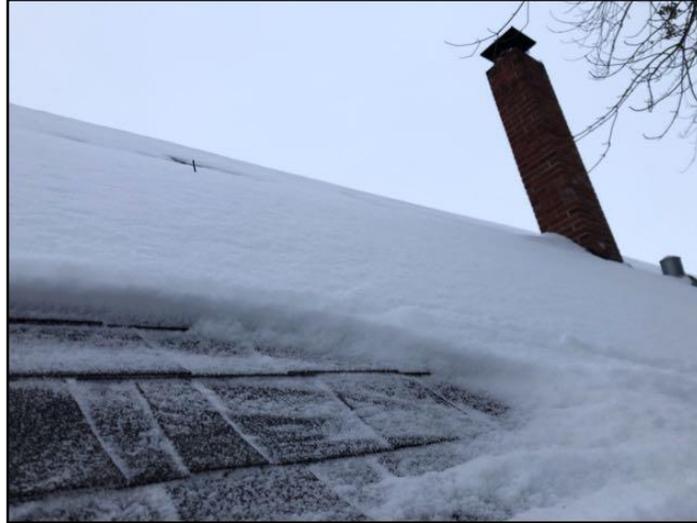
Roof is concealed by near complete snow cover. Refer to sellers disclosure.

Snow/ice/frost

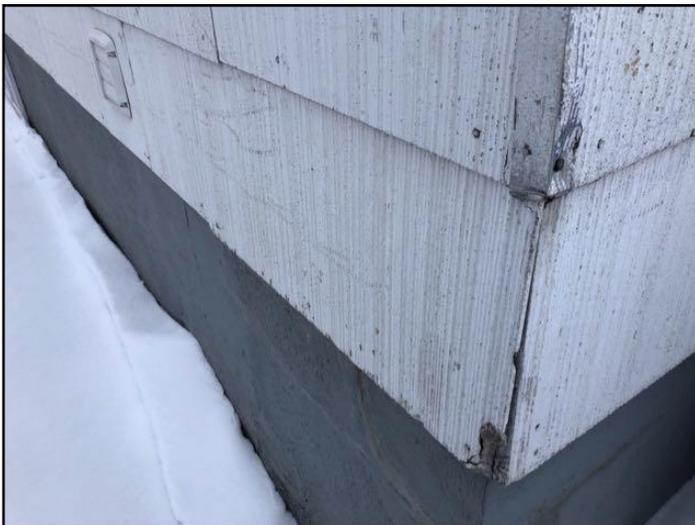
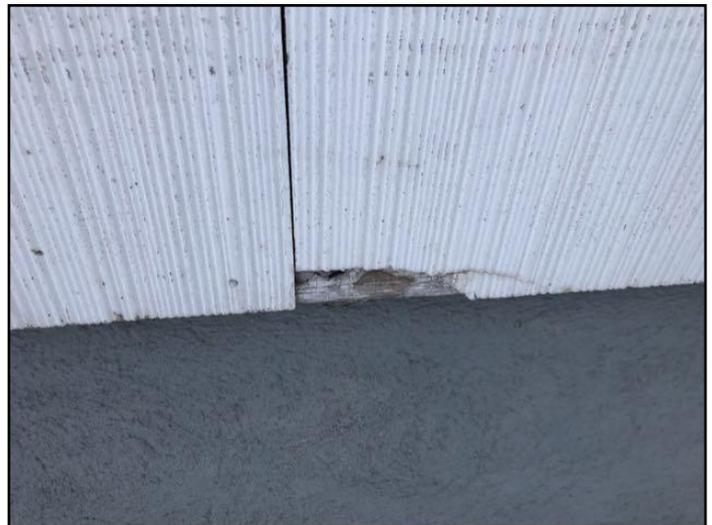
3. Condition: • The siding material appears to be asbestos cement. There is typical minor damage in several areas. Recommend repairing where needed; if replacement is desired it is usually advisable to minimize disturbance of the material. Presence of asbestos can only be confirmed by laboratory testing.

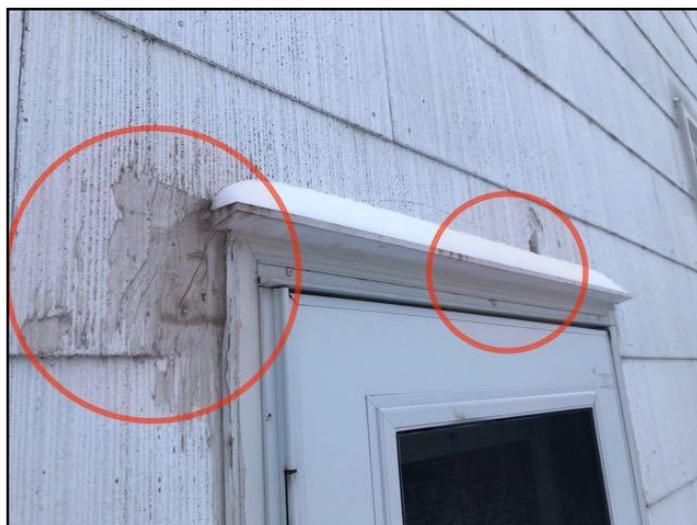
4. Condition: • Damage

Noted damage and patched repairs around the back (north) exterior door. Monitor repairs for adequacy.

Damage

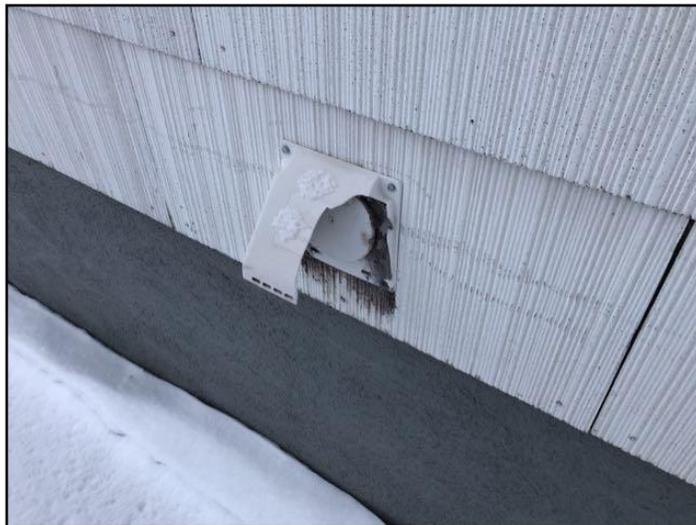
5. Condition: • Cover damaged

Laundry vent cover damaged. Replace.

Cover damaged

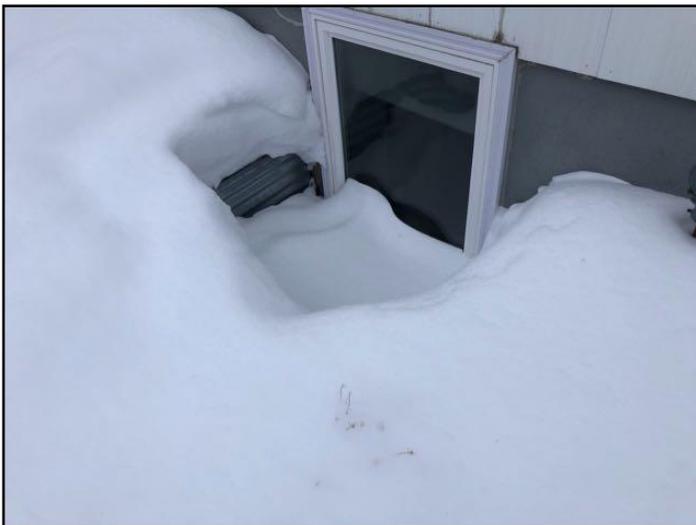
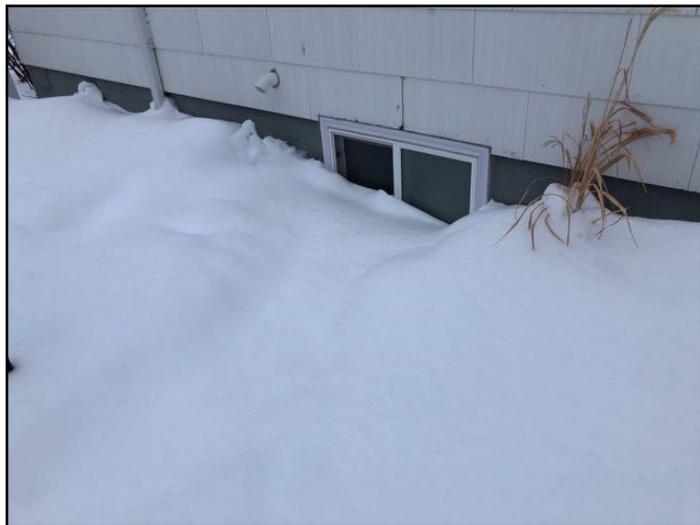
6. Condition: • Noted snow accumulation inside window wells. If drains are not present, water can pool and leak during melt. If no drains are present consider using covers to limit snow accumulation in the window well.

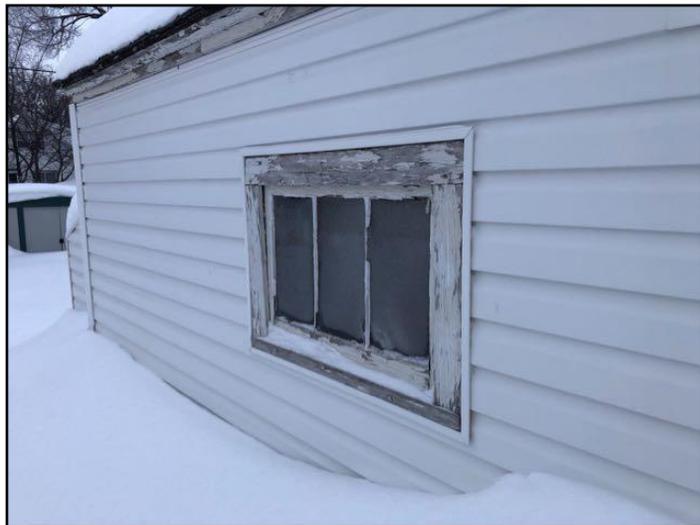
7. Condition: • Typical low quality structure

Typical low quality structure

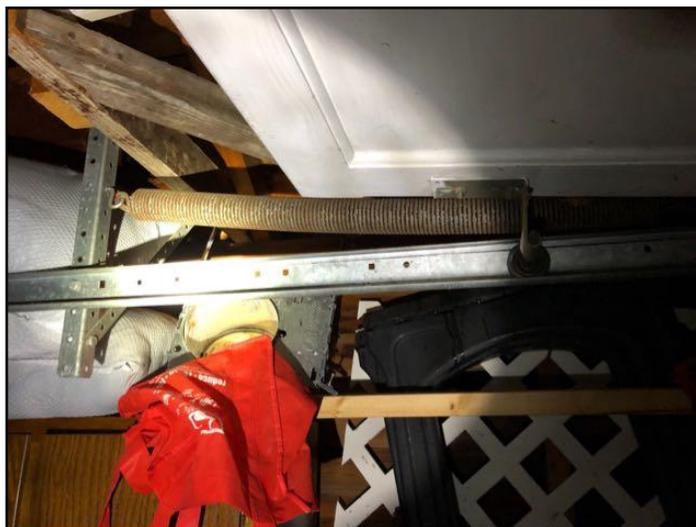
9. Condition: • [Missing safety cables](#)

Missing safety cables

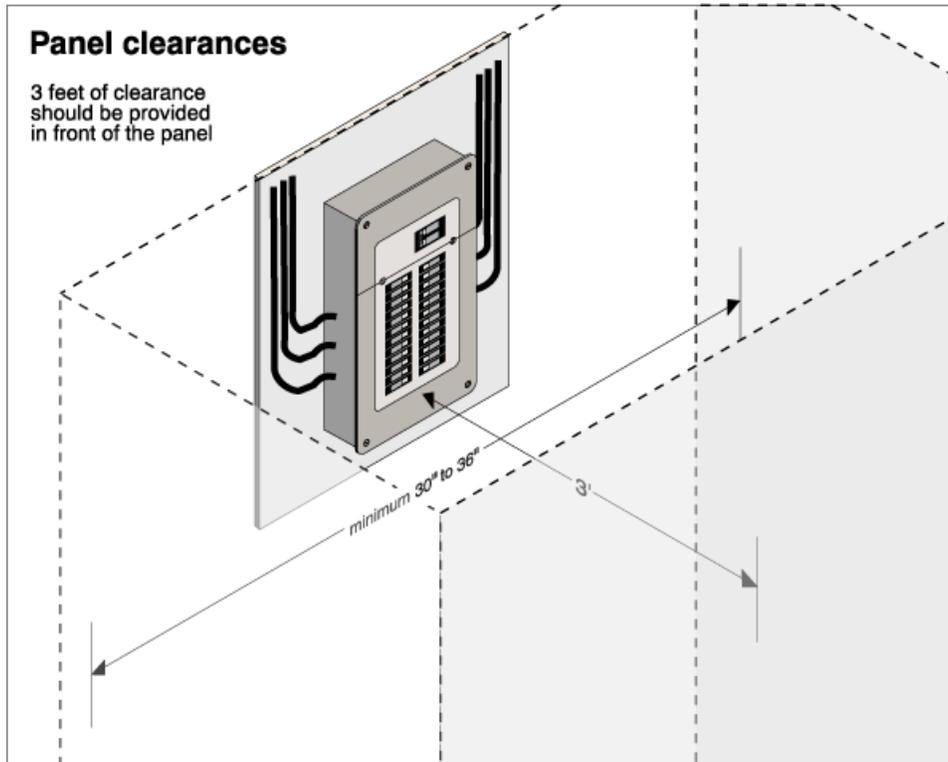
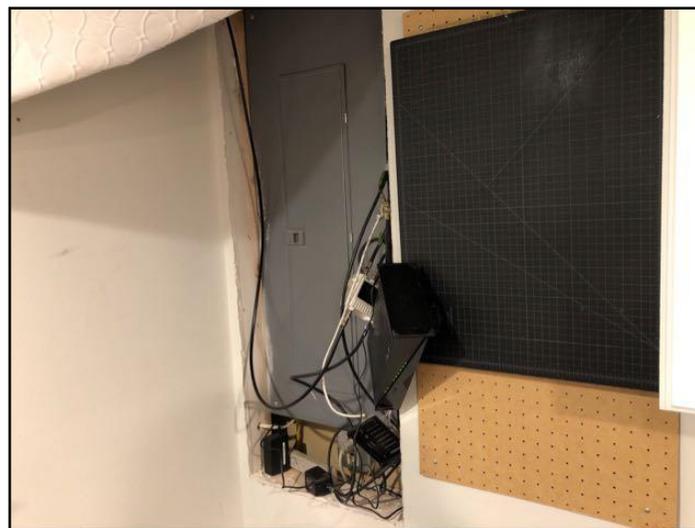
11. Condition: • [Poor access](#)

Poor access to service panel due to router and coax cable. Recommend re mounting network equipment away from the panel to allow clear access.

Poor access

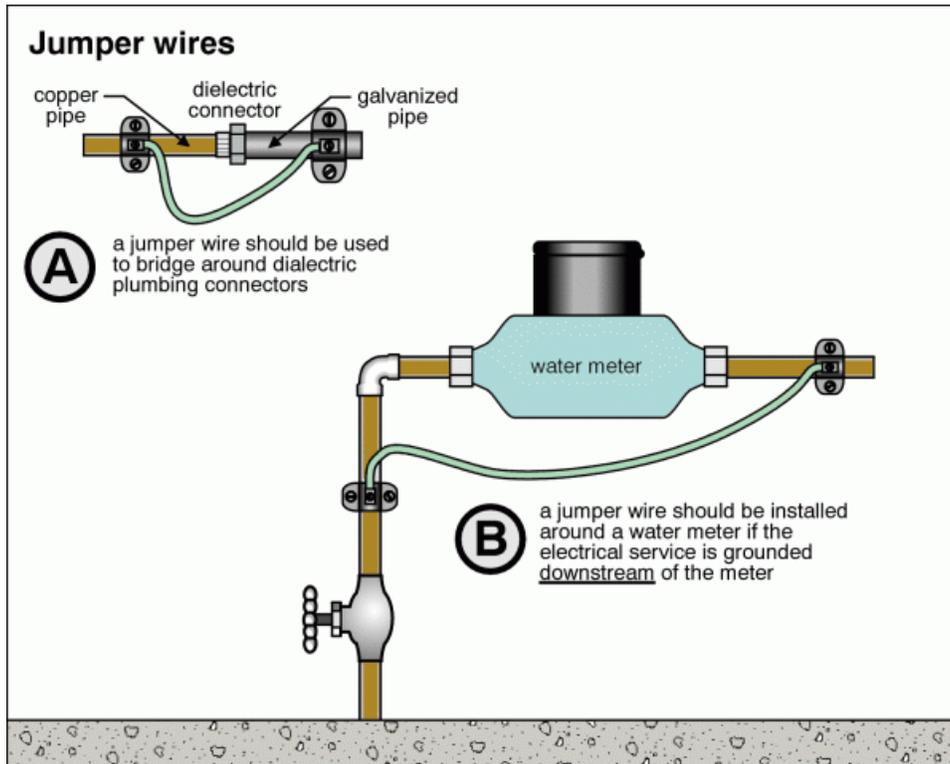
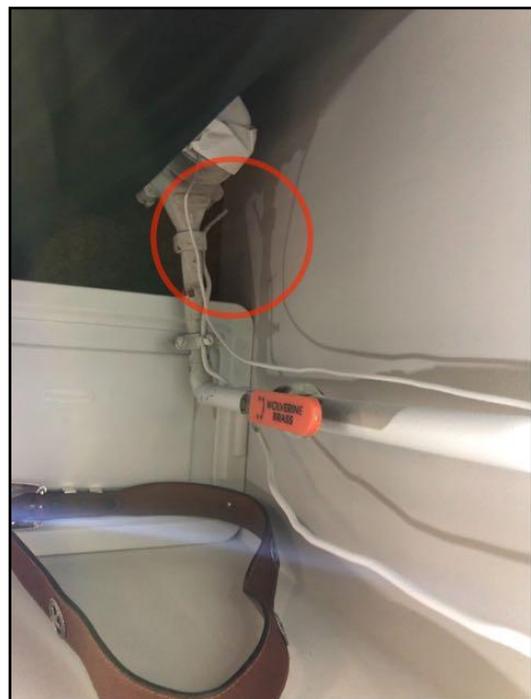
12. Condition: • [No jumper for meters and valves](#)

No jumper for meters and valves

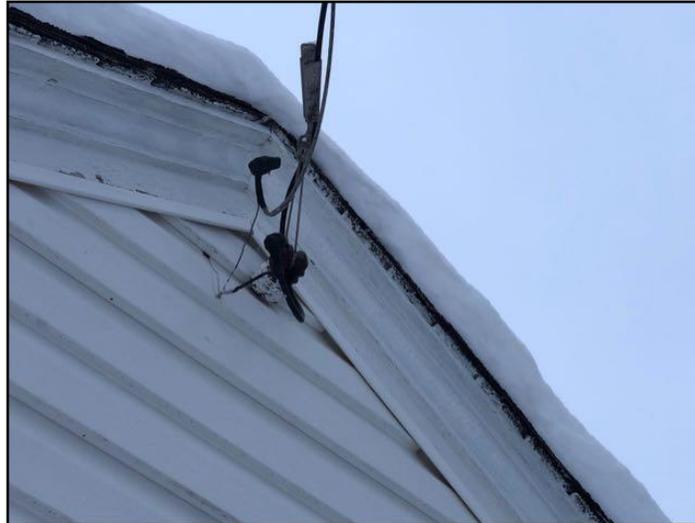
13. Condition: • Noted small gauge wire spliced with overhead cable from house to garage. Garage electrical components inaccessible due to storage. Recommend evaluation by electrician.

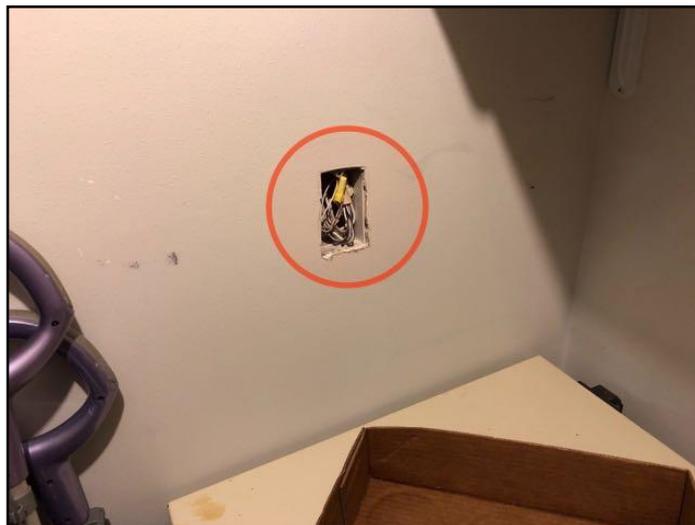
14. Condition: • [Cover loose or missing](#)

Cover loose or missing

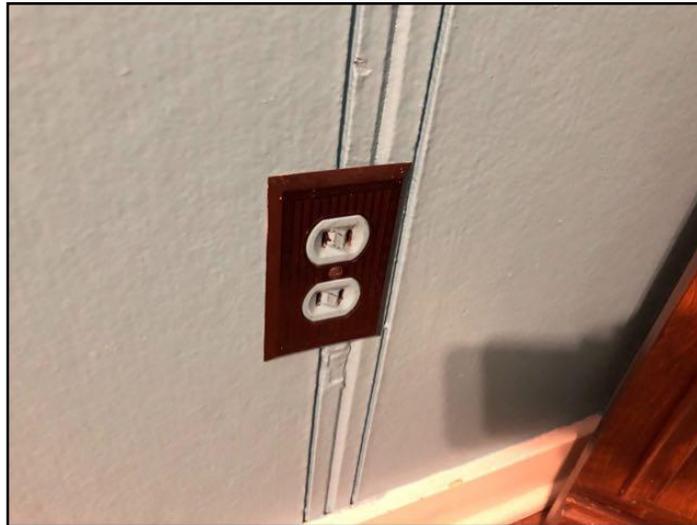
15. Condition: • [Some of the receptacles are older 2 prong type. This is not a defect, but does indicate lack of an equipment ground.](#) If updating the receptacles is desired, refer to the link for further reading.

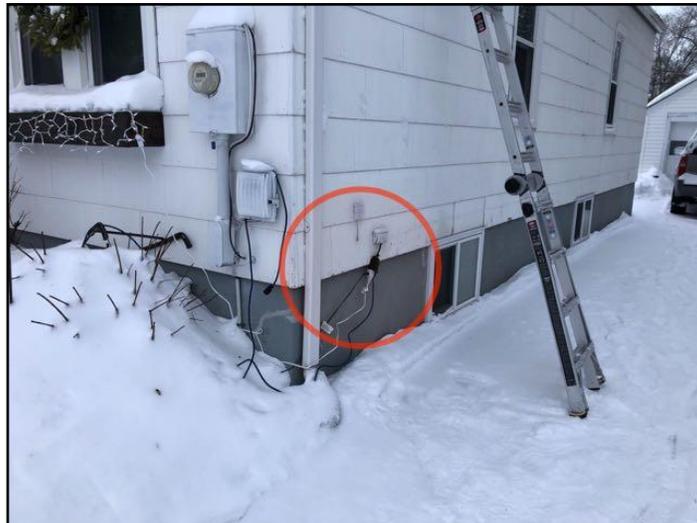
16. Condition: • [Test faulty on GFCI/GFI \(Ground Fault Circuit Interrupter\)](#)

Exterior GFCI receptacle does not trip. Consult electrician to replace faulty unit.

Test faulty on GFCI/GFI (Ground Fault...

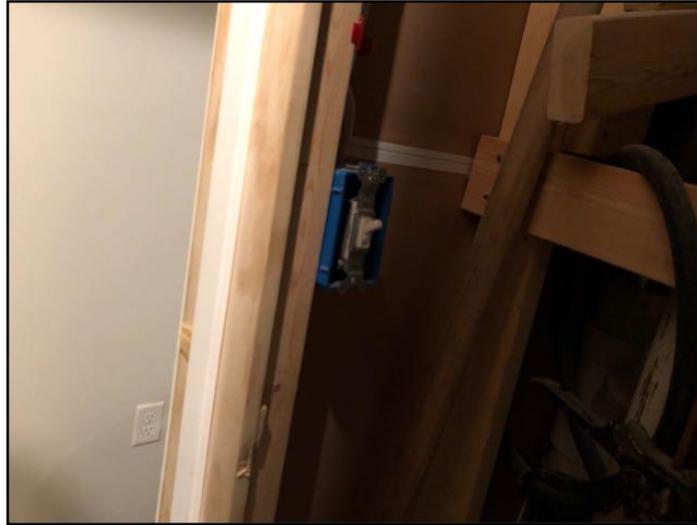
17. Condition: • For switch is missing

For switch is missing

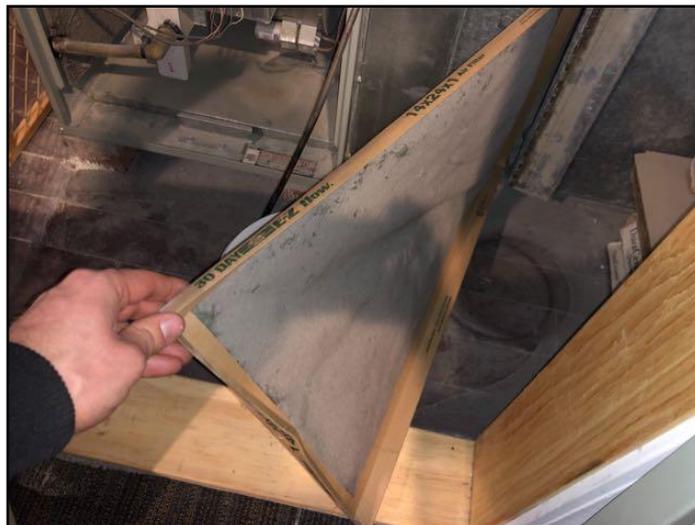
20. Condition: • [Dirty](#)

Filter is dirty and is a low quality "rock filter." Replace and consider using a higher quality pleated filter to improve IAQ and protect circulation equipment.

Dirty

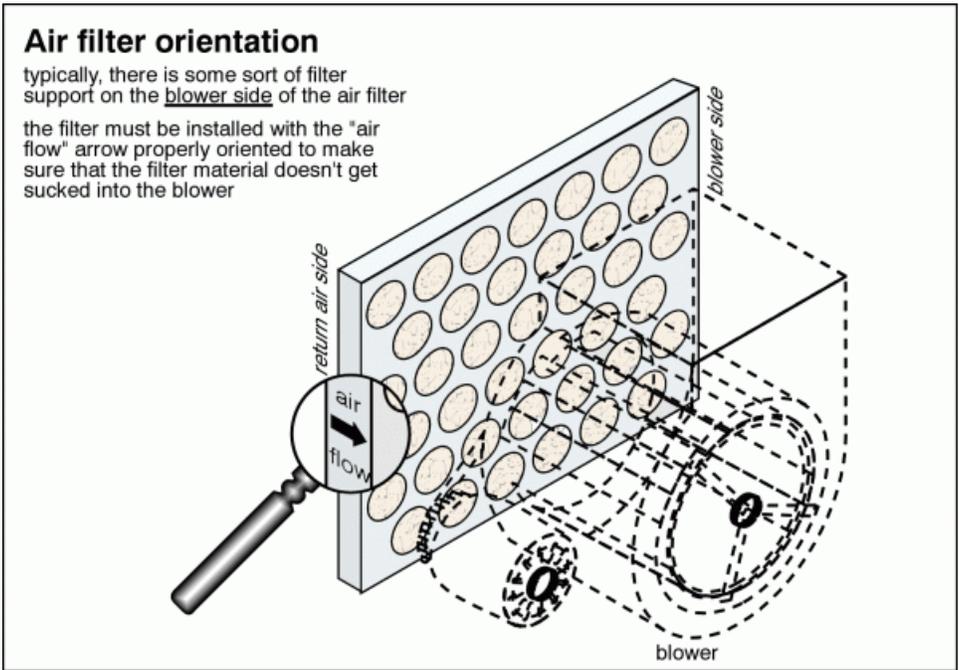
21. Condition: • [Loose or collapsed](#)

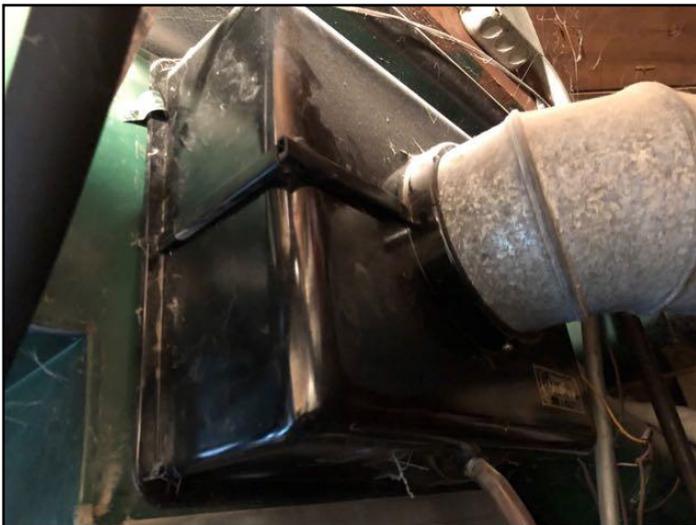
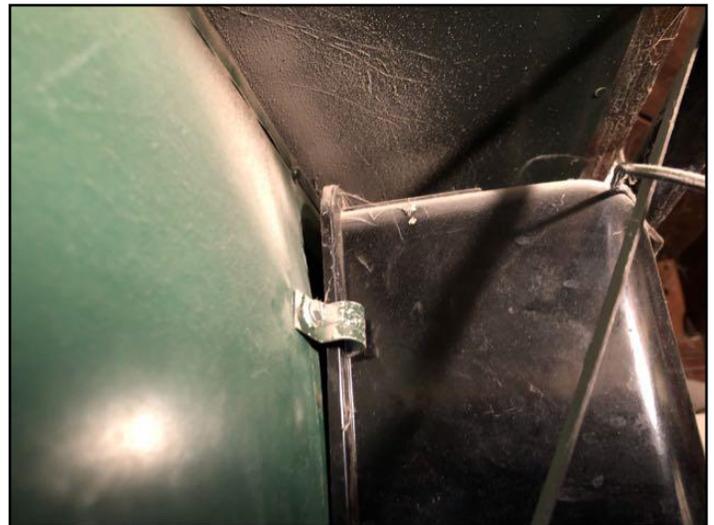
22. Condition: • The central humidifier is installed loosely on the duct. Recommend better securing and sealing around the duct.

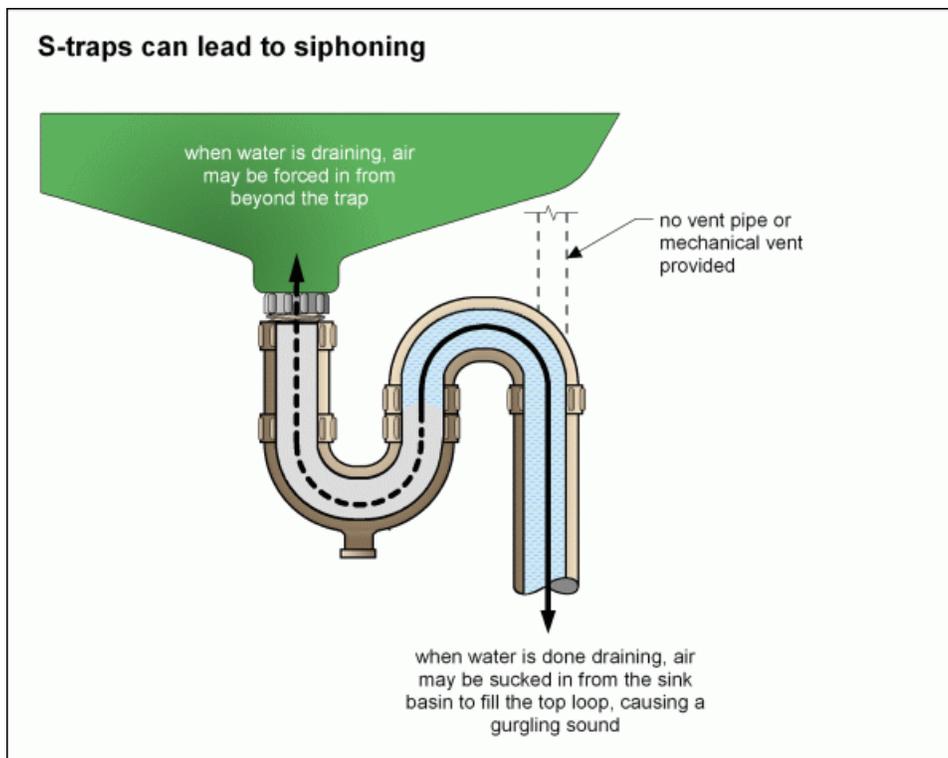
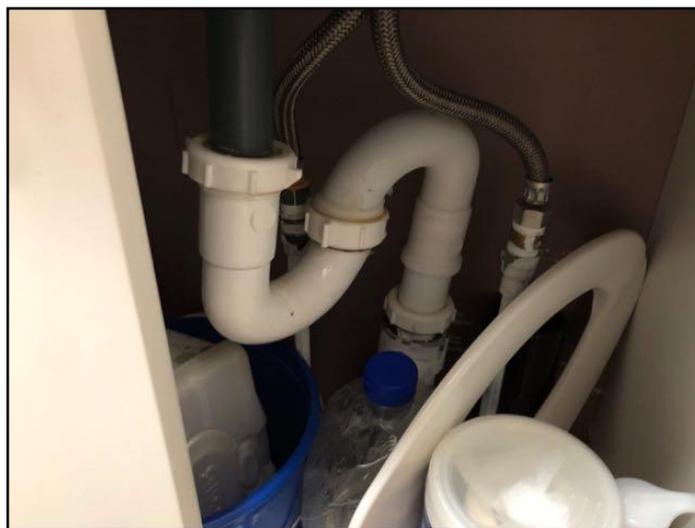
26. Condition: • [S trap noted on bathroom sink. This trap design can be vulnerable to siphoning. If sewer gas odors are suspected, consult a plumber to correct. See link for further reading on S traps.](#)

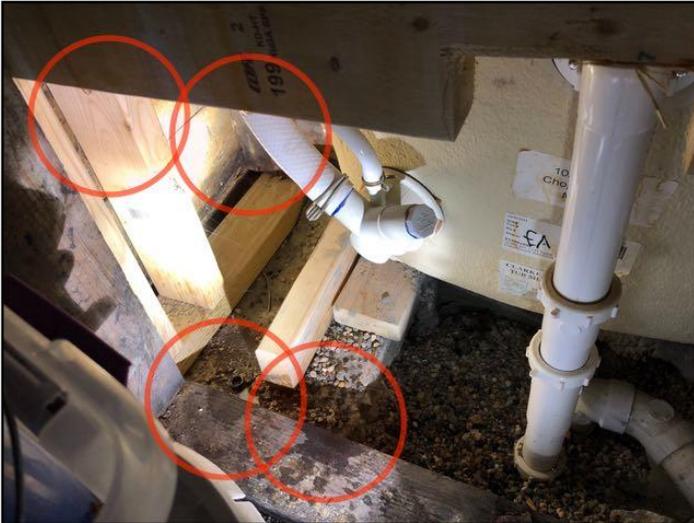
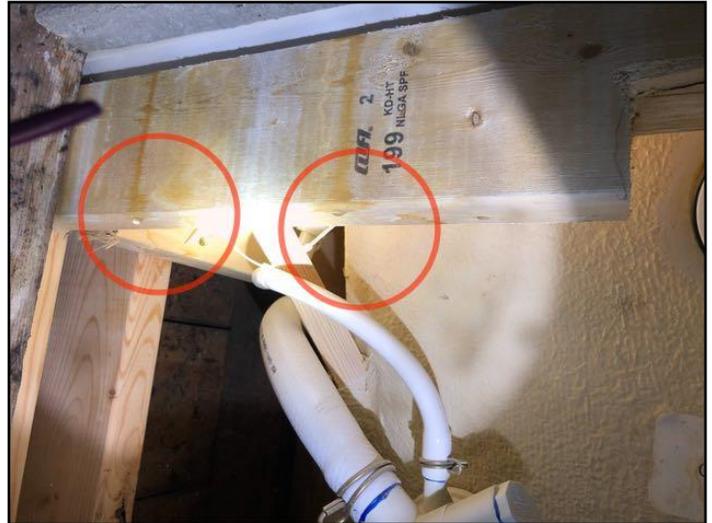
27. Condition: • [Leak](#)

Noted a leak in the plumbing access around the jacuzzi tub. The leak may be due to inadequate caulking on the surround. Consult a plumber to diagnose and repair.

Leak
