INSPECTION REPORT

For the Property at:
123 RAINY STREET
FARGO, ND 58103

Prepared for: JOHN DOE
Inspection Date: Monday, February 11, 2019
Prepared by: Cody Lewis

RE: Report No. 1193, v.2
123 Rainy Street
Fargo, ND
58103

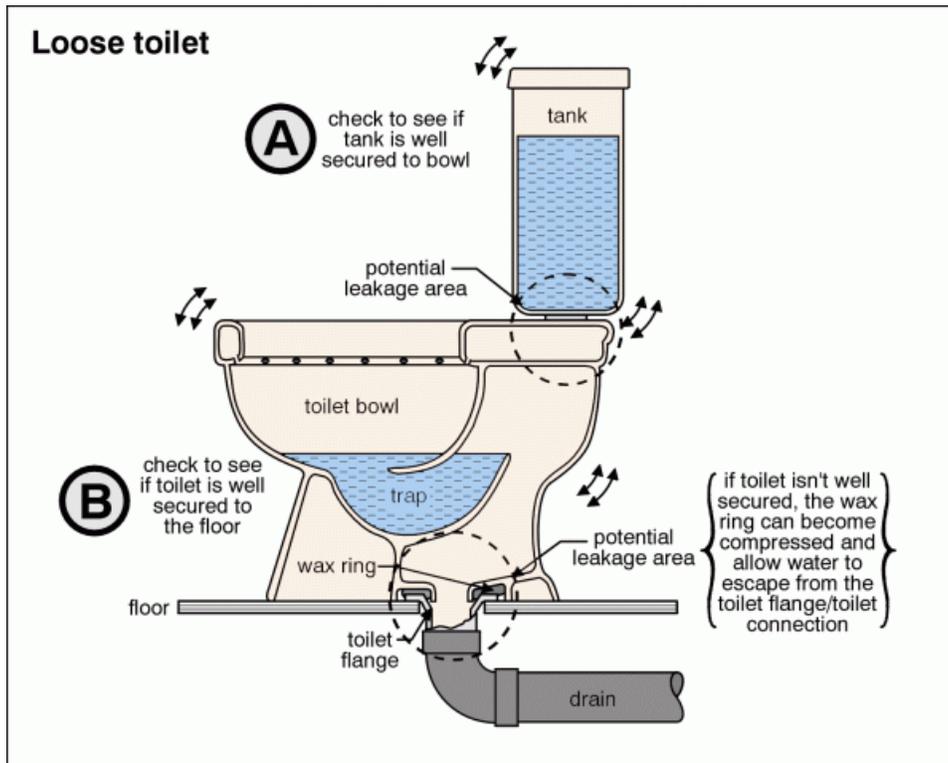
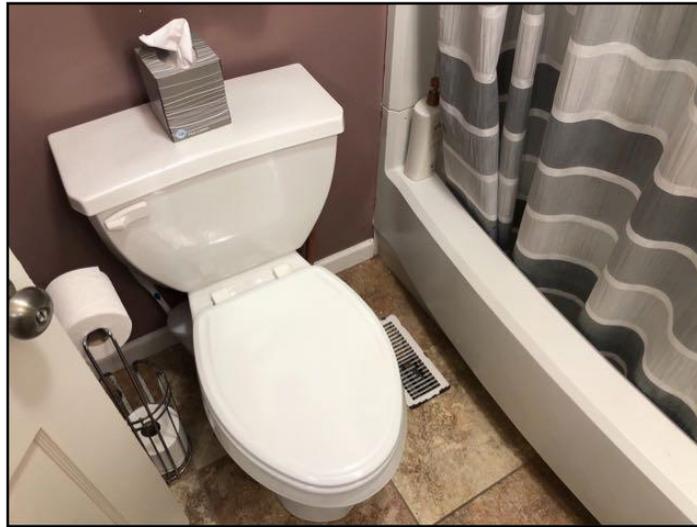
30. Condition: • [Loose](#)

Main floor toilet is very loose. Consult a plumber to secure and, if necessary, replace the wax ring to prevent leaks

Loose

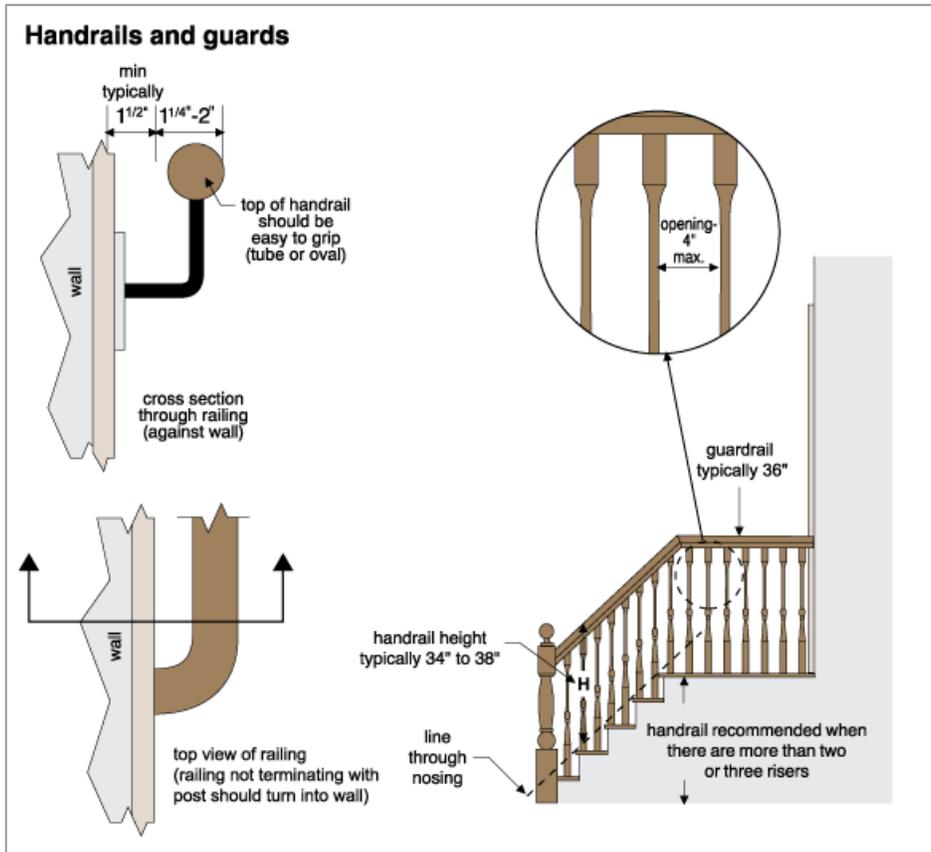
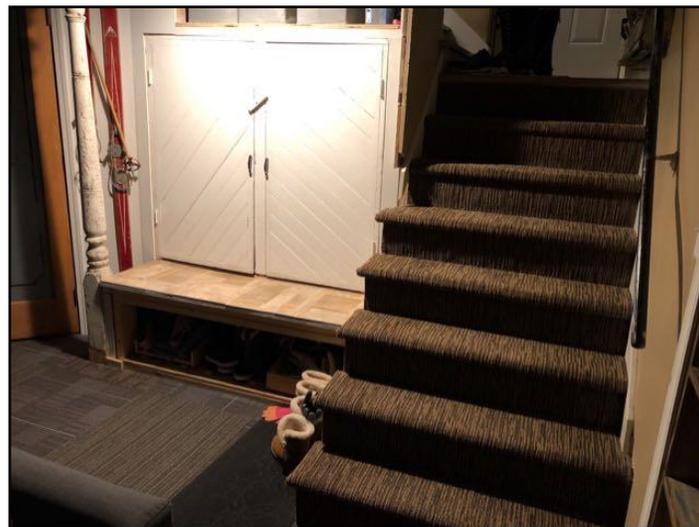
32. Condition: • [Missing](#)

Missing
