Your Inspection Report

781 Craven Rd Toronto, ON

INSPECTION DATE: Tuesday, September 13, 2016

RE: Report No. 55209 781 Craven Rd Toronto, ON

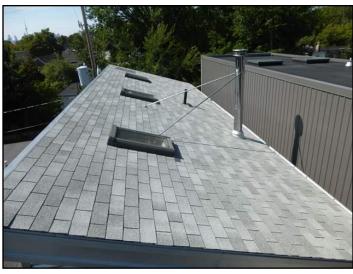
Asphalt shingles

Approximate age: • The roof covering appears to be within the first half of its normal life expectancy.

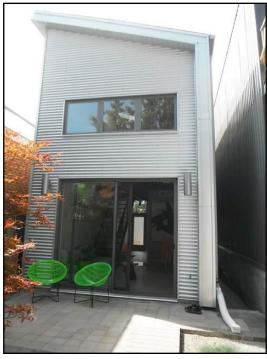
View from rear

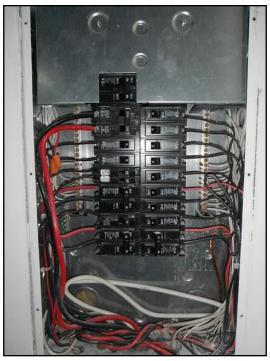
Breakers - First Floor

Condition: • Breaker for the boiler is the same size as the main disconnect (100 amps).

Condition: • Wrong size to protect wire

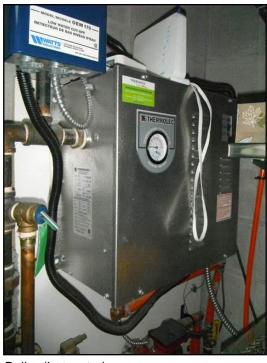
Boiler (hot water)
