# INSPECTION REPORT

For the Property at:  
**123 EXAMPLE WAY**  
CENTRAL POINT, OR 97502

Prepared for: JOHN DOE  
Inspection Date: Friday, March 9, 2018  
Prepared by: Zach Macormic

RE: Report No. 1028, v.5  
123 Example Way  
Central Point, OR  
97502

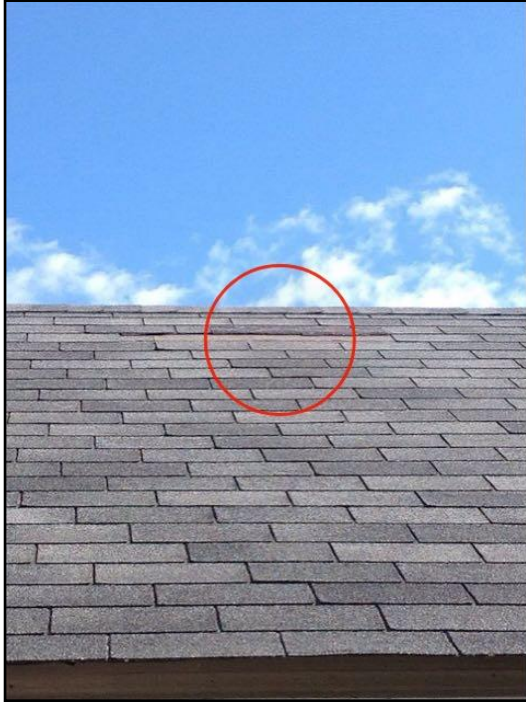
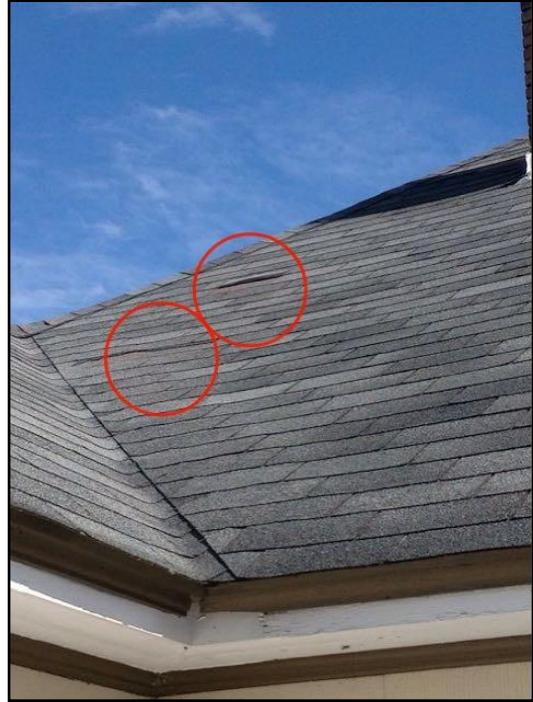
I noted about 7 missing shingles on the roof. It was raining at the time of inspection and I did not note any active leaking in the home's attic space. In my opinion, I believe the roof has about 5 years of useful life left if repairs are made. I recommend a professional roofer replace the missing shingles and give a more exact useful life estimation.

30. Missing Shingles

31. Missing Shingles

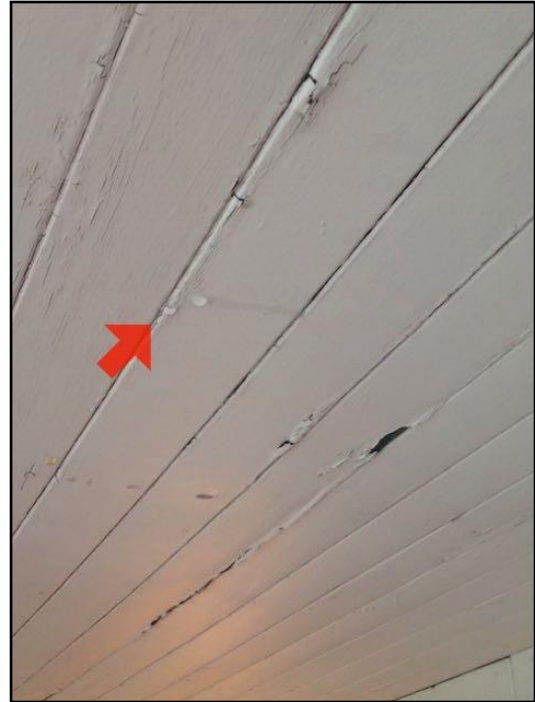
I noted a small leak over the porch. I believe the leak was caused by the lack of proper flashing on the flat roofing above. I used my laser level and found that the ceiling was sagging four inches in the middle. The flat roofing appeared to be recently recoated to possibly fix this condition. I believe the moisture had aided the ceiling sagging, but the patio (not the home) framing appears to be structurally questionable. I recommend consulting with a qualified roofer for repairing the leak and consulting with a qualified framing contractor for repairing the sagging porch.

35. Leak over porch

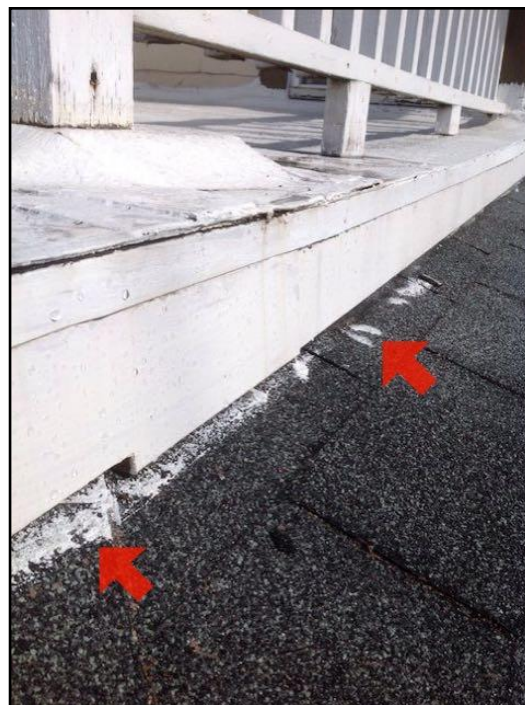
36. Recent Coating

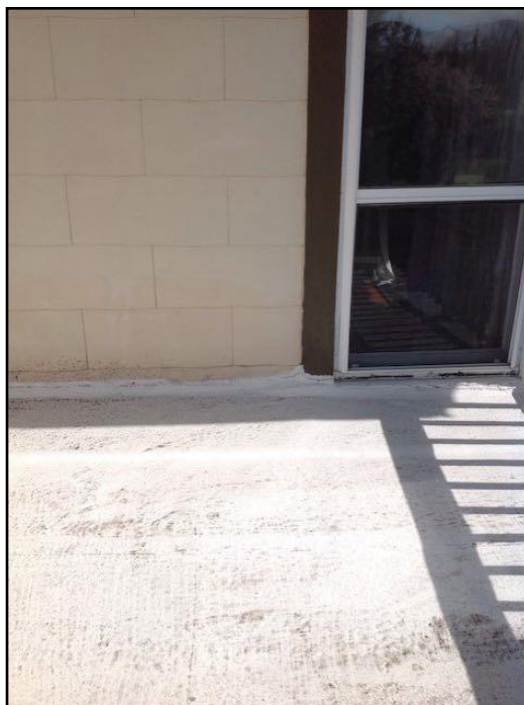
**5. Condition:** • The flat roofing about the porch has questionable flashing to prevent water from entering between the home and roof framing.

39. Questionable Flashing

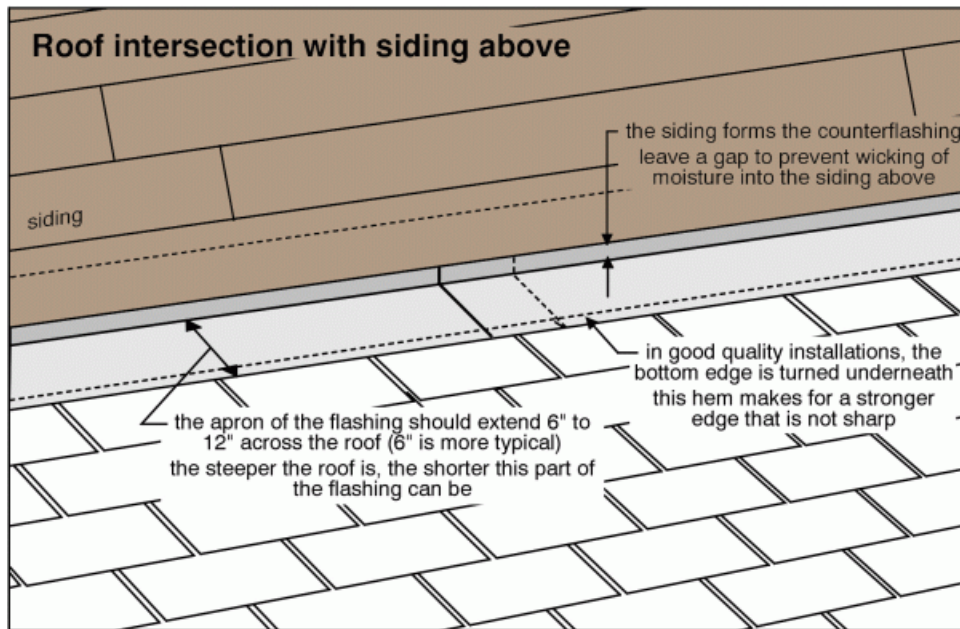
All roof to wall connections have a piece of wood as the flashing. Water will be allowed to sit under this trim and decompose the wood. I was unable to determine if any flashing exists behind this trim. I recommend a qualified roofer

40. Improper Flashing

evaluate this condition to recommend a possible fix.

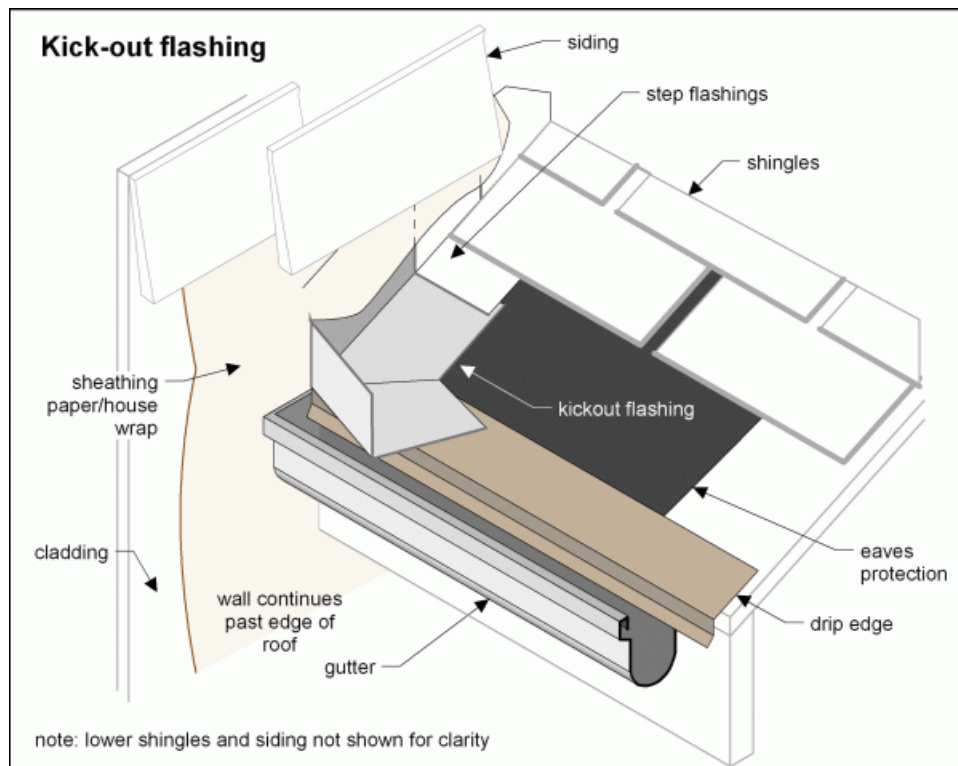
Kickout flashing does not exist at the roof to wall connections. Here water is allowed to run down along the side of the home. I recommend kickout flashing be installed to prevent moisture damage to the home.

**41. No kickout flashing**

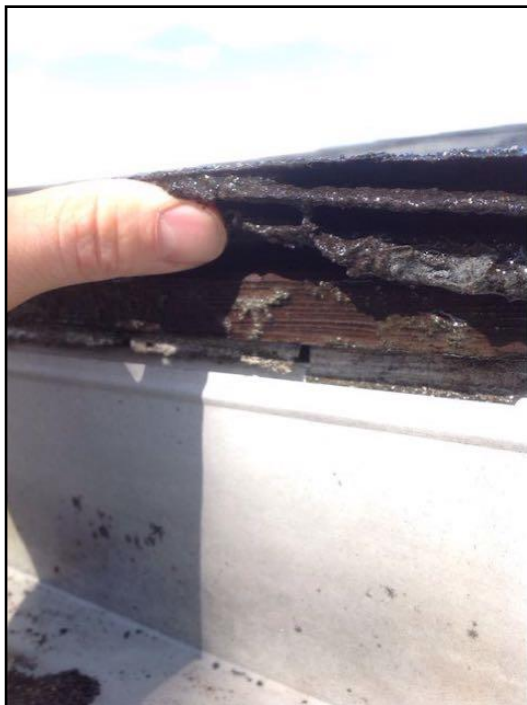
I did not note any drip edge installed on the home. The wood sub-sheeting was wet and will eventually allow the moisture to decompose the edge. I recommend drip edge be installed to help prevent moisture damage to the home.

42. Missing Dripedge

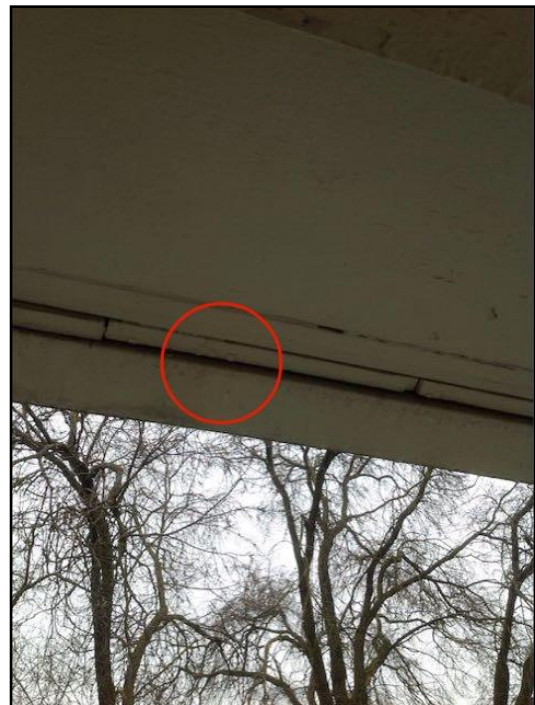
43. Leak behind gutter

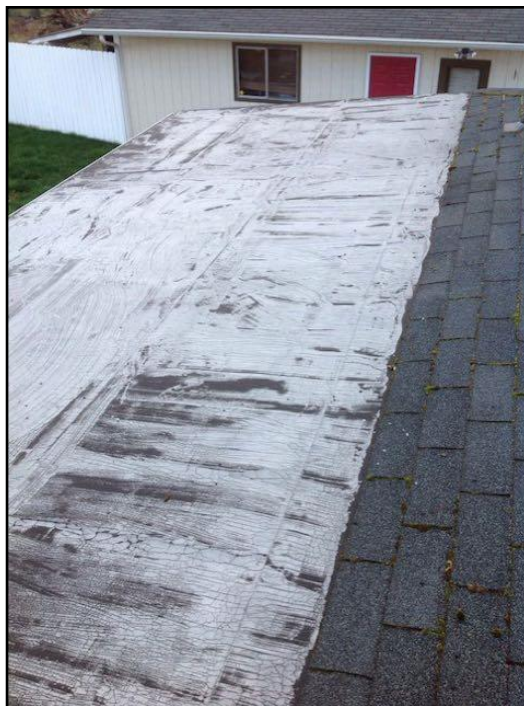
I believe this roof was installed at the same time as the front porch roof, but the front porch has had a recent new protective coating.

44. Aging Flat Roof

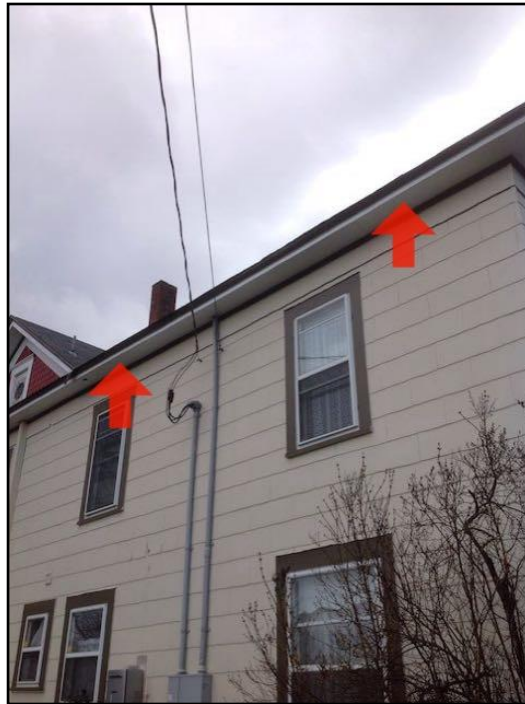
No Gutters were found on the home. I highly recommend gutters and downspouts be installed to divert water away from the home. Water allowed to pool at the outside foundation will allow moisture under the home and can cause structural movement and moisture damage.

47. Missing Gutters

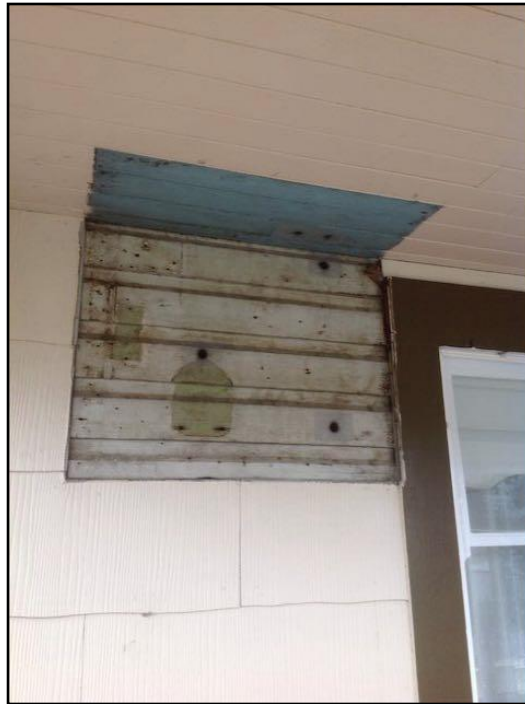
Missing siding under the porch. As this condition is under the roof, it is mostly a cosmetic condition.

50. Siding - incomplete / missing

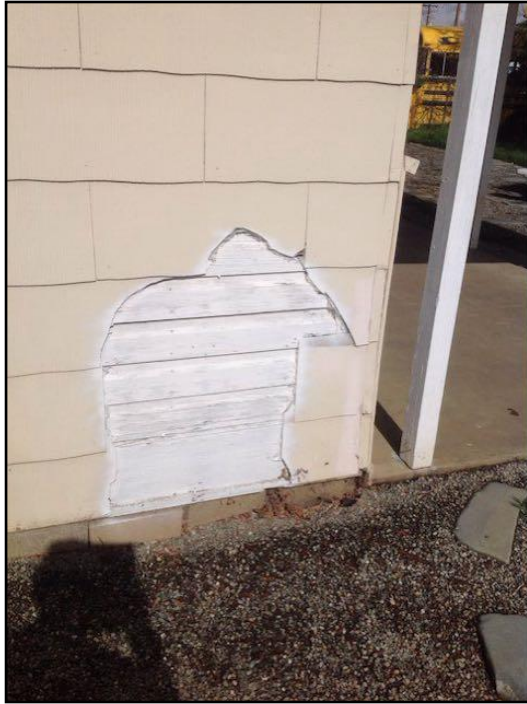
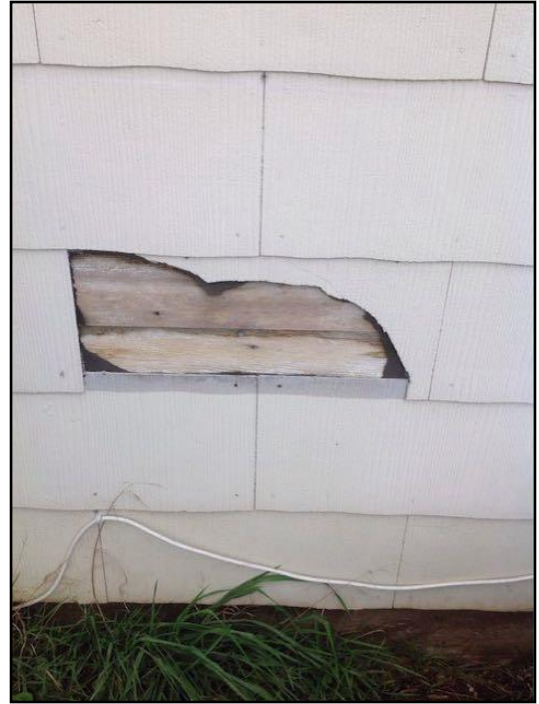
I noted several areas of the home with missing pieces of siding. This condition may allow water to enter the wall space and cause moisture damage. I recommend a qualified person install new siding to prevent this condition. This condition may be noted as a condition of lending by an appraiser. I believe this siding to be Transite asbestos cement siding. I recommend taking adequate precautions when repairing replacing it.

51. Siding - incomplete / missing

52. Siding - incomplete / missing

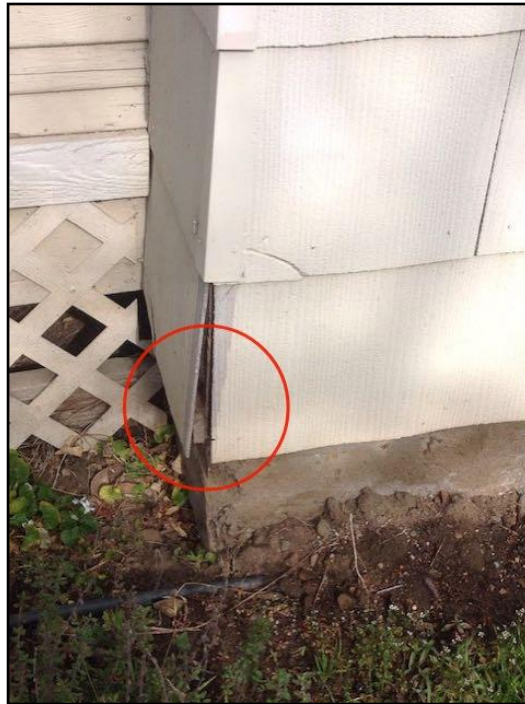
Missing corner flashing. I recommend corner flashing be installed to prevent moisture damage to the home.

55. Flashings missing

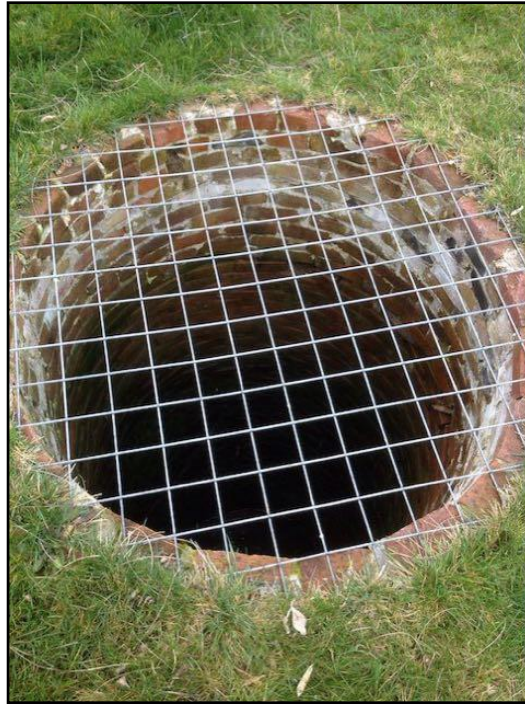
19. Condition: • I noted a large hand dug well in the backyard. The grate over it seemed inadequate at preventing a fall if

a person or large animal were to walk over it. I highly recommend some kind of strong fall protection be installed over the well. This condition has a chance of being called out by an appraiser as a condition of lending.

58. Fall Hazard

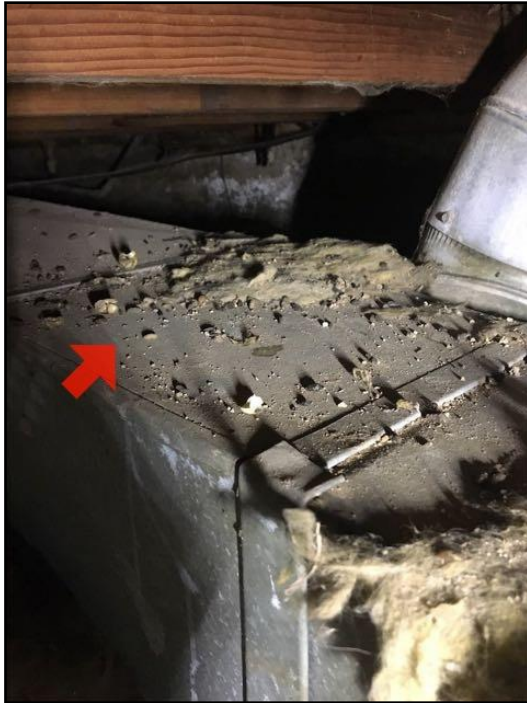
**20.** • I noted a fair amount of animal activity in the crawlspace. I found lots of mice droppings and what appear to be small animal droppings. I highly recommend inclosing all vents with a fine mesh screen to prevent rodents from entering the home and causing damage.

62. Pest Evidence

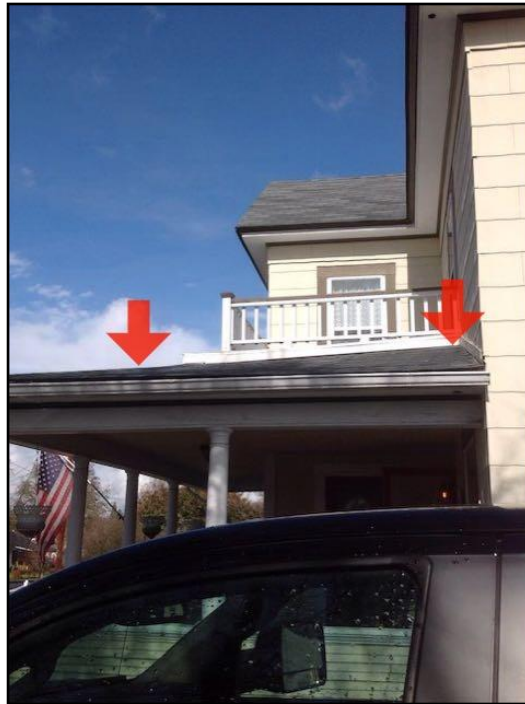
68. Sag and twist

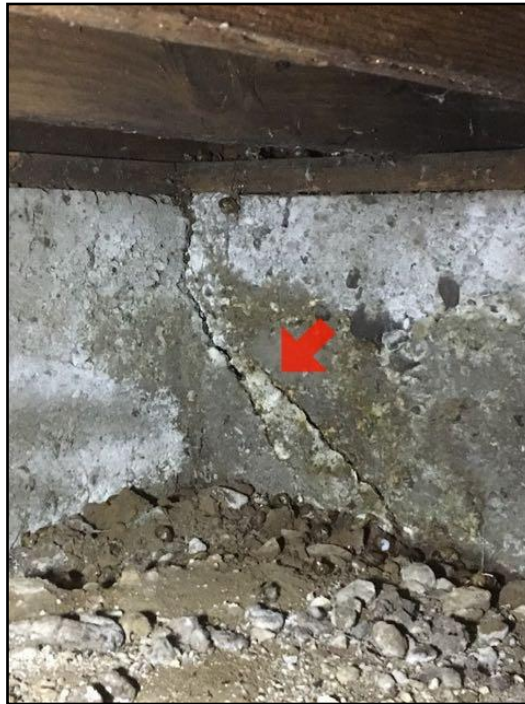
I noted a crack in the foundation at the west corner of the home. Cracks of this size aren't uncommon for homes of this age and I don't believe the foundation has been structurally compromised. I recommend applying sealant inside the cracks to prevent water from entering and keeping an eye on it to see if the condition worsens. I recommend consulting a foundation professional for a possible remedy.

69. Cracked

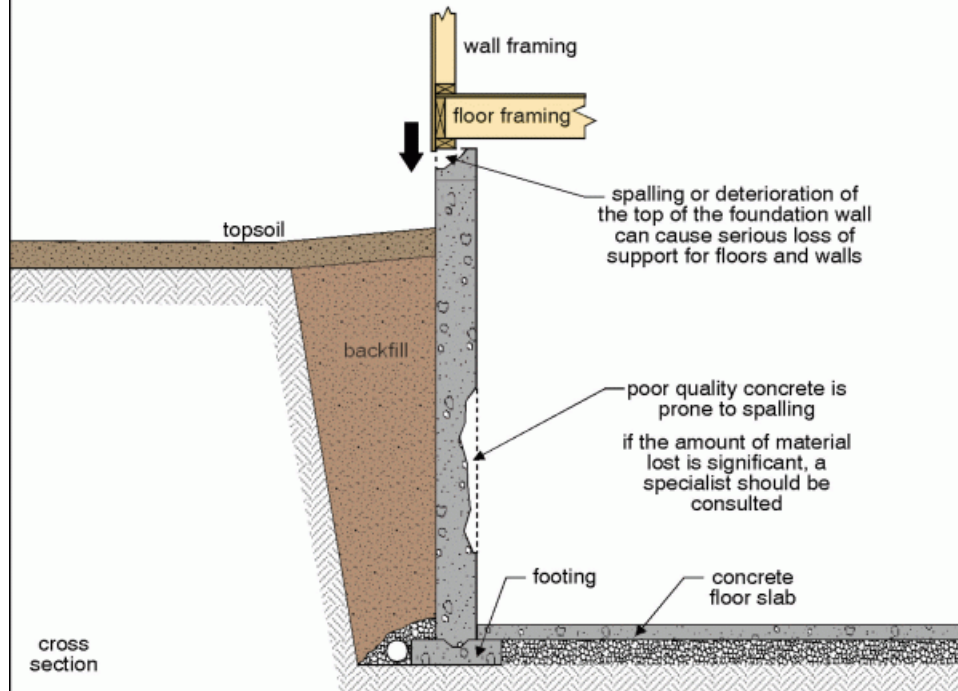
70. Spalling, crumbling or broken material

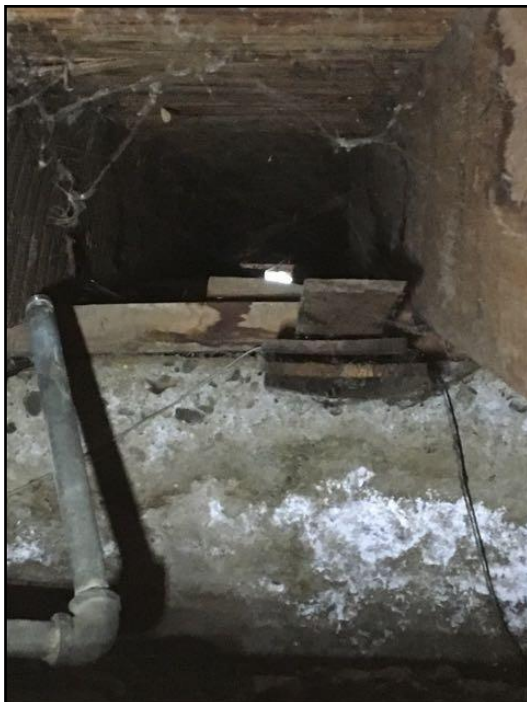
been shimmed up in some locations. Each joist should have direct bearing to the foundation to support the load of the house. It appears this condition has existed for years (if not original). I do recommend providing a shim under each individual joist to provide direct load bearing.

73. Gaps under sills

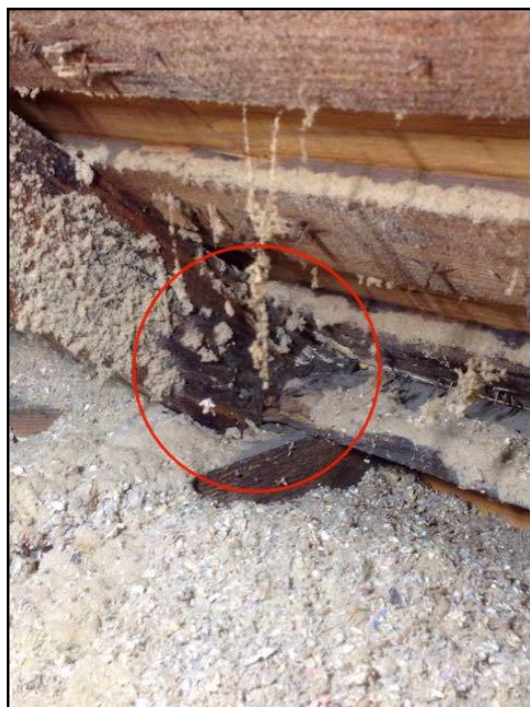
81. Rot damage

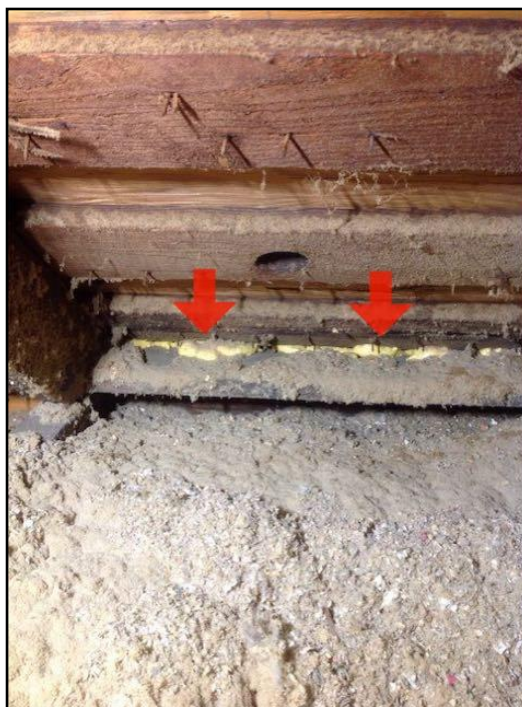
82. Spray foam

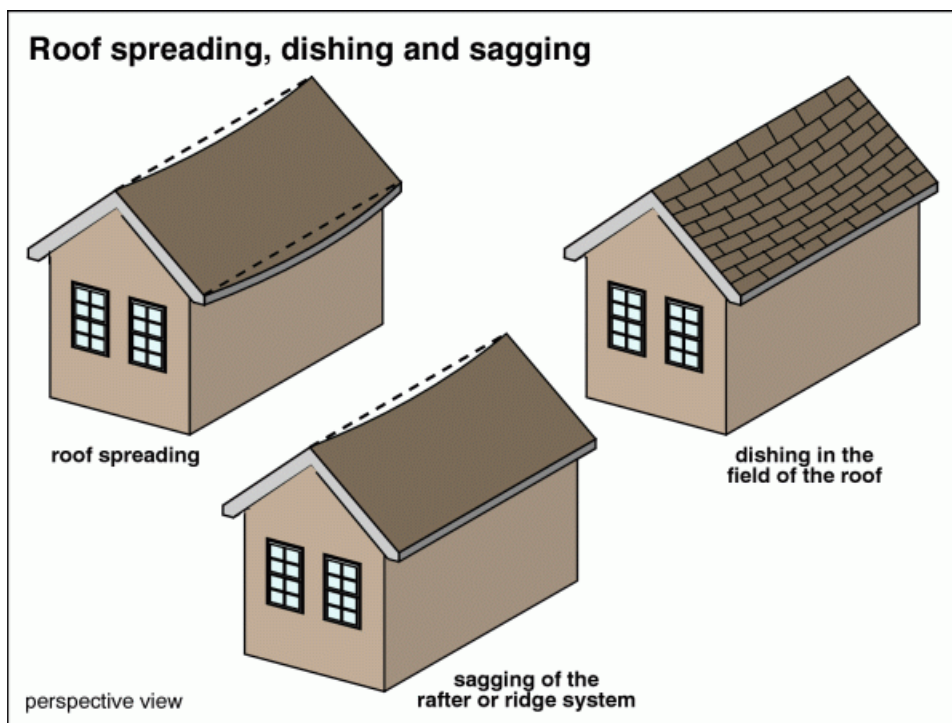
I noted the porch hip showed obvious signs of sagging. This is likely due to insufficient roof joist framing. I recommend consulting a professional contractor to discuss a possible remedy.

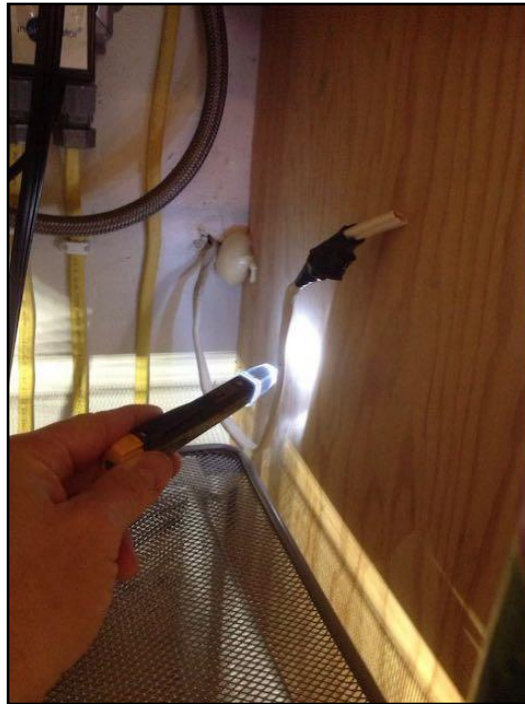
92. Abandoned wire under the sink

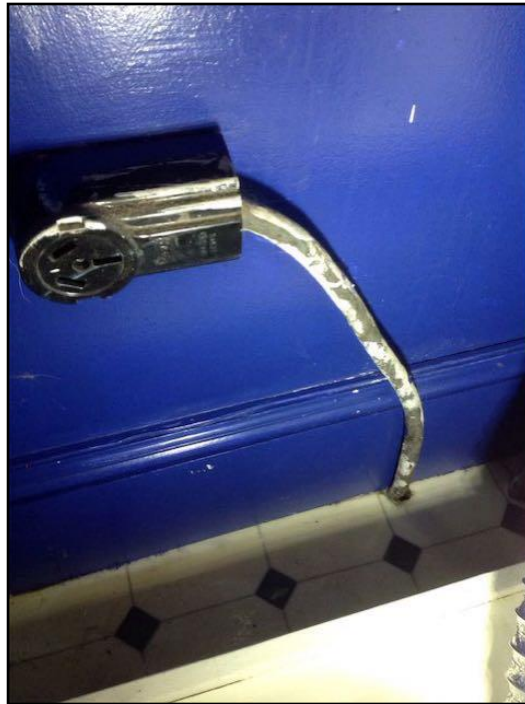
95. Exposed to damage

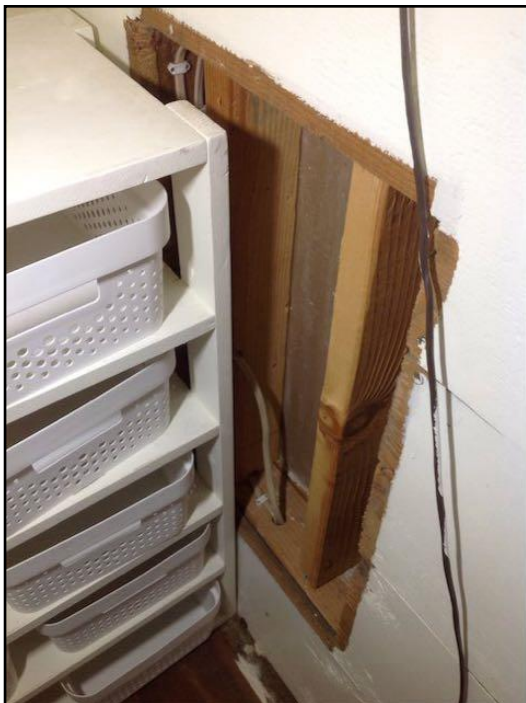
I noted several areas with exposed wires. All wires connections should be inside an approved junction box, the protective wire jacket needs to extend all the way into the junction box, and all wires within the living space should be protected from damage. I recommend a qualified electrician fix all of these conditions to avoid a possible shock and fire hazard.

100. Exposed to damage

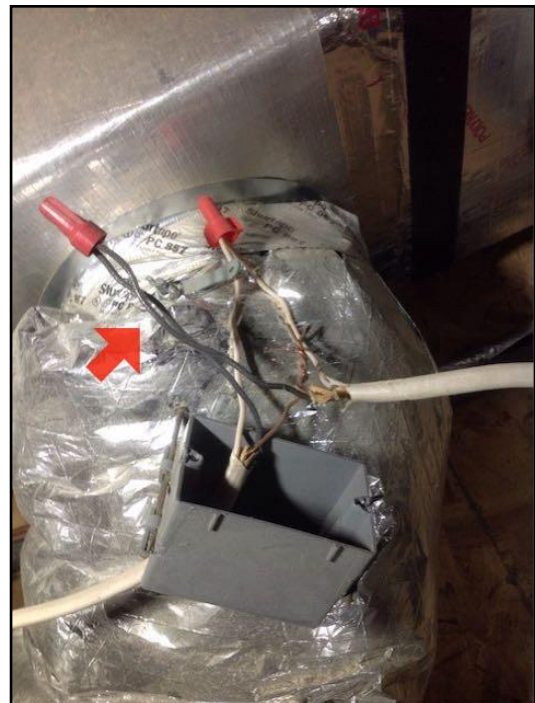
101. Exposed Wire Junction

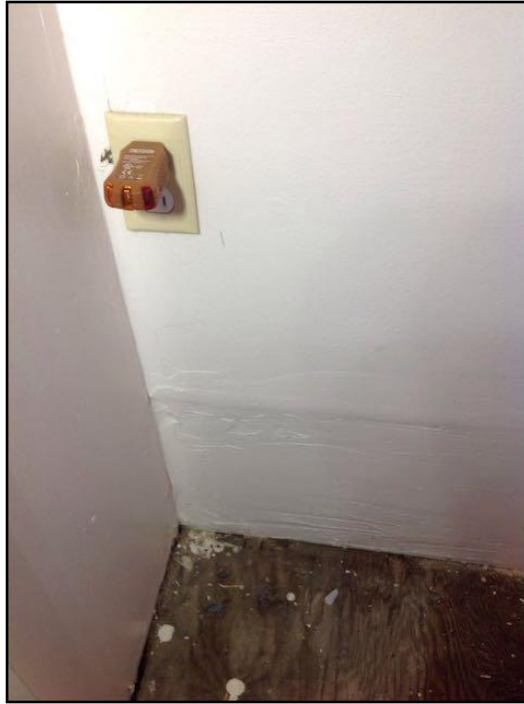
**106.** *Inoperative Outlet in Master Closet*

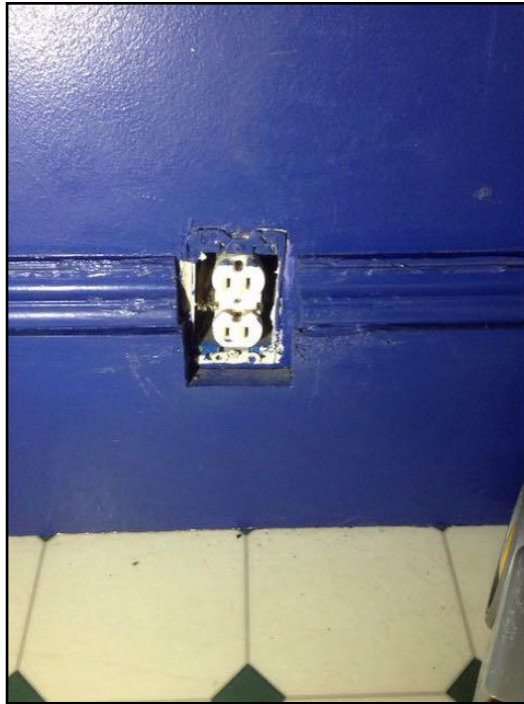
All outlet cover plates should be installed to prevent electric shock. I recommend outlet covers be installed.

108. Missing Cover Plate

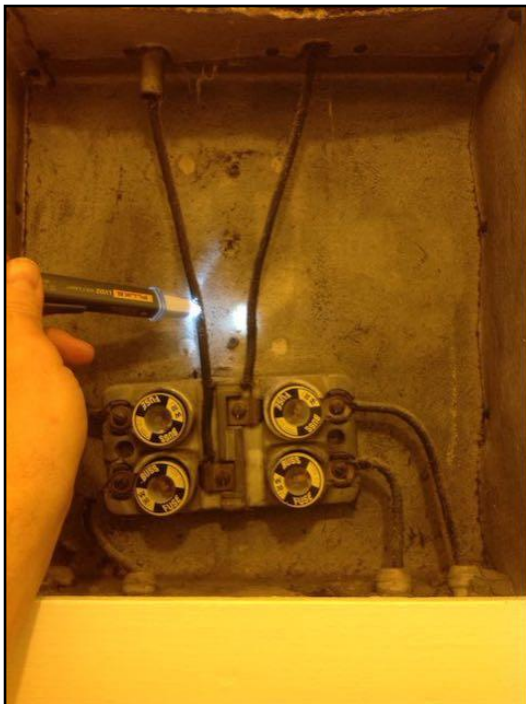
112.

**General:** • I noted old knob and tube remnants that are not currently in use.

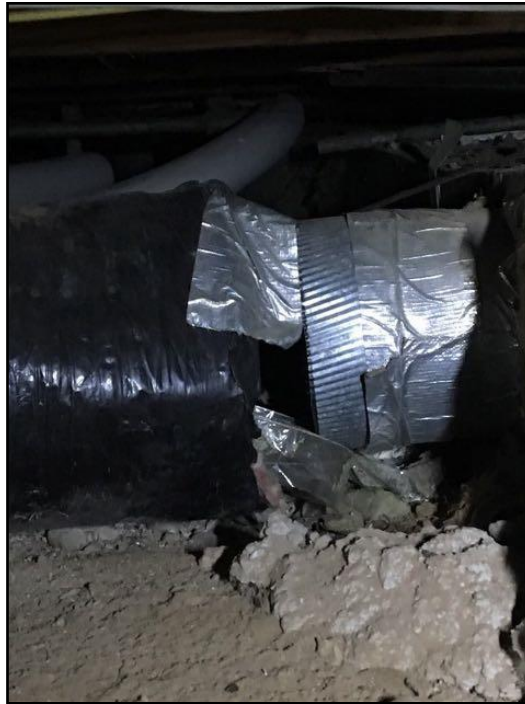
I noted one duct in the crawlspace that was completely disconnected and actively blowing air into the crawlspace. I recommend this be reconnected to help with energy efficiency.

127. Disconnected duct

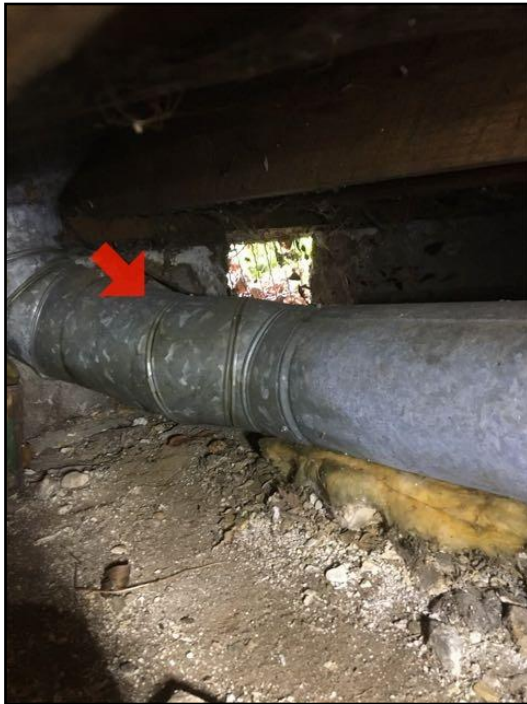
128. Insulation missing, damaged

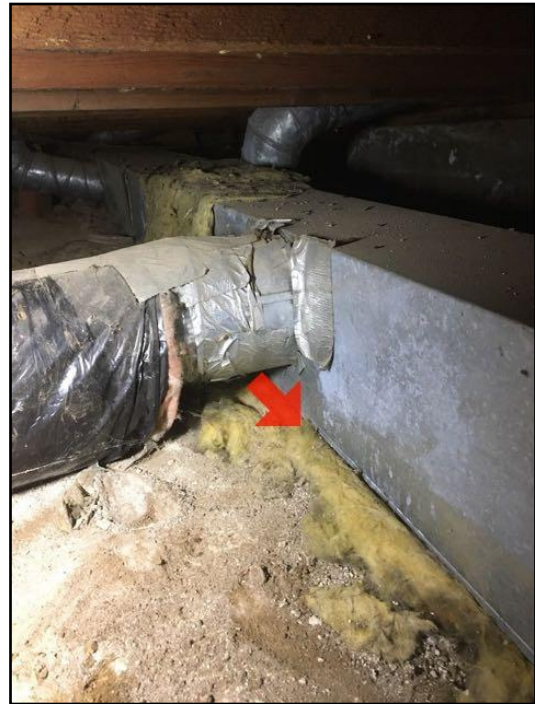
129. Disconnected ducts

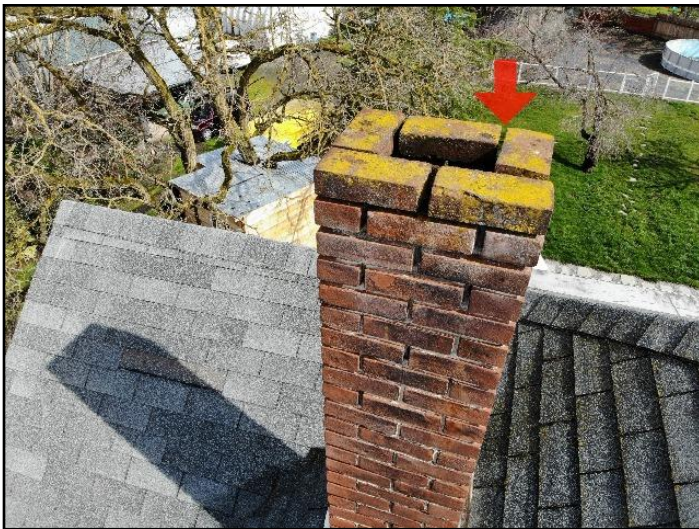
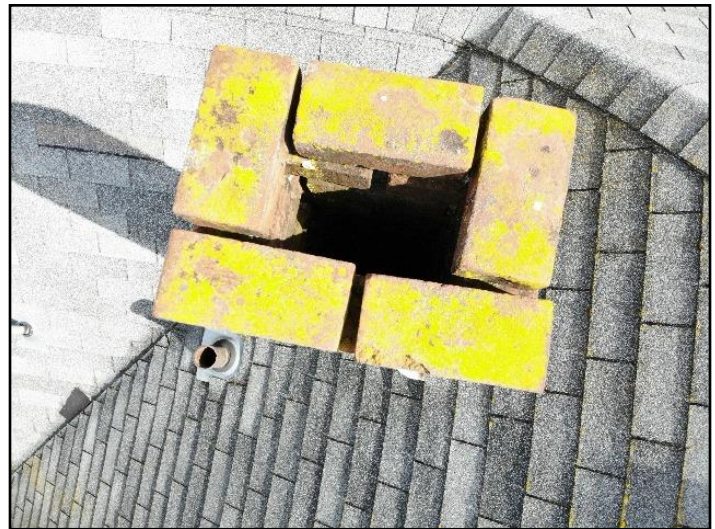
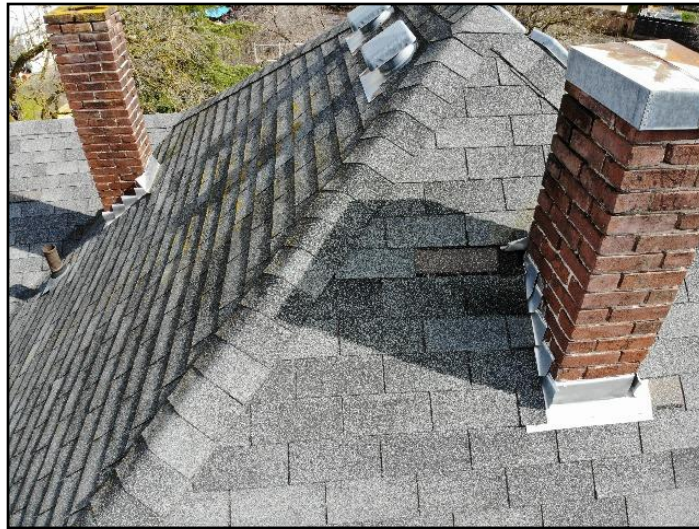
I noted two non-functional chimneys. One is capped off and appears to be in relatively good condition. The other is not capped and the top few layers of bricks appear to have no mortar at all. I recommend this condition be evaluated and corrected by a professional.

130. Loose, missing or deteriorated masonry

131. Loose, missing or deteriorated masonry

132. Loose, missing or deteriorated masonry

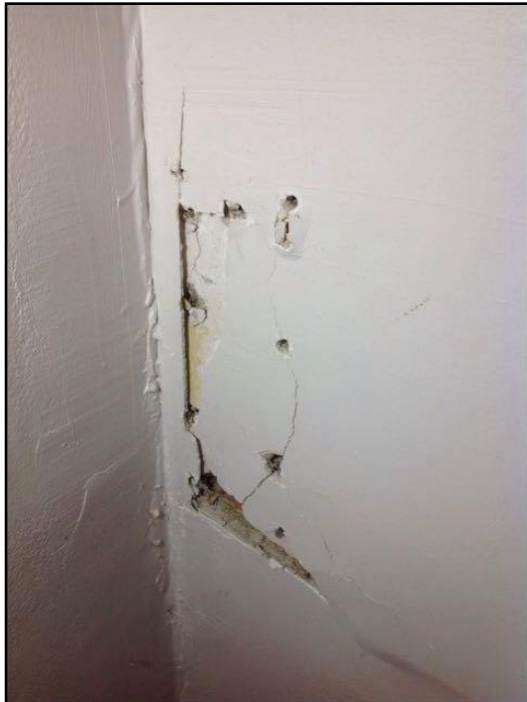
The second picture shows wall covering damage from something that was installed in the master closet.

**161.** Wall Damage in Master Closet

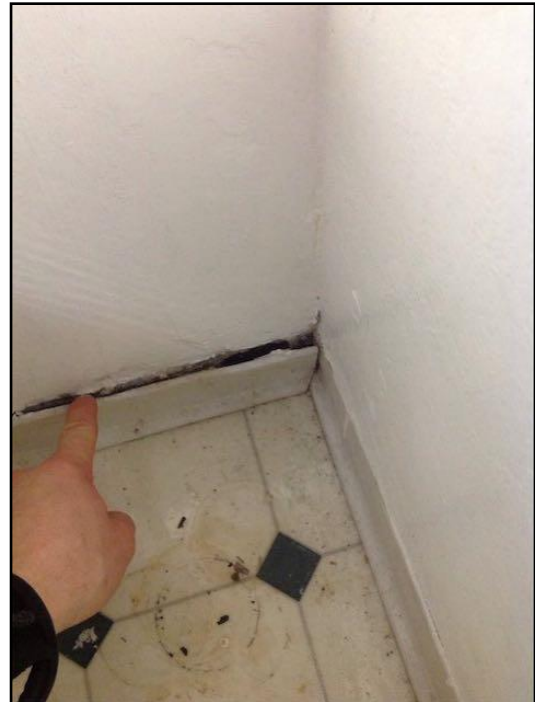
**162.** Crumbling Plaster

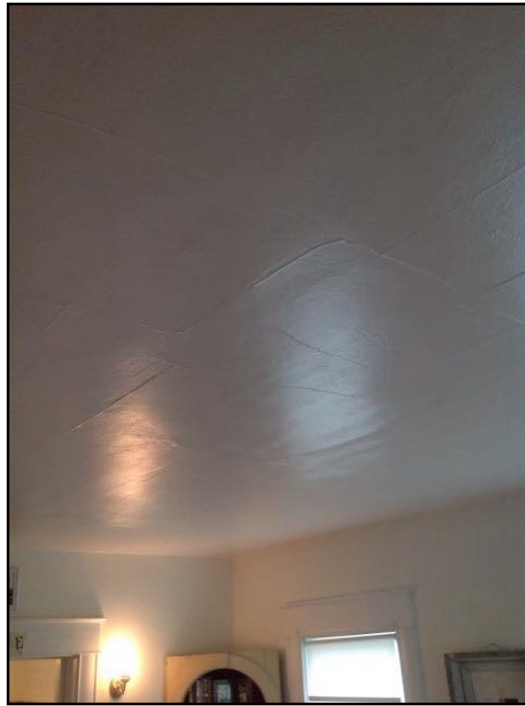
163. Ceiling Cracks

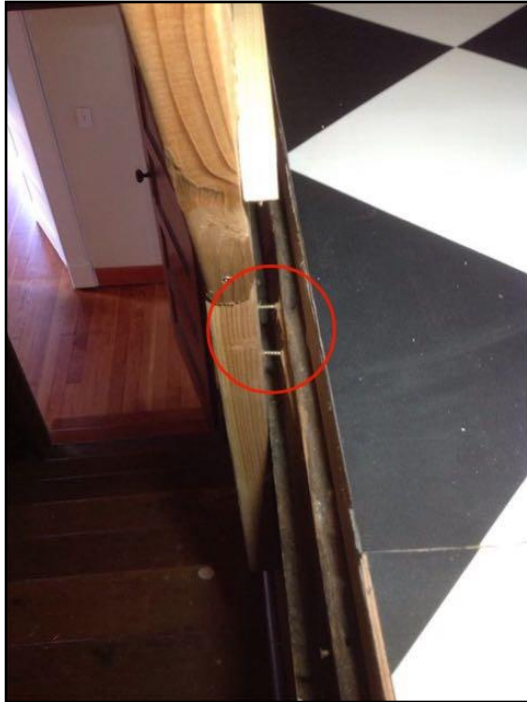
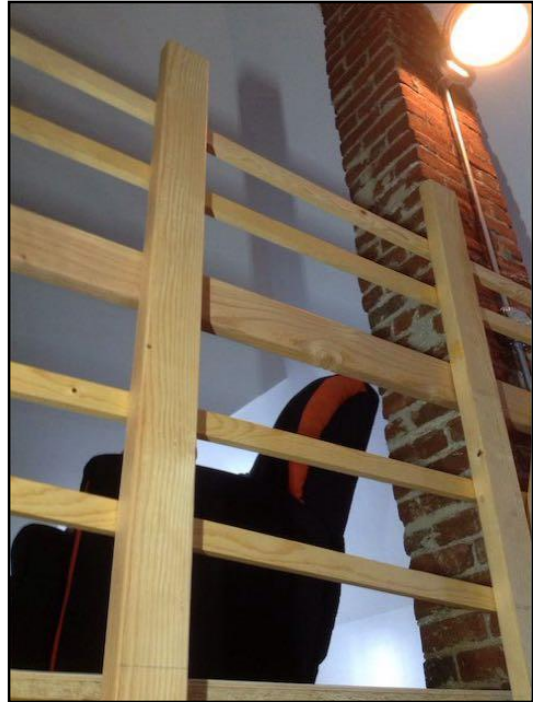
166. Loose handrail

167. Loose handrail

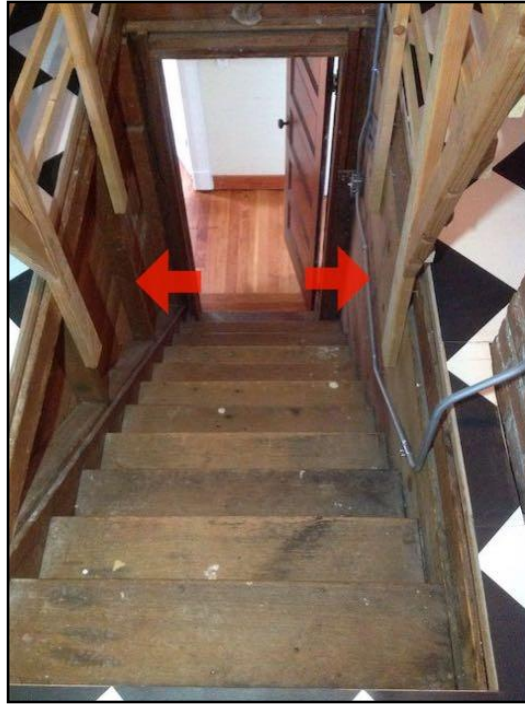
I noted the upper stairwell does not have a handrail. I recommend one be installed to help prevent an accidental fall. This condition has a good chance of being noted as a condition of lending by an appraiser.

168. Missing Handrail
