# Prism Home

## YOUR INSPECTION REPORT

100 N. Main Street  
My Village, GA

Wednesday, June 27, 2018

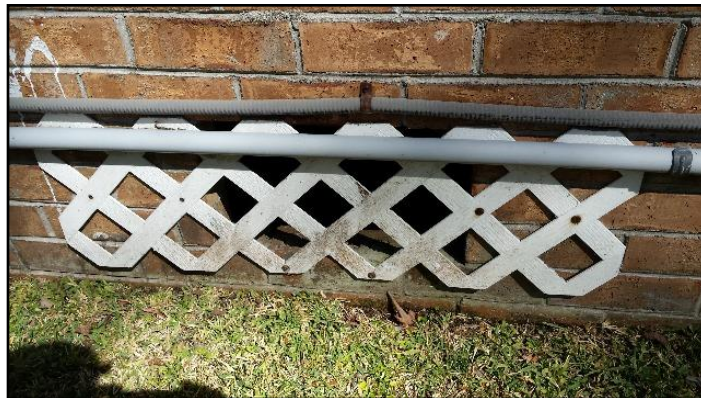
- The crawl space is not properly secured to keep pestilence from entering the space. Recommend the openings screened to keep unwanted infestations from inhabiting the space under the home.

**Implication(s):** Damage to insulation, ducting and wiring.

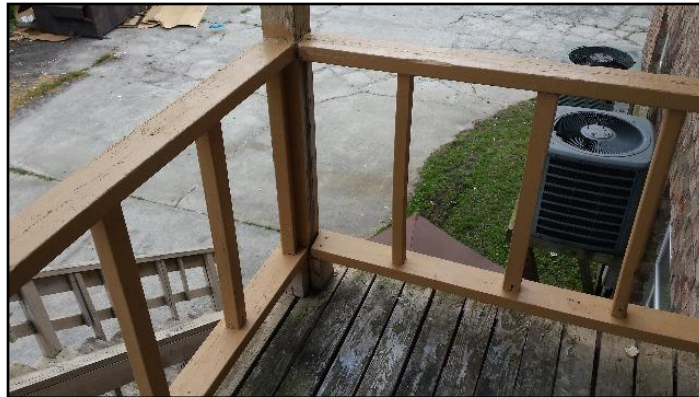
The opening between the pickets to the balcony railing are too far apart. Recommend adding pickets to decrease opening size to no more than 4 inches as required by building code to reduce risk of fall injury to small child or pet.

**Implication(s):** Fall hazard

*Openings between spindles (balusters) too...*

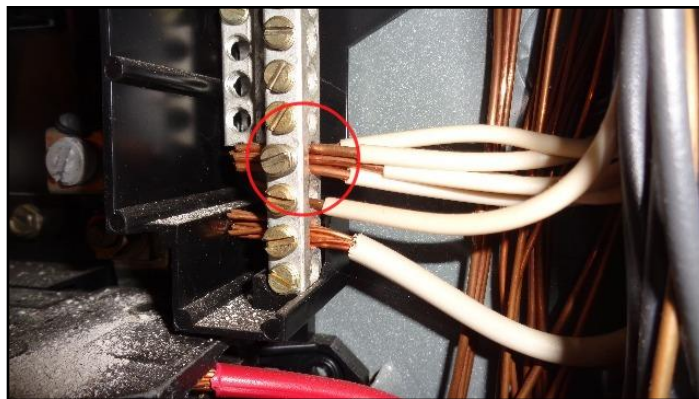
**Condition:** • There are 4 neutral wires secured under one connector screw in the electric panel. At the time of this homes build no more than 2 wires were allowed per connector screw. Recommend an electrician separate the wires to provide proper torque.

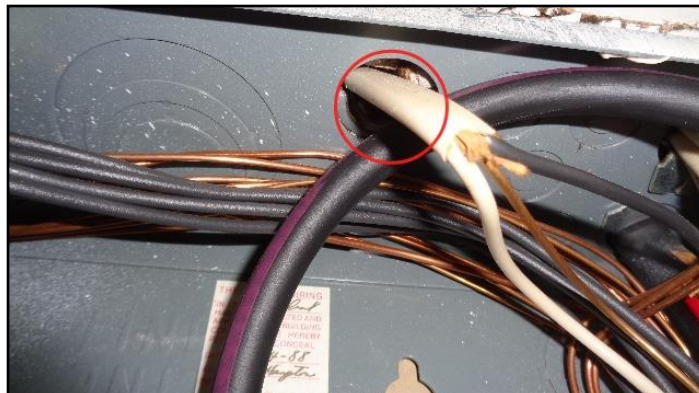
Added wire (done post construction) installed through the top of electric panel is not secured with a romex connector or anti strain device. Recommend the wire installation corrected by an electrician with install reviewed to terminus end.

**Implication(s):** Electric shock | Fire hazard

*Not well secured*

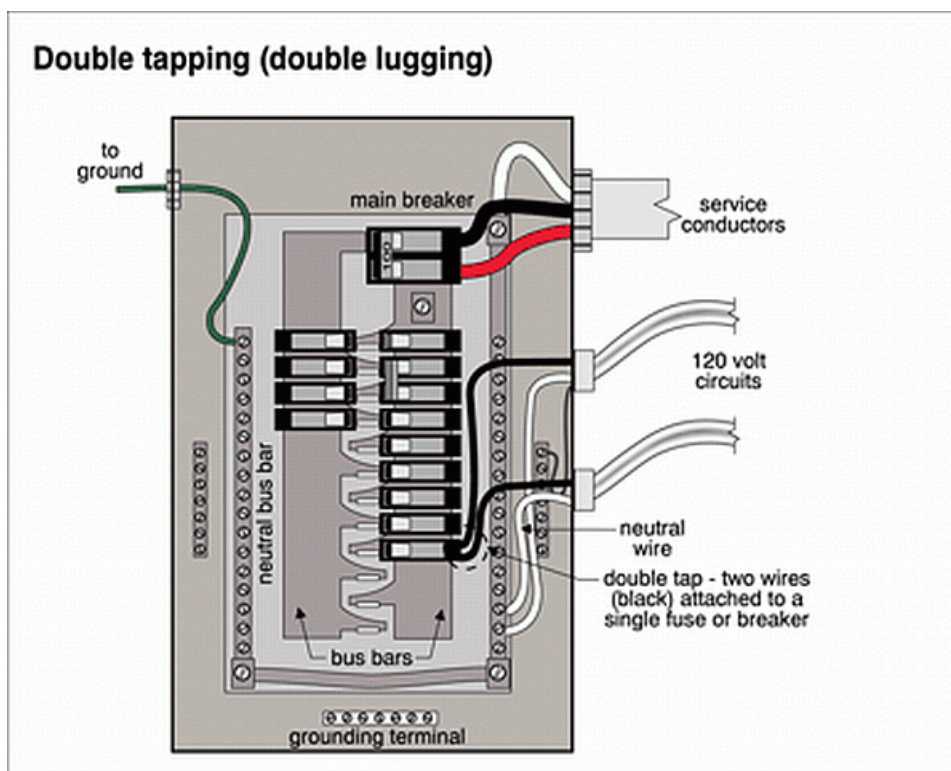
Breaker is housing two wires. Recommend an electrician add an additional breaker to house the extra wire.

**Implication(s):** Fire hazard

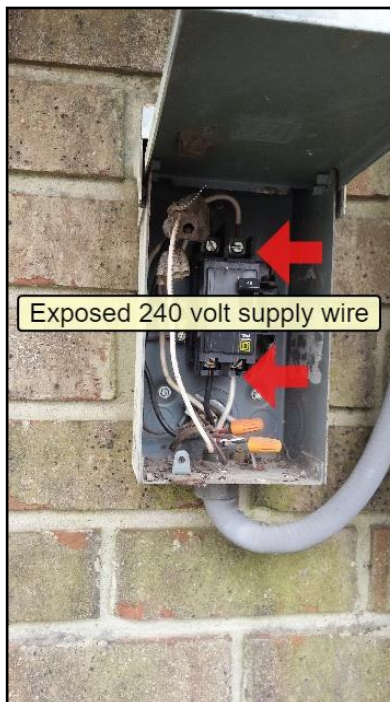
**Condition:** • The 240 volt 30 amp electric supply disconnect box for the Trane air conditioner is missing the inner component which protects the supply wire. As the box is located within reach of children it is recommended that the box be replaced as an immediate concern. Recommend this work done by an electrician.

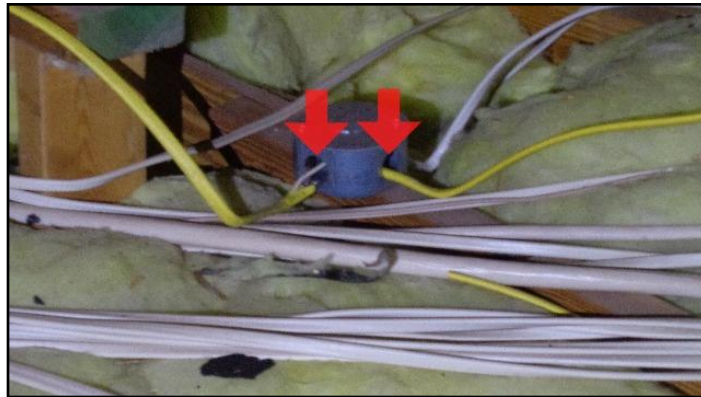
**Condition:** • Added circuit wire located in attic space, wires are missing romex connectors at junction box knock out locations and are not properly secured within 1 foot of leaving the box, metal boxes are required to be grounded. Recommend electrician review and correct the added wiring.

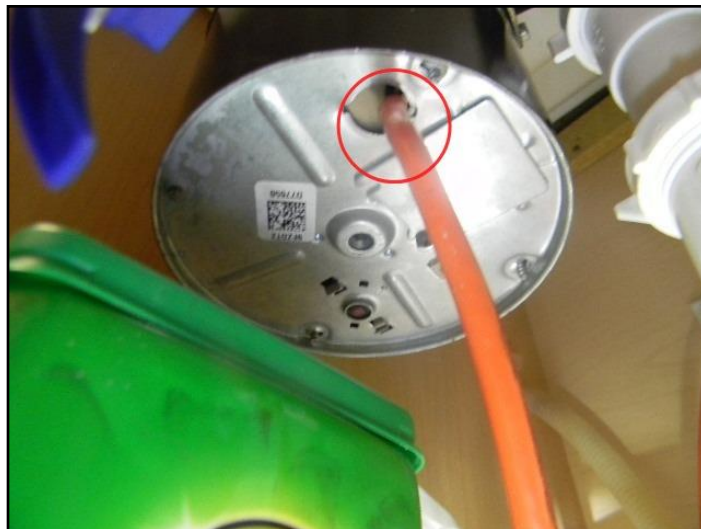
The electric supply to the waste disposal is not properly secured and missing romex connector at the disposal connection. Recommend an electrician review and correct the electric supply to the waste disposal unit.

**Implication(s):** Electric shock | Fire hazard | Interruption of electrical service

*Loose connections*

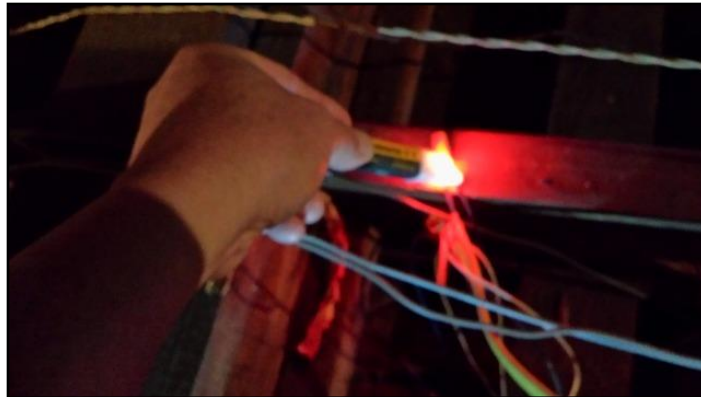
Live unprotected abandon wire found in the attic space to the left of attic hatch. Recommend an electrician properly terminate the wire in a junction box or remove.

*Abandoned wire*

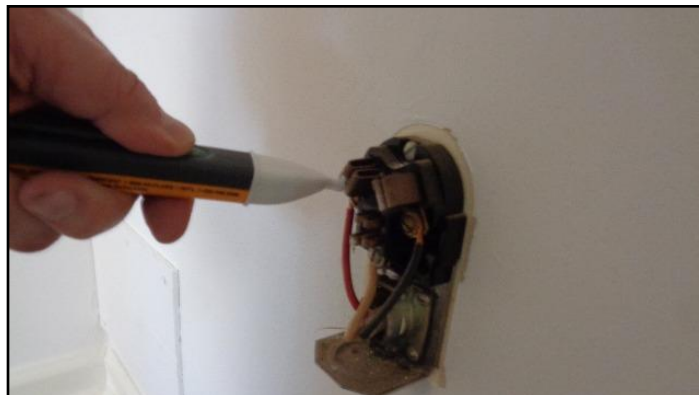
The 240 volt receptacle for the electric dryer is not operational. Recommend an electrician review and correct to provide for electric supply to dryer (no gas connection provided).

**Implication(s):** Equipment inoperative

*Inoperative*

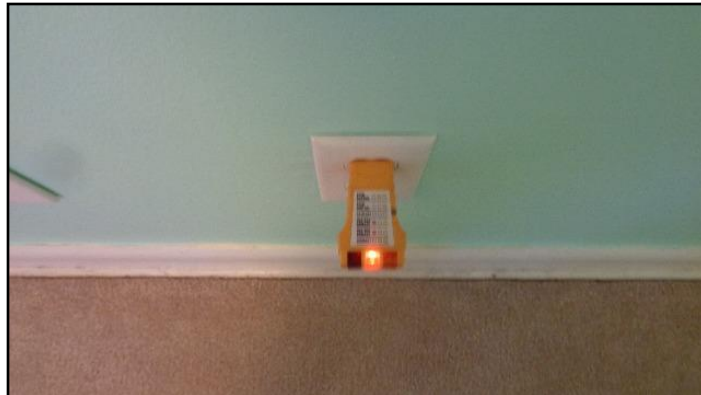
The receptacle located in the front guest bedroom is missing a ground connection (open ground). Recommend an electrician review and correct.

*Ungrounded*

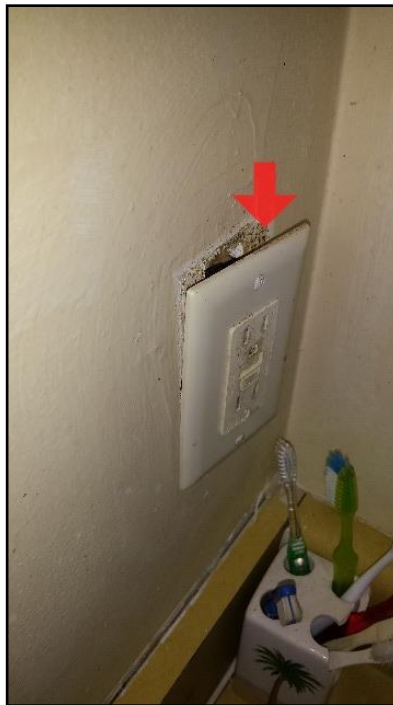
Recommend an electrician repair loose receptacle located second floor hall bath.

**Implication(s):** Electric shock | Fire hazard

*Loose*

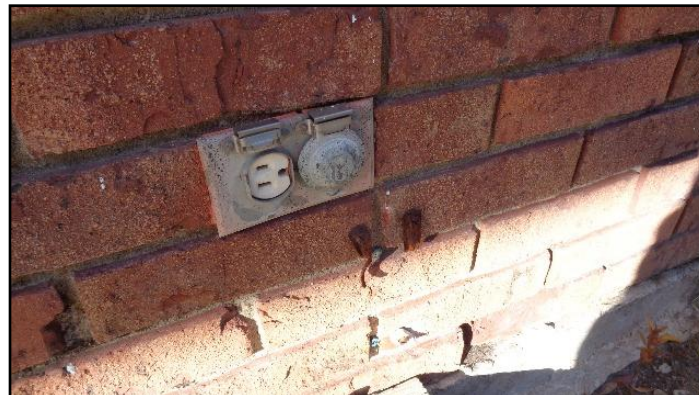
GFCI protection is missing to the receptacle located near the front entry door, cover is also damaged. Recommend an electrician install a GFCI receptacle and replace the damaged cover.

No GFCI/GFI (Ground Fault Circuit...

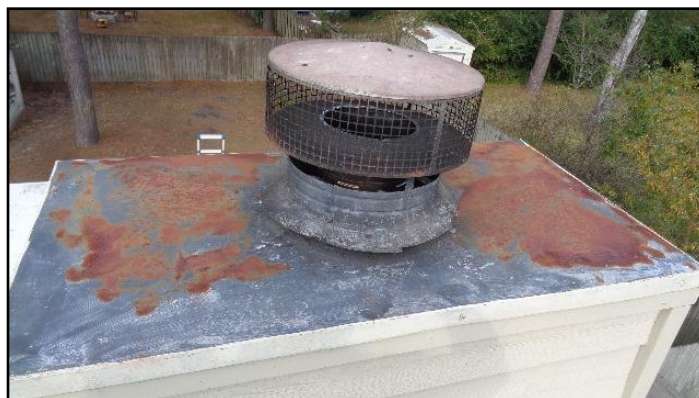
**Condition:** • Fireplace chimney crown has surface rust developed. Recommend clean, prime and paint the fireplace chimney crown to prolong useful life.

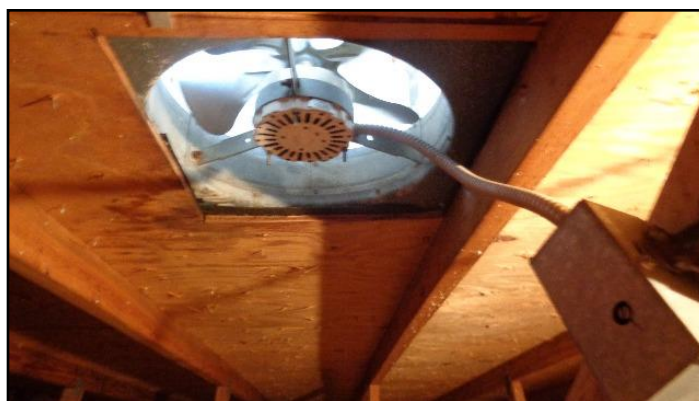
The thermostatically controlled roof top vent fan for the attic space is not operational.. Recommend replace the worn unit.

**Implication(s):** Increased cooling costs | Reduced comfort

*Inoperative in summer*

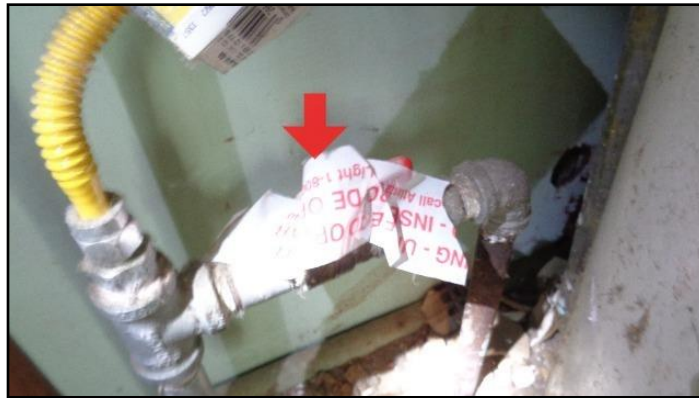
The gas provider shut the gas off to the in law suite furnace due to a leak at the connection. Recommend a plumber review and correct (I did not test this furnace).

**Implication(s):** Equipment not operating properly | Fire or explosion

*Improper connections*

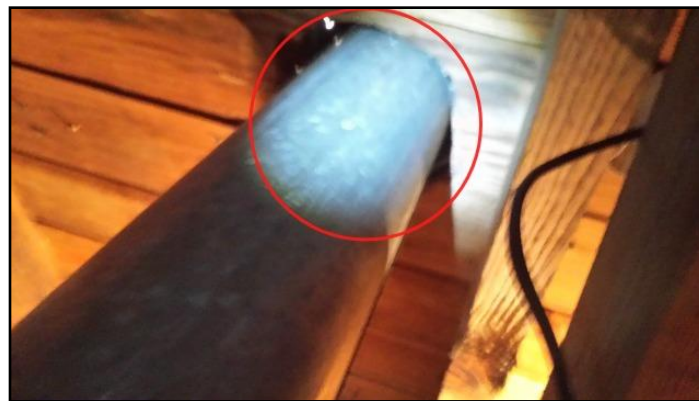
The water heater vent pipe is in contact with combustible materials. Water heater vent pipes are required to have a minimum of a 1 inch clearance from combustibles to reduce risk of fire. Recommend repairs made to cut material away to provide the clearance.

**Implication(s):** Fire hazard

*Combustible clearance*

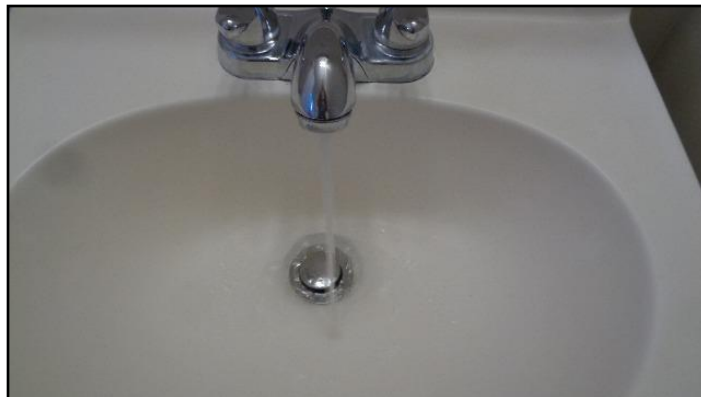
The isolation valve to the hallway bath sink faucet was discovered off at time of the inspection. When the valve was turned on water flowed through the sink faucet while the faucet handle was in the off position. Recommend a plumber repair or replace the leaking faucet.

**Implication(s):** Chance of water damage to contents, finishes and/or structure

*Drip, leak*

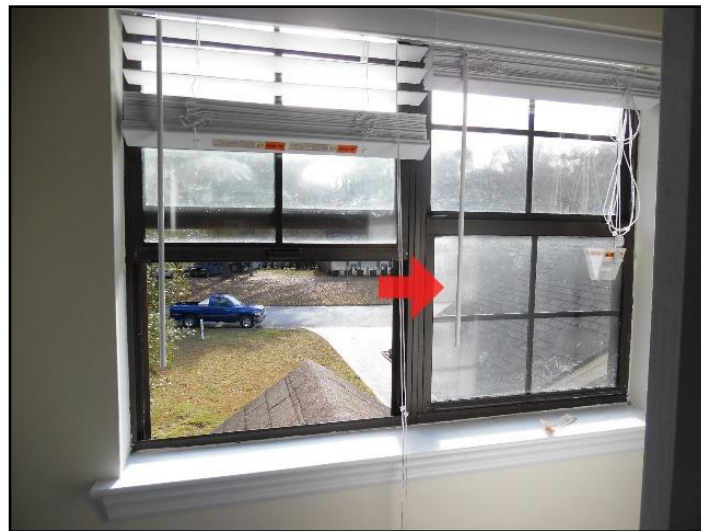
Window located in front bedroom will not stay open when raised. Recommend repairs made to secure the loose sash hardware to maintain the window in a open position when raised.

*Won't stay open*

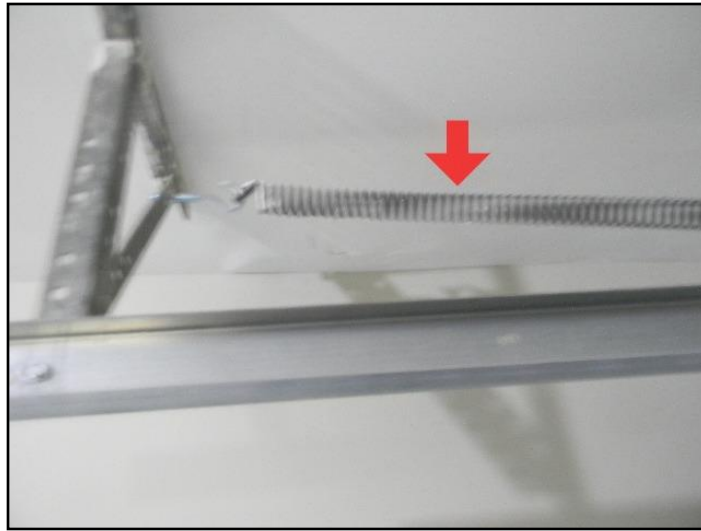
**Condition:** • Safety cables are missing through e garage overhead door springs. The cables are required to harness the spring when in the event of spring breakage to protect from physical injury. Recommend a garage door specialist install the missing safety equipment.

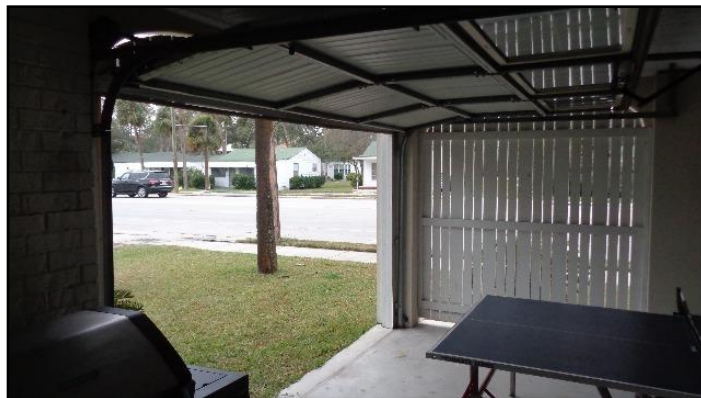
The auto door opener for the garage would not function to close the door, suspect safety equipment is out of alignment. Recommend a garage door specialist review and correct.

**Implication(s):** Equipment not operating properly

*Difficult to open or close*

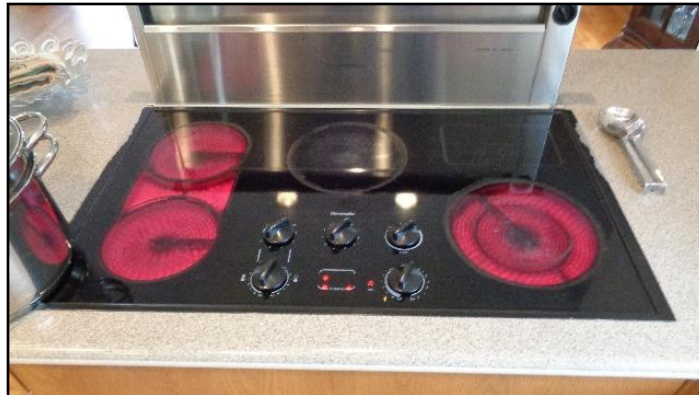
The right rear burner to the stove was not operational at time of the inspection. Recommend an appliance technician repair.

*Burner inoperative*

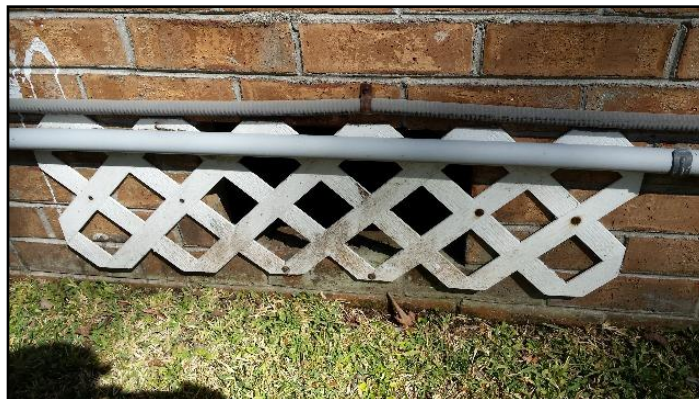
1. • The crawl space is not properly secured to keep pestilence from entering the space. Recommend the openings screened to keep unwanted infestations from inhabiting the space under the home.

**Implication(s):** Damage to insulation, ducting and wiring.

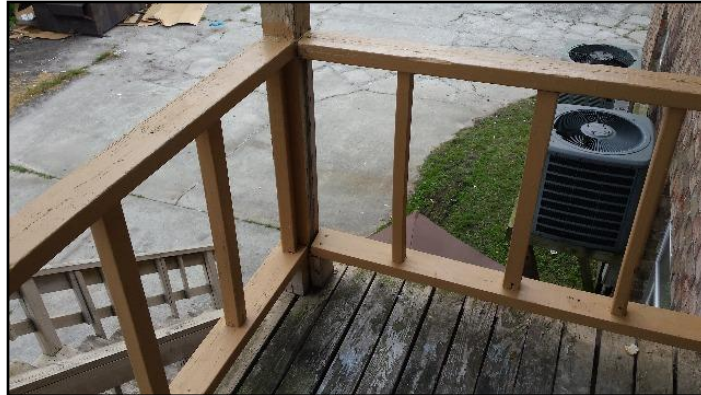
The opening between the pickets to the balcony railing are to far apart. Recommend adding pickets to decrease opening size to no more than 4 inches as required by building code to reduce risk of fall injury to small child or pet.

**Implication(s):** Fall hazard

*Openings between spindles (balusters) too...*

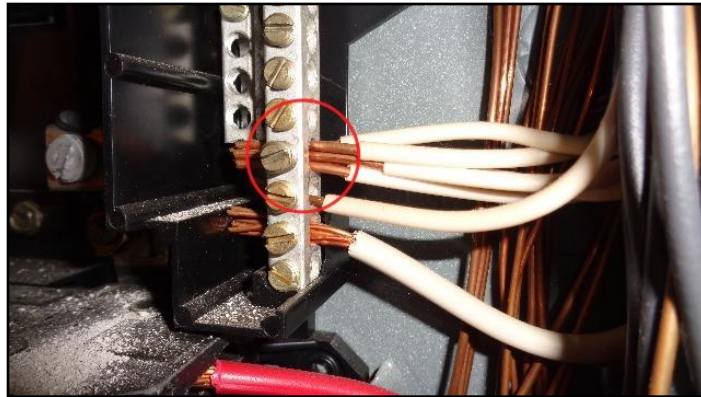
**3. Condition:** • There are 4 neutral wires secured under one connector screw in the electric panel. At the time of this homes build no more than 2 wires were allowed per connector screw. Recommend an electrician separate the wires to provide proper torque.

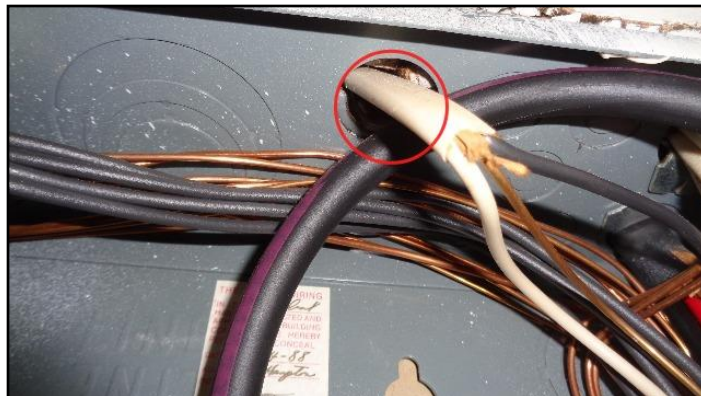
Added wire (done post construction) installed through the top of electric panel is not secured with a romex connector or anti strain device. Recommend the wire installation corrected by an electrician with install reviewed to terminus end.

**Implication(s):** Electric shock | Fire hazard

*Not well secured*

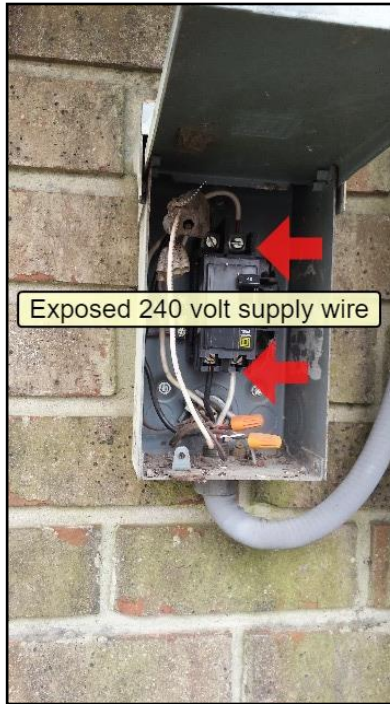
**6. Condition:** • The 240 volt 30 amp electric supply disconnect box for the Trane air conditioner is missing the inner component which protects the supply wire. As the box is located within reach of children it is recommended that the box be replaced as an immediate concern. Recommend this work done by an electrician.

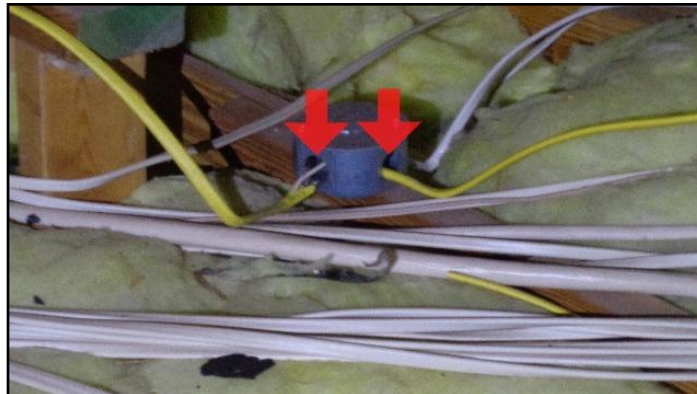
**7. Condition:** • Added circuit wire located in attic space, wires are missing romex connectors at junction box knock out locations and are not properly secured within 1 foot of leaving the box, metal boxes are required to be grounded. Recommend electrician review and correct the added wiring.

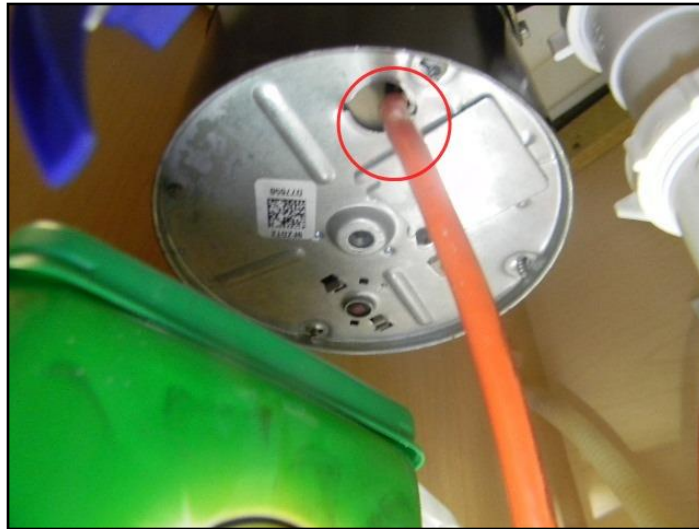
The electric supply to the waste disposal is not properly secured and missing romex connector at the disposal connection. Recommend an electrician review and correct the electric supply to the waste disposal unit.

**Implication(s):** Electric shock | Fire hazard | Interruption of electrical service

*Loose connections*

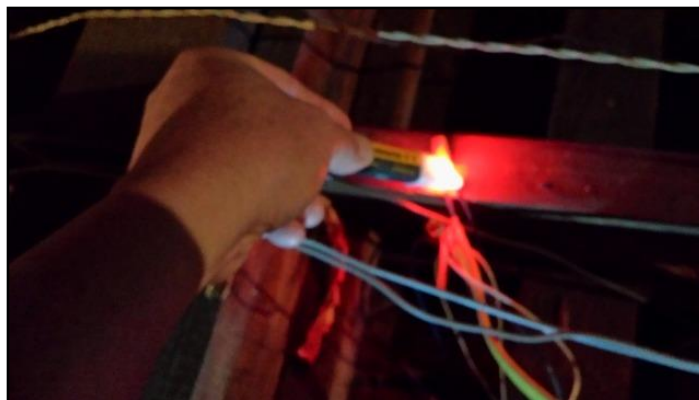
Live unprotected abandon wire found in the attic space to the left of attic hatch. Recommend an electrician properly terminate the wire in a junction box or remove.

*Abandoned wire*

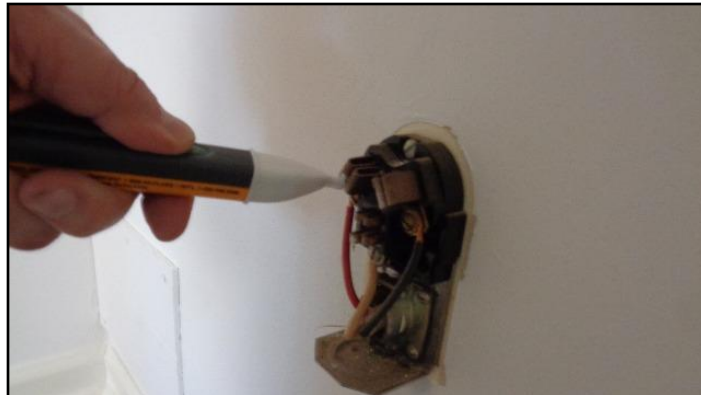
**10. Condition:** • [Inoperative](#)

*Inoperative*

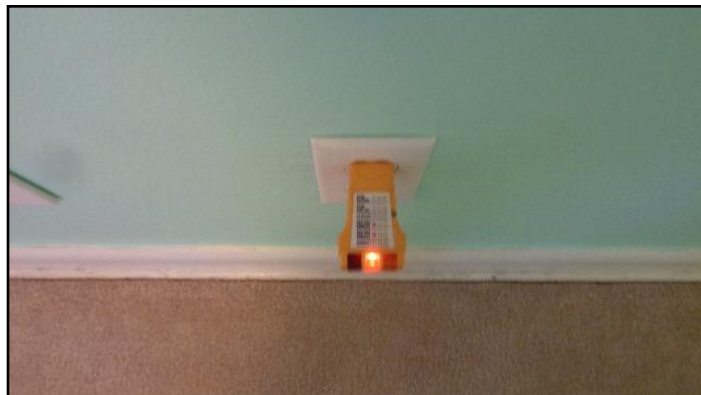
**11. Condition:** • [Ungrounded](#)

*Ungrounded*

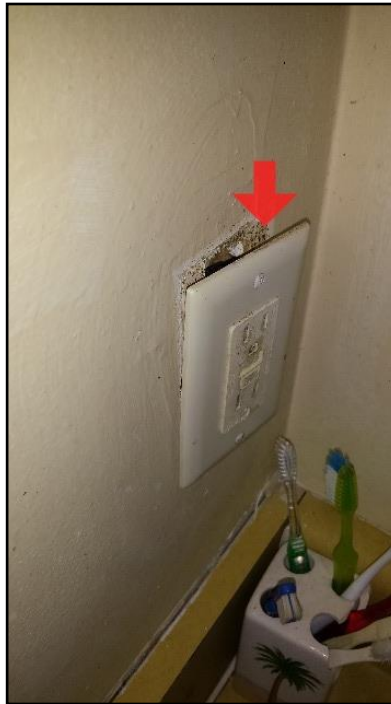
Recommend an electrician repair loose receptacle located second floor hall bath.

Loose

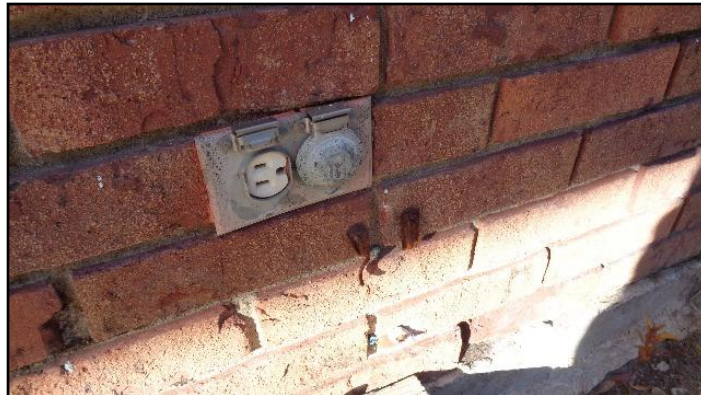
**13. Condition:** • [No GFCI/GFI \(Ground Fault Circuit Interrupter\)](#)

*No GFCI/GFI (Ground Fault Circuit...*

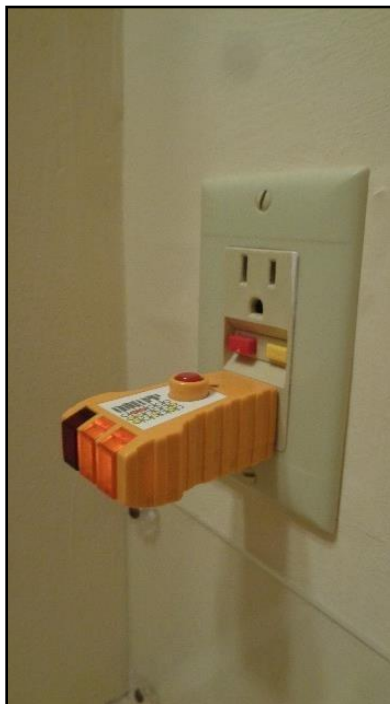
**14. Condition:** • [Test faulty on GFCI/GFI \(Ground Fault Circuit Interrupter\)](#)

*Test faulty on GFCI/GFI (Ground Fault...*

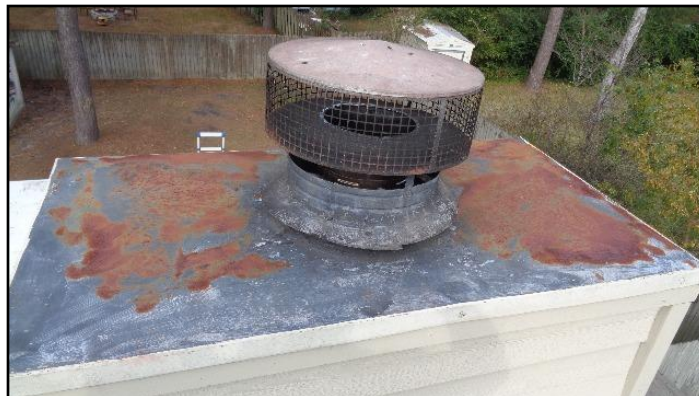
**16. Condition:** • Fireplace chimney crown has surface rust developed. Recommend clean, prime and paint the fireplace chimney crown to prolong useful life.

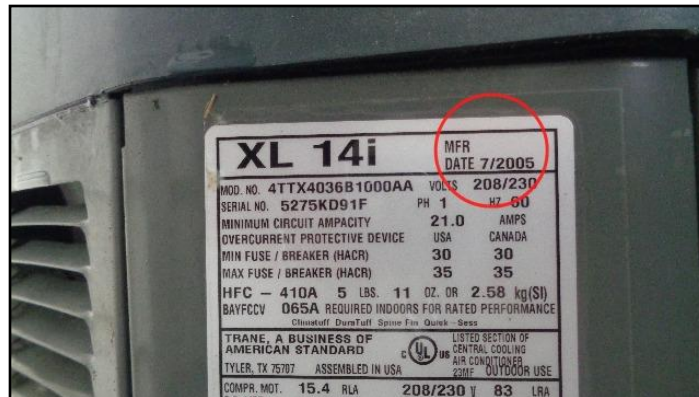
#### 17. Condition: • [Near end of life expectancy](#)

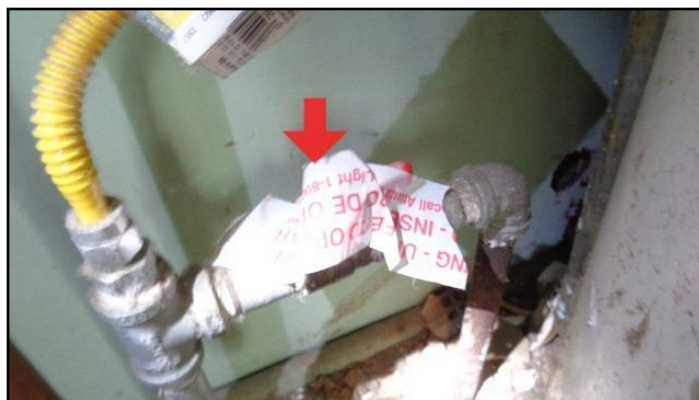
**Implication(s):** Equipment not operating properly | Fire or explosion

*Improper connections*

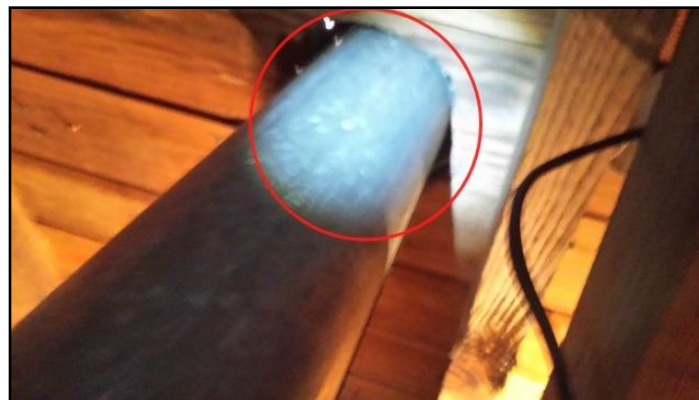
*Combustible clearance*

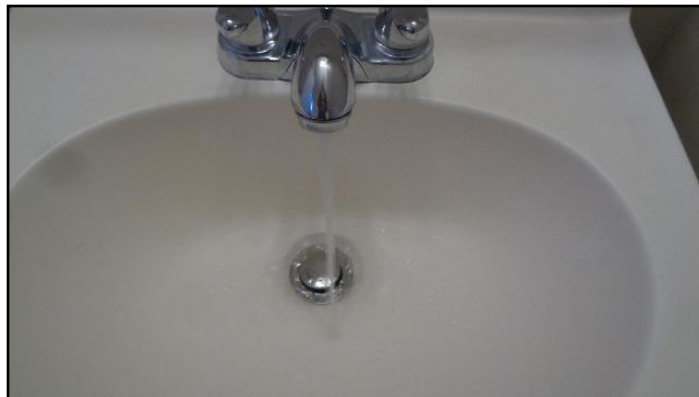
*Drip, leak*

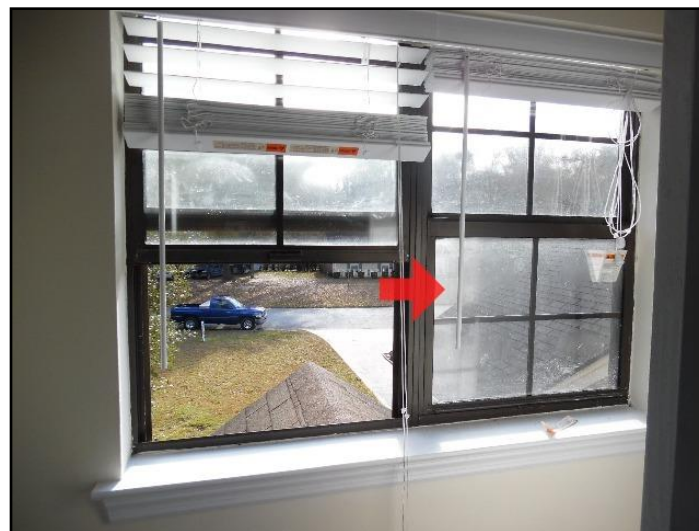
*Won't stay open*

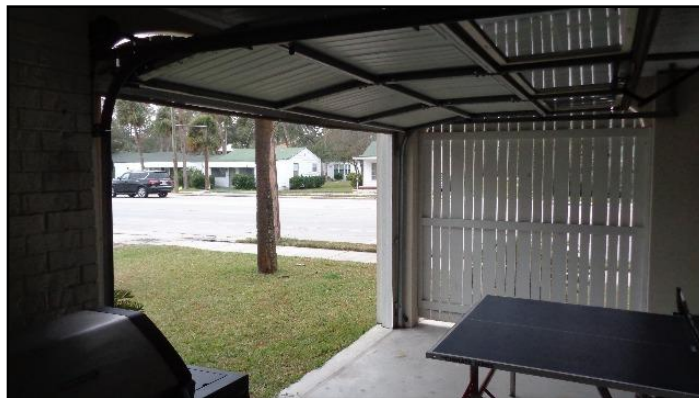
## 26. Condition: • [Difficult to open or close](#)

The auto door opener for the garage would not function to close the door, suspect safety equipment is out of alignment. Recommend a garage door specialist review and correct.

*Difficult to open or close*

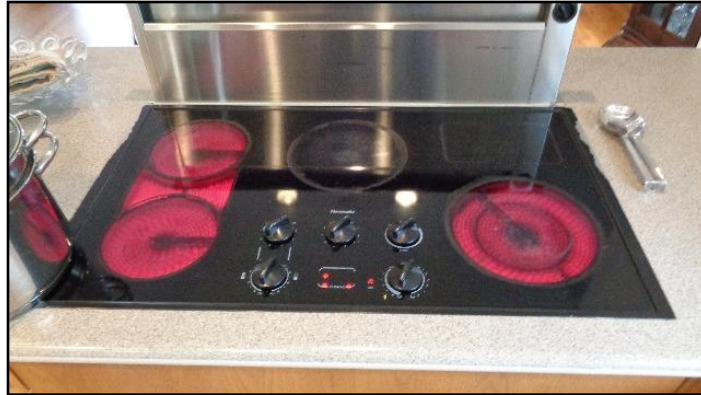
*Burner inoperative*
