YOUR INSPECTION REPORT

54 Humber Trail
Toronto, ON M6S 4C1

INSPECTION DATE:
Tuesday, February 4, 2020

RE: Report No. 2605
54 Humber Trail
Toronto, ON
M6S 4C1

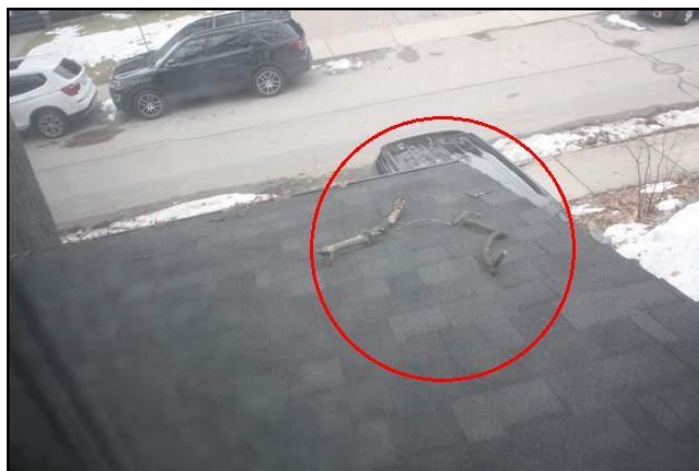
Condition: • Debris/moss

1. Debris example

Task: Clean

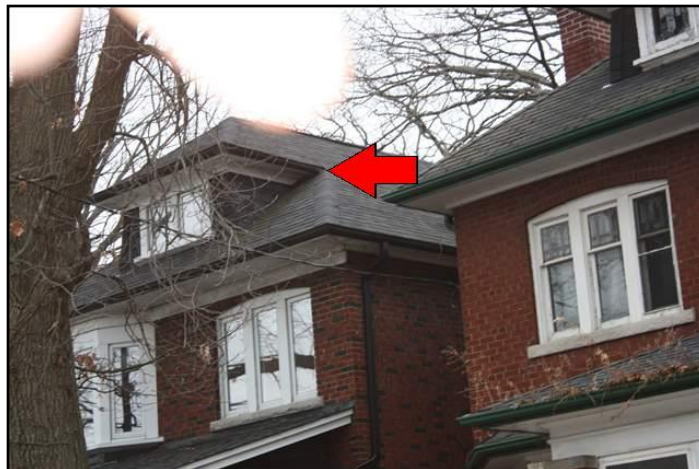
Condition: • [Discharge onto roofs](#)

2. Discharge onto roofs

Improvement recommendation - Provide downspouts from upper gutters to lower gutters to prevent premature wear to Shingles

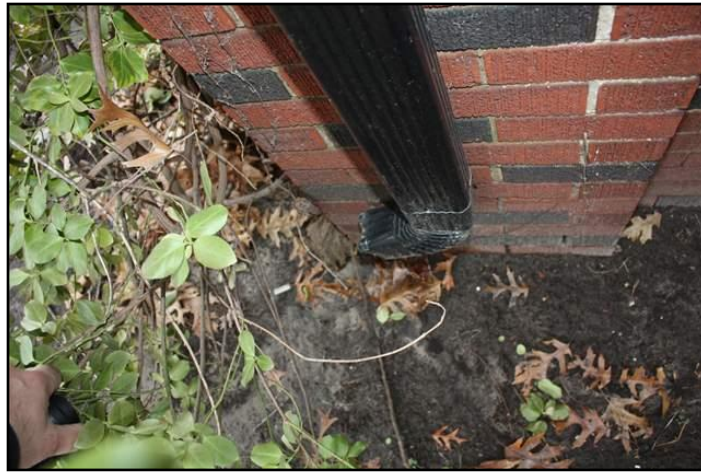
Condition: • [Discharge too close to building](#)

3. Discharge too close to building

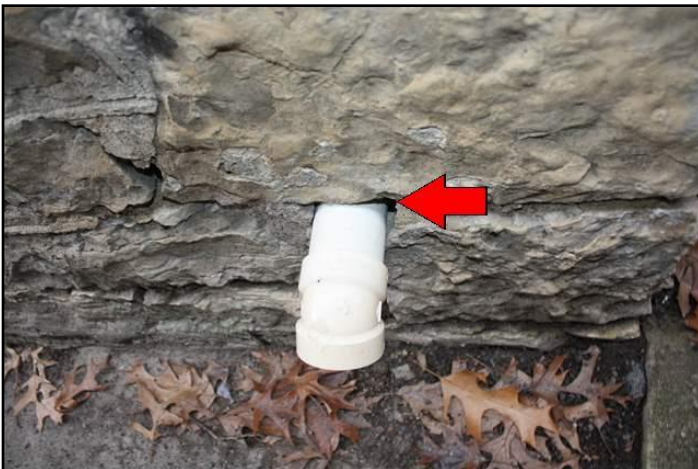
Condition: • [Caulking missing or ineffective](#)

4. Caulking missing or ineffective

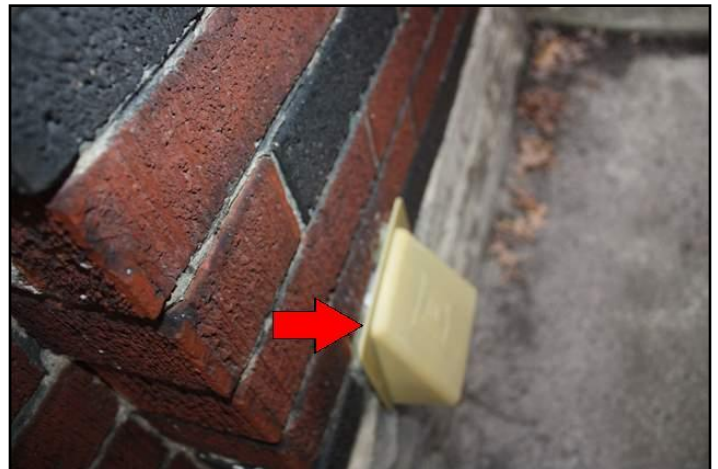
5. Caulking missing or ineffective

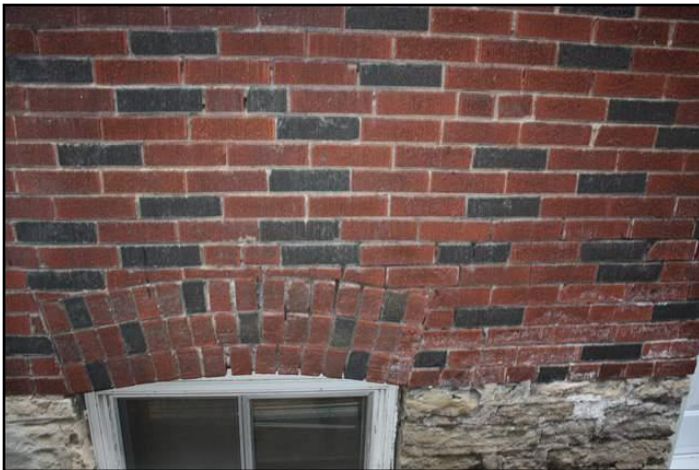
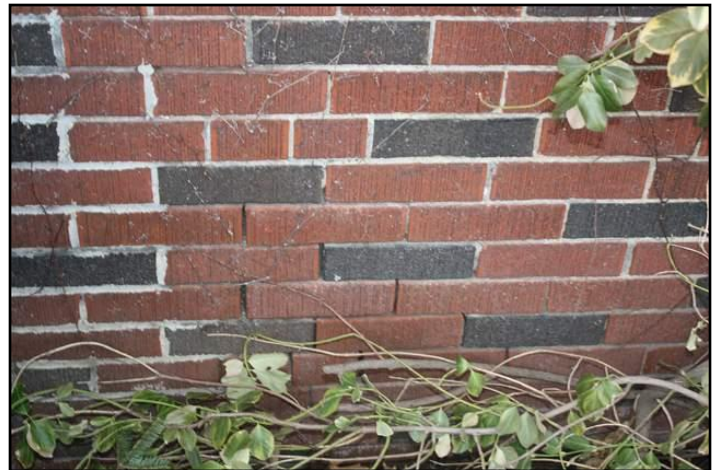
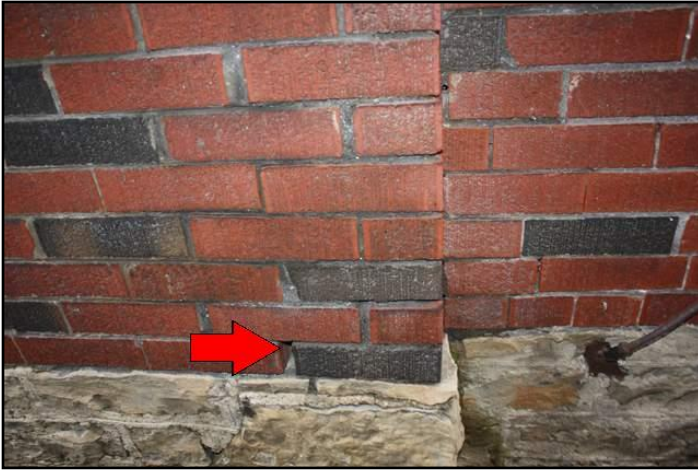
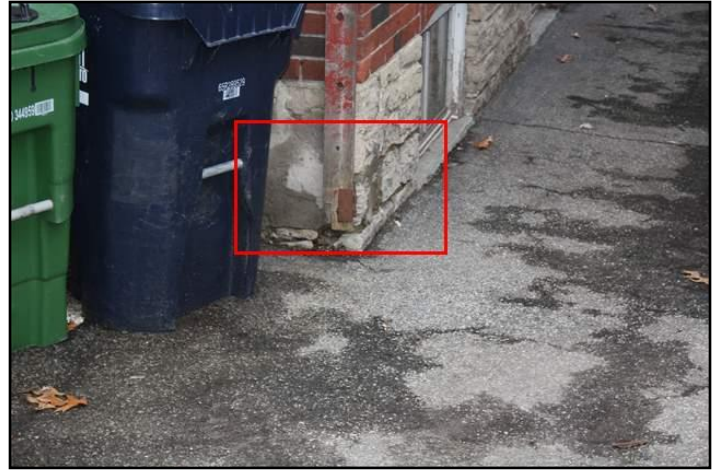
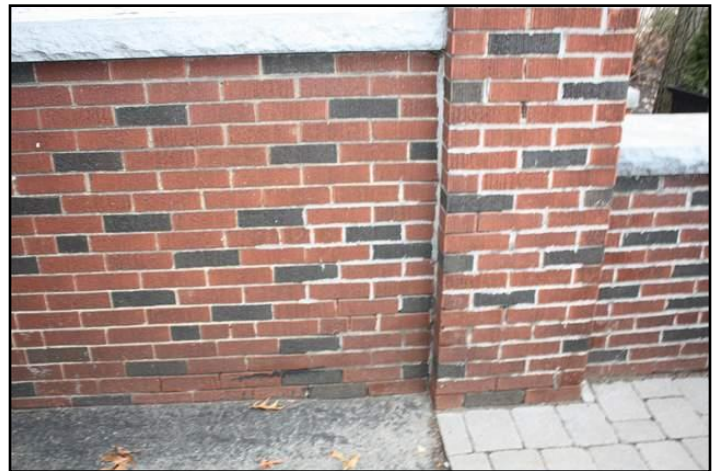
Condition: • [Mortar deterioration](#)

Provide mortar (Repointing, Tuck pointing) at various areas of the exterior brick and the stone foundation. This is very common maintenance for homes of this age. The photos show a sampling.

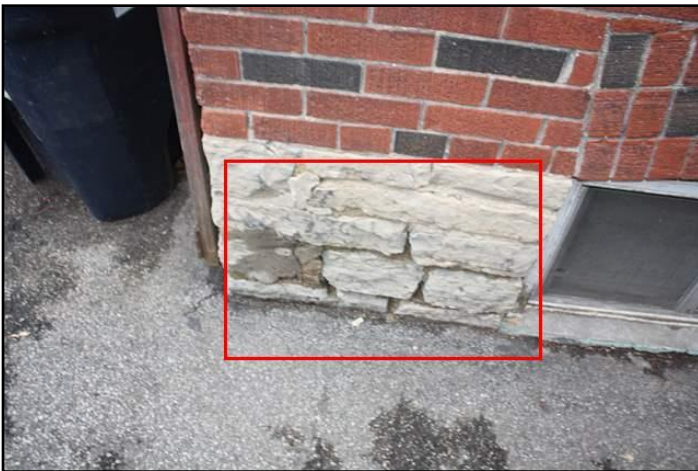
10. Mortar deterioration example at foundation

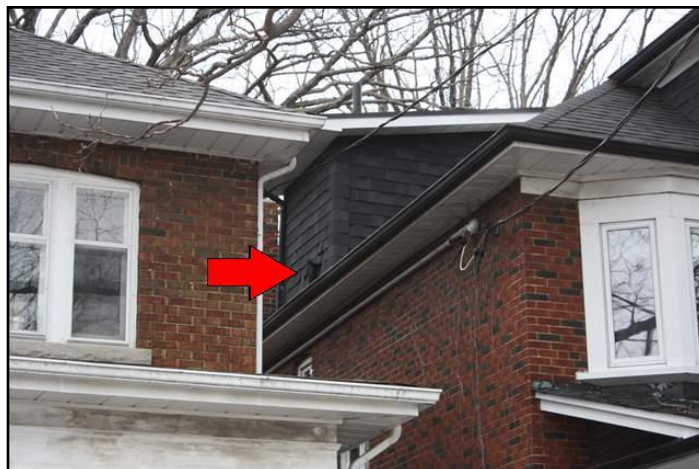
Condition: • [Loose, missing or torn tabs](#)

12. Loose, missing or torn tabs

Task: Repair

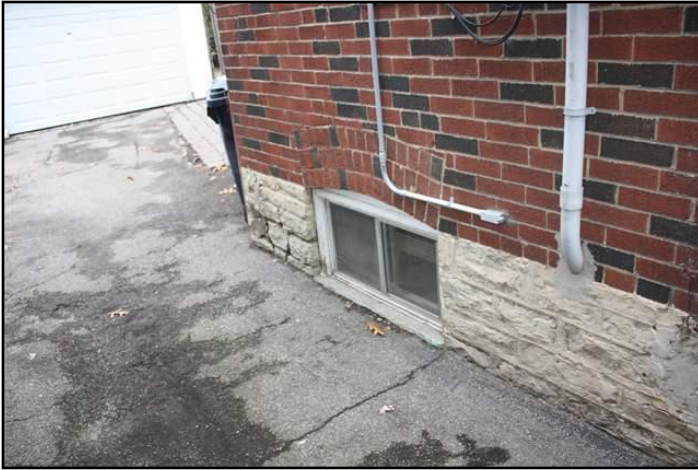
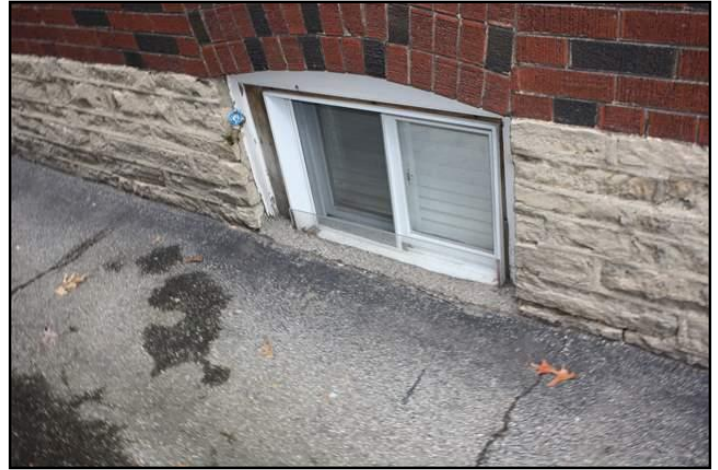
Condition: • Window sill is at or below grade.

13. Window sill is at or below grade.

It is common to find basement windows at grade on older homes. Modern standards now require that windows sills be above grade by 6-inches. Prudent to monitor for now and upgrade as required particularly if any moisture intrusion is noted.

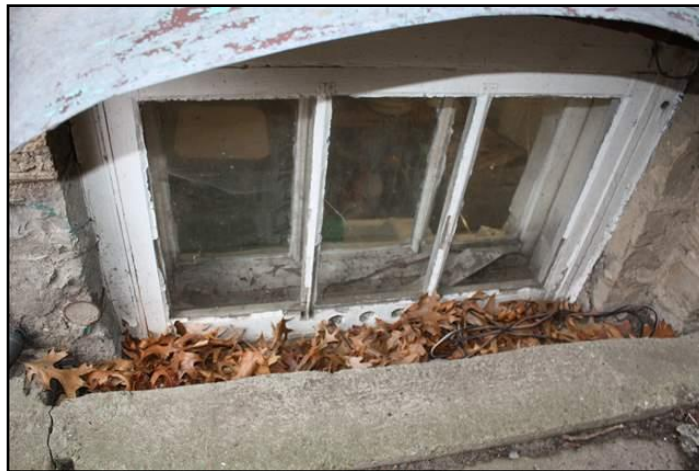
15. Older style window well.

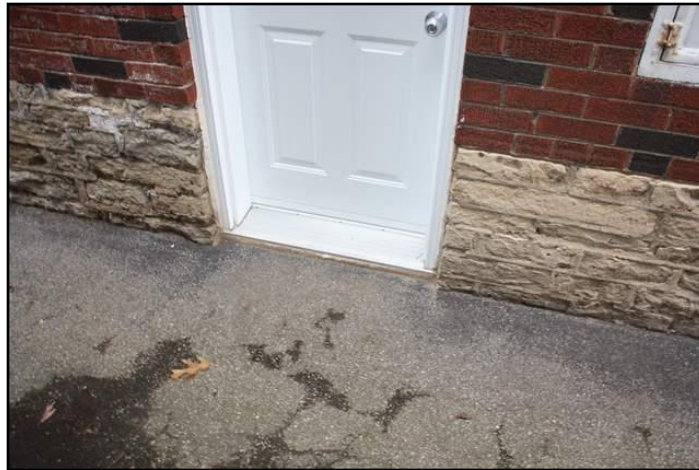
Condition: • Threshold too low

16. Threshold too low

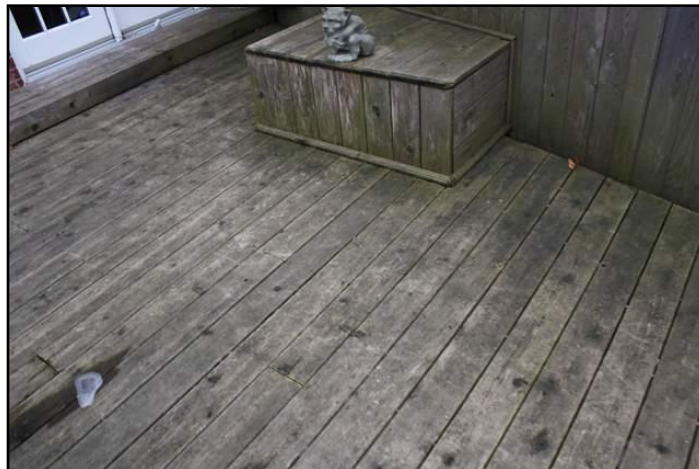
Condition: • [Paint or stain needed](#)

17. Paint or stain needed

Task: Improve

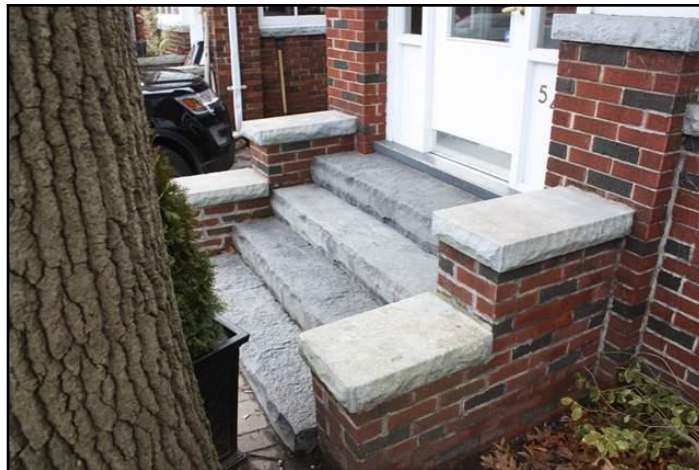
Condition: • [Missing](#)

18. Missing

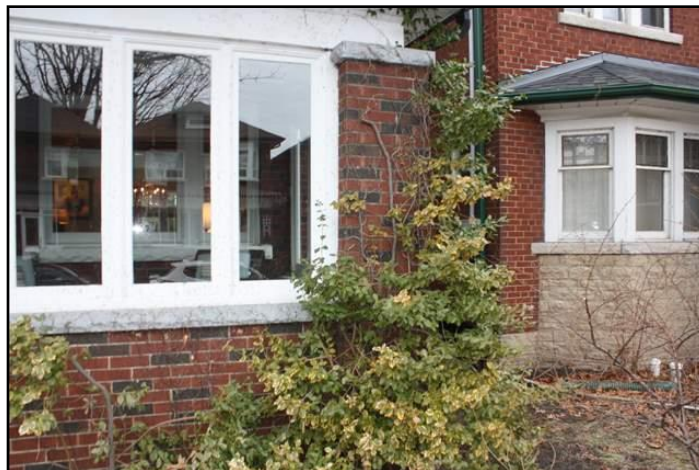
Condition: • Vines on building

Vines can cause problems with clogging gutters and downspouts, obstructing vents, damaging masonry, allowing rodents access to walls, roof and attic, discolouration of siding. etc.

19. Vines on building

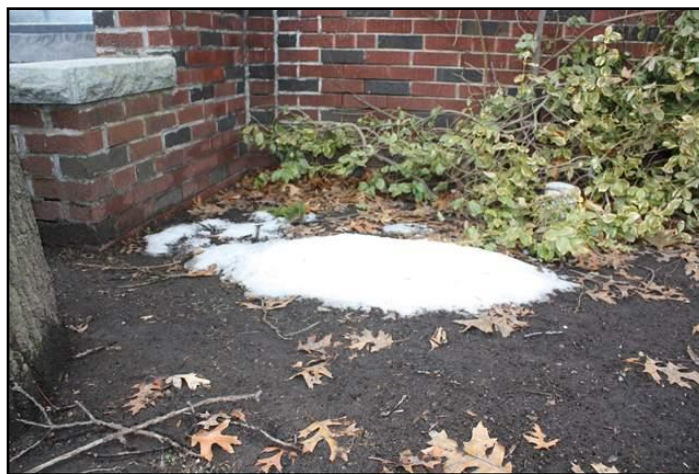
Condition: • Low Areas.

20. Low Areas.

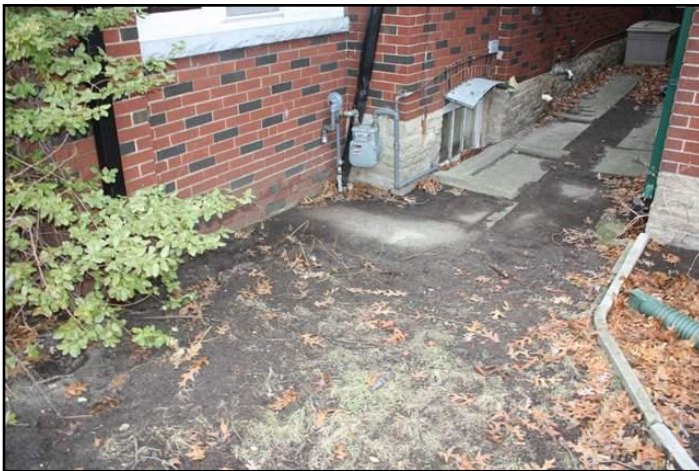
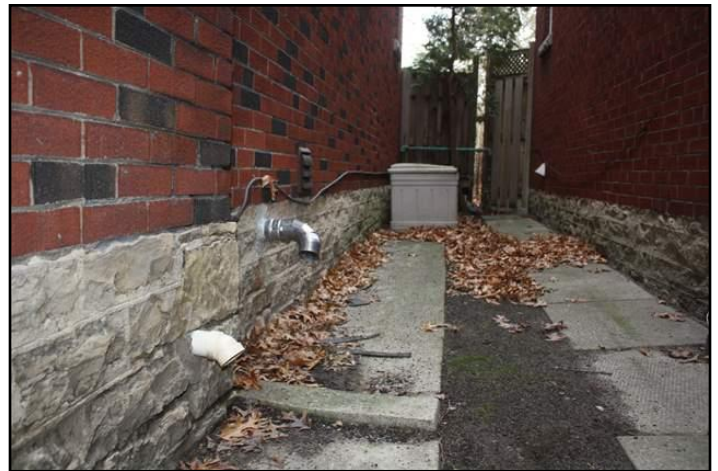
Condition: • [Improper slope or drainage](#)

21. Improper slope or drainage

Task: Correct / Replace

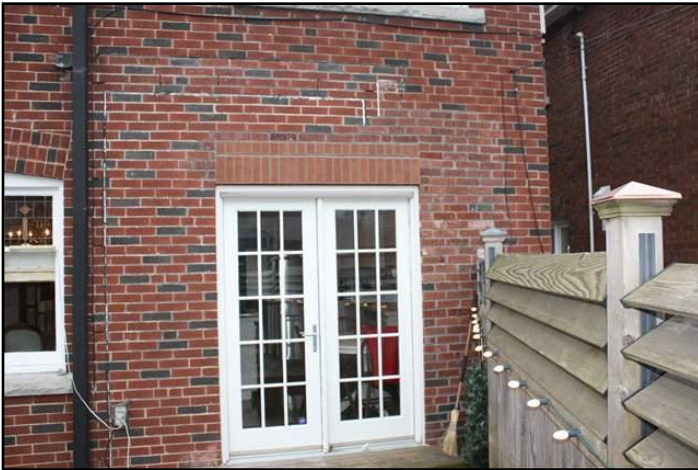
Condition: • [Prior repairs](#)

23. Prior repairs

Task: For Your Information / Monitor

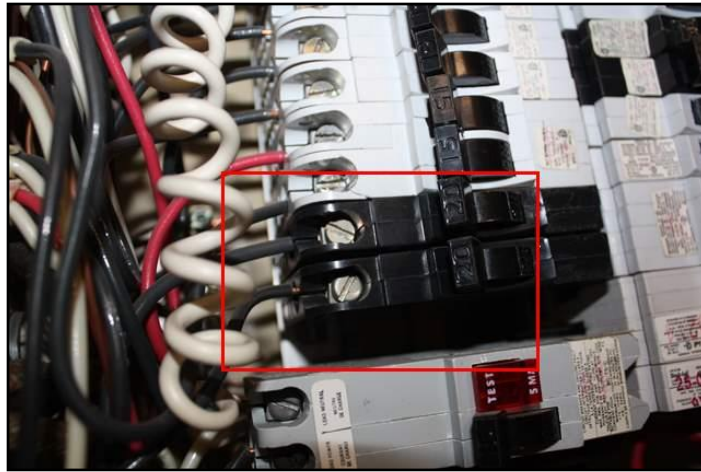
Condition: • [Fuses or breakers too big](#)

25. Fuses or breakers too big

20-amp breaker with 14-gauge copper wire. Replace with 15-amp breaker unless it is powering an appliance or equipment that requires a larger breaker on start up.

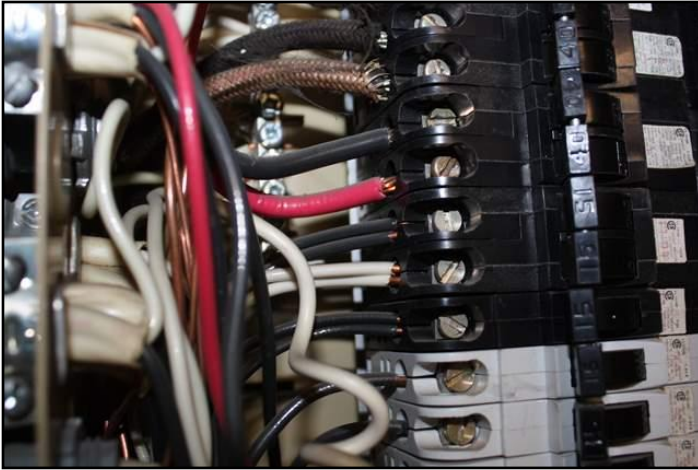
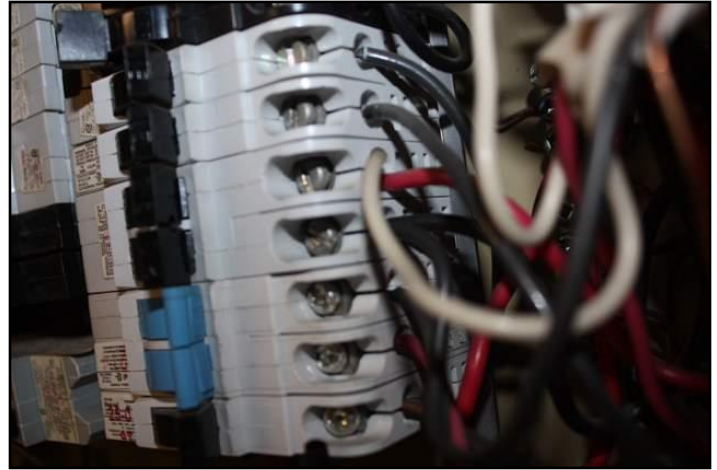
Condition: • [Double taps](#)

26. Double taps

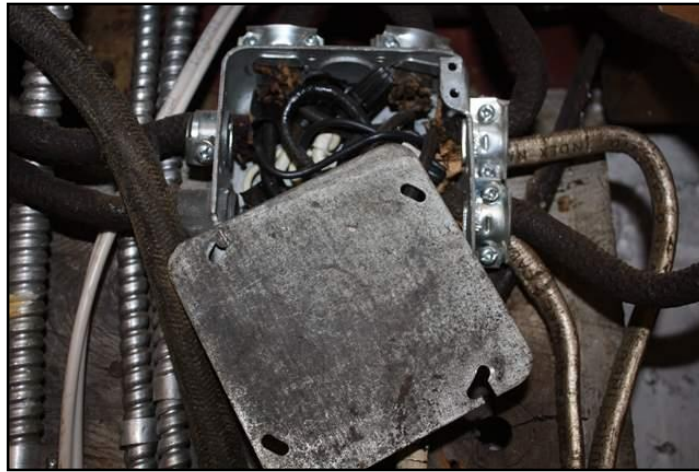
DISTRIBUTION SYSTEM \ Knob-and-tube wiring**Condition:** • [Outdated](#)

We found a mix of varying ages of wiring in the home, including Knob and tube wiring, post knob and tube ungrounded wiring, and modern grounded wiring. Some of the old and new wiring is connected together in junction boxes. Knob and tube wiring was installed pre-1950 in all homes, therefore it is common to find this type of wiring in most homes built before 1950 unless the wiring has been fully upgraded. Most of the wiring in the home is behind walls and ceilings and not observed therefore we cannot provide an estimate as to the extent of knob and tube found.

Implication(s): Nuisance | Potential problem when obtaining home insurance**Location:** Various**Task:** Consult with your insurer for their requirements**Time:** Prior to obtaining insurance**Cost:** Depends on work needed, but typically \$1000-\$2000 per room.

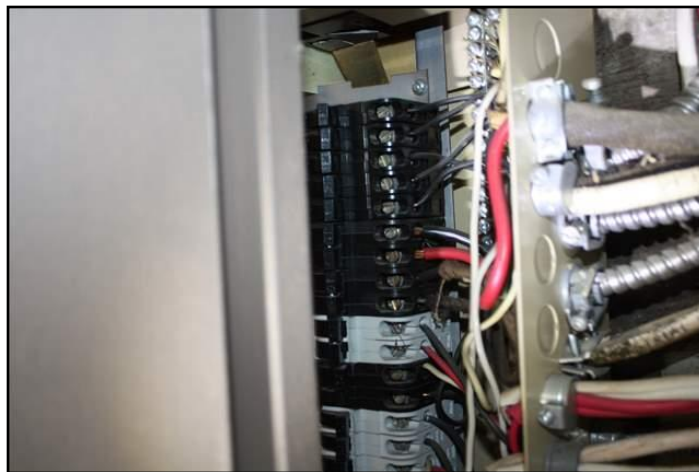
Condition: • [Improper color coding](#)

29. Improper color coding

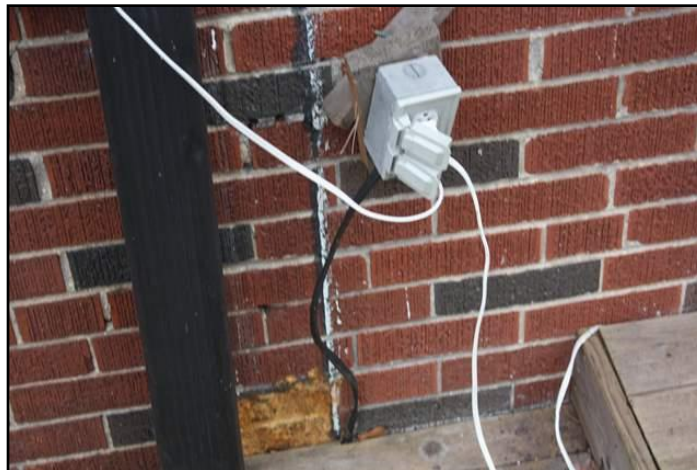
Condition: • [GFCI/GFI needed \(Ground Fault Circuit Interrupter\)](#)

30. GFCI/GFI needed (Ground Fault Circuit...

Task: Replace

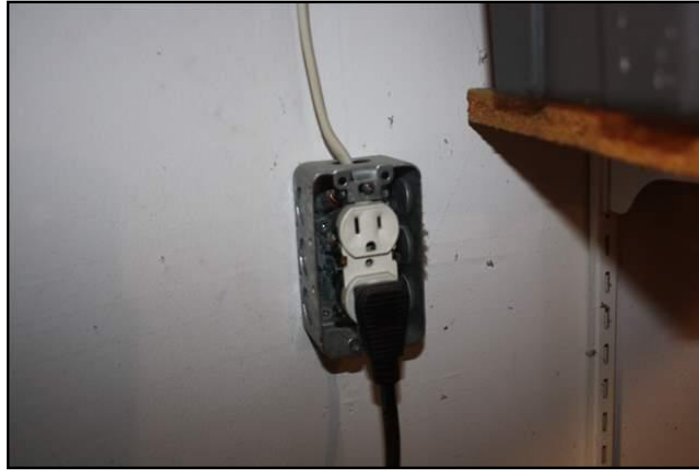
Condition: • For outlet (receptacle) is missing

31. For outlet (receptacle) is missing

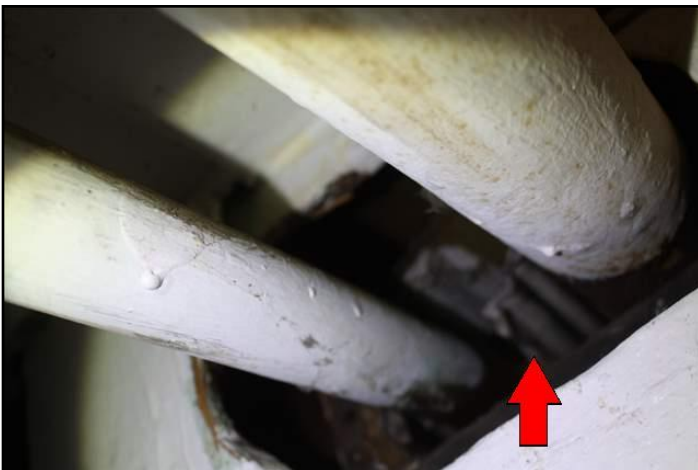
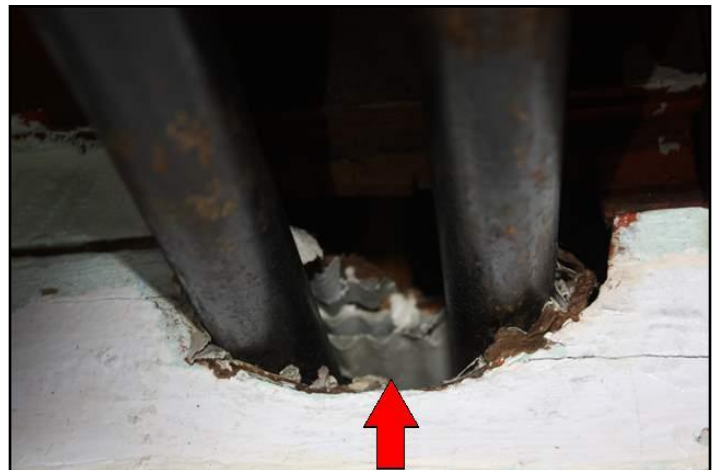
Condition: • The insulation on the boiler or heating pipes may contain asbestos. Health Canada recommends the insulation be left in place undisturbed. If the insulation is damaged or is to be disturbed, and if it contains asbestos (confirm with Laboratory test), precautions should be taken that asbestos fibers are not released into the house air during the work. Please see the Asbestos article in the Supplementary section of the text.

The seller had the accessible portions of the wrap removed from the piping in the boiler room. Where the piping penetrates the wall and / ceilings the wrap can still be observed at inaccessible areas. This type of insulation wrap was the prevalent type used on hot water boiler/radiator piping during this era and we observe this frequently. The photos show a sampling

Location: Basement**Task:** Further Evaluation prior to disturbing / Removing**Time:** Discretionary - see note**Cost:** Consult with specialist when necessary.

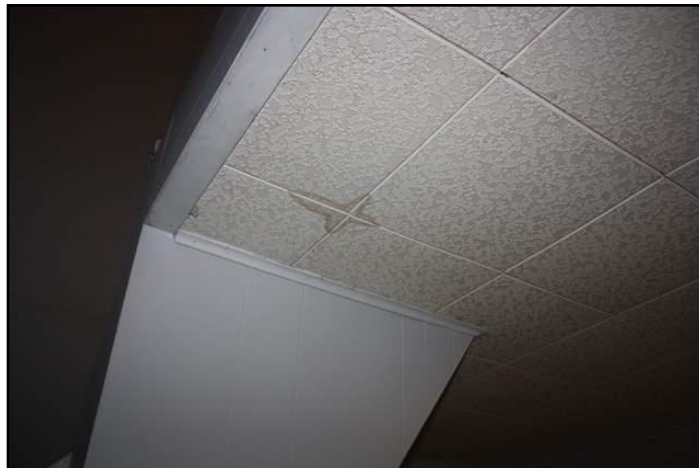
Condition: • Stains

Appearance of minor stain noted at ceiling. Tested with moisture meter and was dry at time of inspection.

35. Stains

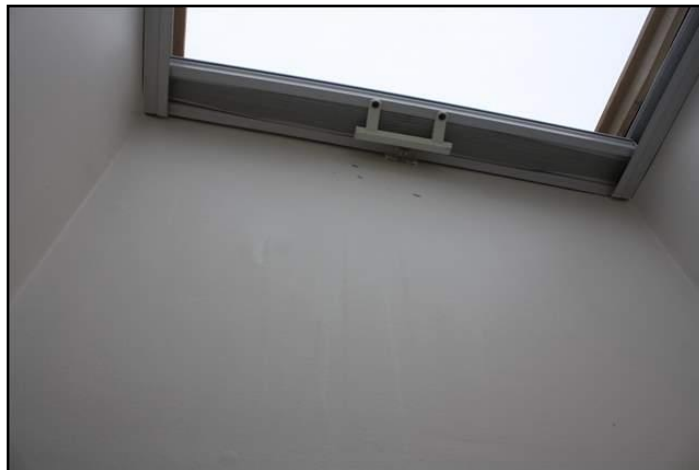
Condition: • [Excess condensation](#)

36. Condensation streaks on wall below skylight

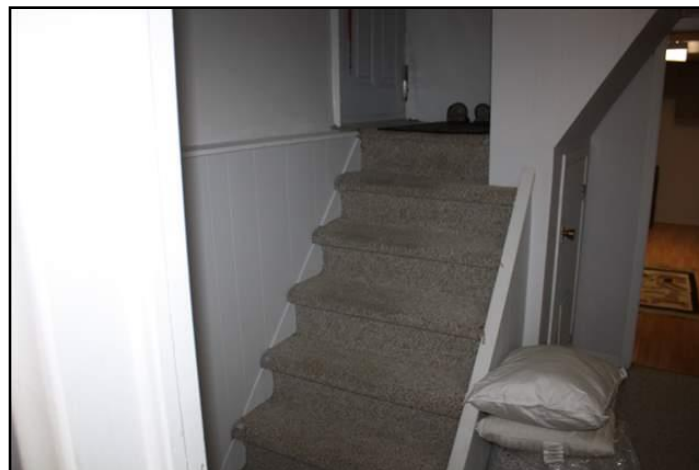
Condition: • [Missing](#)

37. Missing handrail

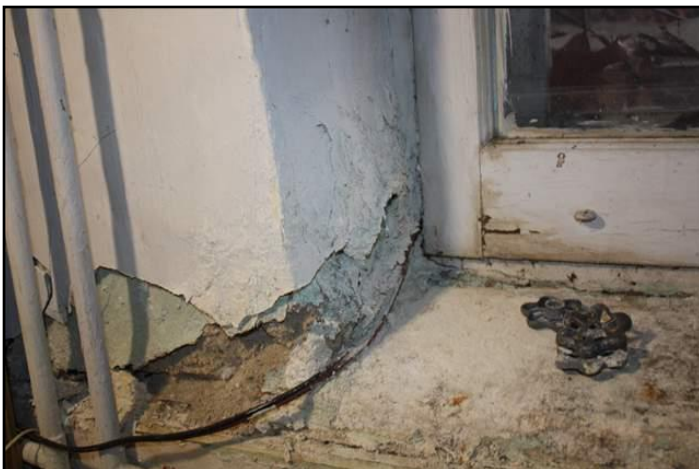
Condition: • [Dampness on floor or walls](#)

Minor dampness noted in boiler room around window and at rear basement. We did not observe any standing water in this area. Condensation is common with stone foundations.

38. Window in boiler room

Task: Monitor / Improve

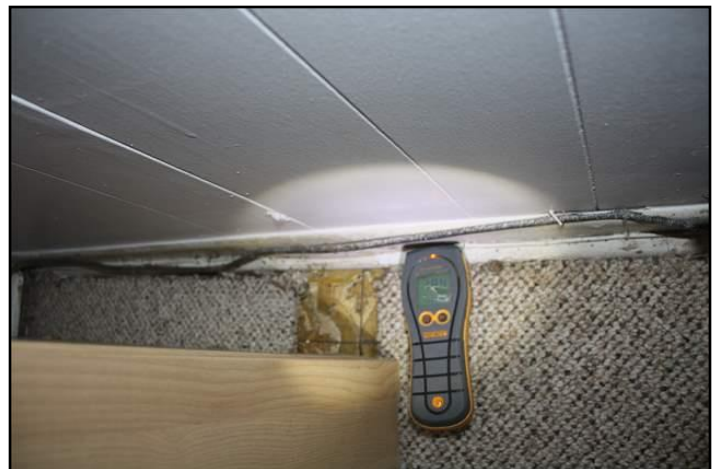
39. Rear basement

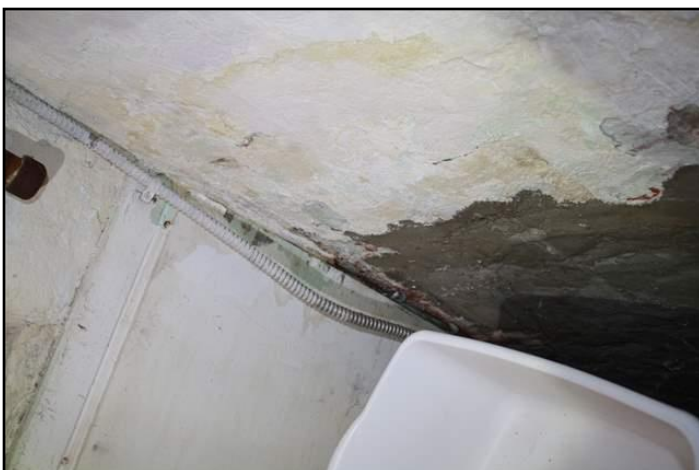
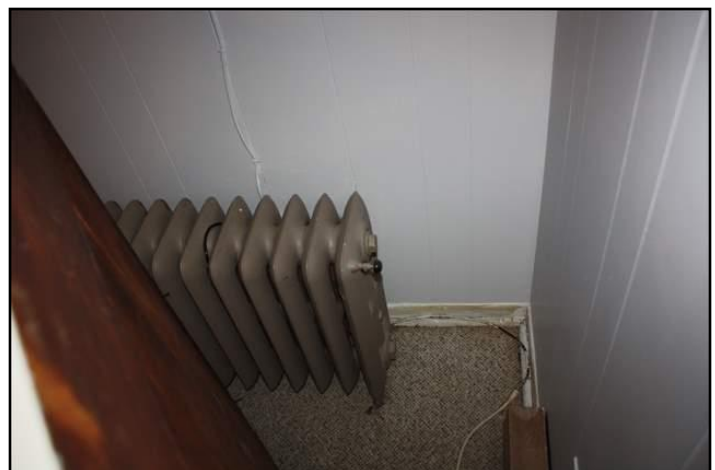
Condition: • [Stains](#)

It is common to find stains/water marks and/or minor dampness in a home of this age with stone or block foundations. Seller noted that the basement has not encountered any major leakage. Condensation can be expected from time to time on older stone foundations. Prudent to monitor especially after heavy rainfalls.

Task: Monitor

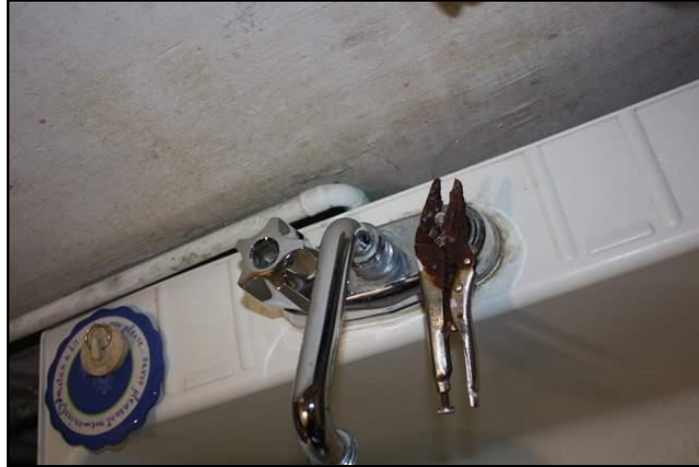
Condition: • Handle damaged

42. Handle damaged

Task: Replace
