Your Inspection Report

19 Somers Avenue
Toronto, ON

Thursday, April 27, 2017

RE: Report No. 2163
19 Somers Avenue
Toronto, ON

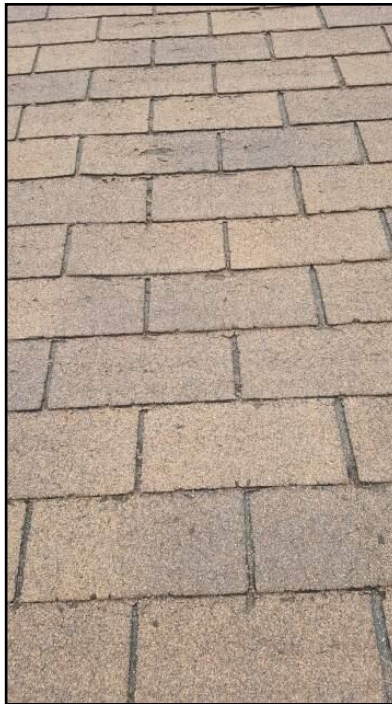
1. Condition: • [Near end of life expectancy](#)

Upper sloped area due for reshingling in near future.

Implication(s): Chance of water damage to contents, finishes and/or structure

3. *Near end of life expectancy*

Task: Replace

Time: 2-3 years

Cost: \$2,500

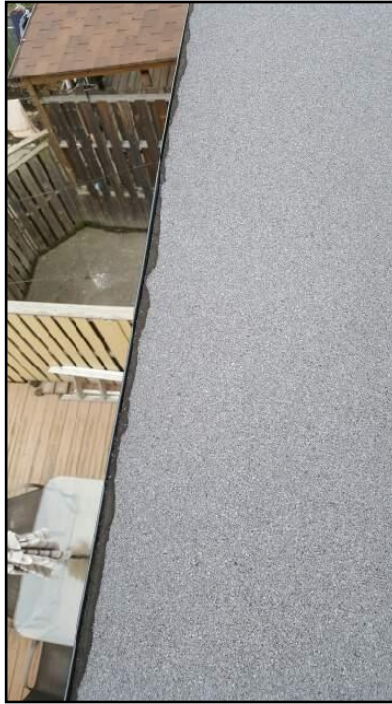
2. Condition: • [Openings at seams or flashings](#)

Implication(s): Chance of water damage to contents, finishes and/or structure

4. *Openings at seams or flashings*

Reseal 2 perimeter edges of flat roof.

Task: Repair

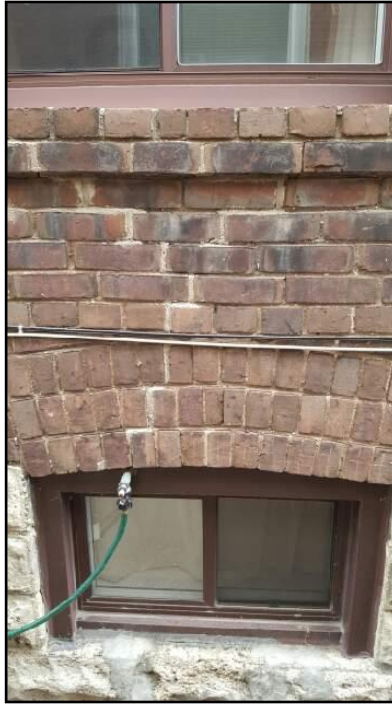
5. Condition: • Typical minor cracks, not structurally significant.

Typical minor cracks are not structurally significant, but indicate areas where foundation is most vulnerable to water entry. Do not accumulate snow against wall and keeps eavestroughs clean.

5. Typical minor crack

Task: Monitor

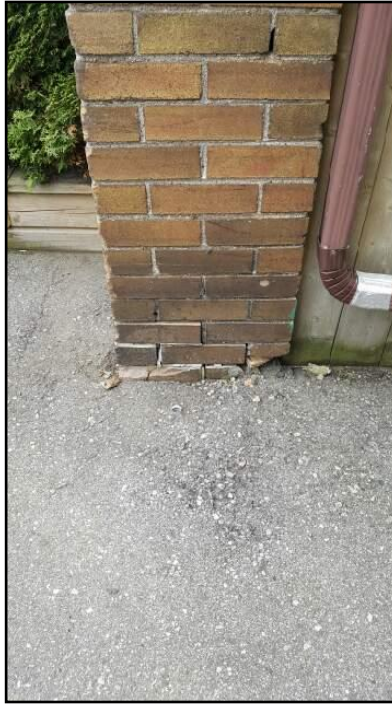
6. Condition: • [Damage](#)

This column provides support to second floor, minor masonry repair needed.

Implication(s): Chance of movement | Weakened structure

6. Damage

Task: Repair

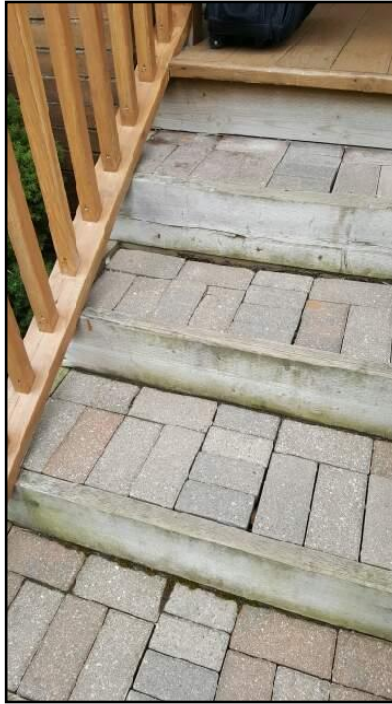
7. Condition: • Trip hazard

Implication(s): Trip or fall hazard

7. Trip hazard

Lift and relay interlocking level with wood facing.

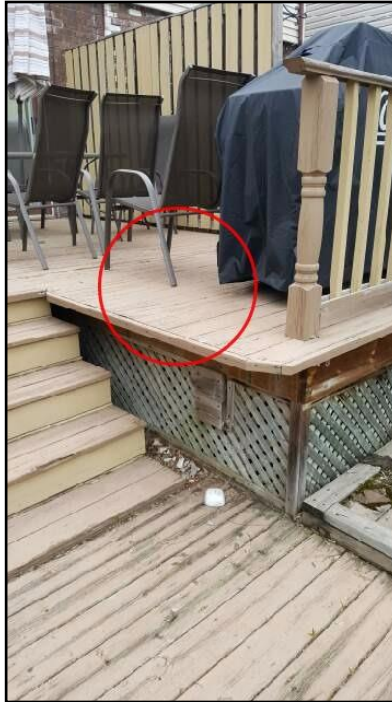
8. Condition: • Incomplete

8. *Incomplete*

Continue guardrail to meet steps.

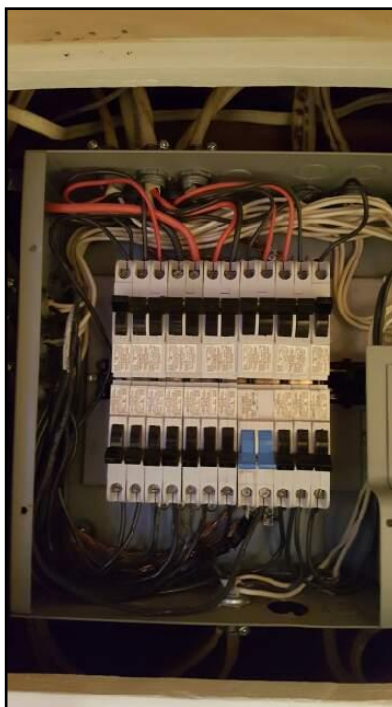
11. Condition: • [Double taps](#)

Implication(s): Fire hazard

9. Double taps

Add breakers at panel and split if nuisance tripping occurs.

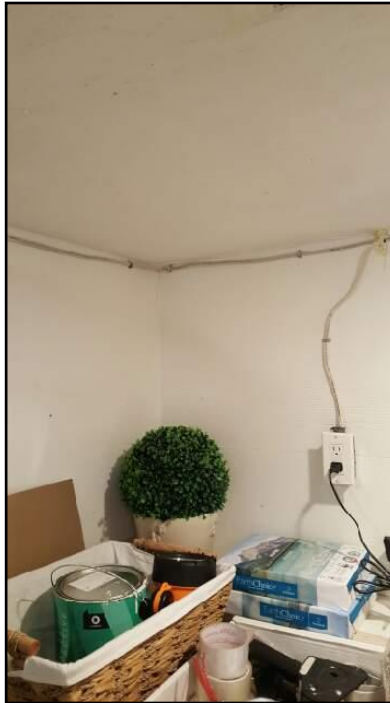
12. Condition: • [Exposed on walls or ceilings](#)

Implication(s): Electric shock

10. Exposed on walls or ceilings

Protect exposed wiring with conduit.

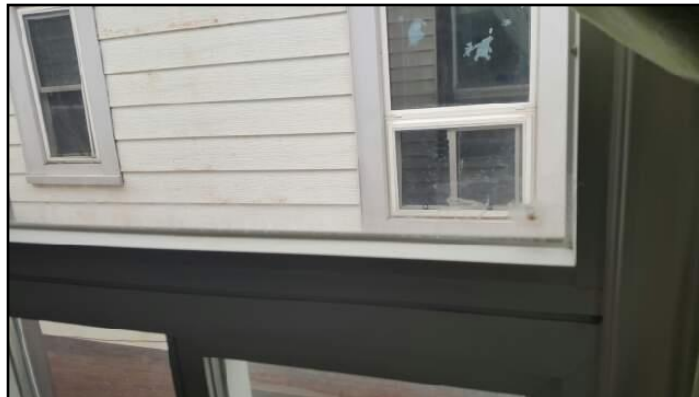
18. Condition: • [Lost seal on double or triple glazing](#)

This issue is cosmetic only.

11. Lost seal on double or triple glazing

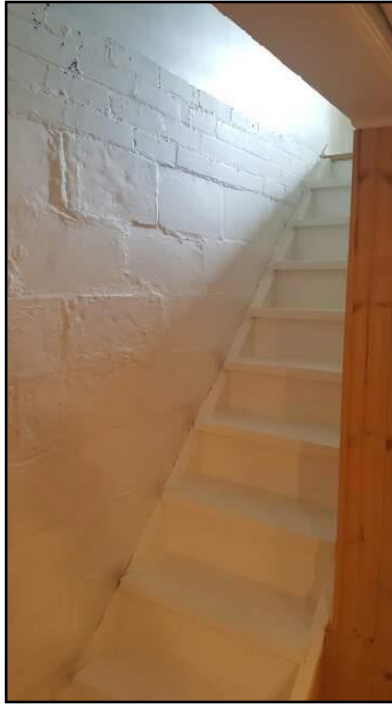
19. Condition: • [Missing](#)

Implication(s): Fall hazard

12. *Missing handrail*

Task: Provide
