YOUR INSPECTION REPORT

FOR THE PROPERTY AT:
915 Ossington Avenue
Toronto, ON M6G 3V3

INSPECTION DATE:
Friday, February 18, 2022

RE: Report No. 7026, v.2
915 Ossington Avenue
Toronto, ON
M6G 3V3

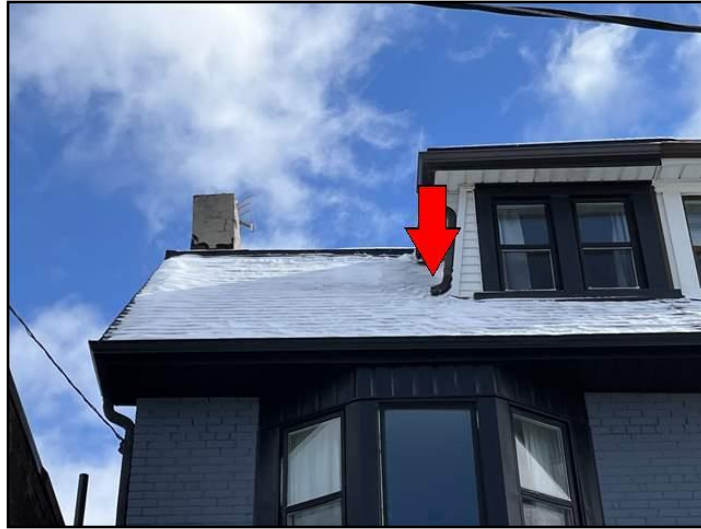
1. Discharge onto roofs

Condition: • [Discharge onto roofs](#)

Improvement recommendation. Extend Downspout to lower gutter to protect roof from premature wear.

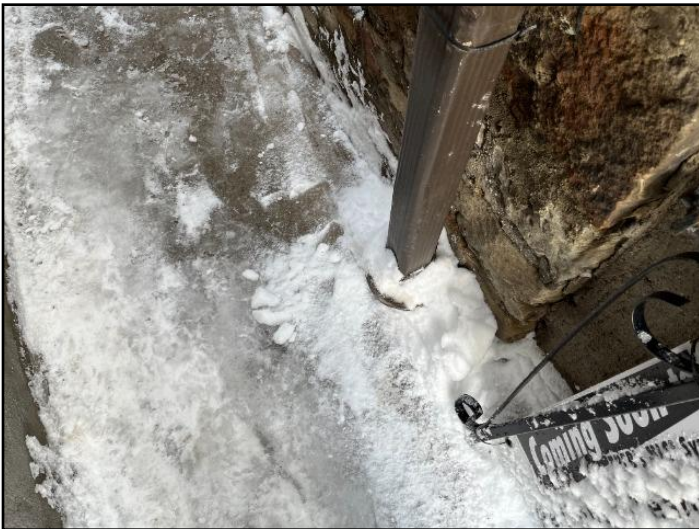
2. Downspouts below grade - Toronto. For more...

Condition: • Downspouts below grade - Toronto.

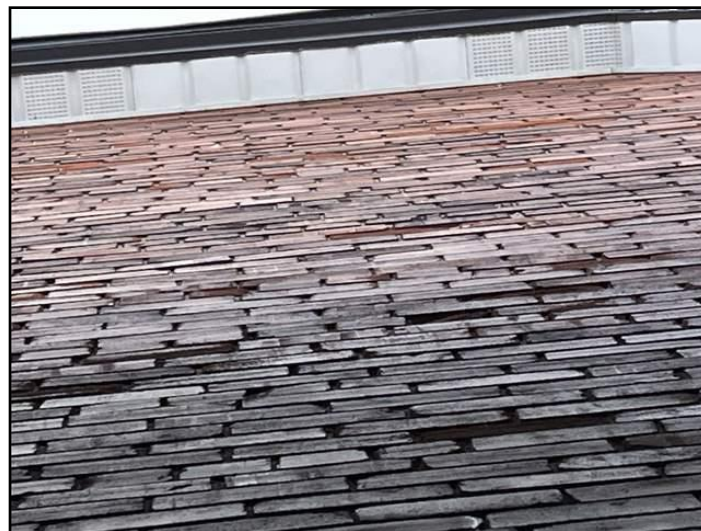
4. Spalling example

Condition: • [Spalling](#)

Spalling and mortar deterioration at various areas of brick. Repair / Replace / Tuck point masonry. This is regular maintenance for a home of this age.

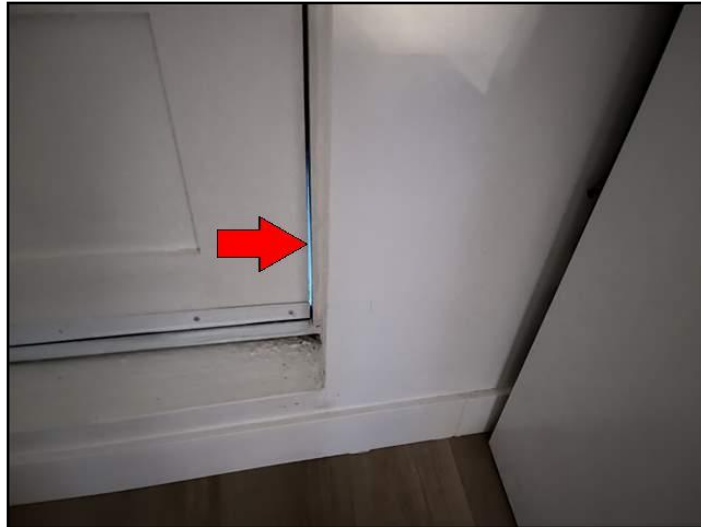
5. Air leaks

Condition: • [Air leaks](#)

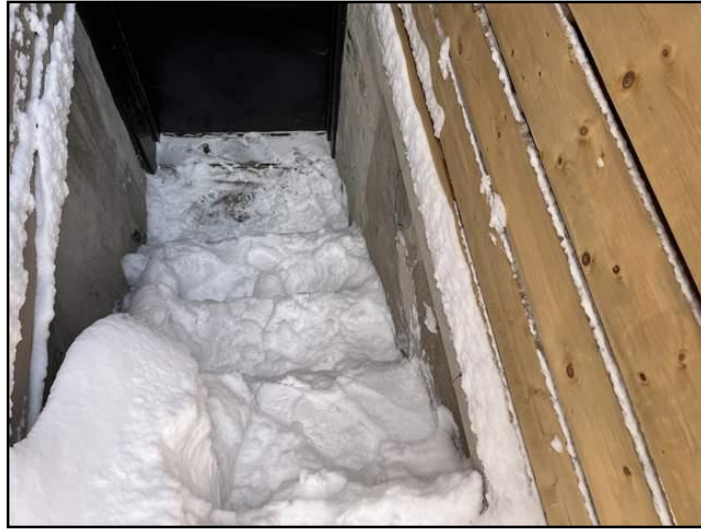
6. handrail needed

Condition: • [Guard and handrail problems](#)

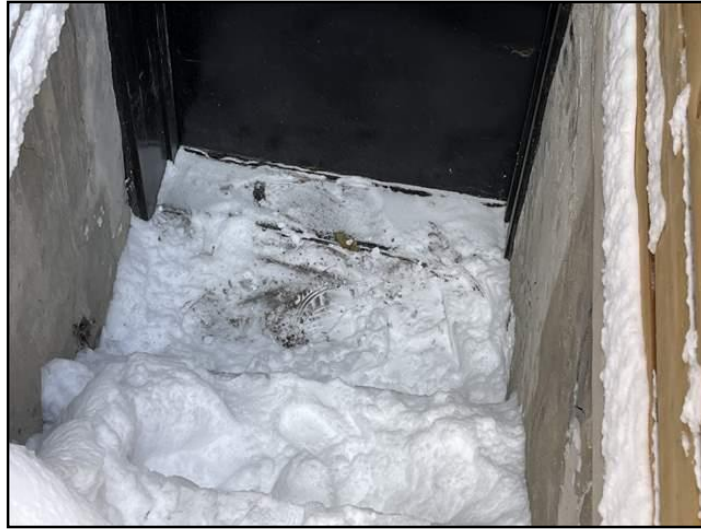
7. Door threshold too low

Condition: • [Door threshold missing, too low, not watertight](#)

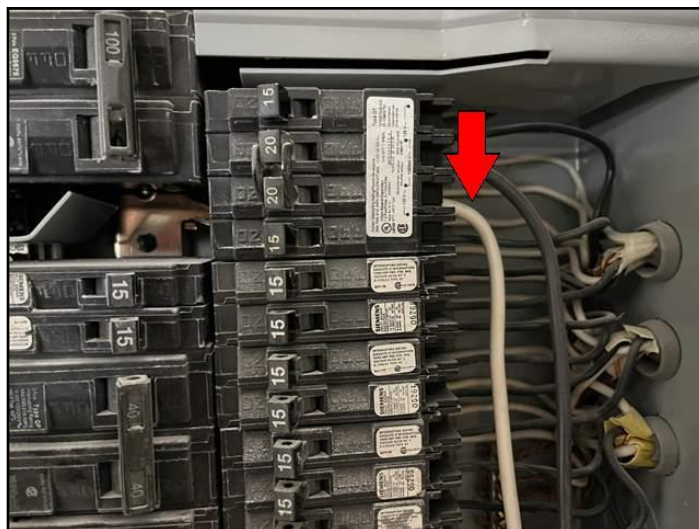
8. White wires connected to breakers not...

Condition: • White wires connected to breakers not identified as hot/live/ungrounded

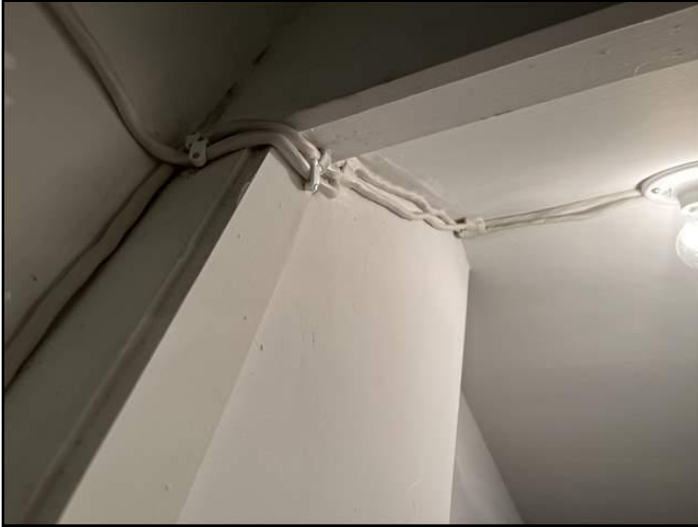
9. Exposed on walls or ceilings

Condition: • [Exposed on walls or ceilings](#)

Task: Correct / Provide conduit

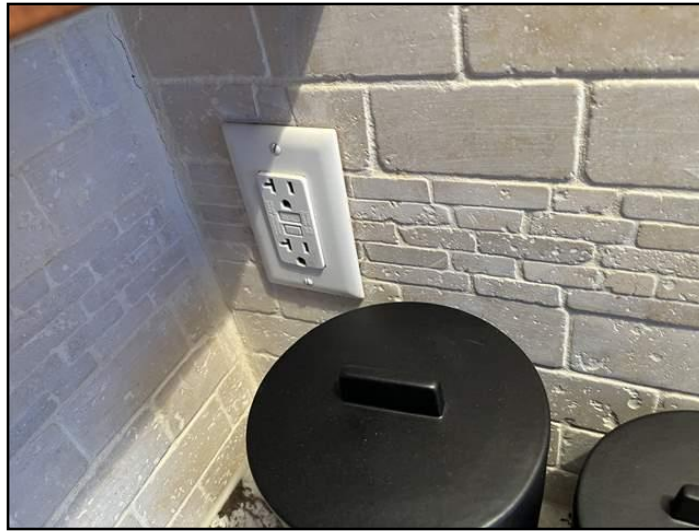
12. Loose

Condition: • [Loose](#)

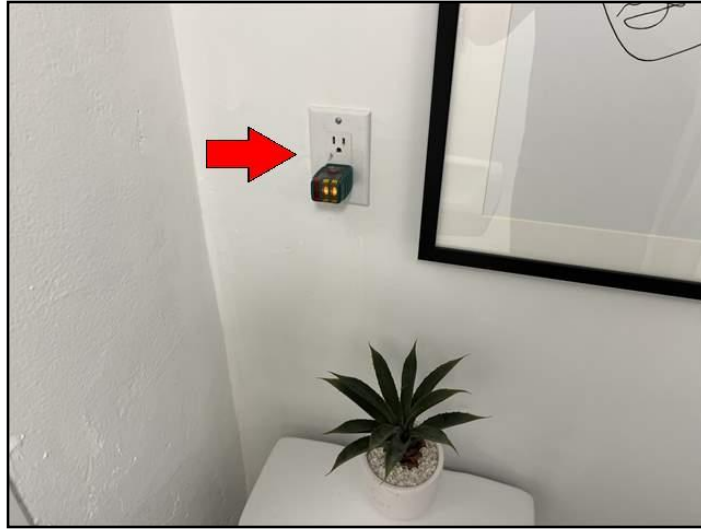
13. GFCI/GFI needed (Ground Fault Circuit...

Condition: • [GFCI/GFI needed \(Ground Fault Circuit Interrupter\)](#)

Task: Replace

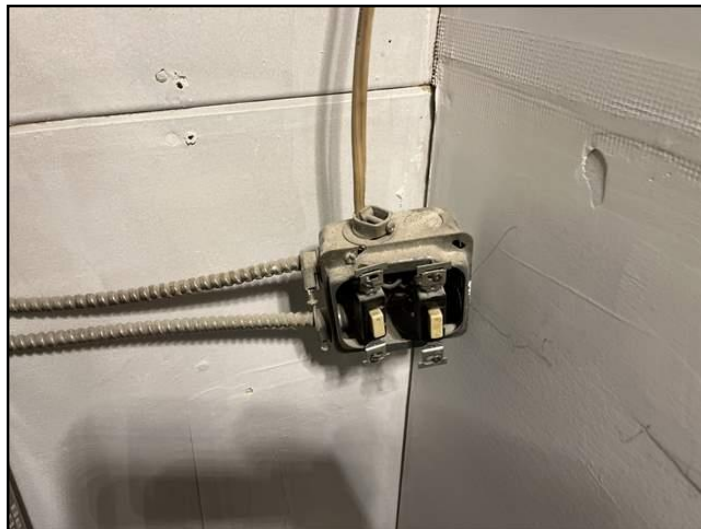
14. For switch is missing

Condition: • For switch is missing

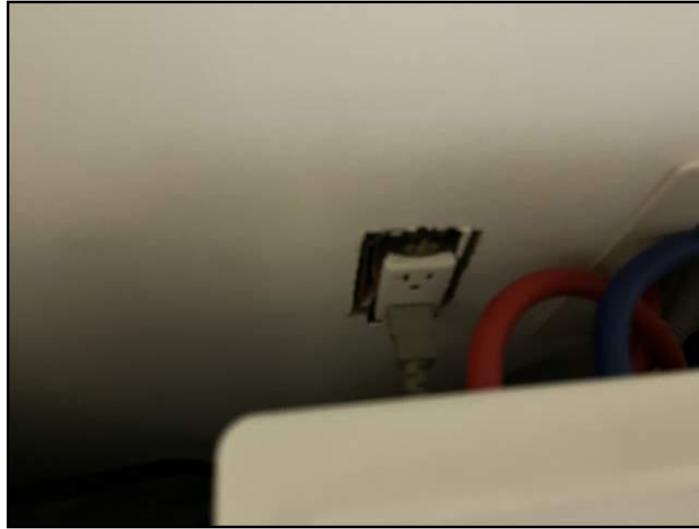
15. For outlet (receptacle) is missing

Condition: • For outlet (receptacle) is missing

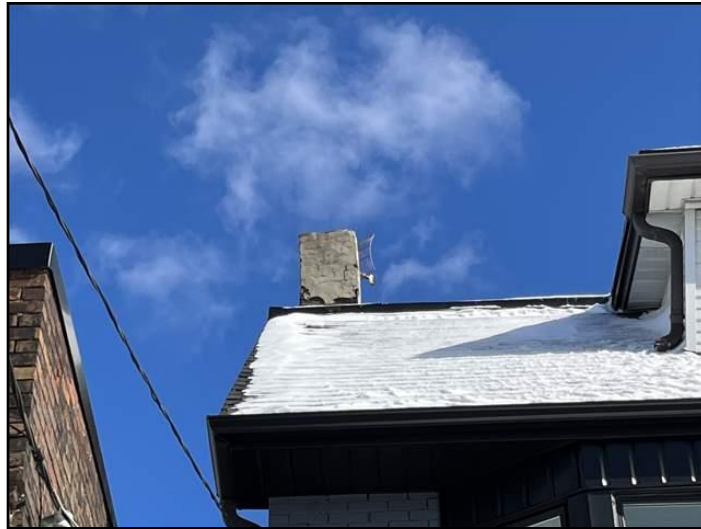
17. Settling or leaning

Condition: • [Settling or leaning](#)

Masonry deterioration and minor leaning observed. If you have no plans to restore and use wood fireplace, consider removing altogether

Task: Remove

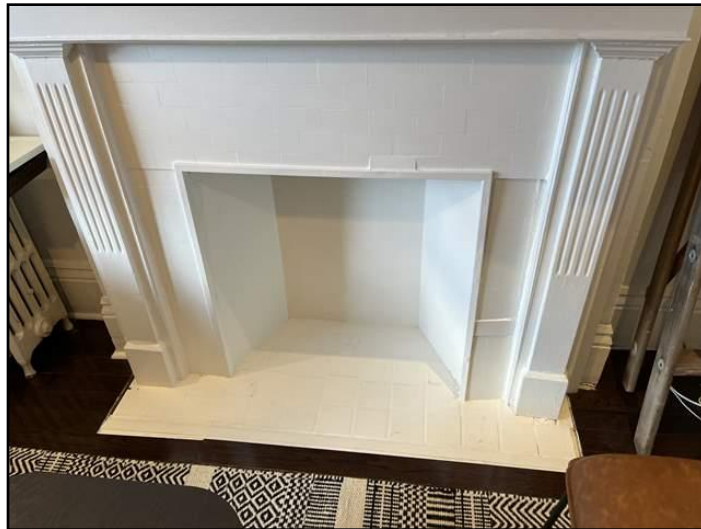
18. Not functional

Condition: • Not functional

Do not use wood fireplaces. If you plan to use in future, consult with chimney specialist and repair/upgrade fireplace, flue and chimney to modern standards.

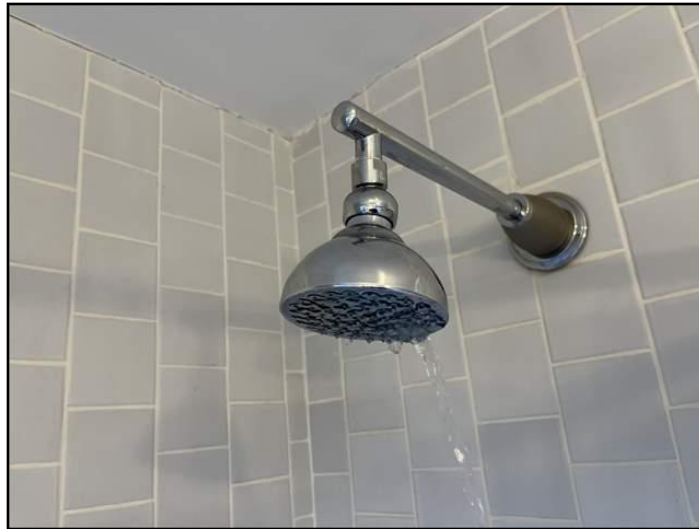
20. Poor pressure when toilet flushed

Condition: • [Poor pressure or flow](#)

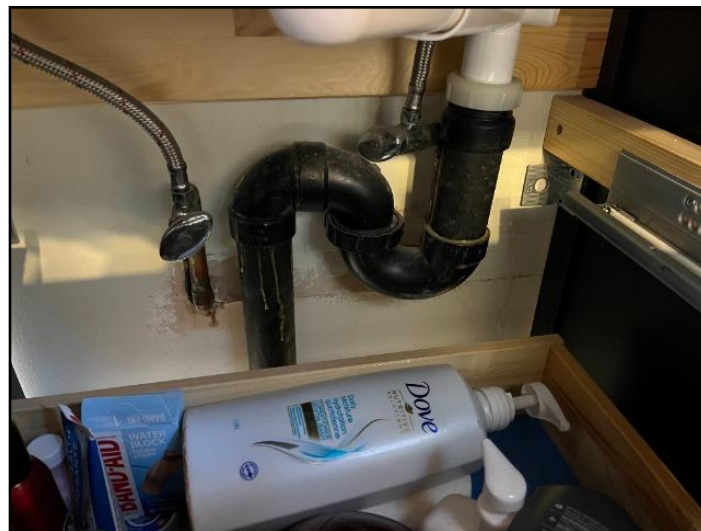
21. Nonstandard shape or material

Condition: • [Nonstandard shape or material](#)

S-traps can lead to siphoning

Task: Replace

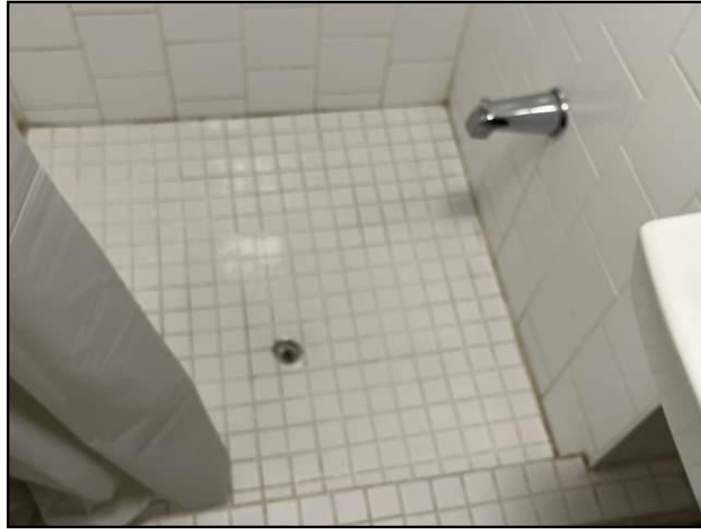
22.

Condition: • The floor drain in the basement shower is smaller than average.

Task: Improve

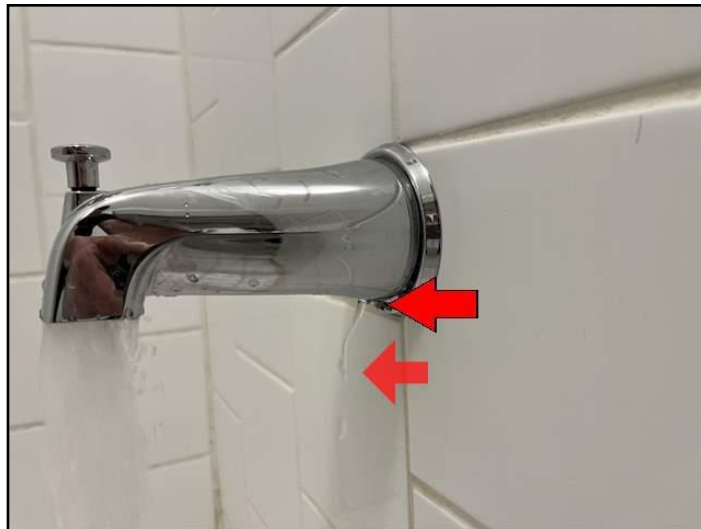
Condition: • [Drip, leak](#)

Water leaks from back of toe tester faucet

23. *Water drips down from faucet connection*

Task: Repair / Replace

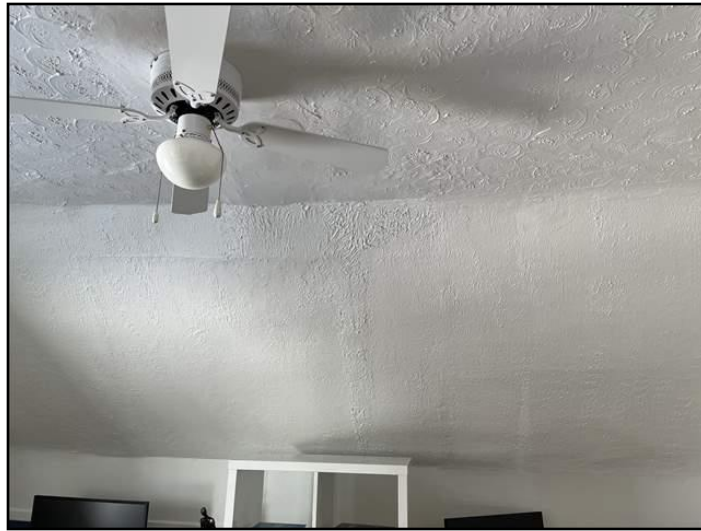
Condition: • [Patched](#)

We noted patching and/or cracks at areas of ceilings at third floor and second floor bedrooms.

Given the home is 90+ years old, these may have been present for some time. We tested ALL patches with moisture meter and all were dry at time of inspection. Seller confirms all repairs are old, prior to their ownership.

24. example from third floor.

Task: For your information / Monitor

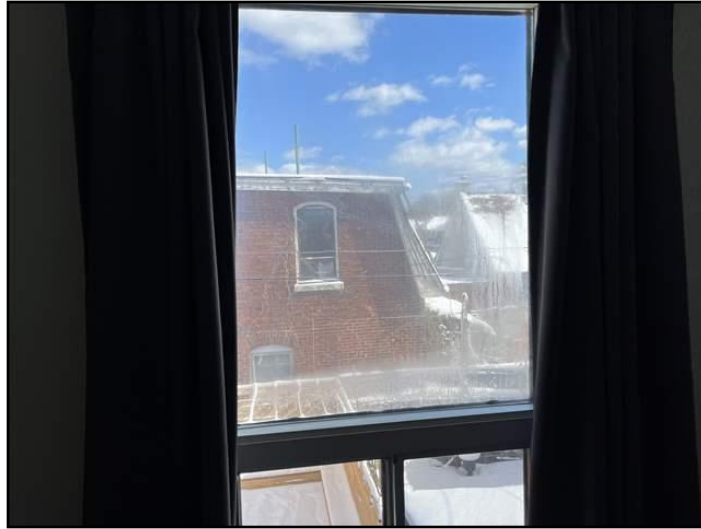
25. Lost seal on double or triple glazing

Condition: • [Lost seal on double or triple glazing](#)

Task: Replace

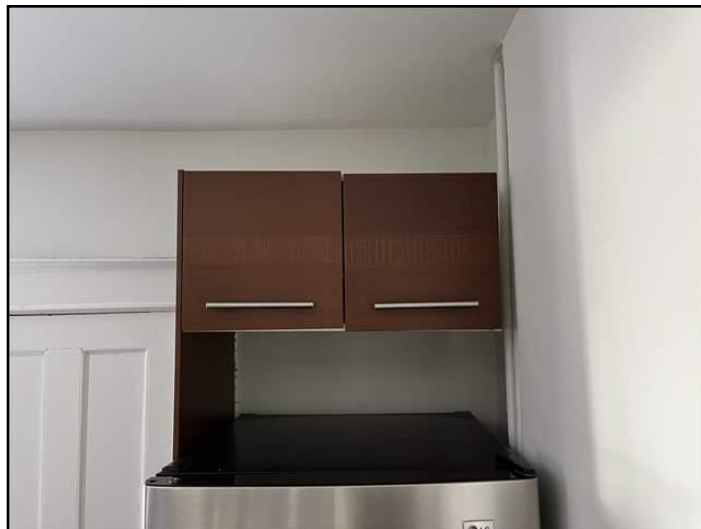
26. Not well secured to wall

Condition: • [Not well secured to wall](#)

Task: Improve support

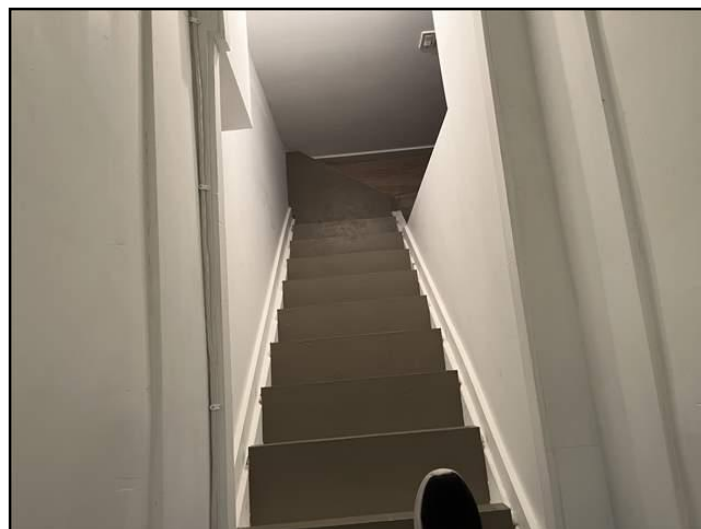
27. Width too small

Condition: • [Width too small](#)

Take caution when using staircase

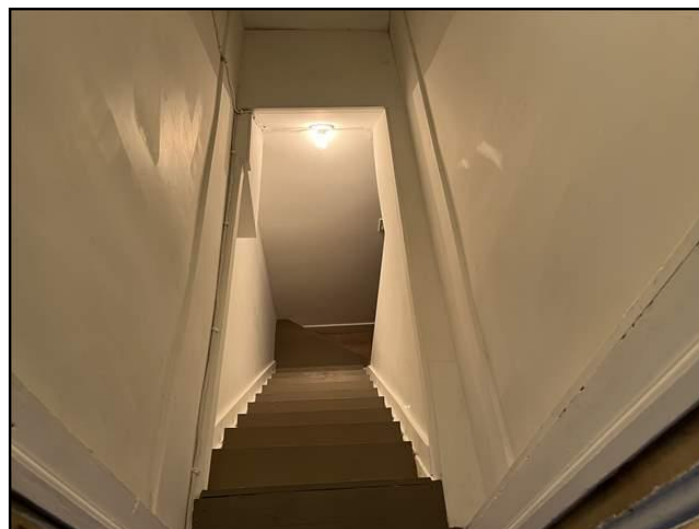
28. Missing

Condition: • [Missing](#)
