INSPECTION REPORT

Sample Home Inspection Report

SAMPLE REPORT

Inspection Date: Wednesday, May 29, 2019

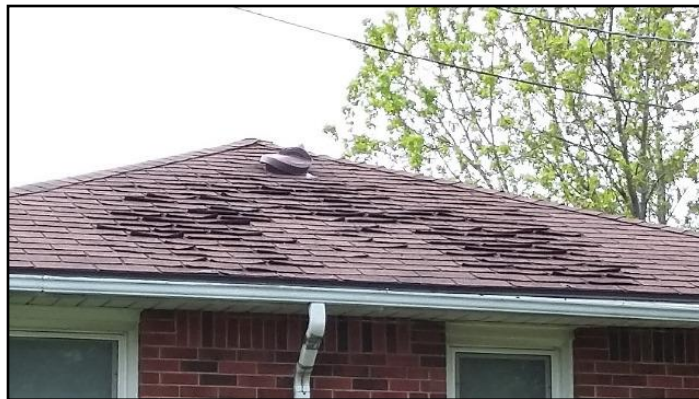
1. Condition: • [Old, worn out](#)

Implication(s): Chance of water damage to contents, finishes and/or structure

Old, worn out shingles

Task: Replace

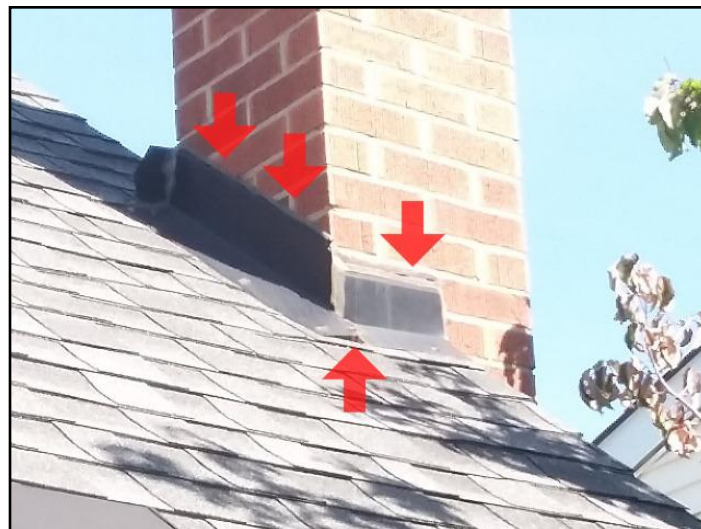
3. Condition: • Failed caulking

Implication(s): Chance of water damage to contents, finishes and/or structure.

Failed caulking & lifted nail

Task: Re-caulk

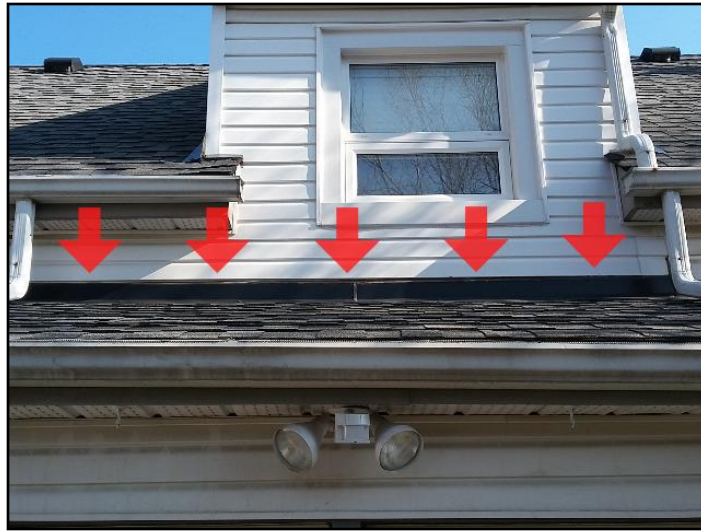
4. Condition: • Failed caulking

Implication(s): Chance of water damage to contents, finishes and/or structure.

Failed caulking

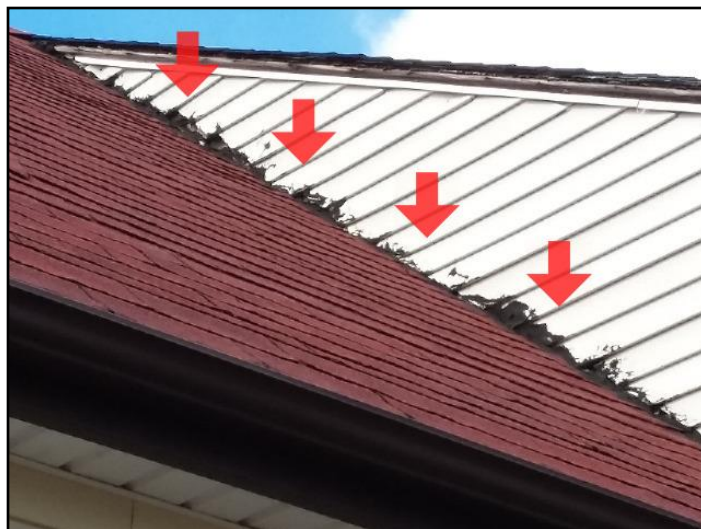
5. Condition: • Leak sealed with roofing tar

Implication(s): Indications of past leakage. Chance of water damage to contents, finishes and/or structure.

Leak sealed with roofing tar

Task: Monitor

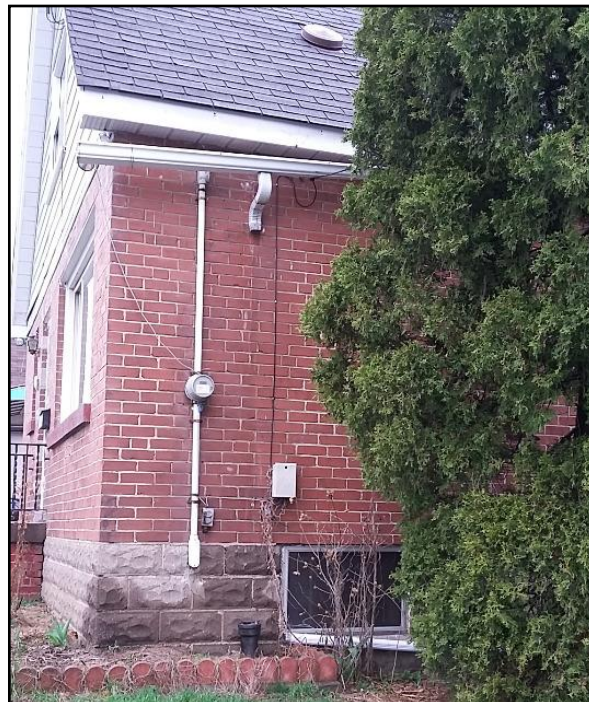
6. Condition: • Missing

Implications: The gutter has pulled away from the house and the downspout is missing. This will cause water to drain adjacent to the house foundation, which is evident by the moisture in the concrete block foundation wall. Chance of foundation damage and basement leakage.

Missing downspout & loose gutter

Task: Repair gutter/Provide downspout

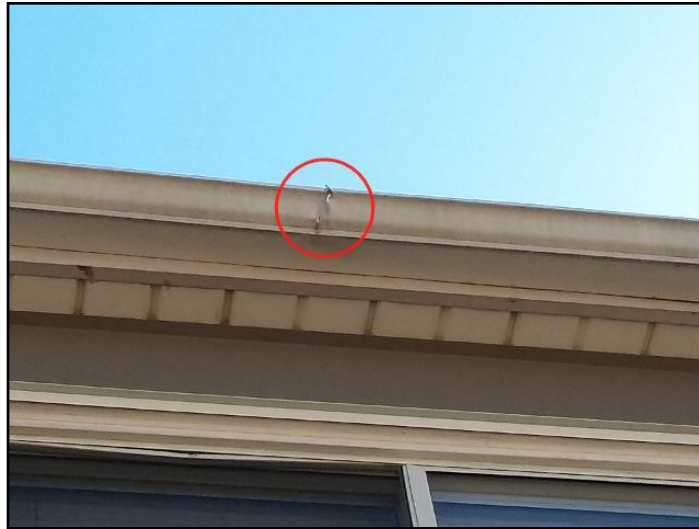
7. Condition: • Damage

Implications: Crack and low spot in gutter can cause water to drain adjacent to the house foundation. Chance of

foundation damage and basement leakage.

Damaged gutter

Task: Repair

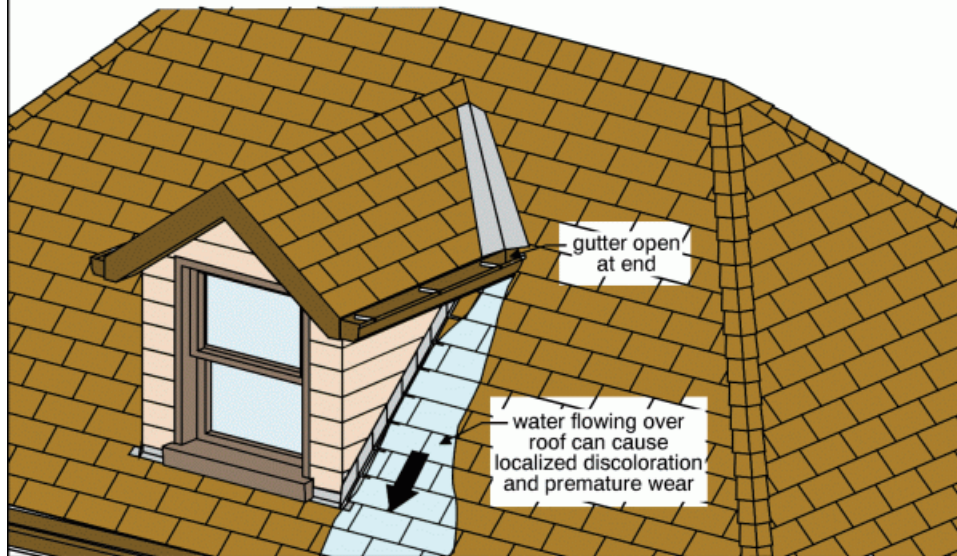
9. Condition: • [Discharge onto roofs](#)

Implications: Upper roof downspout discharging onto the lower roof has caused premature wear to the asphalt shingles. Chance of water damage to contents, finishes and/or structure. Continued damage to asphalt shingles.

Downspout running across roof

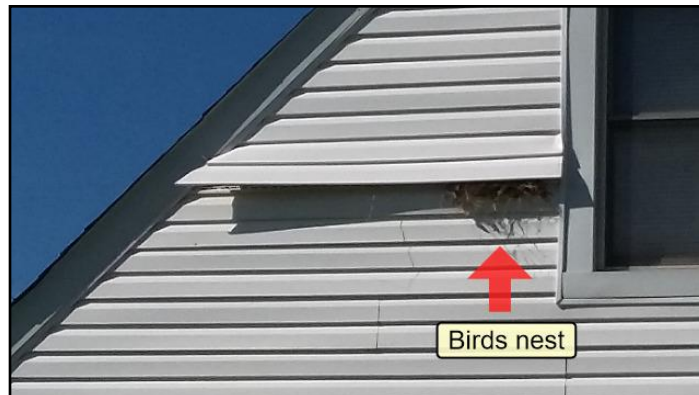
10. Condition: • [Loose or missing pieces](#)

Implication(s): Chance of water damage to contents, finishes and/or structure

Loose piece of siding and birds nest

Task: Repair and remove the birds nest

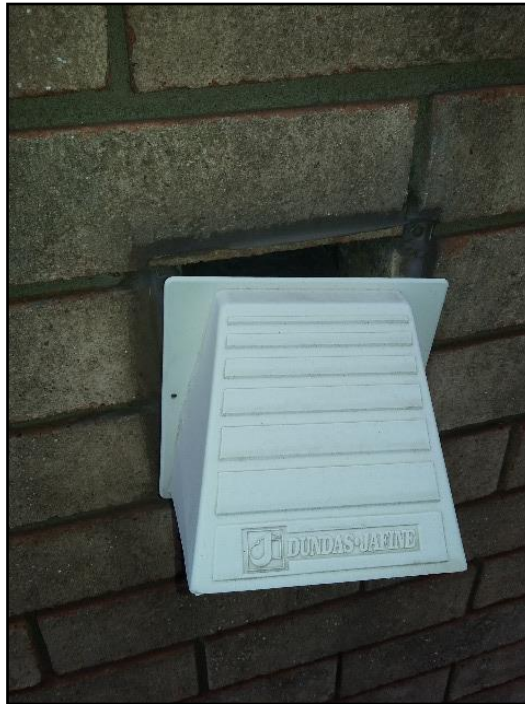
11. Condition: • Dryer vent not secured and sealed to house.

Implication(s): Chance of water damage to contents, finishes and/or structure. Insect and animal entry into house.

Not secured and sealed

Task: Repair

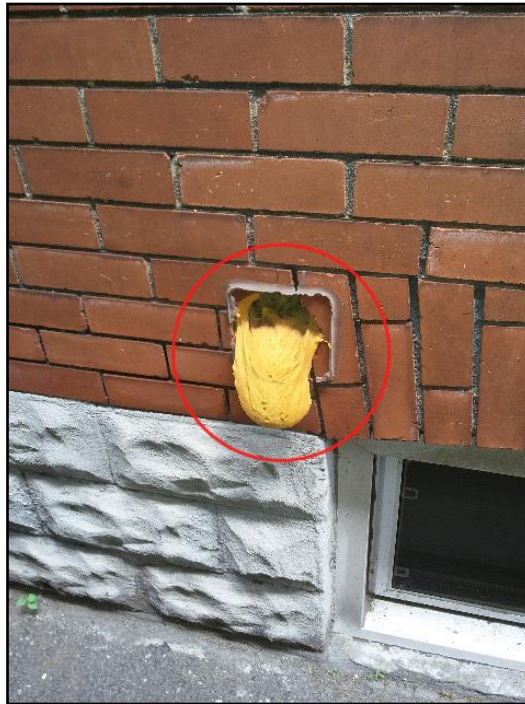
12. Condition: • Abandoned dryer vent sealed improperly.

Abandoned dryer vent sealed improperly

Task: Repair

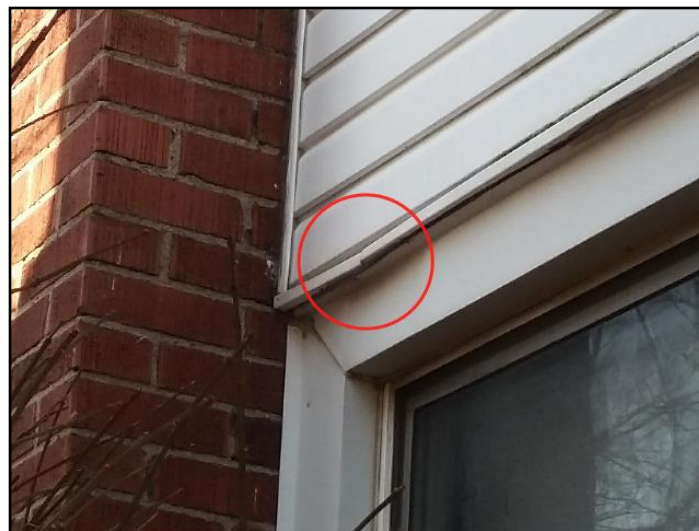
13. Condition: • Incomplete

Implications: The flashing above the window should consist of a single piece of vinyl so it can shed water properly. It is constructed of two separate pieces which can allow water to enter the building. Chance of water damage to contents, finishes and/or structure.

Inadequate flashing

Task: Replace flashing

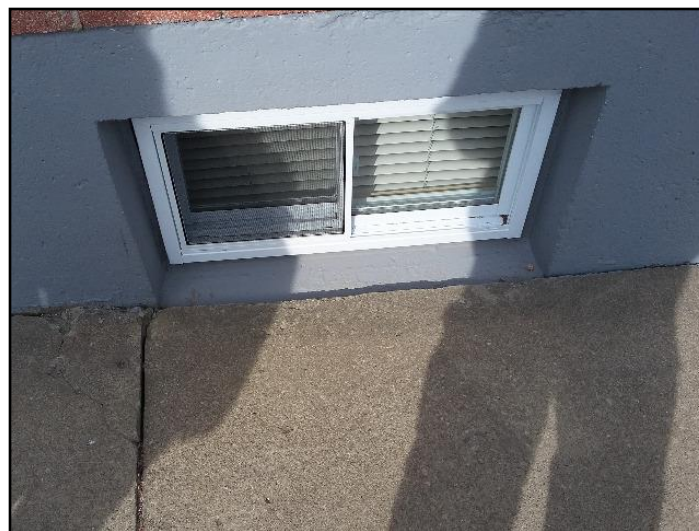
14. Condition: • [Missing](#)

The window is below the grade of the driveway and there is no window well to keep water from entering the building. Determining the extent of the water entry into the basement was limited due to the basement being newly finished with new drywall, paint and carpeting. As a result, invasive investigation would be required in order to determine if past leakage has occurred and to what extent, if any, damage was done. This is beyond the scope of a standard home inspection.

Implication(s): Chance of water damage to contents, finishes and/or structure | Material deterioration

Missing window well

Task: Further evaluation

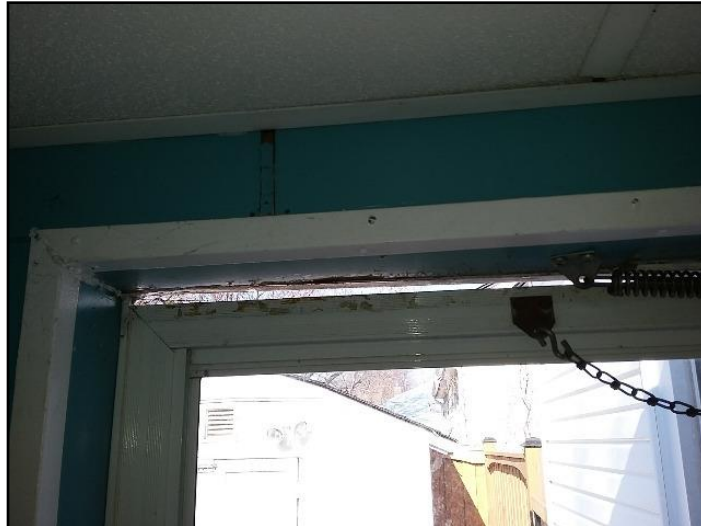
15. Condition: • [Deformation](#)

Deformation of door frame

Task: Monitor and correct if conditions change

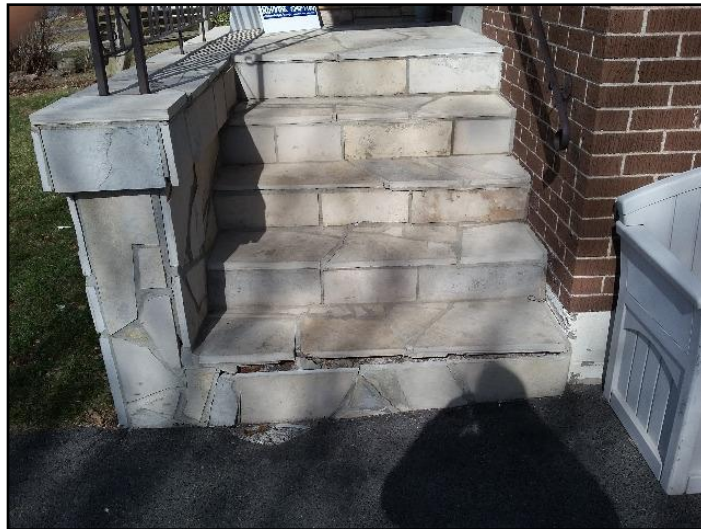
16. Condition: • Cladding on the front porch/stairs is coming off/mortar cracking

Implication(s): Safety hazard

Cladding coming off of front porch/stairs

Task: Repair or replace

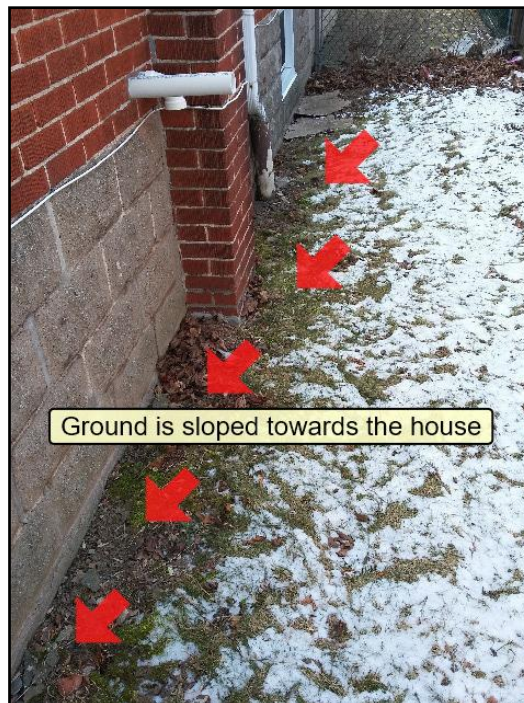
17. Condition: • [Improper slope or drainage](#)

Implications: The grading (ground) is sloping toward the house directing water towards the house foundation. Chance of water damage to contents, finishes, structure, foundation and/or basement leakage.

Improper slope or drainage

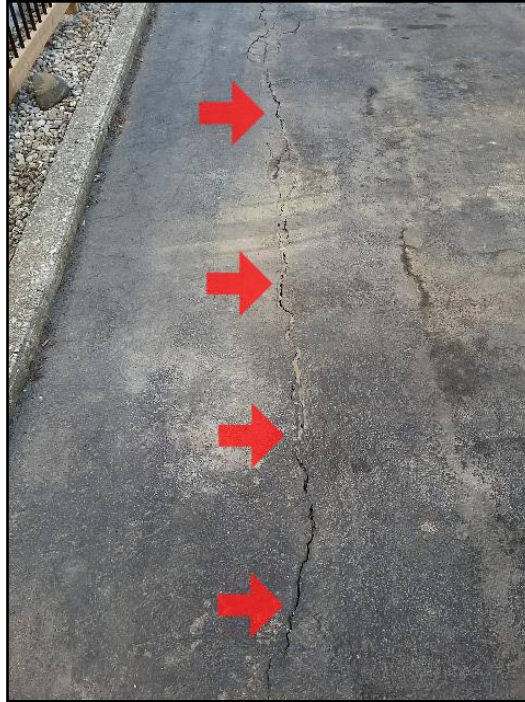
18. Condition: • [Cracked or damaged surfaces](#)

Implications: Cracks in the asphalt can cause the driveway to deteriorate during freeze/thaw cycles shortening the life of the driveway.

Cracks in asphalt driveway

Task: Fill in cracks

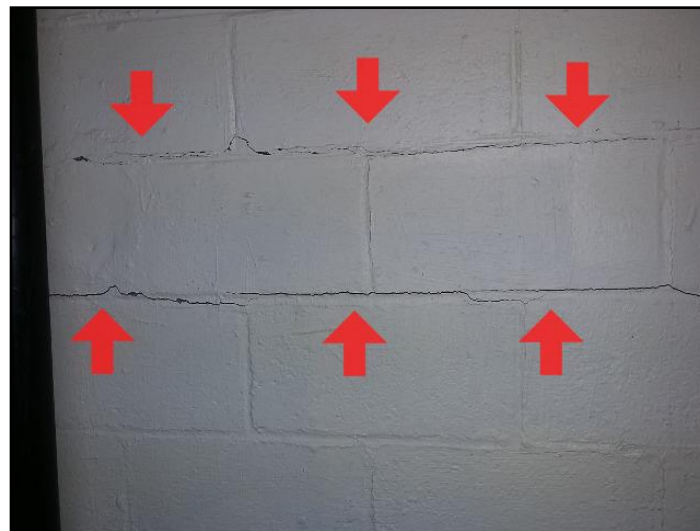
20. Condition: • [Cracked horizontally](#)

Note 1: There are horizontal cracks on the basement concrete block foundation wall. There is also a small amount of bulging. Monitor and consult a structural engineer if conditions change.

Note 2: Finishing and insulating the foundation wall in this area could cause the condition to worsen. It is recommended that you consult with a structural engineer or an appropriate contractor prior to doing such a renovation.

Horizontal cracks

Task: Monitor

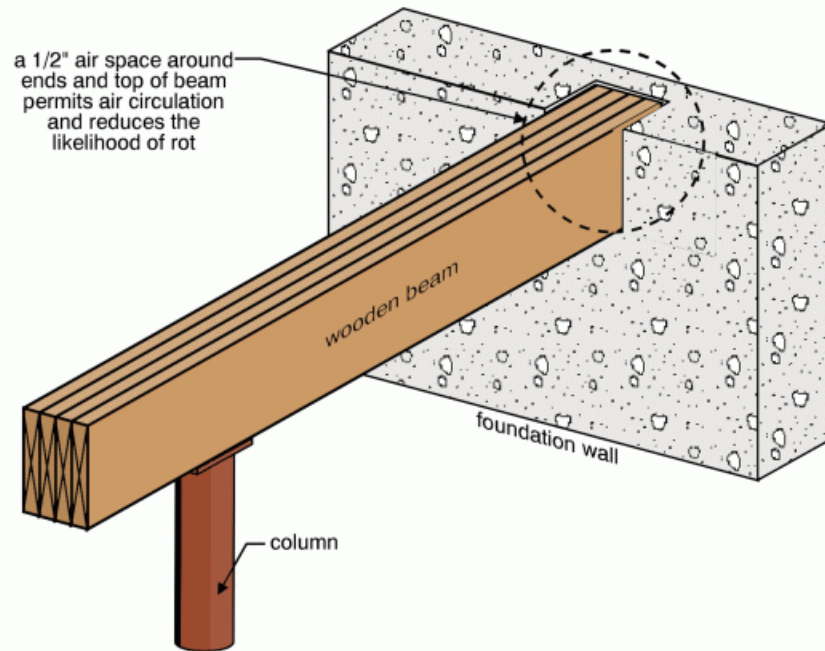
21. Condition: • No air gap at the end of wood beams

Implication(s): If the beam gets wet there is no air gap to allow it to dry out. Chance of structural damage.

No air gap at the end of wood beam

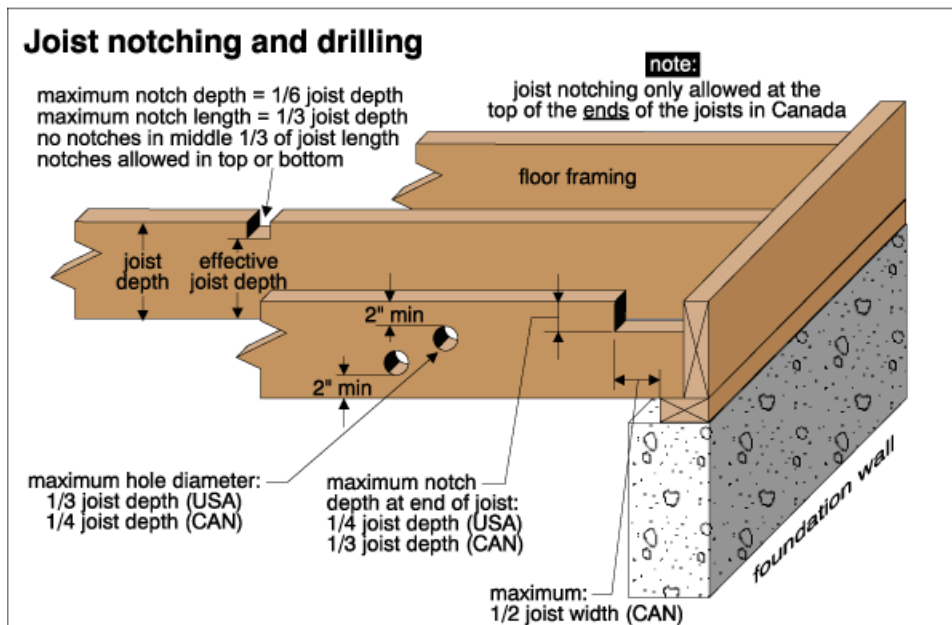
22. Condition: • [Notches or holes](#)

The holes are too close to the bottom of the joists. This appears to have been like this for sometime. There were no failures observed with the joists at the time of the inspection.

Holes too close to the bottom of the joists

Task: Monitor

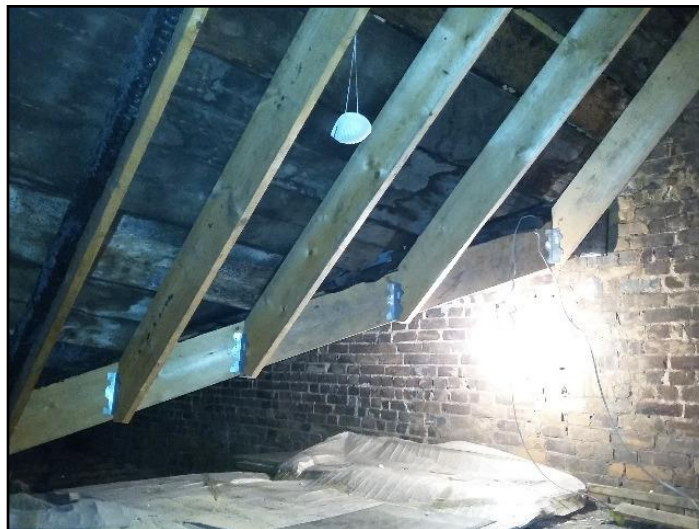
23. Condition: • [Rot, fire or insect damage](#)

There is fire damage to the rafters and roof planks. New rafters have been added either separately or by being sistered (attached) to the old burned rafters. The valley rafter is too small. As a result, the jack rafters that have been attached to it have had their bottoms, where they attach to the valley rafter, cut off. The rafter hangers are also the wrong type for the application. As a result, the repairs do not appear to be adequate.

Fire damage & questionable repair

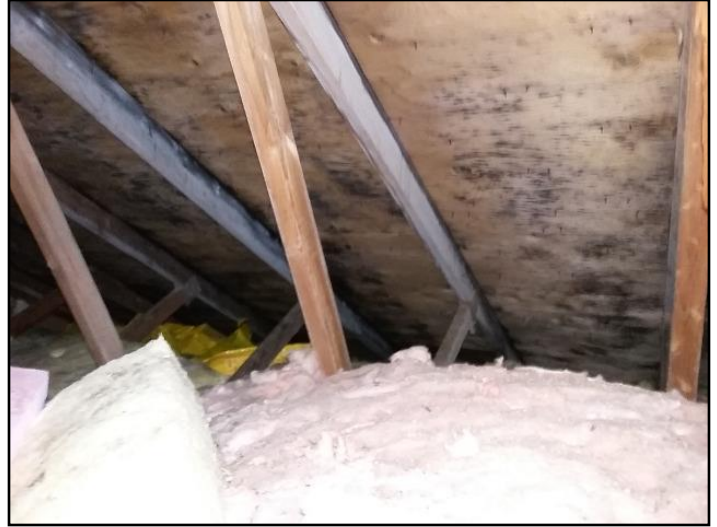
24. Condition: • [Mold](#)

Apparent mold growth

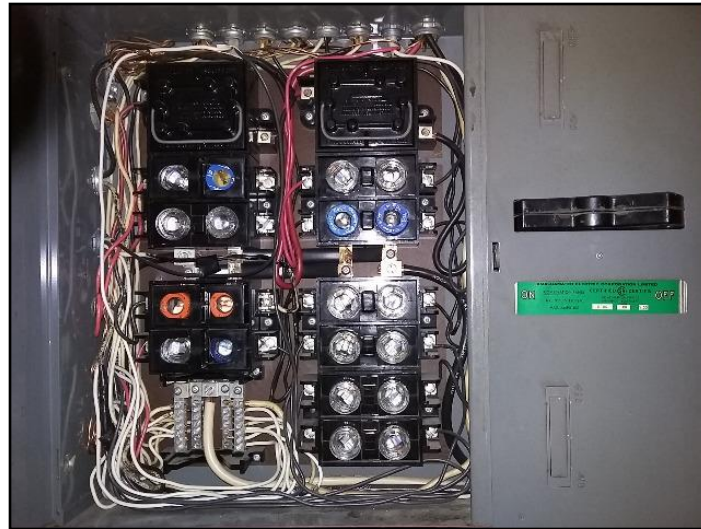
27. Condition: • Distribution panel is full.

Distribution panel is full.

Task: Further evaluation

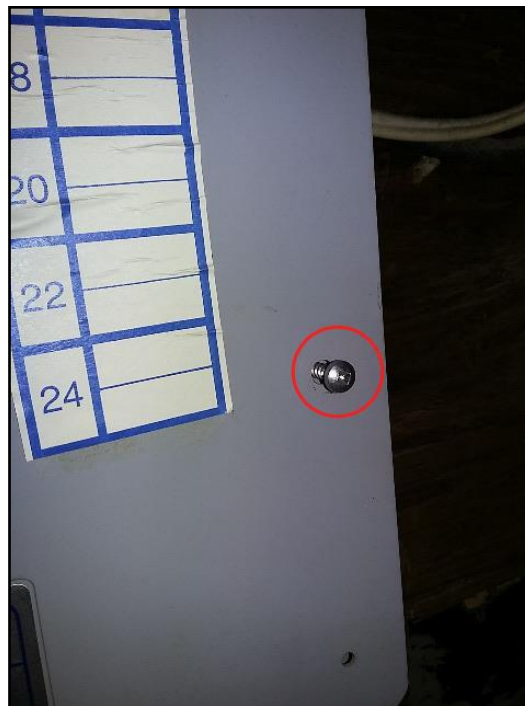
28. Condition: • Improper screw

Improper screw

Task: Remove & provide an appropriate screw

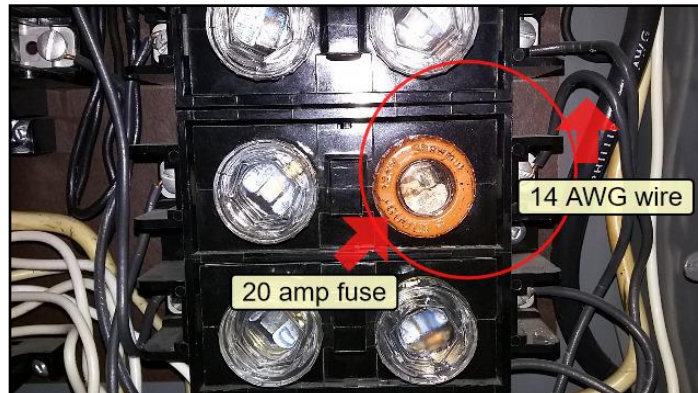
29. Condition: • [Fuses or breakers too big](#)

Implication(s): Equipment overheating | Fire hazard

Fuse too big, wrong size

Task: Replace with a 15 amp fuse

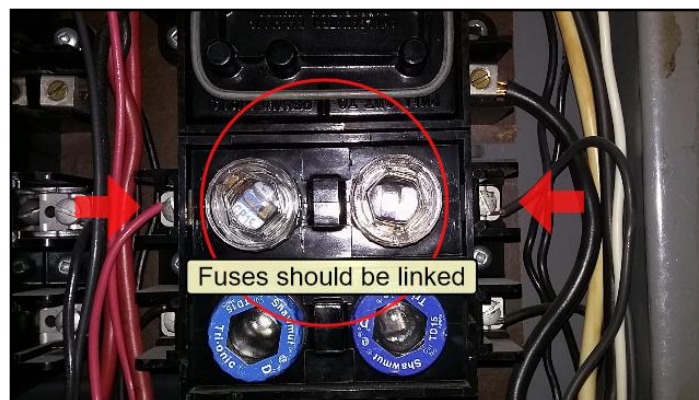
30. Condition: • [No links for multi-wire circuits](#)

Task: Correct

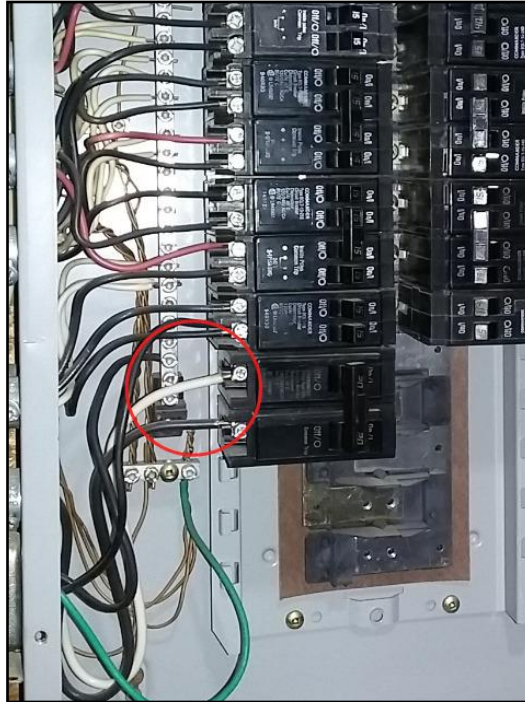
31. Condition: • White wire being used as hot (live) wire not marked with black electrical tape.

White (hot) wire not marked with black tape

Task: Correct

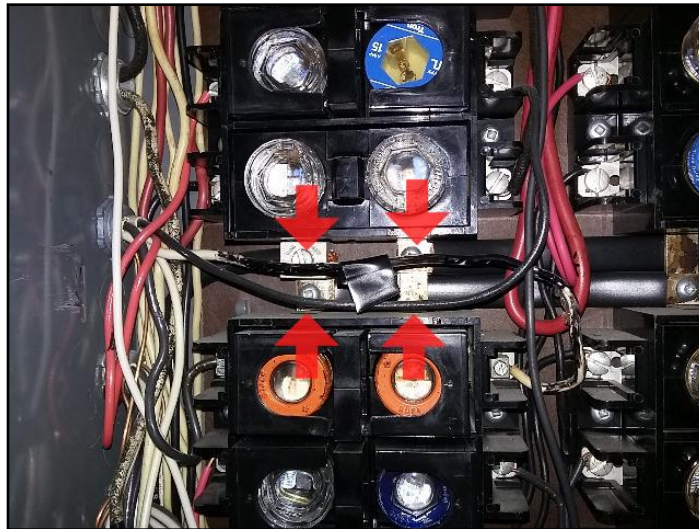
32. Condition: • [Wire crossing bus connections](#)

Implication(s): Electric shock | Fire hazard

Wires crossing bus connections

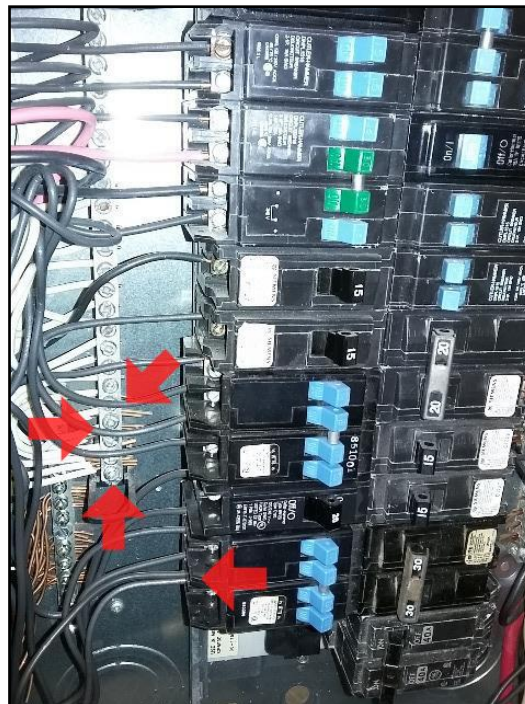
33. Condition: • [Double taps](#)

Implication(s): Fire hazard

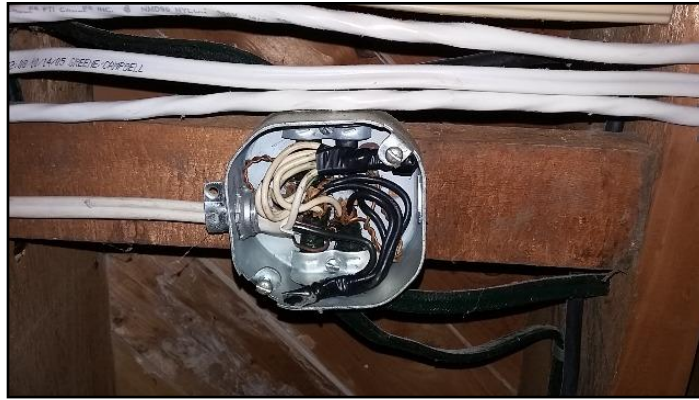
34. Condition: • [Cover loose or missing](#)

Implication(s): Electric shock | Fire hazard

Missing cover

Task: Provide

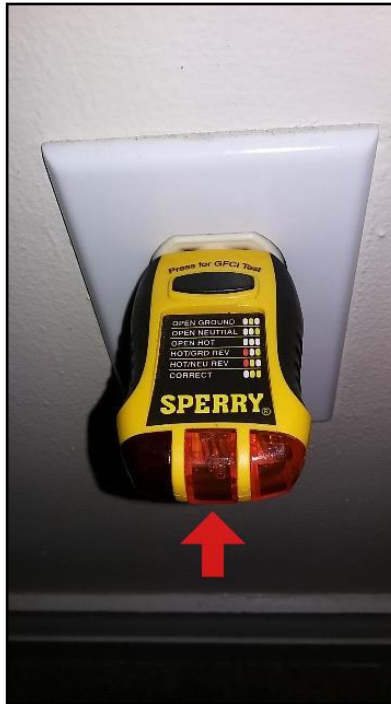
35. Condition: • [Ungrounded](#)

There are ungrounded outlets (recepticals) throughout the house. This is typical for the age of the house. People have lived in the house for many years without the outlets being grounded, however, ungrounded outlets can be a safety issue and do not provide proper protection for modern electrical appliances such as computers. The ESA (Electrical Safety Authority) recommends having ungrounded outlets protected with a GFCI.

Ungrounded

Task: Further evaluation

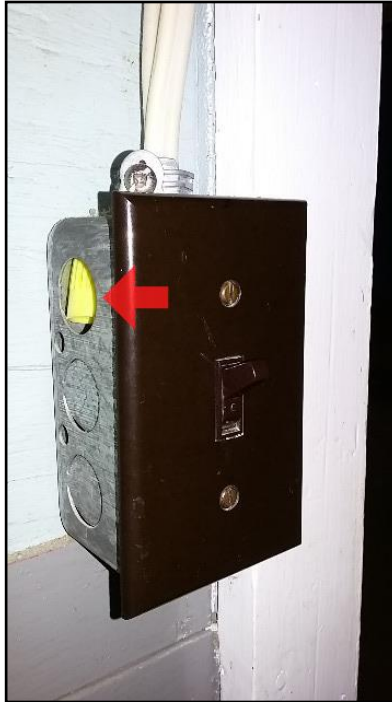
37. Condition: • Missing knockout (hole) in light switch box

Implication(s): Someone could put their finger through the knockout and touch a live wire. Electrical shock hazard

Missing knockout (hole)

Task: Repair/cover

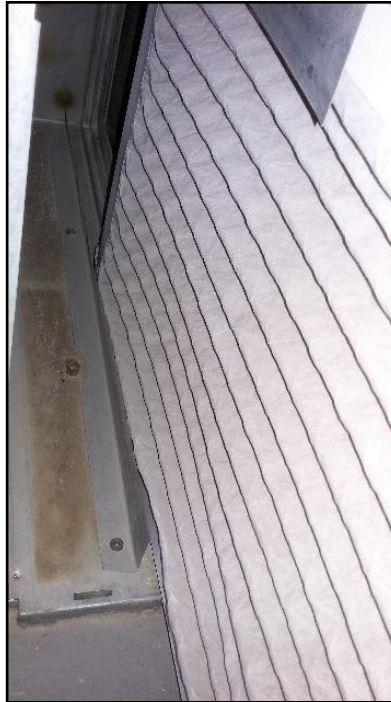
41. Condition: • [Dirty](#)

Dirty air filter

Task: Replace

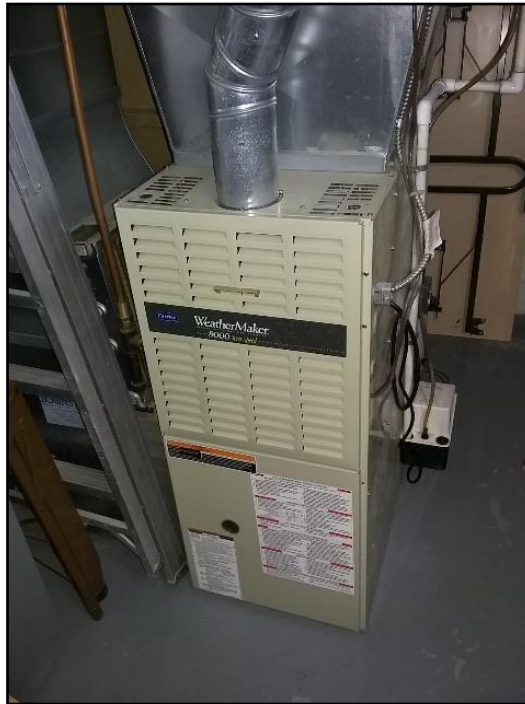
43. Condition: • [Near end of life expectancy](#)

The typical live expectancy for a mid-efficiency gas furnace is 15-20 years. The furnace is 20 years old and is nearing the end of its life expectancy. There is no way to know how long the furnace will last or when it will need to be replaced.

Expect to have to replace the furnace in the near future.

Implication(s): Equipment failure | No heat for building

Near end of life expectancy

Task: Monitor and replace when necessary

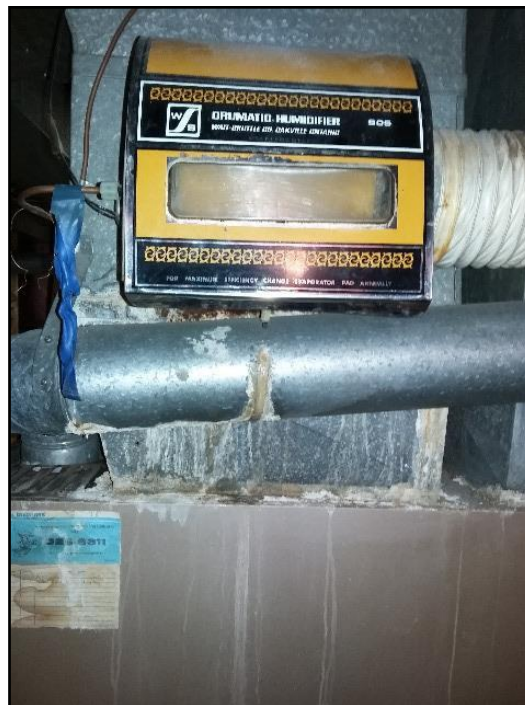
44. Condition: • [Leak](#)

The humidifier has been leaking for some time. There is rust and mineral buildup on the humidifier, vent connector, plenum and furnace cabinet. Humidifiers require regular maintenance and cleaning and the lack of cleaning can promote microbial growth.

Implication(s): Chance of water damage to contents, finishes and/or structure | Damage to equipment

Leaking

Task: Service/Replace/Clean

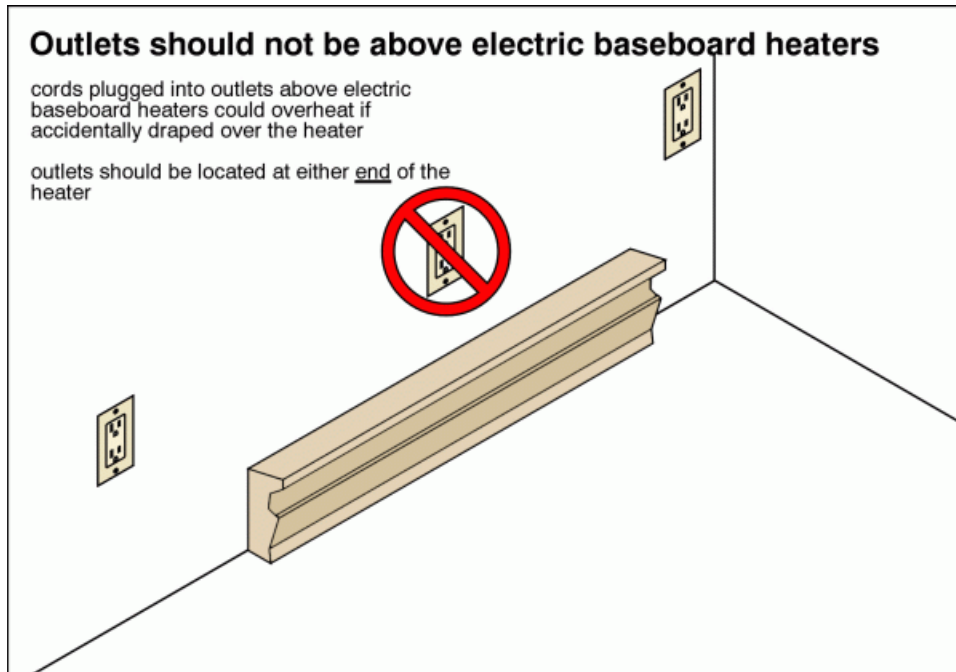
45. Condition: • [Electrical receptacle above heater](#)

Implication(s): Fire hazard

Electrical receptacle above baseboard heater

Task: Move electrical outlet away from the baseboard heater.

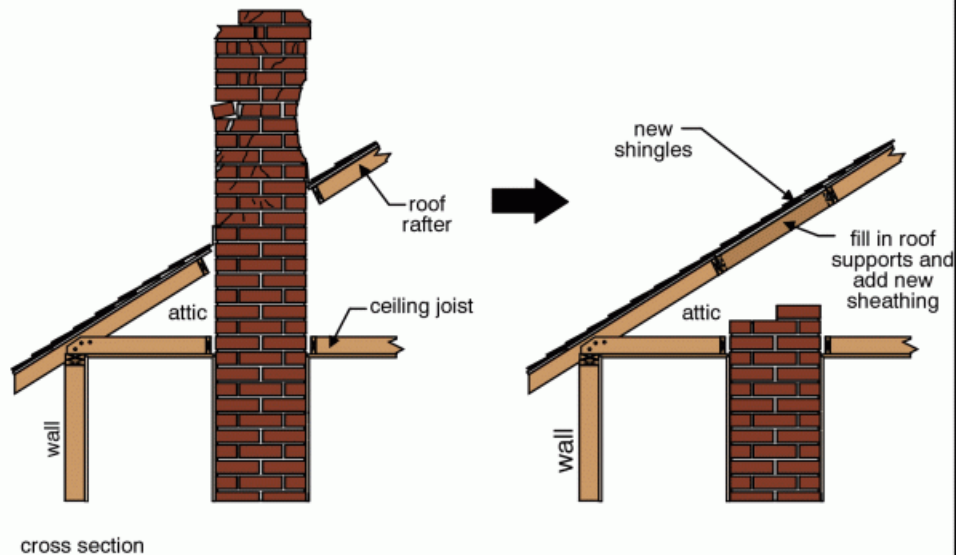
46. Condition: • [Loose, missing or deteriorated masonry](#)

Implications: Continued masonry and mortar deterioration. Pieces of masonry falling to the ground and eventual chimney collapse which is a safety issue.

Chimney deterioration

Task: The chimney is no longer in use. It is recommended to remove the chimney down to roof level. This work should be done by a qualified chimney mason and/or roofing contractor.

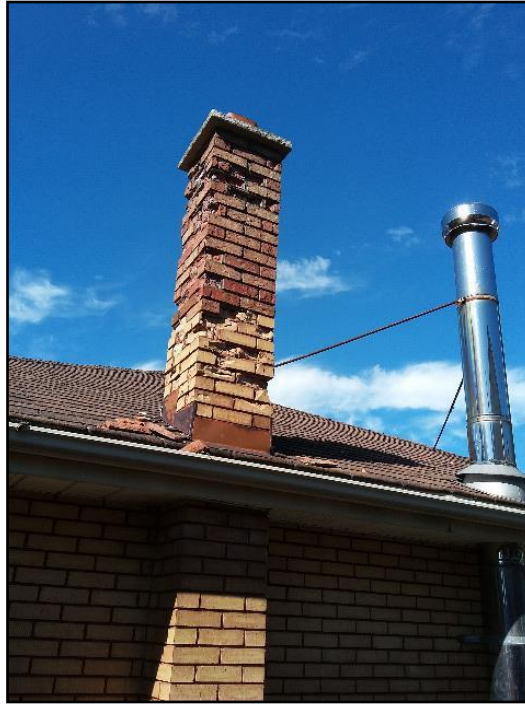
Loose, missing or deteriorated masonry

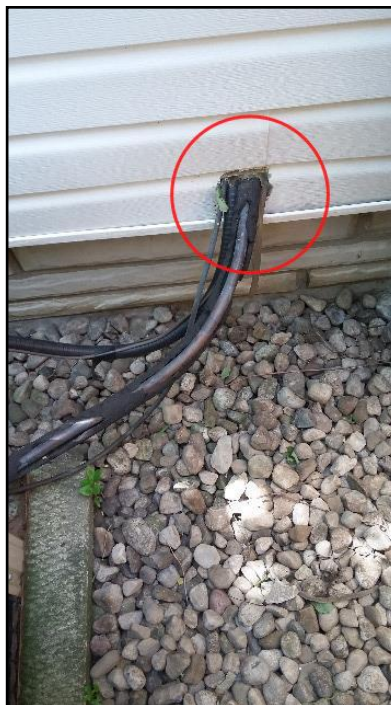
48. Condition: • Missing electrical shutoff

Implication(s): Electricity to the air conditioner is difficult to shut off in the event of an emergency or for servicing.

Missing electrical shutoff

Note: In the meantime, locate and make note of the air conditioner fuses in the electrical panel. Removing the fuses is the way to shut off the electricity to the air conditioner.

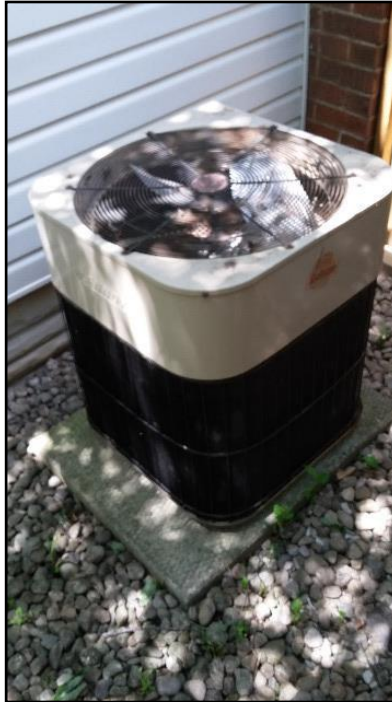
49. Condition: • Past life expectancy

The air conditioner is 28 years old. Typical life expectancy is 15 to 20 years. There is no way to know when the air conditioner will fail and need to be replaced. Expect to have to replace the air conditioner in the near future.

Implication(s): Equipment failure | Reduced comfort

Past life expectancy

Task: Monitor and replace when necessary

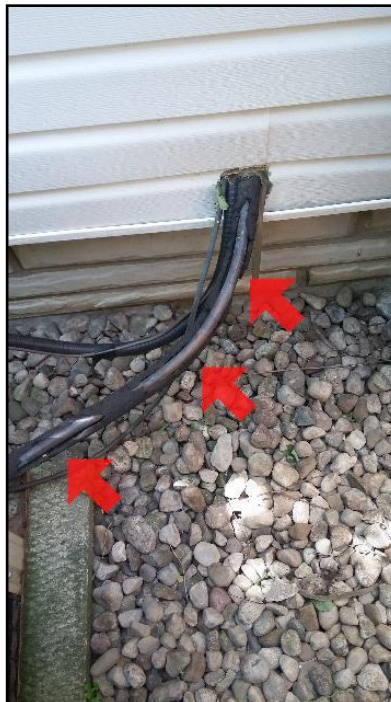
Insulation - missing/deteriorated

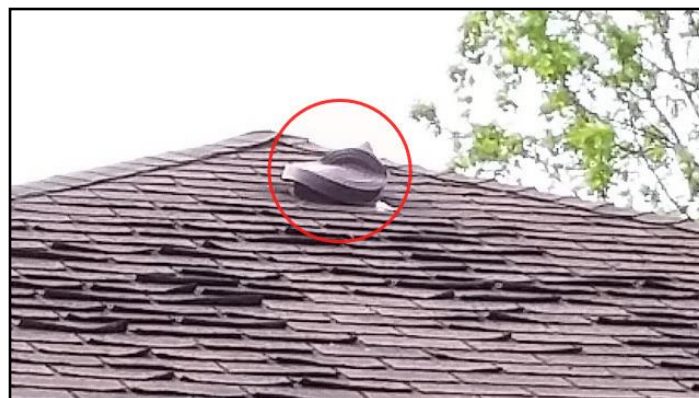
53. Condition: • [Damage](#)

Damaged roof vent

Task: Replace

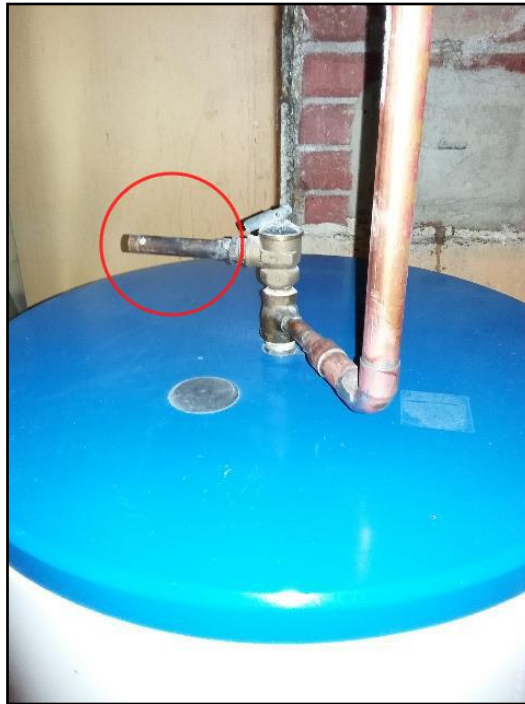
Discharge tube missing

Task: Provide

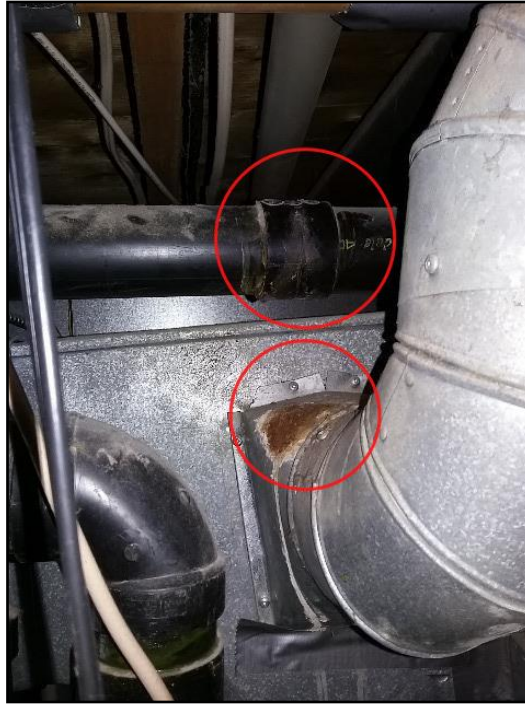
Leaking ABS piping

Task: Further evaluation by a licensed plumber.

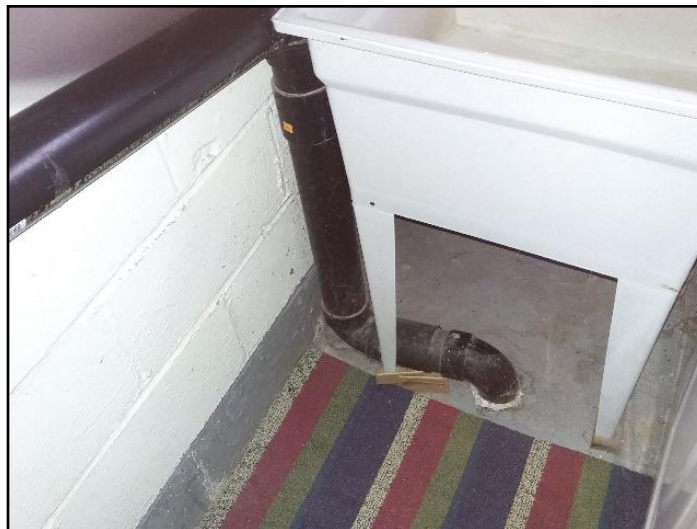
Waste pipe in floor drain

Task: Correct

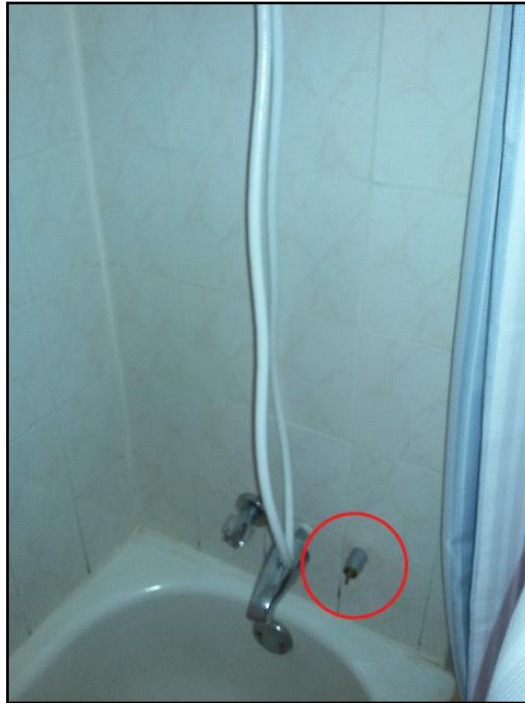
FIXTURES AND FAUCETS \ Bathtub**59. Condition:** • Missing handle**Implication(s):** There is no proper way to turn the cold water to the bathtub on and off.**Location:** First floor/Addition**Task:** Provide**Time:** As soon as possible

Missing handle

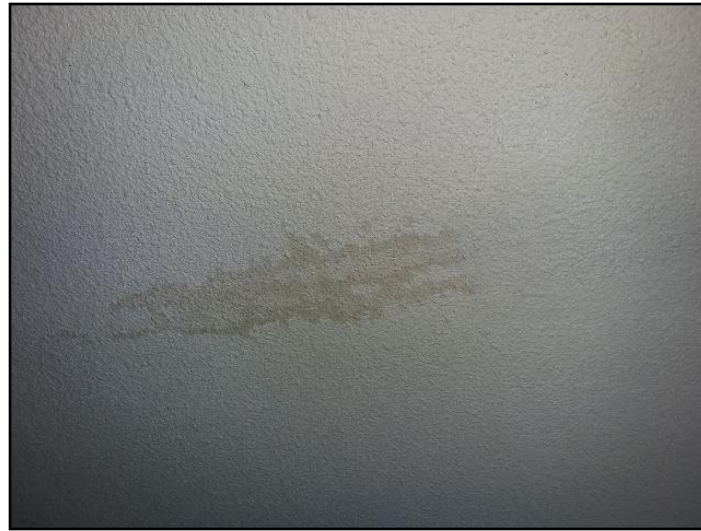
Water stains on dining room ceiling

Task: Monitor

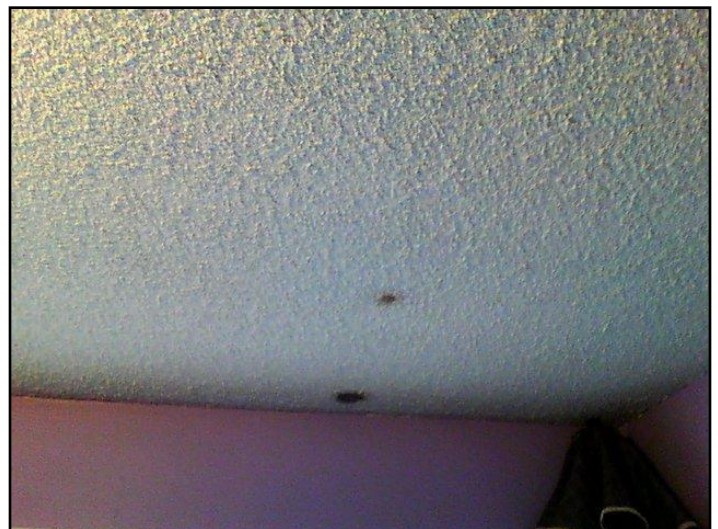
61. Condition: • Stains on bedroom ceiling.

Ceiling stains

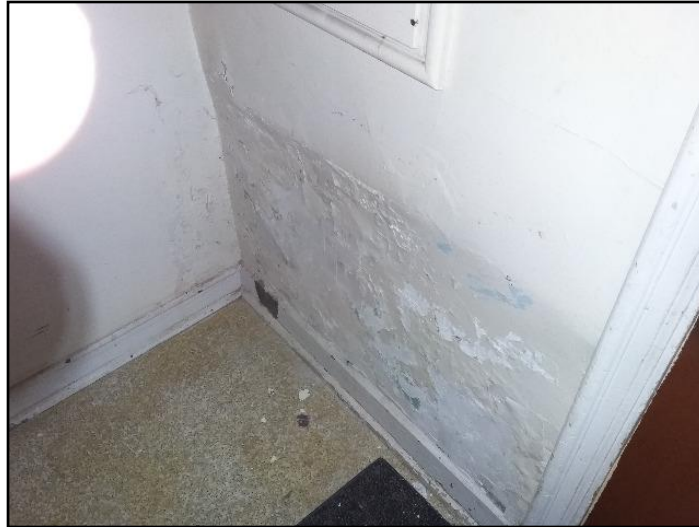
Water damage

Task: Repair & further evaluation by a licensed contractor.

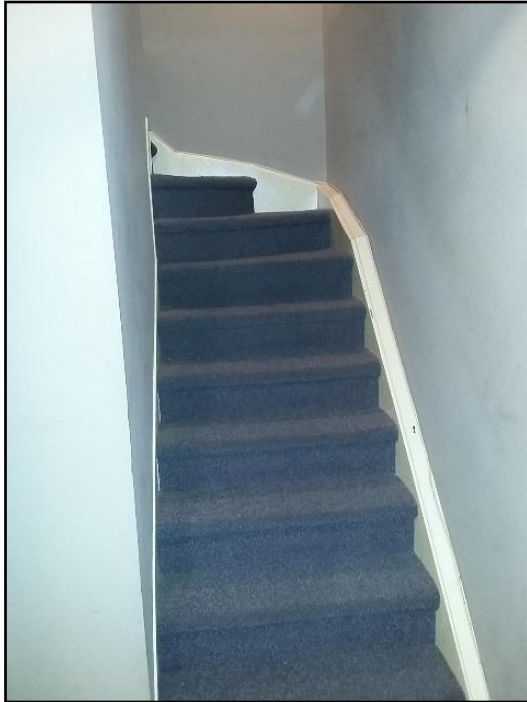
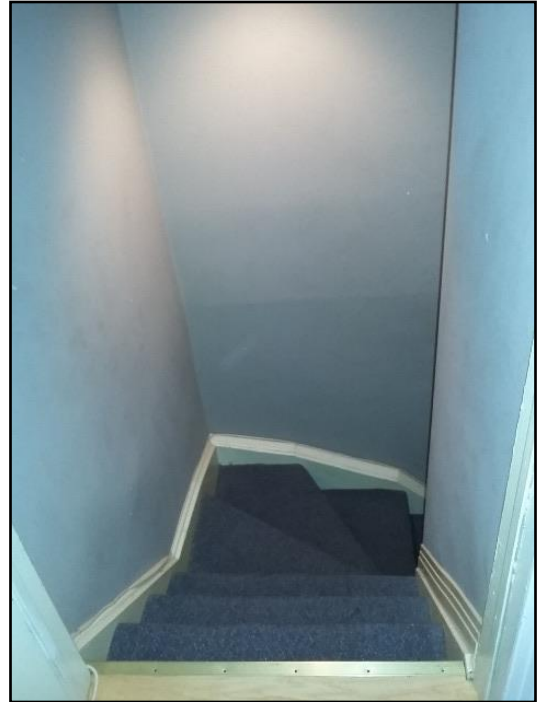
Missing handrails

Task: Provide

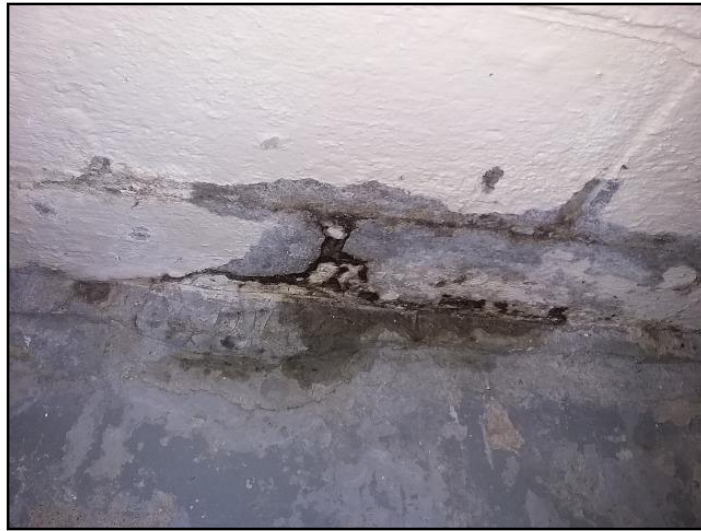
Leakage and apparent mold growth

Task: 1. Clean apparent mold growth. 2. Monitor basement leakage.
