Your Inspection Report

Somewhere In Time Lane
Osseo, WI 54758

INSPECTION DATE:
Sunday, January 13, 2019

RE: Report No. 1057, v.3
Somewhere In Time Lane
Osseo, WI
54758

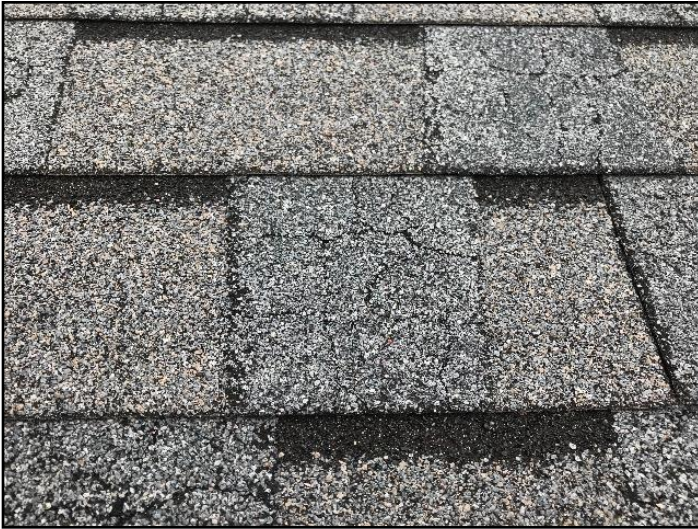
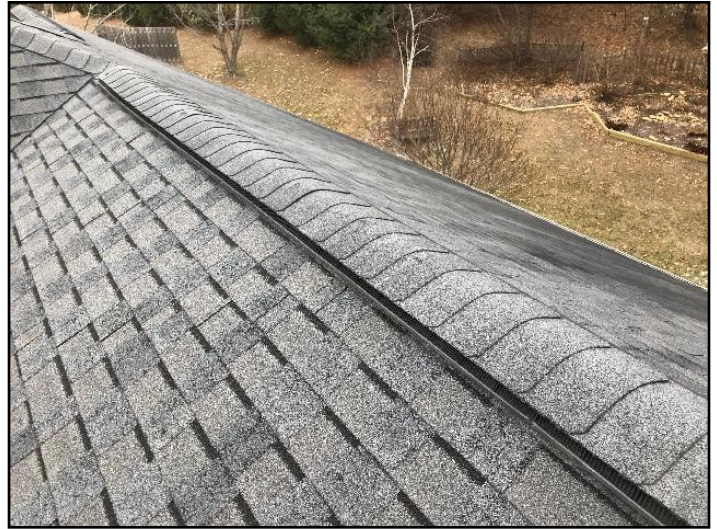
1. **Condition:** • Asphalt shingles covering the roof on this home exhibited moderate general deterioration commensurate with the age of the roof. They appeared to be adequately protecting the underlying home structure at the time of the inspection.

Asphalt shingles covering the roof on this...

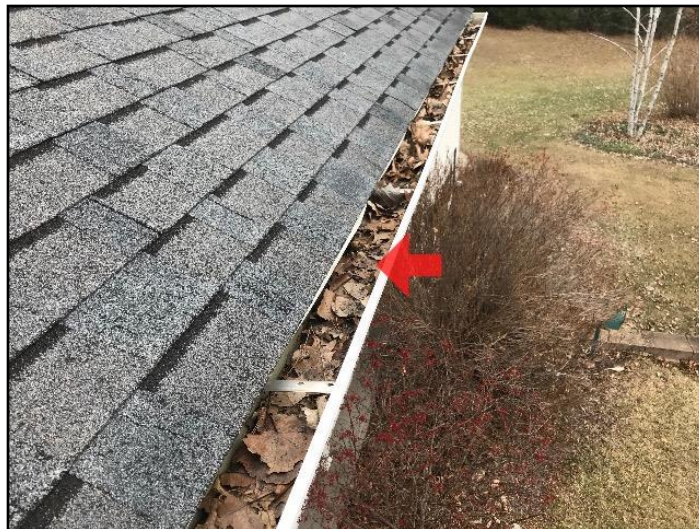
7. Condition: • Dirty/debris

Dirty/debris

Task: Clean

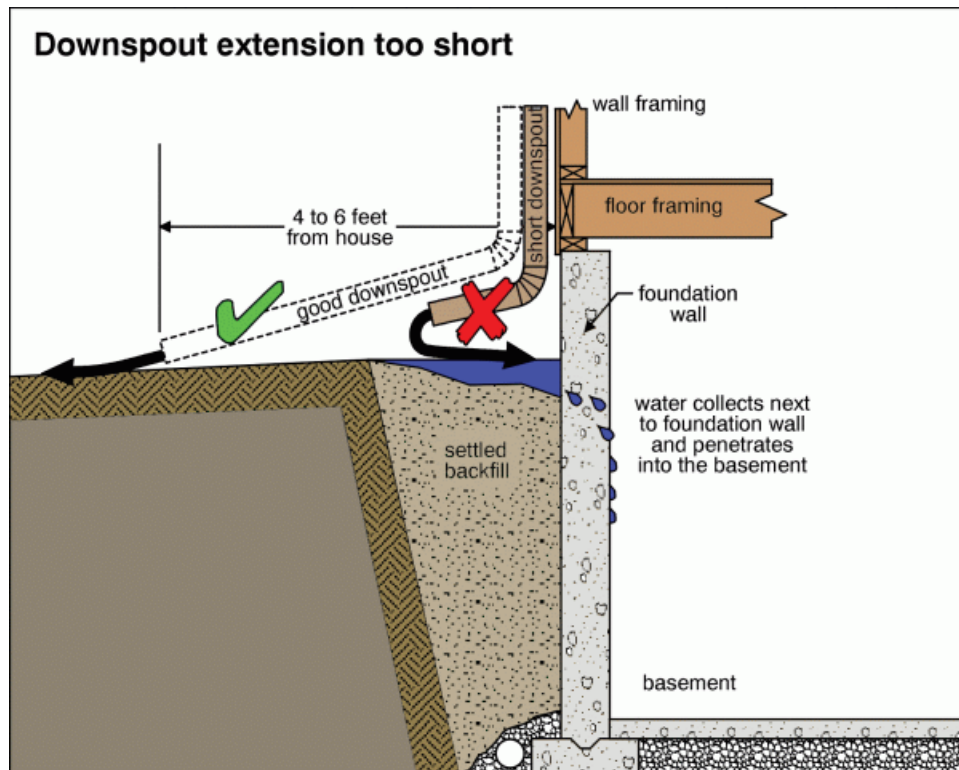
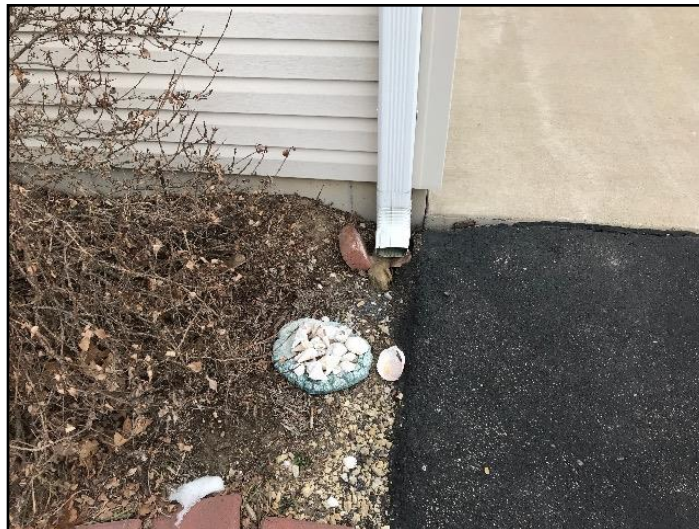
9. Condition: • [Should discharge 6 feet from building](#)

Implication(s): Chance of water damage to contents, finishes and/or structure

Should discharge 6 feet from building

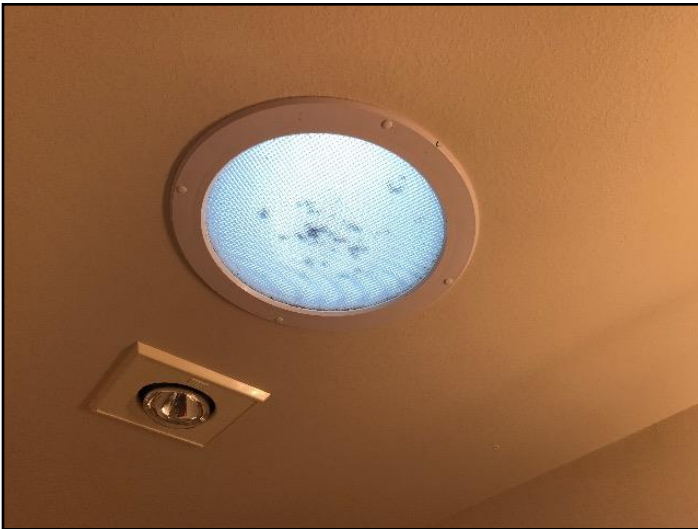
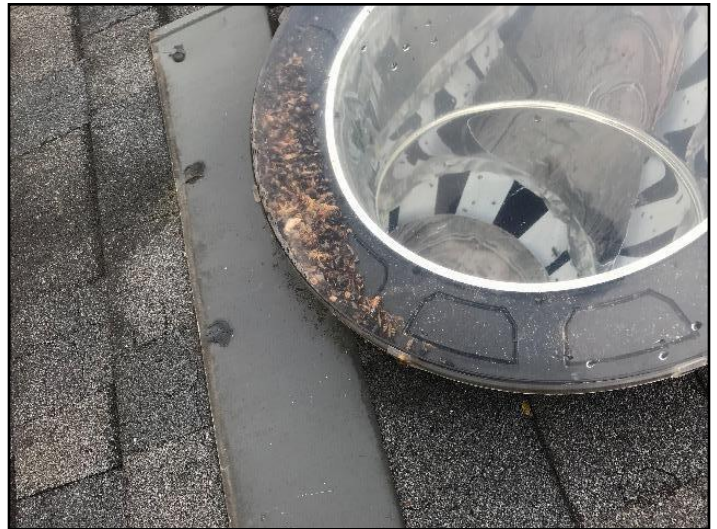
15. Condition: • On the day of the inspection dead insects appeared inside the sky light. Recommend contacting a qualified contractor to locate the insect entrance and repair.

Insects

Task: Improve

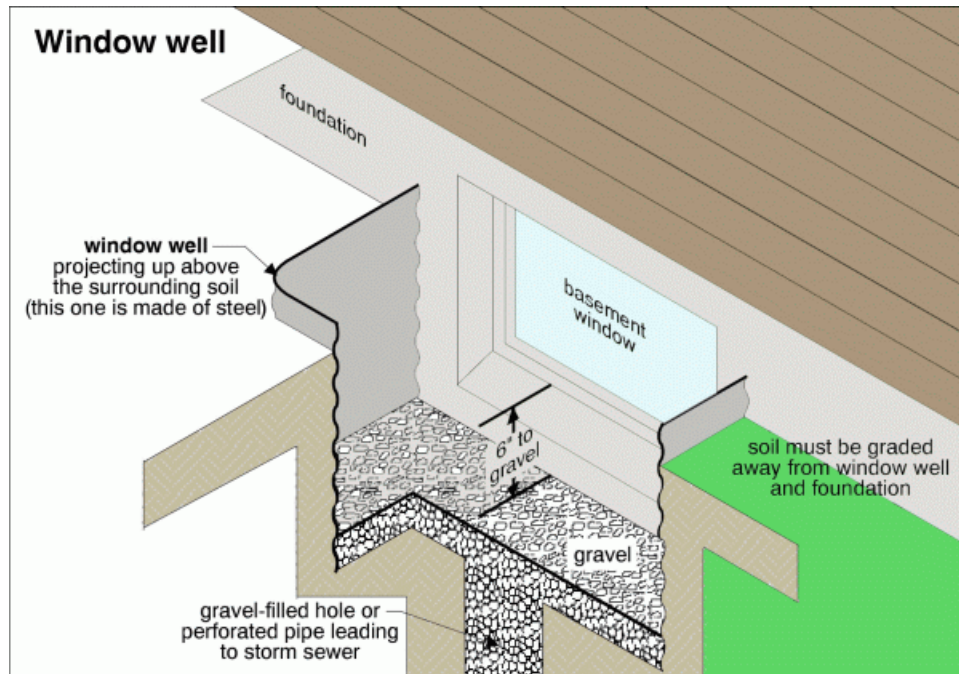
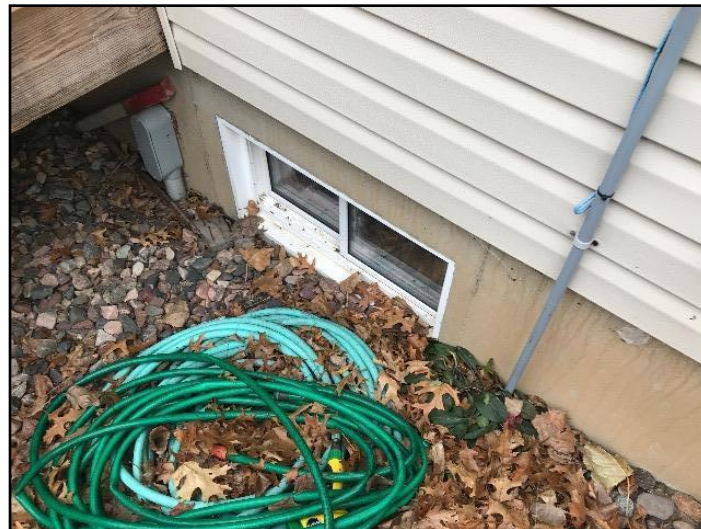
16. Condition: • [Missing](#)

Implication(s): Chance of water damage to contents, finishes and/or structure | Material deterioration

Missing window wells

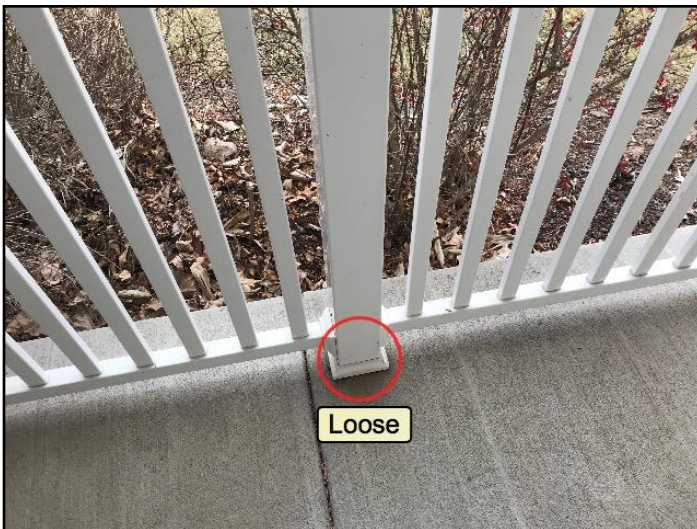
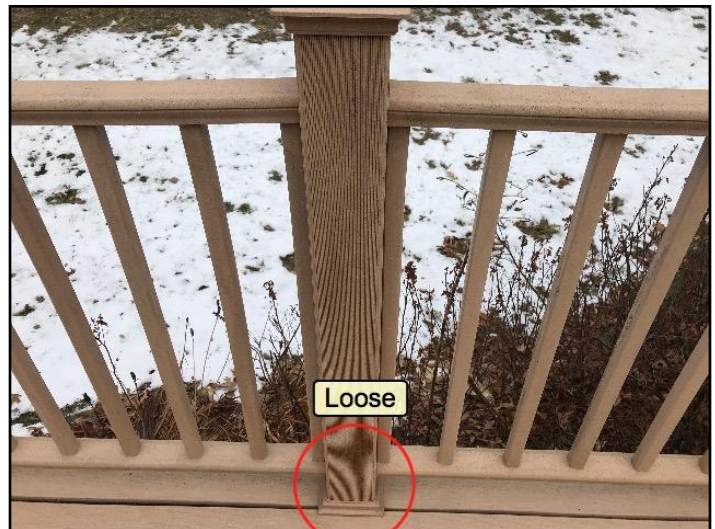
24. Condition: • [Loose](#)

Implication(s): Fall hazard

Front porch

Back deck.

Task: Improve

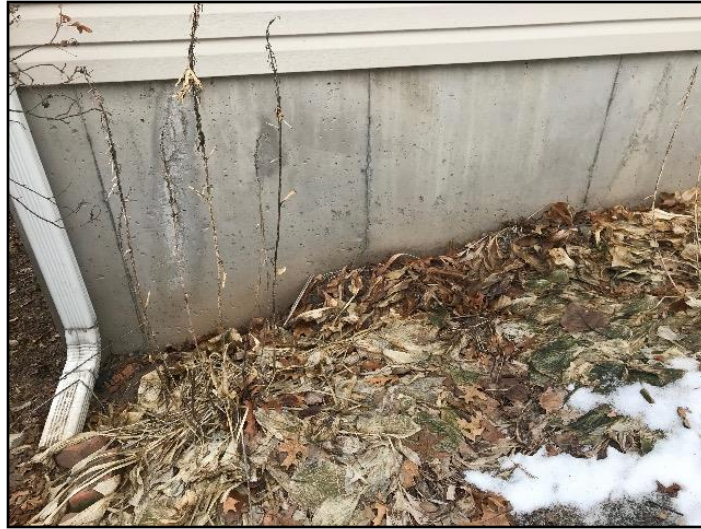
26. Condition: • [Improper slope or drainage](#)

At the time of inspection it appeared various areas around the foundation had settled and were sloping toward the foundation. Recommend filling low areas to prevent water intrusion.

Implication(s): Chance of water damage to contents, finishes and/or structure

Improper slope or drainage

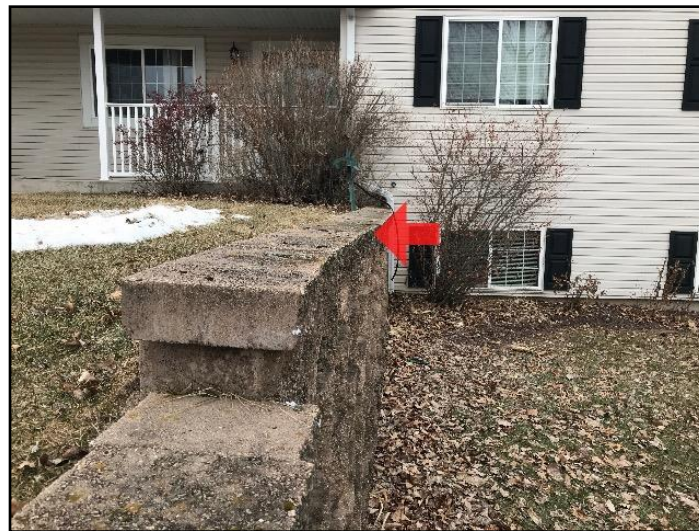
31. **Condition:** • [Bowling or bulging](#)

The retaining wall appears to have bowed slightly over time. Recommend monitoring for future bowing.

Bowing or bulging

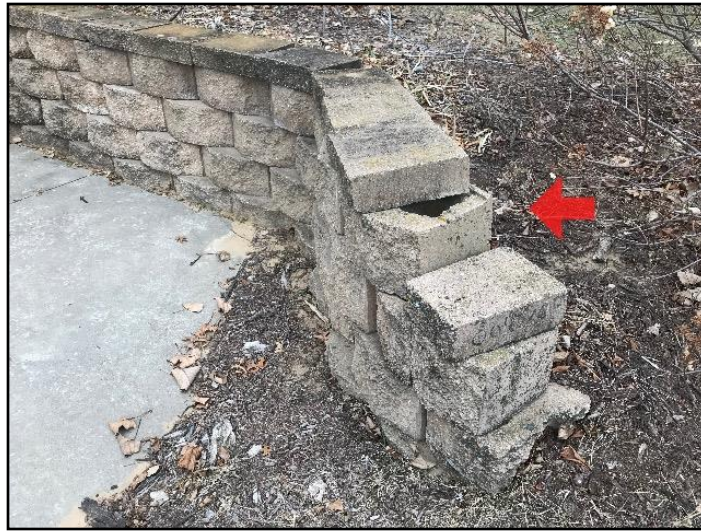
32. Condition: • [Settling or shifting](#)

Settling or shifting

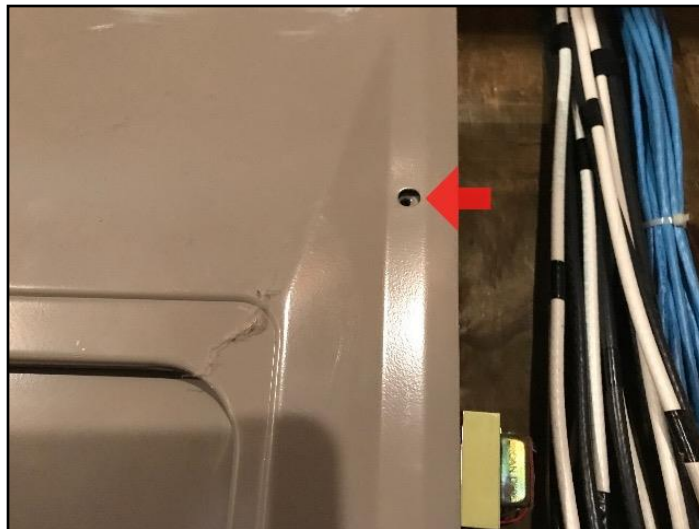
46. Condition: • Missing screws in the front panel of the breaker box. Recommend providing.

Missing screws

Task: Provide

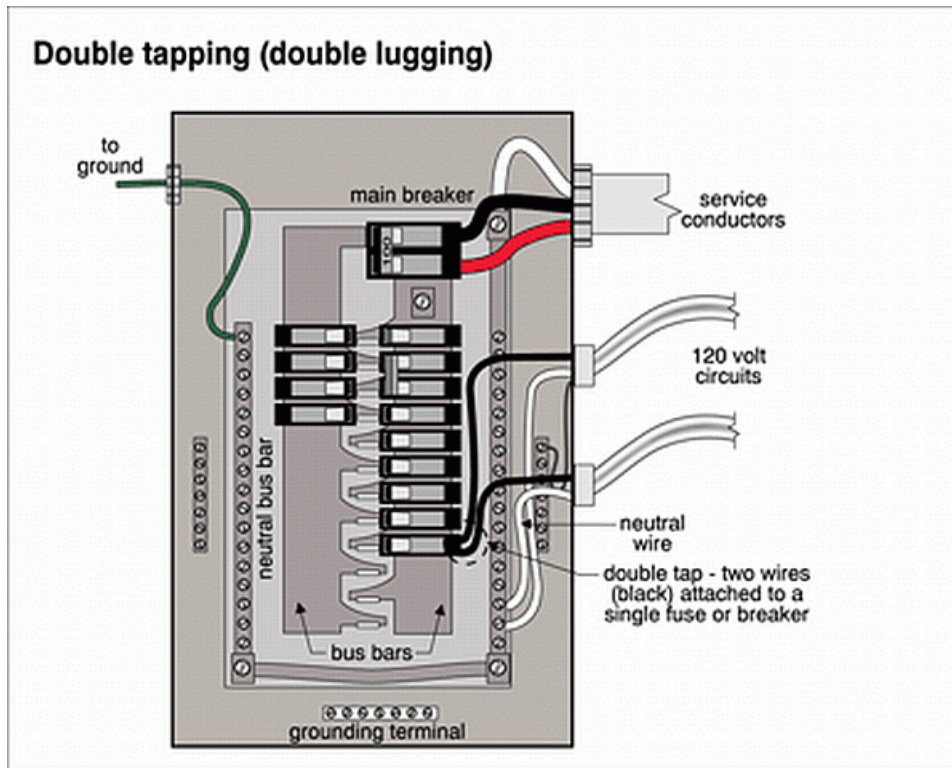
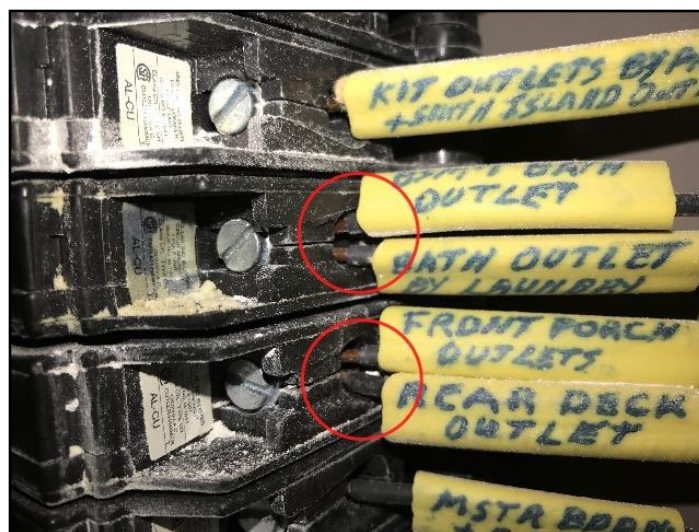
48. Condition: • [Double taps](#)

Implication(s): Fire hazard

Double taps

Recommend further evaluation by a certified electrician.

Task: Improve

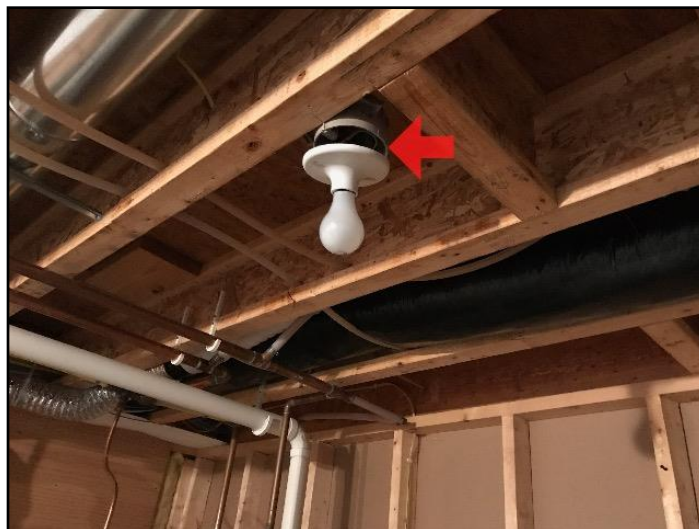
56. Condition: • [Loose](#)

Implication(s): Electric shock | Fire hazard

Location: Basement

Loose light fixtures in utility room

Task: Repair

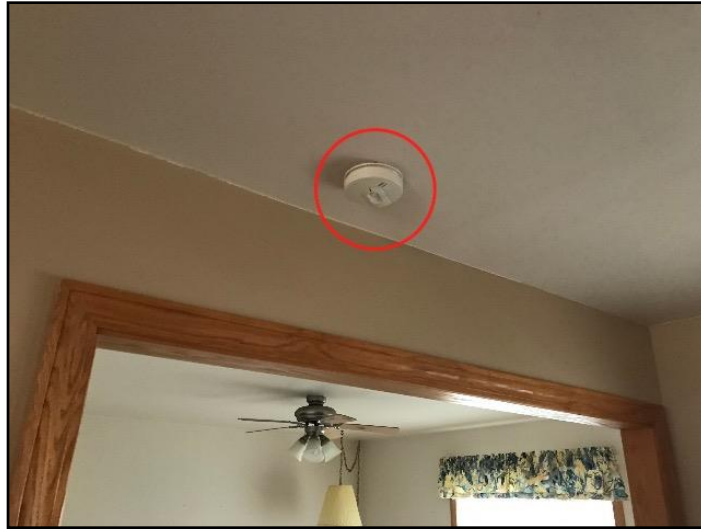
57. Condition: • On the day of the inspection multiple smoke/CO alarms had a weak alarm sound. Recommend further

evaluation and repair or replace where needed.

Weak chirping sound

Task: Improve

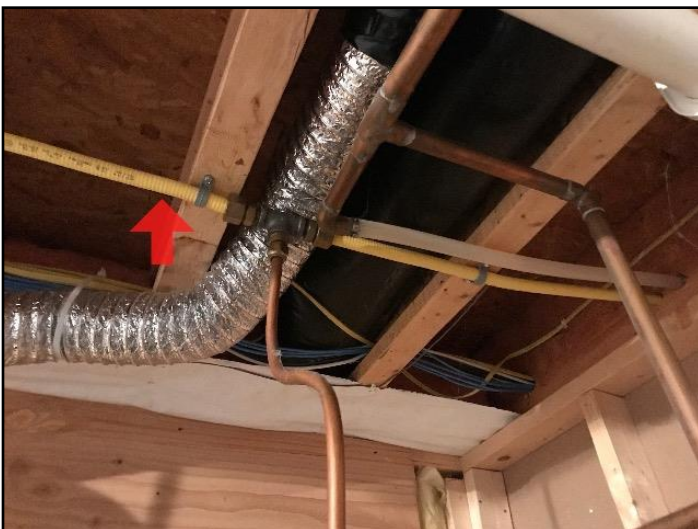
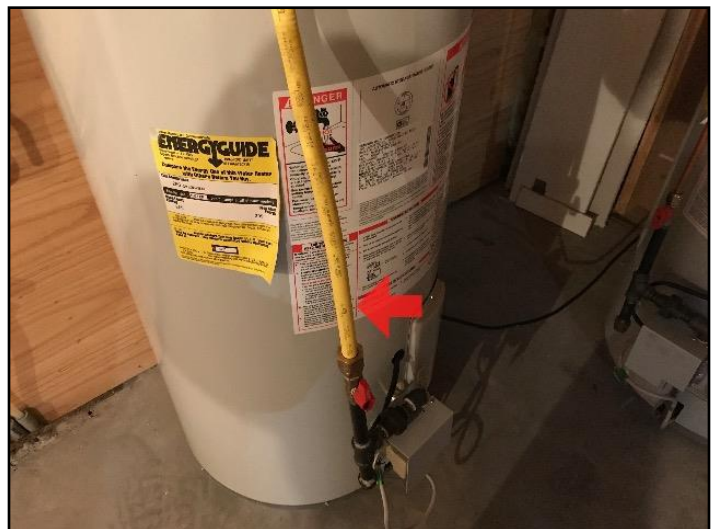
58. Condition: • Properly bonding and grounding of a Corrugated Stainless Steel Tubing (CSST) system may reduce the risk of damage and fire from a lightning strike. Lightning is a highly destructive force. Even a nearby lightning strike that does not strike a structure directly can cause systems in the structure to become electrically energized. Differences in potential between systems may cause damage to the CSST, including holes. Bonding and grounding reduces the risk of arcing and other related damage. At the time of the inspection I was unable to determine if the CSST was bonded.

Yellow CSST

Recommend further evaluation by a licensed electrician.

Task: Further evaluation

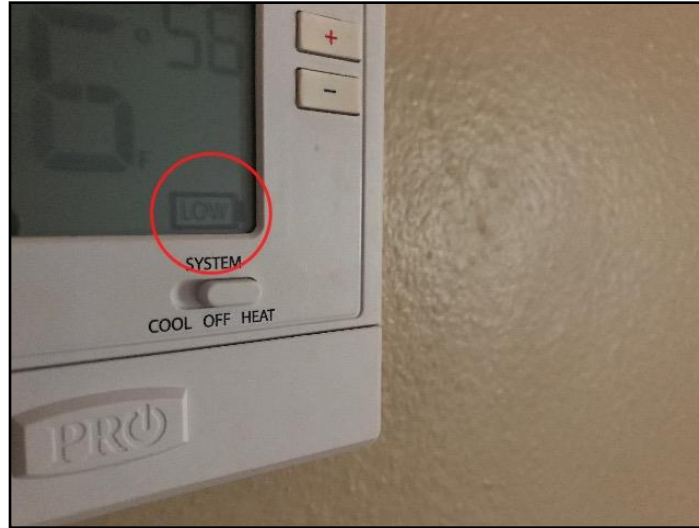
Furnace thermostat indicated a low battery. Recommend replacement.

Low battery

Task: Service

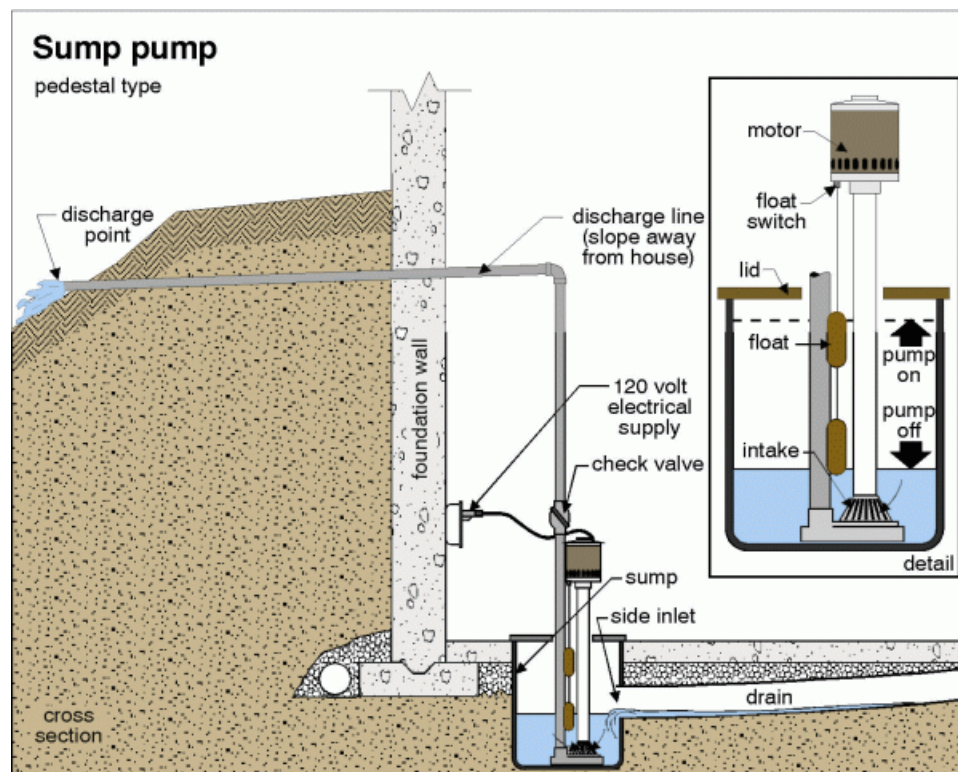
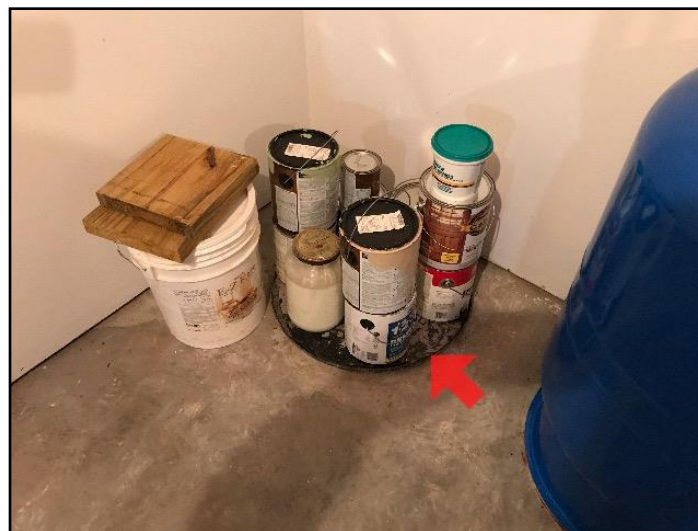
76. **Condition:** • [Missing](#)

Implication(s): Chance of water damage to contents, finishes and/or structure | Equipment failure

Missing sump pump

Task: Provide

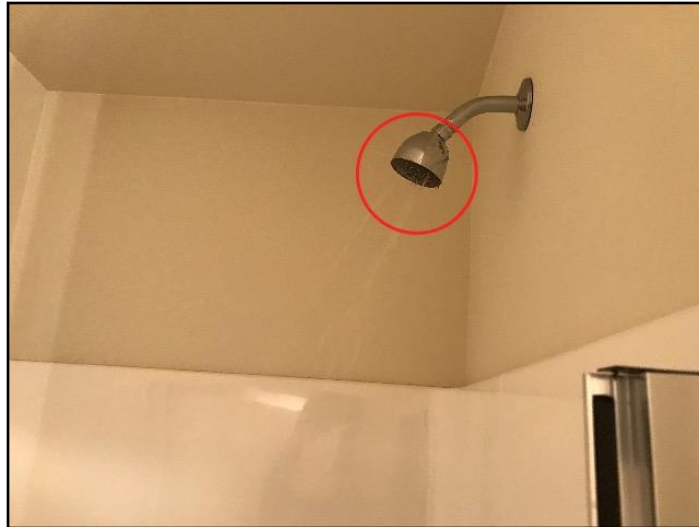
80. Condition: • [Aerator - obstructed](#)

On the day of the inspection the shower head was had limited water pressure. Recommend cleaning or replacing to improve water pressure.

Implication(s): Reduced water pressure and volume

Aerator - obstructed

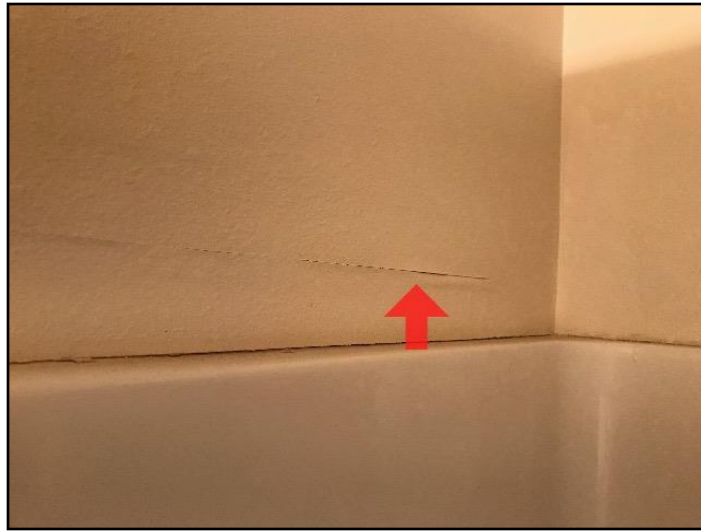
Shower stall

84. Condition: • On the day of the inspection the sheet rock seam above the shower appears to have opened up. Recommend repairing to prevent water intrusion behind the sheet rock.

Task: Repair

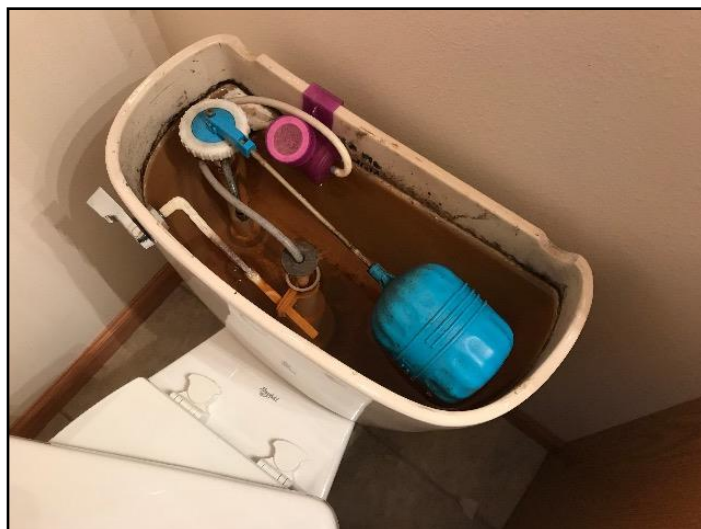
87. Condition: • [Obstructed or weak flush](#)

On the day of the inspection the toilets were slow to fill. The tanks appeared to have a water residue buildup. Recommend cleaning to prevent premature failure.

Residue build up.

Task: Improve

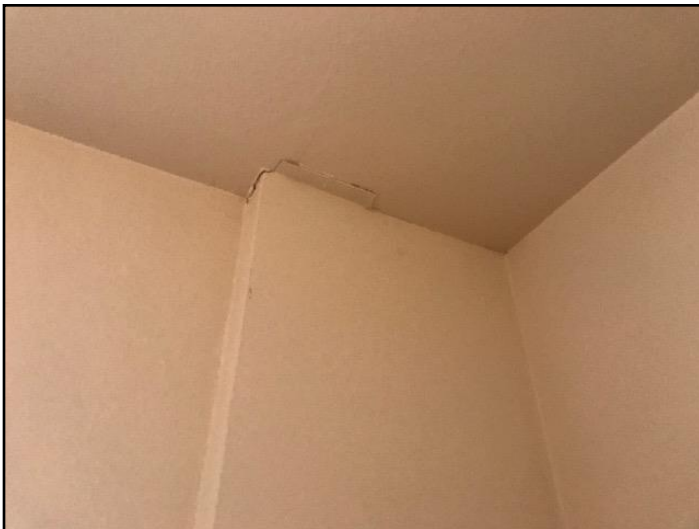
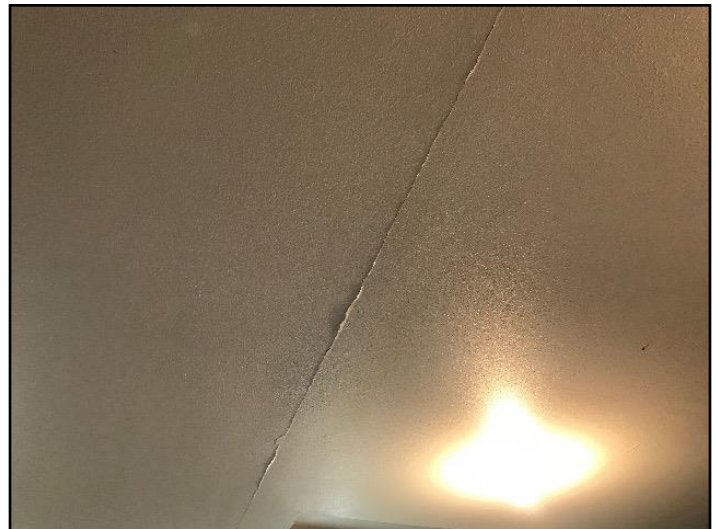
88. Condition: • Typical garage ceiling and wall flaws appeared. Recommend repairing on your discretion.

Typical garage flaws

typical garage flaws

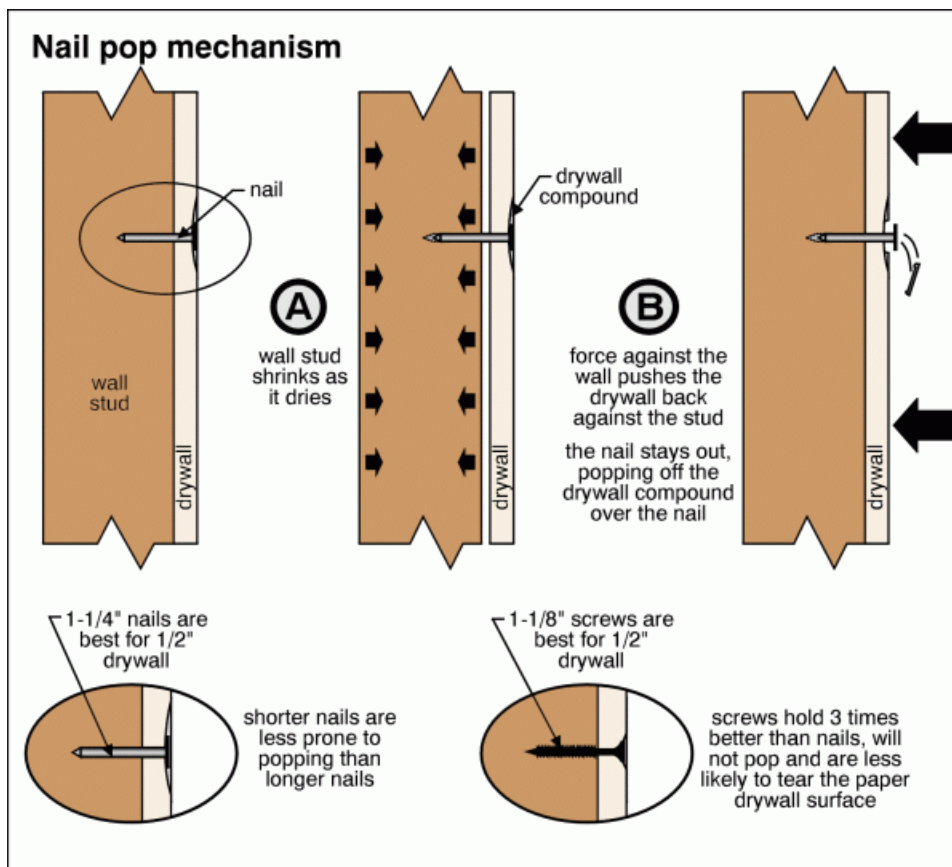
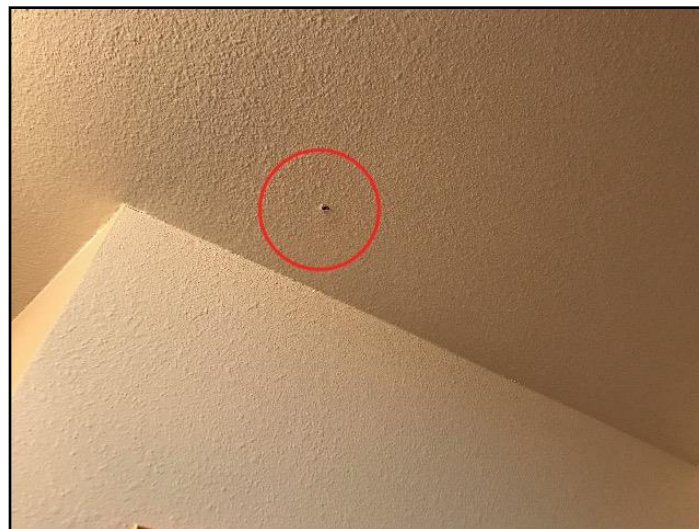
90. Condition: • [Nail pops](#)

Nail pops

Task: Monitor

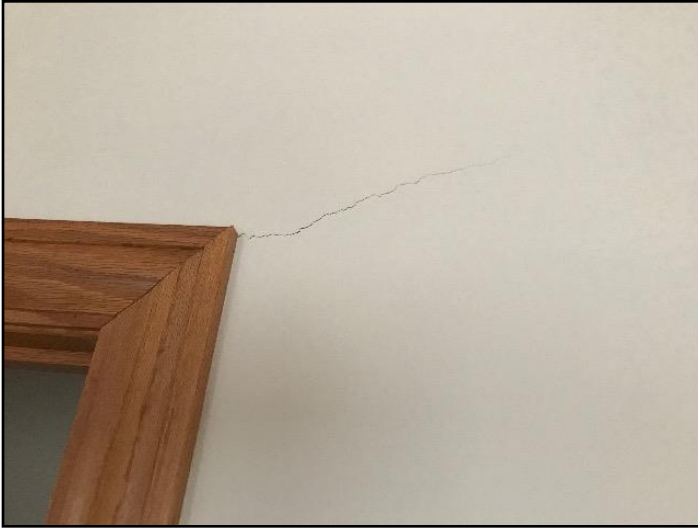
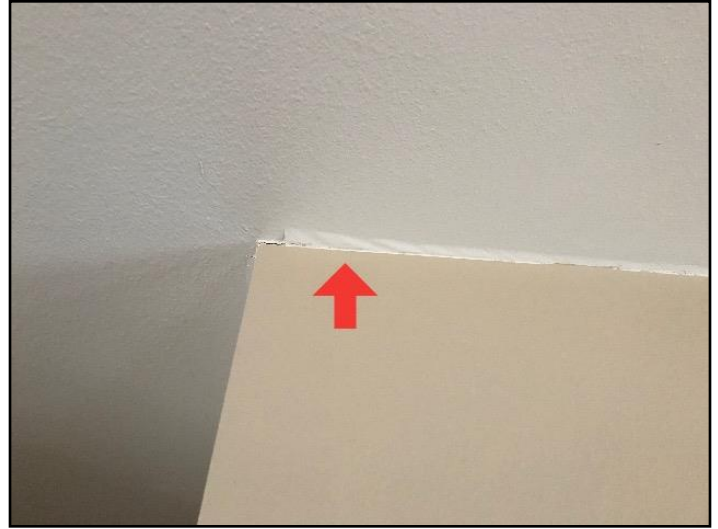
92. Condition: • [Typical flaws](#)

Though typical flaws exist water intrusion common indicators are not evident.

Typical flaws

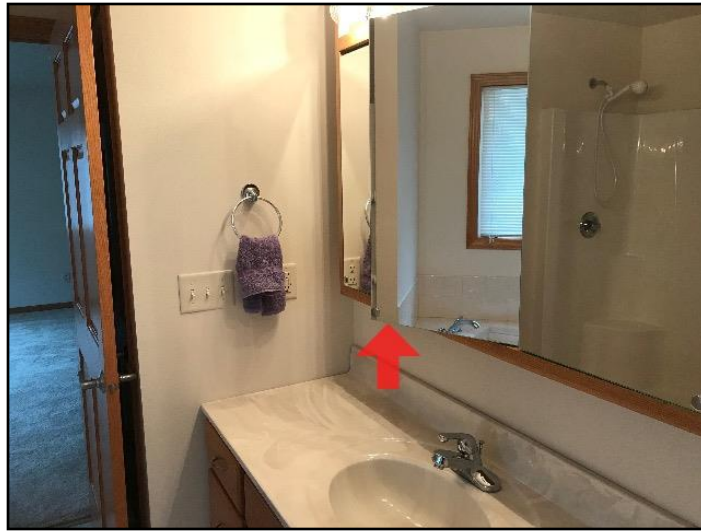
97. Condition: • On the day of the inspection multiple medicine cabinet latches above the bathroom vanities did not operate as they should. Recommend repairing as needed.

Mirror latch inoperable

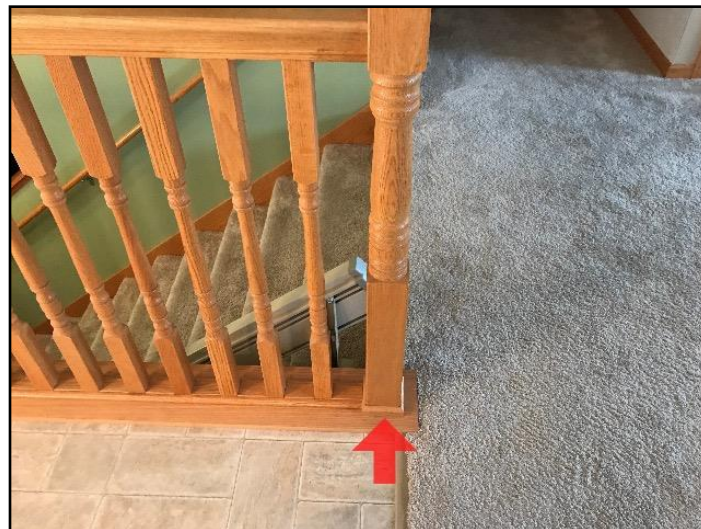
Handrail support

101. Condition: • [Loose](#)

At the time of the inspection the handrail leading to the upstairs has loosened over time. Recommend monitoring and improving if it becomes worse.

Implication(s): Fall hazard

Loose guardrail post.

Task: Monitor
