Your Inspection Report

1380 Lincoln Road
Windsor, ON N8Y 2J1

RE: Report No. 5469
1380 Lincoln Road
Windsor, ON
N8Y 2J1

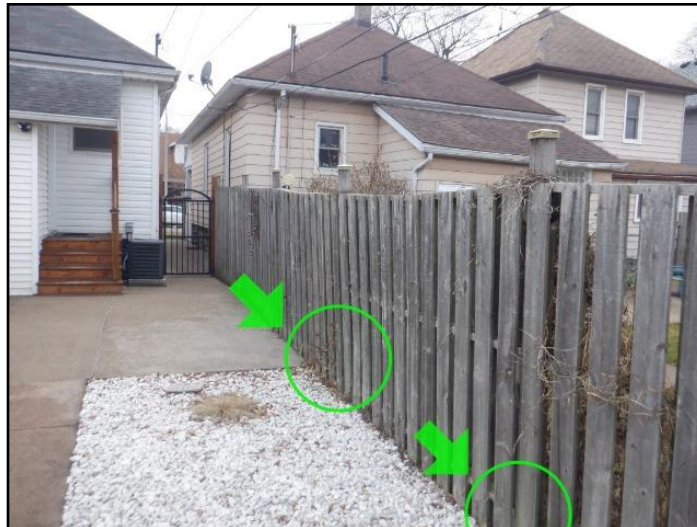
8. Condition: • The back yard has a few fence posts that were broken. These loose posts will needed to be repaired/ replaced.

19. *Few broken fence posts*

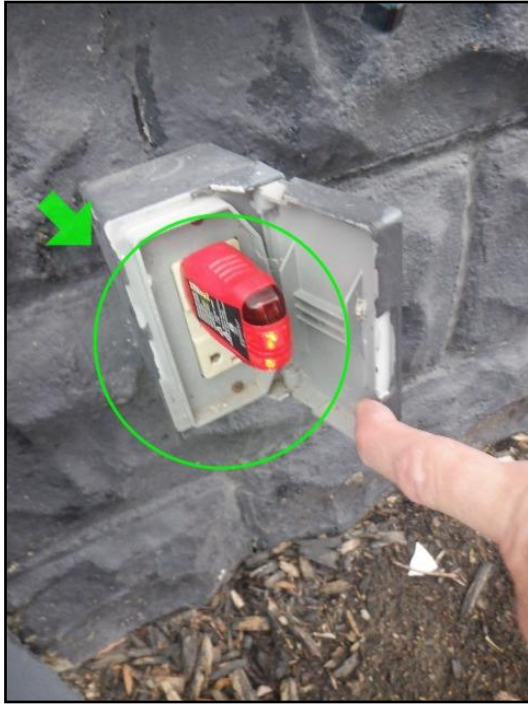
9. Condition: • The front GFI is faulty and the rear GFI is missing.

20. Faulty GFI

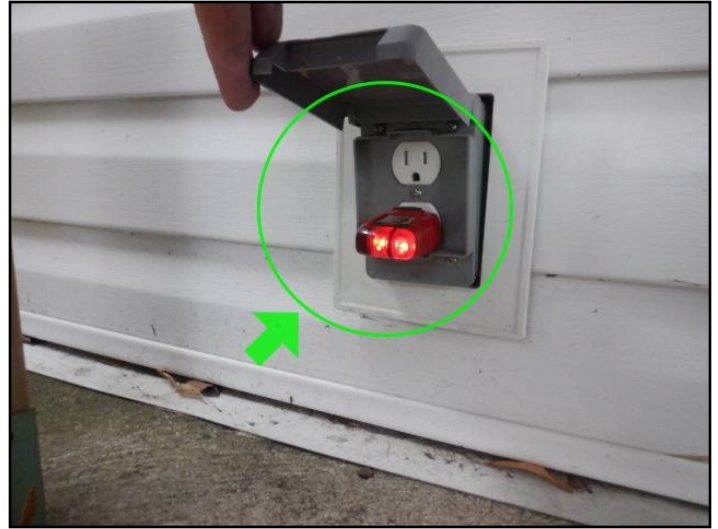
21. Missing GFI

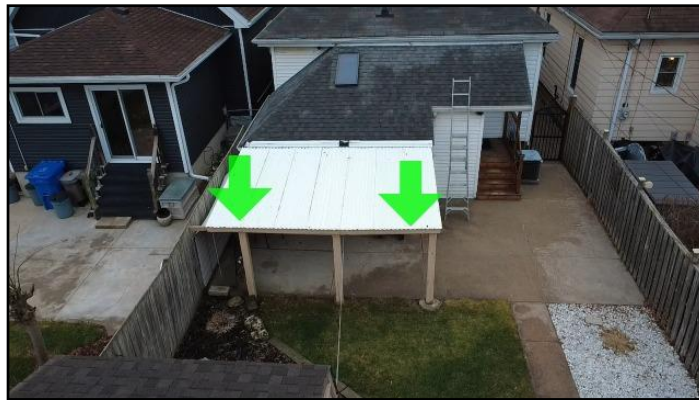
22. Install trough and downspout

10. Condition: • I would recommend that the rear small patio roof have an eave trough installed and a downspout to help keep water away from the slab.

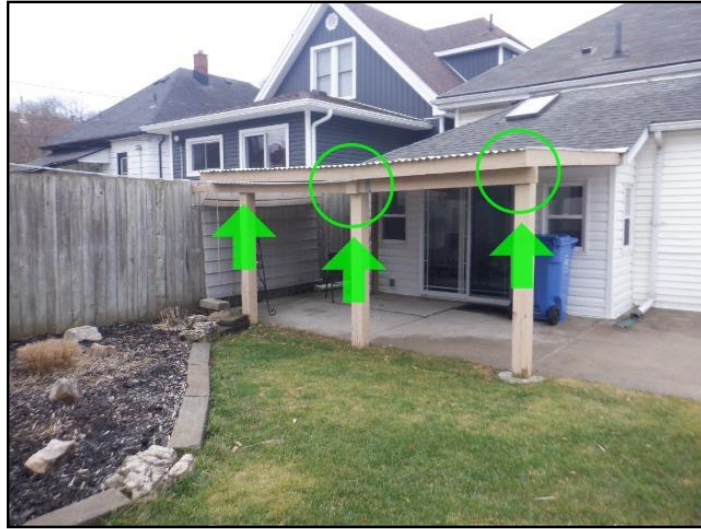
11. Condition: • The rear small patio roof needs to have a full double header added to support the weight of snow load. The current one does not span the full width and is being held up with deck screws. Mods need to be done here for adequate support.

23. Reinforce header for snow loads

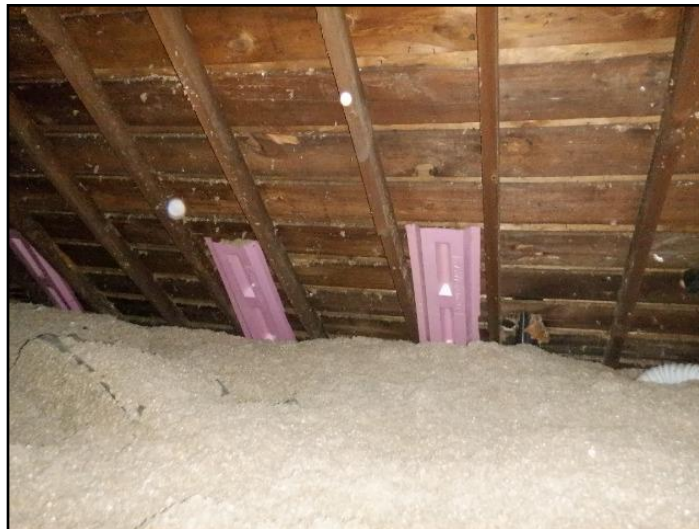
- New finishes/paint
- Insulation
- Main attic could not be walked because of insulation covering the ceiling joists.

38. Limited Walking

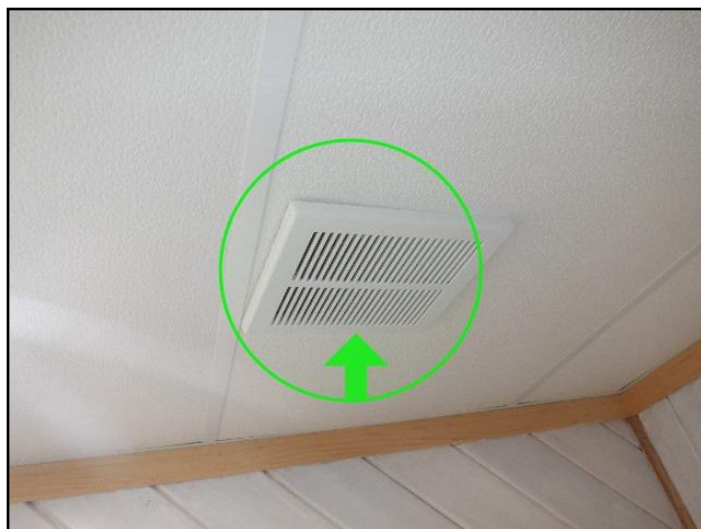
25. Condition: • The lower bathroom fan is very weak and should be replaced. Ensure this is installed correctly and vented to the exterior of the home.

73. Lower bath/ weak fan

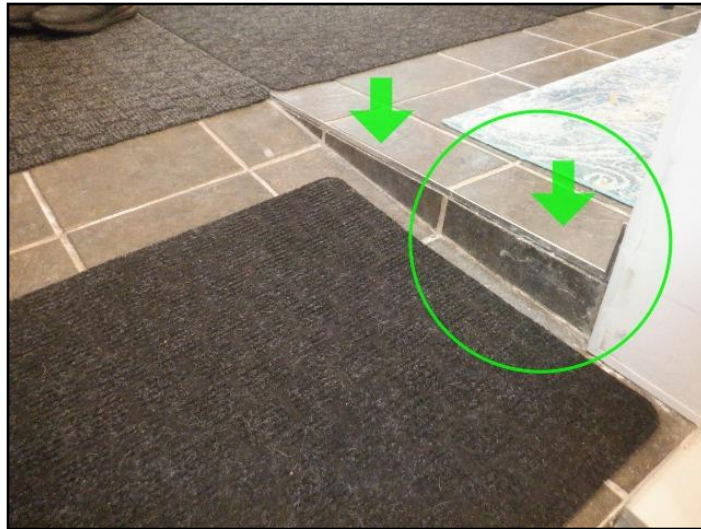
30. Condition: • There does appear to be a small trip hazard in the floor transition to the rear small addition. This is being noted for safety.

94. Trip Hazard
