INSPECTION REPORT

For the Property at:
1234 NEW HOME
SE WISCONSIN, WI

Prepared for: EXAMPLE REPORT
Inspection Date: Friday, December 11, 2020
Prepared by: David Gross

RE: Report No. 1143, v.5
1234 new Home
SE Wisconsin, WI

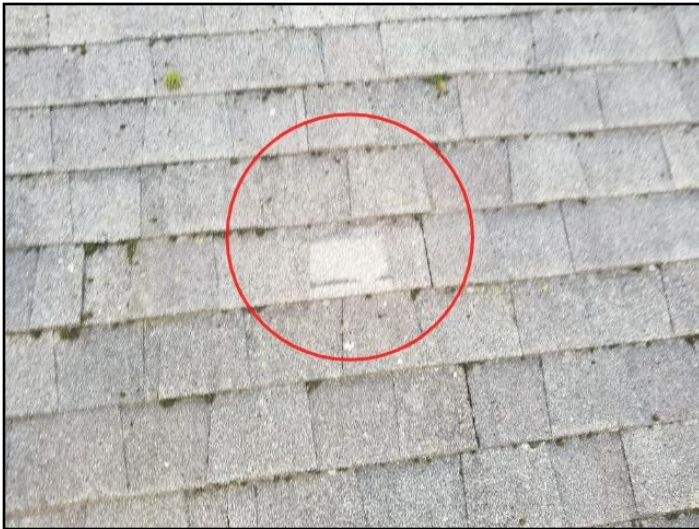
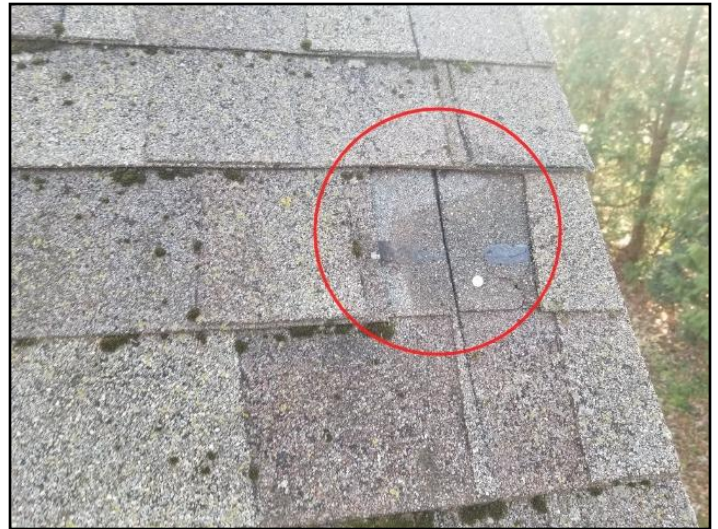
Various shingles have damage to them on West side of roof above flat roof. Have repaired by roofing contractor

1. Missing, loose or torn

2. Missing, loose or torn

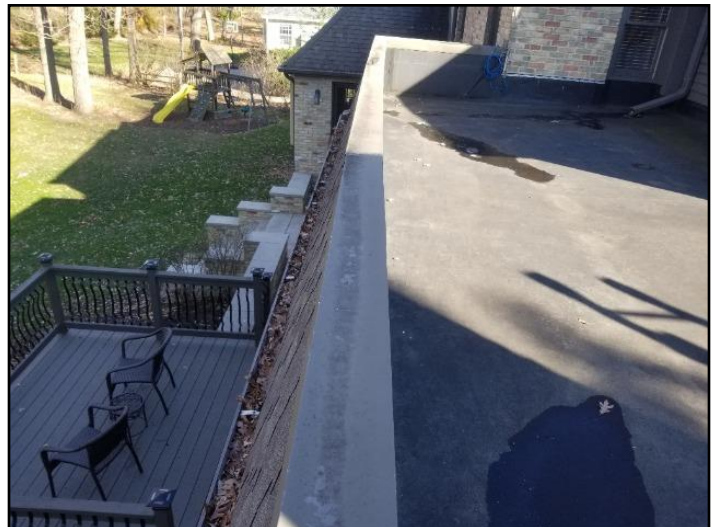
Noted heat tape along NW side of second floor. Roofs may need to be shoveled off periodically after heavy snow events to prevent ice damming.

6. Vulnerable to ice damming

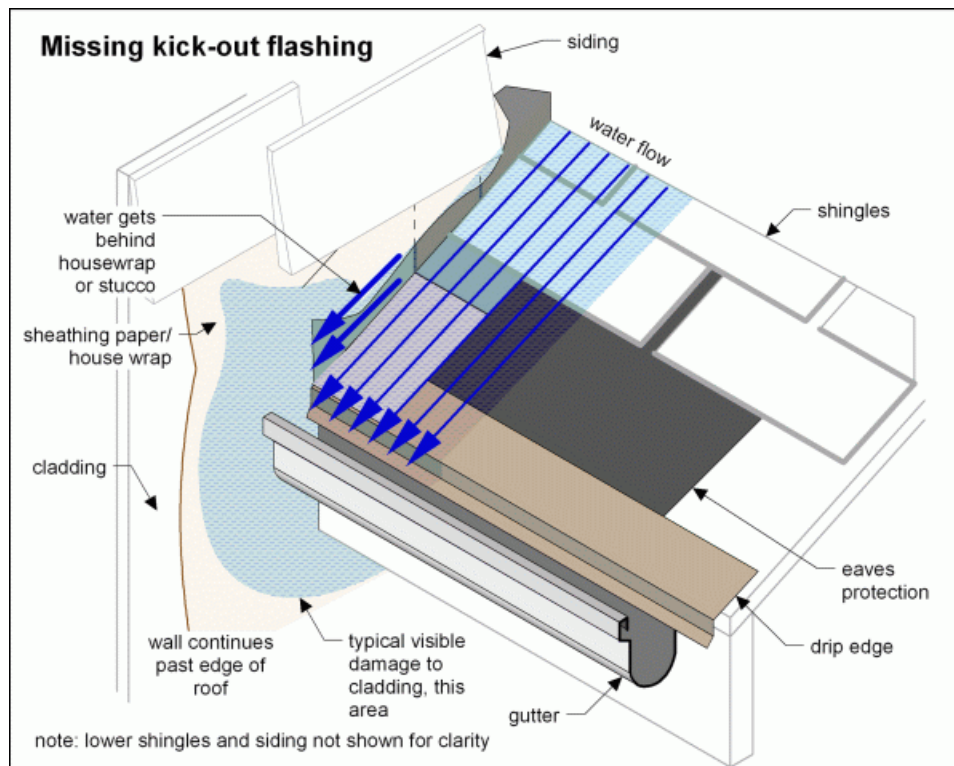
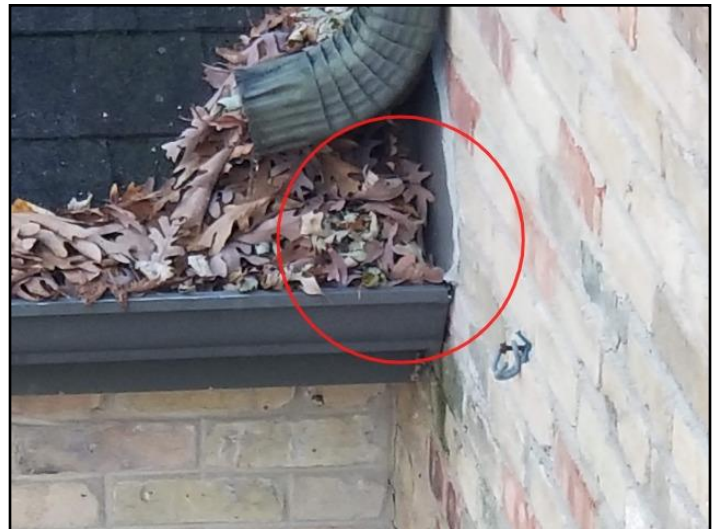
17. Kickout flashing - missing

18. Kickout flashing - missing

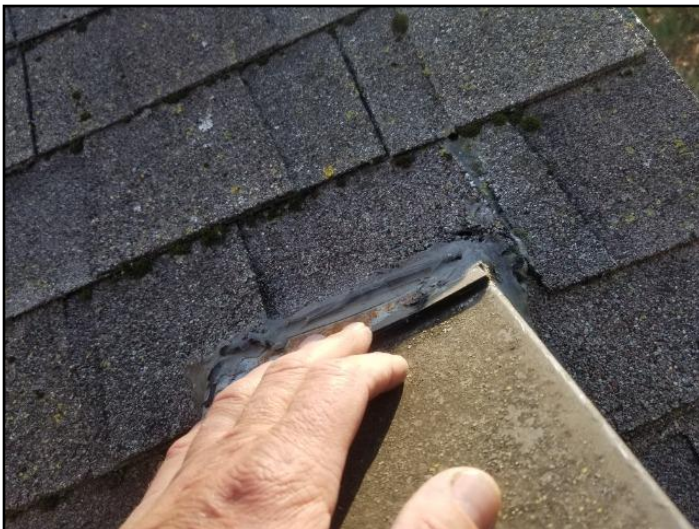
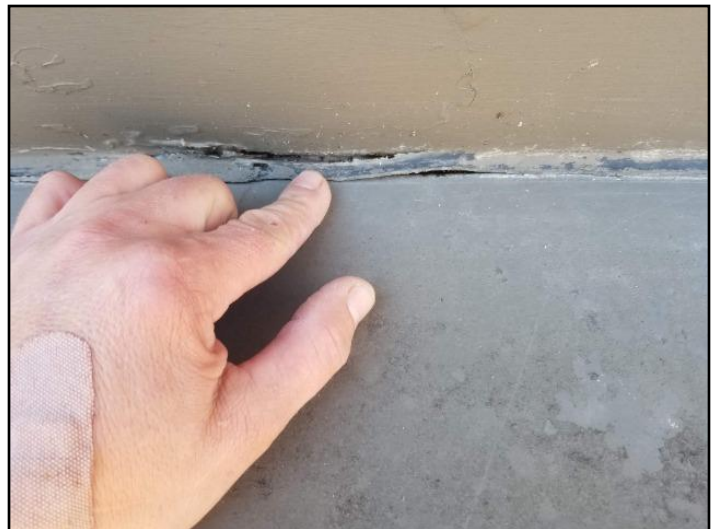
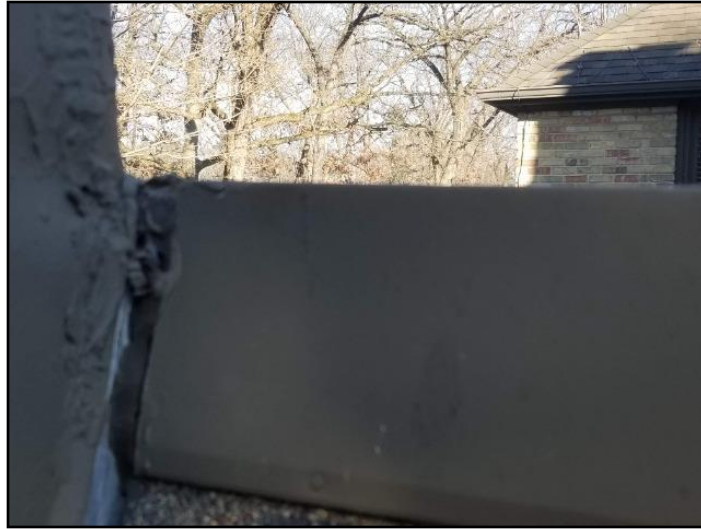
Flat roof has few areas where the caulking has failed. Have roofer point up the areas on parapet to roof flashing, and along chimney.

20. Failed caulking

21. Failed caulking

22. Failed caulking

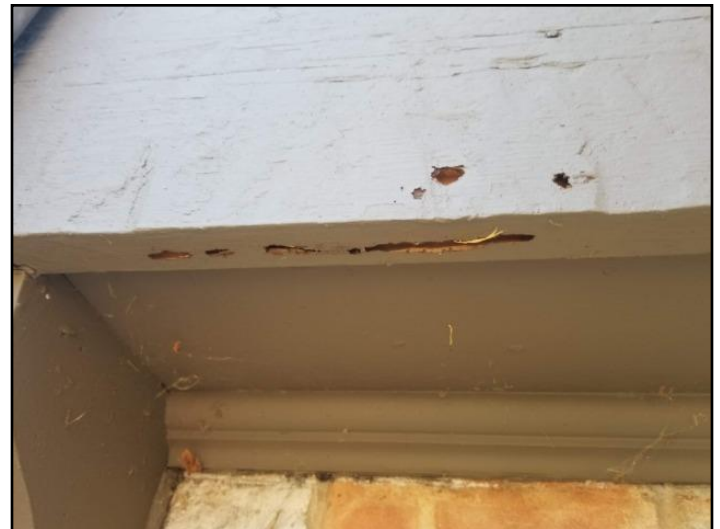
Noted areas of rot on soffit under the sidewall roof junctions by kitchen window. Recommend having contractor repairing rotted wood and installing kickout flashing above wood

27. Rot or insect damage

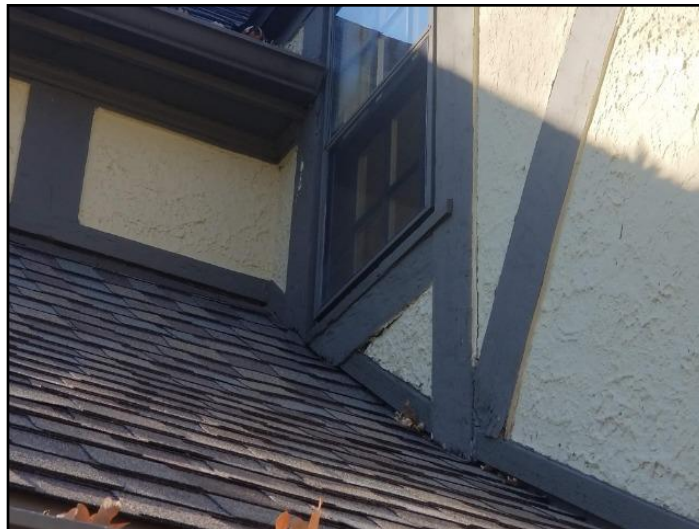
30. Paint

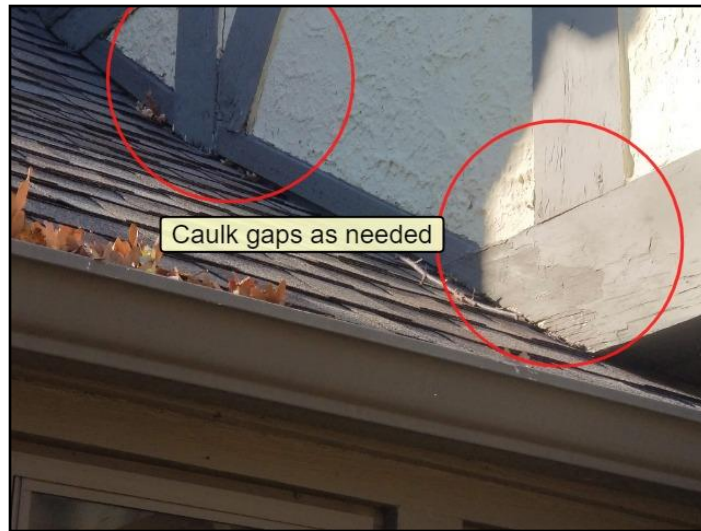
Apply caulking in gaps and junctions of different wall materials to decrease moisture penetration

31. Caulking missing or deteriorated

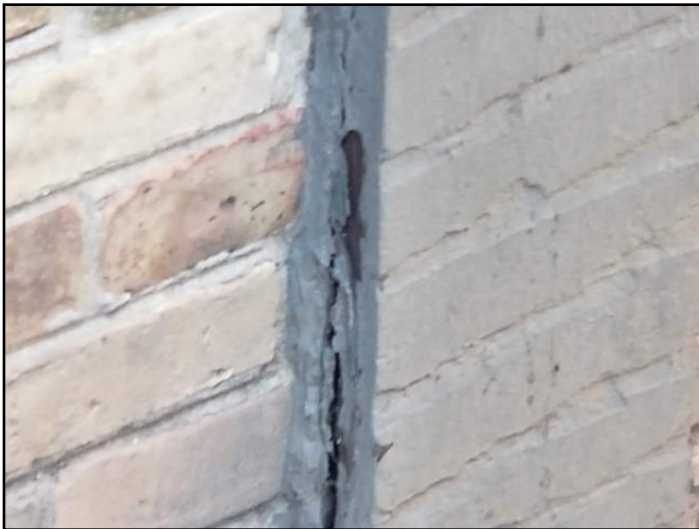
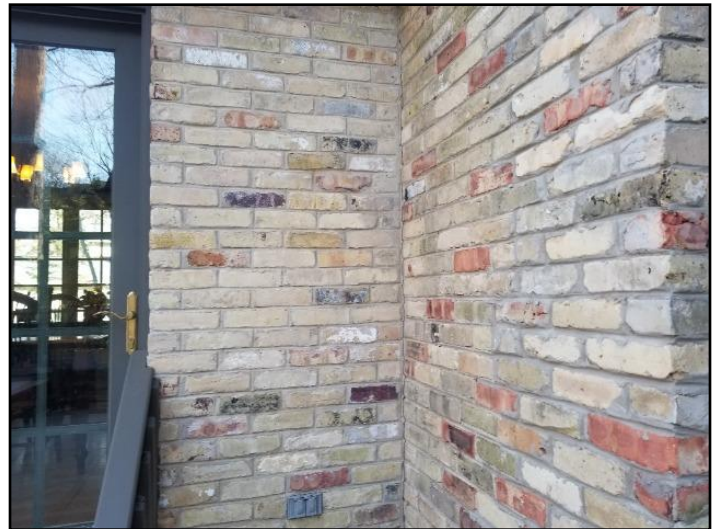
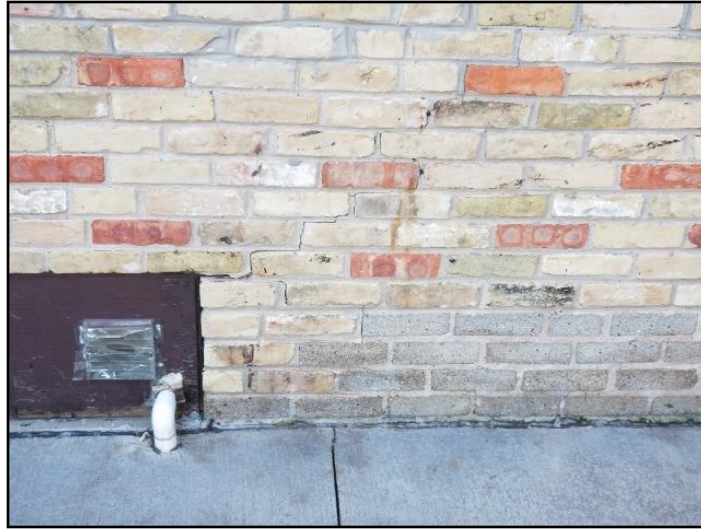
Minor cracks on North side of home. Have qualified contractor seal cracks with exterior concrete caulking for vertical application.

32. Cracked

33. Cracked

34. Cracked

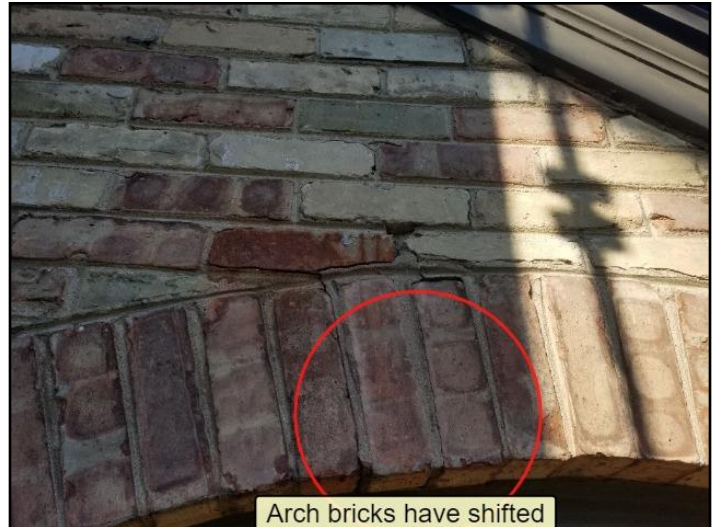
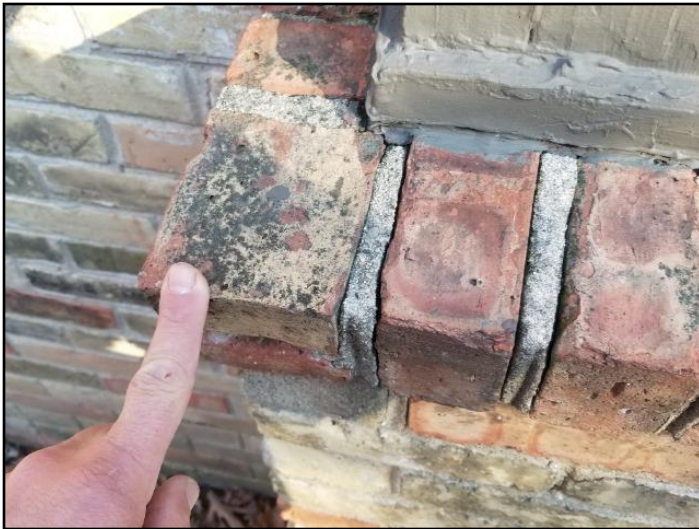
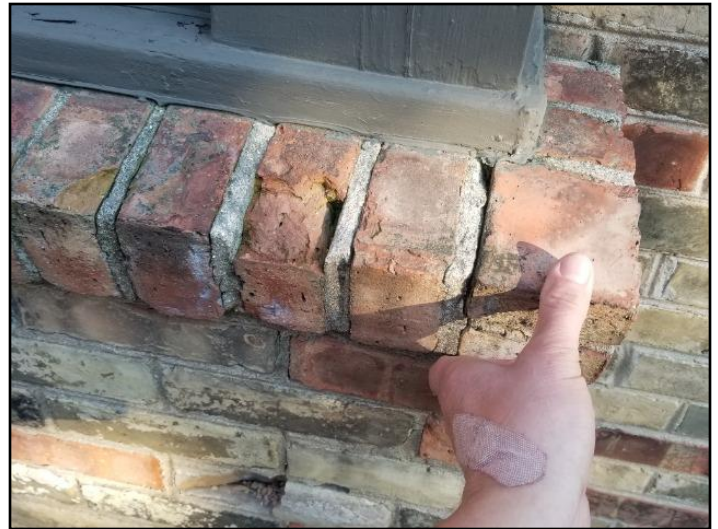
Noted motion of archway bricks over front door. Noted loose brick soldiers on West side of house. Have mason evaluate and repair as needed.

36. Masonry deterioration

37. Masonry deterioration

38. Masonry deterioration

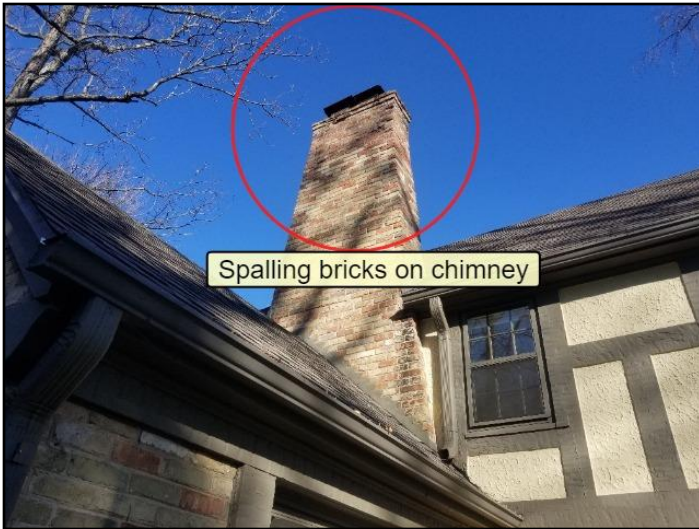
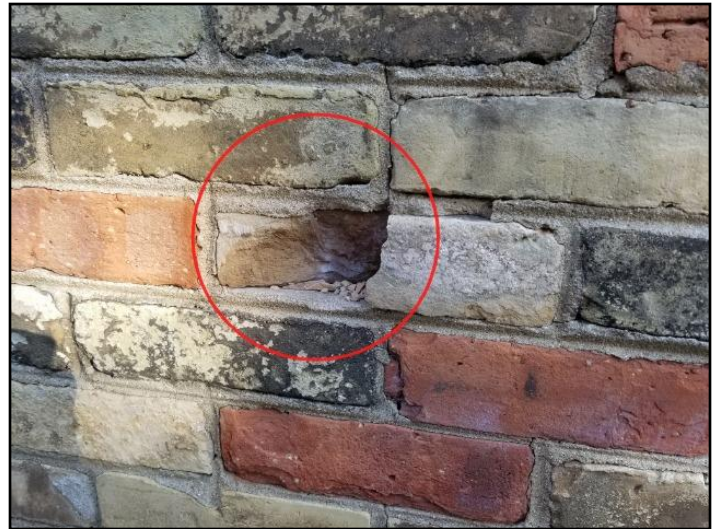
Have mason repair various spalled bricks on chimney, rear patio and near front porch.

39. Spalling

40. Spalling

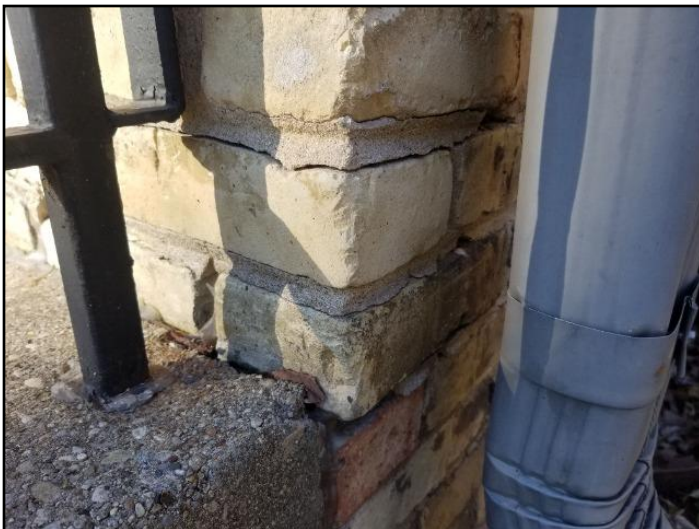
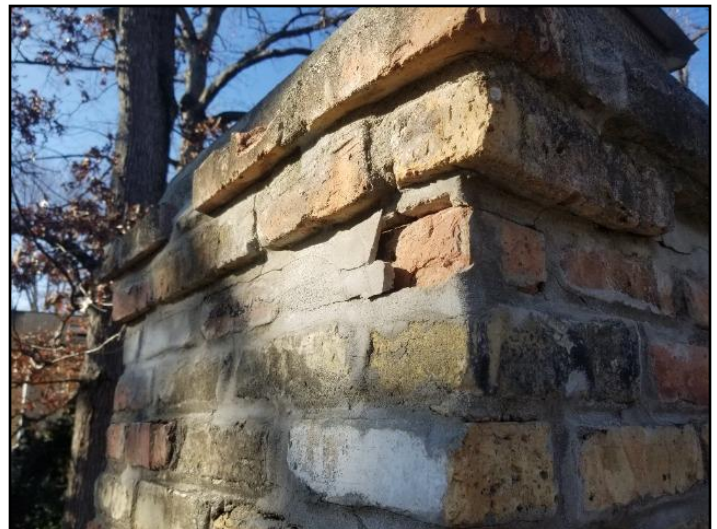
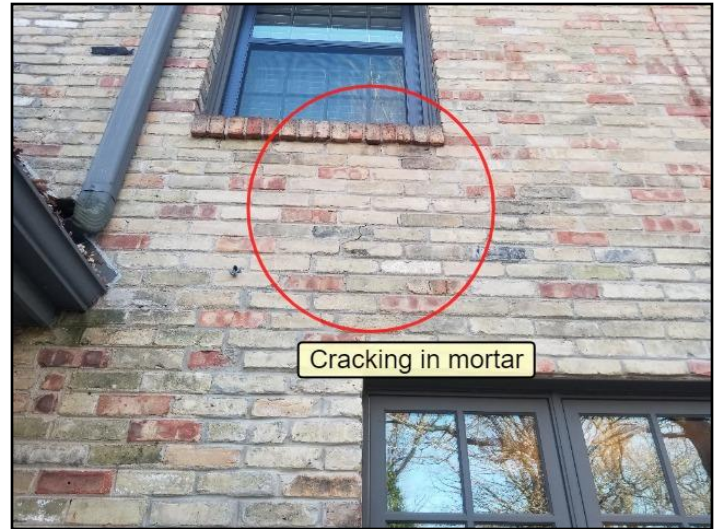
41. Mortar deterioration

42. Mortar deterioration

44. Mortar deterioration

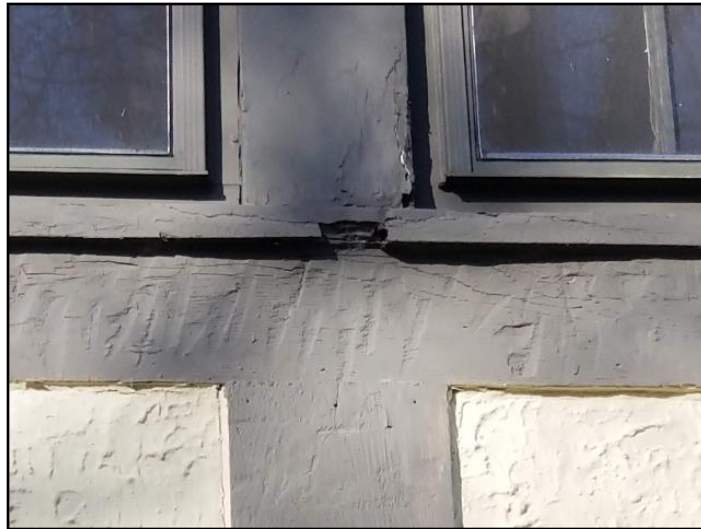
45. Damage

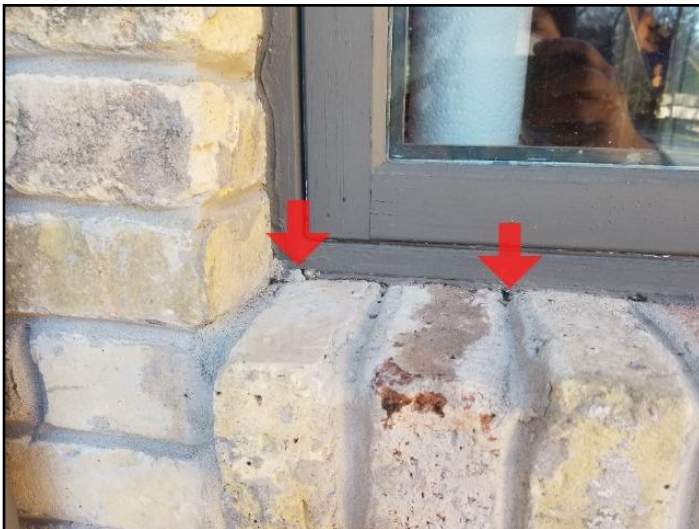
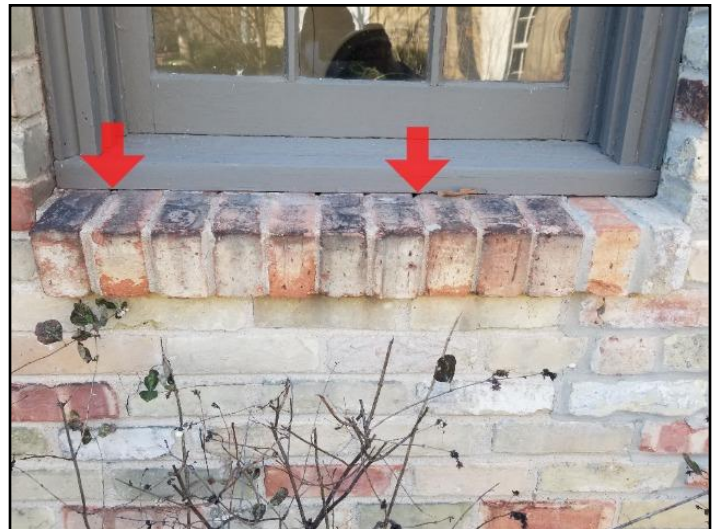
Noted minor gaps between bricks and trim around windows and doors. Clean joints and install appropriate caulking to decrease moisture intrusions.

46. Caulking loose, missing or deteriorated

47. Caulking loose, missing or deteriorated

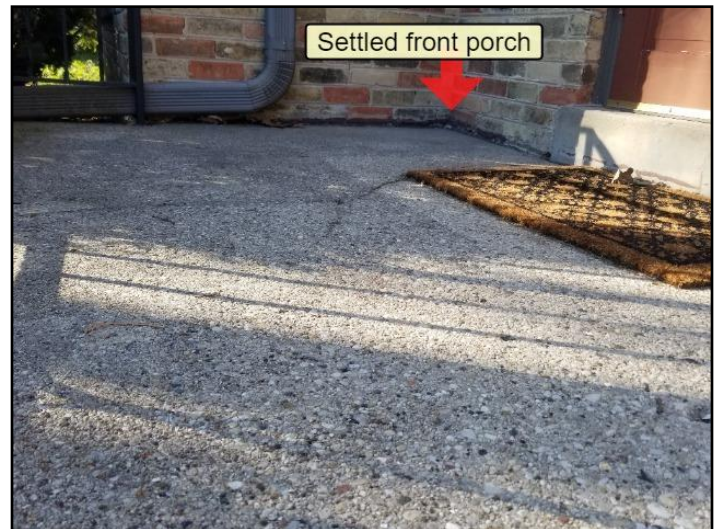
Front porch pitched towards home. Seal gaps along home to decrease moisture intrusion. In future have contractor correct porch pitch as needed.

54. Improper slope or drainage

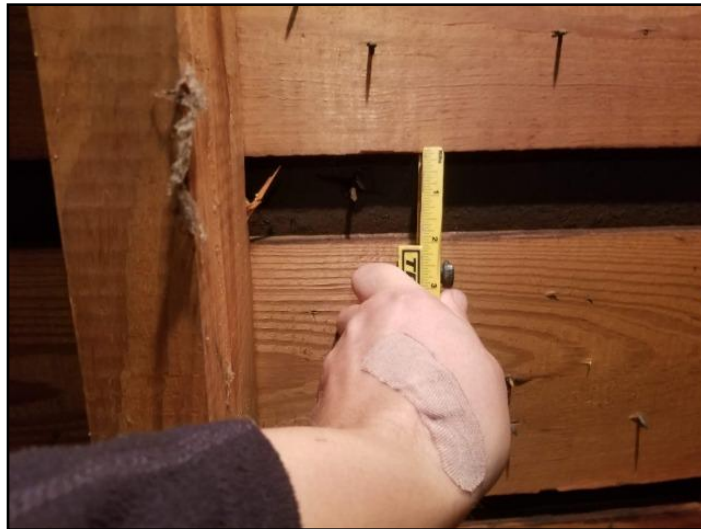
58.

41. Condition: • Roof decking is planking. Large gaps between boards. When having roof replaced it will need to have new sheathing/decking installed over the existing planks.

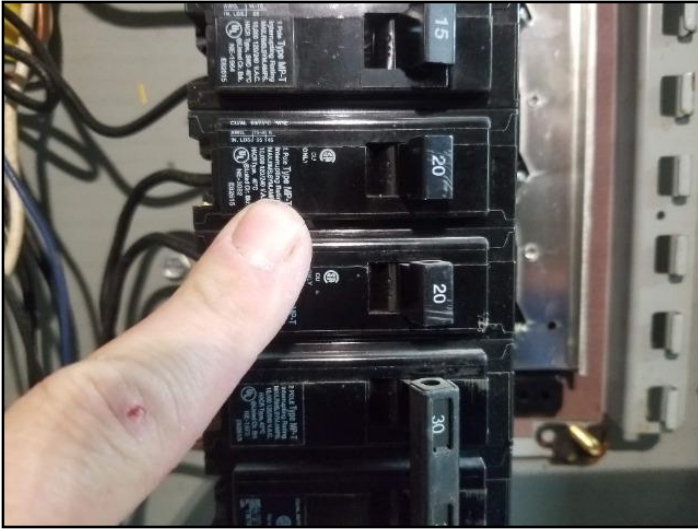
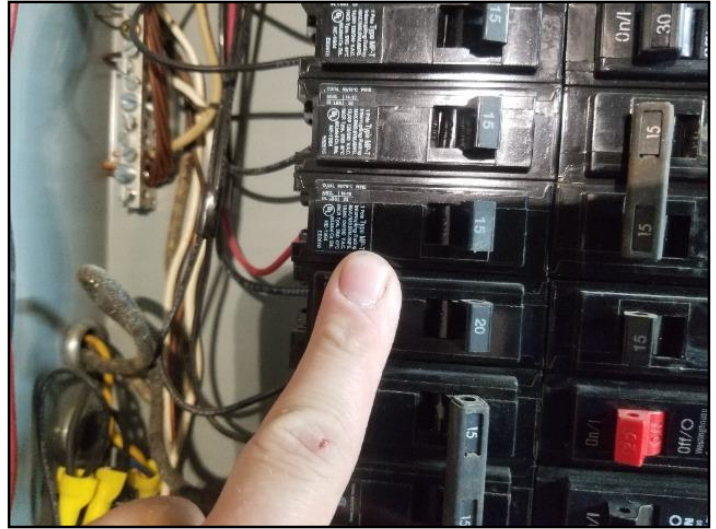
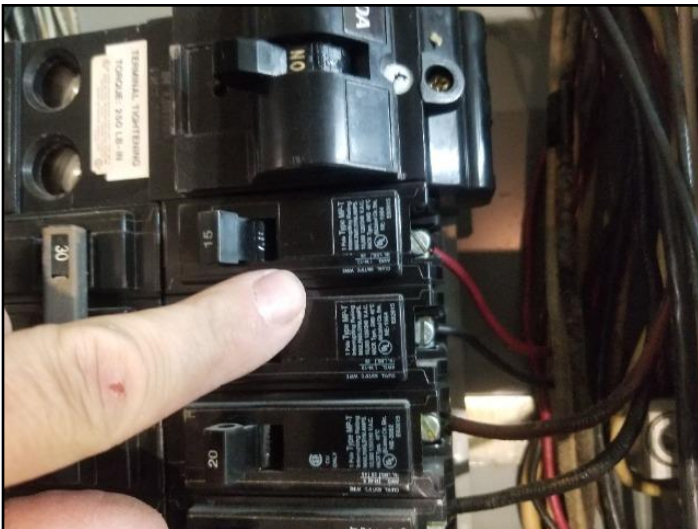
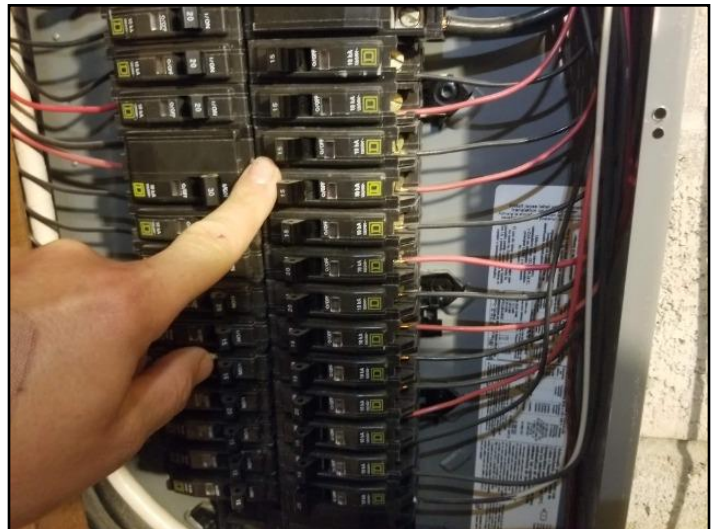
Noted multiple 2 wire circuits sharing a common neutral in both panels. Each panel had 4-6 circuits sharing the neutrals. Have qualified contractor, or electrician repair as needed.

59. Breaker bridge missing

60. Breaker bridge missing

61. Breaker bridge missing

62. Breaker bridge missing

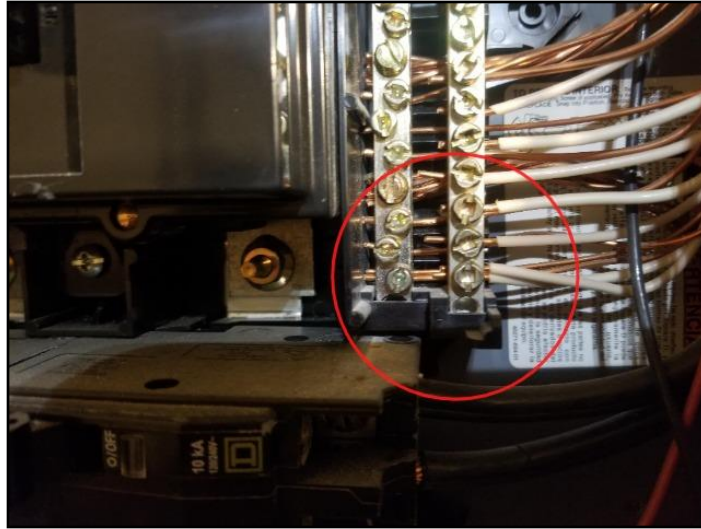
63. Double taps

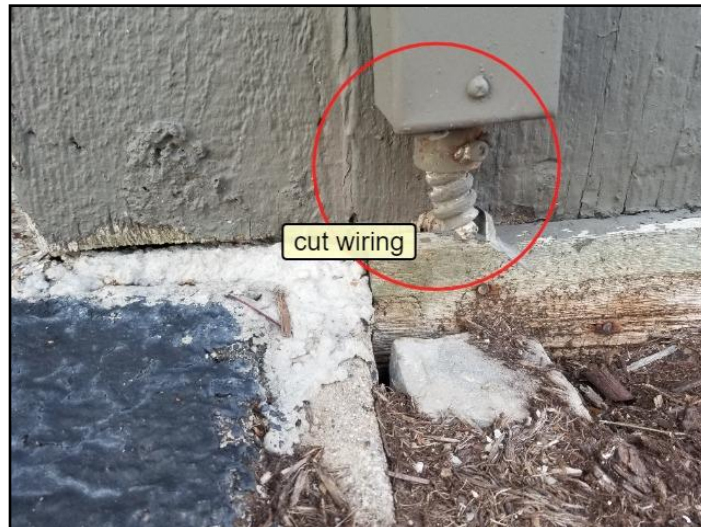
65. Abandoned wire

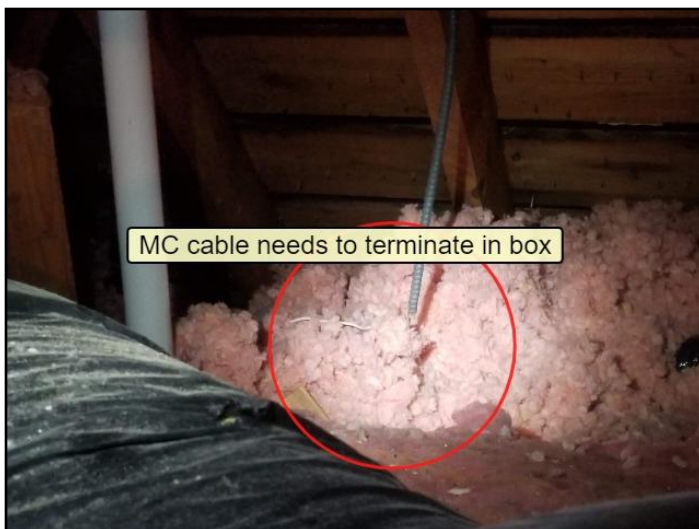
66. Exposed in attics

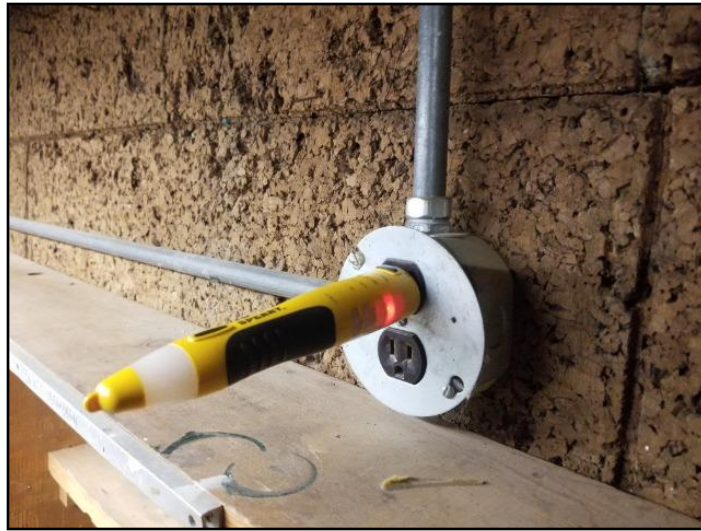
73. Ungrounded

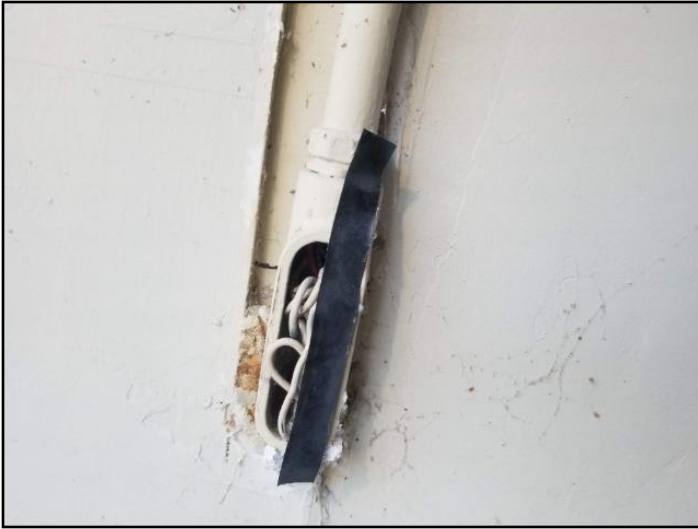
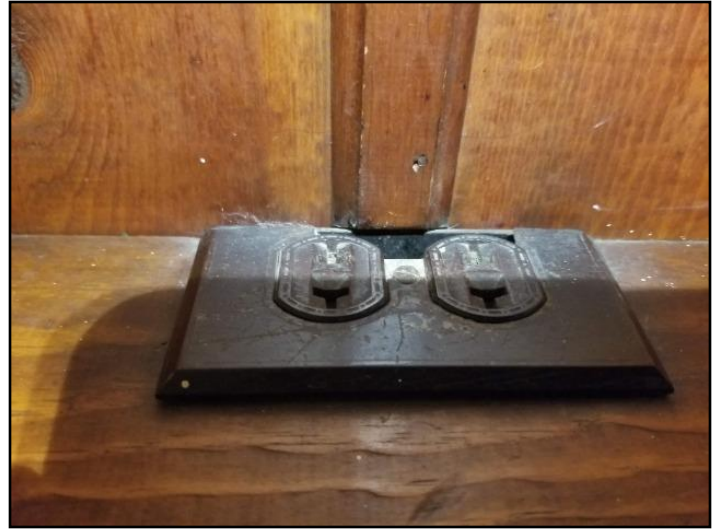
77. Missing

78. Missing

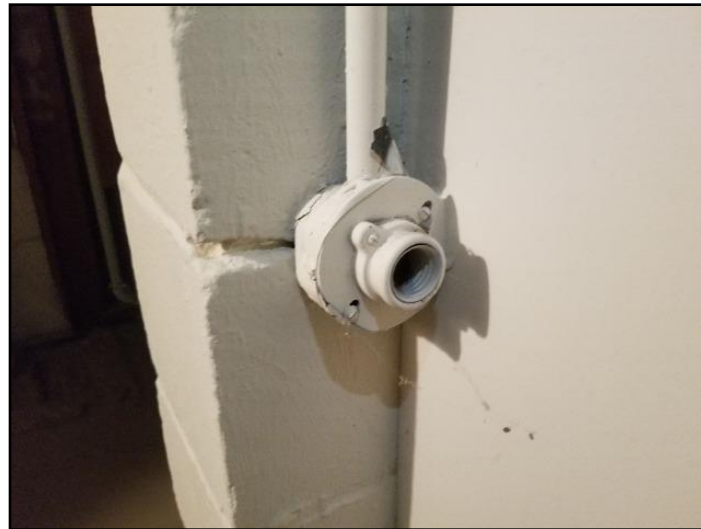
79. Obsolete

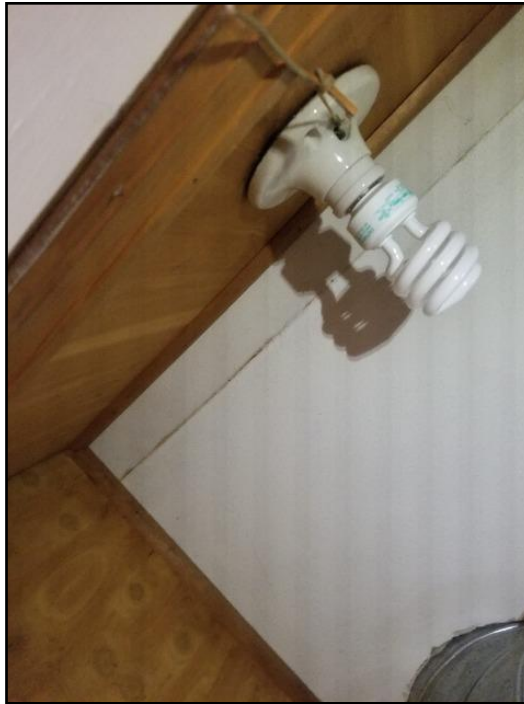
54. Condition: • [Improper closet lighting](#)

80. *Improper closet lighting*

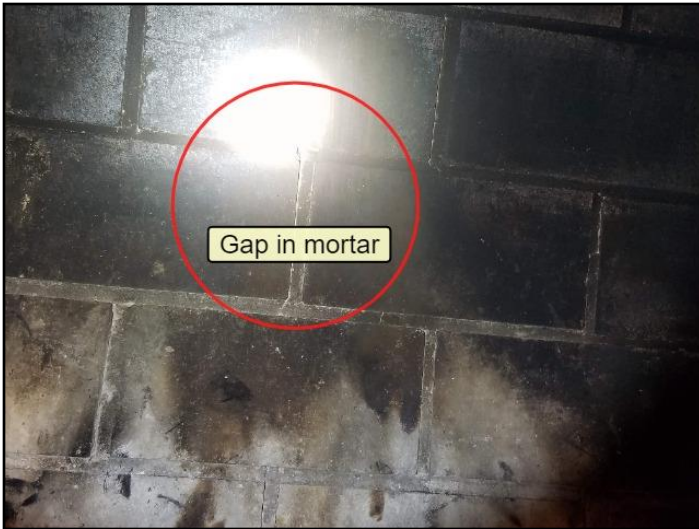
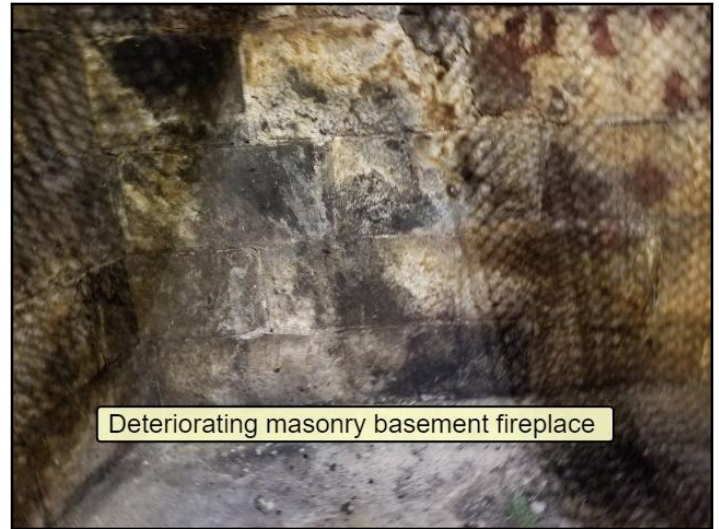
86. Deteriorated, missing or loose masonry or...

87. Deteriorated, missing or loose masonry or...

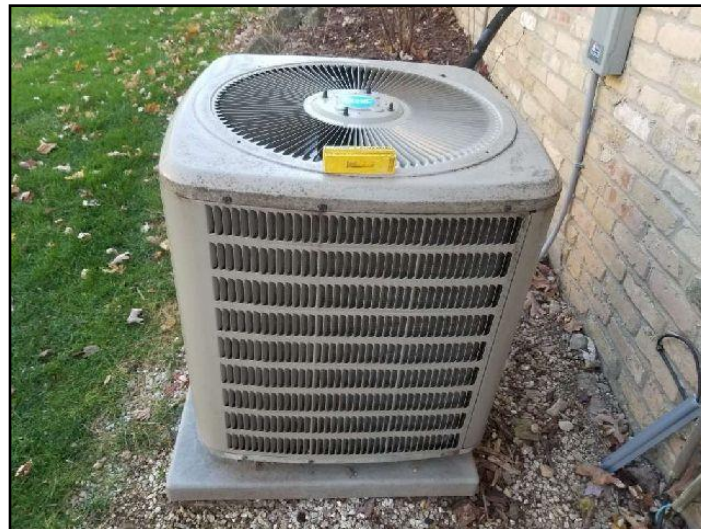
90. Out of level

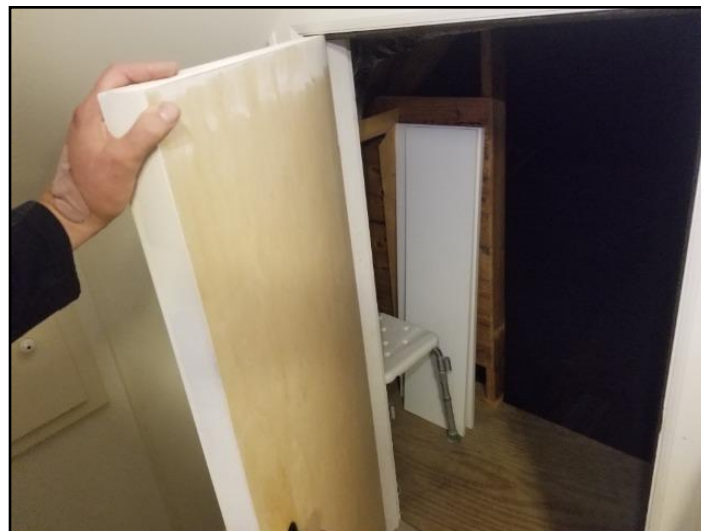
91. Not insulated

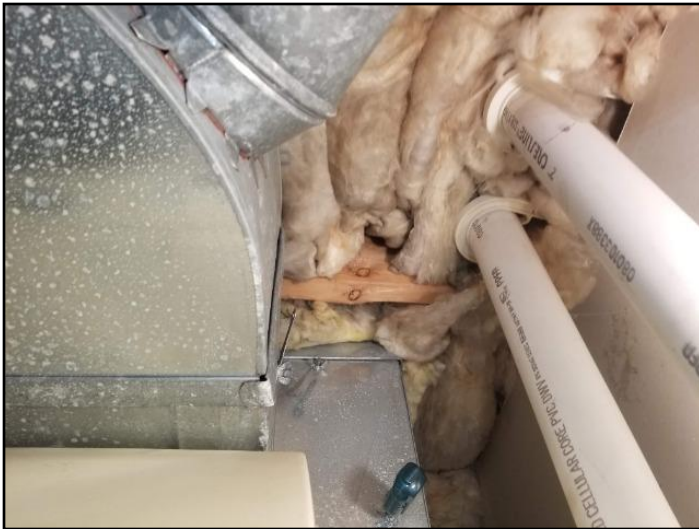
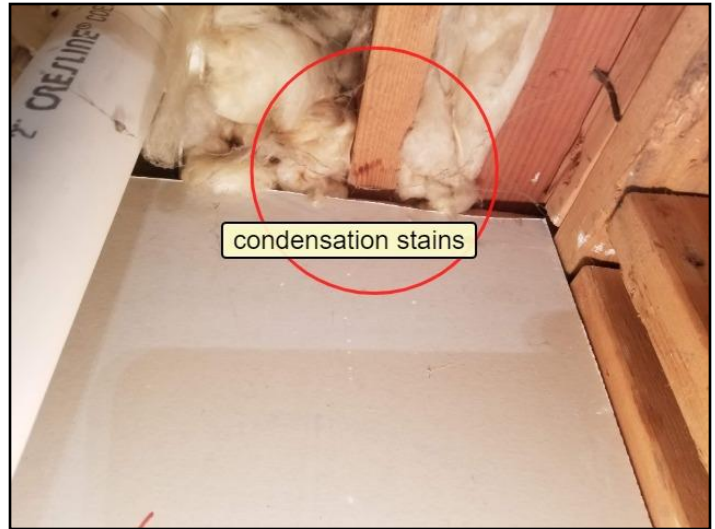
111. Missing

112. Missing

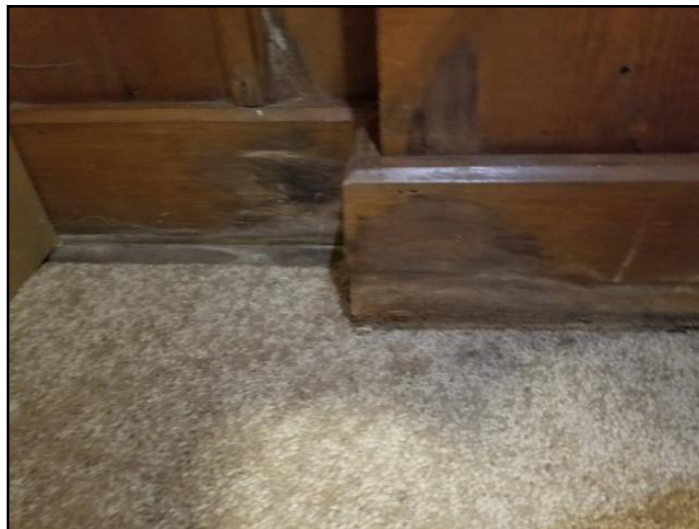
115. Water damage

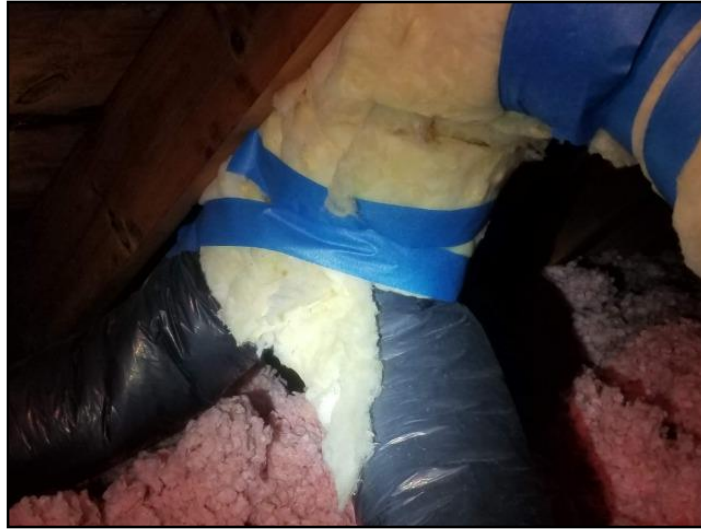
Condition: • Multiple ducts are combined to a single termination. Each vent should have it's own termination point on the exterior of the house

116. Multiple ducts are combined to a single...

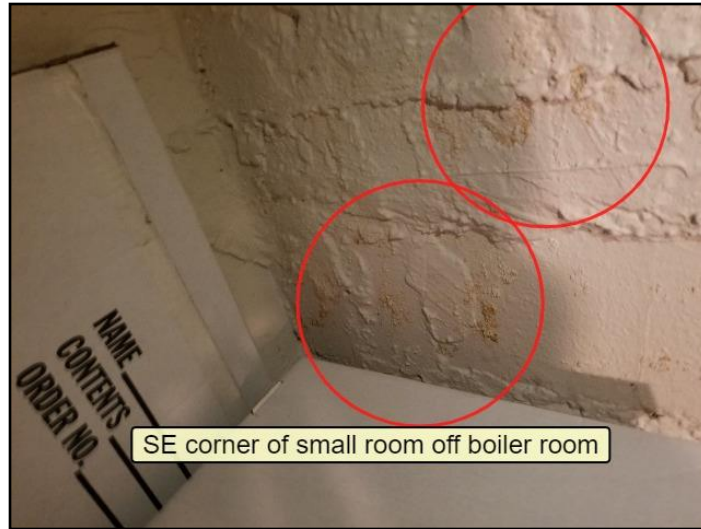
117. Efflorescence

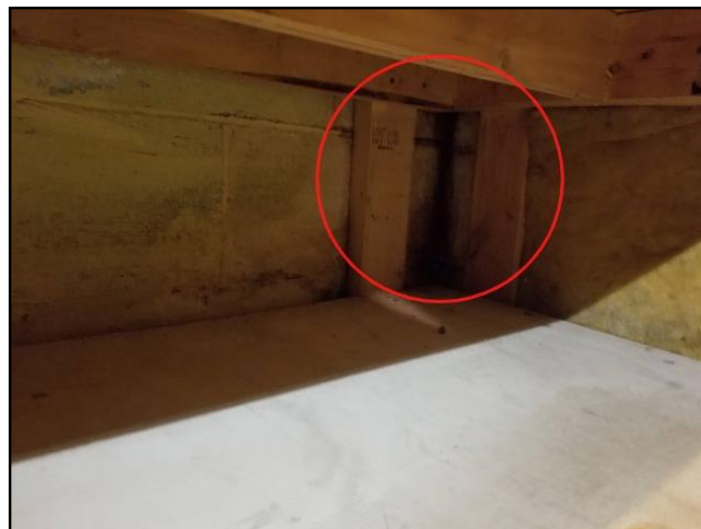
Noted organic growth on wall under gun cabinet. Mold Control is available at most hardware stores. If treating yourself, be sure to follow all safety precautions by wearing personal protection equipment.

118. Organic Growth

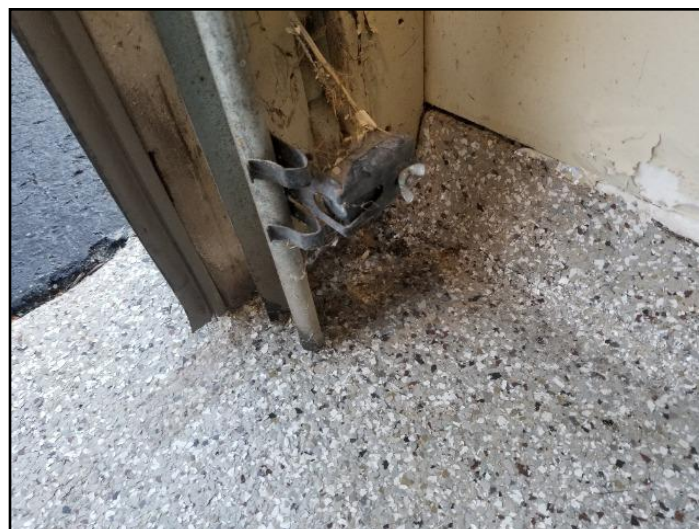
119. Sensors poorly located
