# YOUR INSPECTION REPORT

79 Durie Street  
Toronto, ON M6S 3E7

INSPECTION DATE:  
Monday, February 28, 2022

RE: Report No. 7024, v.2  
79 Durie Street  
Toronto, ON  
M6S 3E7

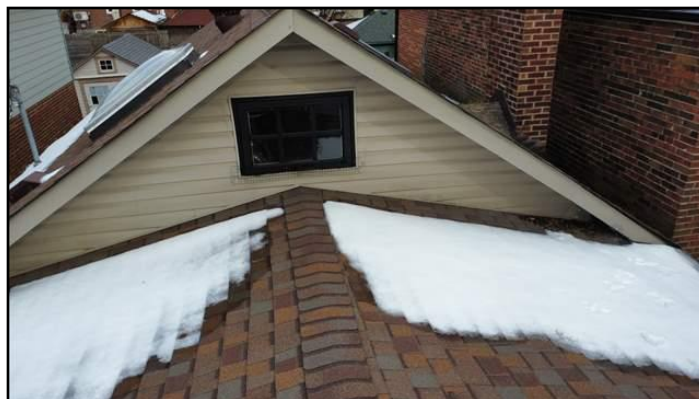
2. Snow Limitation

**Condition:** • Snow on roof limited/restricted inspection. Inspect roof in the Spring when the snow has melted.

**Location:** Exterior Roof

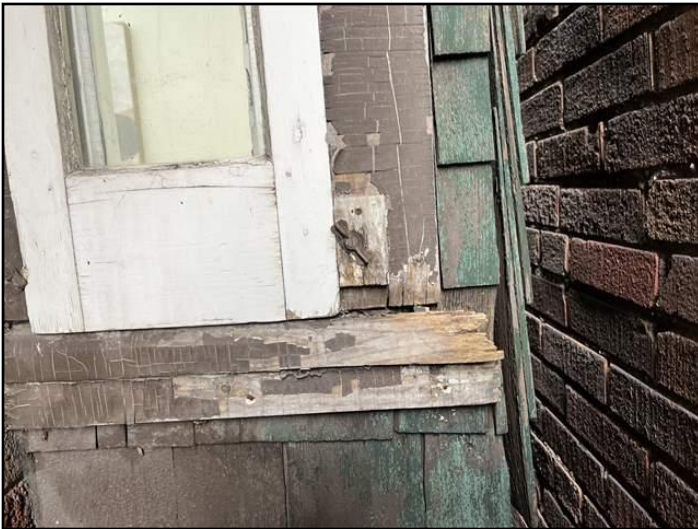
3. Cracked, split or broken

**Condition:** • [Cracked, split or broken](#)

**Task:** Repair or replace

**Time:** Less than 1 year

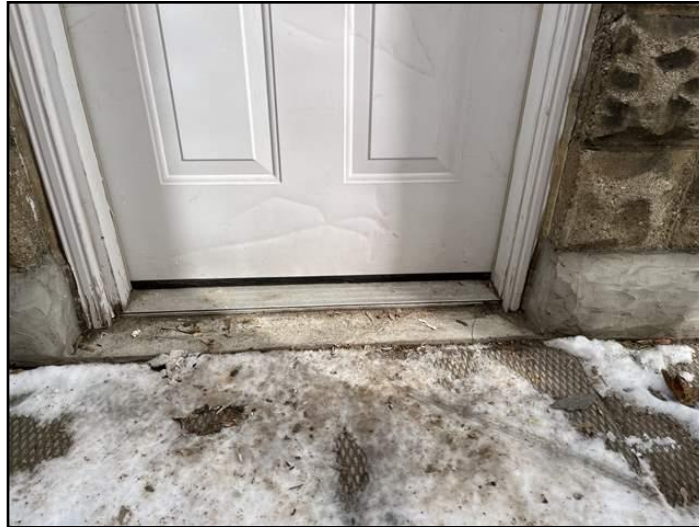
5. Threshold too low

**Condition:** • Threshold too low

On the other hand, it also makes it more prone to snow buildup/leakage.

While it is probably not practical to improve the current situation, it will be important to keep any weatherstripping/caulking in good condition.

**Task:** Monitor / Improve

**Time:** If/as necessary

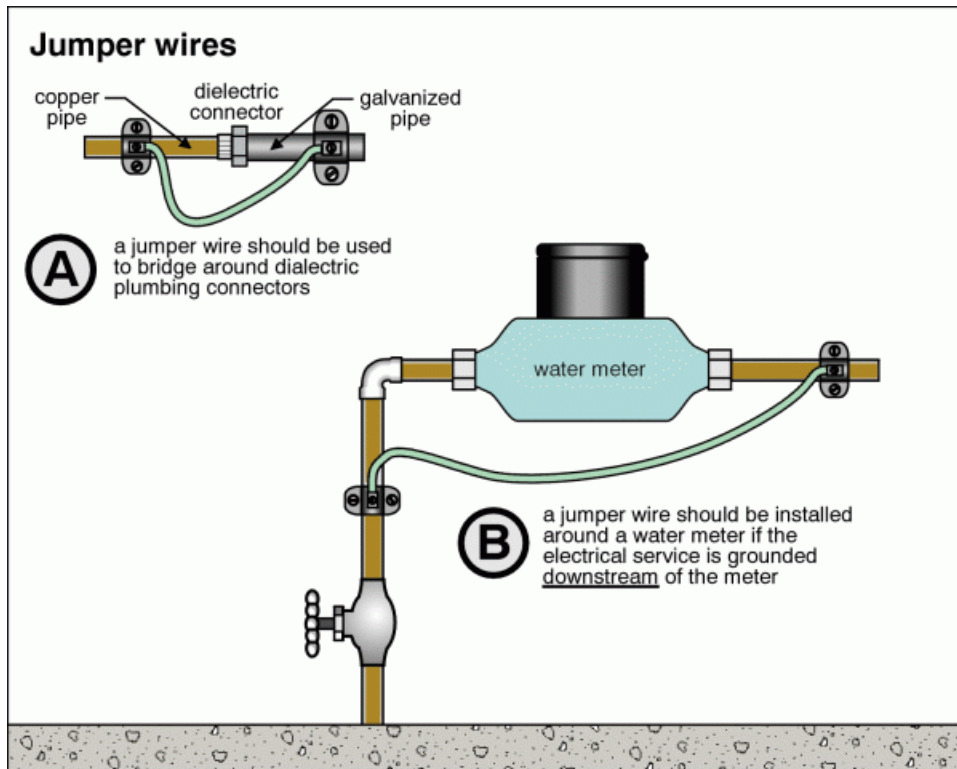
**Condition:** • [No jumper for meters and valves](#)

**Time:** As soon as possible

**Cost:** Minor

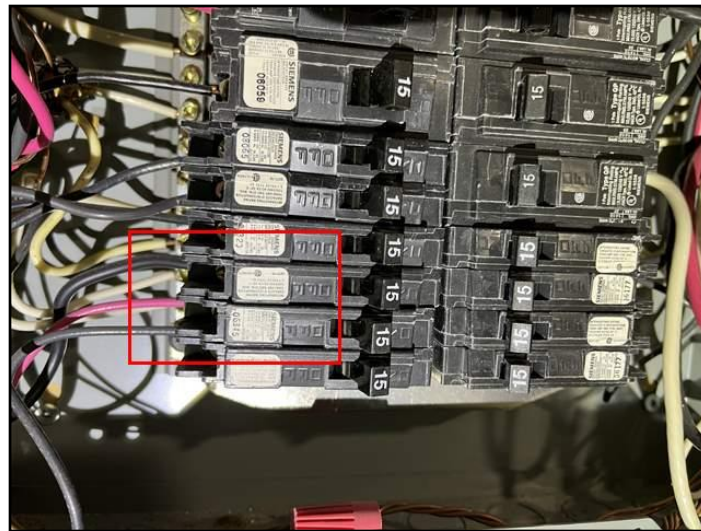
6. No links for multi-wire circuits

**Condition:** • [No links for multi-wire circuits](#)

**Cost:** Less than \$100

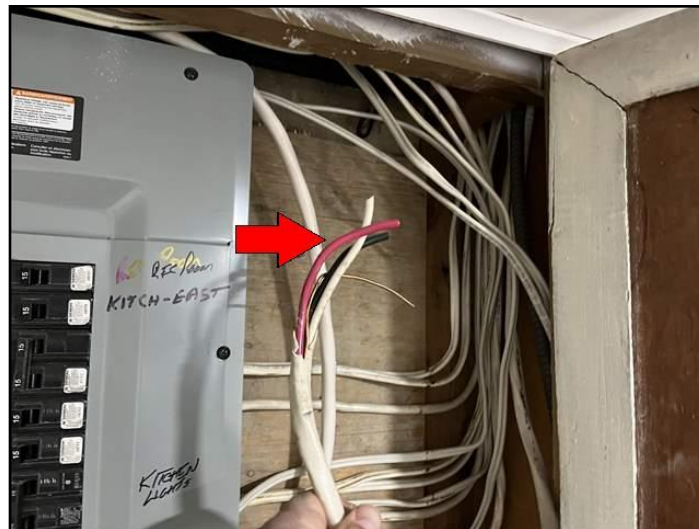
7. Abandoned wire

**Condition:** • [Abandoned wire](#)

**Task:** Remove or Provide junction box

**Time:** Less than one year

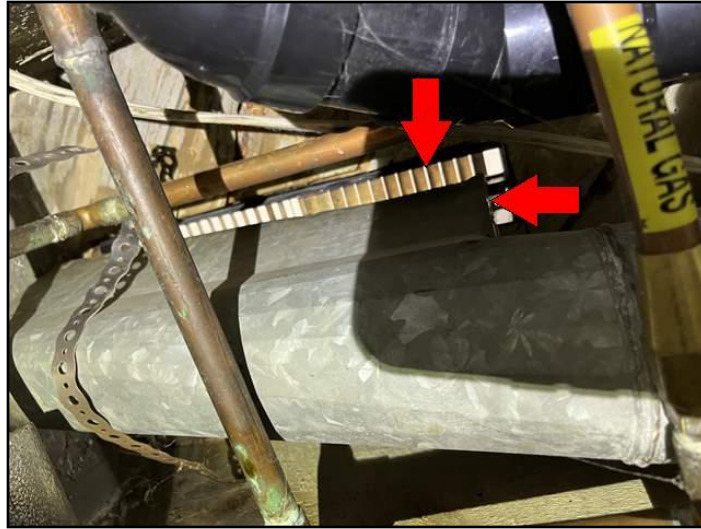
8. Disconnected ducts

**Condition:** • [Disconnected ducts](#)

**Task:** Repair

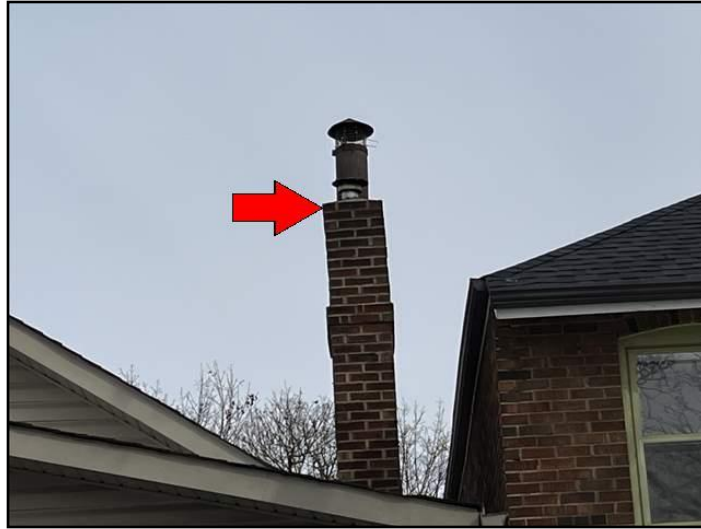
9. No drip edge on cap (crown)

**Condition:** • [No drip edge on cap \(crown\)](#)

**Time:** Less than 2 years

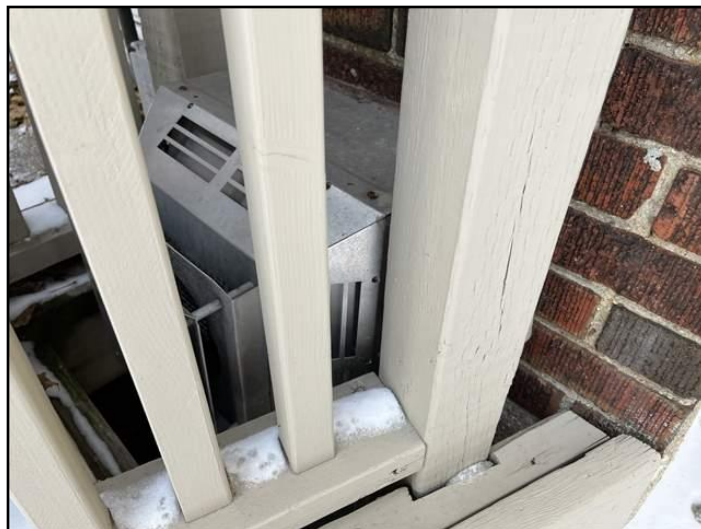
10. rear direct vent

**Condition:** • [Inoperative](#)

Also have specialist check rear direct vent combustible clearance requirements before usage.

**Task:** Service / Repair

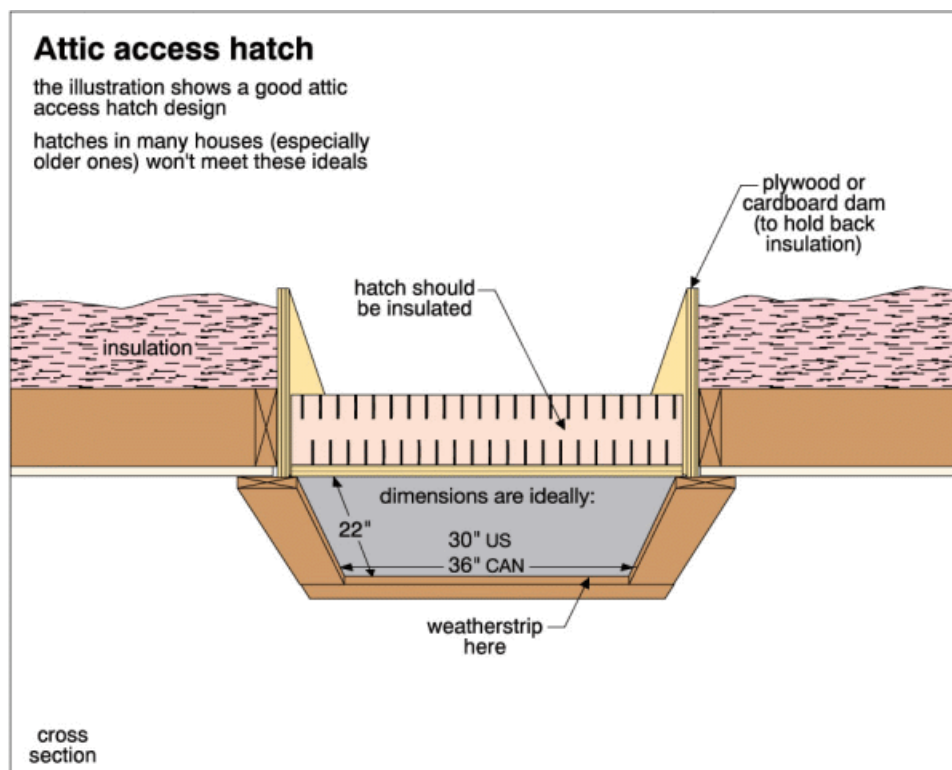
**Condition:** • [Missing](#)

No Access to attic from the interior. Attics are important areas. Provide access so the attic space can be inspected for issues with: roof framing, insulation, water damage, mold, asbestos, exhaust ducts, etc.

**Task:** Provide access and inspect

**Time:** As soon as possible

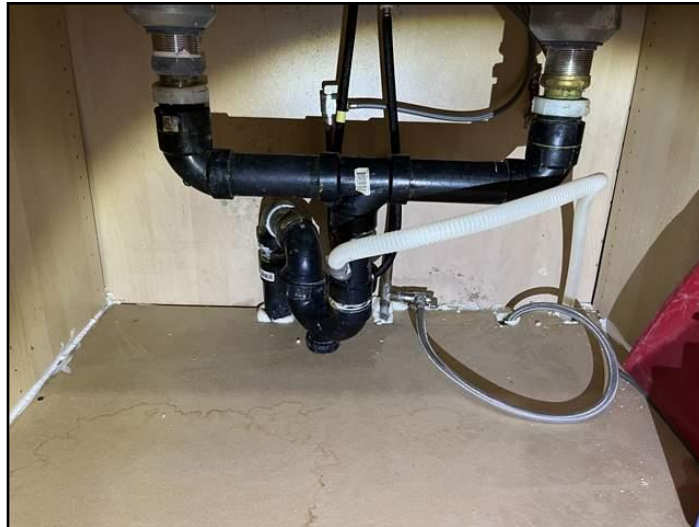
**13.** *Nonstandard shape or material*

**Condition:** • [Nonstandard shape or material](#)

**Task:** Monitor / Improve

**Time:** As Needed

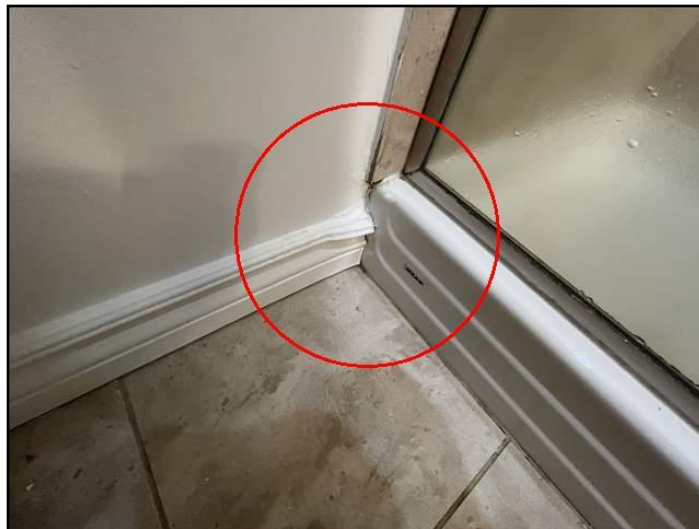
14.

**Condition:** • Prior leakage at shower stall. Seller notes area has been sealed/repaired

**Location:** First Floor Bathroom

**Task:** For Your Information

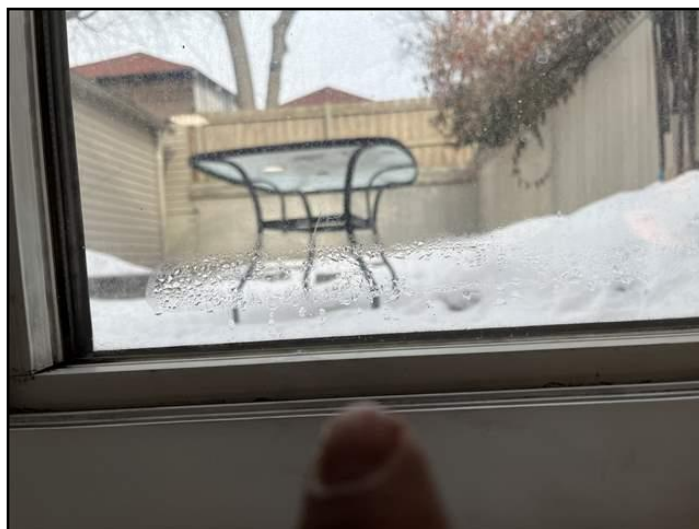
15. one example of lost seal

**Condition:** • [Lost seal on double or triple glazing](#)

We inspected a representative number of windows. Approximately 5 with lost seals were noted (condensation between panes of glass)

**Task:** Replace

**Time:** Discretionary

**Cost:** \$200 - \$500 Each

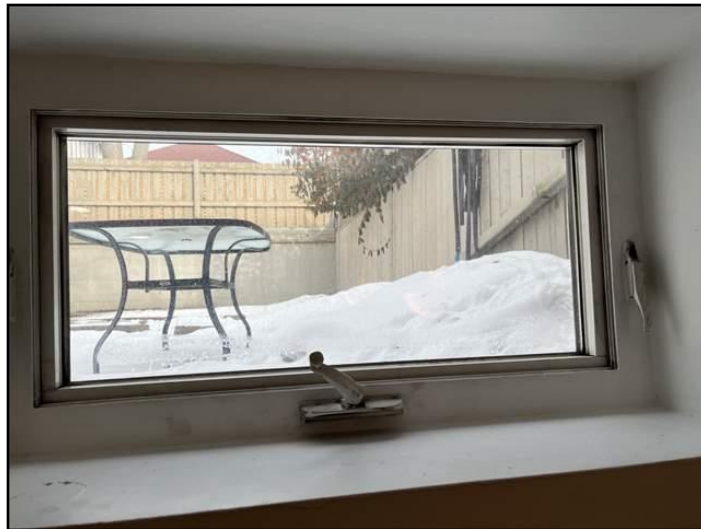
16. Broken hardware

**Condition:** • [Broken](#)

**Task:** Repair / Replace

**Time:** Less than 1 year

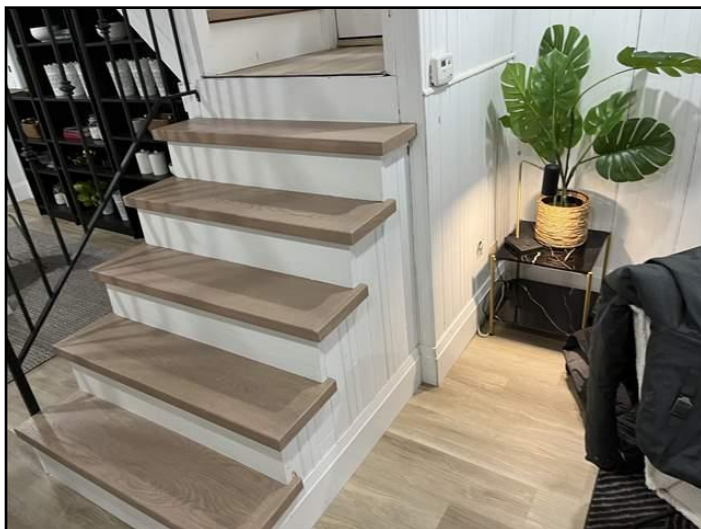
17. Missing on open side

**Condition:** • [Missing](#)

**Time:** Less than 1 year
