# YOUR INSPECTION REPORT

47 Kenneth Avenue  
Toronto, ON M6P 1J1

INSPECTION DATE:  
Friday, September 8, 2017

RE: Report No. 2163  
47 Kenneth Avenue  
Toronto, ON  
M6P 1J1

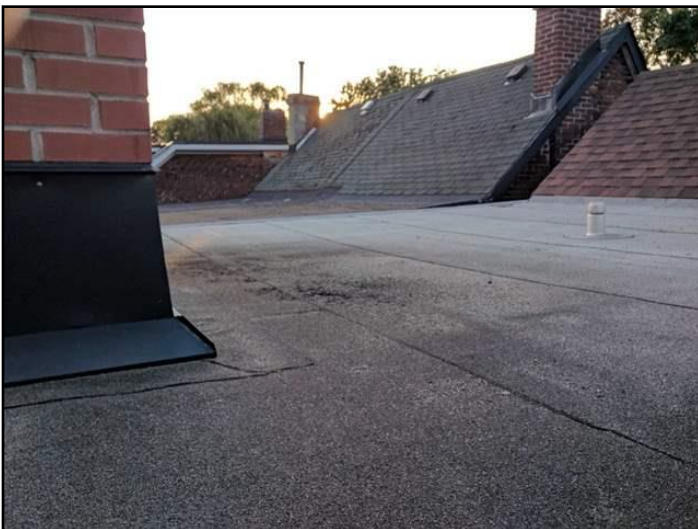
**Condition:** • [Near end of life expectancy](#)

The flat was inspected by a professional roofing company, Eileen Roofing. The homeowner noted that the current flat roof is approximately 20 years old. Eileen Roofing, observed that the roof is aging with typical wear - Granule loss and areas of the roof covering show evidence of ponding. which is caused by low areas on the roof. Overall the roof covering is nearing the end of its normal lifespan and replacement is likely needed in approximately 2 years.

1. Near end of life expectancy

**Task:** Replace

**Time:** Less than 2 years

**Cost:** \$7,000 - \$12,000

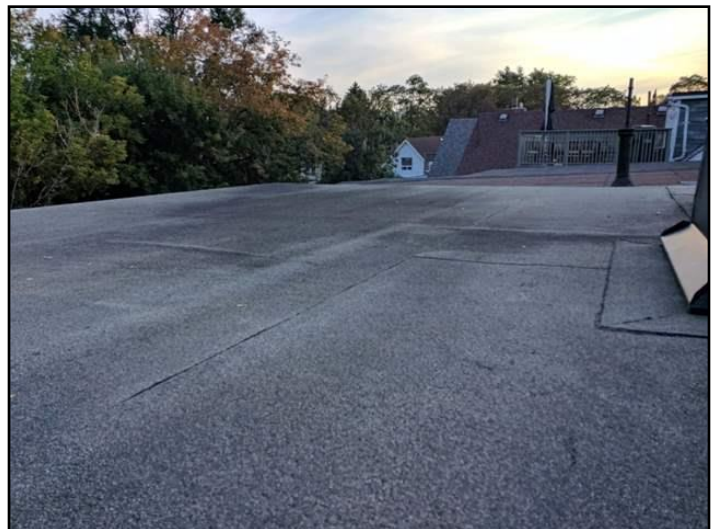
2. Near end of life expectancy

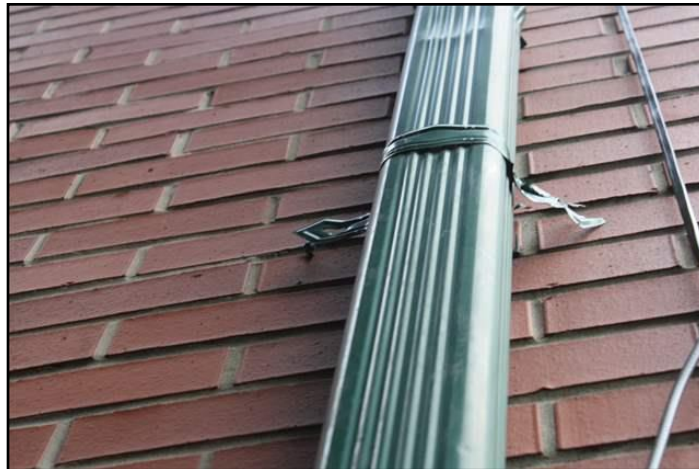
Condition: • [Not well secured](#)

Implication(s): Leakage

Location: Right Side Exterior

3. Not well secured

Task: Improve

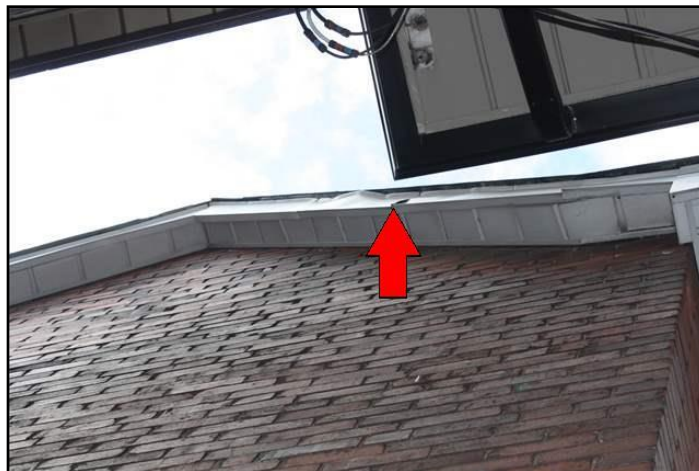
Condition: • [Damage](#)

Implication(s): Chance of water damage to contents, finishes and/or structure

Location: Left Side Exterior

4. Damage

Task: Repair or replace

Time: Less than 1 year

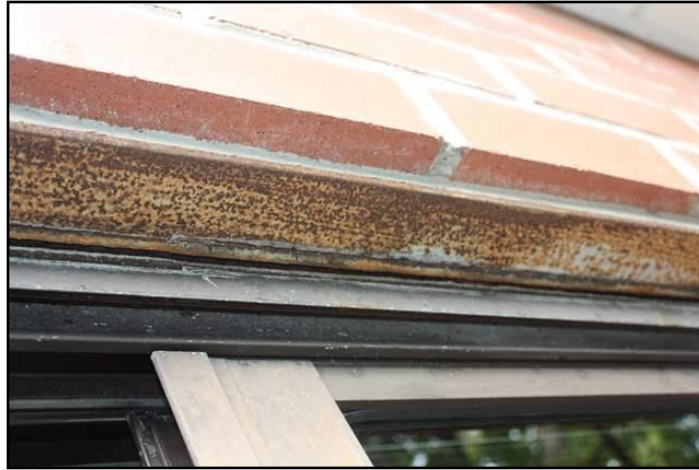
**Condition:** • [Caulking missing or ineffective](#)

**Implication(s):** Chance of water damage to contents, finishes and/or structure

**Location:** Various Exterior

5. Example

**Task:** Improve

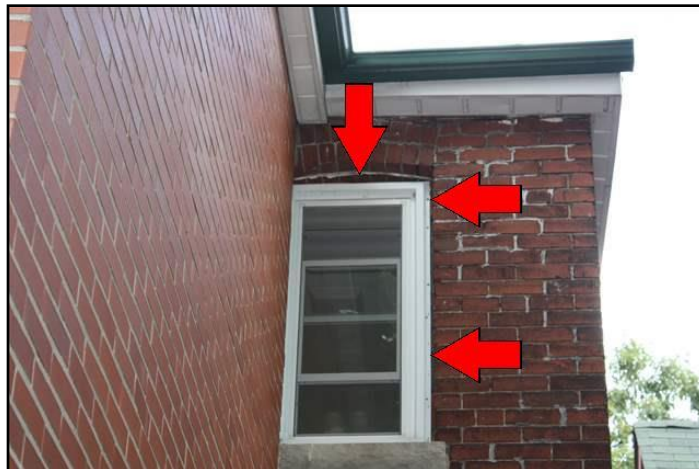
**Condition:** • [Missing or loose pieces](#)

**Implication(s):** Chance of water damage to contents, finishes and/or structure

**Location:** Rear Exterior

6. Missing or loose pieces

**Task:** Correct - Provide flashing or trim

**Time:** Less than 1 year

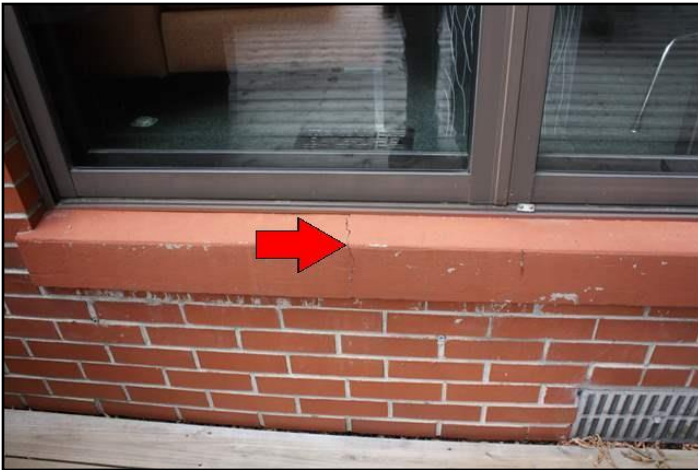
Minor crack at sill noted. Patch to prevent further damage

7. Minor sill cracks

**Task:** Patch

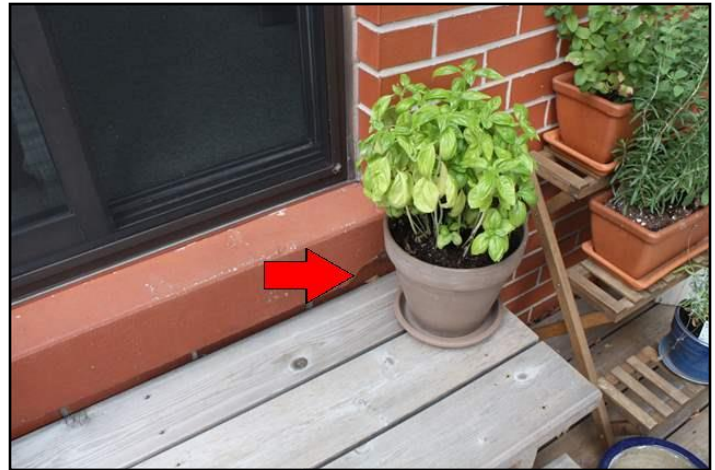
**Condition:** • [Sill deteriorated](#)

8. Sill deteriorated

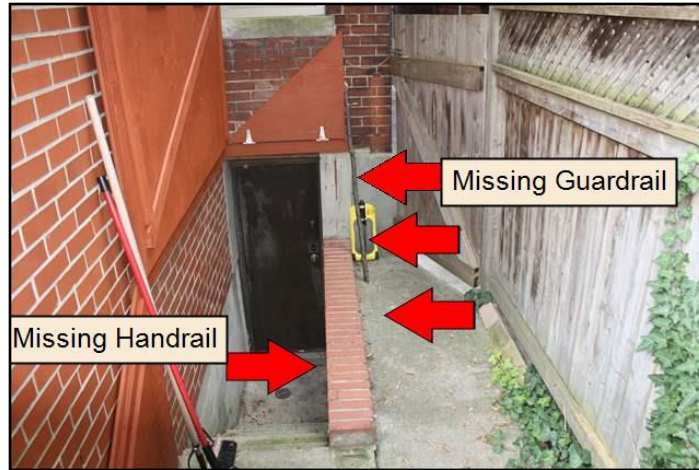
**Condition:** • [Guard and handrail problems](#)

**Implication(s):** Fall hazard

**Location:** Rear Exterior

9. Guard and handrail problems

**Task:** Provide Guardrail and Handrail

**Time:** As Soon As Possible

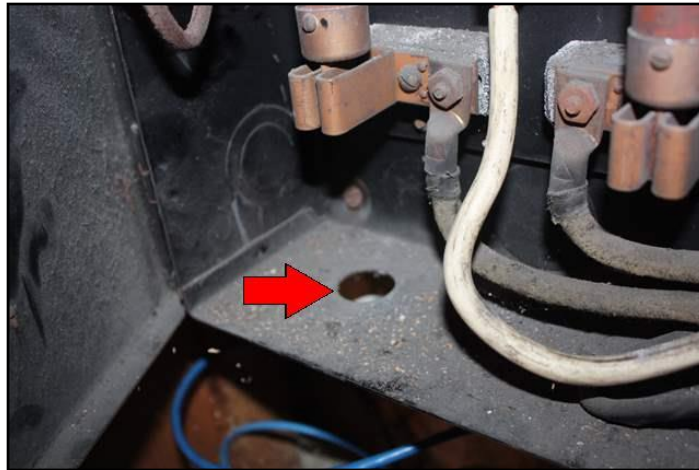
**Condition:** • [Unprotected openings](#)

**Implication(s):** Electric shock

**Location:** Basement service box

10. Unprotected openings

**Task:** Correct

**Time:** Immediate

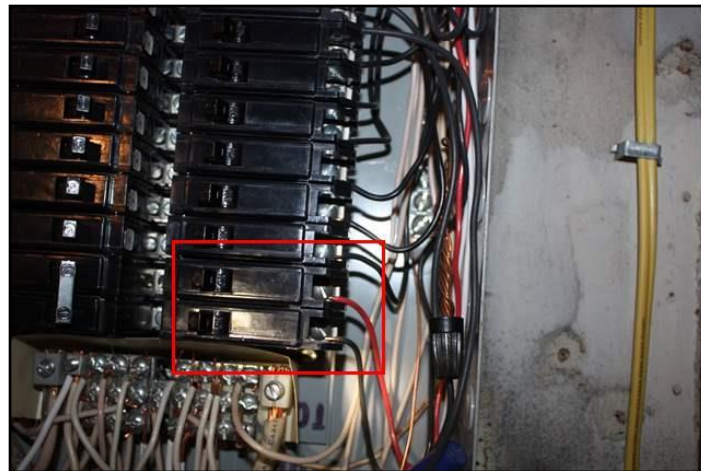
**Condition:** • [No links for multi-wire circuits](#)

**Implication(s):** Electric shock

**Location:** Basement Panel

11. No links for multi-wire circuits

**Task:** Correct

**Time:** As Soon As Possible

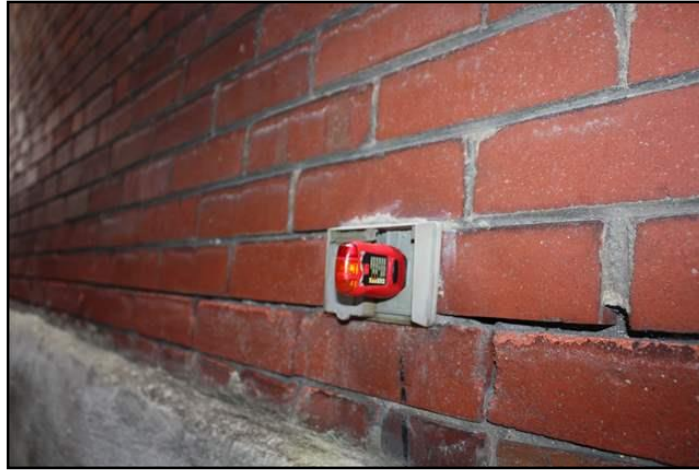
**Condition:** • [Reversed polarity](#)

**Implication(s):** Electric shock

**Location:** Exterior Wall

12. *Reversed polarity*

**Task:** Correct

**Time:** Prior to first use

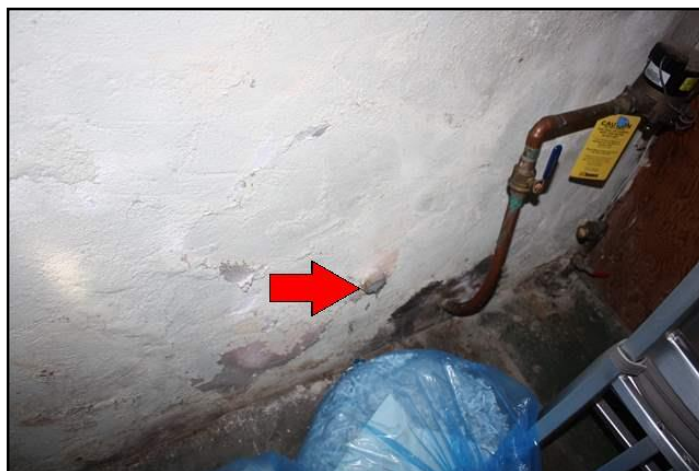
13.

**Condition:** • An abandoned pipe filled with concrete was noted entering through foundation wall at the front basement. We find these commonly on older homes. These pipes could be anything - old water lines, gas piping, oil piping, electrical conduits, and less commonly, oil piping leading to underground oil tanks. Verification of these abandoned pipes are outside the scope of a home inspection. If desired, further investigation would be required to determine its former use.

**Location:** Front Basement

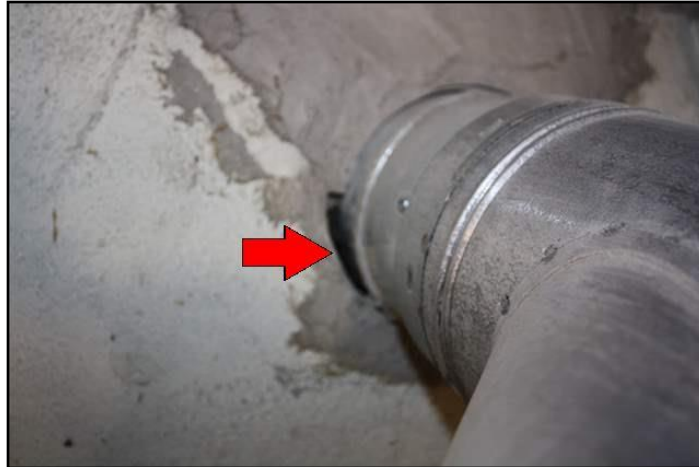
14.

**Condition:** • Gap where vent connector enters chimney

**Location:** Basement

**Task:** Correct

**Time:** Prior to first use

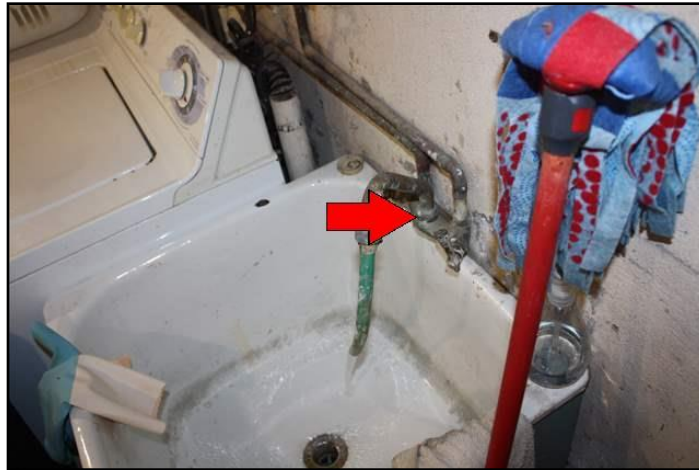
**Condition:** • [Loose](#)

**Implication(s):** Equipment failure

16. Loose

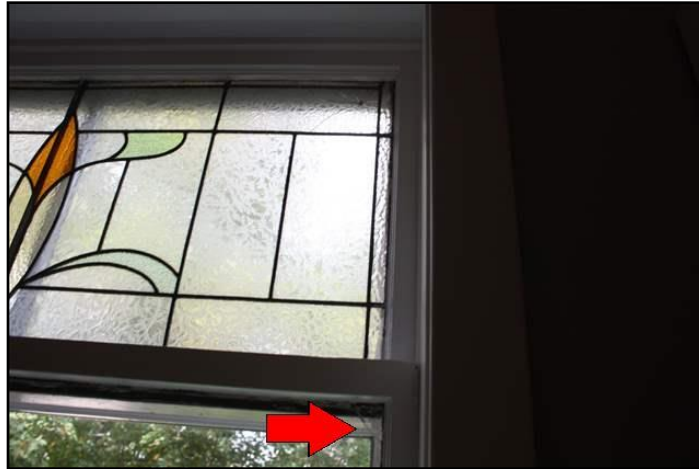
**Condition:** • [Cracked](#)

17. Cracked

**Task:** Replace

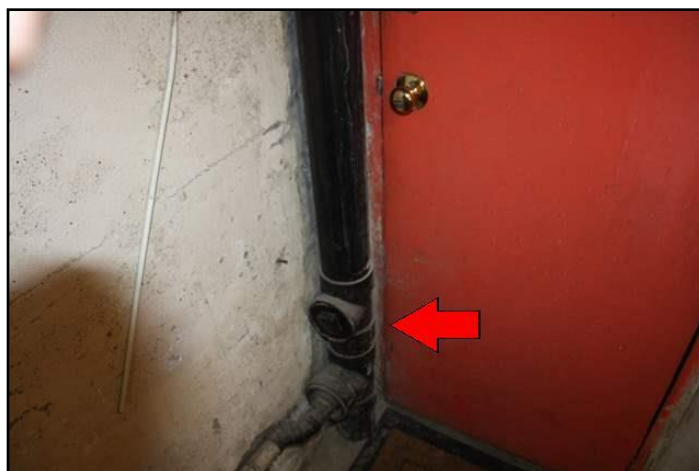
**Condition:** • [Loose or poor fit](#)

**Implication(s):** Chance of damage to finishes and structure

18. Loose or poor fit
