YOUR INSPECTION REPORT

12 Cormier Heights
Toronto, ON M8Z 0B5

INSPECTION DATE:
Friday, September 14, 2018

RE: Report No. 2329, v.2
12 Cormier Heights
Toronto, ON
M8Z 0B5

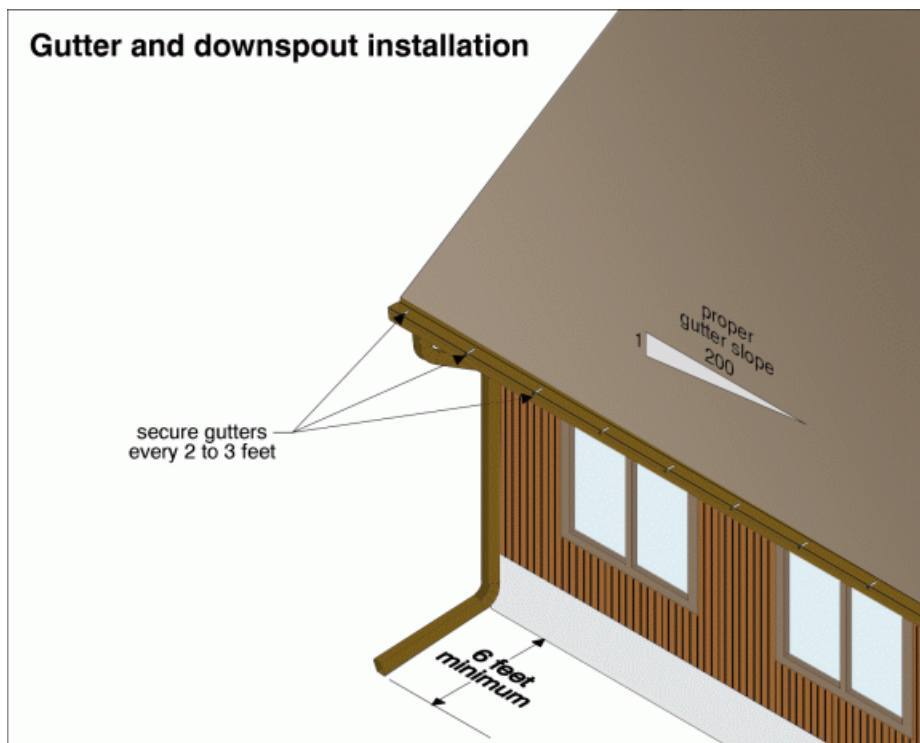
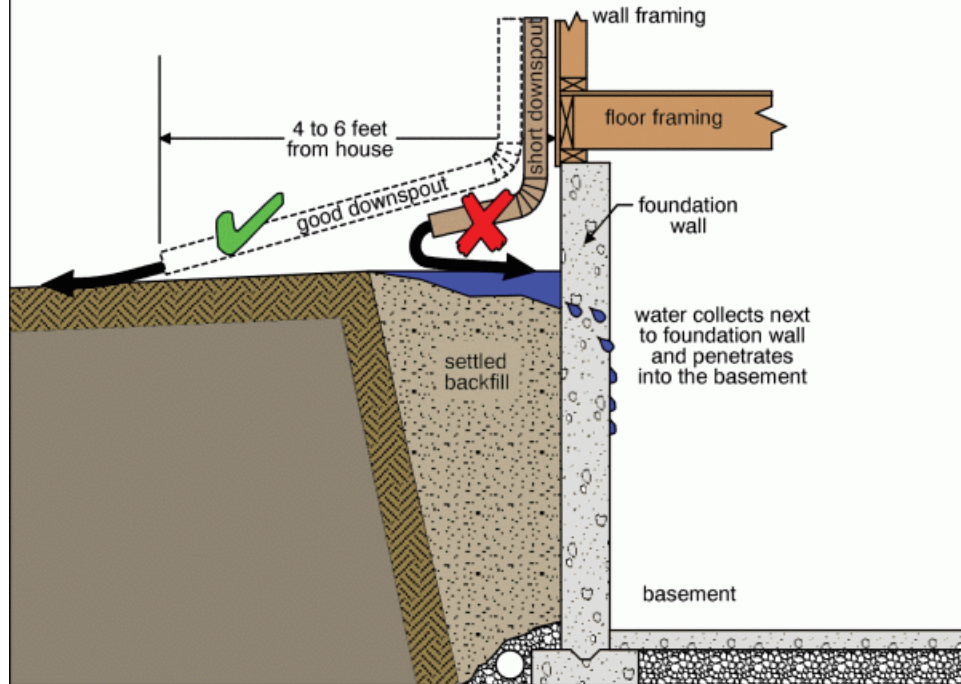
Condition: • [Discharge too close to building](#)

Implication(s): Chance of water damage to contents, finishes and/or structure

Downspout extension too short

Task: Improve

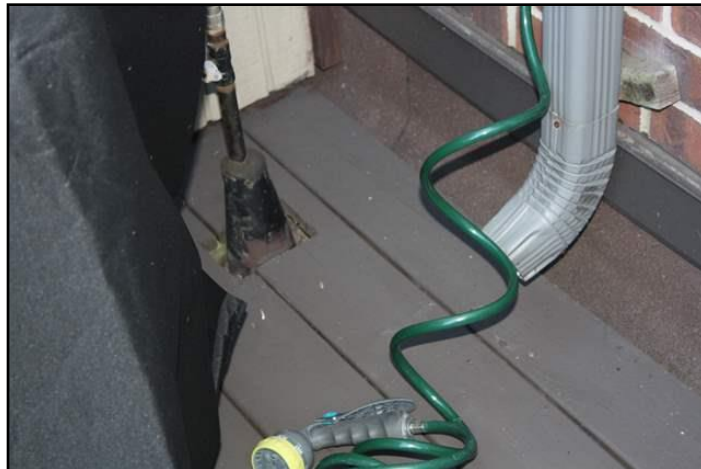
1. Discharge too close to building

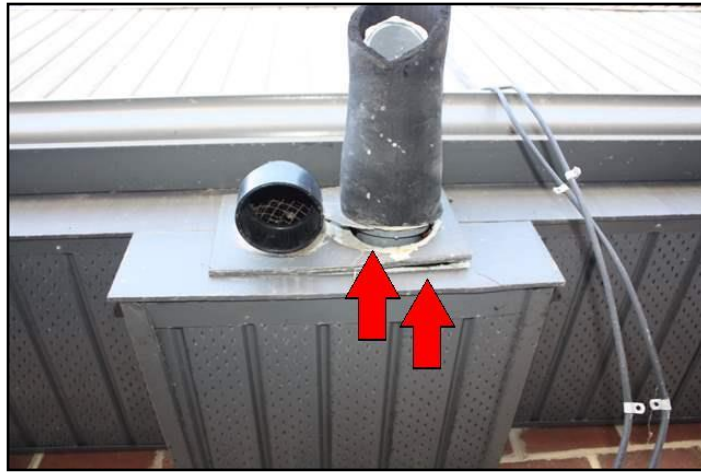
Condition: • [Caulking missing or ineffective](#)

Implication(s): Chance of water damage to contents, finishes and/or structure

Location: Rear Exterior Vent

2. Caulking missing or ineffective

Task: Improve

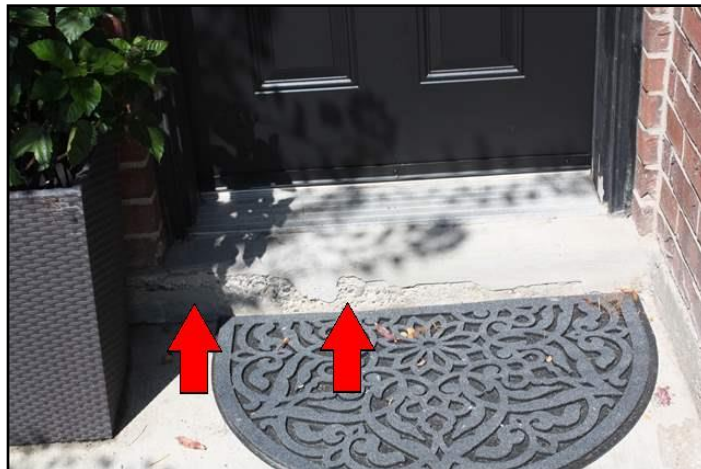
Condition: • [Parging damaged or missing](#)

Implication(s): Shortened life expectancy of material | Chance of damage to structure

Location: Front Exterior sill

3. Parging damaged or missing

Task: Improve

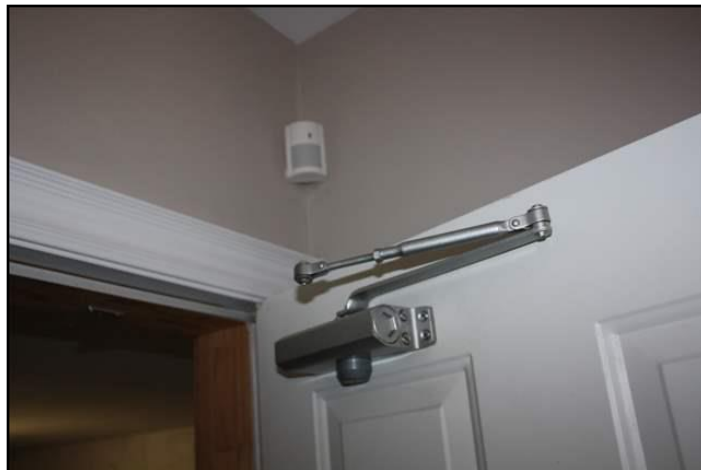
Condition: • Self-Closer Damaged.

Implication(s): Carbon monoxide safety

4. Self-Closer Damaged.

Task: Repair / Replace

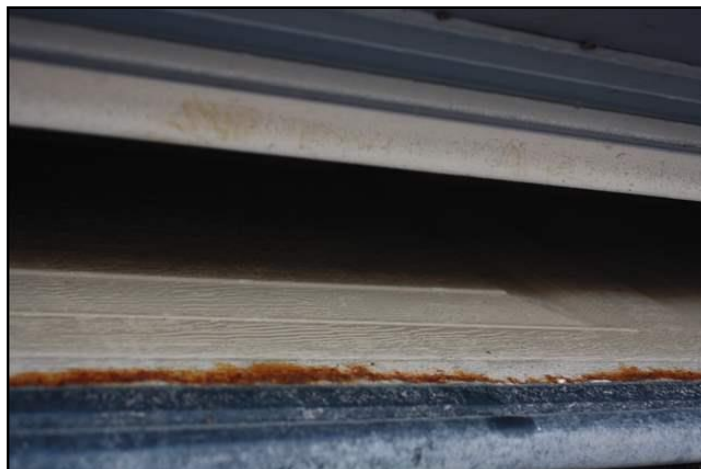
5.

Condition: • Rust

Implication(s): Damage to equipment

Location: Rear Exterior Garage Door

Task: Replace

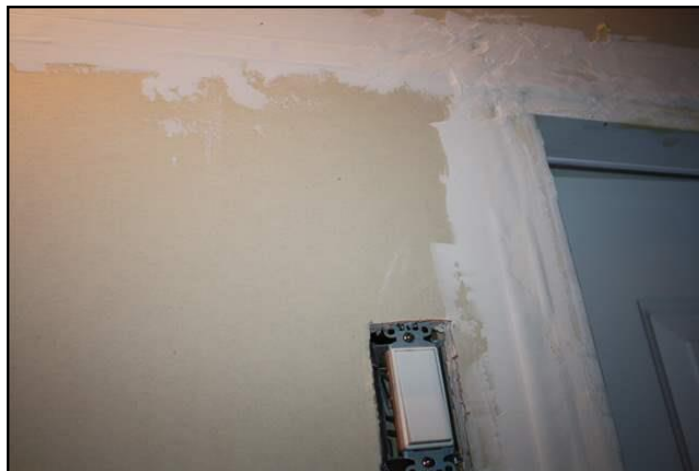
Condition: • For switch is missing

Location: Garage

6. For switch is missing

Task: Cover

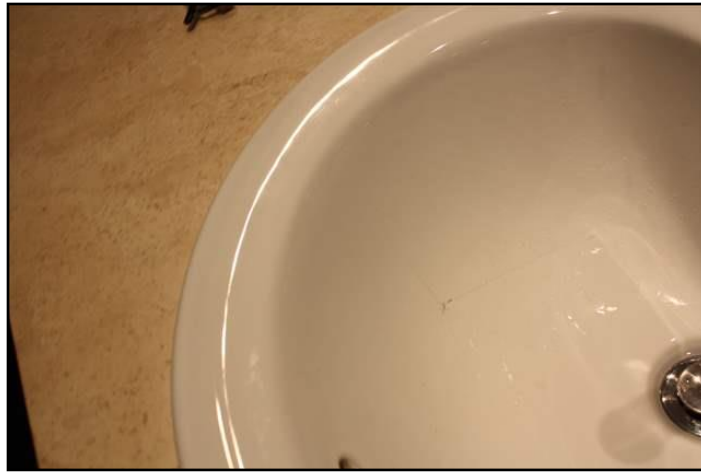
Condition: • [Surface defects](#)

Implication(s): Hygiene issue

Location: Top Floor Master Bathroom

7. Surface defects

Task: Replace

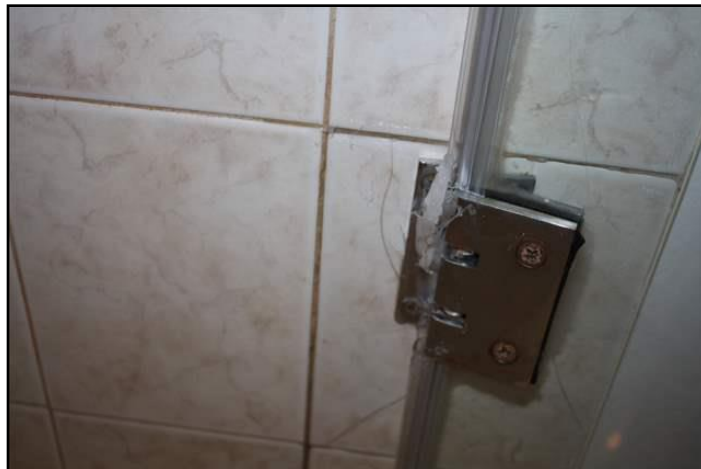
Condition: • [Tile loose, broken or missing tile](#)

Implication(s): Chance of water damage to contents, finishes and/or structure

Location: Master Bathroom

8. Tile loose, broken or missing tile

Task: Repair / Replace

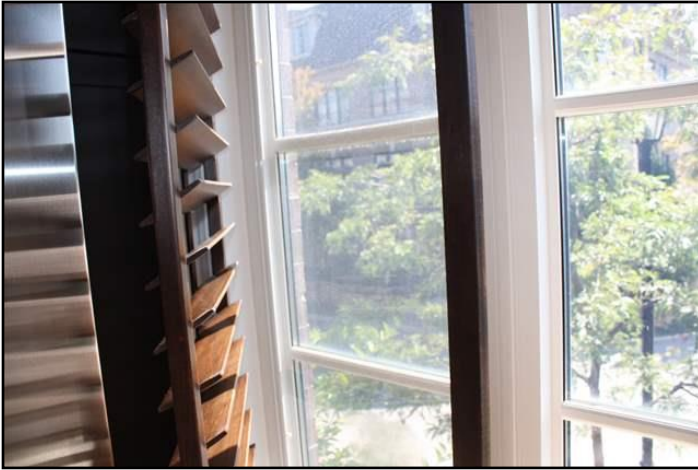
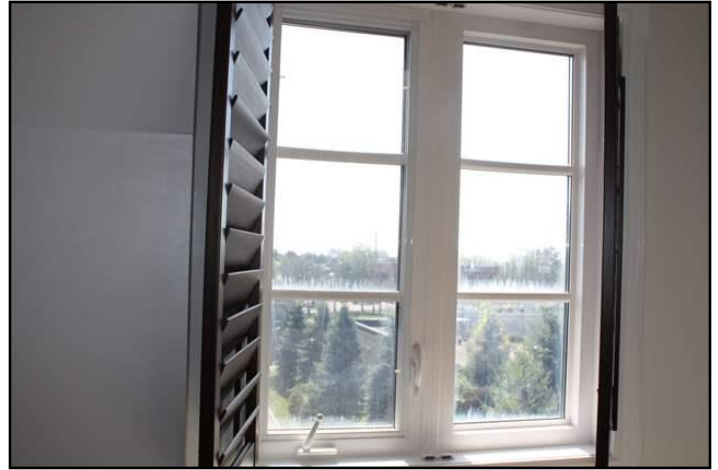
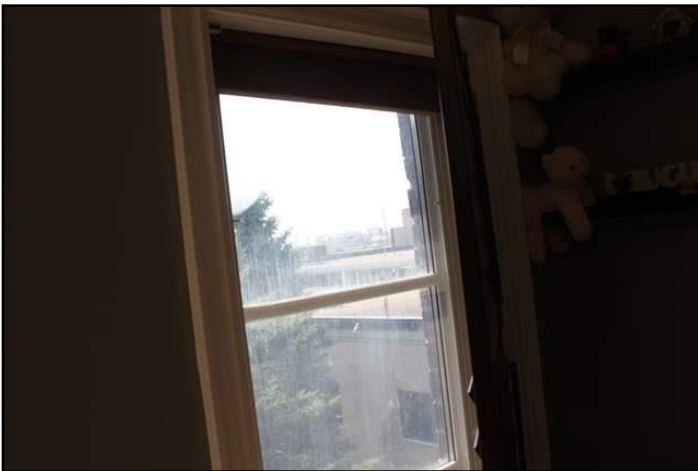
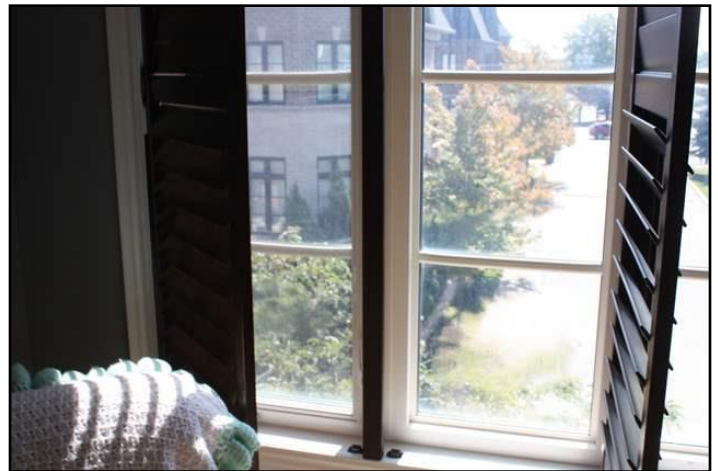
Condition: • [Lost seal on double or triple glazing](#)

Many windows were noted with condensation between the panes of glass. photos are a sampling only

Implication(s): Shortened life expectancy of material

10. Lost seal on double or triple glazing

Task: Replace
