YOUR INSPECTION REPORT

493 Glenlake Avenue
Toronto, ON M6P 1G9

INSPECTION DATE:
Thursday, September 7, 2023

RE: Report No. 7266, v.2
493 Glenlake Avenue
Toronto, ON
M6P 1G9

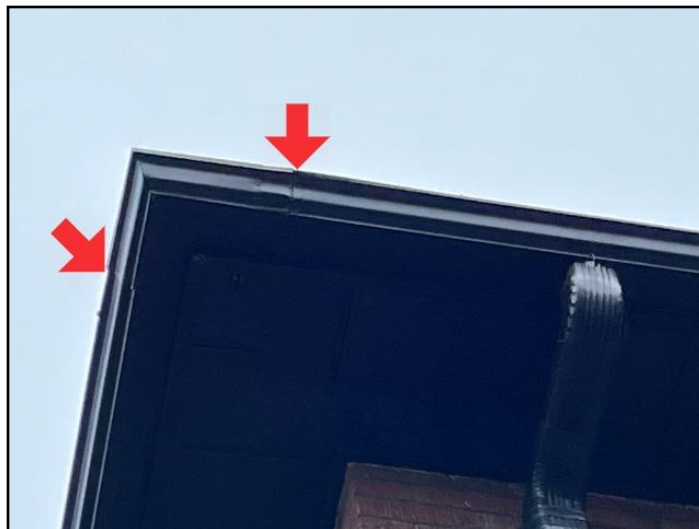
3. example of gutter joint

Condition: • [Leak](#)

Leaking/dripping noted at various gutter joints.

Time: Less than 1 year

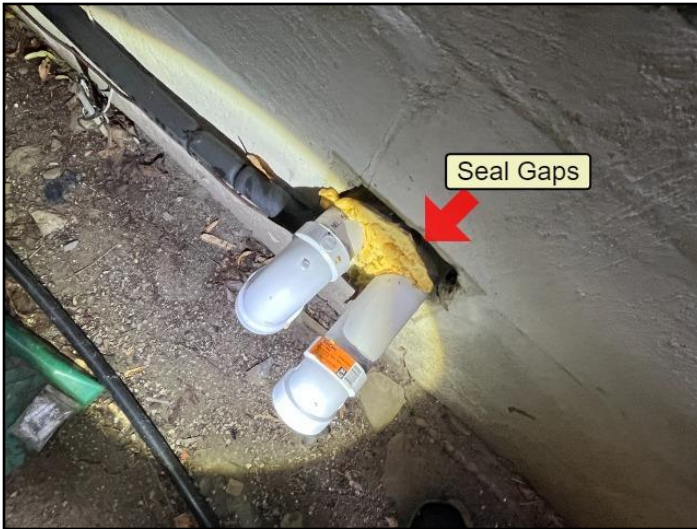
Condition: • [Caulking missing or ineffective](#)

4. Caulking missing or ineffective

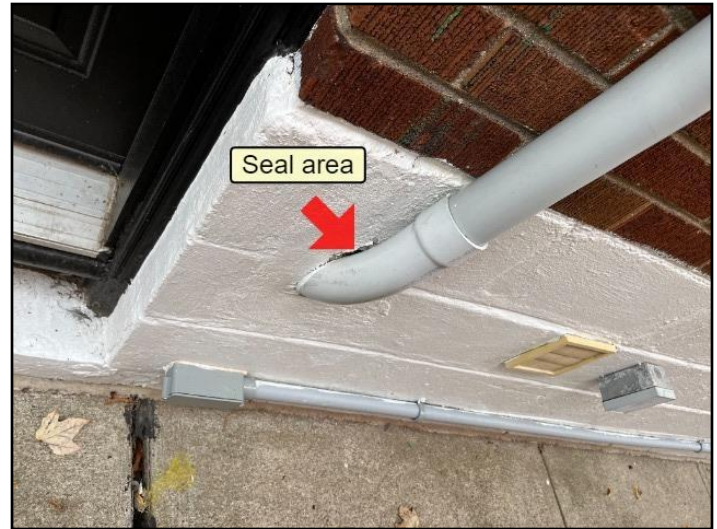
5. Caulking missing or ineffective

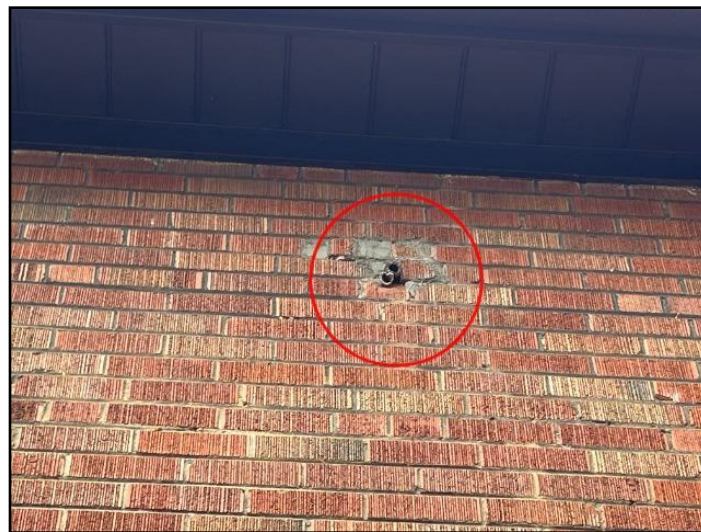
Condition: • Gap at Wall

6. Gap at Wall

Time: Less than 1 year

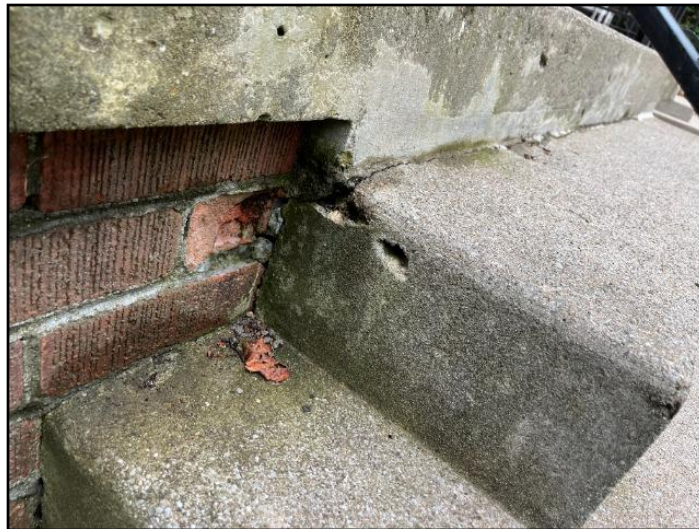
Porch brick skirting - Spalling bricks noted in some areas. Repair

7. example of spalled area

Task: Repair

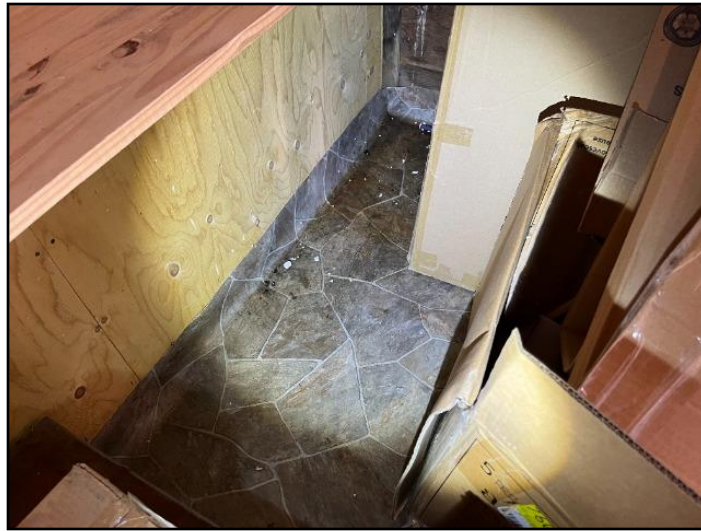
Condition: • [Improper slope](#)

The garage floor slopes towards the rear of the garage. The condition of the substrate was not observed as it is covered by vinyl flooring. Ideally floors should slope toward the driveway. Water was noted at rear garage floor. Discretionarily you may consider improving slope or installing a floor drain to help drain water.

8. Improper slope

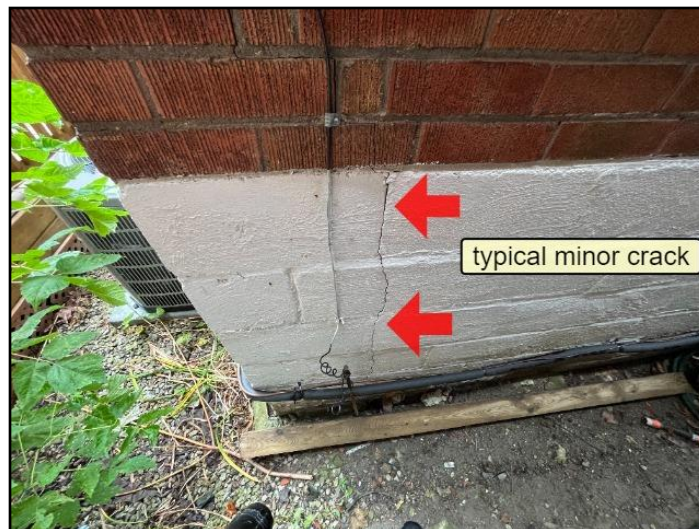
Condition: • Typical Minor Cracks - Block, Brick, Stone

Almost all houses with concrete block, brick or stone foundations have minor settlement and/or cracks. Monitor all cracks for movement and nuisance water leakage. Repair cracks only if necessary

9. Example of typical minor crack

Task: Monitor / Repair

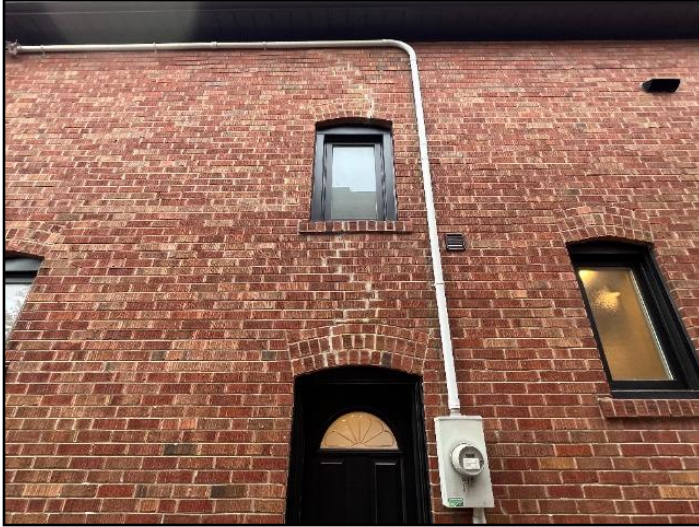
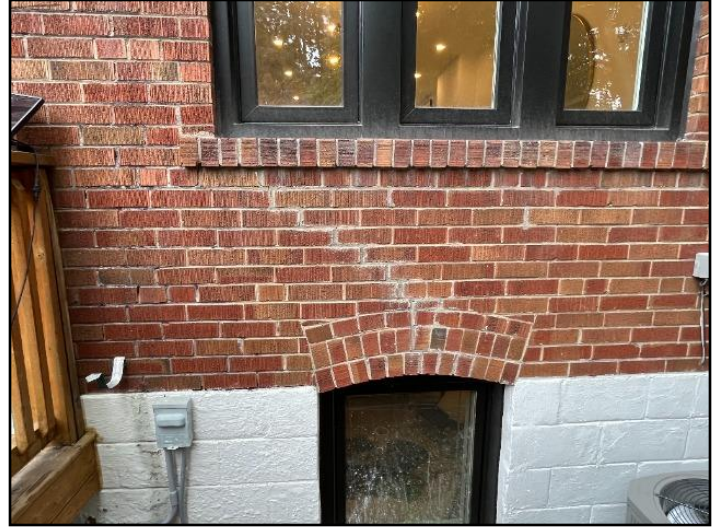
Condition: • [Cracked](#)

Settlement cracks noted at wall. These are very common on solid masonry walls and typically show up above/below windows and doors. Our recommendation is to repair the cracks (Tuckpoint mortar and patch bricks) to prevent water entry and/or further damage and monitor for any new activity. Crack repairs / maintenance can be expected ongoing with most buildings of this age.

10. Cracks or prior repairs

11. Cracks or prior repairs

Task: Repair and monitor

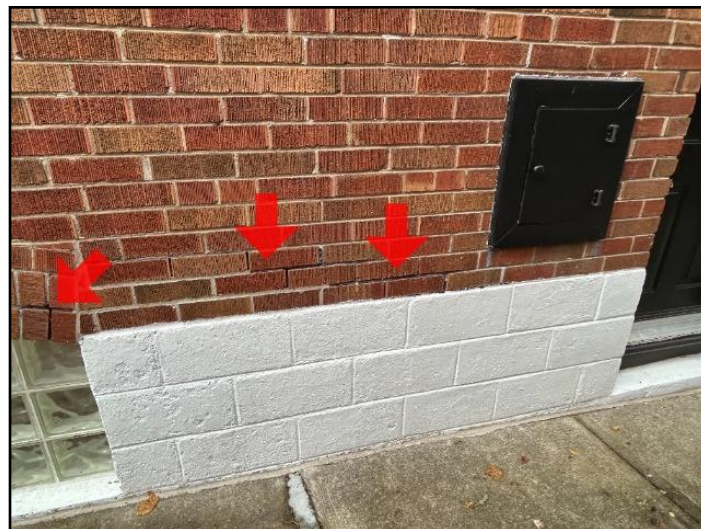
12. example

Condition: • [Mortar deteriorating](#)

Repointing / Tuck-Pointing of mortar needed at a few areas of brick. This is COMMON MAINTENANCE for all homes of this age. Overall brick and mortar is in good condition. photos show a sampling

Task: Repair / Tuckpoint

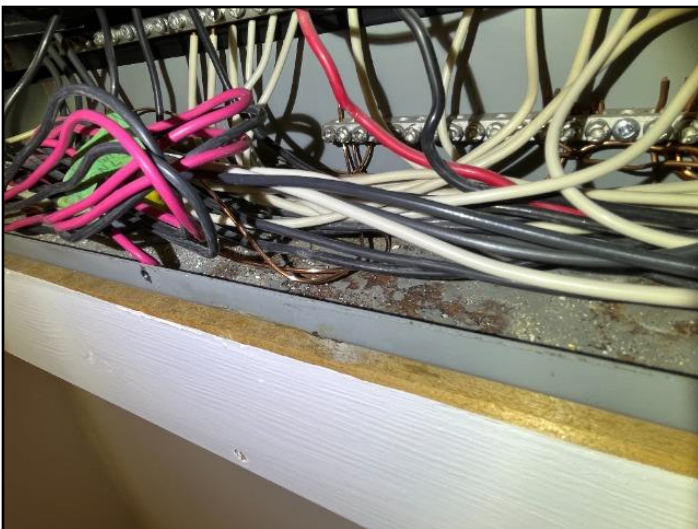
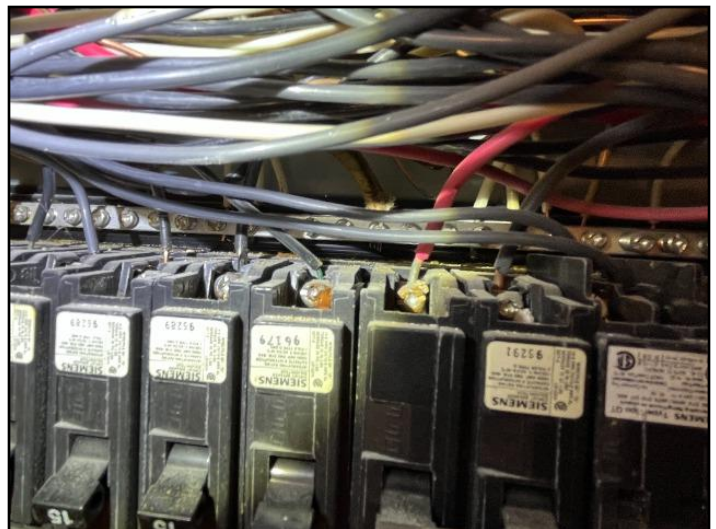
Condition: • [Rust or water in panel](#)

A minor amount of rust was noted inside panel and at a few breaker connections. When correcting other items in panel noted in report, have electrician assess and advise if any further action is needed.

13. Rust

14. Rust

Task: Further evaluation

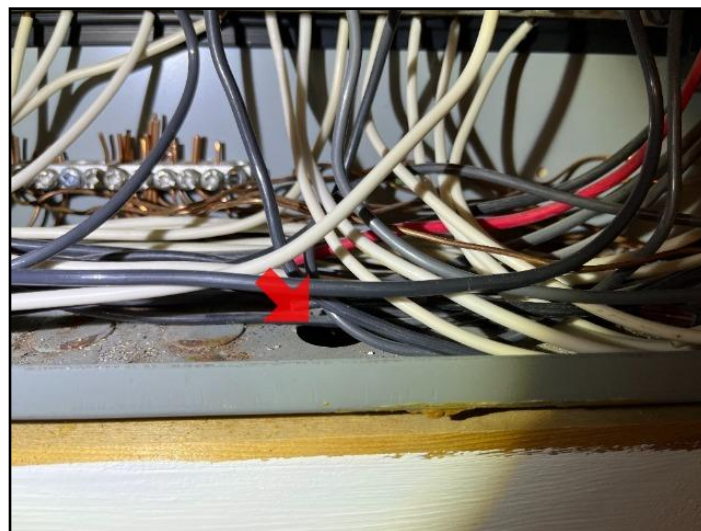
Condition: • [Openings in panel](#)

15. Openings in panel

Time: As Soon As Possible

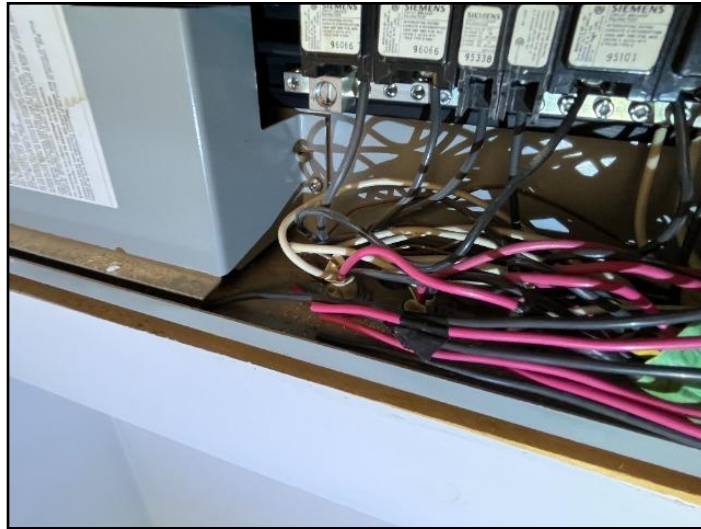
Condition: • [Abandoned wires in panel](#)

16. Abandoned wires in panel

Time: Less than 1 year

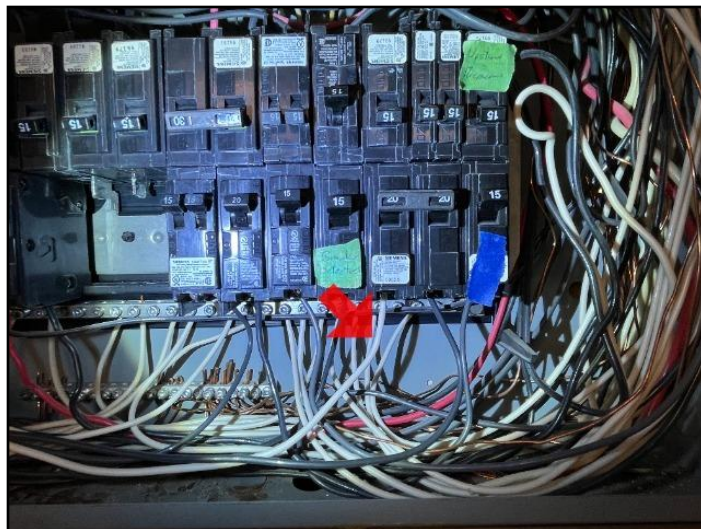
Condition: • White wires connected to breakers not identified as hot/live/ungrounded

17. White wires connected to breakers not...

Task: Correct

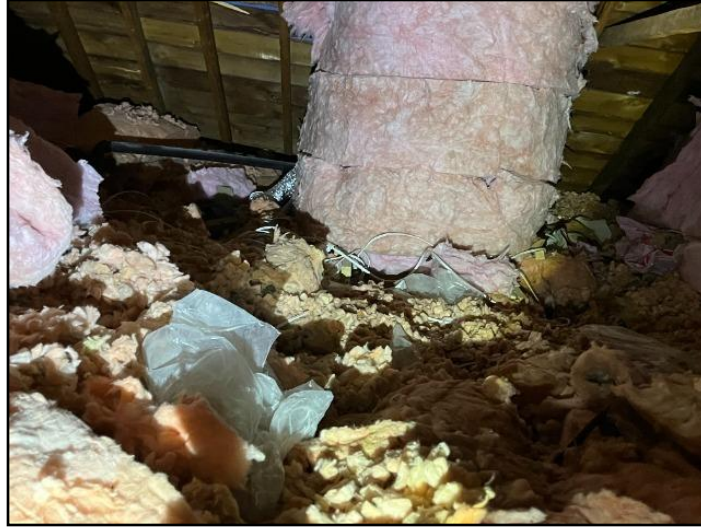
Condition: • [Exposed in attics](#)

18. Exposed wiring in attic

Task: Further evaluation / Improve

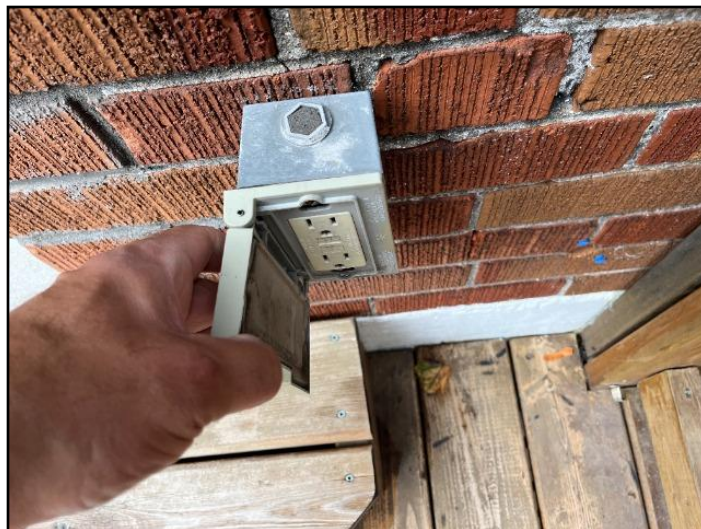
Condition: • [Inoperative](#)

19. Inoperative

Task: Repair / Replace

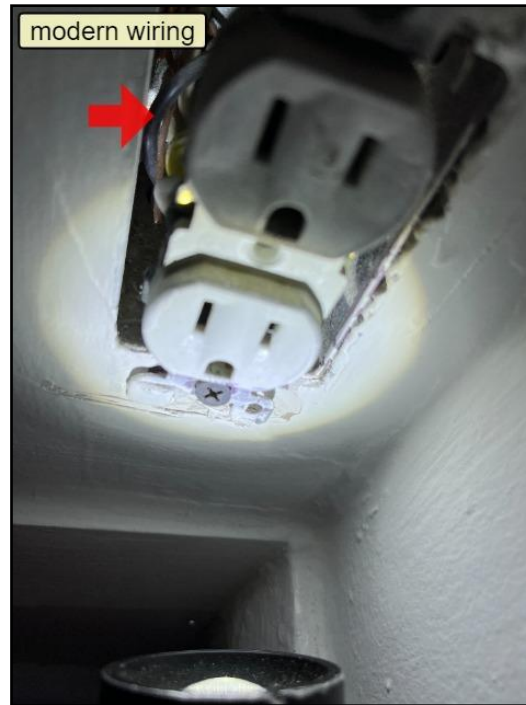
Condition: • [Ungrounded](#)

We observed a few ungrounded outlets at bedrooms. We removed the covers to check wiring type and modern wiring was observed in these outlets. Have electrician connect the ground wire to these outlets. If no ground wire is present, we

recommend using GFI outlets in these areas.

20. Ungrounded

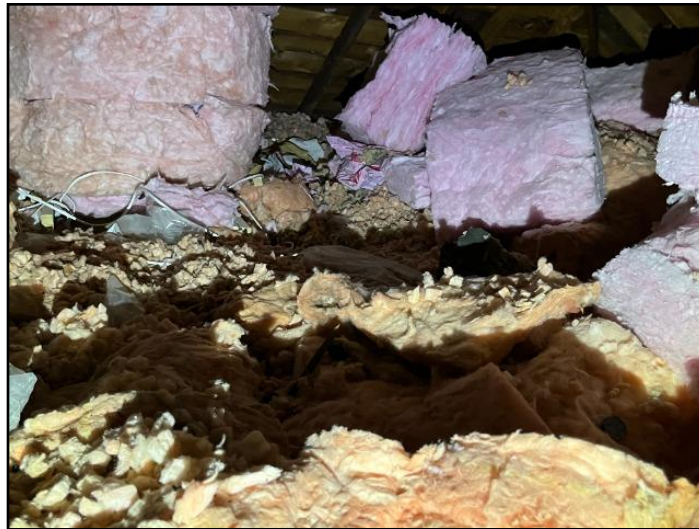
Condition: • [Gaps or voids](#)

21. Gaps or voids

Task: Upgrade

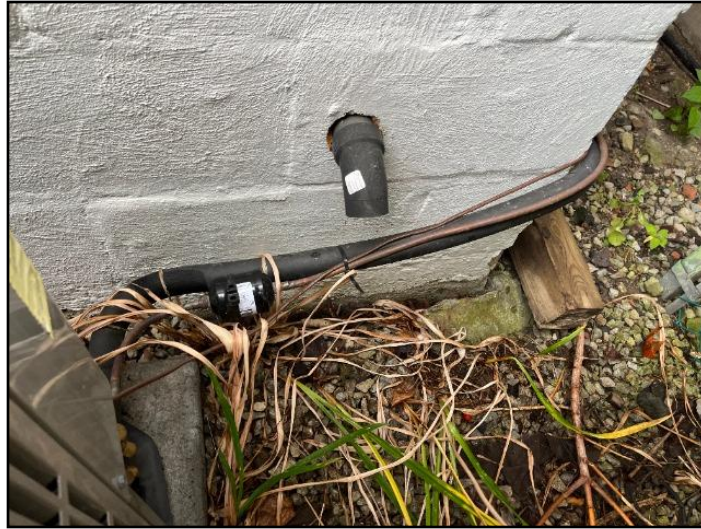
Condition: • [Discharges less than 6 feet from home](#)

23. *Discharges less than 6 feet from home*

Task: Improve
