Your Inspection Report

162 Medland Street
Toronto, ON M6P 2N5

INSPECTION DATE:
Wednesday, March 25, 2026

RE: Report No. 9187, v.3
162 Medland Street
Toronto, ON
M6P 2N5

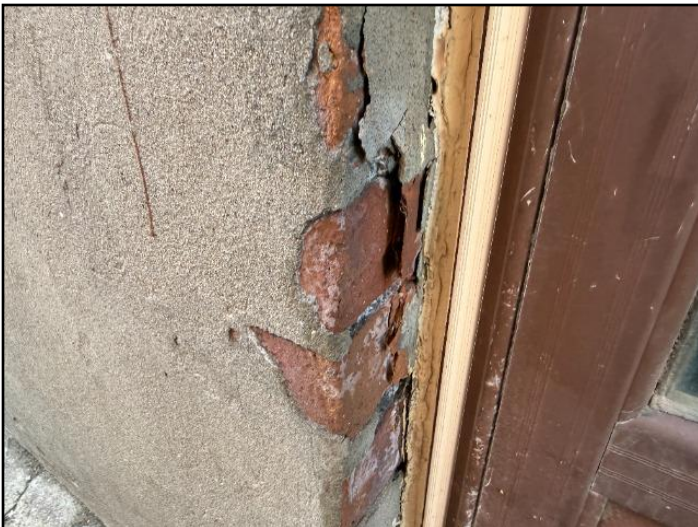
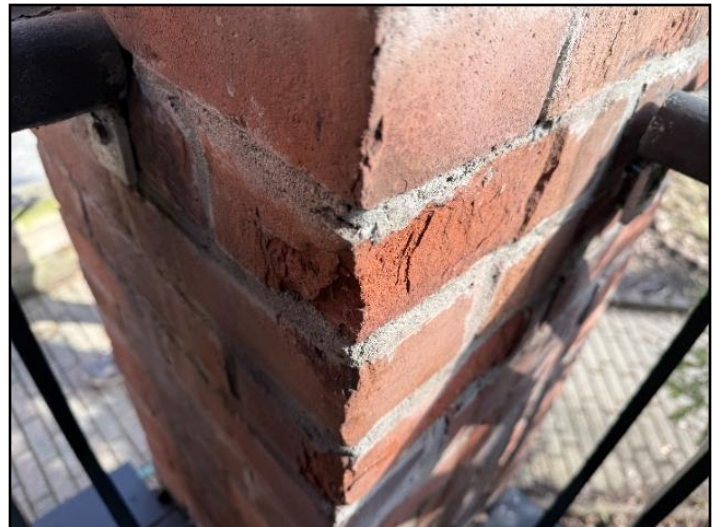
Condition: • Masonry and/or mortar deterioration

3. example at right side door

4. example at column

Tuckpoint / Repoint mortar and patch/repair spalled masonry. This is typical maintenance for a home of this age.

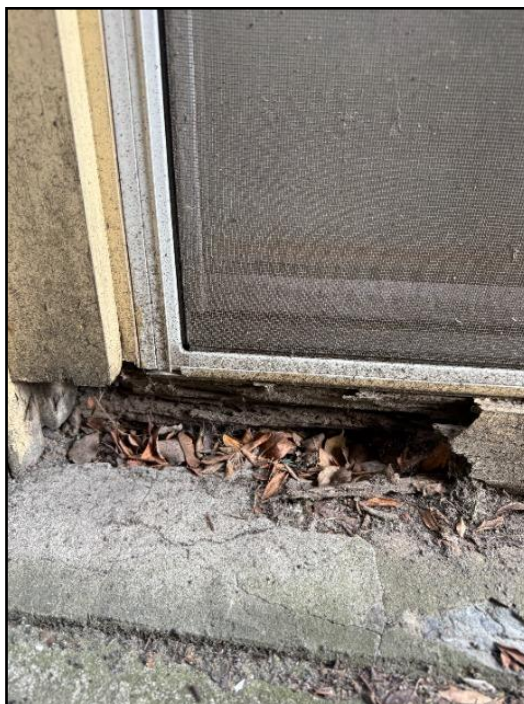
Condition: • [Rot](#)

5. one example

Task: Replace or Cap

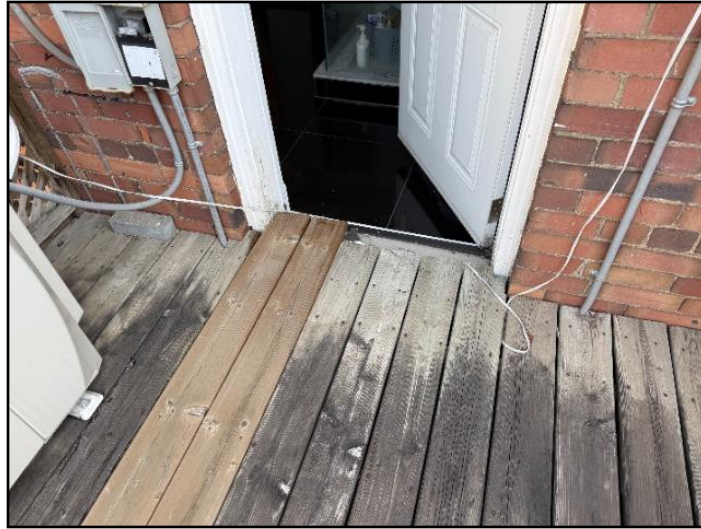
Condition: • Threshold too low

Having a minimal step makes the inside/outside transition easier. On the other hand, it also makes it more prone to snow buildup/leakage.

6. Threshold too low

While it is probably not practical to improve the current situation, it will be important to keep any weatherstripping/caulking in good condition.

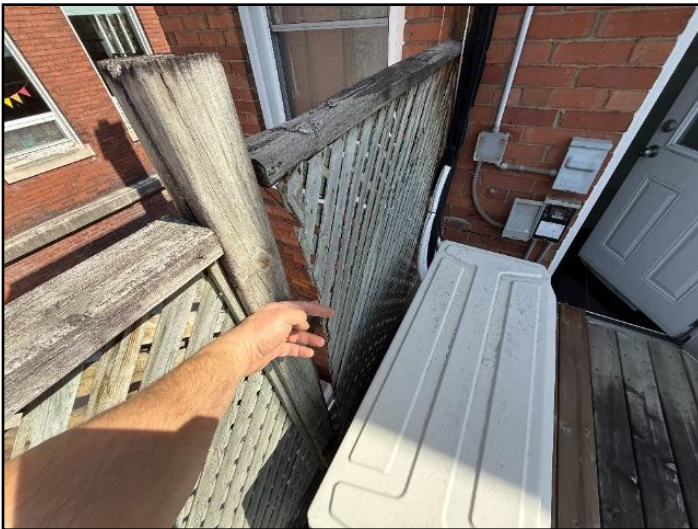
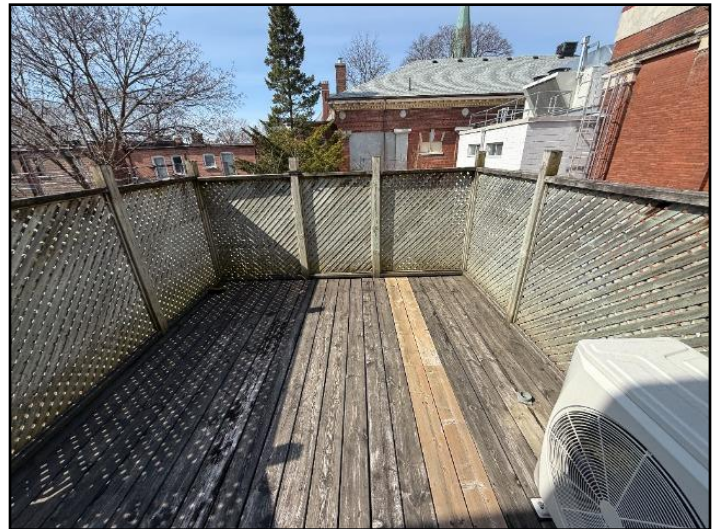
Condition: • [Ineffective](#)

Guard components were loose/weak at portions of the second floor deck. Lattice is not an appropriate guard material, and one section was loose/open, creating a fall hazard.

7. Ineffective

8. Ineffective

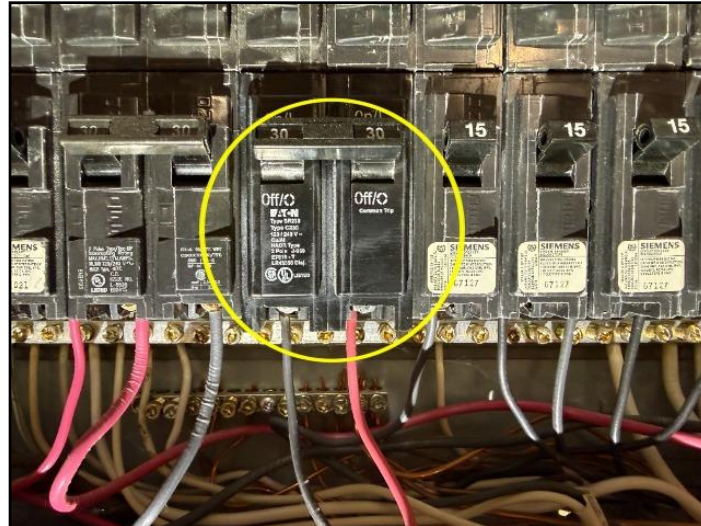
Condition: • [Fuses or breakers too big](#)

Implication(s): Equipment overheating | Fire hazard

10. breakers too big

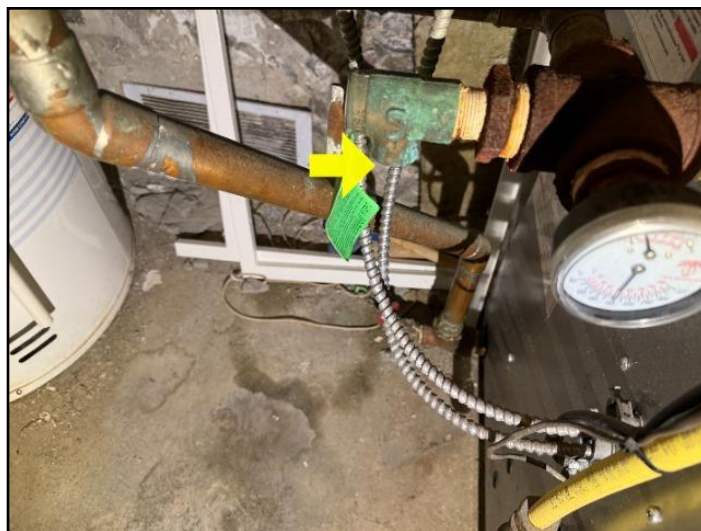
- Condition: • [No pipe extension](#)
- Implication(s): Scalding
- Location: Basement Boiler room / area
- Task: Provide
- Time: Less than 6 months
- Cost: Minor

11. No pipe extension

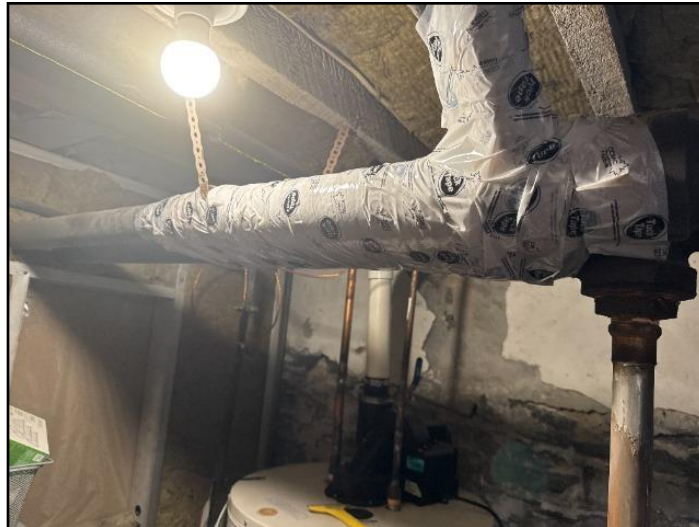
- Condition: • The insulation wrap on heating piping may contain asbestos. This type of older pipe insulation is common for the age of the home. If intact, it is generally best left undisturbed. If damaged, or if removal or renovation is planned, laboratory testing and proper asbestos precautions are recommended to help prevent fibre release. Exposed areas appeared wrapped/sealed with tape at the time of inspection. Visible portions only. Similar material may

12. example

Task: Do not disturb / Consult asbestos specialist prior to removal or renovation

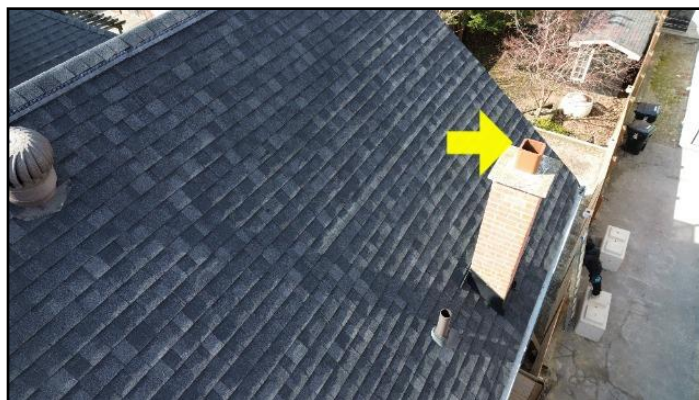
Condition: • [Rain cap missing or damaged](#)

13. Rain cap missing or damaged

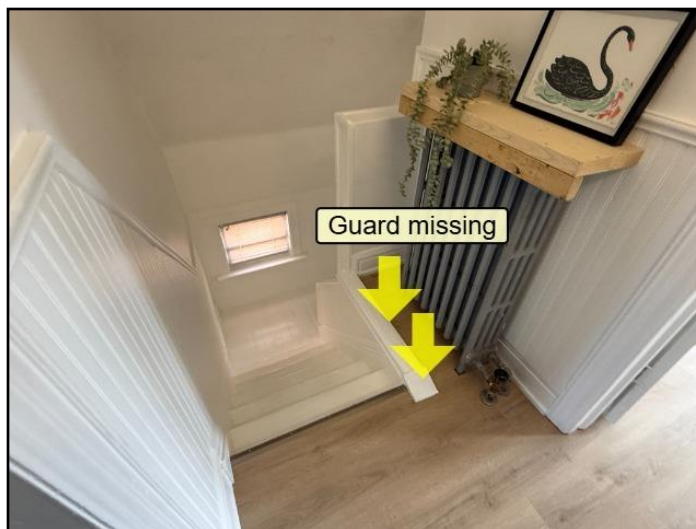
Condition: • [Missing](#)

Implication(s): Fall hazard

15. Missing Guard and handrails
