INSPECTION REPORT

For the Property at:
208 SAMPLE STREET
NASHVILLE, TN 37214

Prepared for: SAMPLE REPORT
Inspection Date: Wednesday, December 13, 2023
Prepared by: Chris Cutrell, 2207

RE: Report No. 1536, v.4
208 Sample Street
Nashville, TN
37214

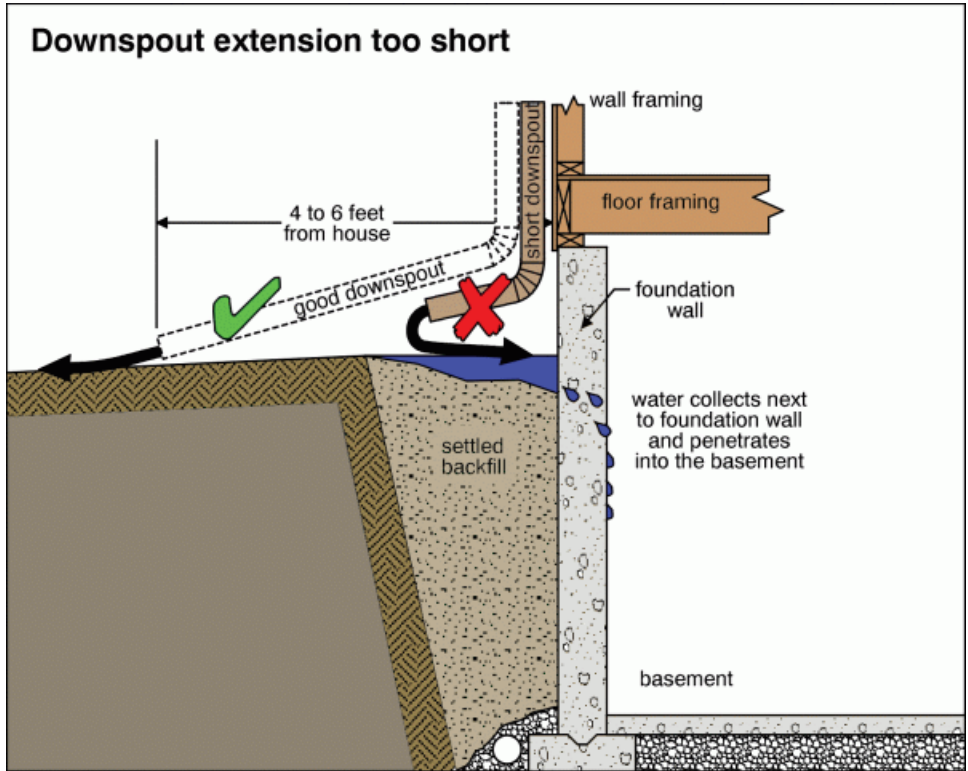
Condition: • Discharge too close to building
Extend downspout to discharge further from building.

Discharge too close to building

Extend downspout to discharge further from building.

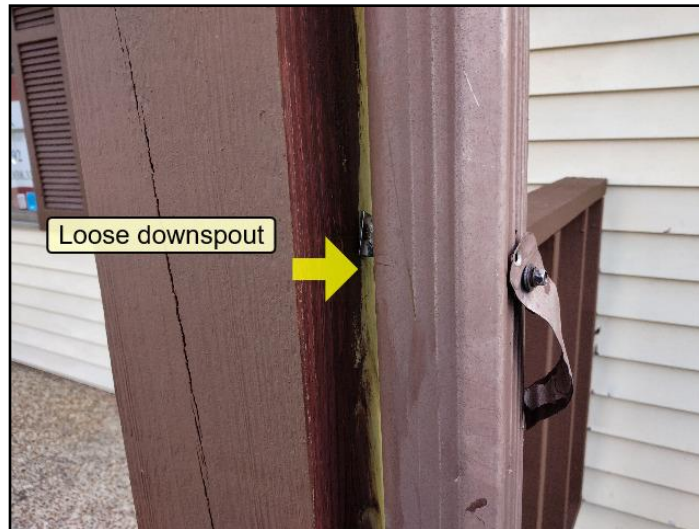
Condition: • Loose
Secure downspout to porch column.
Location: Front Porch
Task: Repair
Time: Immediate

Loose

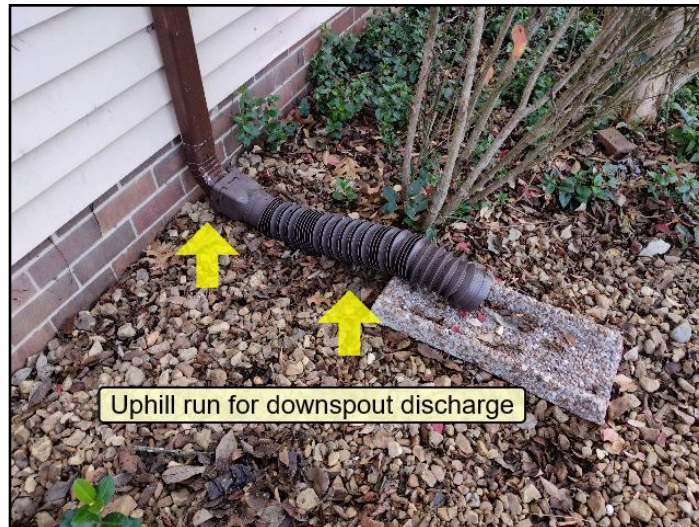
Condition: • Unconventional Installation
Correct installation of downspout extender to eliminate uphill path for water.
Location: Northwest Exterior Wall
Task: Correct
Time: Immediate

Unconventional Installation

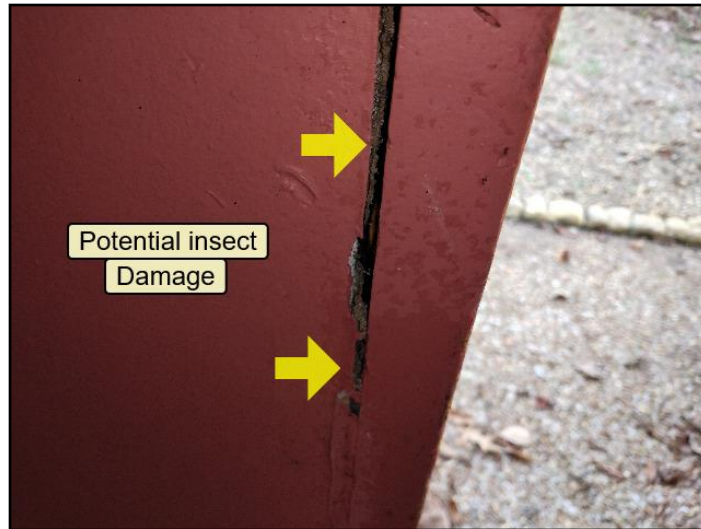
Condition: • Rot or insect damage

Rot or insect damage

Repair damage to wall around door frame.

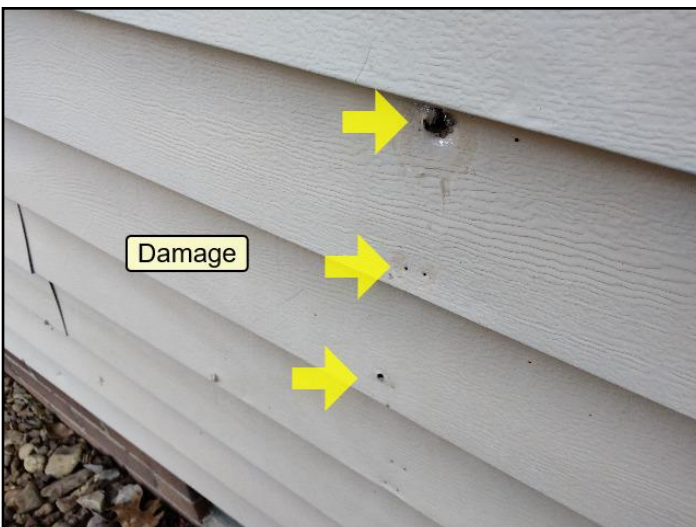
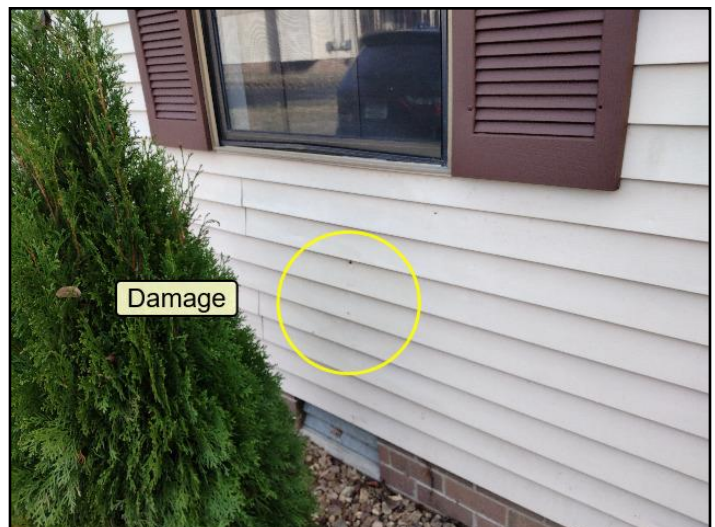
Condition: • Damage

Damage

Seal holes in metal siding.

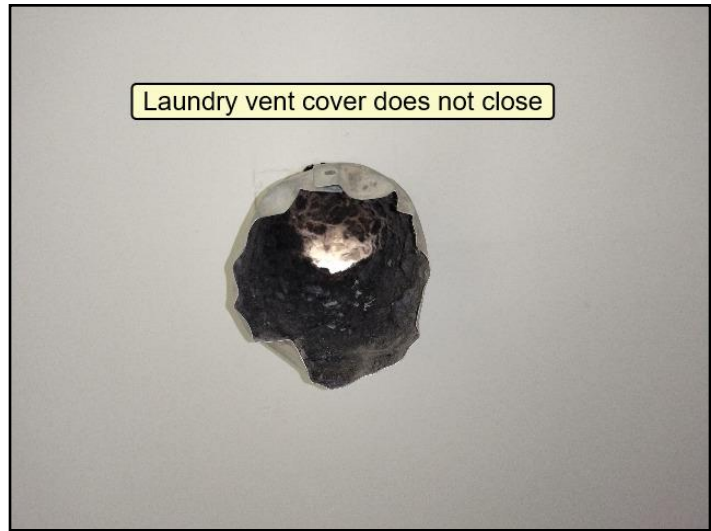
Condition: • Cover does not close properly
Clean / Repair cover to shut when not in use.

Cover does not close properly

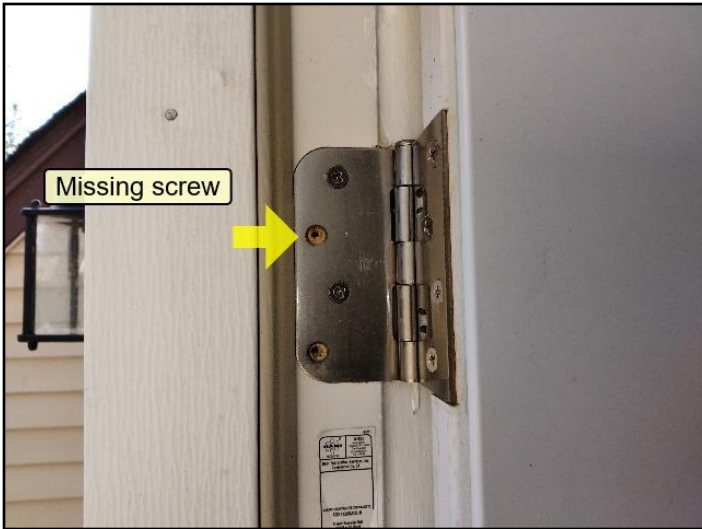
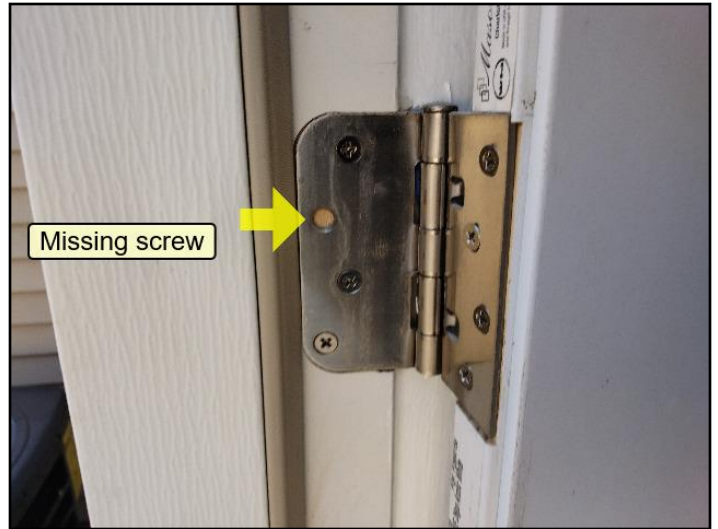
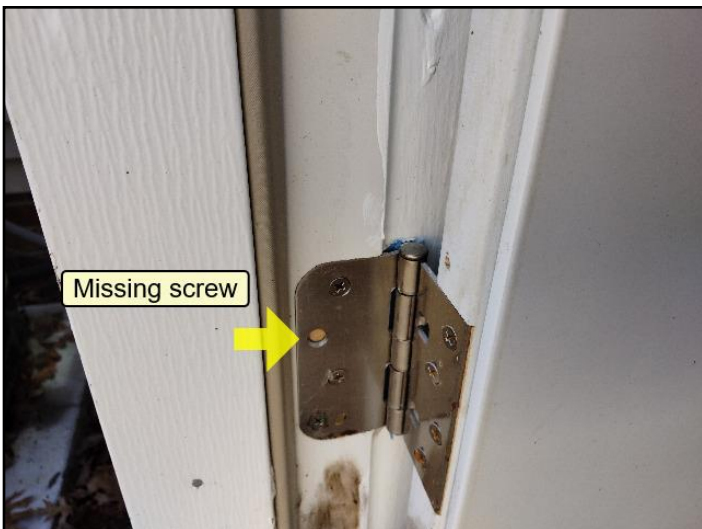
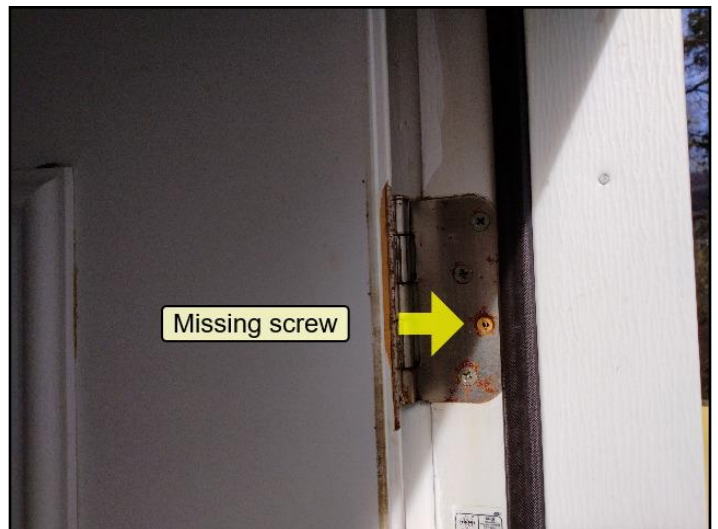
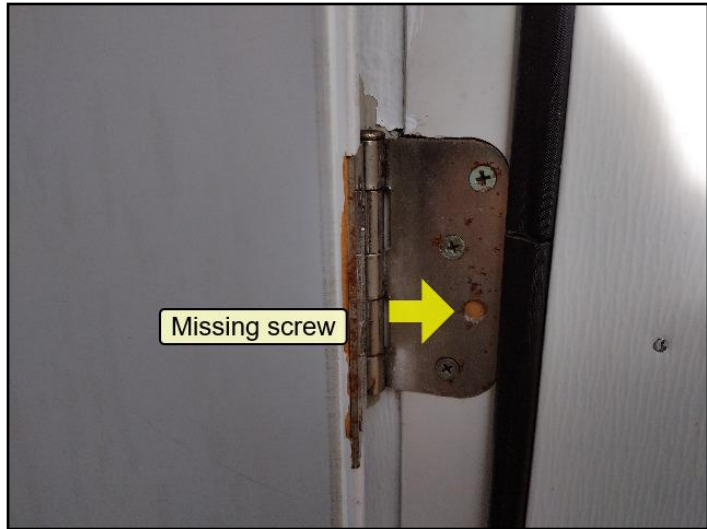
Condition: • Missing or damaged
Install missing screws in hinges of front and back doors.

Missing or damaged

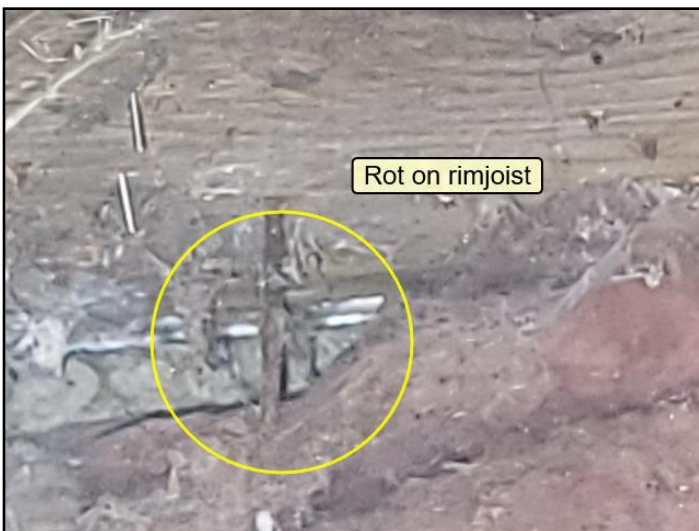
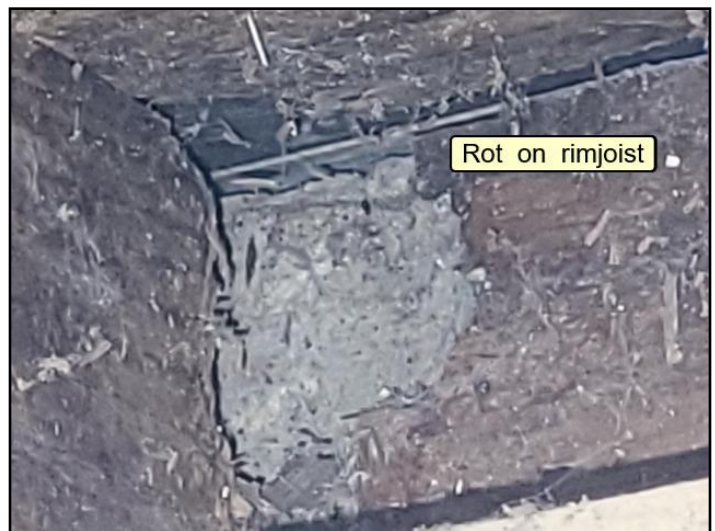
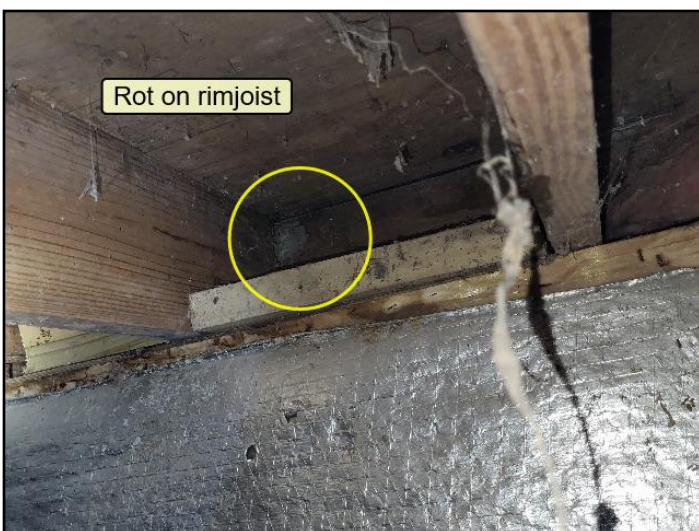
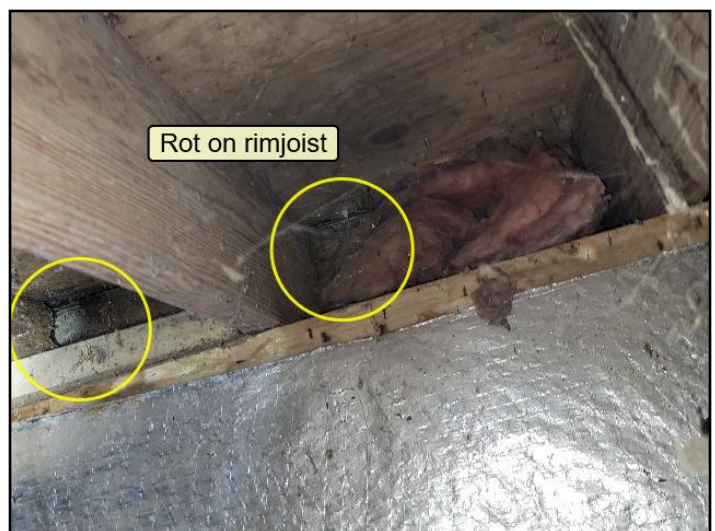
Condition: • Rot

Rot in crawlspace under kitchen sink.

Potential for hidden damage.

Rot

Repair rotted wood.

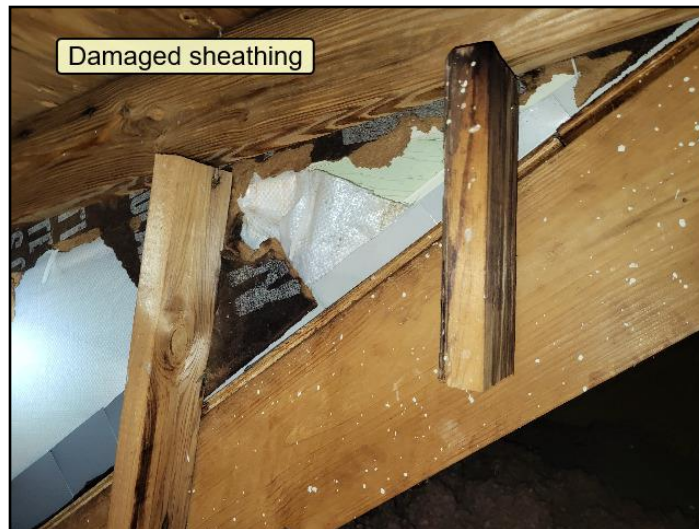
Condition: • Damage

Damage

Repair sheathing in attic exterior wall.

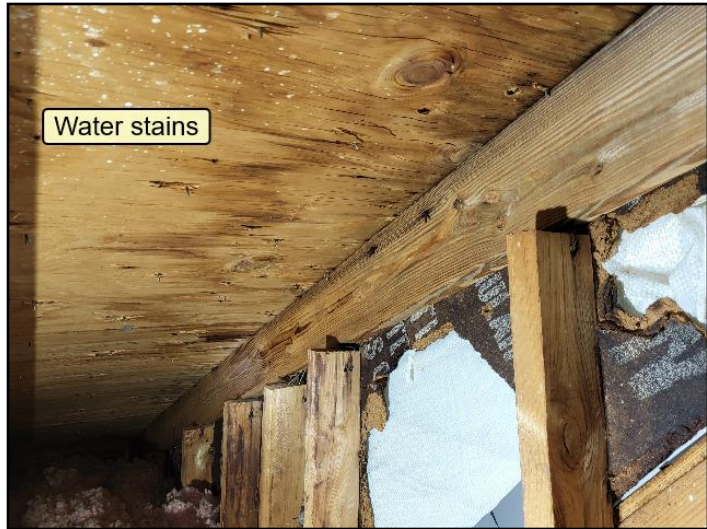
Condition: • Water stains

Water stains

Monitor water stain in attic for moisture.

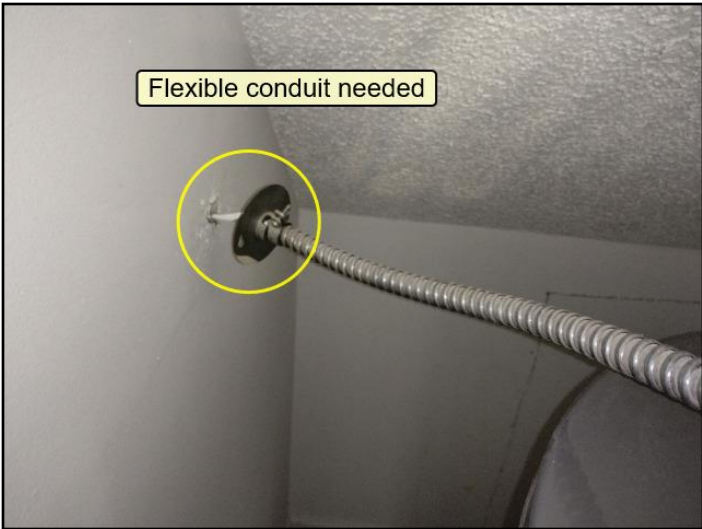
Condition: • Flexible conduit needed

Flexible conduit needed

Provide the correct length of flexible conduit for water heater.

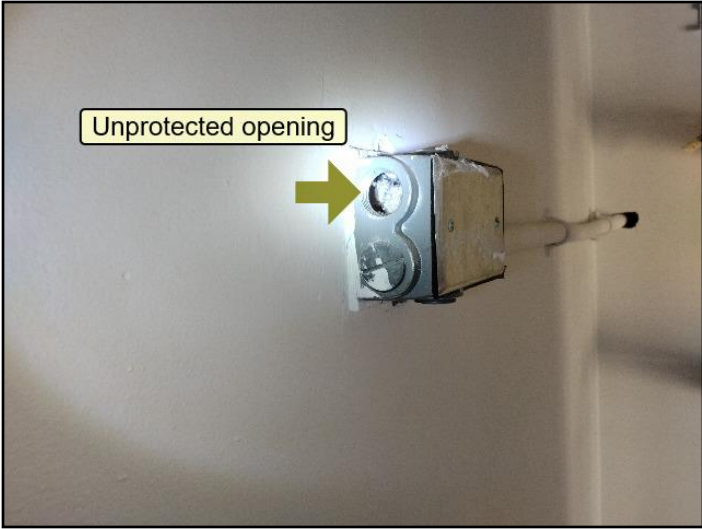
Condition: • Unprotected Openings
Seal unprotected opening in junction box.

Unprotected Openings

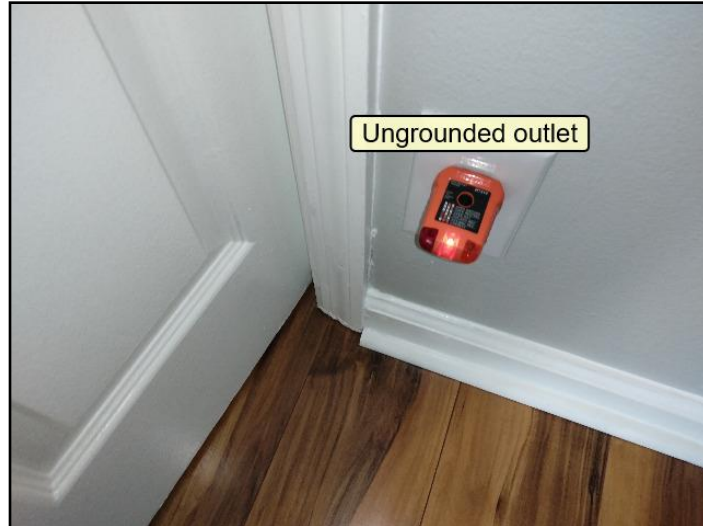
Condition: • Ungrounded
Correct wiring to outlet to provide proper ground.

Ungrounded

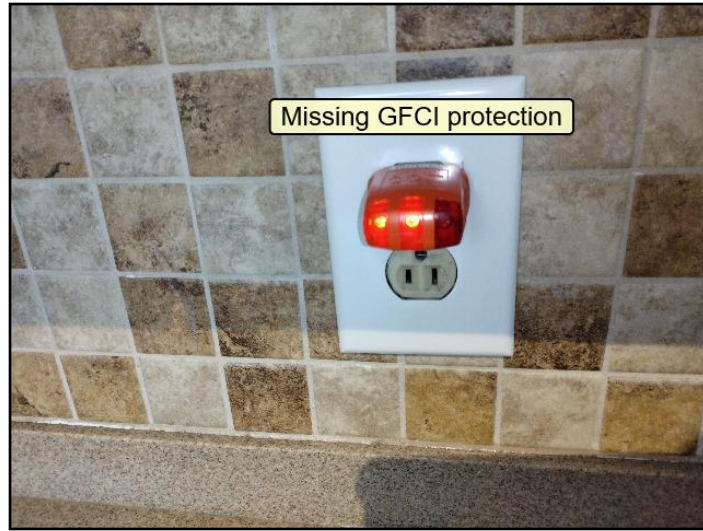
Condition: • GFCI/GFI needed (Ground Fault Circuit Interrupter)
Install GFCI protection for all outlets servicing countertops in kitchen.

GFCI/GFI needed (Ground Fault Circuit...

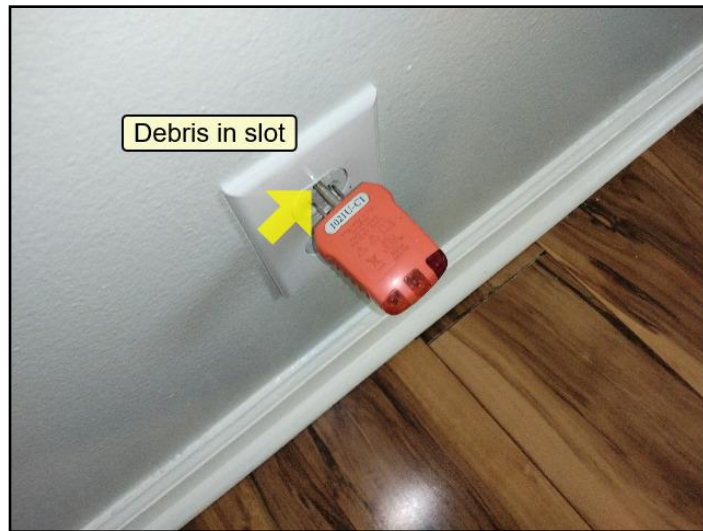
Condition: • Obstructed by paint
Remove debris from ground slot in outlet.
Location: Second Floor Bedroom
Task: Correct
Time: Immediate

Obstructed by paint

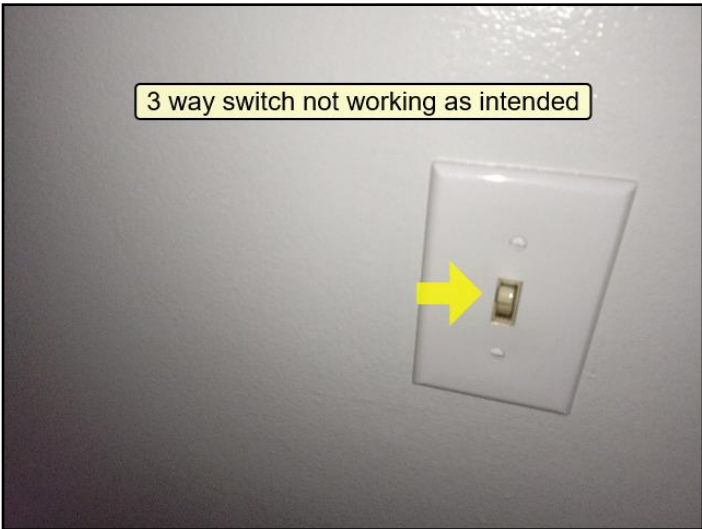
Condition: • 3-way not working as intended
Correct wiring to 3 way switch in stairway.
Implication(s): Nuisance | Fall hazard
Location: Staircase
Task: Correct

3-way not working as intended

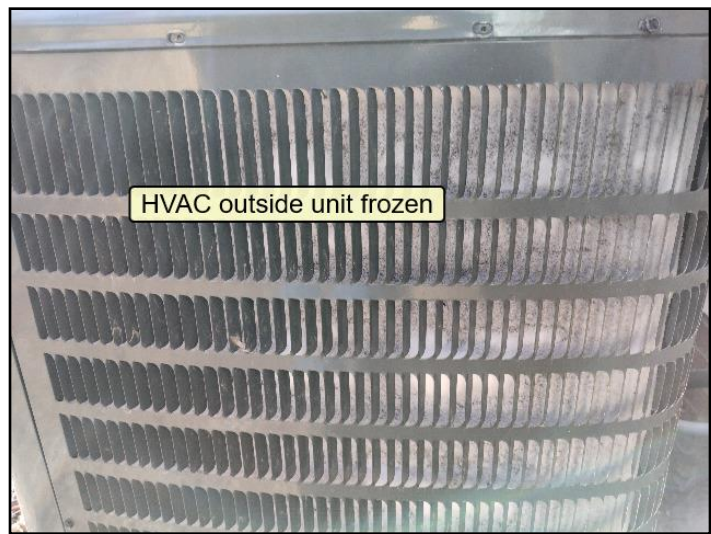
Condition: • Iced up

Iced up

Service heat pump before operating.

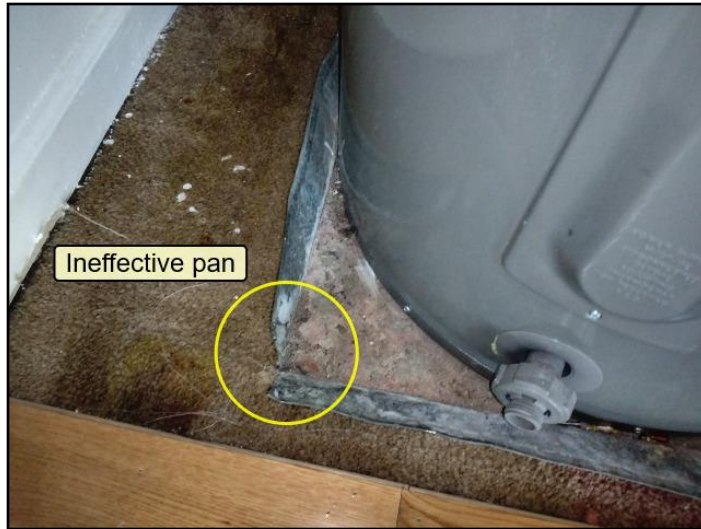
Condition: • Safety pan and drain defect

Safety pan and drain defect

Repair safety pan to contain flooding.

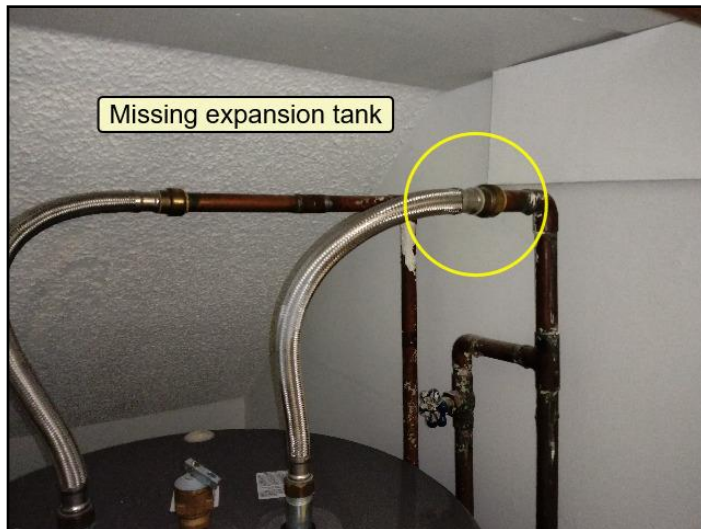
Condition: • Expansion tank missing
Install expansion tank near water heater.

Expansion tank missing

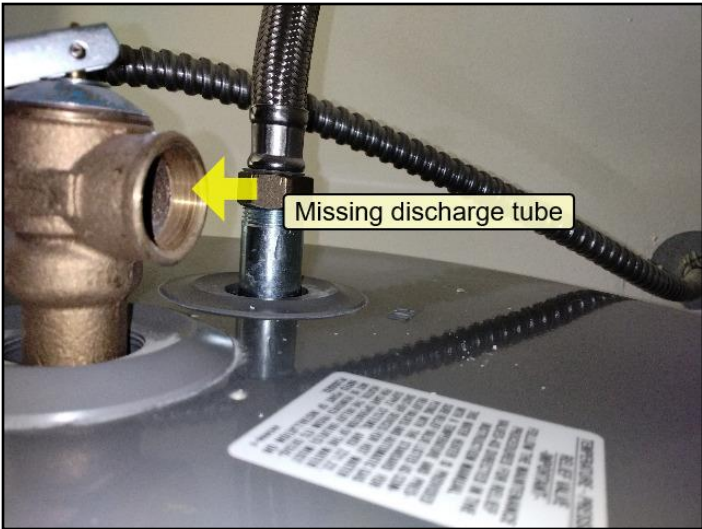
Condition: • Discharge tube missing
Install discharge tube on water tank.

Discharge tube missing

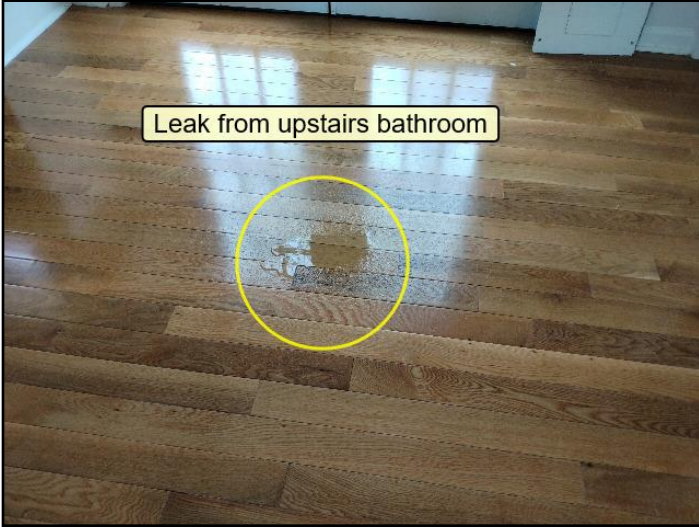
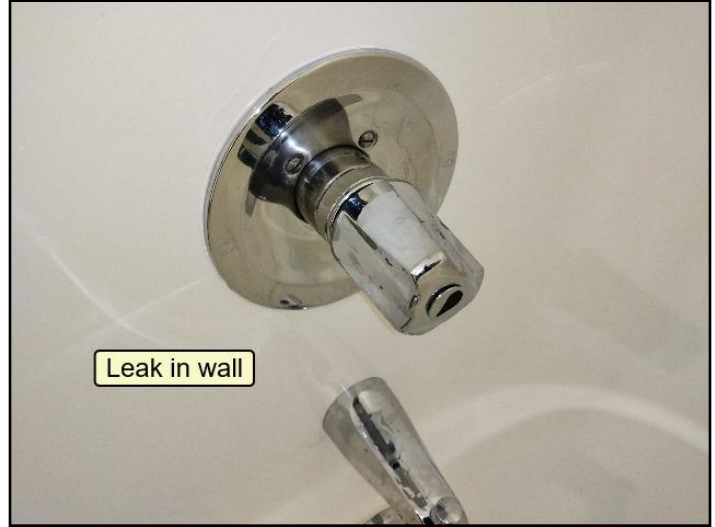
Condition: • Leak
Repair leak in wall of hallway bathroom.

Leak

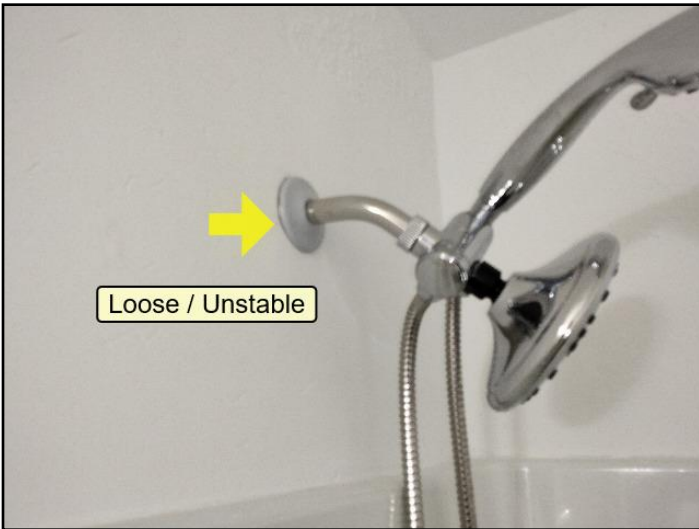
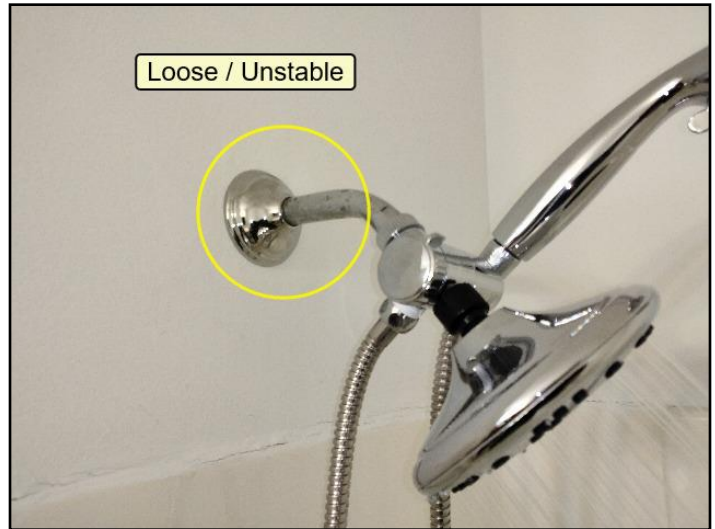
Condition: • Loose or unstable
Secure plumbing in wall to prevent movement.
Implication(s): Chance of water damage to structure, finishes and contents
Location: Bathroom
Task: Repair
Time: Immediate

Loose or unstable

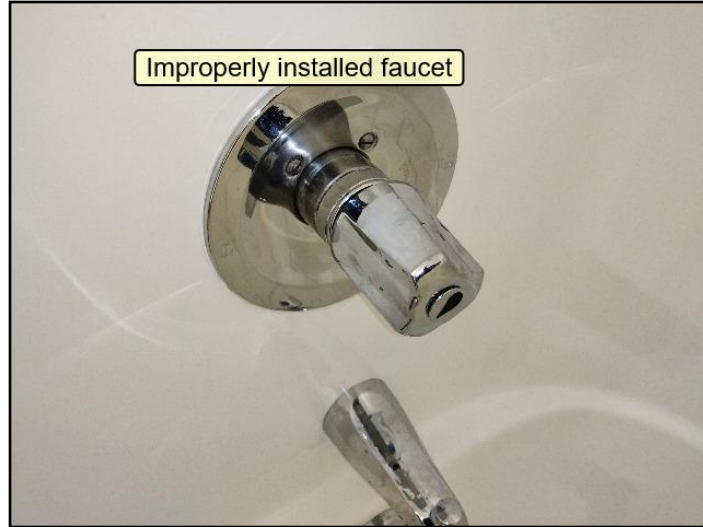
Condition: • Hot and cold faucets not identified clearly
Correct plumbing so faucet operates OFF, COLD, HOT.
Implication(s): Nuisance | Reduced operability | Physical injury

Hot and cold faucets not identified clearly

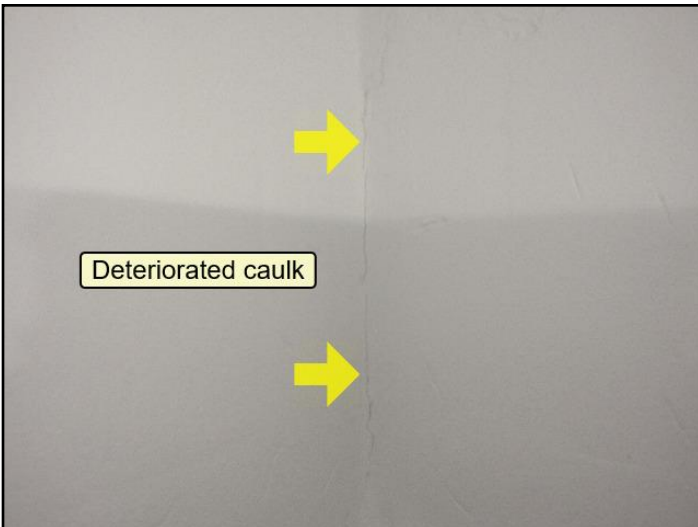
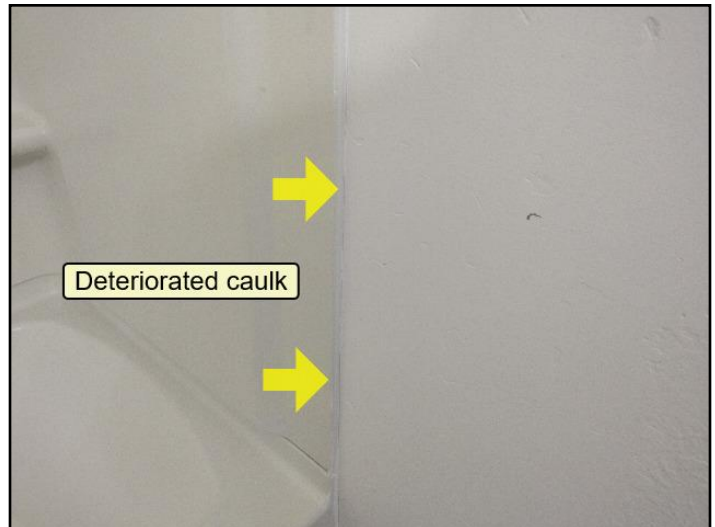
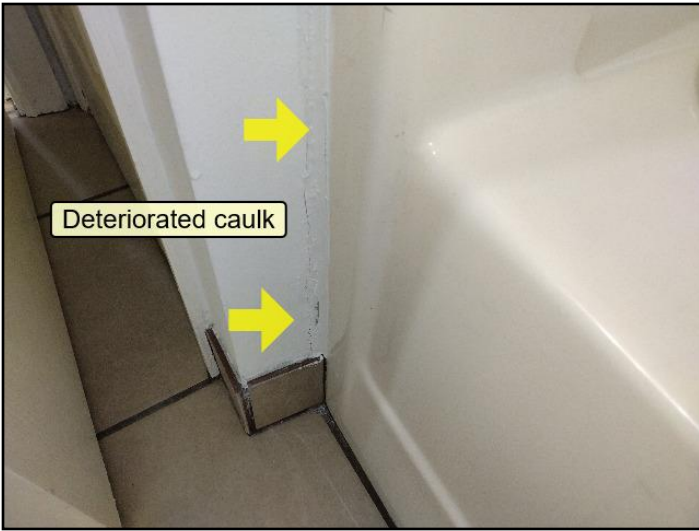
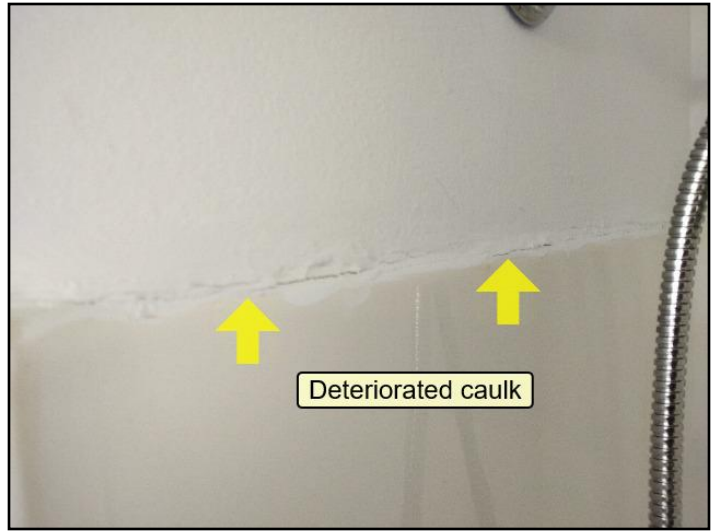
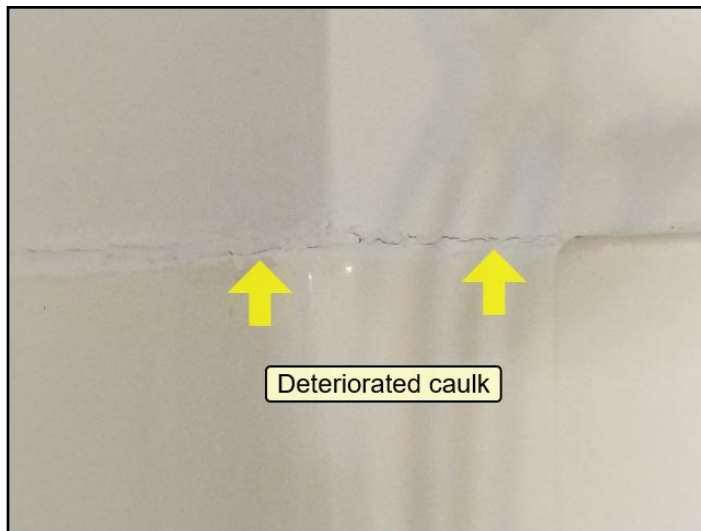
Condition: • Caulking loose, missing or deteriorated
Repair caulk around bathtub enclosures.

Caulking loose, missing or deteriorated

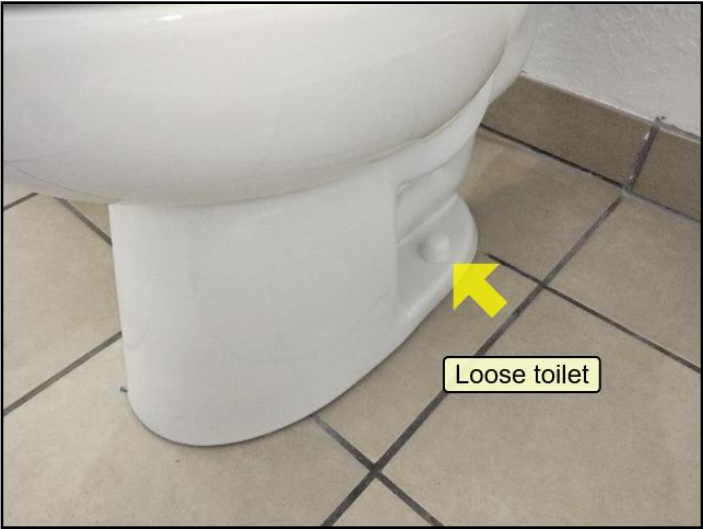
Condition: • Loose

Loose

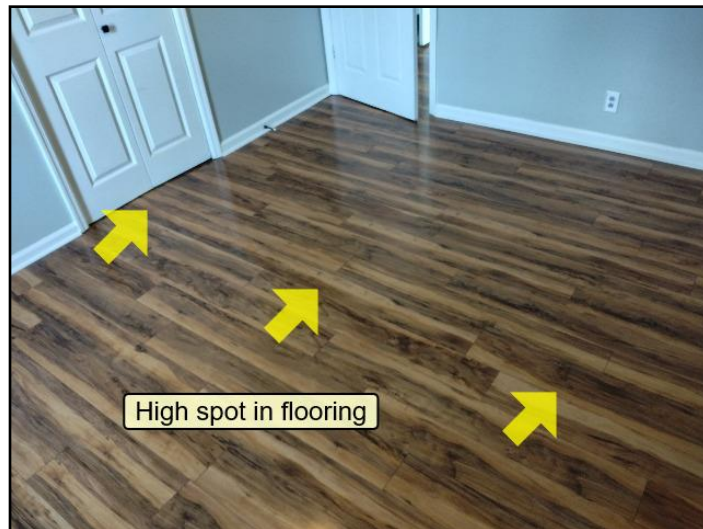
Condition: • Uneven subfloor
Monitor for changes or movement in bedroom floor.
High spot in bedroom floor.
Location: Second Floor Bedroom
Task: Monitor
Time: Ongoing

Uneven subfloor

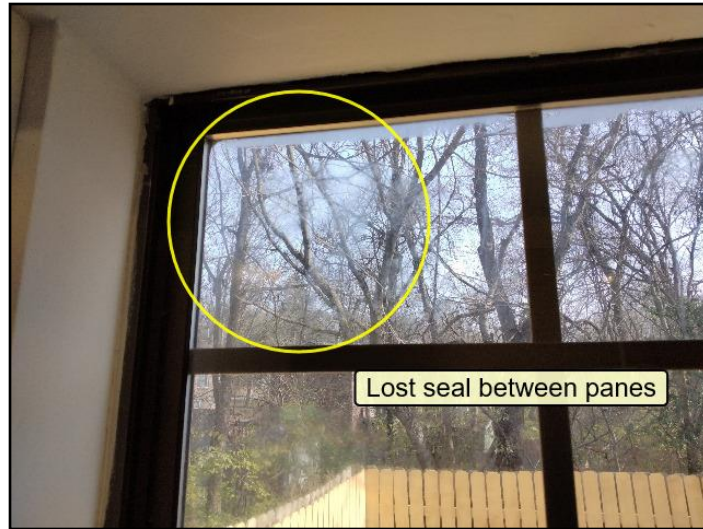
Condition: • Lost seal on double or triple glazing
Repair / Replace window panes that has lost seal.
Implication(s): Shortened life expectancy of material
Location: Kitchen
Task: Repair
Time: Immediate

Lost seal on double or triple glazing

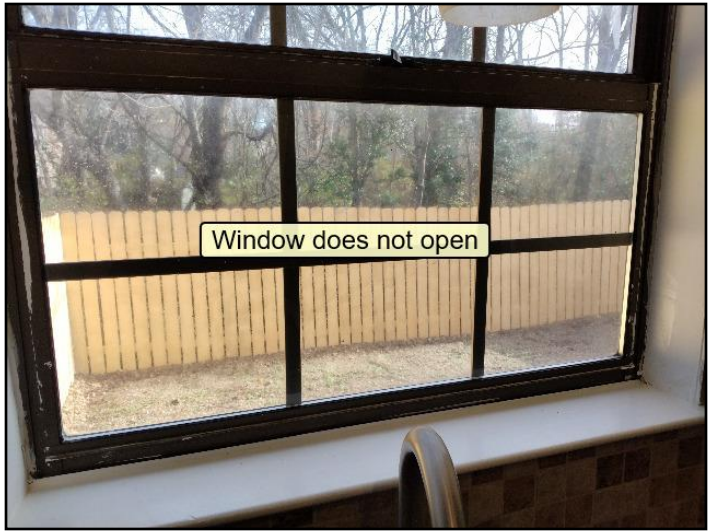
Condition: • Inoperable

Inoperable

Repair windows for normal operation.

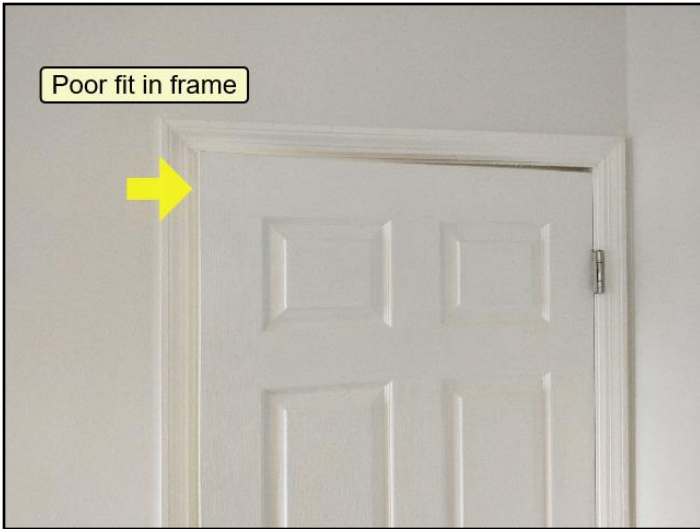
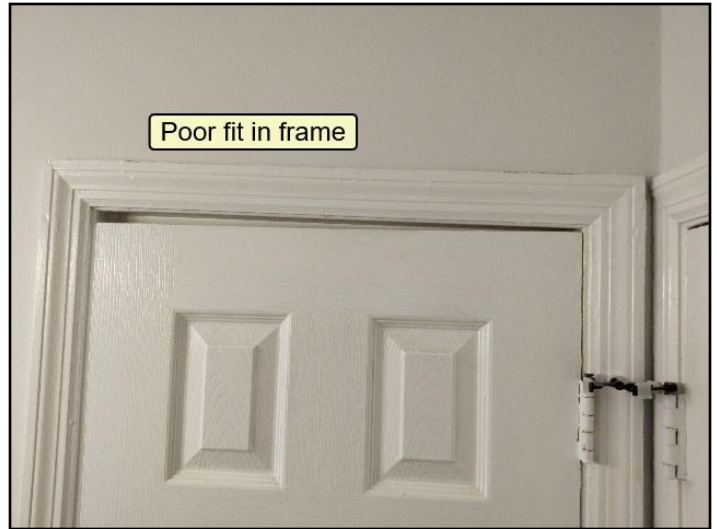
Condition: • Loose or poor fit
Adjust hardware for proper fit in frames.
(downstairs bedroom, upstairs bathroom)

Loose or poor fit

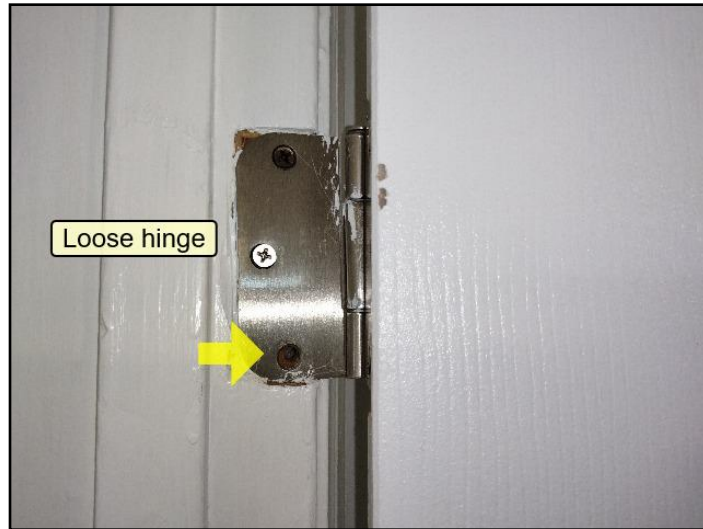
Condition: • Loose

Loose

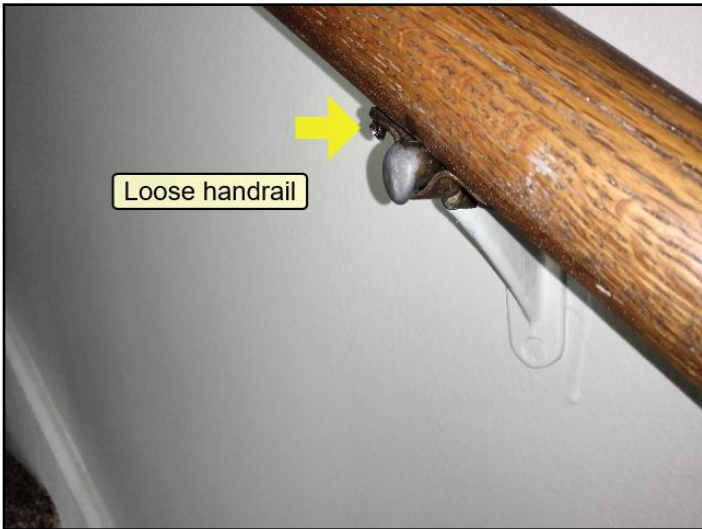
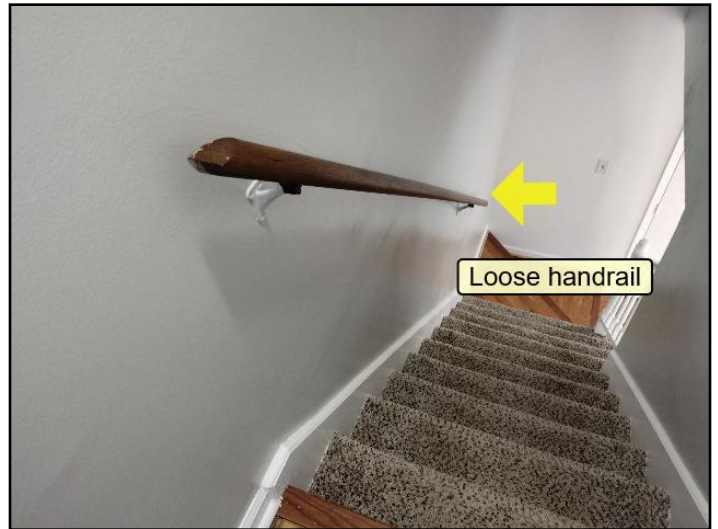
Condition: • Loose

Loose

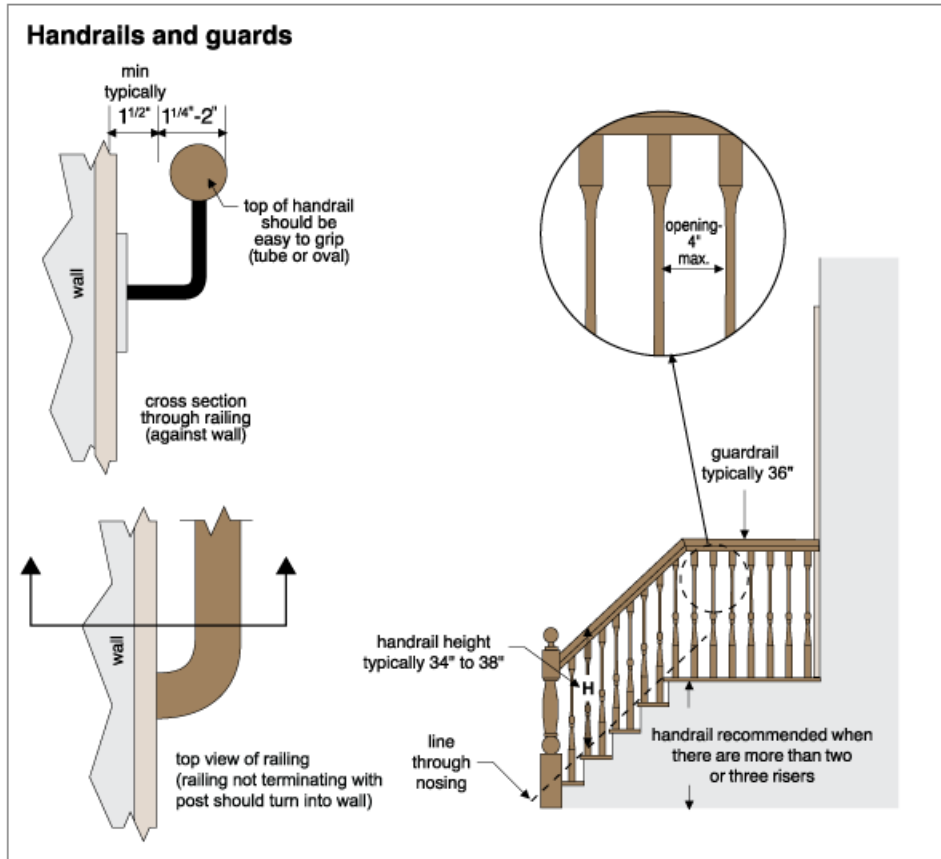
Condition: • Too far apart

Too far apart

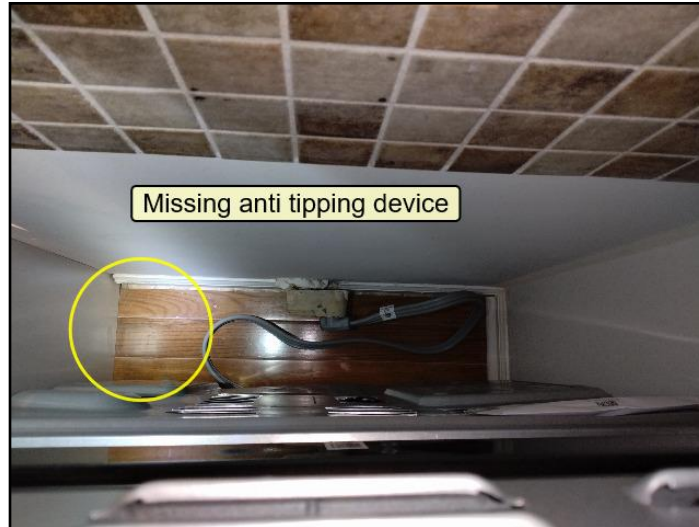
Condition: • Anti-tipping device missing
Install anti tipping device behind oven.

Anti-tipping device missing

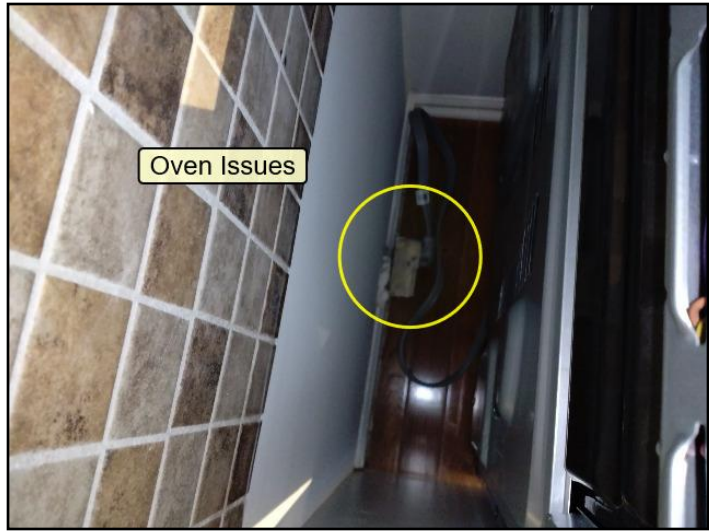
Condition: • Loose Electrical Connection

Odor is similar to burning wiring smell.

Loose Electrical Connection

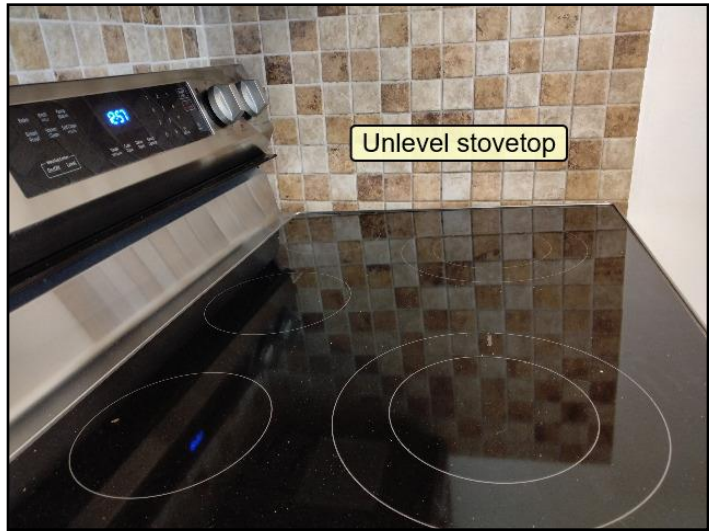
Condition: • Incomplete Installation
Complete installation by leveling appliance in position.
Location: Kitchen
Task: Correct
Time: Immediate

Incomplete Installation

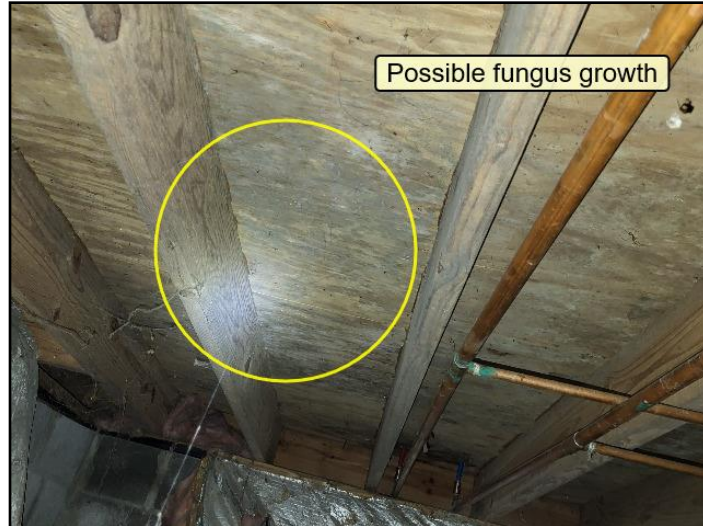
Condition: • Suspected Possible Fungus Growth
Some deposits on floor joists.
Suspected possible mold or fungus.
Recommended to have mold inspection conducted to determine presence of harmful mold.
Location: Various Crawl Space

Suspected Possible Fungus Growth
