YOUR INSPECTION REPORT

1234 Main Avenue
Sioux Falls, SD 57104

Friday, July 28, 2017

RE: Report No. 1001, v.6
1234 Main Avenue
Sioux Falls, SD
57104

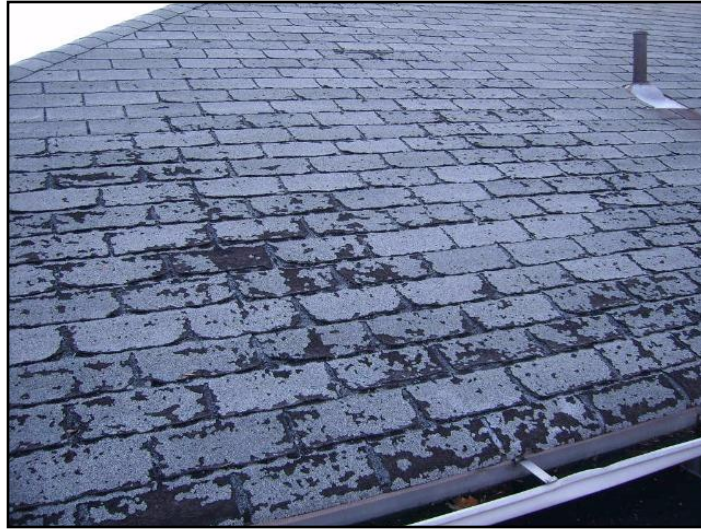
Condition: • [Granule loss](#)

Implication(s): Chance of water damage to contents, finishes and/or structure

Granule loss

Task: Replace

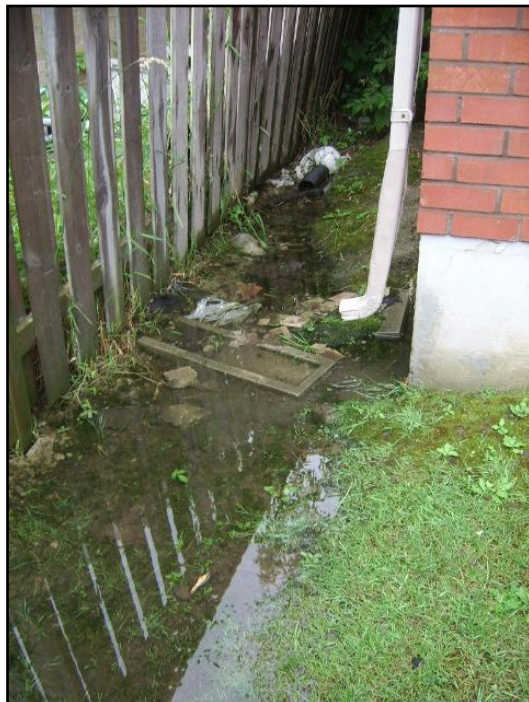
Condition: • [Discharge too close to building](#)

Implication(s): Chance of water damage to contents, finishes and/or structure

Downspouts end too close to building

Task: Improve

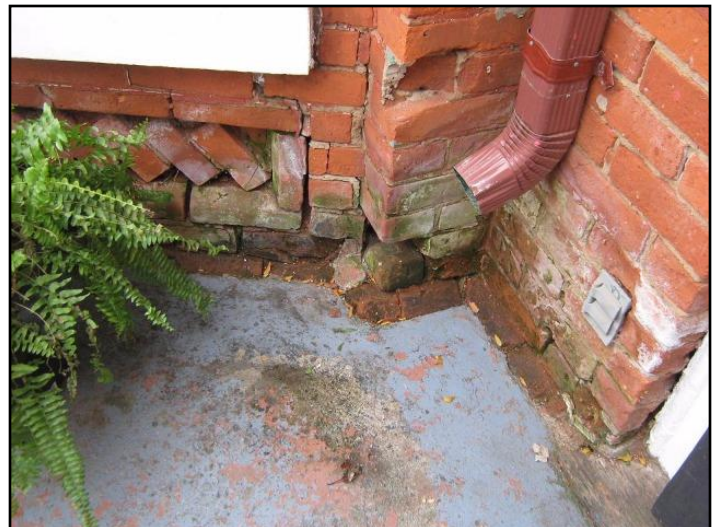
Condition: • [Leak](#)

Implication(s): Chance of water damage to contents, finishes and/or structure

Leak

Task: Improve

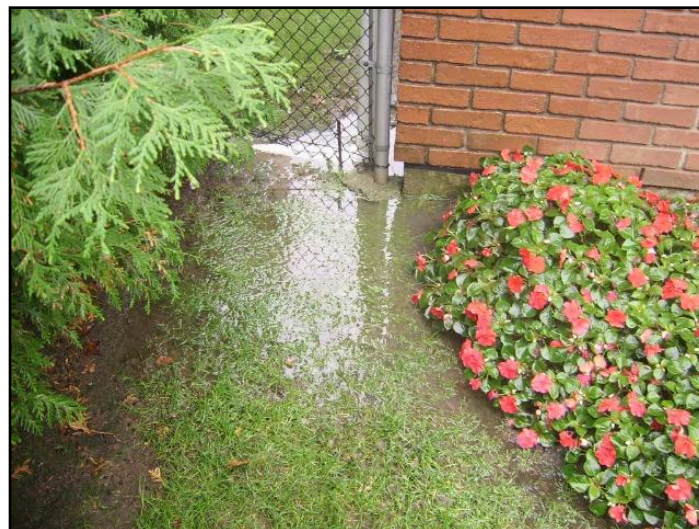
Condition: • [Improper slope or drainage](#)

Implication(s): Chance of water damage to contents, finishes and/or structure

Improper slope

Task: Improve

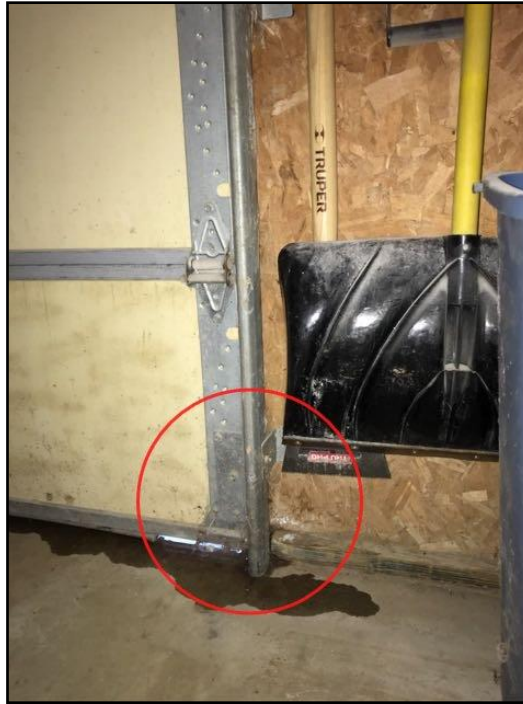
Condition: • Sensors Missing

Implication(s): Safety issue

Sensors Missing

Task: Repair

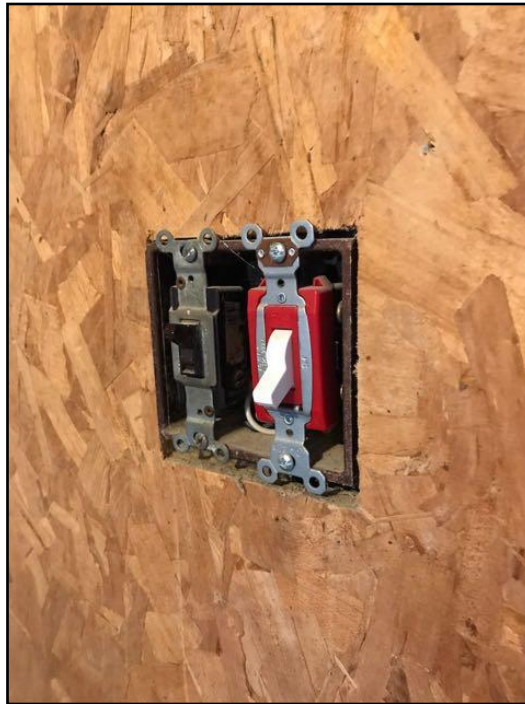
Condition: • [Missing](#)

Implication(s): Electric shock

Missing Cover

Task: Improve Safety issue

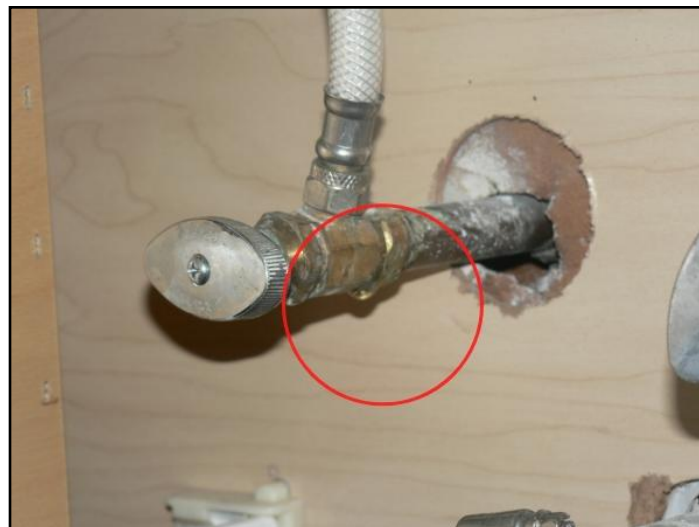
Condition: • [Leak](#)

Implication(s): Chance of water damage to contents, finishes and/or structure | Sewage entering the building

Leak

Task: Repair or replace

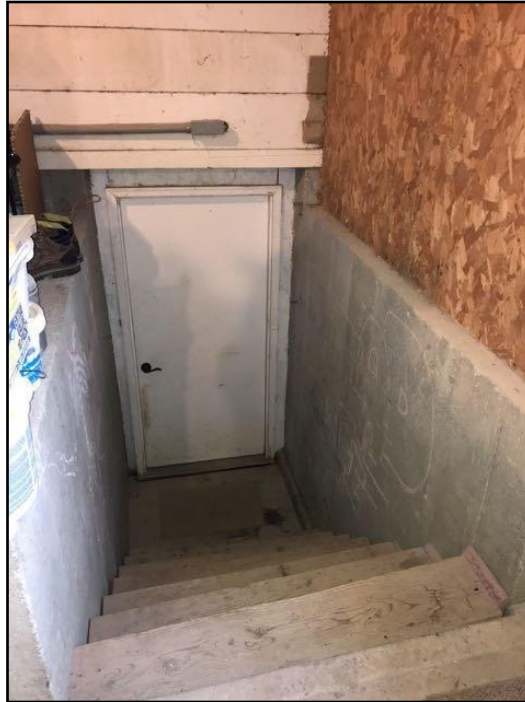
Condition: • [Missing](#)

Implication(s): Fall hazard

Missing handrail

Task: Repair Safety issue

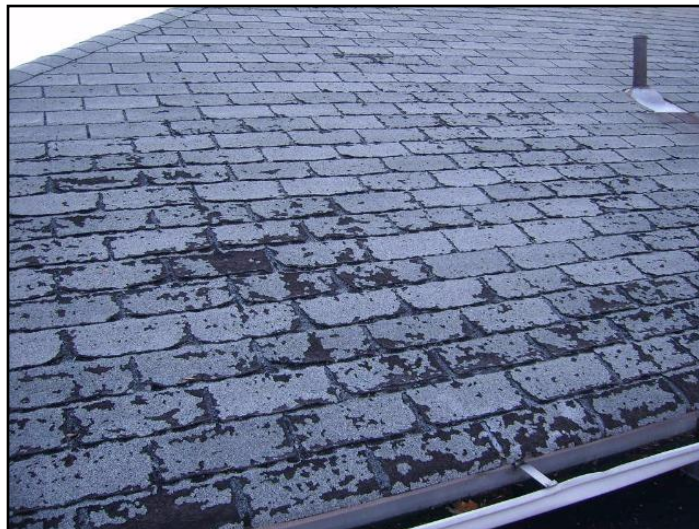
1. Condition: • [Granule loss](#)

Implication(s): Chance of water damage to contents, finishes and/or structure

Granule loss

Probability of leakage: • High

Approximate age: • 20 years

Task: Replace

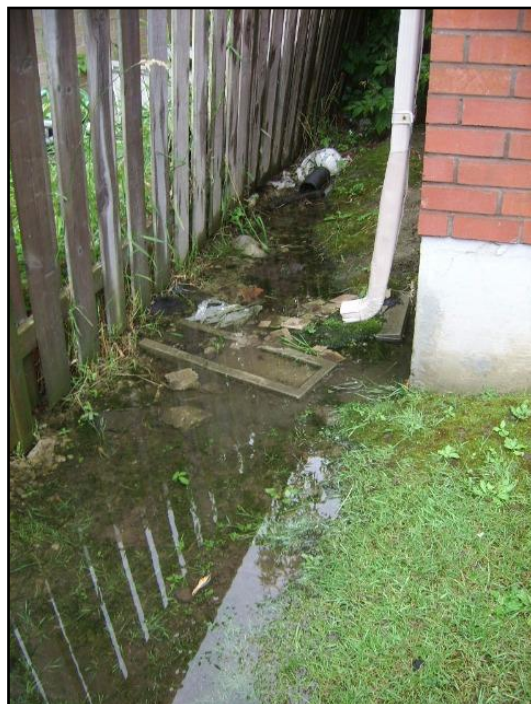
2. Condition: • [Discharge too close to building](#)

Implication(s): Chance of water damage to contents, finishes and/or structure

Downspouts end too close to building

Task: Improve

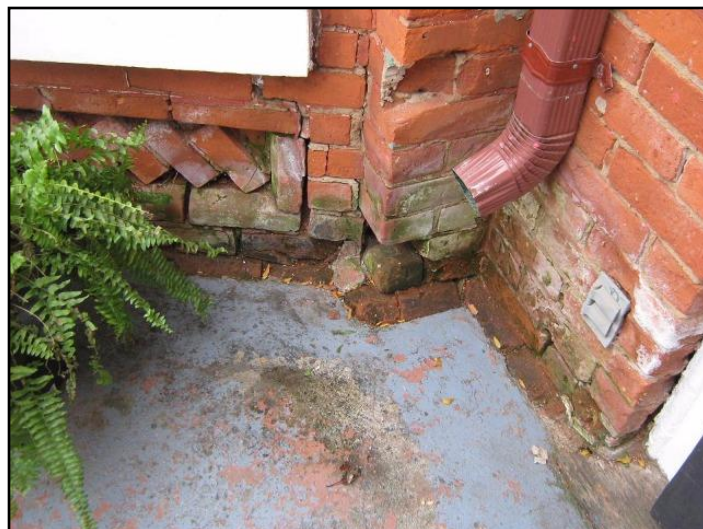
3. Condition: • [Leak](#)

Implication(s): Chance of water damage to contents, finishes and/or structure

Leak

Task: Improve

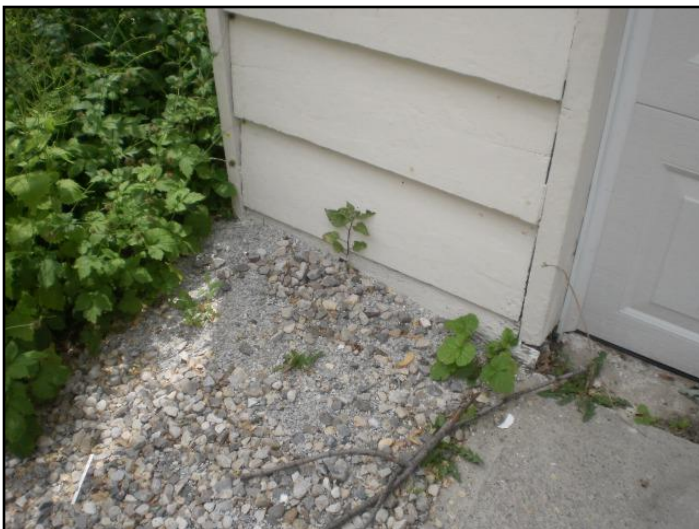
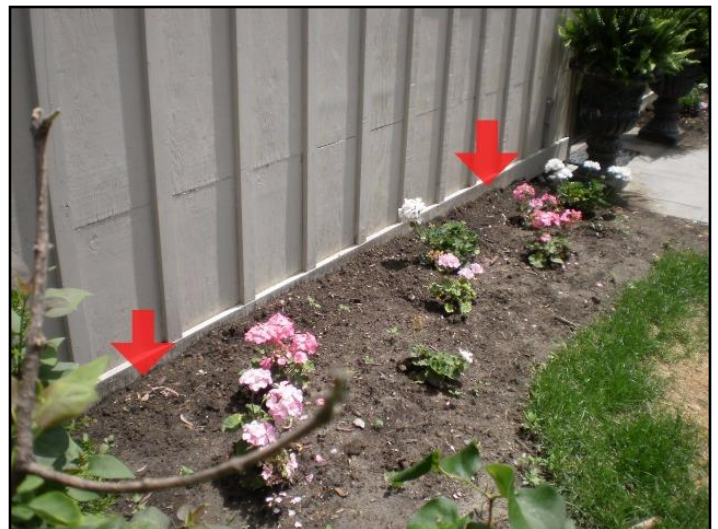
4. Condition: • [Too close to grade](#)

Implication(s): Chance of water damage to contents, finishes and/or structure | Material deterioration | Rot |

Insect damage

Too close to grade

Task: Correct

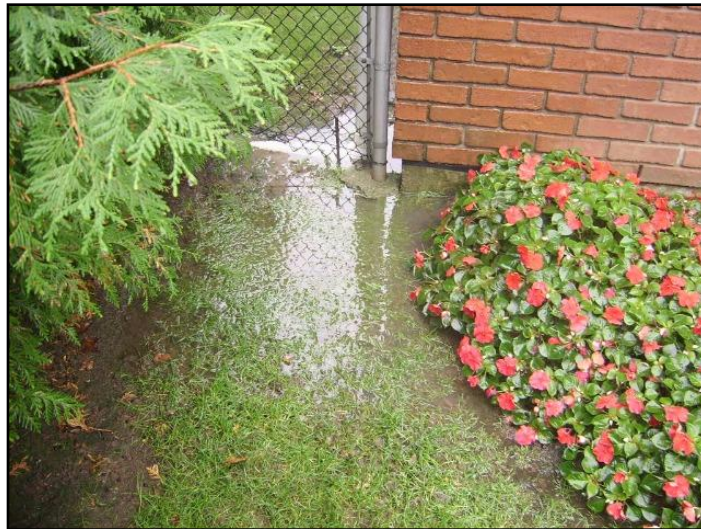
5. Condition: • [Improper slope or drainage](#)

Implication(s): Chance of water damage to contents, finishes and/or structure

Improper slope

Task: Improve

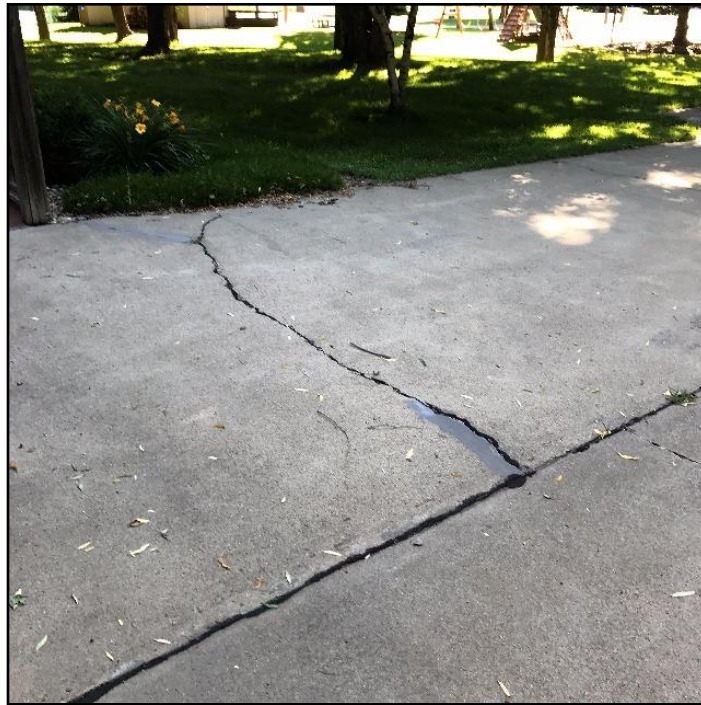
6. Condition: • [Cracked or damaged surfaces](#)

Implication(s): Trip or fall hazard

Concrete

Task: Monitor

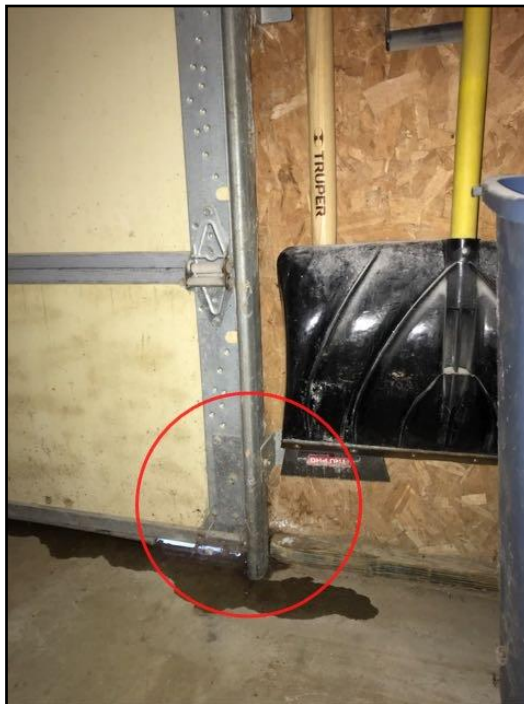
7. Condition: • Sensors Missing

Implication(s): Safety issue

Sensors Missing

Task: Repair

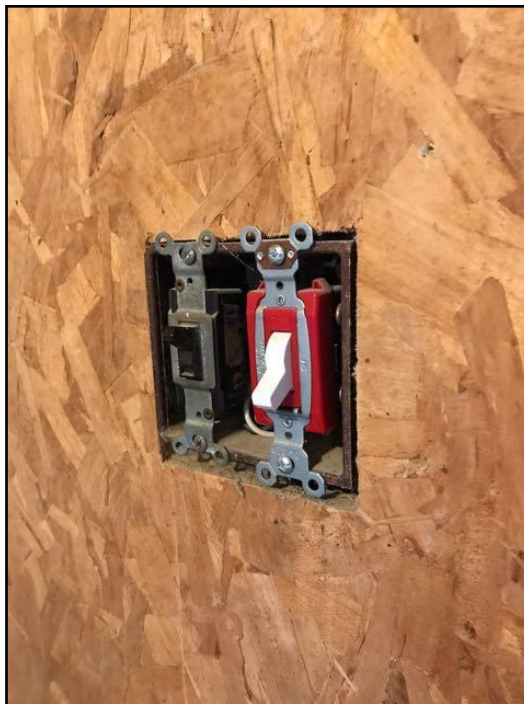
8. Condition: • [Missing](#)

Implication(s): Electric shock

Missing Cover

Task: Improve Safety issue

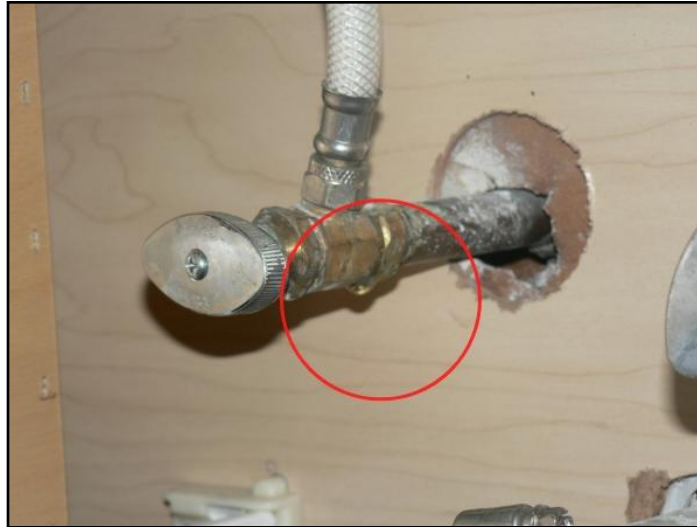
9. Condition: • [Leak](#)

Implication(s): Chance of water damage to contents, finishes and/or structure | Sewage entering the building

Leak

Task: Repair or replace

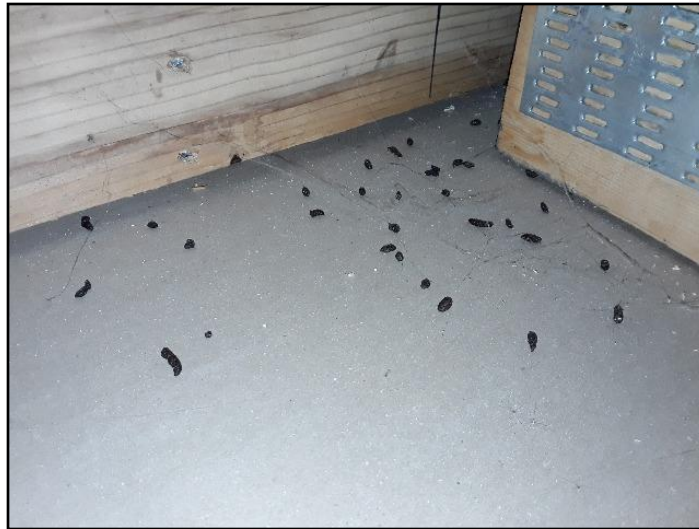
10. • Pest Droppings

Pest Droppings

Task: Further evaluation by professional

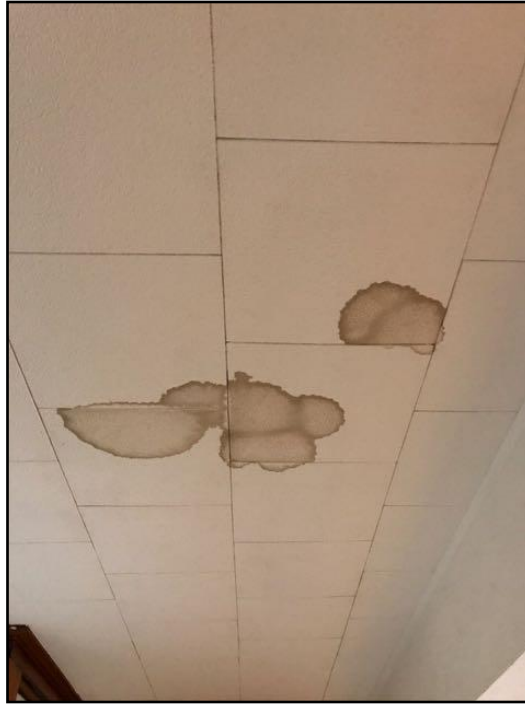
11. Condition: • Water stains

No current moisture present

Implication(s): Chance of water damage to contents, finishes and/or structure

Water stain

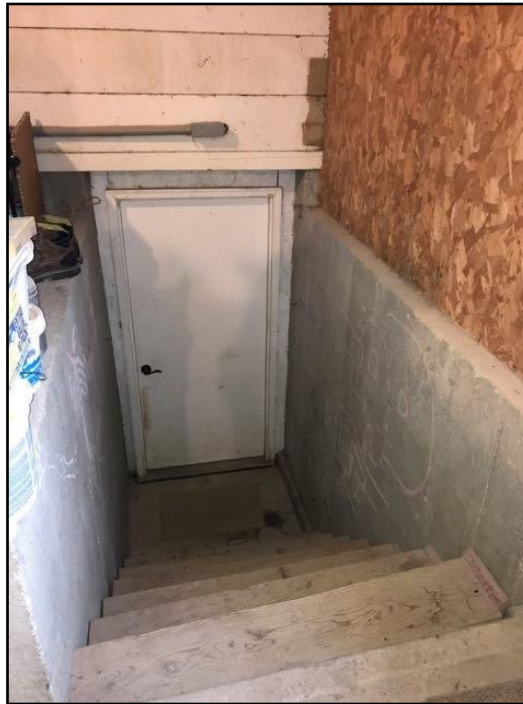
12. Condition: • [Missing](#)

Implication(s): Fall hazard

Missing handrail

Task: Repair Safety issue
