# YOUR INSPECTION REPORT

1018 Bloom Road  
Danville, PA 17821

Friday, September 11, 2020

RE: Report No. 1003, v.2  
1018 Bloom Road  
Danville, PA  
17821

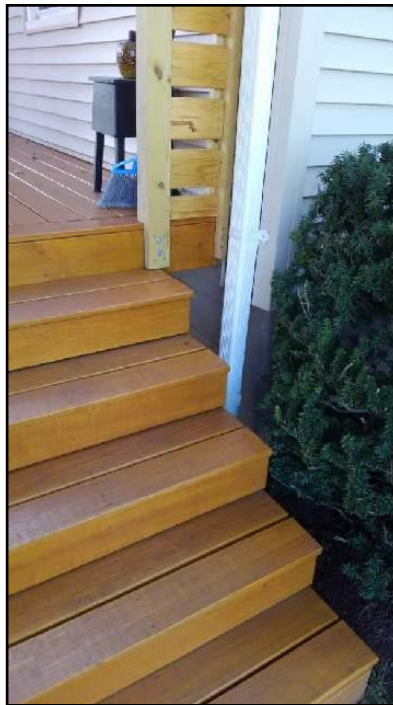
Condition: • [Missing](#)

Implication(s): Fall hazard

*Missing*

Task: Repair

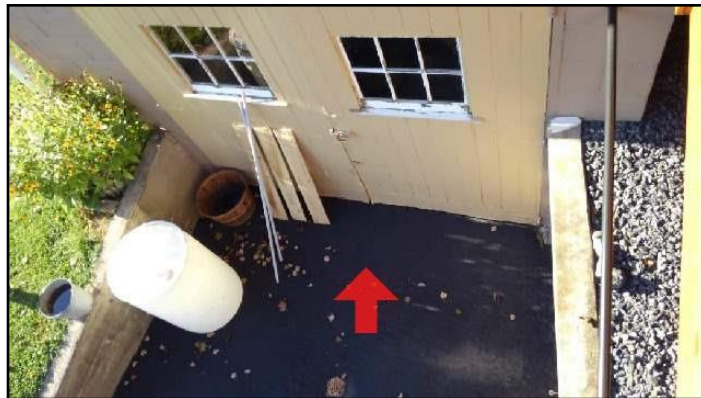
Condition: • [Improper slope or drainage](#)

**Implication(s):** Chance of water damage to structure, finishes and contents

Walk/patio sloping towards house

Improper slope or drainage

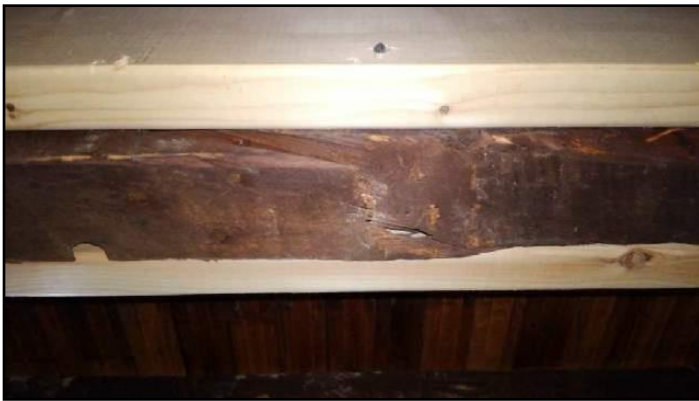
**Condition:** • [Split or damaged](#)**Implication(s):** Weakened structure | Chance of structural movement**Location:** Basement**Task:** Further evaluation

*Split or damaged*

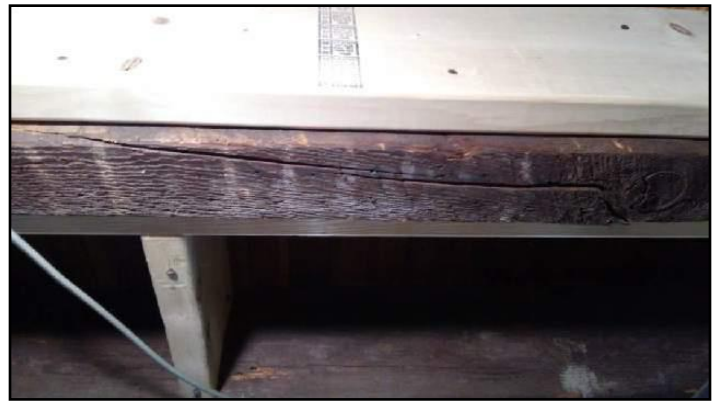
*Split or damaged*

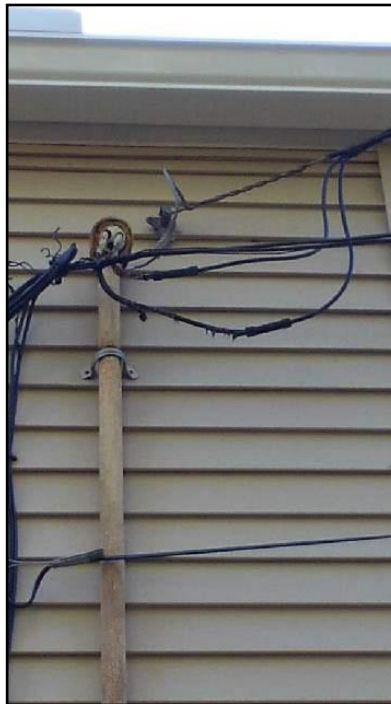
**Condition:** • [Damaged, frayed wires](#)

**Implication(s):** Electric shock | Interruption of electrical service

*Damaged, frayed wires*

**Task:** Repair

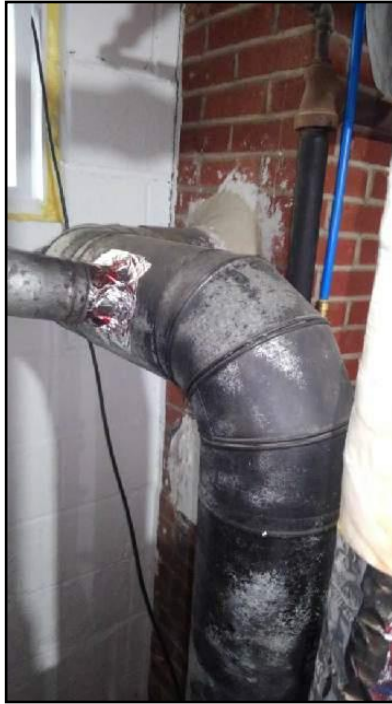
**Condition:** • water heater vent pipe slope is downward facing , should be sloped upward

**Implication(s):** possible backdrafting

*Damage or corroded*

**Task:** Improve

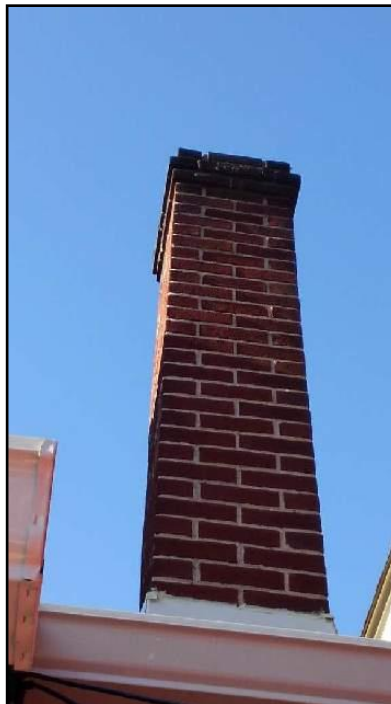
**Condition:** • [Missing](#)

**Implication(s):** Chance of water damage to structure, finishes and contents | Shortened life expectancy of material

Missing

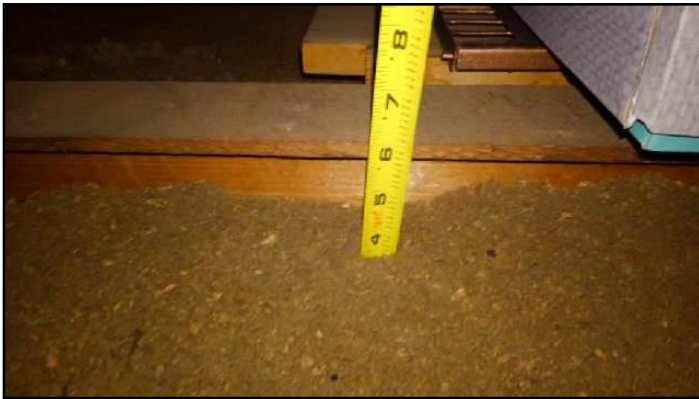
4 inches

**Condition:** • [Amount inadequate](#)

**Implication(s):** Increased heating and cooling costs

**Task:** Further evaluation

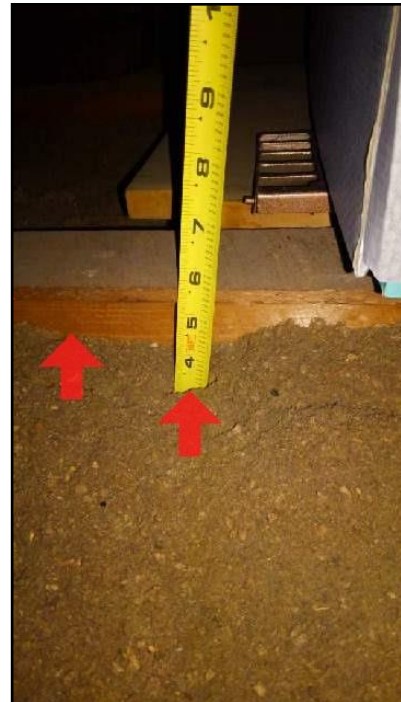
4 inches

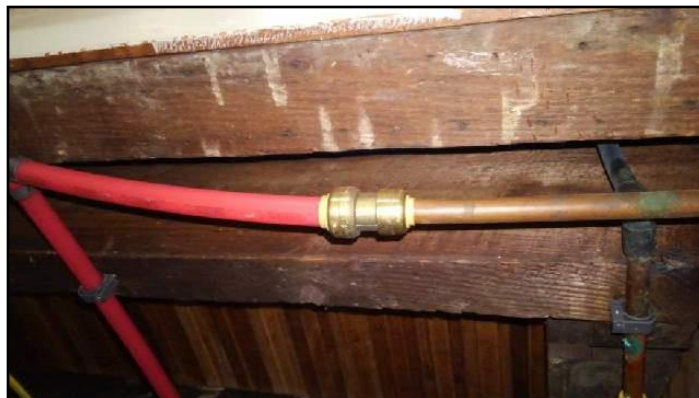
**Condition:** • [Poor support](#)

**Implication(s):** Chance of water damage to structure, finishes and contents | Leakage

*Inadequate support*

**Task:** Repair

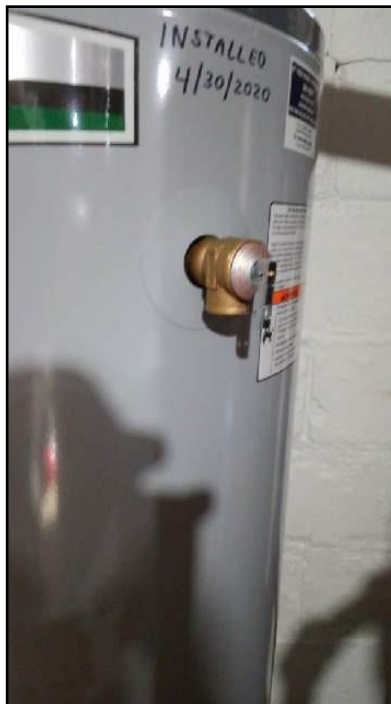
**Condition:** • [Missing](#)

**Implication(s):** Steam explosion

Missing

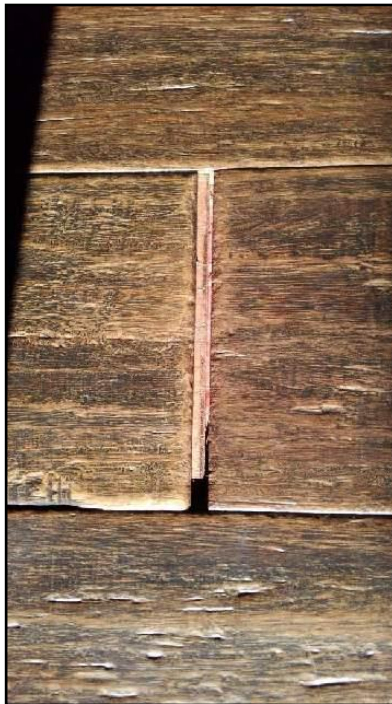
Condition: • [Open seams](#)

Implication(s): Trip or fall hazard

*Open seams*
