# Your Inspection Report

294 Roncesvalles Ave  
Toronto, ON

**INSPECTION DATE:**  
Thursday, October 13, 2016

RE: Report No. 55639  
294 Roncesvalles Ave  
Toronto, ON

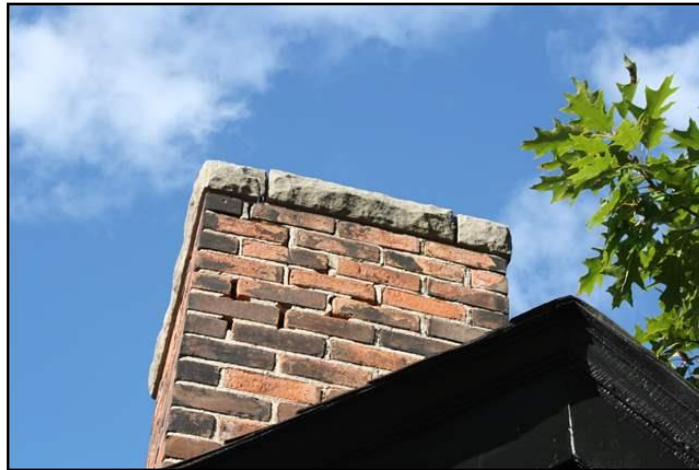
**Condition:** • [Abandoned \(vulnerable area for leaks\)](#)

*Abandoned (vulnerable area for leaks)*

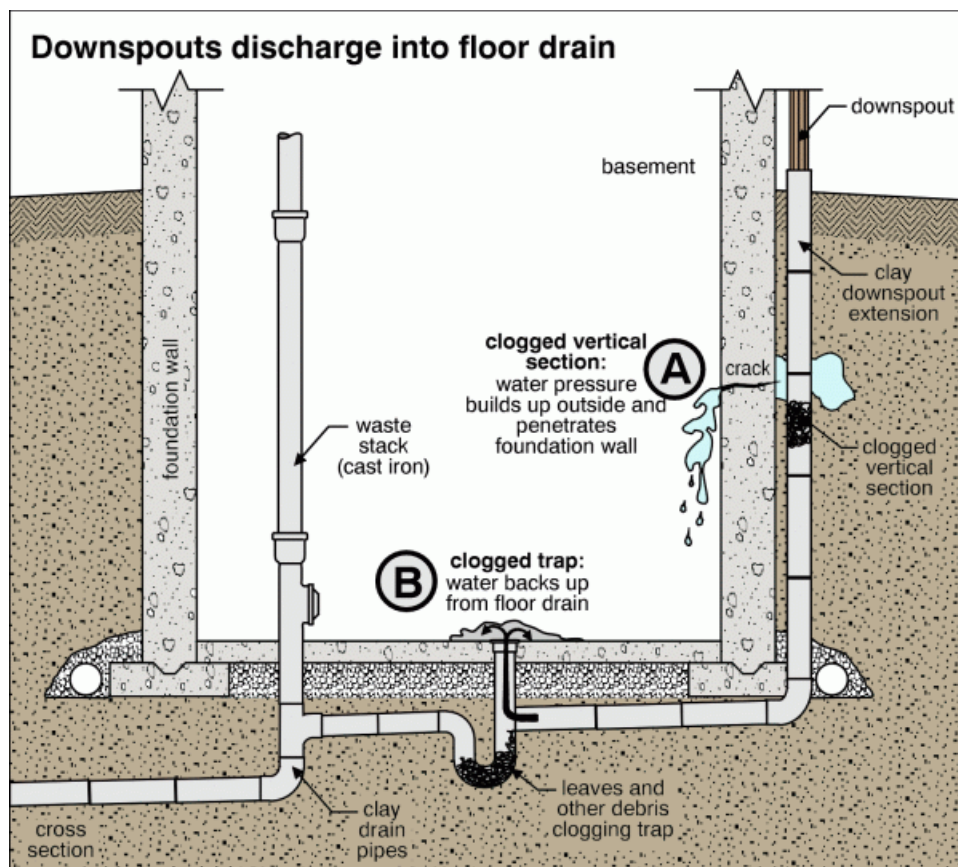
**Condition:** • Downspouts discharge below grade

**Implication(s):** While the current arrangement is convenient and a good method to deal with rain water, if the drain pipe becomes clogged and/or deteriorated, there is a greater risk of water backing up and leaking into the basement. Note: On newer houses the drain may go into the weeping tile (not the floor drain).

**Task:** Monitor/Improve

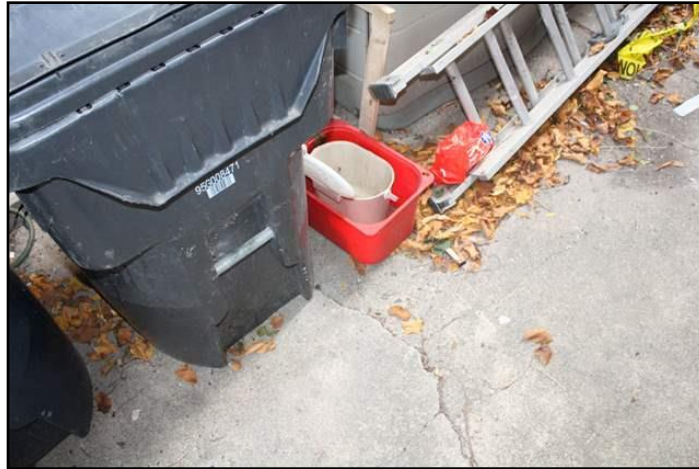
**Condition:** • Low areas

*Low areas*

**Task:** Repair / Replace

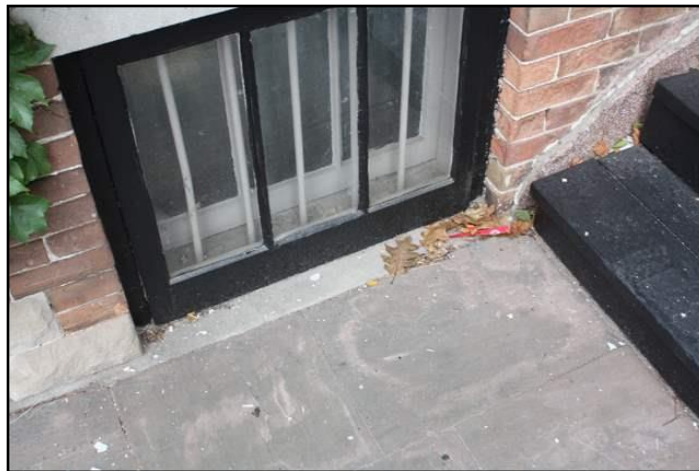
**Condition:** • Sill - clearance inadequate (above grade level)

*Sill - clearance inadequate (above grade...*

**Task:** Monitor / Improve

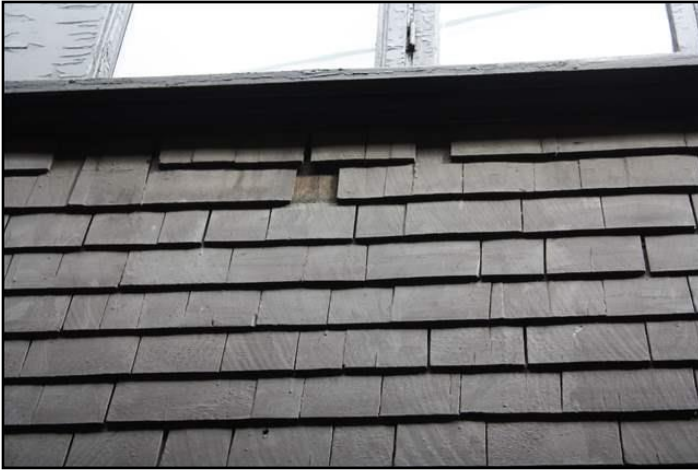
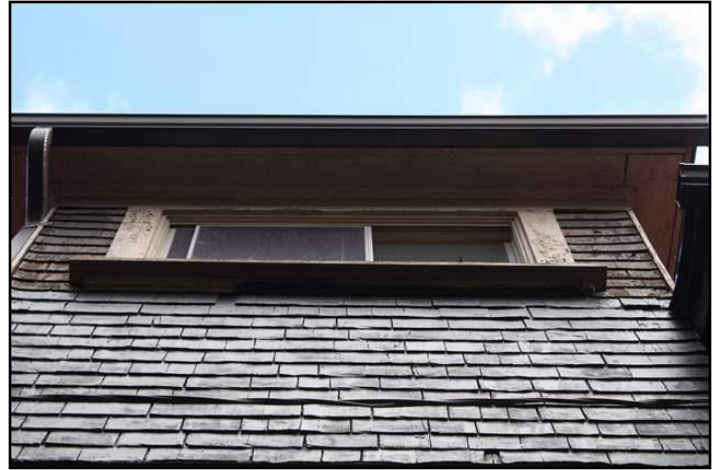
**Condition:** • [Damage](#)

Missing wood shingles

Damage

**Task:** Repair

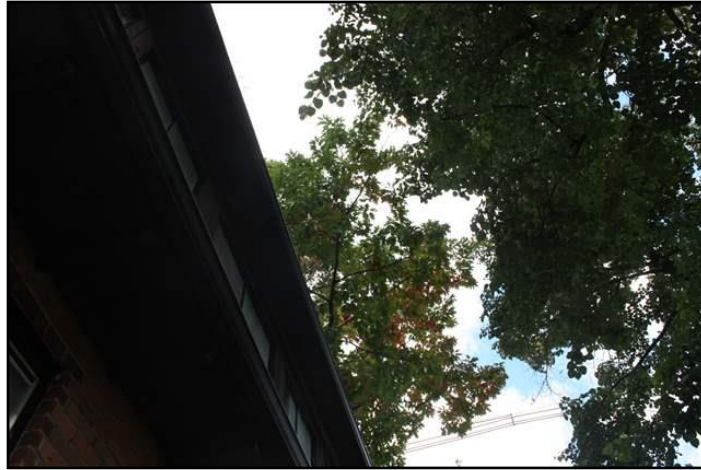
**Condition:** • [Shrubs/Trees - too close to building \(trimming needed\)](#)

*Shrubs/Trees - too close to building...*

**Task:** Improve

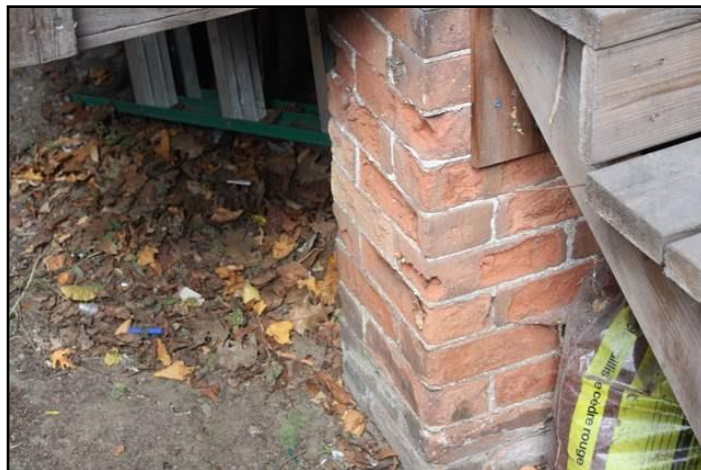
**Condition:** • [Spalling](#)

*Spalling*

**Task:** Repair

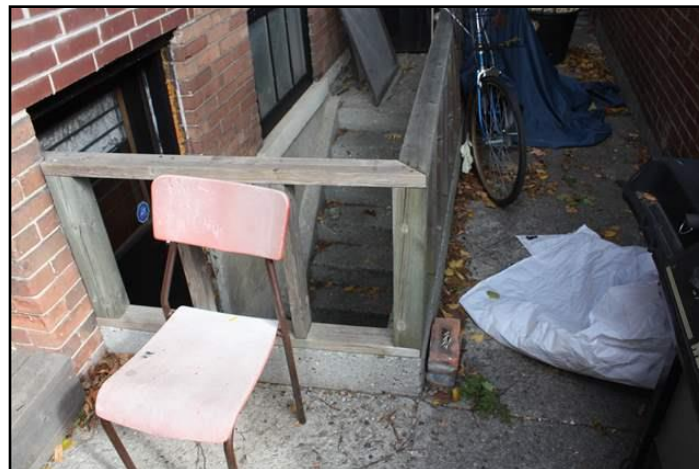
**Condition:** • [Openings too large](#)

Openings too large

**Task:** Repair / Replace Guardrails

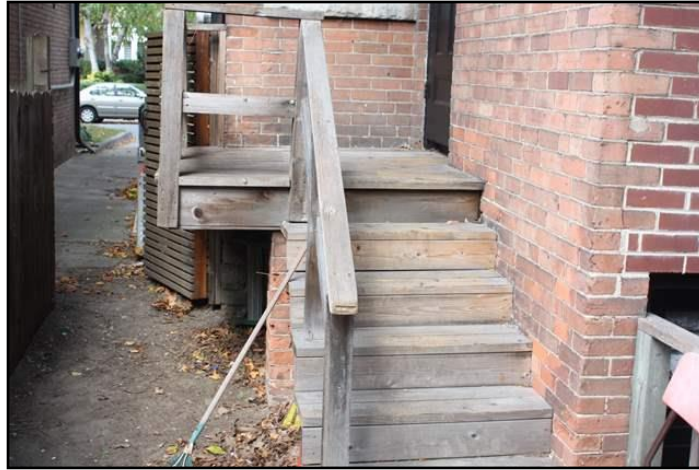
**Condition:** • Boards poorly supported

*Boards poorly supported*

**Task:** Repair / Replace

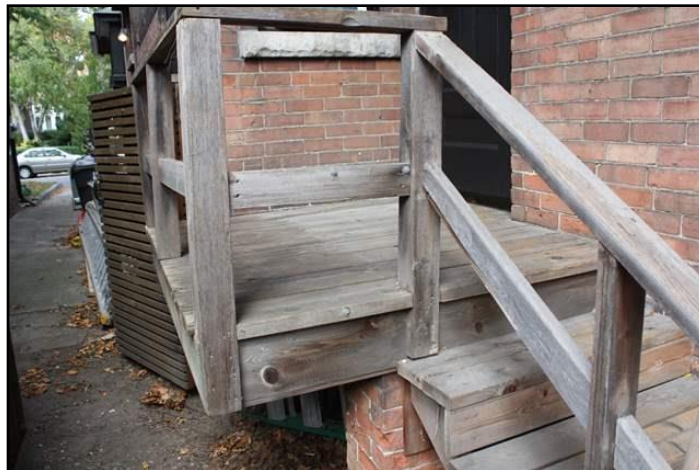
**Condition:** • Railing climbable

*Railing climbable*

**Task:** Replace

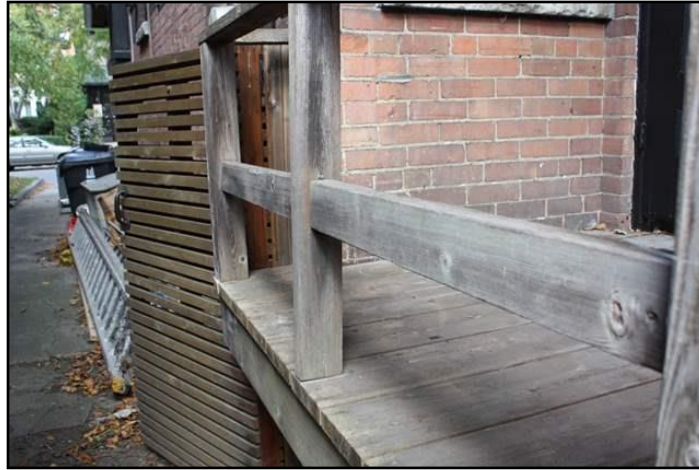
**Condition:** • Railing not secure

*Railing not secure*

**Task:** Repair / Replace

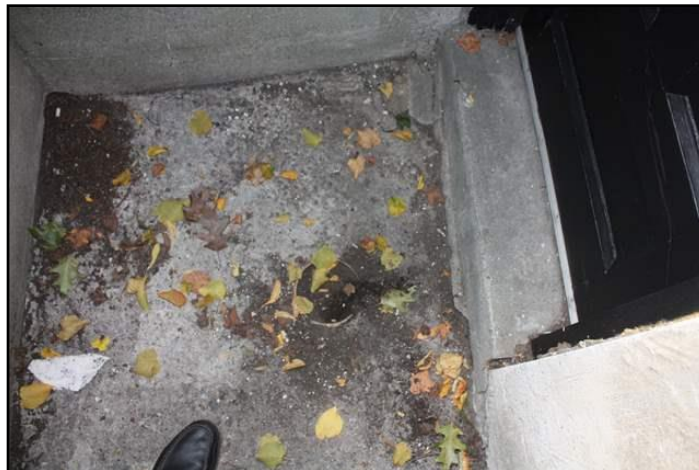
**Condition:** • [Drain ineffective](#)

*Drain ineffective*

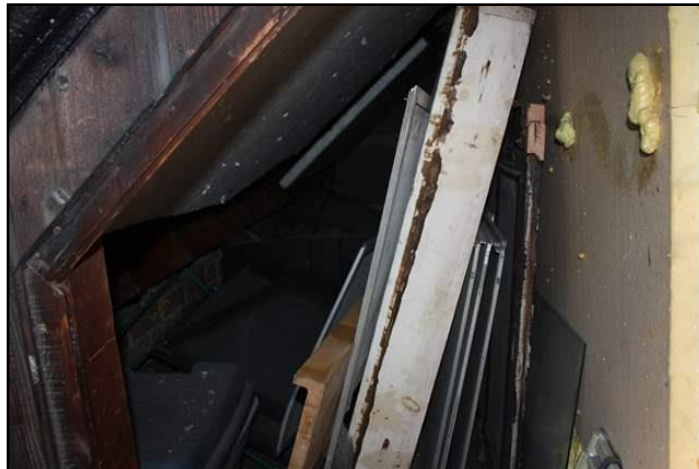
**Condition:** • Attic - restricted access

*Attic - restricted access*

**Task:** Remove storage and inspect

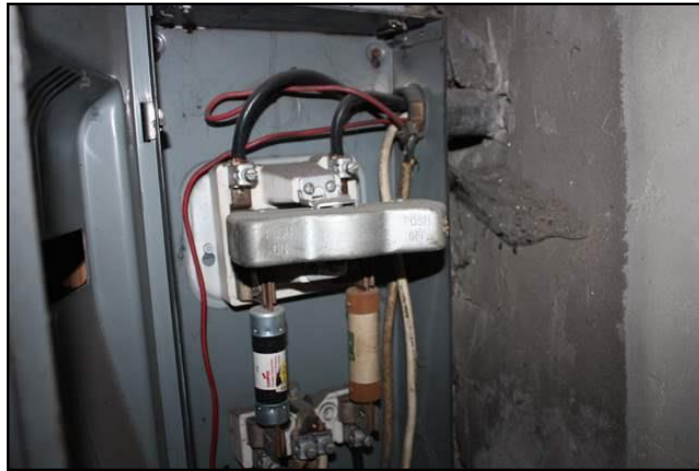
\*\*\*THE MAIN SERVICE BOX FUSES ARE 100-AMP. THE MAIN SERVICE CONDUCTORS ARE 3-GAUGE AWG AND ARE SUITABLE WITH 100-AMP FUSES

100 amps (240 Volts)

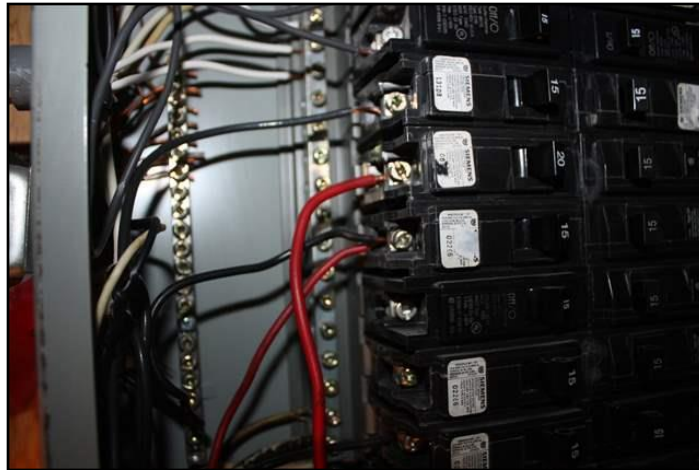
**Condition:** • [Double-taps](#)

*Double-taps*

**Task:** Correct**Time:** Immediate**Cost:** Minor**Double tapping (double lugging)**

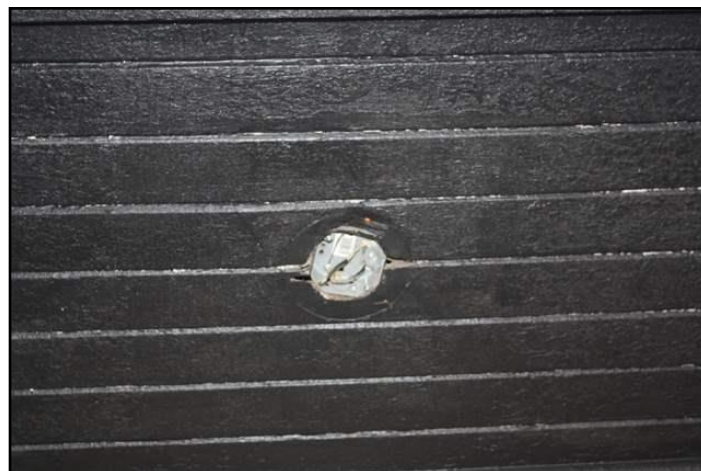
**Condition:** • [Missing on junction boxes](#)

*Missing on junction boxes*

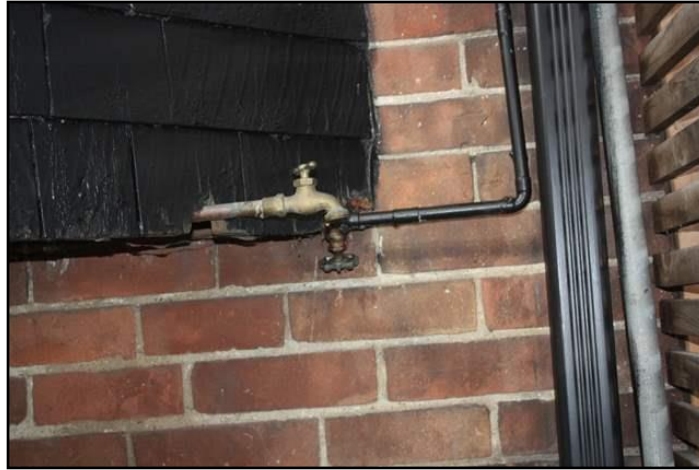
**Condition:** • [Loose](#)

*Loose*

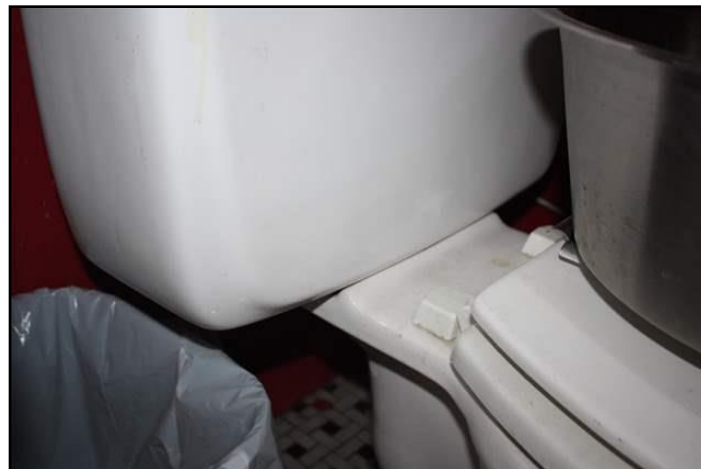
**Condition:** • [Leak](#)

Leak

**Task:** Replace

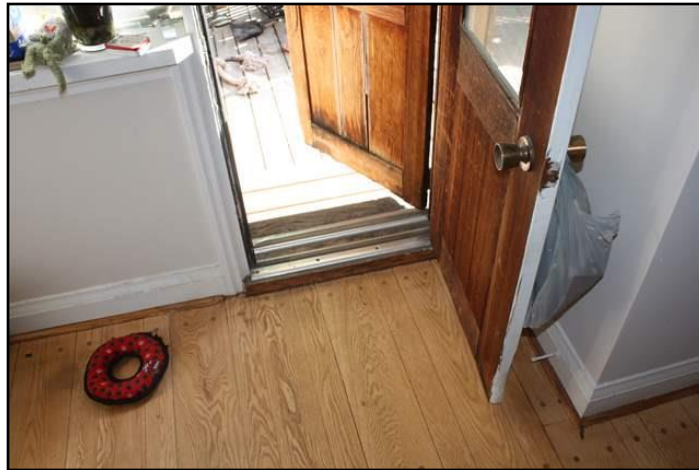
**Condition:** • [Adjustment needed](#)

*Adjustment needed*

**Task:** Repair / Replace
