# YOUR INSPECTION REPORT

123 Hudson St. NE  
St. Michael , MN

Tuesday, June 28, 2016

RE: Report No. 1001, v.3  
123 Hudson St. NE  
St. Michael , MN

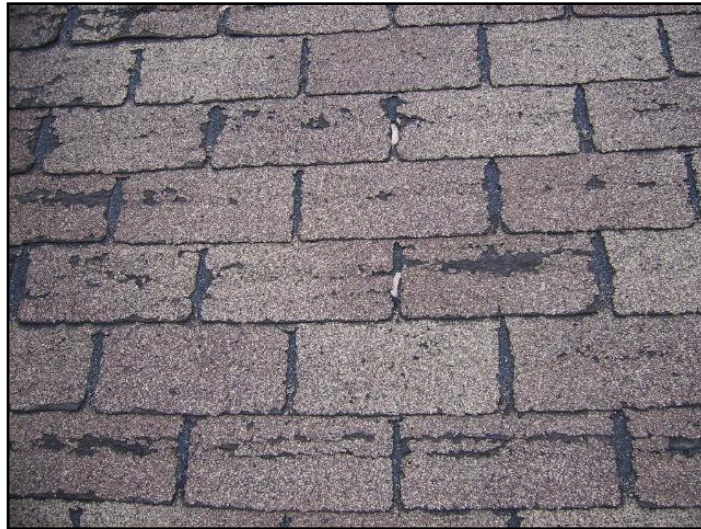
1.

**Condition:** • [Granule loss](#)

**Implication(s):** Chance of water damage to contents, finishes and/or structure

**Location:** South

**Task:** Replace

**Time:** Less than 1 year

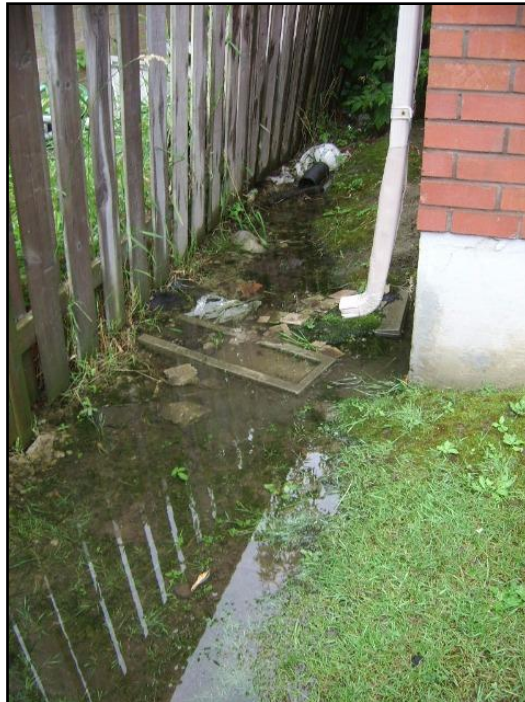
**Condition:** • [Downspouts end too close to building](#)

Down spouts does not extend past building, currently water flows towards the house foundation

**Implication(s):** Chance of water damage to contents, finishes and/or structure

2. Down spout too close to house

**Task:** Improve

**Time:** Immediate

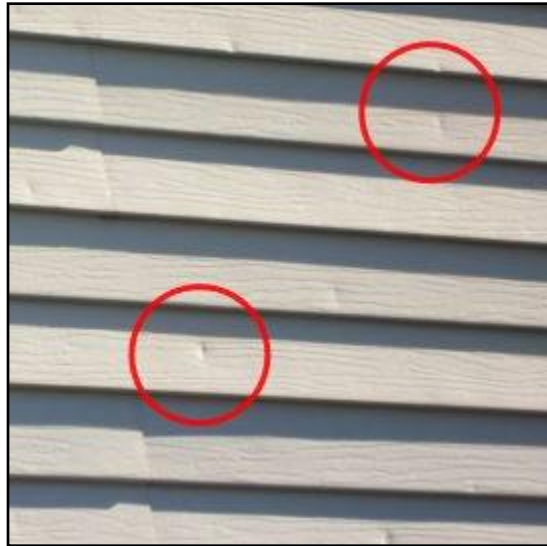
**Condition:** • [Mechanical damage](#)

Hail damage to the siding on the North and West side

**Implication(s):** Cosmetic defects | Chance of water damage to contents, finishes and/or structure

4. Mechanical damage

**Task:** Repair

**Time:** Immediate

**Cost:** \$300 - \$500

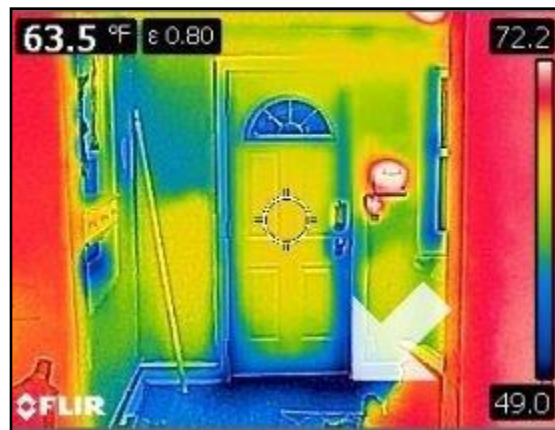
**Condition:** • [Loose or poor fit](#)

Kitchen door seal it not able to properly seal as the door frame is not level. As see in the pictures cold air is entering the house.

**Implication(s):** Chance of damage to finishes and structure

5. Loose or poor fit

**Task:** Repair- Level door frame so door may seal correctly.

**Time:** Immediate

**Cost:** \$100 - \$200

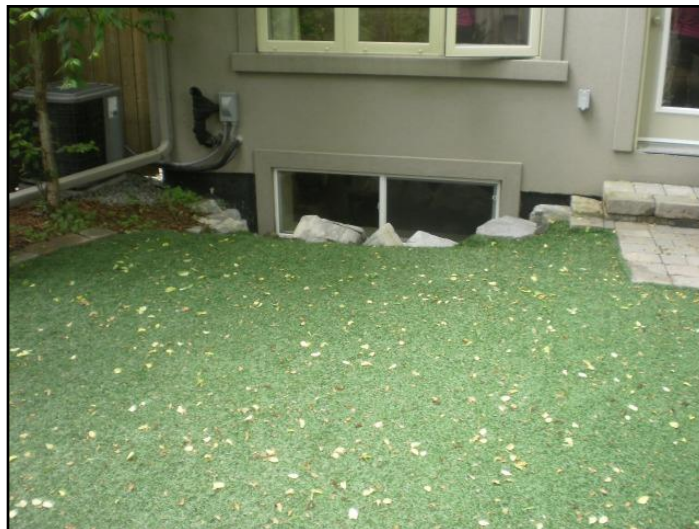
6.

**Condition:** • [Improper slope](#)

Yard slopes towards foundation

**Implication(s):** Chance of water damage to contents, finishes and/or structure

**Task:** Improve

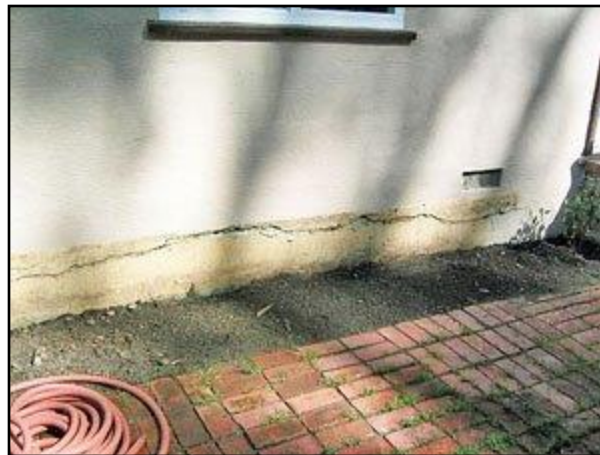
**Condition:** • [Cracked horizontally](#)

Large horizontal crack in foundation on the south side

**Implication(s):** Chance of structural movement

7. Cracked horizontally

**Task:** Repair

**Time:** Immediate

**Cost:** \$1,500 - and up

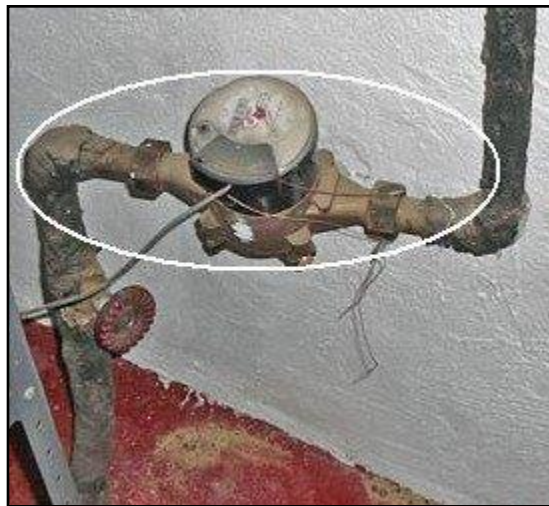
**Condition:** • [No jumper for meters and valves](#)

Jumper cable missing on meter

**Implication(s):** Electric shock

8. No jumper for meters and valves

**Task:** Provide

**Time:** Immediate

**Cost:** \$100 - \$200

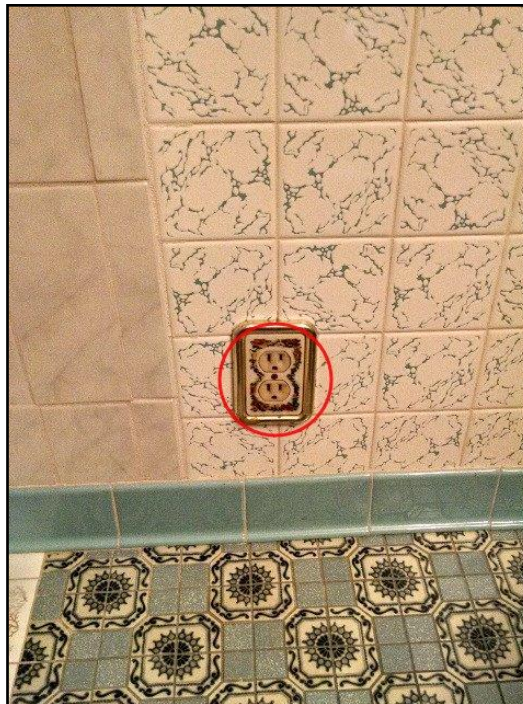
**Condition:** • [No GFCI \(Ground Fault Circuit Interrupter\)](#)

**Implication(s):** Electric shock

9. No GFCI (Ground Fault Circuit Interrupter)

**Task:** Replace

**Time:** Immediate

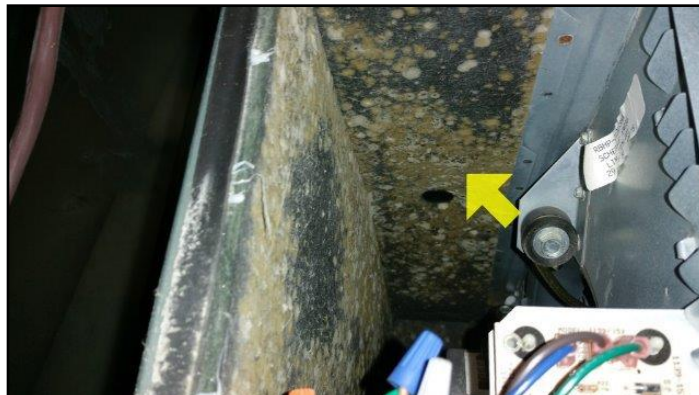
**Condition:** • [Dirty](#)

was located in the furnace cabinet and filter. System will need mold remediation immediately.

**Implication(s):** Increased heating costs | Reduced comfort

10. Dirty

**Task:** Clean

**Time:** Immediate

**Cost:** \$300 - \$700

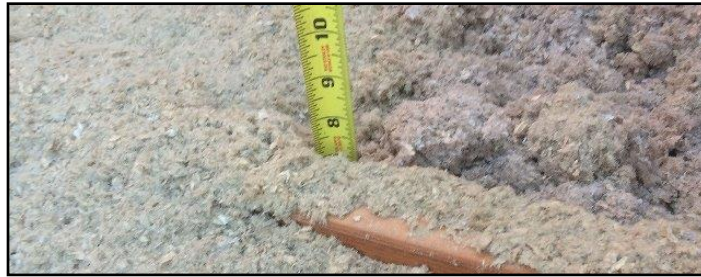
**Condition:** • [Amount less than current standards](#)

The attic does not have an adequate amount of insulation. With the current level of 7 inches or an R-Value of only 28. 2015 energy code requires a minimum of an R-Value of 49. Currently at risk for ice dams and condensation.

**Implication(s):** Increased heating and cooling costs

11. Amount less than current standards

**Task:** Improve

**Time:** Immediate

**Cost:** \$1,500 - \$2,000

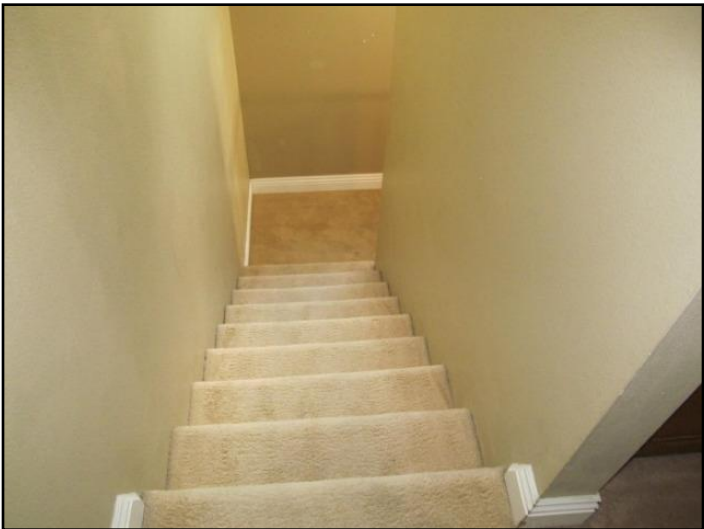
**Condition:** • [Missing](#)

Handrail missing on stairwell to basement.

**Implication(s):** Fall hazard

12. Missing

**Task:** Provide

**Time:** Immediate

**Cost:** Less than \$100

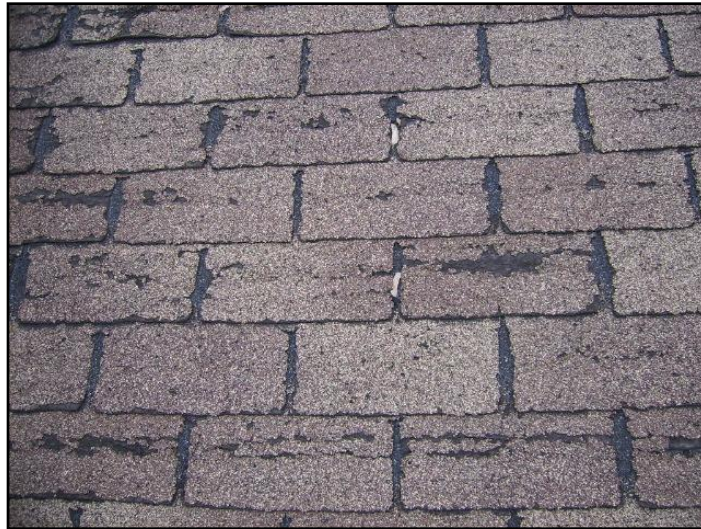
13.

**1. Condition:** • [Granule loss](#)

**Implication(s):** Chance of water damage to contents, finishes and/or structure

**Location:** South

**Task:** Replace

**Time:** Less than 1 year

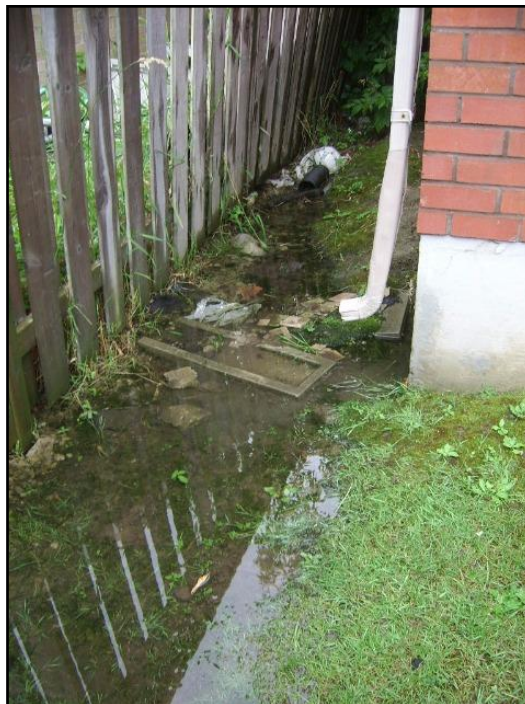
**2. Condition:** • [Downspouts end too close to building](#)

Down spouts does not extend past building, currently water flows towards the house foundation

**Implication(s):** Chance of water damage to contents, finishes and/or structure

14. Down spout too close to house

**Task:** Improve

**Time:** Immediate

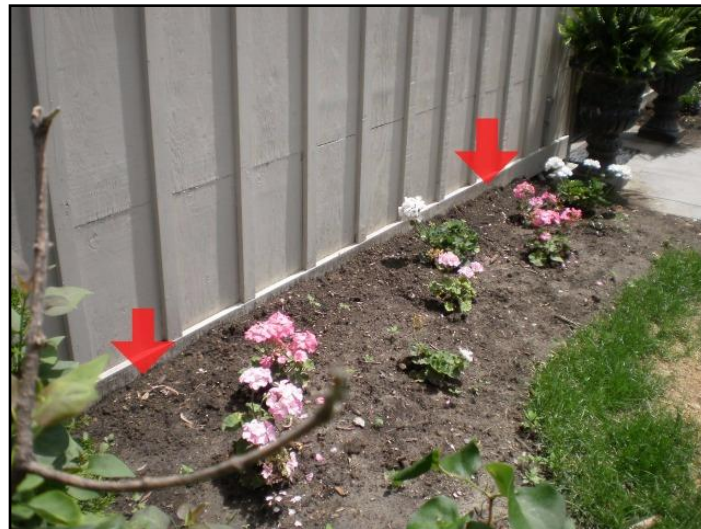
15.

#### 3. Condition: • [Too close to grade](#)

Wood Siding is too close to grade.

**Implication(s):** Chance of water damage to contents, finishes and/or structure | Material deterioration | Rot | Insect

**Task:** Correct

**Time:** Less than 1 year

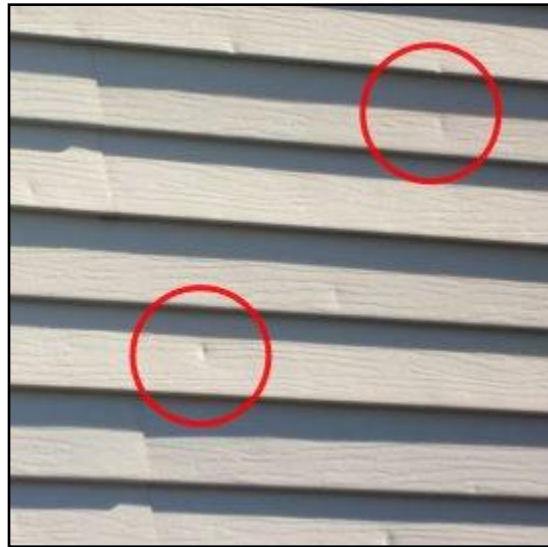
### 4. Condition: • [Mechanical damage](#)

Hail damage to the siding on the North and West side

**Implication(s):** Cosmetic defects | Chance of water damage to contents, finishes and/or structure

16. Mechanical damage

**Task:** Repair

**Time:** Immediate

**Cost:** \$300 - \$500

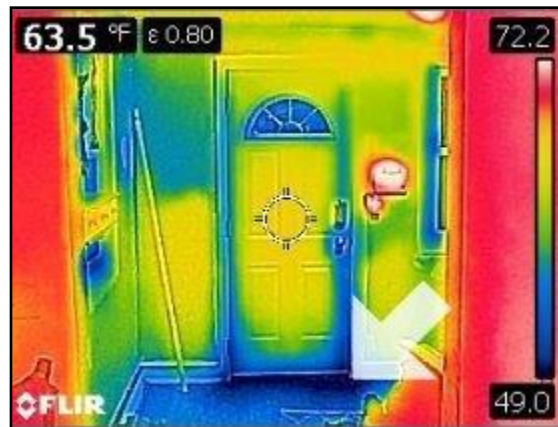
**5. Condition:** • [Loose or poor fit](#)

Kitchen door seal it not able to properly seal as the door frame is not level. As see in the pictures cold air is entering the house.

**Implication(s):** Chance of damage to finishes and structure

17. Loose or poor fit

**Task:** Repair- Level door frame so door may seal correctly.

**Time:** Immediate

**Cost:** \$100 - \$200

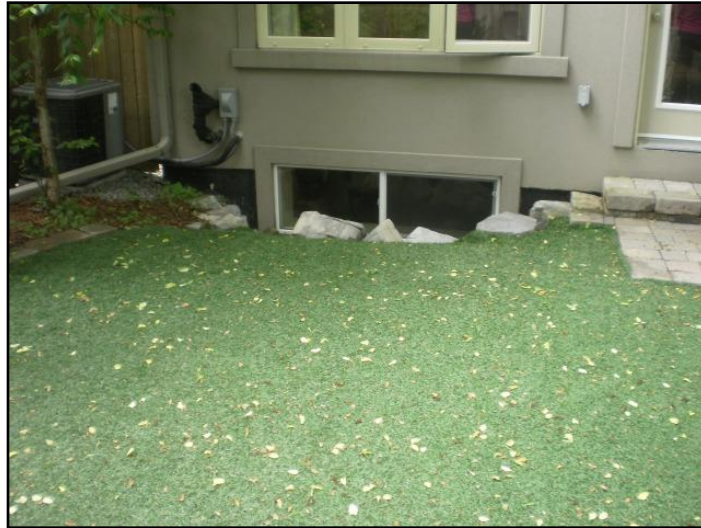
18.

**6. Condition:** • [Improper slope](#)

Yard slopes towards foundation

**Implication(s):** Chance of water damage to contents, finishes and/or structure

**Task:** Improve

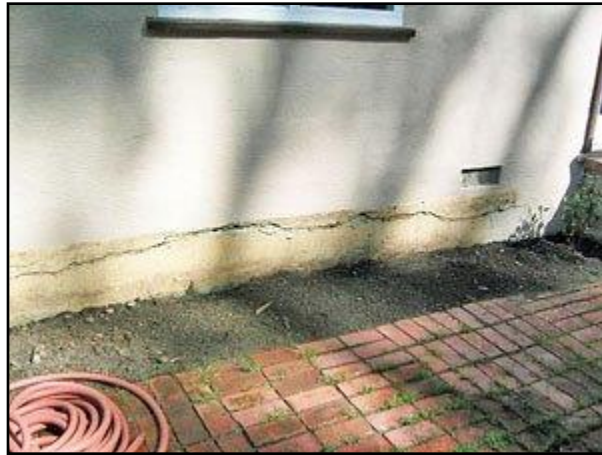
**7. Condition:** • [Cracked horizontally](#)

Large horizontal crack in foundation on the south side

**Implication(s):** Chance of structural movement

19. Cracked horizontally

**Task:** Repair

**Time:** Immediate

**Cost:** \$1,500 - and up

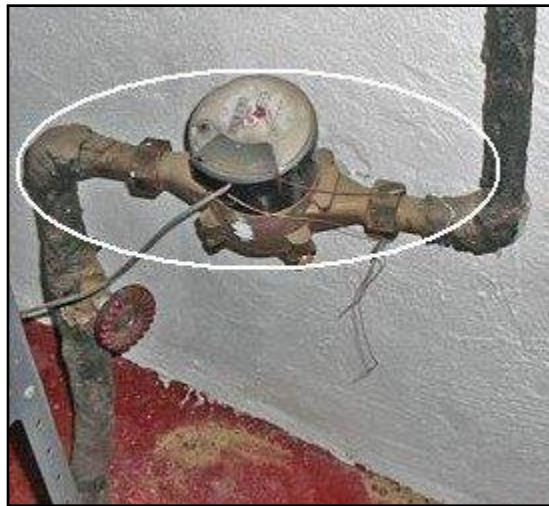
8. Condition: • [No jumper for meters and valves](#)

Jumper cable missing on meter

Implication(s): Electric shock

20. No jumper for meters and valves

Task: Provide

Time: Immediate

Cost: \$100 - \$200

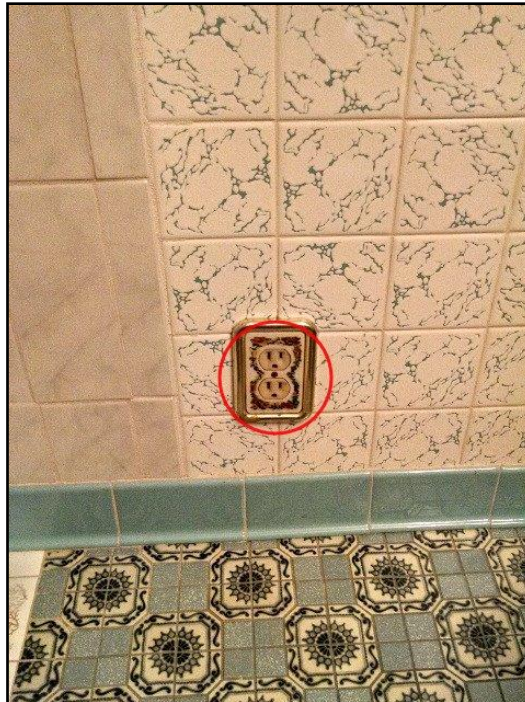
9. Condition: • [No GFCI \(Ground Fault Circuit Interrupter\)](#)

Implication(s): Electric shock

21. No GFCI (Ground Fault Circuit Interrupter)

Task: Replace

Time: Immediate

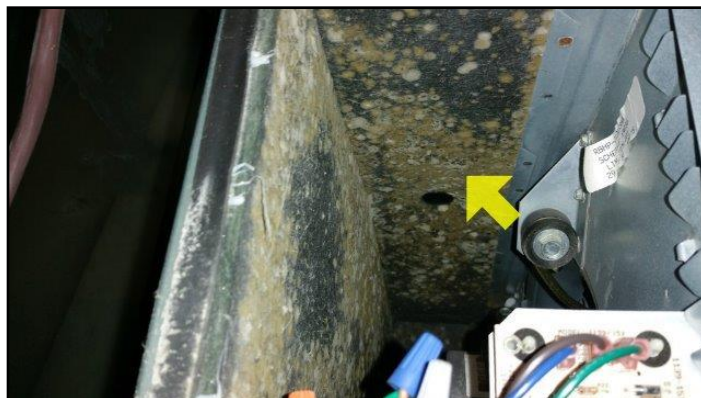
**12. Condition:** • [Dirty](#)

22. Dirty

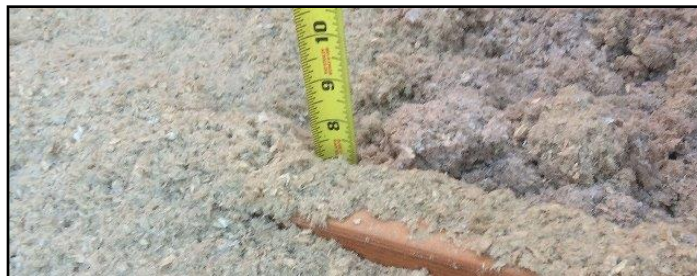
**13. Condition:** • [Amount less than current standards](#)

**23.** Amount less than current standards

**Time:** Immediate

**Cost:** \$1,500 - \$2,000

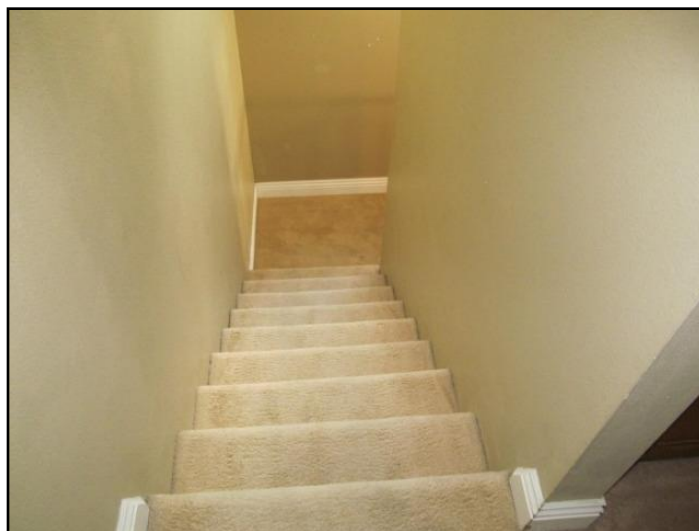
**14. Condition:** • [Missing](#)

Handrail missing on stairwell to basement.

**Implication(s):** Fall hazard

24. Missing

**Cost:** Less than \$100
